**Goldstar Fashion (ID: 22982)**  
**Sumi Apparels (Pvt) Ltd. (ID: 9920)**  
**Disari Poly Print & Packaging Ind. Ltd.**  
**Disari Washing Plant**

A-112, 113, (West side) BSCIC, Tongi, Gazipur  
(+23.895039N, 90.414413E)

17.APRIL.2014

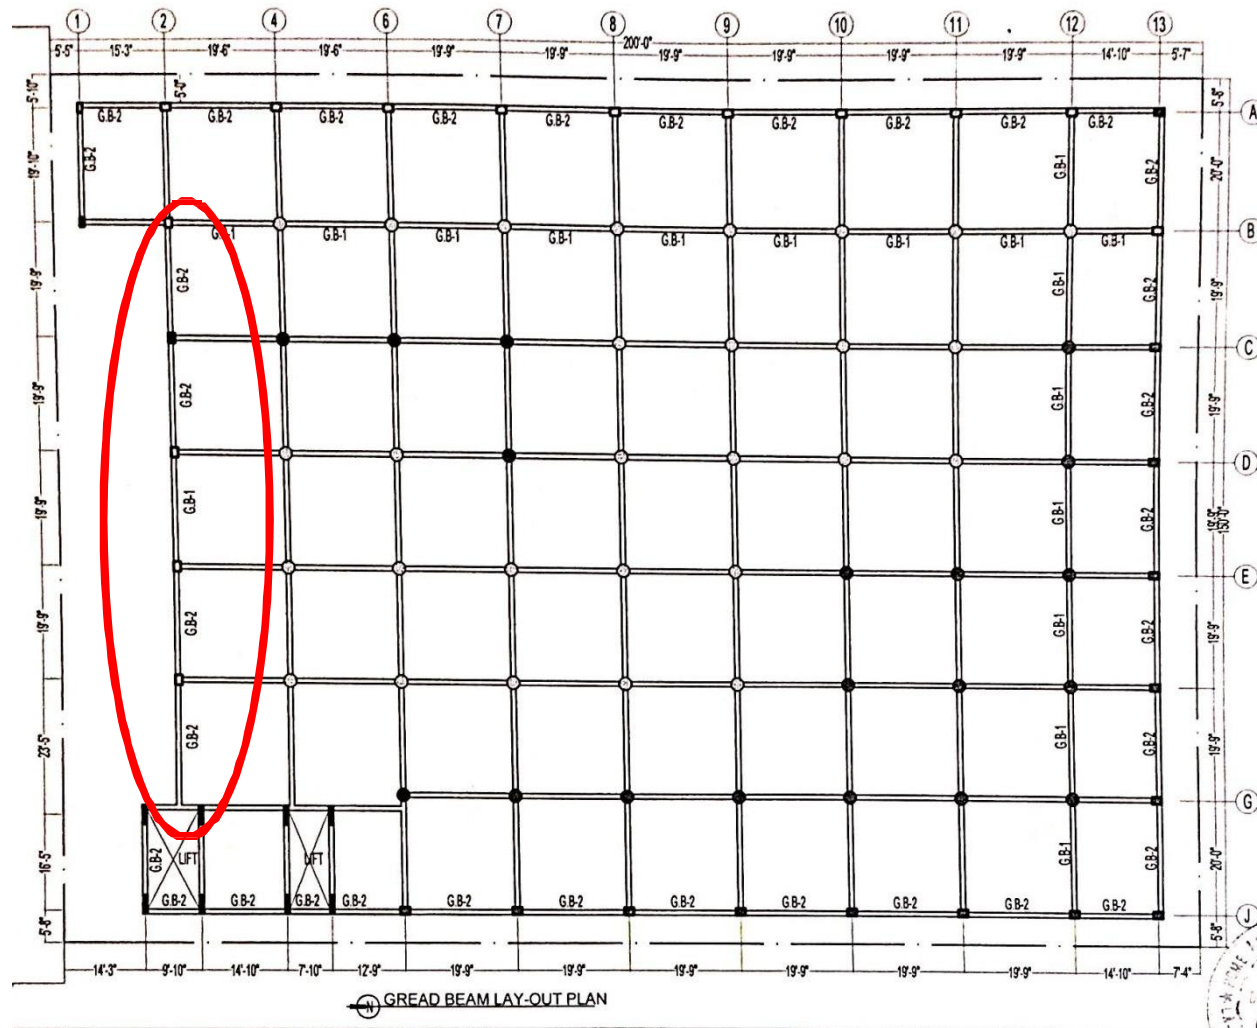
Priority 1 Concern

Structural drawings do not match current state or permit drawings. Cantilevers not shown. A courtyard shown on the permit drawings has been built over.

Structural drawings do not match current state. Reinforcing steel in columns and beams, cantilever lengths, and mezzanines observed do not match structural drawings. In particular, two mezzanines (one 1st story and one 2nd story) were discovered, neither of which was properly shown on structural drawings.

- The factory Structural Engineer stated that the columns and footings were designed for 8 floors (5 floors, 2 mezzanines, and a roof slab), however this is not shown on structural plans and plans to build more were observed.
- The Structural Engineer is to review the site conditions and modify drawings to suit existing conditions.

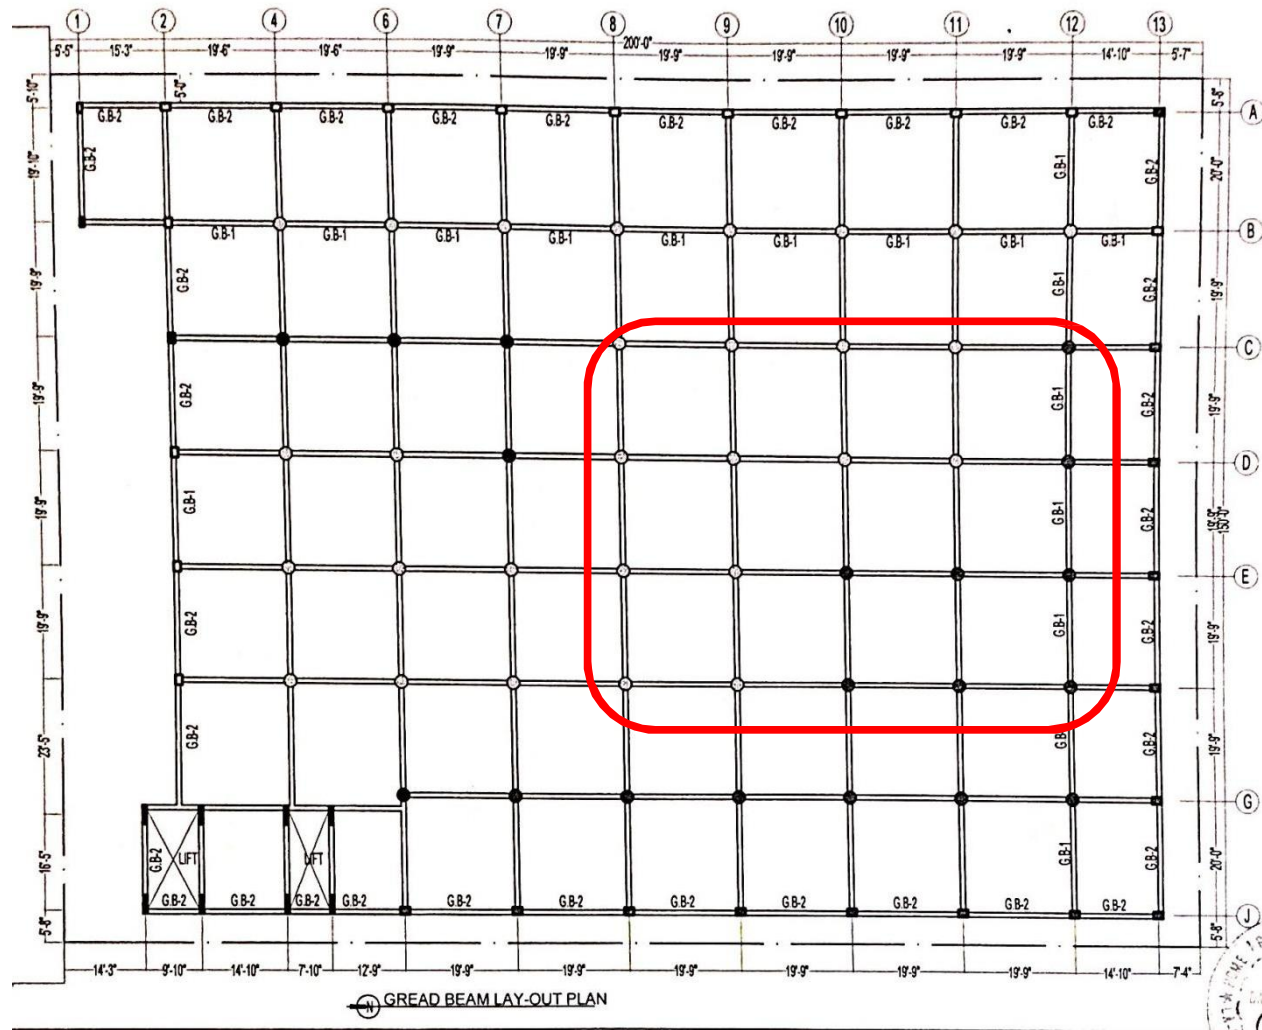
Major Concern

Structural drawings do not match current state or permit drawings. Courtyard shown on permit drawings has been built over. The two existing mezzanines are not shown on the permit drawings.

Permit drawings do not match structural drawings or current building. The permit drawings were designed for an 8 storey building, however the structural drawings were designed for a six storey building. In addition, an atrium is shown on the permit drawings, which was not built.

- The structural drawings were designed for 6 storeys (plus two mezzanines) however permit drawings indicate 8 storeys (plus two mezzanines).
- No more floors should be constructed until a full Detailed Engineering Assessment is carried out.

- Submit updated drawings for revised permit drawings.

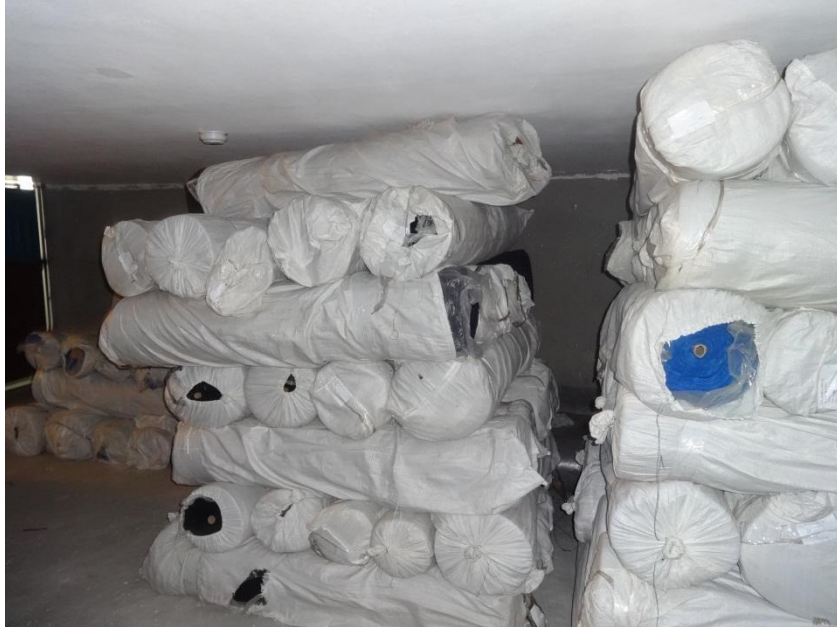
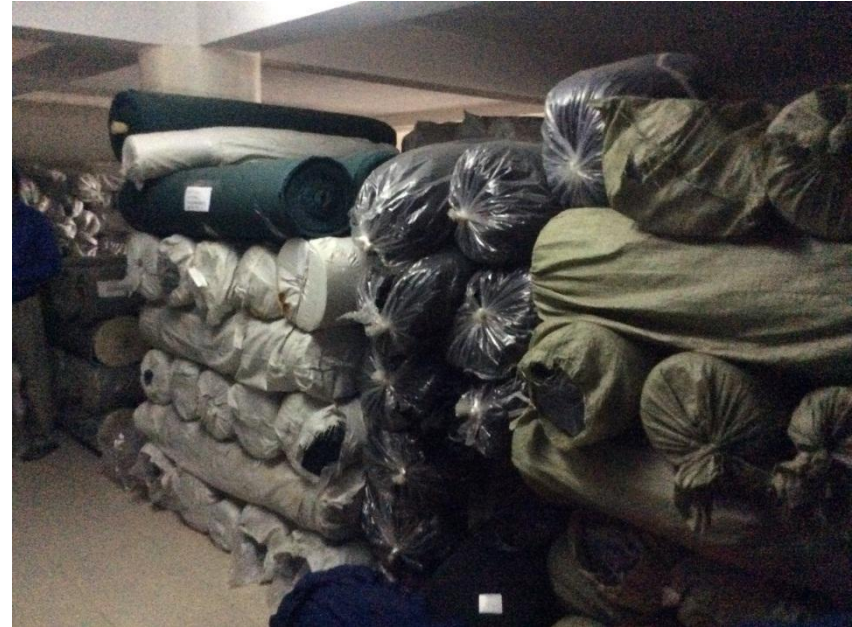
High storage loads on two floors. The rolls of yarn were calculated as 12kPa.

Storage was discovered on the 1<sup>st</sup> storey mezzanine and the 1<sup>st</sup> floor in excess of 12kPa. No loading plans were made available, and in addition the mezzanine was not shown on the structural drawings.

- Storage loading to be removed from these two floors down to 5kPa maximum until an engineering assessment is carried out to determine the load carrying capacity.

- Loading plans be drawn and provided to owner/management for use.

- Continue to implement the Loading Plan.

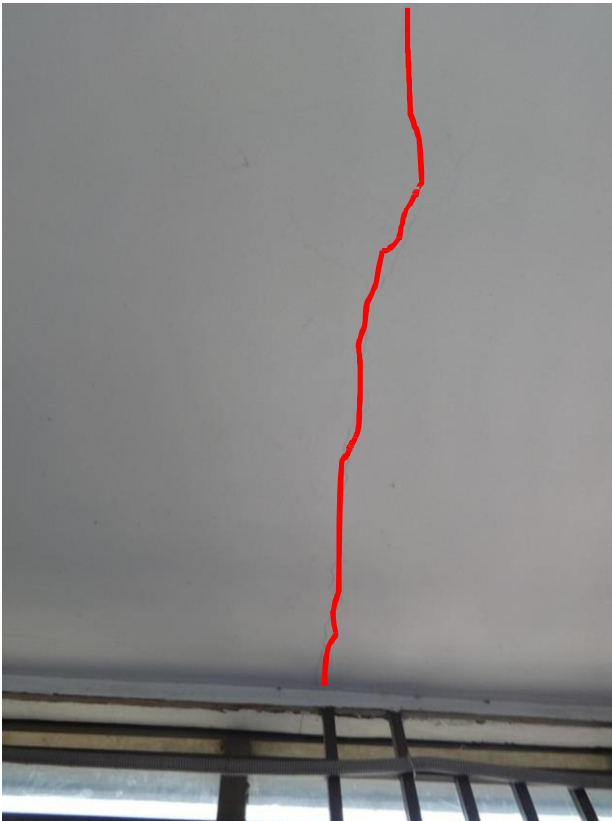
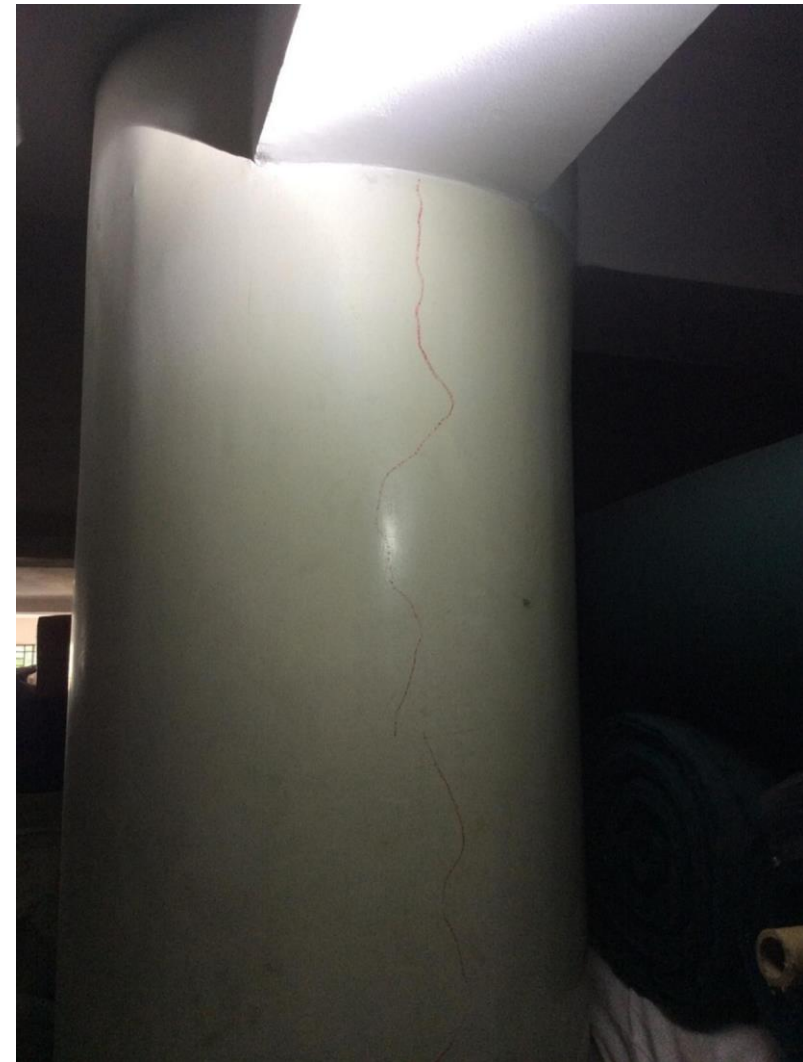
3<sup>rd</sup> Priority 1 Concern

Cracking in beams, slabs and one isolated crack in column. Cracks are shown in red for clarity

Hairline to small cracking was observed in the slabs and beams on several floors. One isolated vertical hairline crack was observed on a 1<sup>st</sup> storey mezzanine column extending from slab to slab.

- Engineering assessment be carried out to determine the cause of the cracks.

- Remedial work be carried as required to repair cracking.

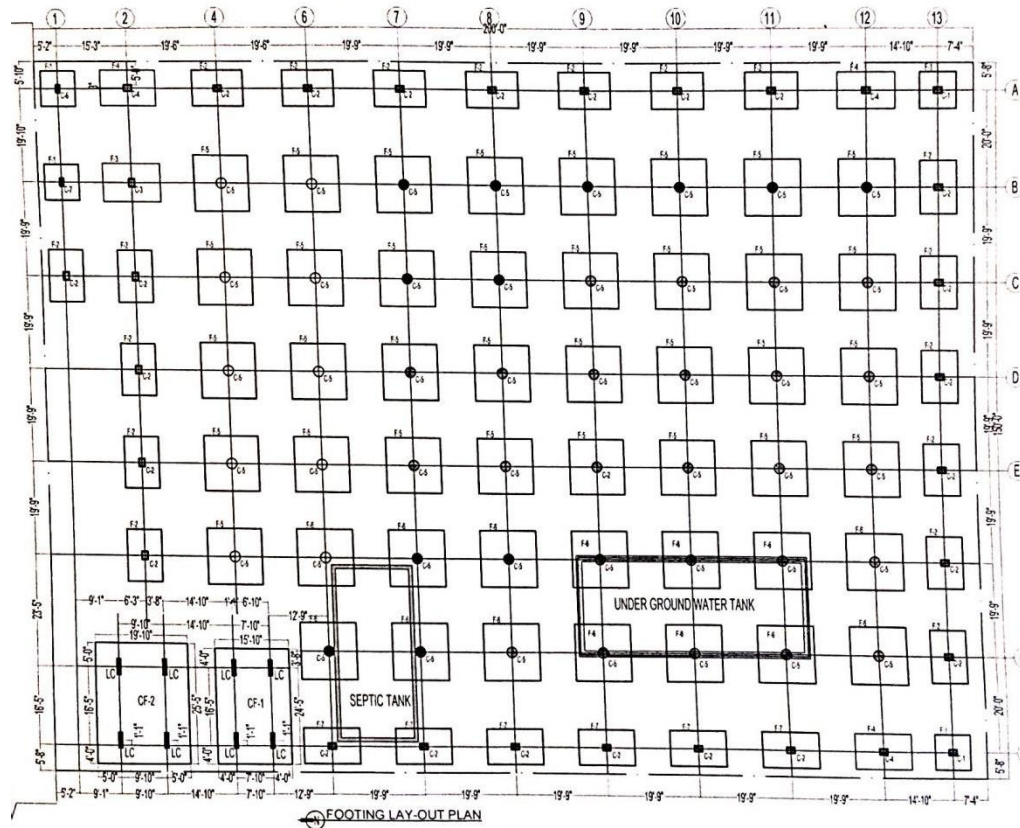
# Overall Stability System

The building did not feature any core or shear walls. Stability was achieved through sway action between beams and columns and masonry infill walls.

We require that these items be investigated in a Detailed Engineering Assessment

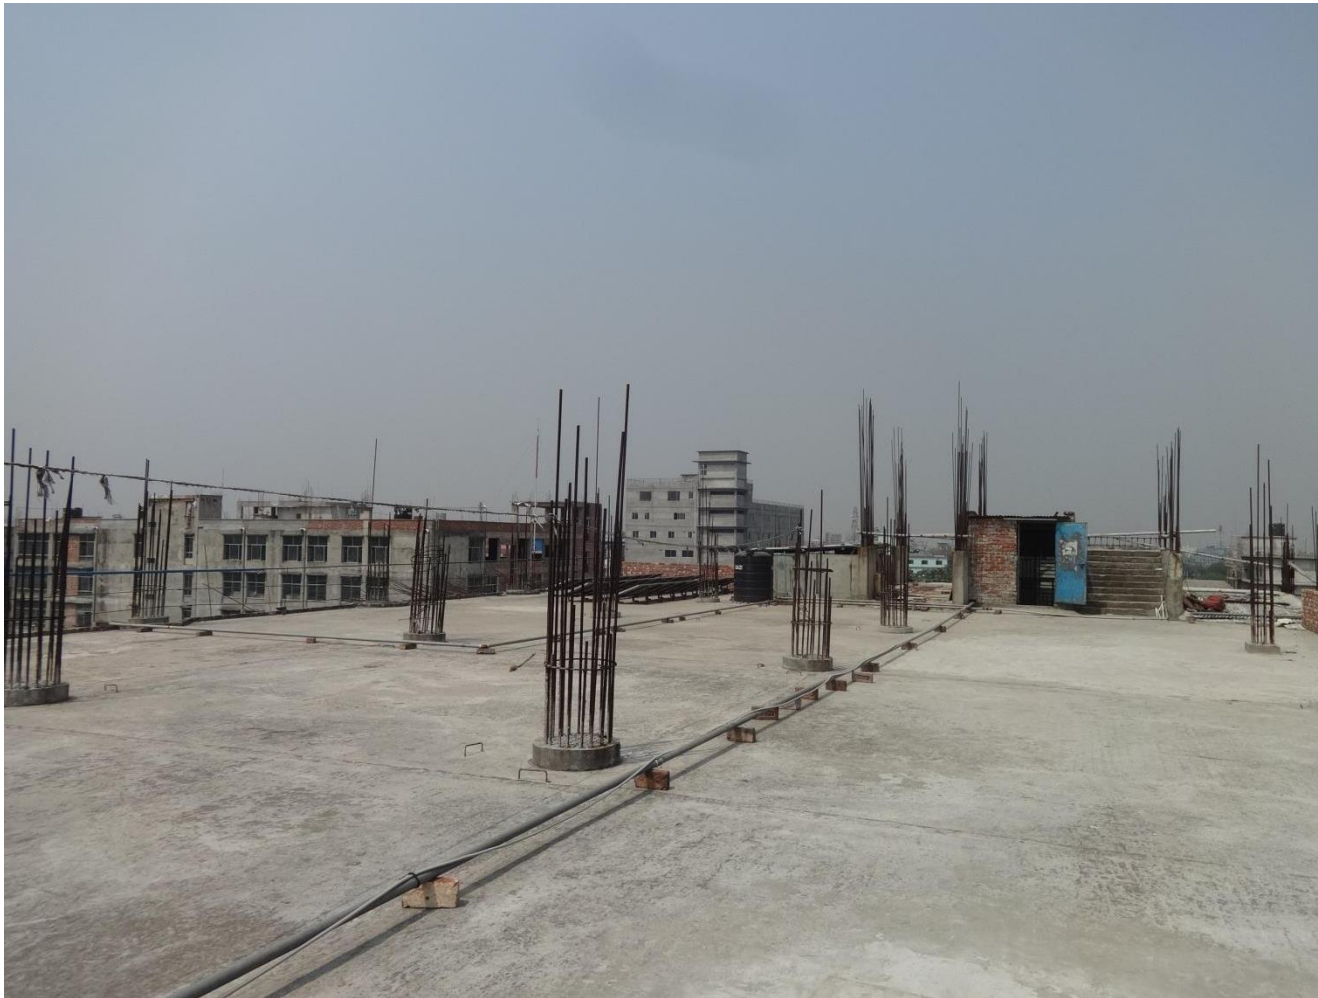
## Water Ingress at Roof Level

No waterproofing membrane was visible on the roof of the building. This means that any cracks in the surface finishes on the roof will allow water to seep into the concrete slab beneath the finishes, and cause long-term soaking of the slab.
