Young 4 Ever Ltd. (9366)

Plot # B-89-90, BSCIC I/A, Fatullah, Narayangonj.

06.AUGUST.2014

Identified Priority 3 Concerns

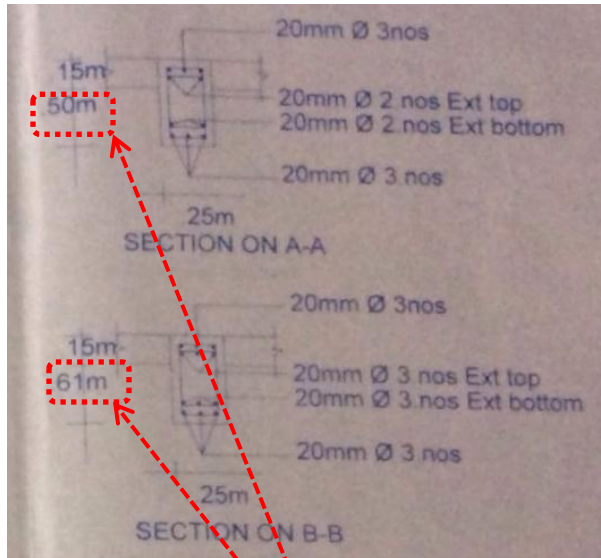
1st Priority 3 Concern

These beam sections on the drawings do not match the actual site conditions.

The actual depth of the beam, below slab level, is just 400mm. The design should also be verified by the factory's Structural Engineer.

The as-built drawings need to be reproduced reflecting the real site conditions.

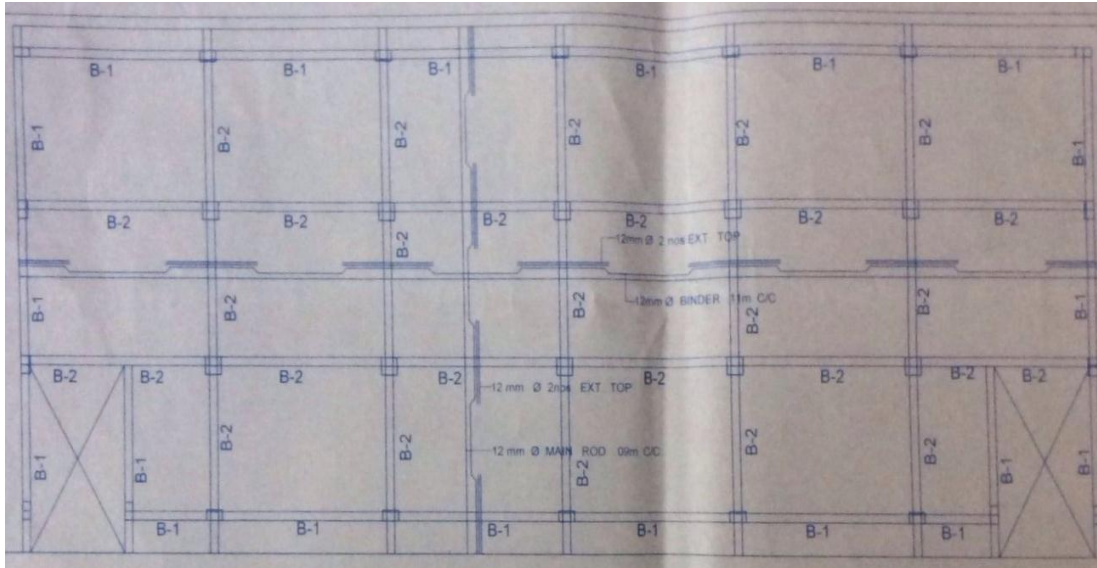
4th Priority 3 Concern

R.C Beam and column frame with a 2-way solid slab
Stability provided by moment frame system only.

Slab Thickness 150mm
Column Size 450x450mm (typ.)
Beam Size 250x650mm (typ.)

Grid 5.72m x 4.35m.

This type of structural framing may be appropriate for the buildings lower than 10 storeys with large plan areas. However, it is required that an Engineer reviews and checks the load cases for the horizontal deflection and storey drift under wind and seismic load.

We require that these items be investigated as part of an Engineering Assessment

5	4th Priority 3 - The factory's Structural Engineer needs to check the building's stability system under lateral loads.	Based on the analysis results carry out any remedial works deemed necessary.	6-months
6	5th Priority 3 - The shed on the 5th floor is a temporary steel structure and needs either to be removed or significantly improved.	Either fully remove the shed or strengthen in accordance with a Structural Engineer's advice.	6-months

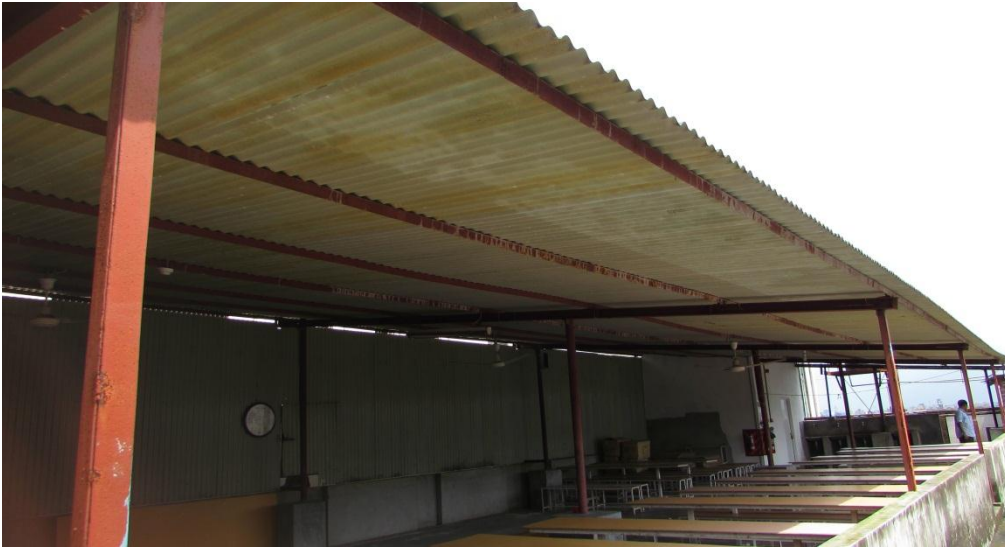
5th Priority 3 Concern

The shed on the 5th floor is only a temporary steel structure with simple connections.

The steel structure very small and doesn't have any bracing.
