# Tusuka Trousers & Jeans Ltd

5 February 2014

# **Building Observations Jeans Building**

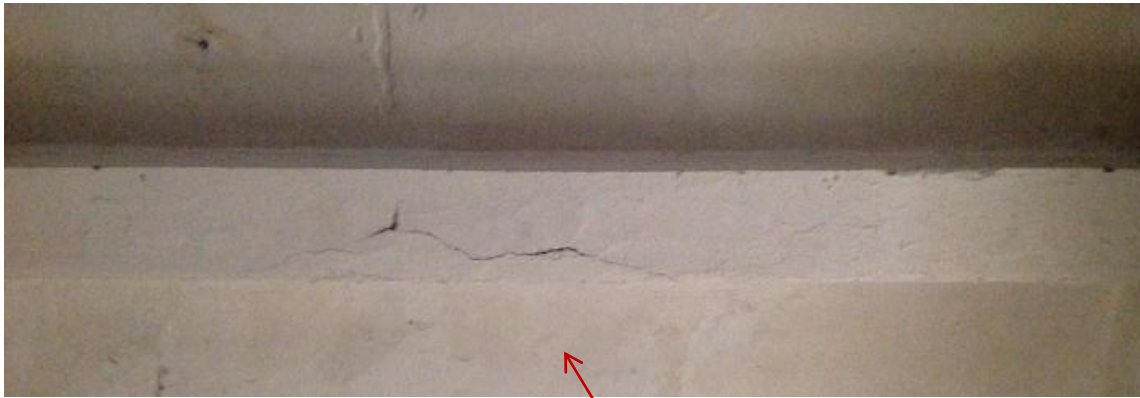
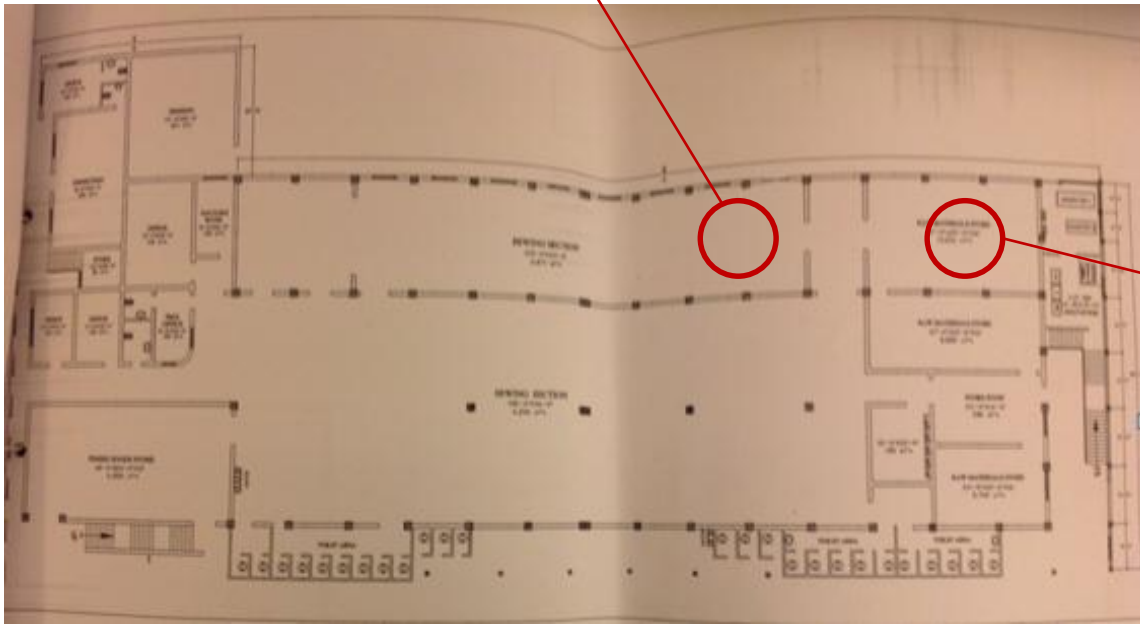
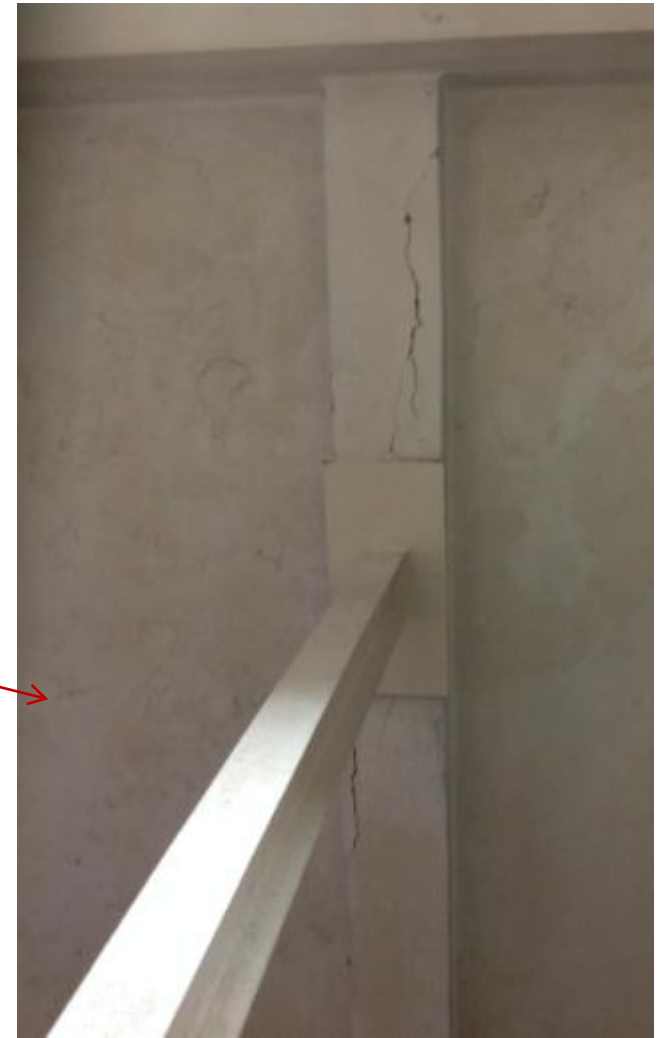
# **Structural cracking of concrete beams and evidence of temporary remedial measures**

**Significant cracks are present on the underside of the First Floor tertiary beams. Some of these beams are propped (and the props are not anchored into the base slab).**

| Item No. | Observation | Recommended Action Plan | Recommended Timeline |
|---|---|---|---|
| 1 | Verify the structural adequacy of the Jeans Building structure – review structural cracking, remedial measures currently in place and load capacity of columns | Detail Engineering Assessment of as built structure of Jeans Building to be commenced as per attached scope. | Immediate - Now |
| 2 | Verify the structural adequacy of the Jeans Building structure – review structural cracking, remedial measures currently in place and load capacity of columns | Building Engineer to carry out survey of as-built structure and note details of any structural cracking. | Immediate - Now |

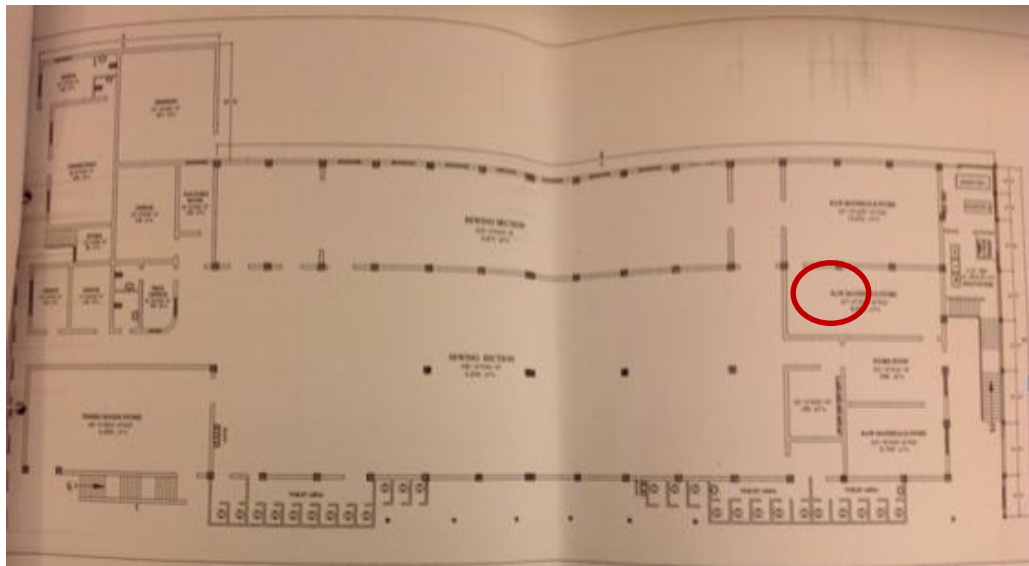
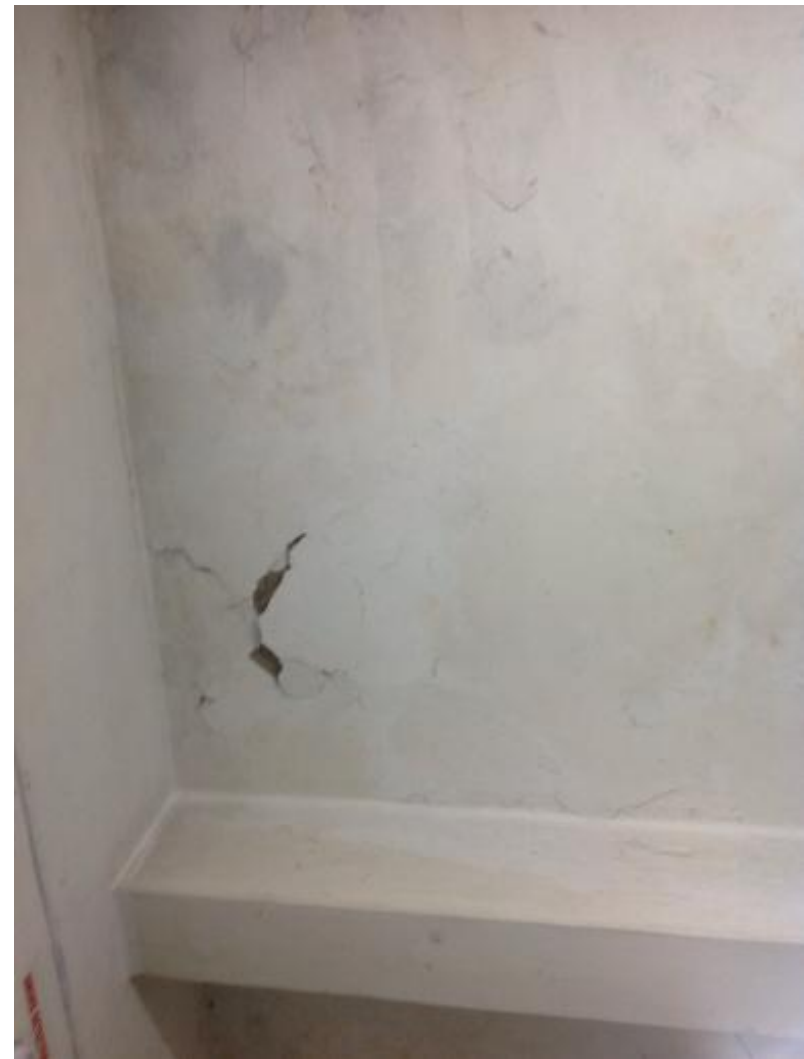
Cracking can be observed on the underside of the slab in one area.

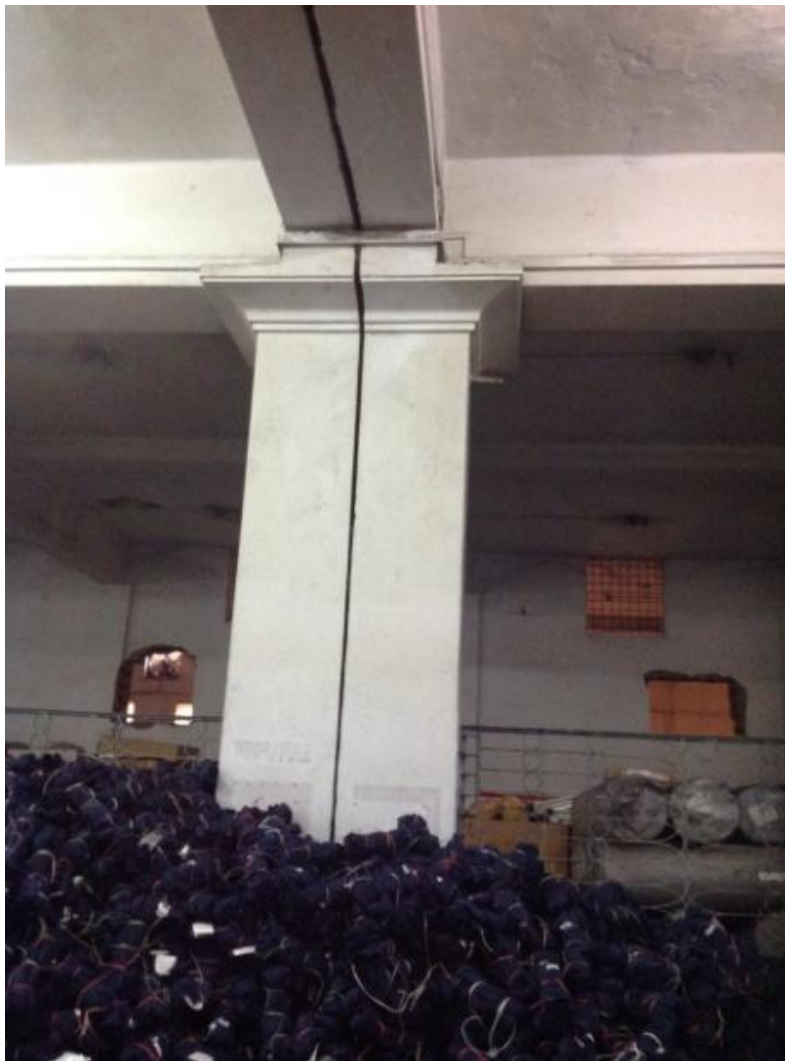
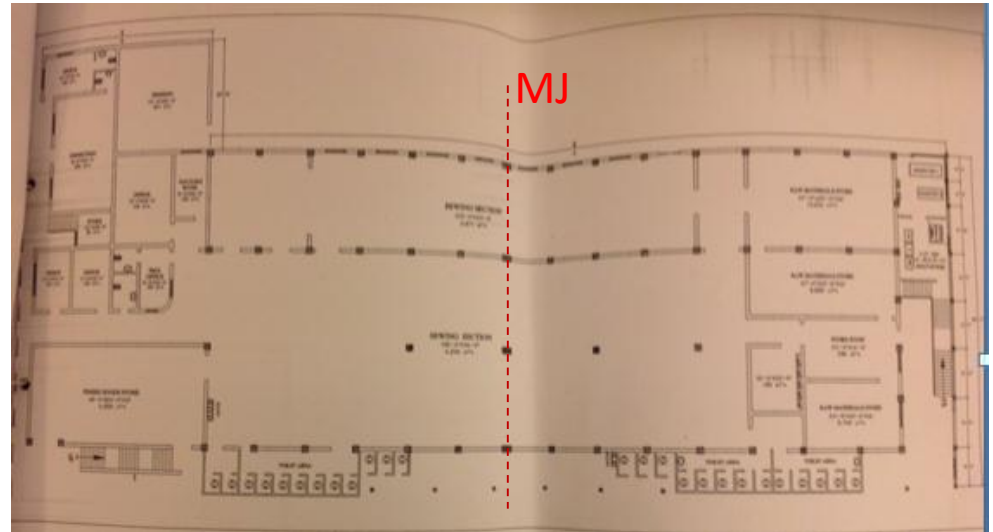
**Movement Joint**

**The structural information available did not provide details of the member sizes, foundations or reinforcement content. The movement joint observed on-site was not noted.**

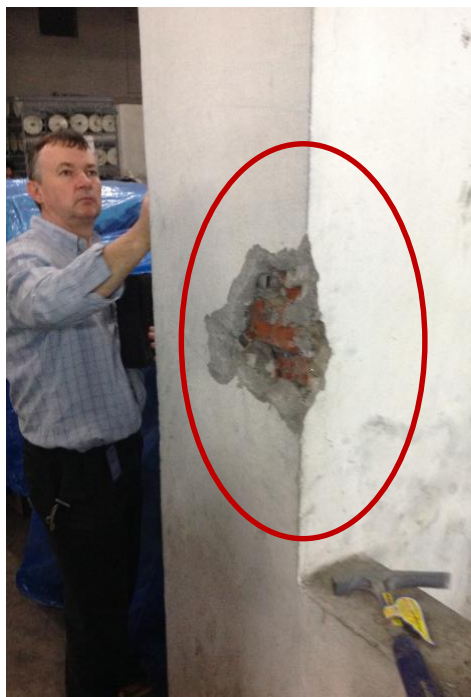
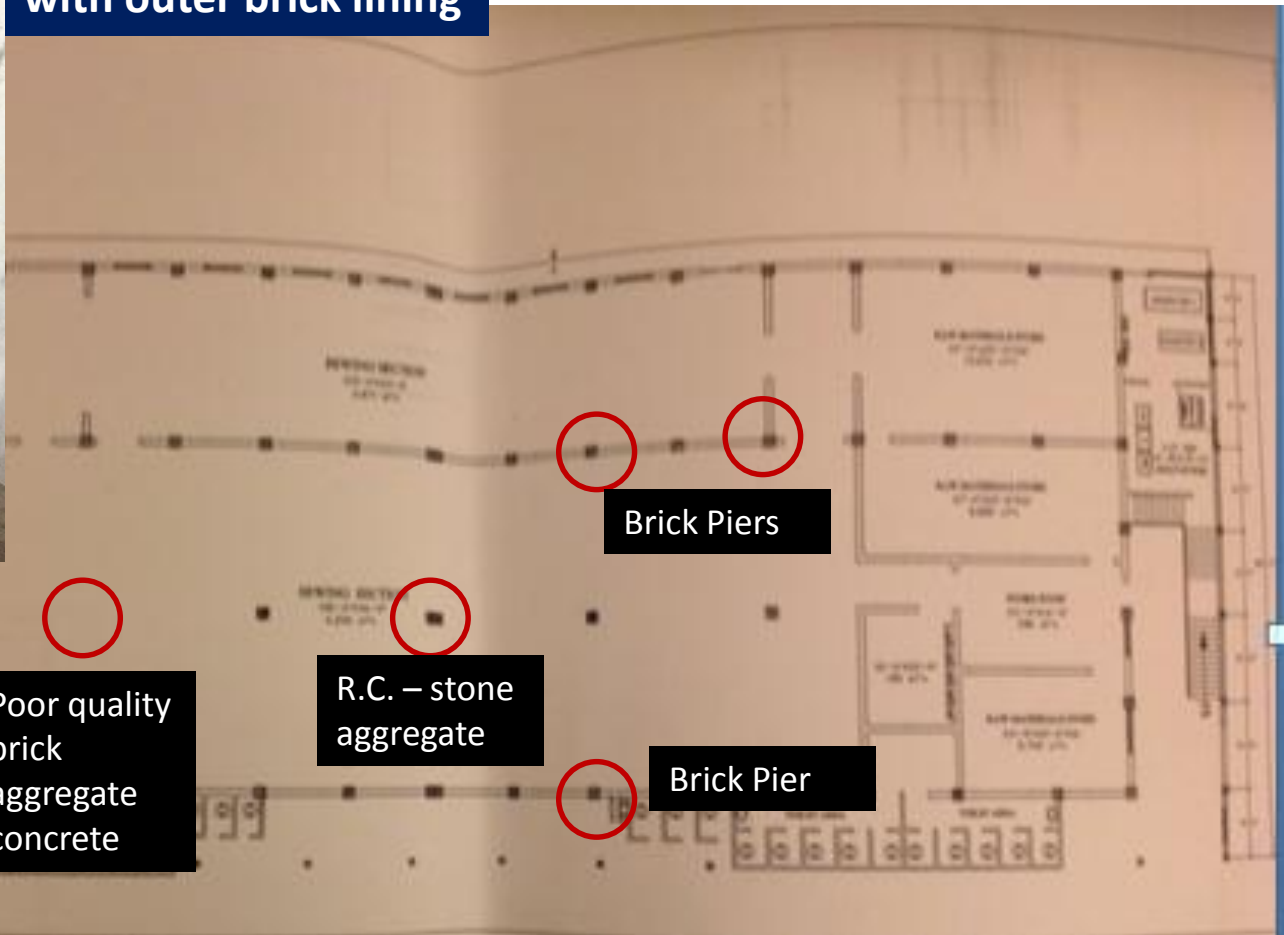
**A number of columns at ground floor level  
appear to be constructed of weak brick  
aggregate concrete or brickwork**

**Brick Pier or column  
with outer brick lining**

**Poor quality  
brick  
aggregate  
concrete**

**The structural information provided did not contain details of column construction. Plaster finish to columns was removed and poor quality brick aggregate with high voids content and apparent brick columns were evident.**

| Item No. | Observation | Recommended Action Plan | Recommended Timeline |
|---|---|---|---|
| 3 | Verify the structural adequacy of the Jeans Building structure – review structural cracking, remedial measures currently in place and load capacity of columns | Verify insitu concrete strengths by cores and existing reinforcement for all columns | Immediate - Now |

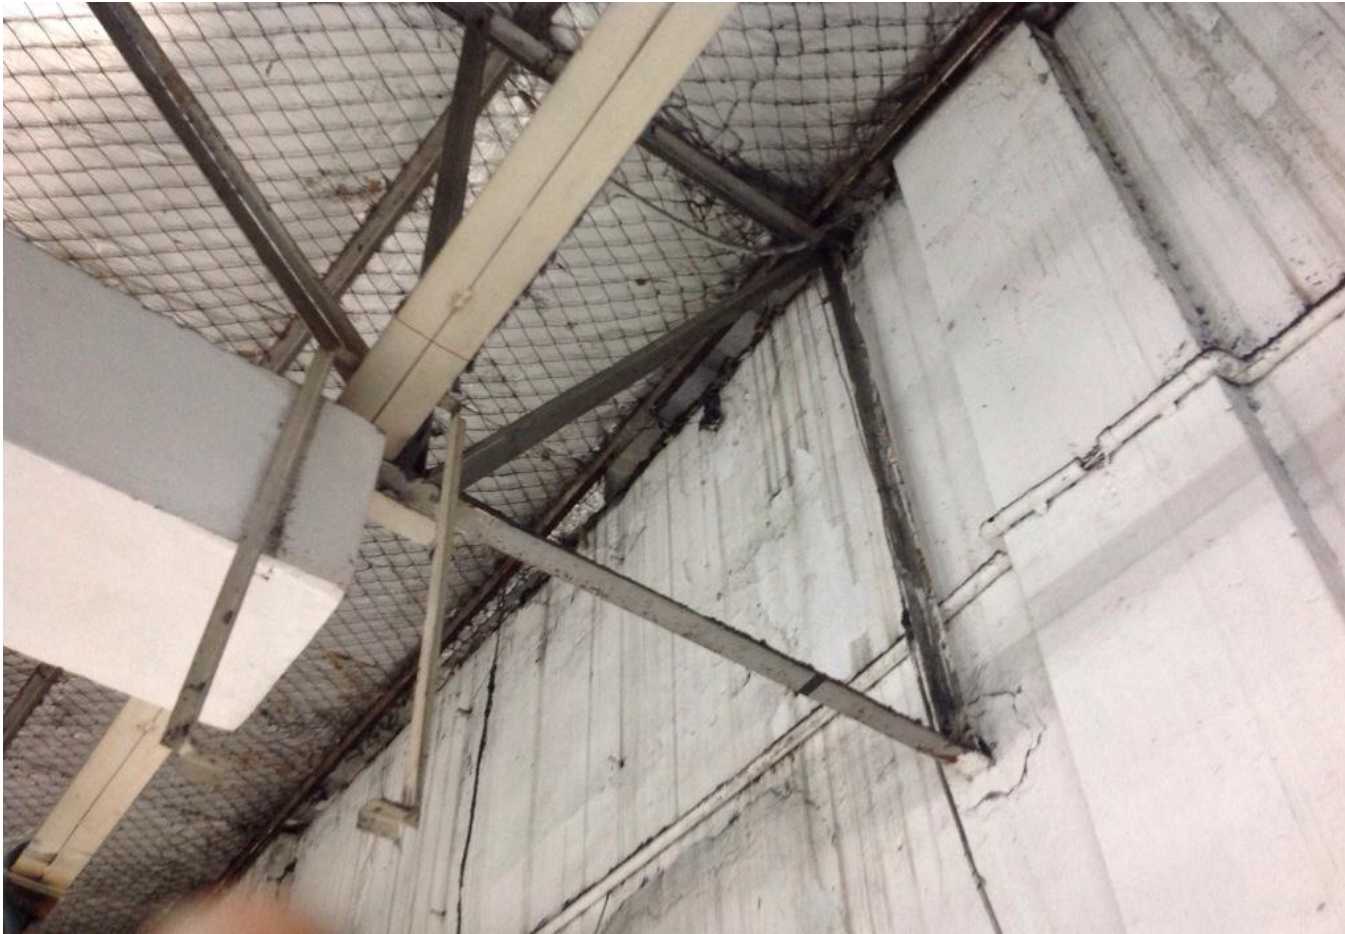
**For much of the length of the Washing Plant, it is connected to the Jeans Building only by the light steelwork roof of the washing plant. Typically, there are indications that this connection is under stress and showing signs of movement. Building Engineer to review .**

| Item No. | Observation | Recommended Action Plan | Recommended Timeline |
|---|---|---|---|
| 8 | Building Engineer to review steelwork connection to Washing Plant | Steelwork connection to Washing Plant to be reviewed by the Building Engineer . This structure is to be designed by the Building Engineer and, if required, upgraded to support code vertical and wind loads or the area should be vacated. | 6-weeks |

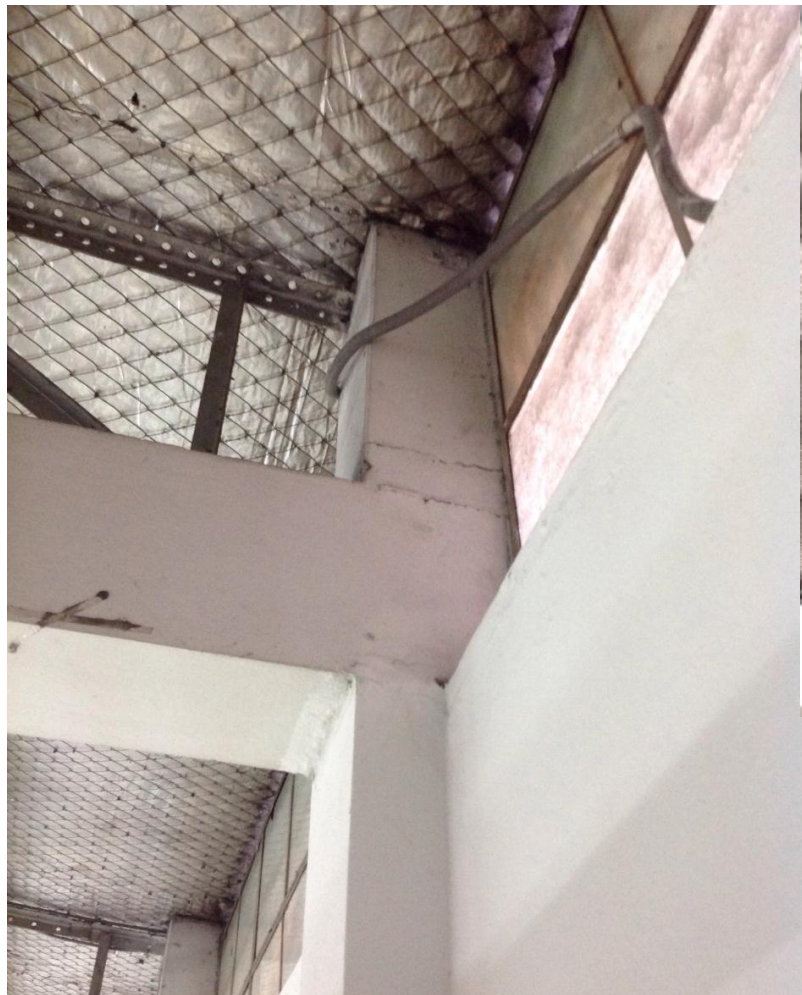
**Cracking at Connection of Lightweight Roof**

**The lightweight roof requires a full structural review.**

| Item No. | Observation | Recommended Action Plan | Recommended Timeline |
|---|---|---|---|
| 9 | Building Engineer to review structural adequacy of Roof | Structural adequacy of 1st floor roof to be reviewed by the Building Engineer . This structure is to be designed by the Building Engineer and, if required, upgraded to support code vertical and wind loads or the area should be vacated. | 6-weeks |

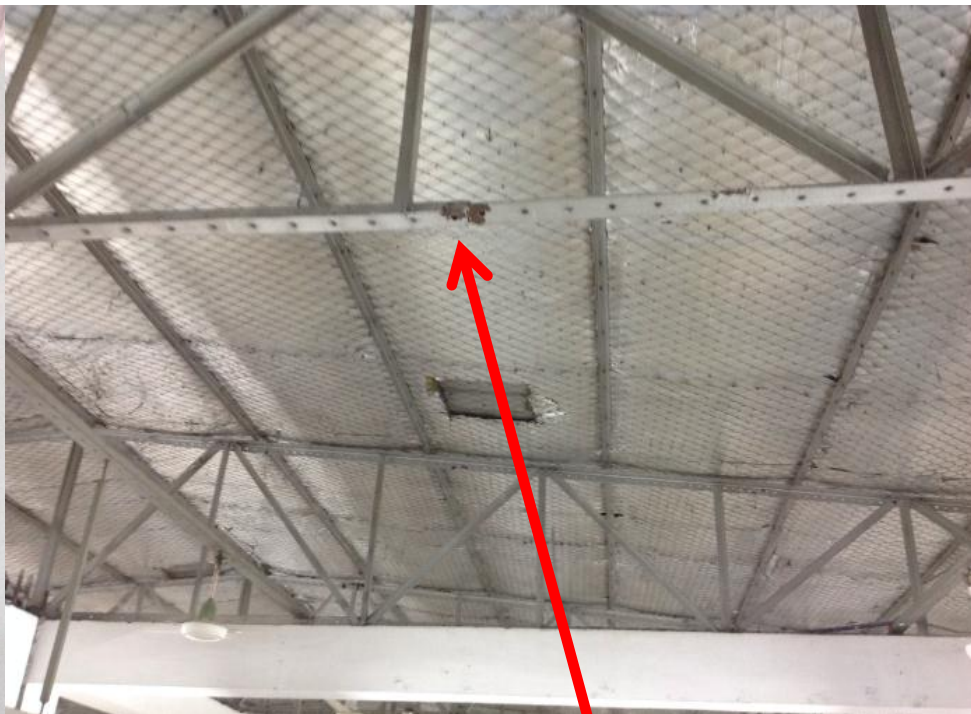
**Bottom chord of truss discontinuous**

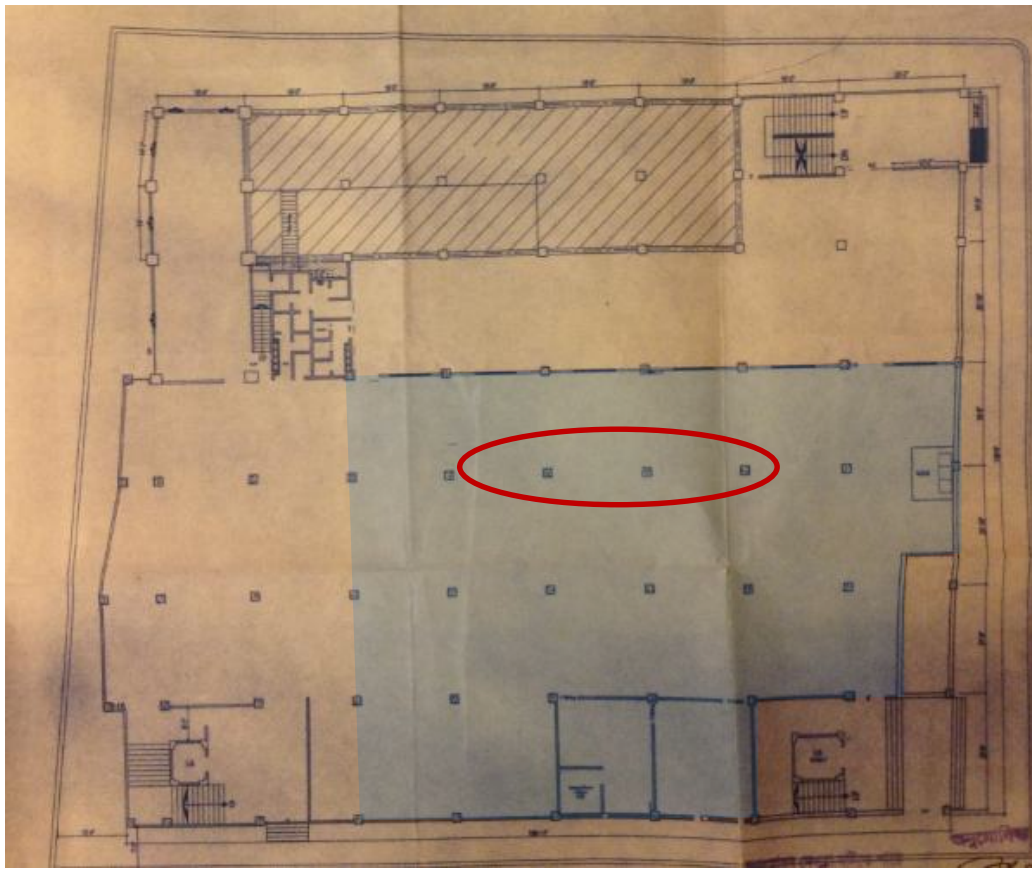
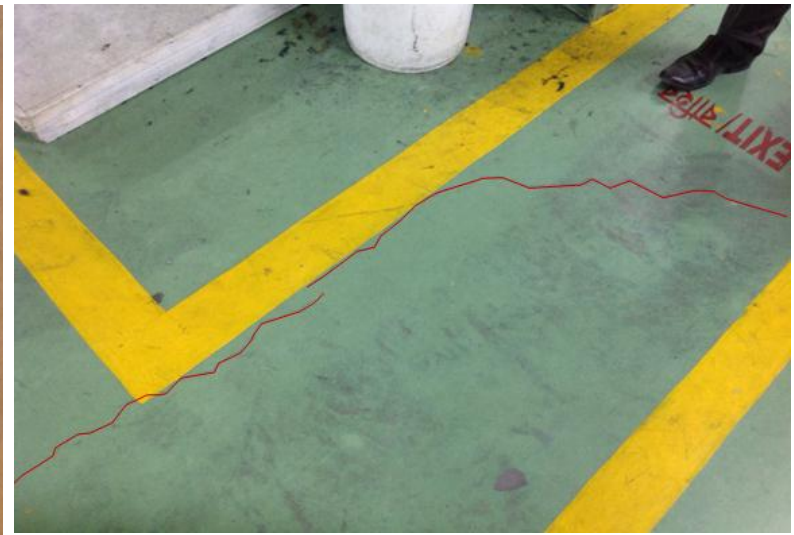
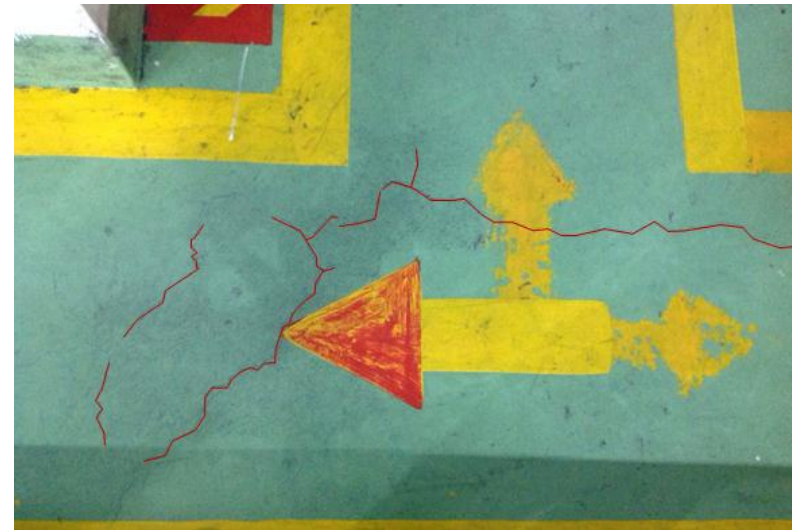
# **Cracking to top of suspended ground floor slab over basement**

**Cracking to Ground Floor Slab**

**Building Engineer to review cracks in Ground Floor  
finishes for potential structural implications.**

| Item No. | Observation | Recommended Action Plan | Recommended Timeline |
|---|---|---|---|
| 10 | Cracking to top of suspended ground floor slab over basement | Sections of floor finish to slab to be removed to investigate if cracks penetrate the building structure. | 6-weeks |
| 11 | Cracking to top of suspended ground floor slab over basement | Building Engineer to carry out design check on slab to confirm that the structure is adequate to carry the design loads | 6-weeks |

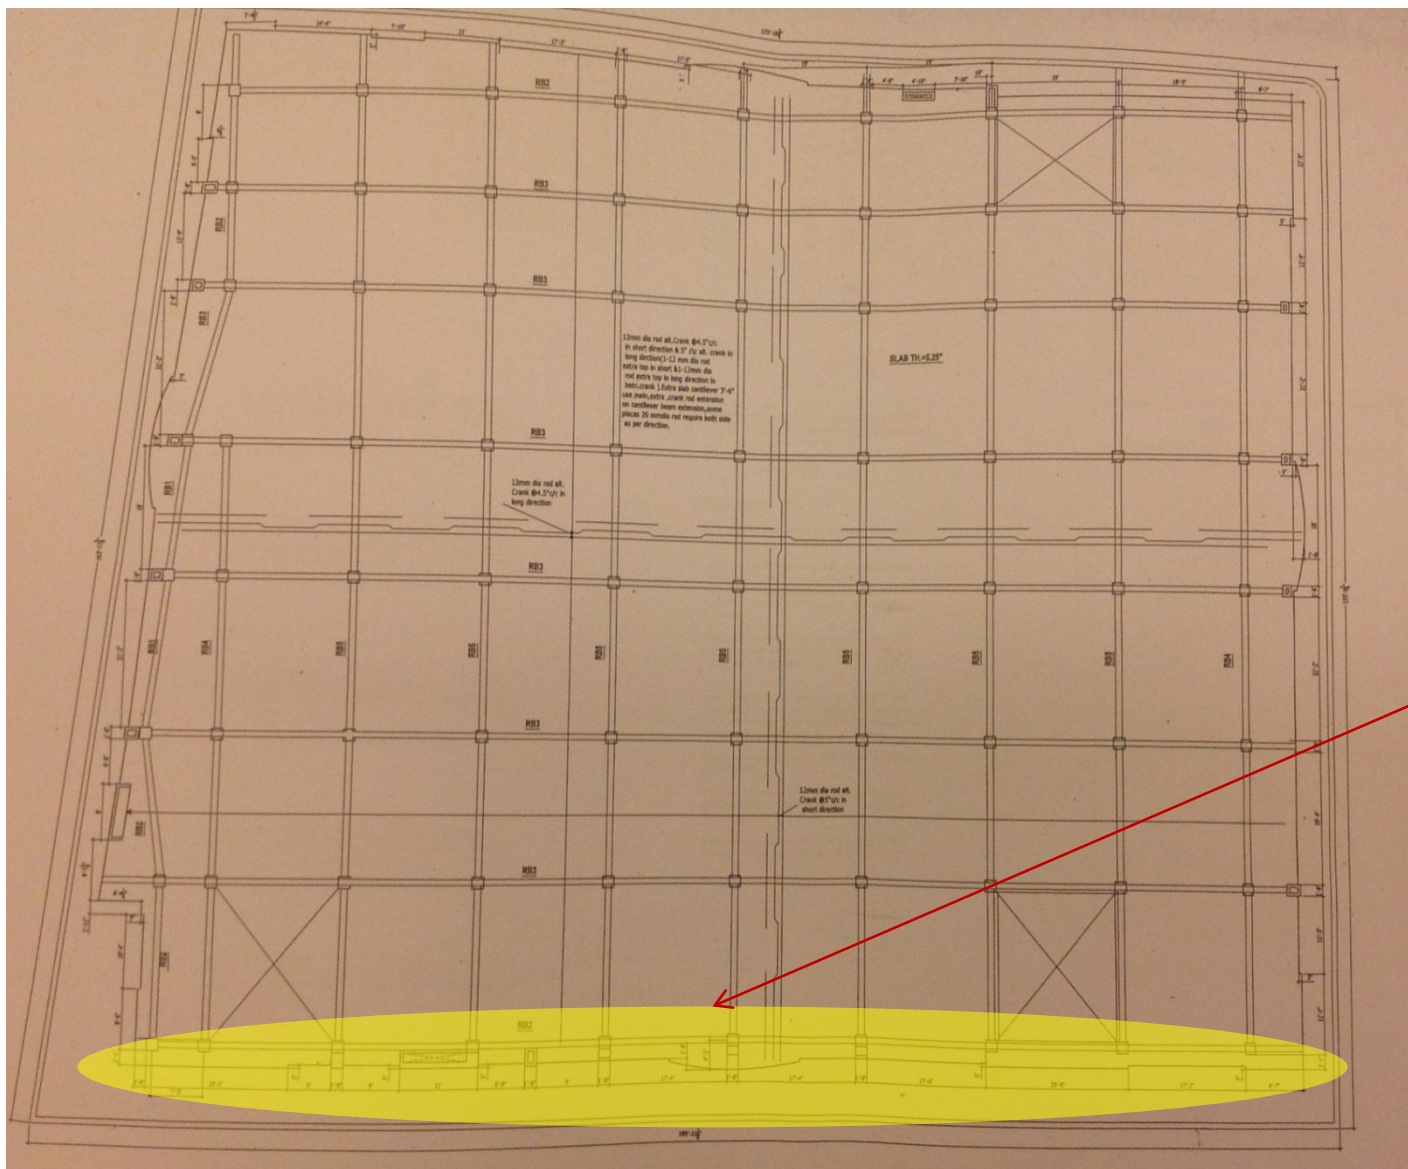
Grid dimensions, in the highlighted area, noted during site inspection do not match the structural drawings

| Item No. | Observation | Recommended Action Plan | Recommended Timeline |
|---|---|---|---|
| 14 | Design check required due to discrepancies between structural drawings and building structure | Complete as-built survey and complete calculations to verify the structural adequacy of the building structure taking account of the survey dimensions. | 6-weeks |

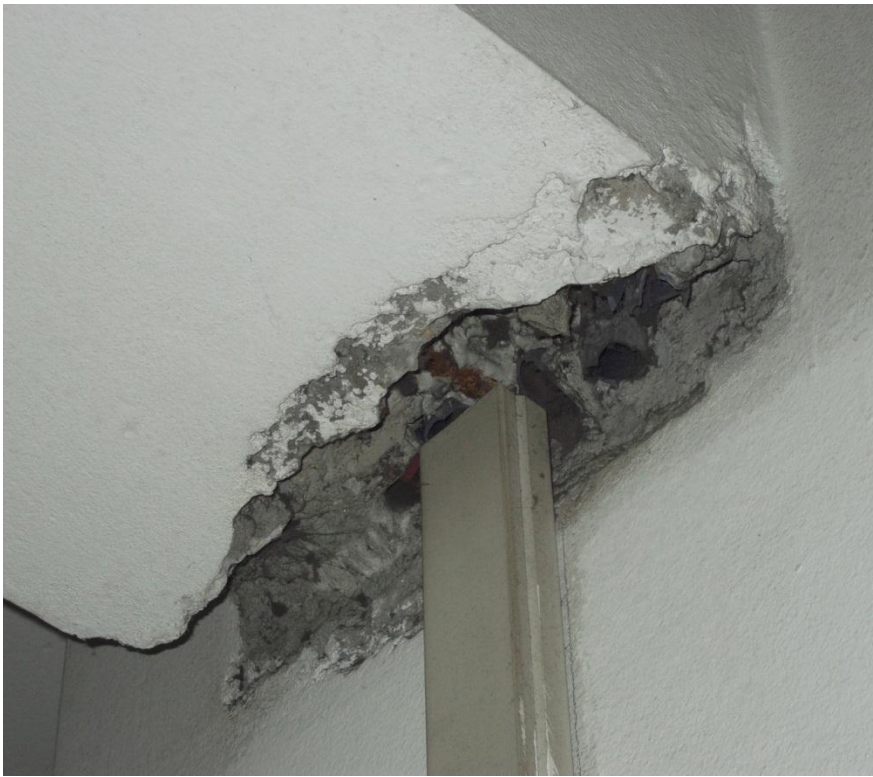
**Soffit of 3<sup>rd</sup> Floor**

# **Damage to underside of beams and visible reinforcement at locations of cast-in electrical conduits**

**A number of beams throughout the building have significant penetrations/damage close to the beam-column connection. This will impact upon the shear and moment capacity of these joints. The Building Engineer should review these connections.**

| Item No. | Observation | Recommended Action Plan | Recommended Timeline |
|---|---|---|---|
| 17 | Damage to underside of beams and visible reinforcement at locations of cast-in electrical conduits | Building Engineer to carry out survey to identify locations where structural capacity of reinforced concrete beams has been reduced by penetrations or electrical conduit installation | 6-weeks |
| 18 | Damage to underside of beams and visible reinforcement at locations of cast-in electrical conduits | Building Engineer to carry out design calculations to verify the adequacy of the structure and to prepare a schedule of remedial works to reinstate the areas affected by the electrical installation | 6-months |

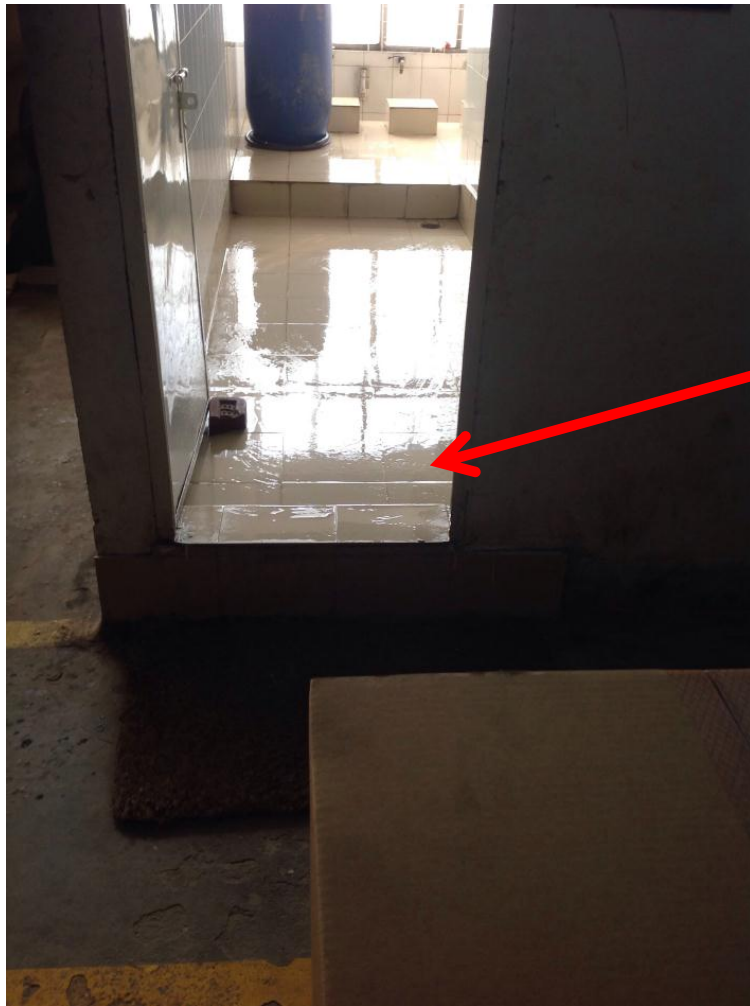
**First Floor**

**Design check required for plinth loading in toilet areas to confirm floor slab/beams load capacity**

**Building Engineer to  
review plinth loadings in  
toilet areas.**

| Item No. | Observation | Recommended Action Plan | Recommended Timeline |
|---|---|---|---|
| 19 | Design check required for plinth loading in toilet areas to confirm floor slab load capacity | Extent of plinth loading within toilet areas to be surveyed and capacity of floor slab to be assessed by Building Engineer to confirm the adequacy of the floor slab and beams | 6-weeks |

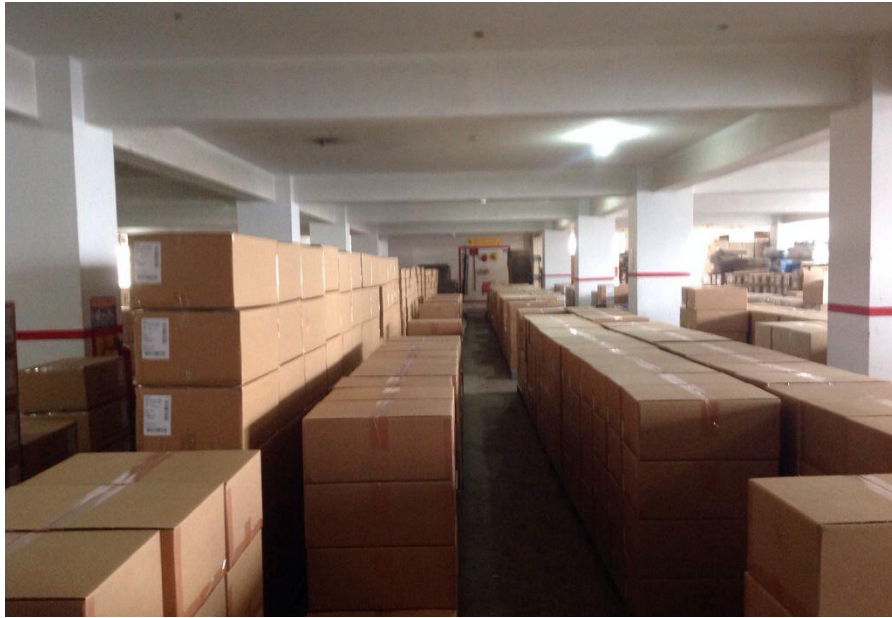
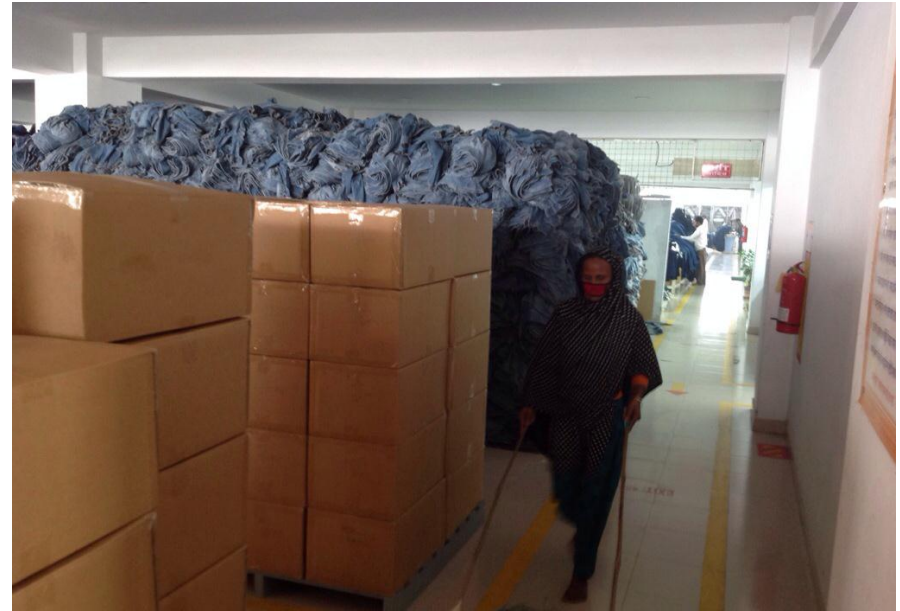
**1<sup>st</sup> Floor**

**Storage loads were observed on the 1<sup>st</sup>, 3<sup>rd</sup>, 6<sup>th</sup> and 7<sup>th</sup> floors.  
Load management plan to be prepared by the Building Engineer and height restrictions to be introduced to prevent future overloading.**

| Item No. | Observation | Recommended Action Plan | Recommended Timeline |
|---|---|---|---|
| 20 | Load management of storage loads | Produce and actively manage a loading plan for all floor plates within the Trousers Building giving consideration to floor capacity and column capacity. (Refer to Item 5) | 6-weeks |

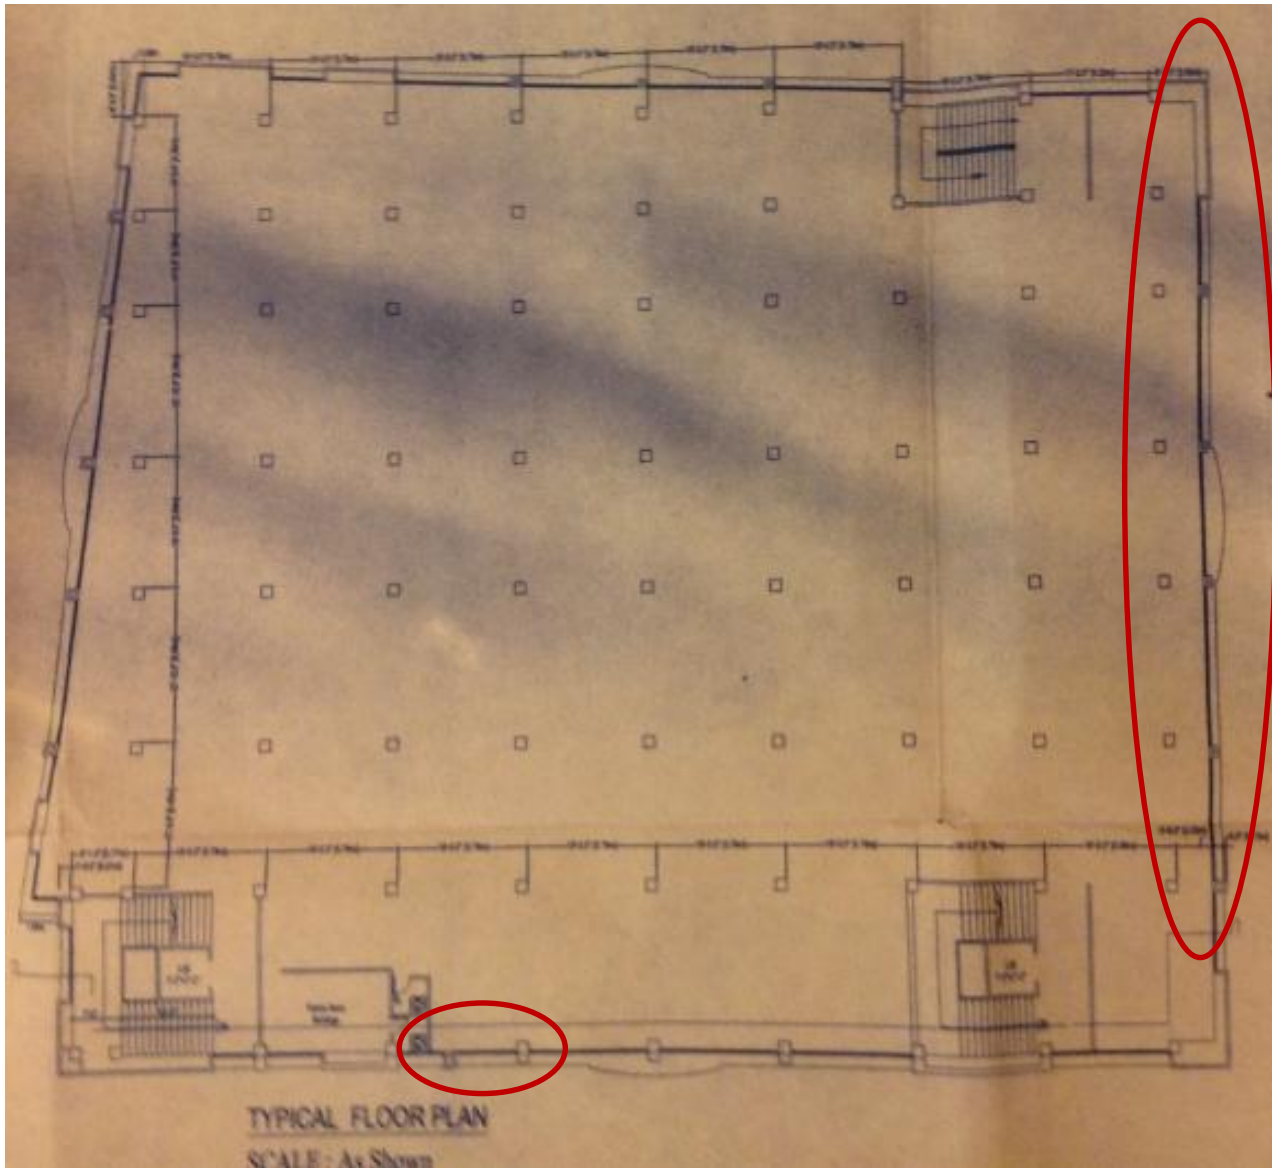
On North face (and one example on East face), there are brick piers along the building perimeter. It is possible these are not intended to be structural.

Many of these brick piers from 1<sup>st</sup> floor upwards are cracked at the line of the interface between concrete beams and the pier.

The Building Engineer should review and ensure that these piers are stable without support from the concrete structure above.

| Item No. | Observation | Recommended Action Plan | Recommended Timeline |
|---|---|---|---|
| 22 | Cracks in brick piers | Sections of plaster finish to wall to be removed and extent of crack to be reviewed by Building Engineer | 6-weeks |
| 24 | Cracks in brick piers | Building Engineer to confirm that adequate lateral restraint is provided to the walls. If required remedial works to be carried out. | 6-months |

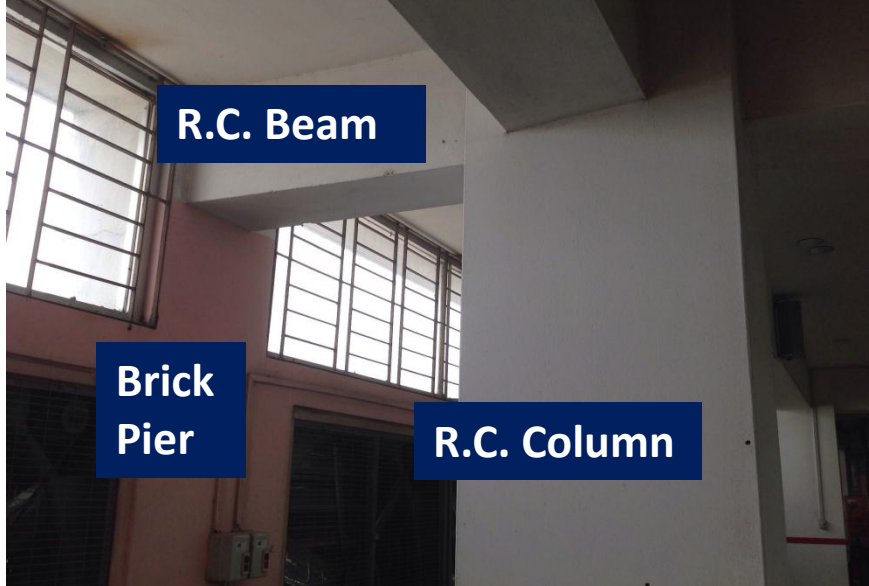
Horizontal Crack around  
brick pier. This example  
was taken on the 6<sup>th</sup> floor.

The Building Engineer  
should review and ensure  
that these piers are stable  
without support from the  
concrete structure above.
