# Abir Fashions (9799)

House # 44, Road # 2, Kutubail (Post Office Road), Fatullah, Narayangonj

23.AUGUST.2014

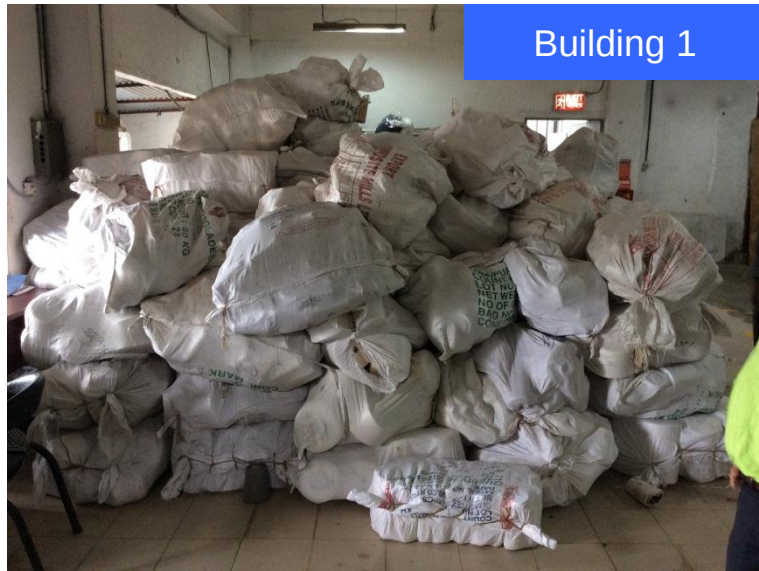
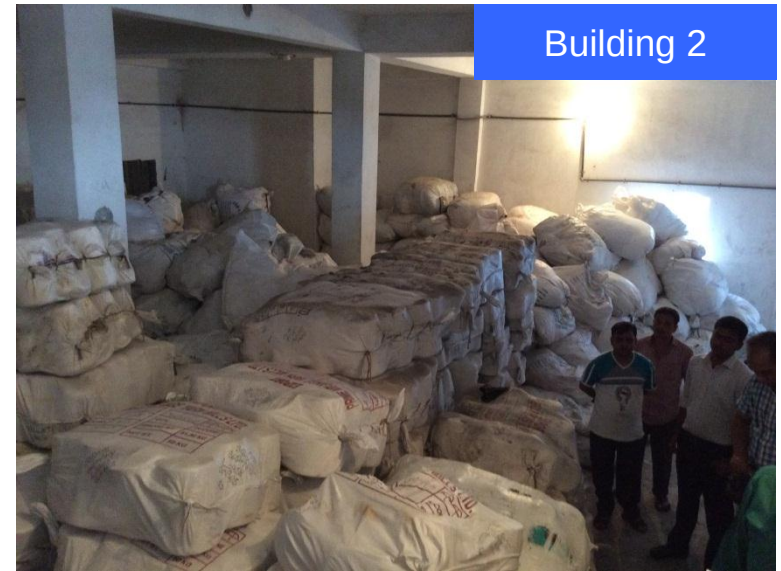
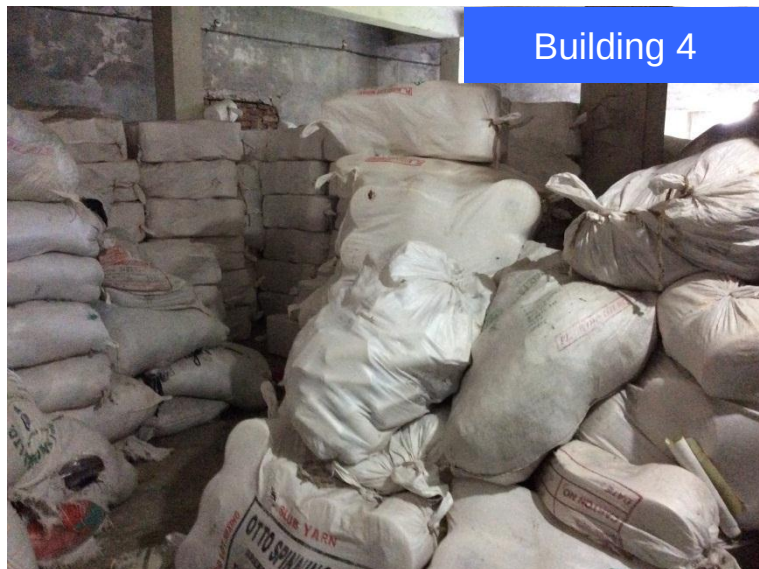
Uncontrolled heavy storage loading was found on the mezzanine, 1<sup>st</sup> floor, 3<sup>rd</sup> floor and 5<sup>th</sup> floor of Building 1 and 1<sup>st</sup> floor and 2<sup>nd</sup> floor of Building 2, Building 3 and Building 4. Loading in these area should be reduced to 2.0 kPa and we require that this concern be investigated in a Detailed Engineering Assessment. Loading plans should be clearly displayed in these areas.

| Item No. | Observation | Recommended Action Plan | Recommended Timeline |
|---|---|---|---|
| 1 | Priority 1 - Uncontrolled heavy storage loading in Building 1, Building 2, Building 3 and Building 4. | Reduce stacking height to ensure total load does not exceed 2.0 kPa.<br>A Detailed Engineering Assessment is required to review the design and loads.<br>Factory Engineer to state the maximum weight that is allowed per square meter. Suggest that state the value on notice boards in these areas. (Loading Plans). | Immediate – Now |
| 2 | Priority 1 - Uncontrolled heavy storage loading in Building 1, Building 2, Building 3 and Building 4. | Adopt some sort of signage/staff guidance to ensure that the maximum weight of storage is not exceeded. (Loading Plans). | 6-weeks |
| 3 | Priority 1 - Uncontrolled heavy storage loading in Building 1, Building 2, Building 3 and Building 4. | Maintain standards of quality control to ensure that storage procedures are correctly followed so that overloading problems do not arise in the future.<br>Maintain and implement Loading Plans. | 6-months |

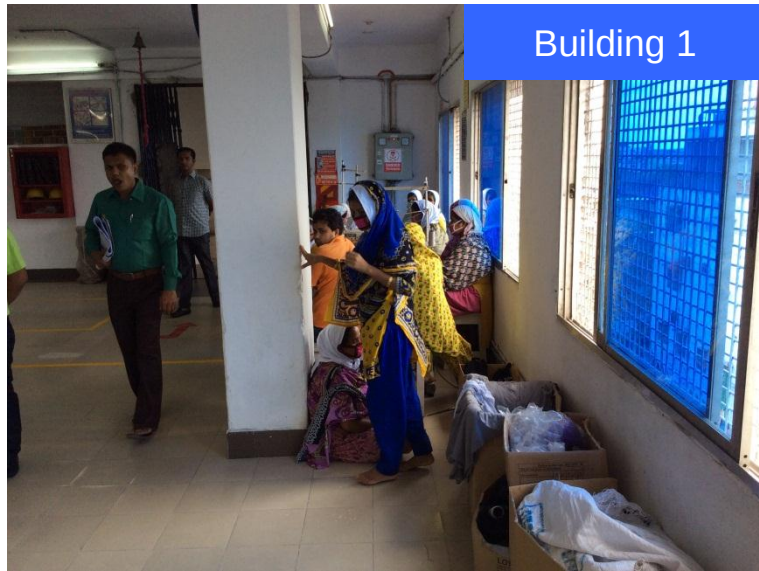
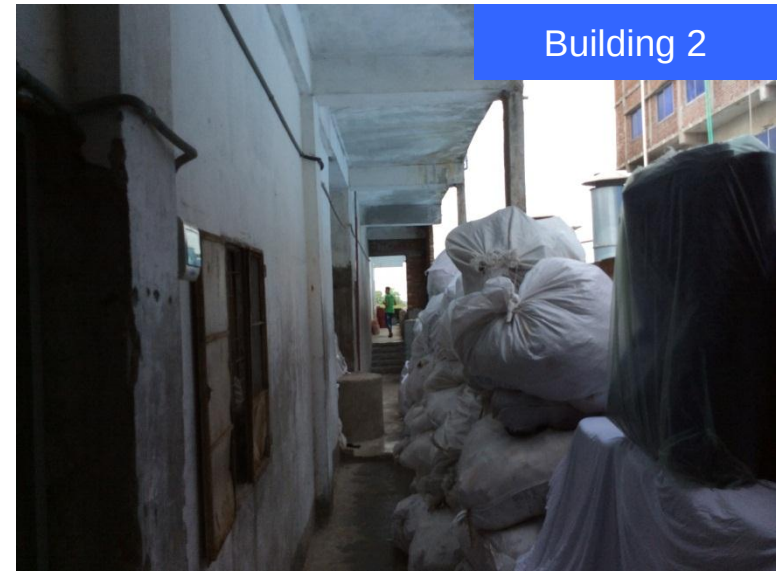
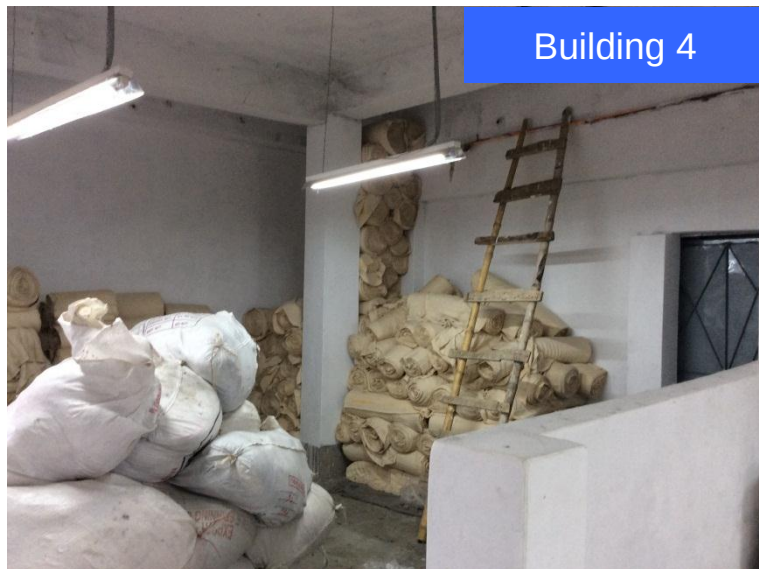
Uncontrolled heavy storage loading was found on the 3<sup>rd</sup> floor and 4<sup>th</sup> floor cantilevered slabs in Building 1 and 1<sup>st</sup> floor and 2<sup>nd</sup> floor of Building 2, Building 3 and Building 4. The loading was also leaning on the brick walls. These lack lateral load resistance. The loading in these areas should be removed and we require that this is investigated in the Detailed Engineering Assessment.

| Item No. | Observation | Recommended Action Plan | Recommended Timeline |
|---|---|---|---|
| 4 | Priority 1 - Uncontrolled heavy storage loading on cantilevered slabs in Building 1, Building 2, Building 3 and Building 4. | Remove heavy storage loading in the area identified above.<br>A Detailed Engineering Assessment is required to review the design and loads.<br>Factory Engineer to state the maximum weight that is allowed per square meter. Suggest that state the value on notice boards in these areas. (Loading Plans). | Immediate – Now |
| 5 | Priority 1 - Uncontrolled heavy storage loading on cantilevered slabs in Building 1, Building 2, Building 3 and Building 4. | Adopt some sort of signage/staff guidance to ensure that the maximum weight of storage is not exceeded. (Loading Plans). | 6-weeks |
| 6 | Priority 1 - Uncontrolled heavy storage loading on cantilevered slabs in Building 1, Building 2, Building 3 and Building 4. | Maintain standards of quality control to ensure that storage procedures are correctly followed so that overloading problems do not arise in the future.<br>Maintain and implement Loading Plans. | 6-months |

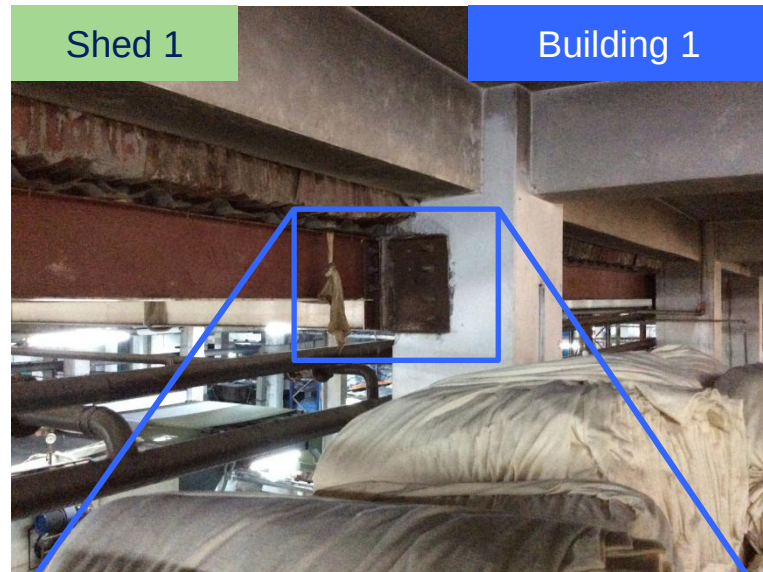
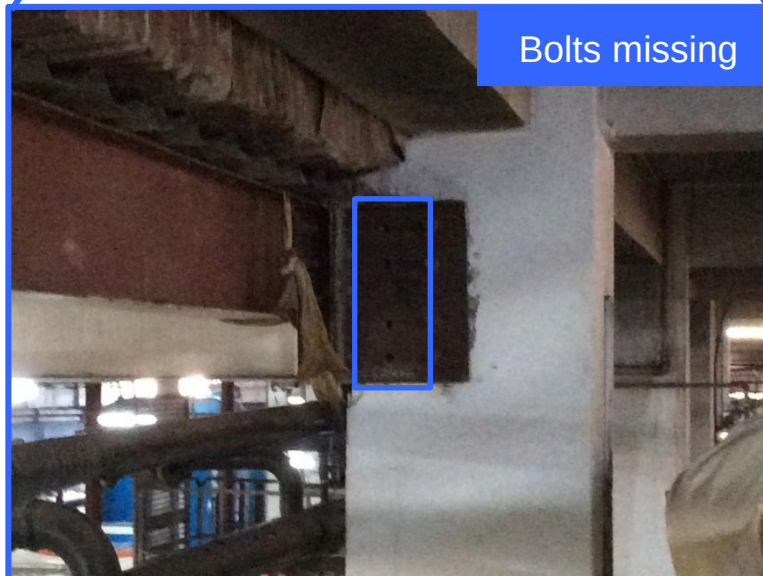
There are bolts missing at the connections between Shed 1 and the existing buildings. These items need to be checked and rectified.

| Item No. | Observation | Recommended Action Plan | Recommended Timeline |
|---|---|---|---|
| 7 | Priority 1 - Bolts missing at the connection between Shed 1 and the existing buildings. | Factory Engineer to check these items in the area identified above and rectify with a suitable methods. | 6-weeks |

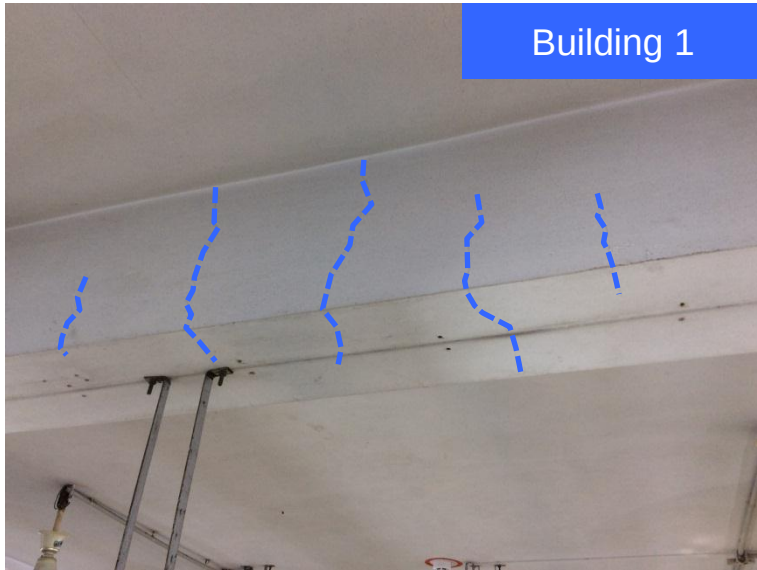
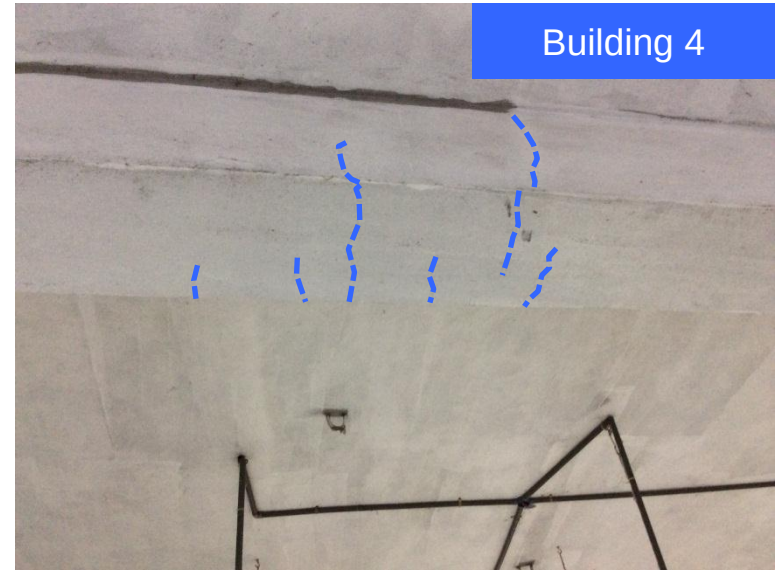
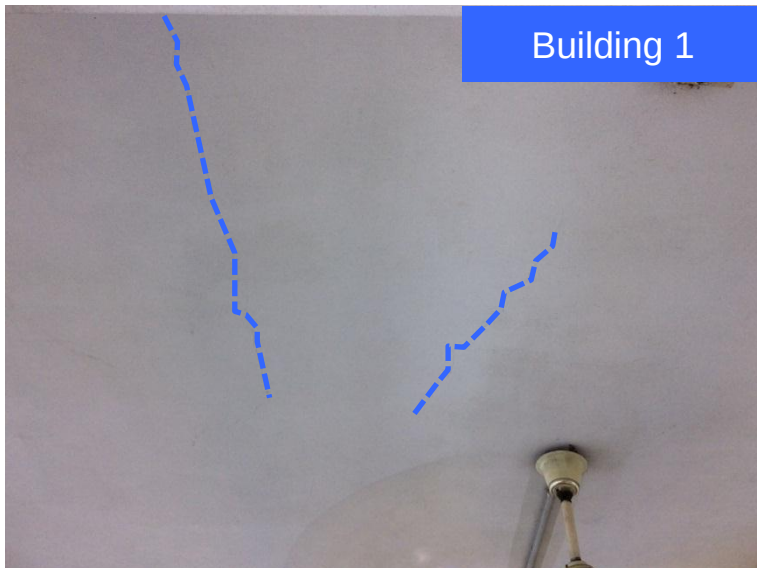
Cracks on 2<sup>nd</sup> floor, 3<sup>rd</sup> floor, 4<sup>th</sup> floor and 5<sup>th</sup> floor beams of Building 1. Cracks on 1<sup>st</sup> floor and 2<sup>nd</sup> floor beams of Building 2, Building 3 and Building 4. And cracks on 3<sup>rd</sup> floor and 4<sup>th</sup> floor slab soffits of Building 1.

The cause of cracks should be investigated by appropriate methods, rectified and then the beams repaired.

| Item No. | Observation | Recommended Action Plan | Recommended Timeline |
|---|---|---|---|
| 8 | Priority 2 - Cracks on beams of Building 1, Building 2, Building 3 and Building 4 and cracks on slab soffits of Building 1. | The Factory Engineer to investigate the cause of cracks by appropriate methods.<br>The cause of the cracks is to be cured.<br>The distress found is to be suitably repaired. | 6-weeks |

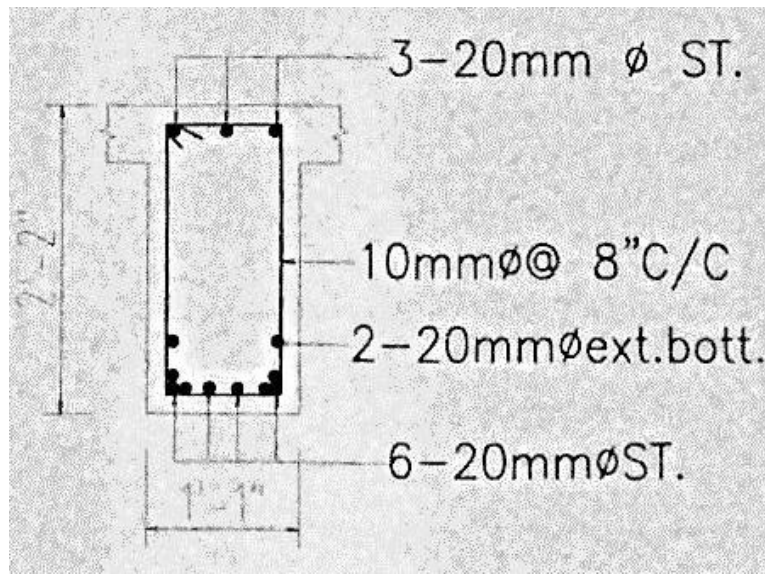
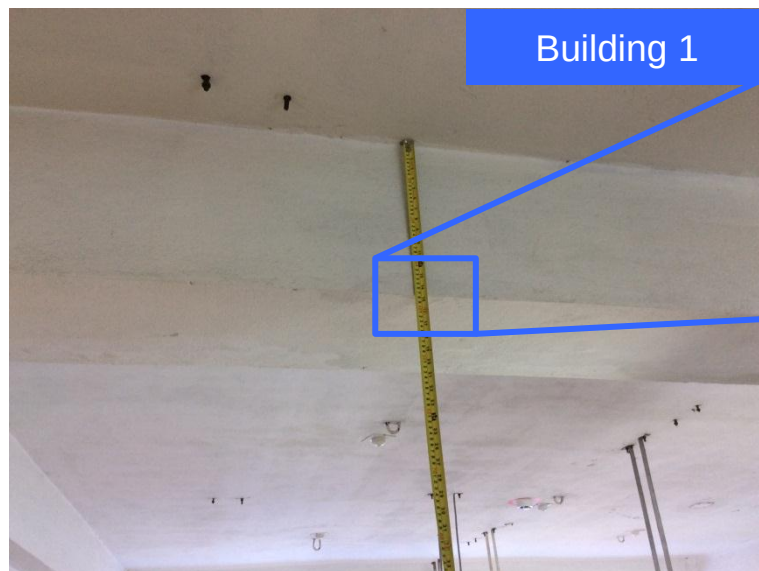
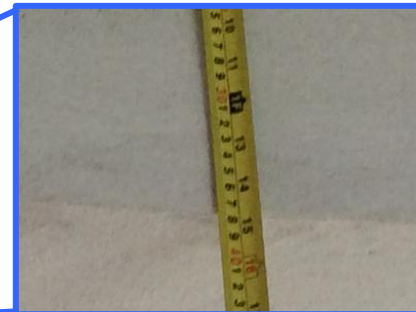
The depth of beam FB-2 measured in situ is 14" excluding slab thickness. This is smaller than those specified on the structural drawings (19" excluded slab thickness).

The structural drawings of Building 1 need to be revised.

| Item No. | Observation | Recommended Action Plan | Recommended Timeline |
|---|---|---|---|
| 9 | Priority 2 - Inadequacies between the drawings and the actual as-built conditions of Building 1. | Factory Engineer to survey the actual conditions and revise the drawings.<br>Any results of the DEA which affect the structure should be taken on board and also represented on the as-built drawings. | 6-weeks |

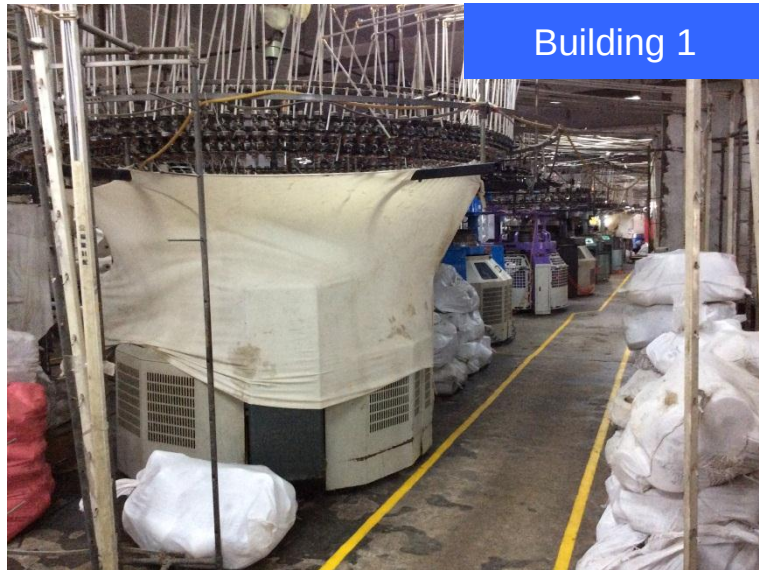
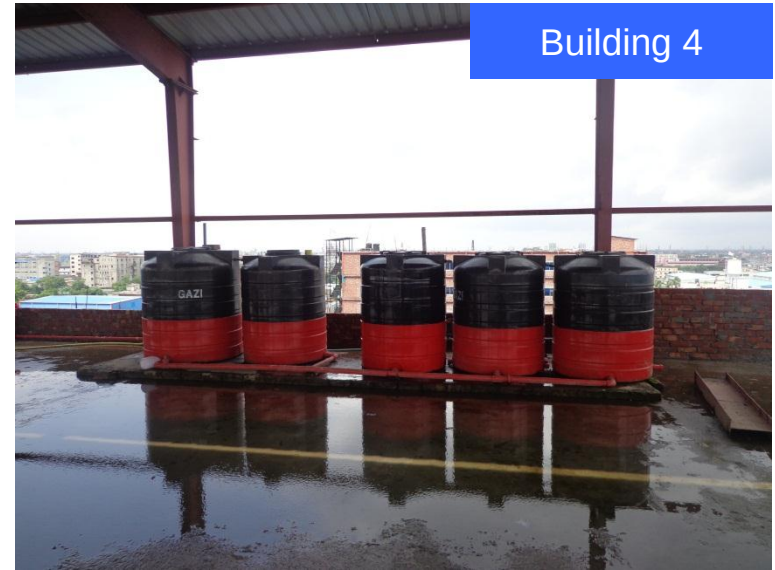
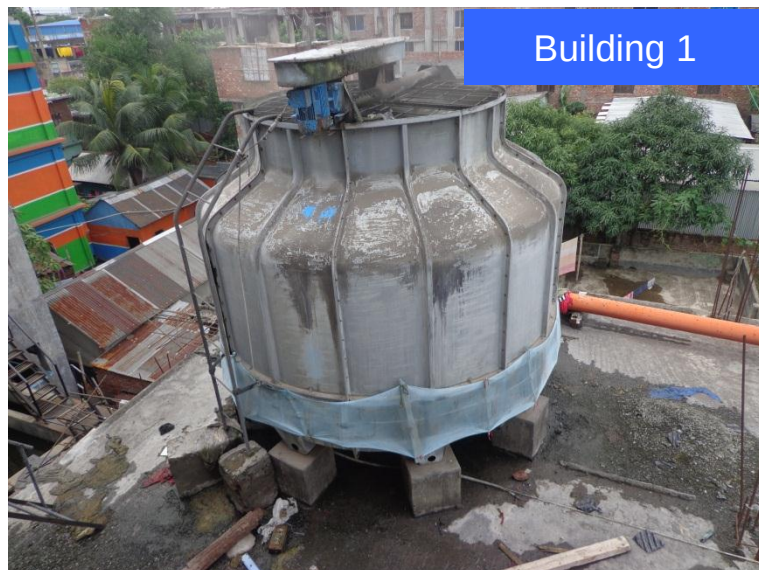
Concerns with the slab supporting knitting machines (1<sup>st</sup> floor) and water tanks (6<sup>th</sup> floor) of Building 1 and cooling tower (roof slab) of Auxiliary Building 1. A capacity check of these slabs and all related elements needs to be carried out.

| Item No. | Observation | Recommended Action Plan | Recommended Timeline |
|---|---|---|---|
| 11 | Priority 2 - Capacity check of slab supporting machines and water tanks in Building 1 and Auxiliary 1. | Factory Engineer to review design, loads and related elements in area identified above to confirm capacity for these items.<br>Or<br>The items in the area identified above should be removed.<br>Or<br>The slabs and/or related elements should be strengthened. | 6-weeks |

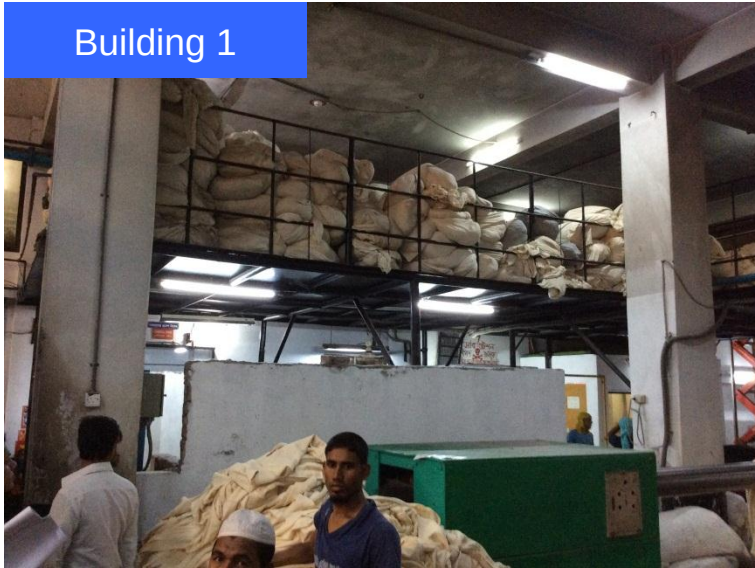
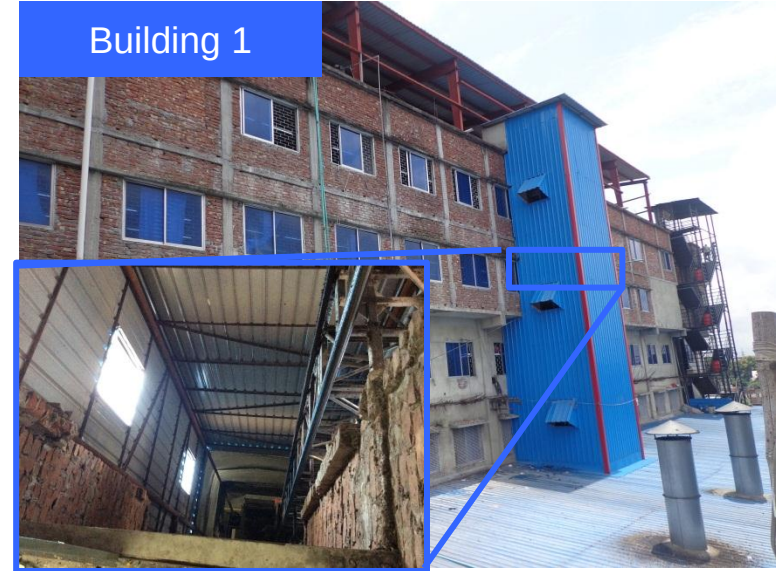
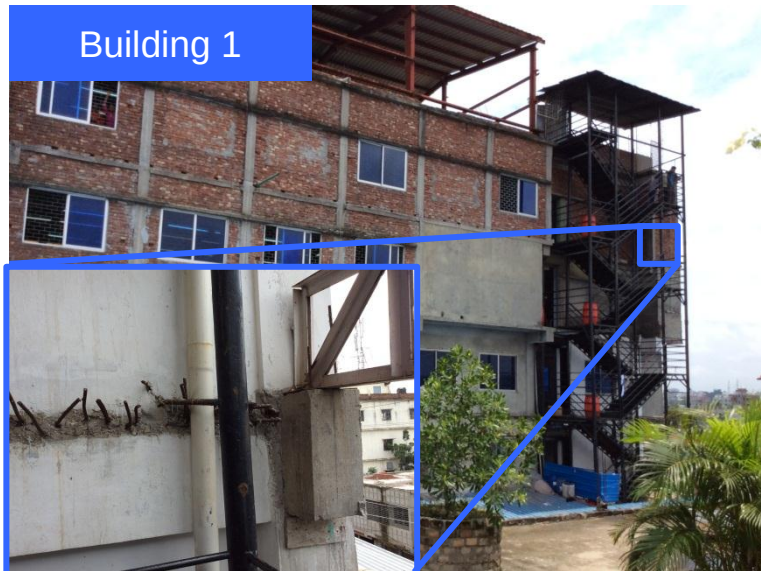
Concerns with stability and capacity of the mezzanine floor, a steel staircase and lift of Building 1.

These should be investigated and strengthened if deemed necessary.

| Item No. | Observation | Recommended Action Plan | Recommended Timeline |
|---|---|---|---|
| 12 | Priority 2 - Stability and capacity of mezzanine, steel staircase and lift of Building 1. | Factory Engineer to review design, loads and related elements in area identified above to confirm capacity and stability for these items.<br>Or<br>These items should be strengthened. | 6-weeks |

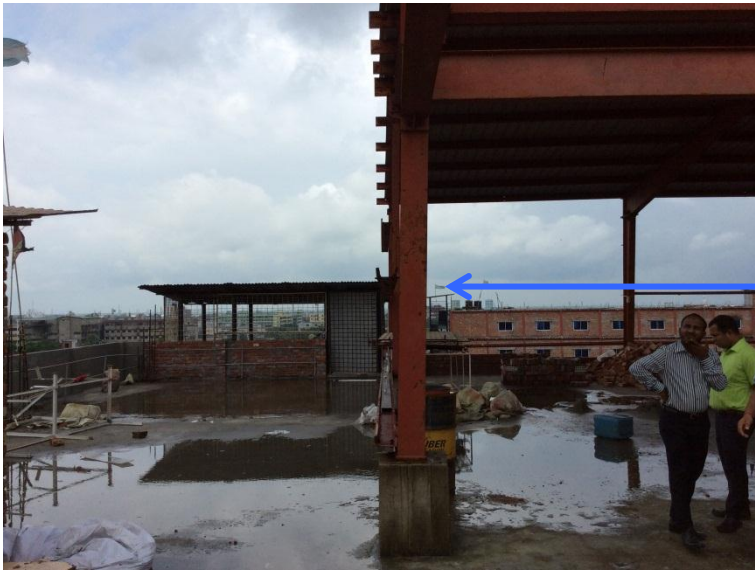
There are inclined columns on the 6<sup>th</sup> floor of Building 1.

Stability for these items and related elements need to be checked.

| Item No. | Observation | Recommended Action Plan | Recommended Timeline |
|---|---|---|---|
| 13 | Priority 2 - Inclined columns in Building 1 and inclined trusses in Shed 1. | Factory Engineer to review design, loads and related elements in area identified above to confirm stability of these items.<br>Or<br>These items should be rectified with a suitable methods. | 6-weeks |

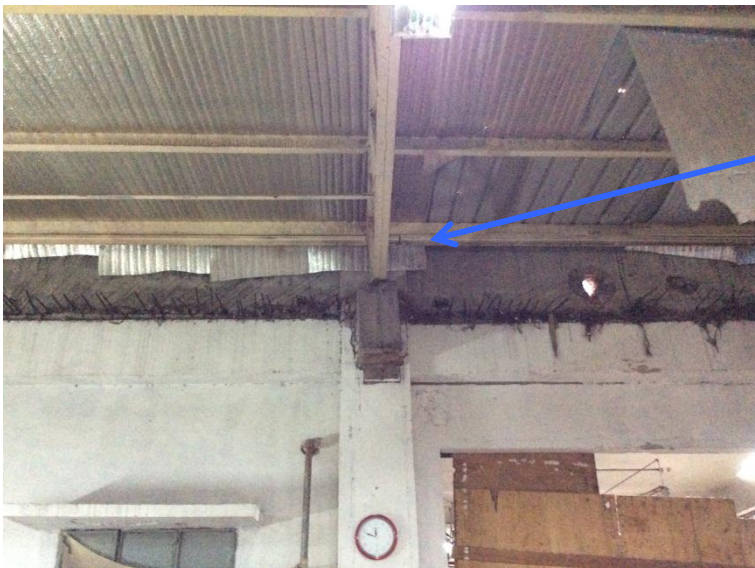
There are inclined roof trusses noted in Shed 1.

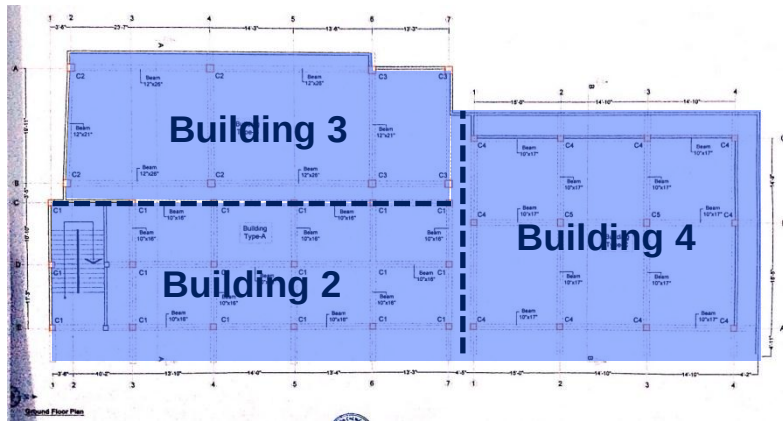
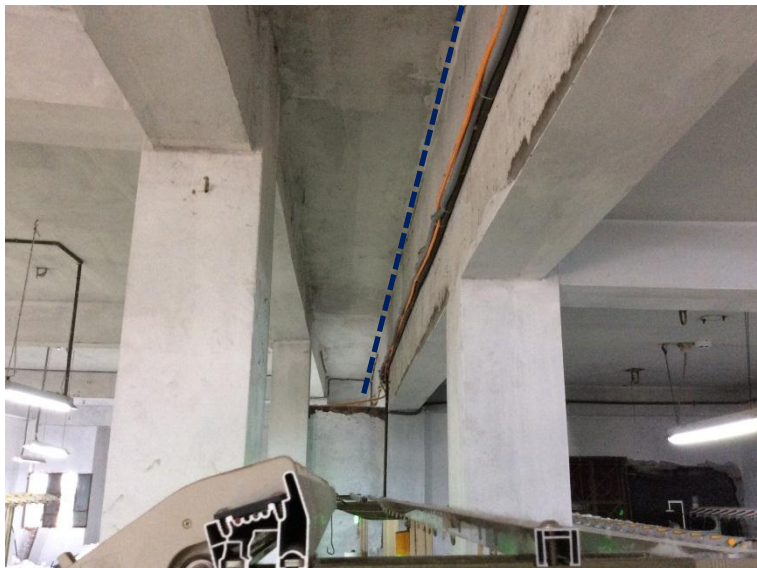
Building 2, Building 3 and Building 4 were connected together. We were informed that there are movement joints between these buildings.

However, the joints were covered with mortar and/or finishes on the floors. The movement joint should be established properly where shown.

| Item No. | Observation | Recommended Action Plan | Recommended Timeline |
|---|---|---|---|
| 14 | Priority 2 - Movement joint to be properly established between Building 2, Building 3 and Building 4. | The Factory Engineer should investigate to prove the capacity of the building in its existing state, a further building approval should be gained for the building as it exists, as altered since the original approval. Alternatively, the extension building should be separated by a non-structural joint and allowed to act as a fully structurally independent structure. | 6-weeks |

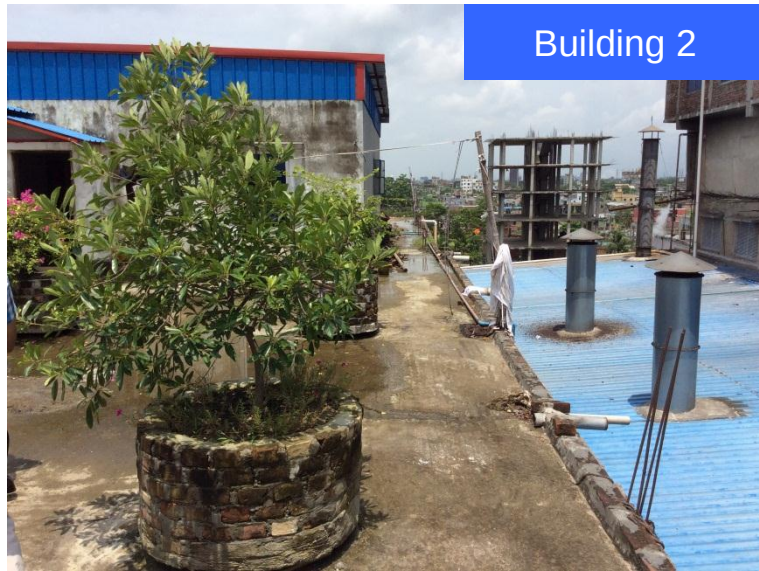
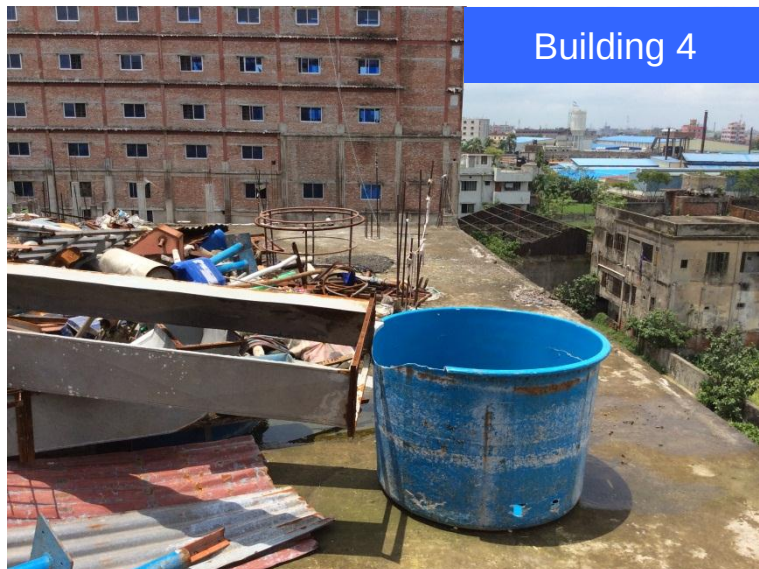
There is no parapet wall around the perimeter of top level of Building 2 and Building 4.

Whilst not a structural issue, this is a significant health and safety risk and should be rectified.

| Item No. | Observation | Recommended Action Plan | Recommended Timeline |
|---|---|---|---|
| 19 | Priority 3 - No parapet wall or guardrail present at the top level of Building 2 and Building 4. | A suitable perimeter parapet wall or guardrail should be constructed along the building perimeter. | 6-months |

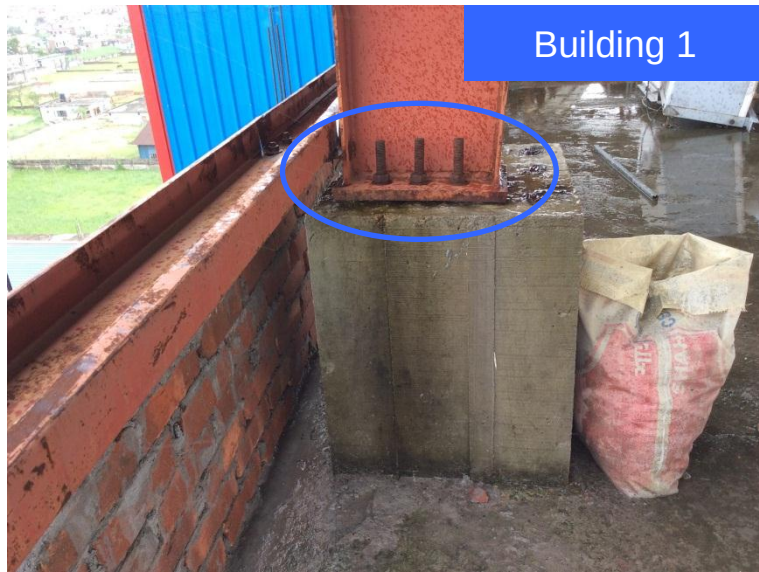
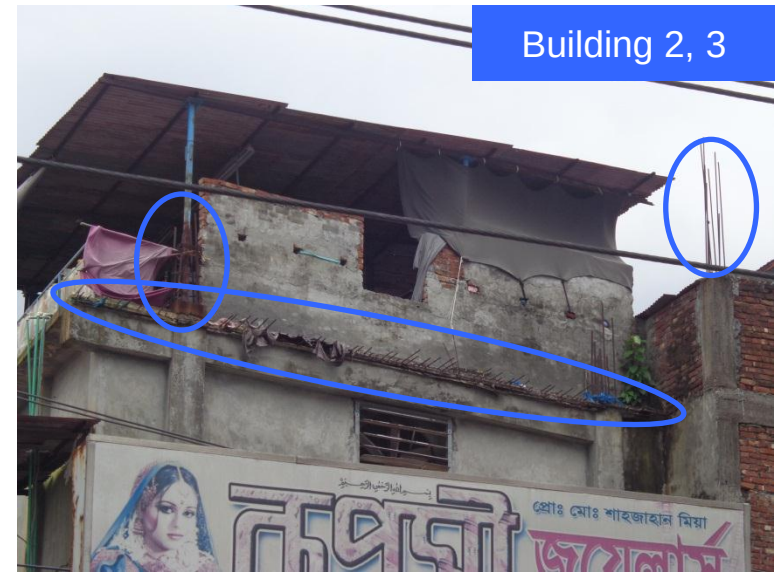
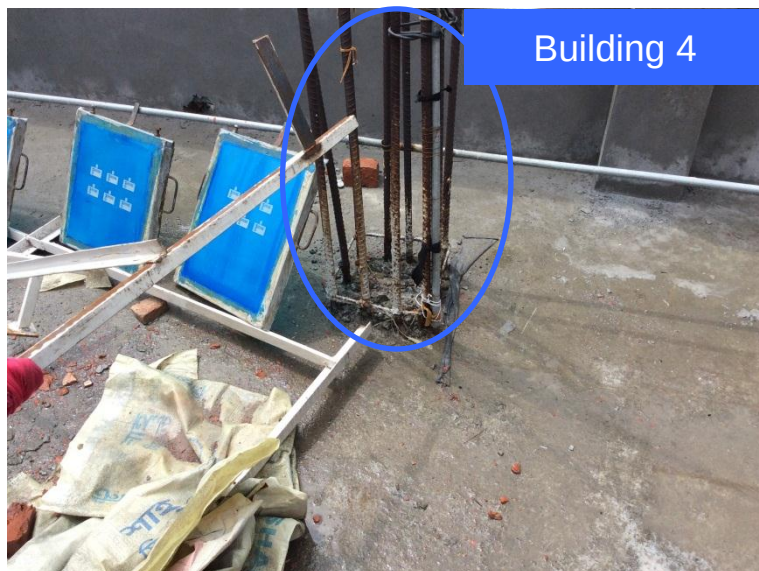
Reinforcement is left exposed on Building 1, Building 2, Building 3 and Building 4. And structural steel elements are also left exposed on Building 1.

| Item No. | Observation | Recommended Action Plan | Recommended Timeline |
|---|---|---|---|
| 20 | Priority 3 - Reinforcement and structural steel left exposed on Building 1, Building 2, Building 3 and Building 4. | For both durability and serviceability, rust proof paint or any appropriate methods is recommended. | 6-months |

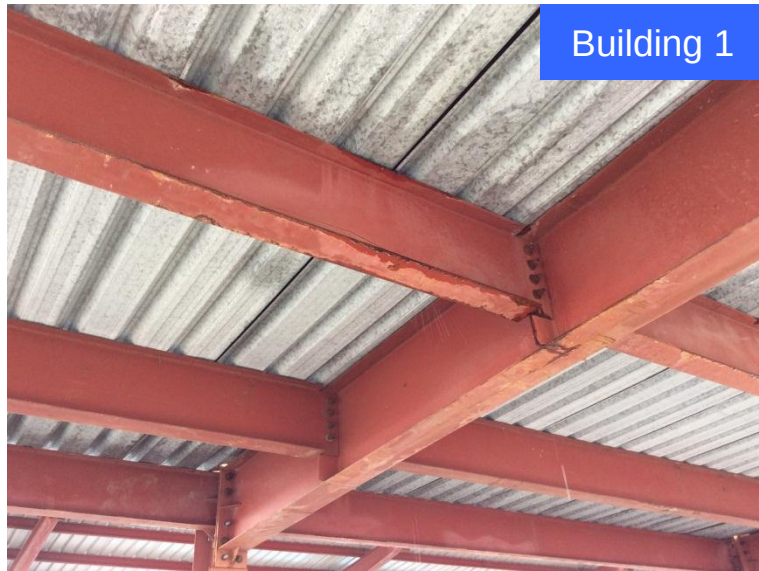
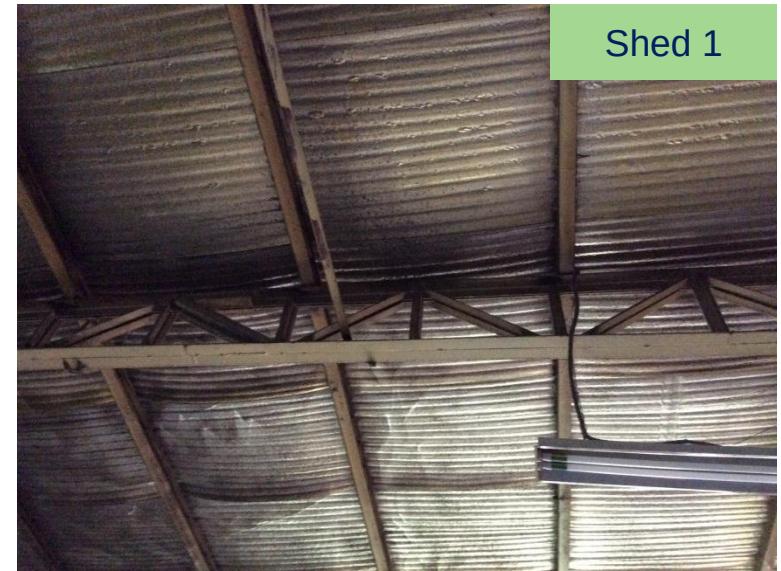
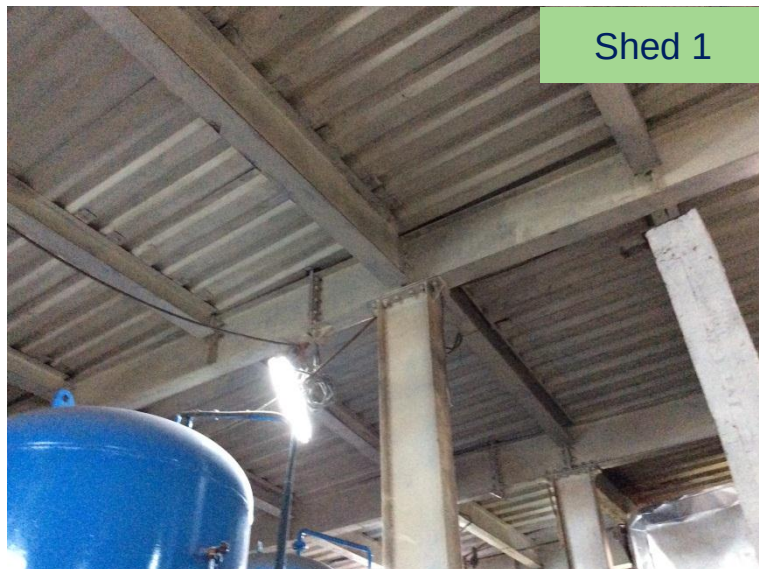
No fireproofing material was noted on any structural steel elements (if required).

| Item No. | Observation | Recommended Action Plan | Recommended Timeline |
|---|---|---|---|
| 21 | Priority 3 - No fireproofing material for structural steel elements (if required). | Fireproofing material for structural steel element is recommended as suggested in BNBC Codes.<br>Maintain standard of quality control and protection of the fire protection. | 6-months |

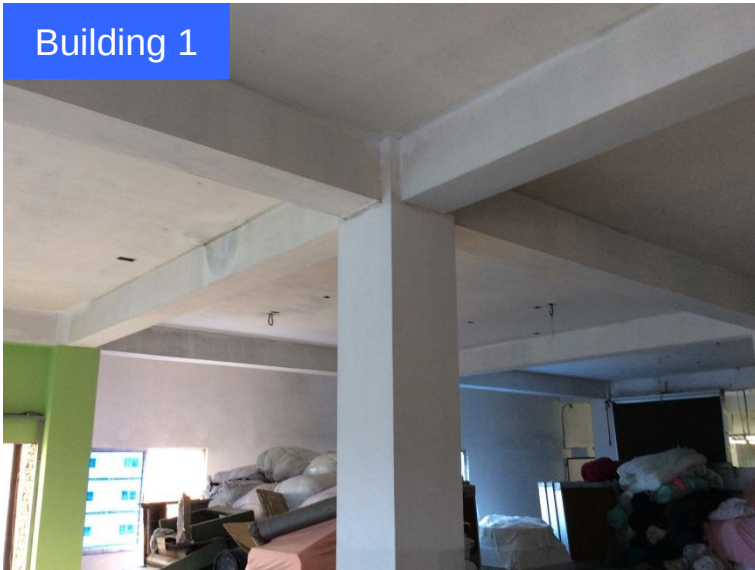
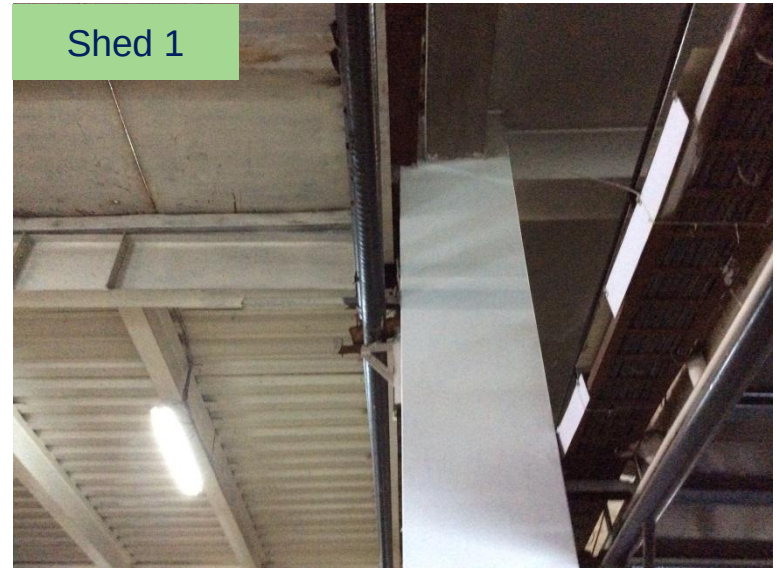
The lateral loading resistance for Building 1, proposed 8 storeys, Building 2, 4 storeys, Building 3, 4 storeys and Building 4, part 3 part 4 storeys are provided by moment frame action without any shear walls and the façade brickwork walls lack moment capacity due to their poor connections with the surrounding columns and beams.

The lateral loading resistance for Shed 1 is provided by moment frame action in one direction but is without bracing in the other. Stability and capacity must be checked especially at the connections. Stability under wind uplift needs to be checked in particular.

We require that the stability of these buildings to be investigated as part of a Detailed Engineering Assessment.

| Item No. | Observation | Recommended Action Plan | Recommended Timeline |
|---|---|---|---|
| 16 | Priority 2 - Overall stability system. | A Detailed Engineering Assessment of the overall building to be carried out and in particular, stability and foundation aspects should be investigated in detail. | 6-weeks |

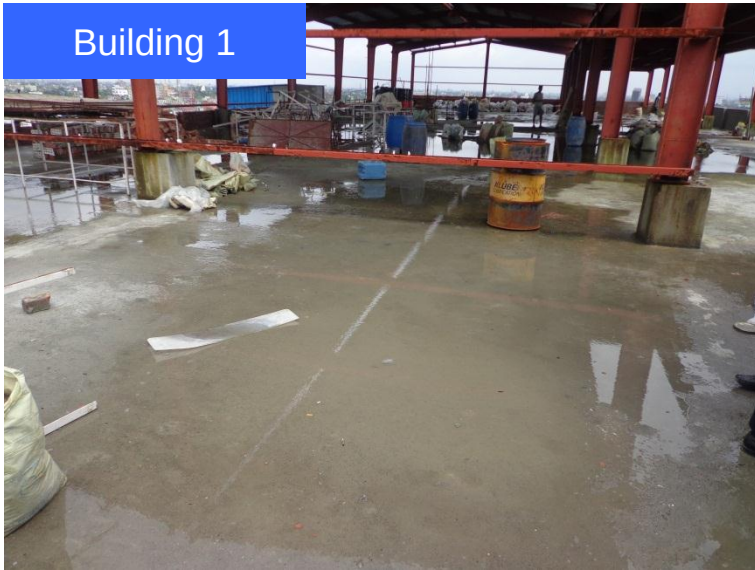
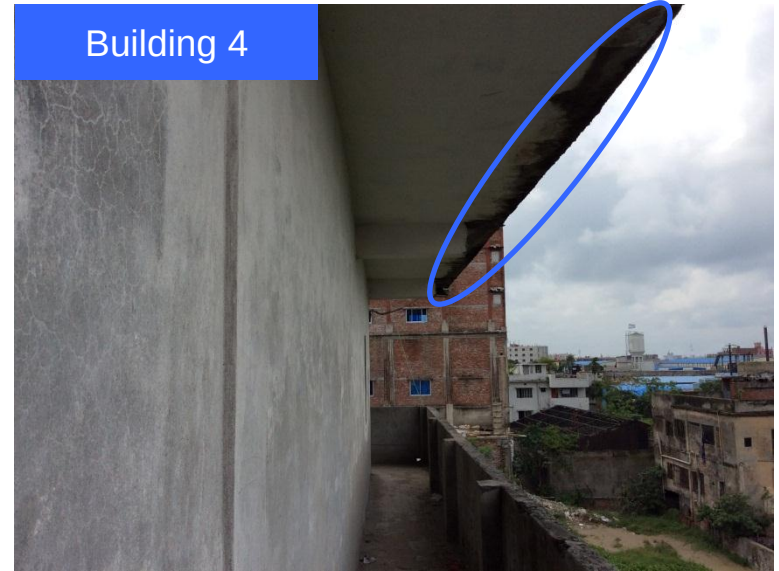
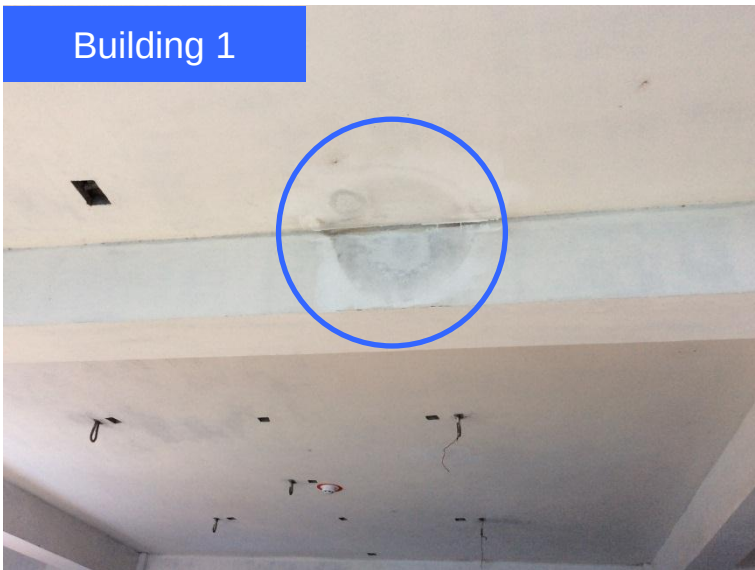
Water distress was noted on slabs, beams and walls in Building 1, Building 2, Building 3 and Building 4. Water ponding was also found at the top level.

| Item No. | Observation | Recommended Action Plan | Recommended Timeline |
|---|---|---|---|
| 18 | Priority 3 - Distress due to water ingress in Building 1, Building 2, Building 3 and Building 4. | Factory Engineer to inspect water damaged structures and repair with a suitable methods.<br>Waterproofing on the roof slab is to be applied. Moreover the roof slab drainage system should be investigated and improved. | 6-months |
