# T Design Sweaters Ltd.(11247)

Jarun, Konabari, Gazipur  
(+23.999426N, 90.325706E)  
24.AUGUST.2014

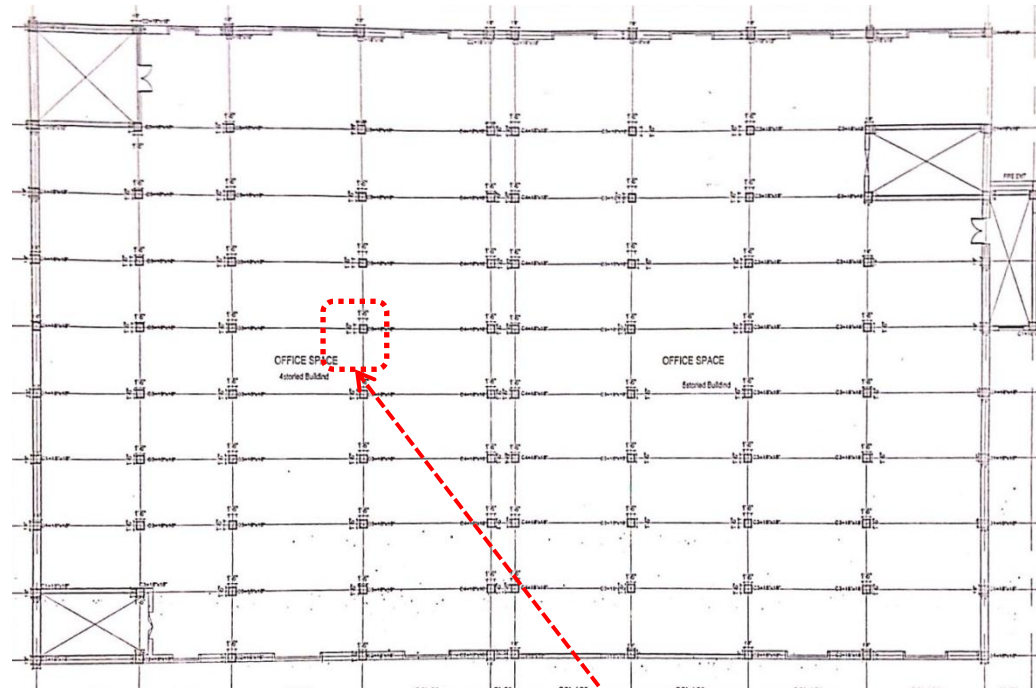
Column to be checked

There were no details of the strengthening work (column jacketing) available to review. There appeared to be some confusing aspects; the original column was a stone aggregate concrete column, the jacketing used brick chip aggregate. The jacketed columns need to be checked for full BNBC code compliance as part of a DEA.

The structural capacity of the columns needs to be carefully assessed based on the exact as-built detailed drawings.

We require that these items be investigated in a Detailed Engineering Assessment.

| Item No. | Observation | Recommended Action Plan | Recommended Timeline |
|---|---|---|---|
| 1 | 1st Priority 1 - The structural capacity of the strengthened columns need to be careful assessed based on the exact as-built detail drawings. | The Structural Engineer, as part of the DEA should investigate and then prepare detail used for the column strengthening work, clearly indicating the rebar arrangement for both the new jacket and the original column. | 6-weeks |
| 2 | 1st Priority 1 - The structural capacity of the strengthened columns need to be careful assessed based on the exact as-built detail drawings. | The structural capacity of the column need to be careful assessed based on what is found. As part of the DEA. | 6-months |

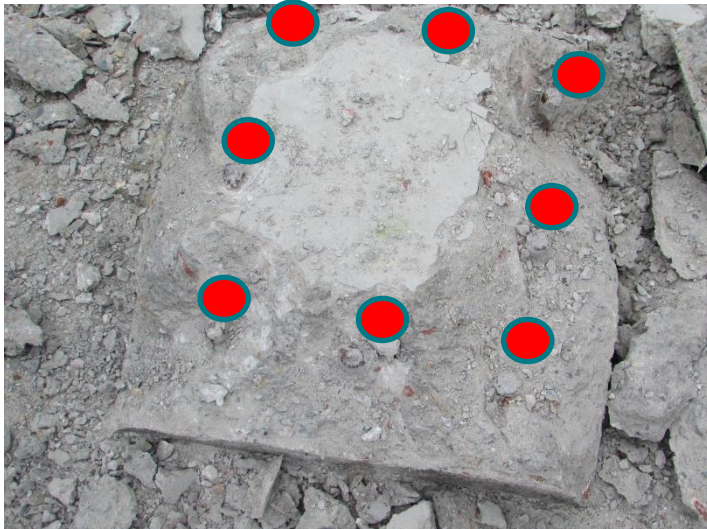
We were informed that column strengthening work has been done. No drawings were provided. The original as-built drawing shows 16 bars in a typical C3 column. On site we found 8 bars in an outer perimeter. A portion of column was further broken down and a further 8 bars were found in an inner perimeter.

There were no drawings for the column strengthening work and the rebar arrangement doesn't match the original as-built drawings.

| Item No. | Observation | Recommended Action Plan | Recommended Timeline |
|---|---|---|---|
| 3 | 2nd Priority 1 - There were no drawings for the column strengthening work and the rebar arrangement doesn't match the original as-built drawings. | The factory's Structural Engineer is to survey the actual conditions and produce the as-built drawings as early as possible. | 6-weeks |

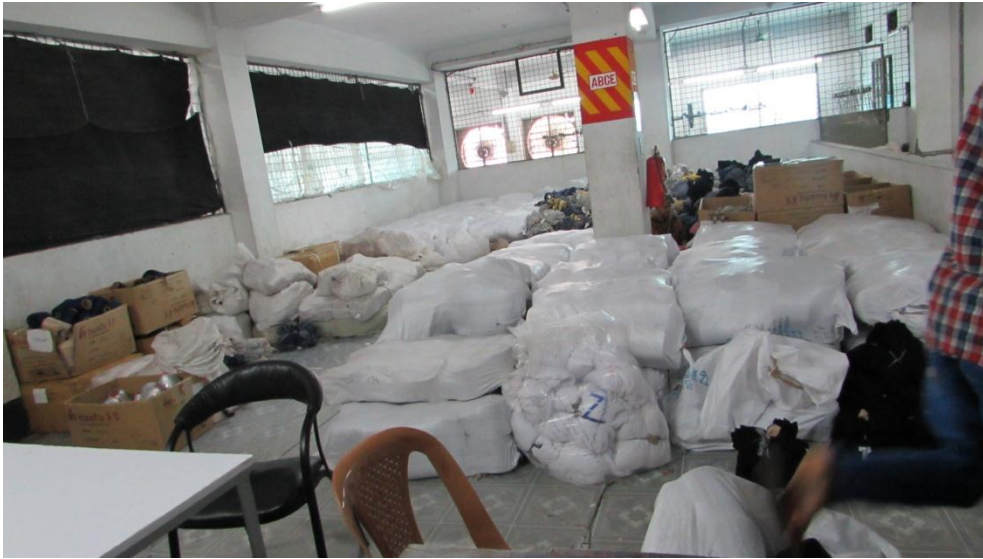
Storage was noted on an upper floor of the building. Although the loading was not very heavy, the factory owner wasn't aware of what allowable load his floors could support. It was suggested that Loading Plans should be developed and used.

Loading Plans should be prepared and maintained.

| Item No. | Observation | Recommended Action Plan | Recommended Timeline |
|---|---|---|---|
| 4 | 1st Priority 2 - Loading Plans should be prepared and maintained. | The factory's Engineer is to produce Loading Plans for each floor and ensure full compliance. | 6-weeks |
| 5 | 1st Priority 2 - Loading Plans should be prepared and maintained. | Maintain and enforce the Loading Plans. | 6-months |

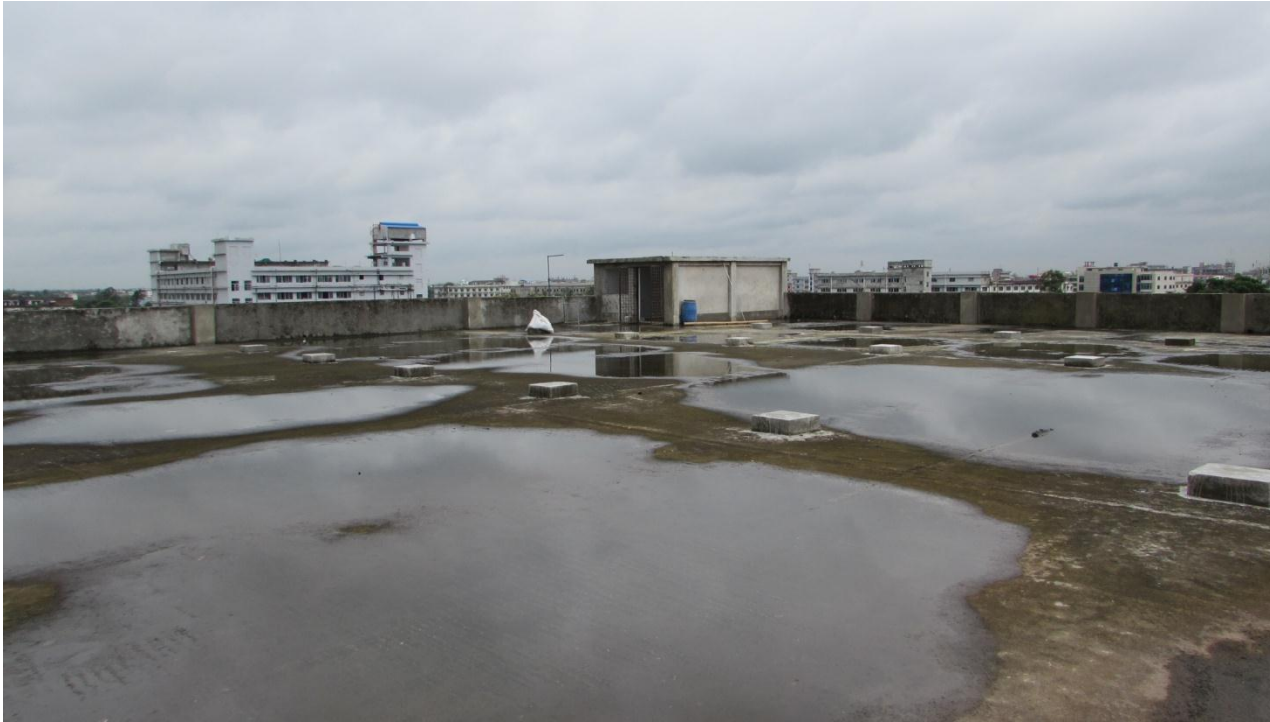
No waterproofing was present on the roof and the drainage system does not work. Water was ponding.

| Item No. | Observation | Recommended Action Plan | Recommended Timeline |
|---|---|---|---|
| 8 | 1st Priority 3 - No waterproofing was present on the roof and the drainage system does not work. Water was ponding. | Provide a proper waterproofing layer on the roof.<br>Improve the roof drainage system generally. | 6-months |

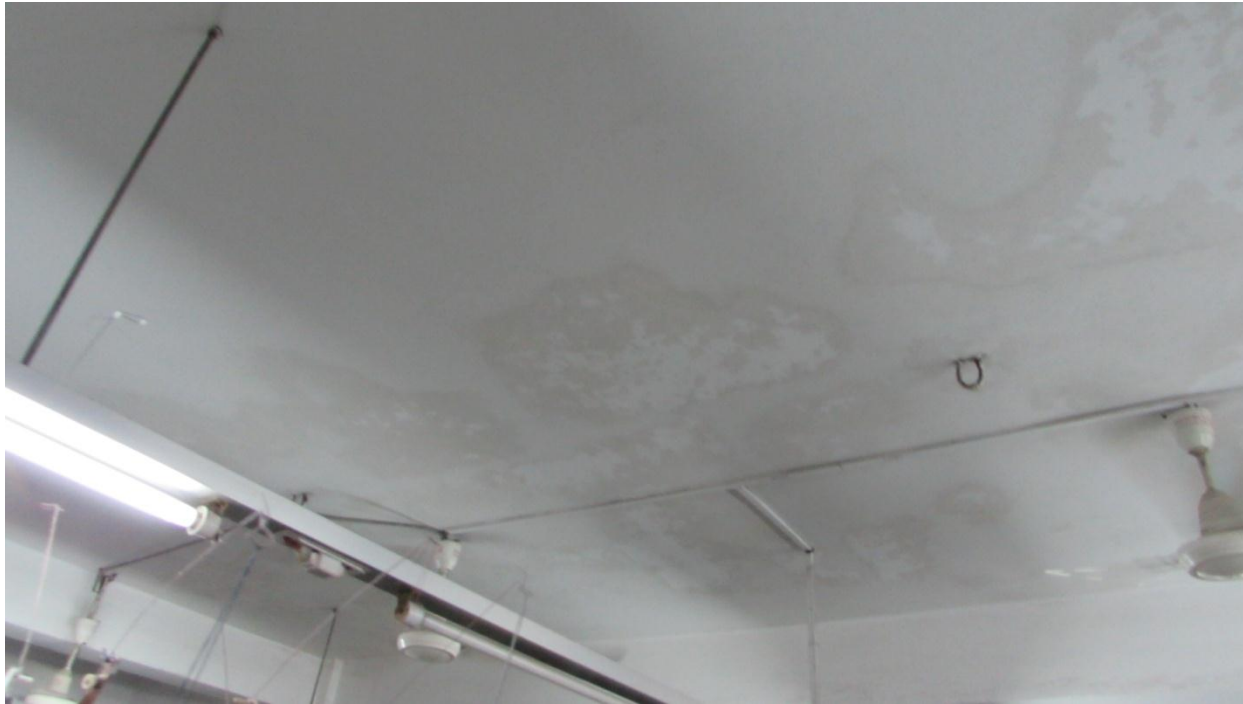
Water leaks are visible in places.

| Item No. | Observation | Recommended Action Plan | Recommended Timeline |
|---|---|---|---|
| 9 | 2nd Priority 3 - Water leaks are visible in places. | The building façades should be protected with a finish and waterproofing needs to be applied to the roof. | 6-months |

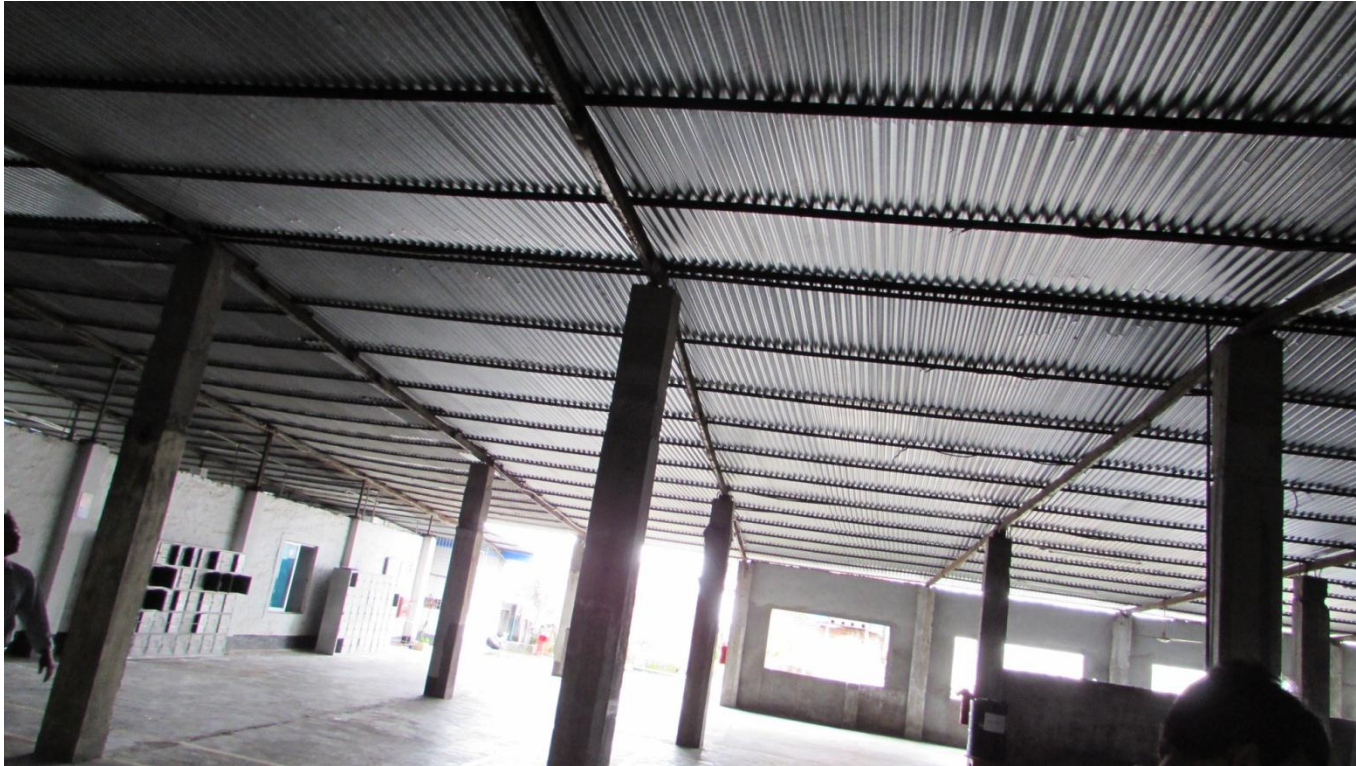
No detailed design was provided for the steel dining shed on the roof.

| Item No. | Observation | Recommended Action Plan | Recommended Timeline |
|---|---|---|---|
| 10 | 3rd Priority 3 - No detailed design was provided for the steel dining shed on the roof. | The factory's Engineer is to check the detailed design for the steel dining shed on roof top.<br>Carry out any strengthening or modification work as necessary. | 6-months |

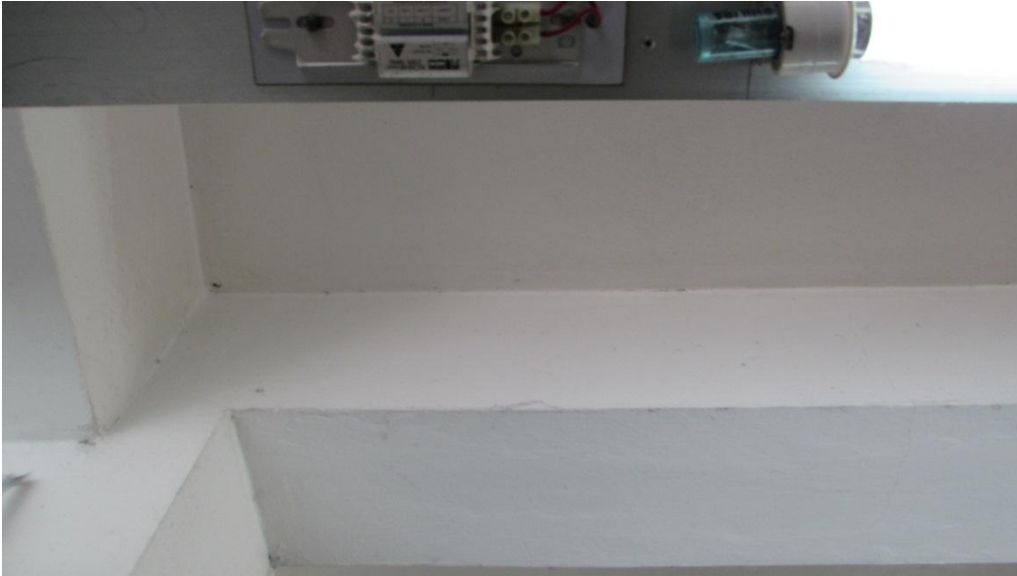
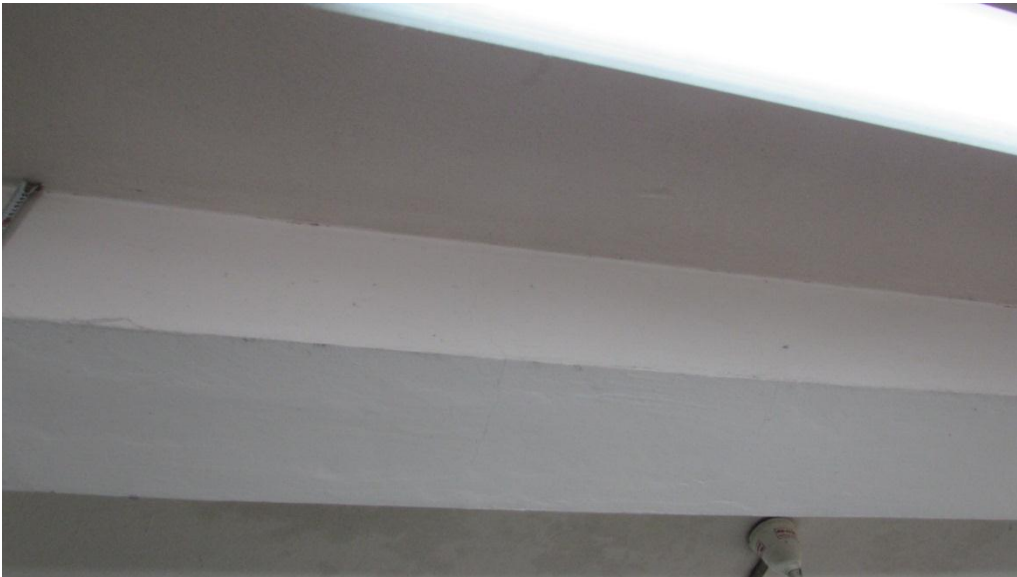
Cracks on beams need to be investigated to determine the cause of the cracking.

The structural capacity of this floor also needs to be assessed.

| Item No. | Observation | Recommended Action Plan | Recommended Timeline |
|---|---|---|---|
| 11 | 4th Priority 3 - Cracks on beams need to be investigated to determine the cause of the cracking. | The cracking on the beams found needs to be investigated to determine the cause.<br>The structural capacity of these floors needs to be assessed. | 6-weeks |
| 12 | 4th Priority 3 - Cracks on beams need to be investigated to determine the cause of the cracking. | Repair and strengthen the slabs locally as necessary. | 6-months |

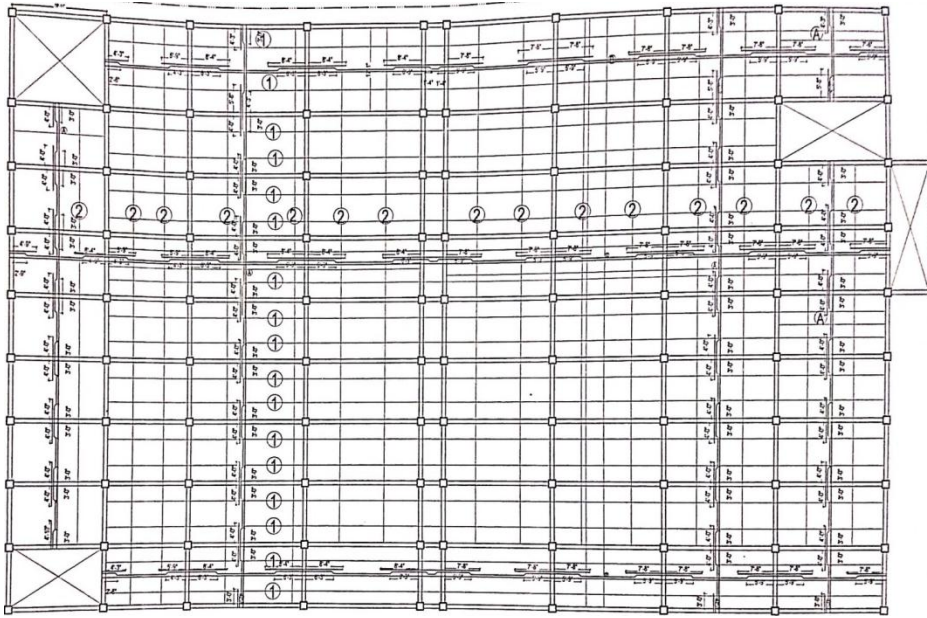
Typical Framing Layout Plan

R.C Beam and column frame with 2-way solid slab.  
Stability provided by moment frame system.

Slab Thickness 152mm  
Original Column Size 340x340mm (typ.)  
Jacketed Column Size 457x457mm (typ.)  
Beam Size 254x457mm(typ.)

Grid 3.84m x 7.93m.

There were no shear walls to resist the lateral load, the building just relies on the moment frame system. This type of structural should be reviewed and checked carefully under lateral wind and seismic loads.

We require that this item is investigated in a Detailed Engineering Assessment

| Item No. | Observation | Recommended Action Plan | Recommended Timeline |
|---|---|---|---|
| 6 | 2nd Priority 2 - The Structural Engineer should to analyse and check the overall lateral stability system as part of the DEA. | The factory's Structural Engineer is to analyse and check the overall structural stability system under lateral wind and seismic loads. As part of the DEA. | 6-weeks |
| 7 | 2nd Priority 2 - The Structural Engineer should to analyse and check the overall lateral stability system as part of the DEA. | Based on the analysis results, consider strengthening or modification works. | 6-months |
