# Experience Clothing Co., Ltd. (9224)

72 & 82, D.E.P.Z., Savar, Dhaka

26.AUGUST.2014

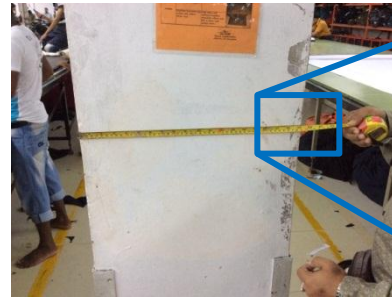
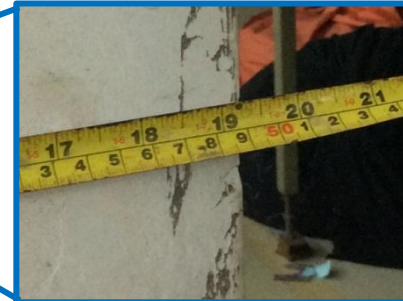
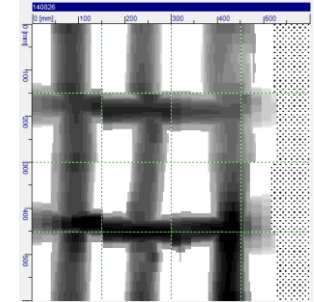
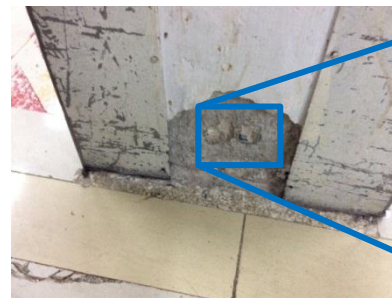
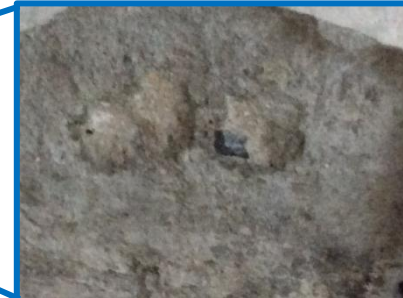
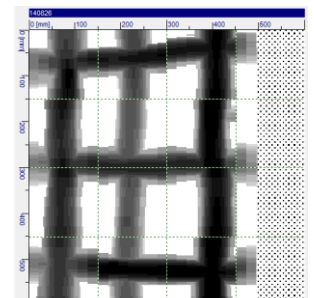
The internal columns at ground level of Building A, shown below, appear to be overstressed. The size of this column is 450 x 450 mm at ground level and carry 5 storeys of Building A with 8.15 m and 8.00 m length spans.

From the information above, for Building A, 5 storeys, the calculation check of these columns show that they appear to be overstressed (FoS = **1.25**).

**Remark:** The sizes of the column's rebar are assessed to be similar to those specified on the structural drawings.

| Item No. | Observation | Recommended Action Plan | Recommended Timeline |
|---|---|---|---|
| 1 | Priority 1 - The internal columns at ground floor level of Building A between grid line A'-E'/6'-9' appear to be overstressed. | Remove any loading applied on this area on 4th floor.<br>Maintain and control the floor loading on 1st floor to 3rd floor to a maximum of 2.0kPa.<br>Factory Engineer to review design, loads and columns stresses in area identified above.<br>Verify insitu concrete stresses either by 100mm dia. cores or existing cylinder strength data for [the identified columns] or [100mm dia. cores from 4 columns].<br>A Detailed Engineering Assessment of Factory to be commenced, see attached scope. | Immediate – Now |
| 2 | Priority 1 - The internal columns at ground floor level of Building A between grid line A'-E'/6'-9' appear to be overstressed. | Produce and actively manage a loading plan for all floor plates within the factory giving consideration to floor capacity and column capacity.<br>The Detailed Engineering Assessment to be completed. | 6-weeks |
| 3 | Priority 1 - The internal columns at ground floor level of Building A between grid line A'-E'/6'-9' appear to be overstressed. | Continue to implement load plan.<br>Carry out fully any and all recommendations of the DEA. | 6-months |

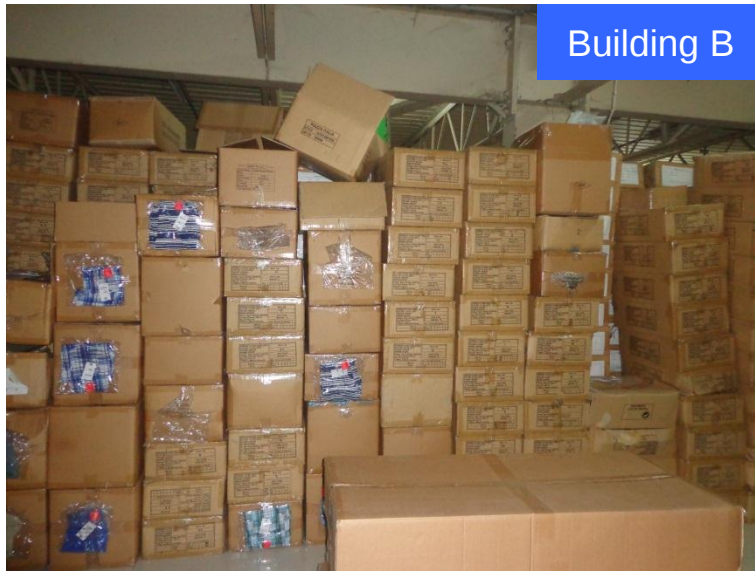
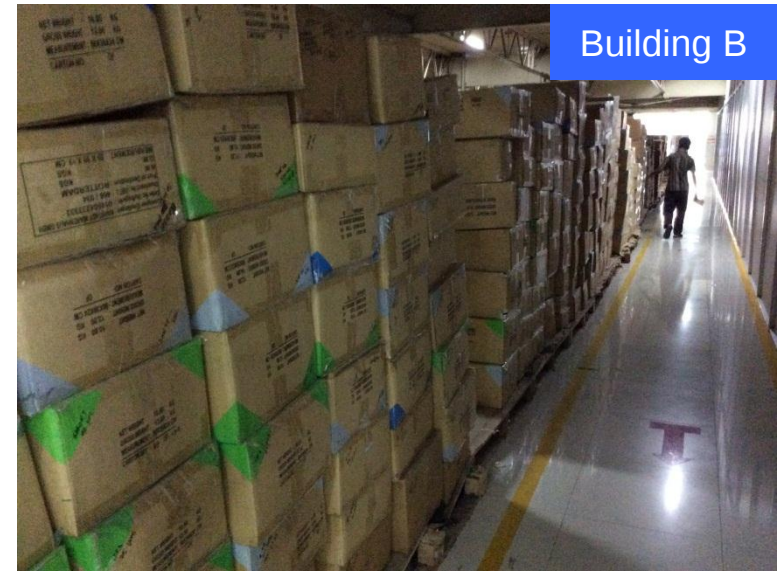
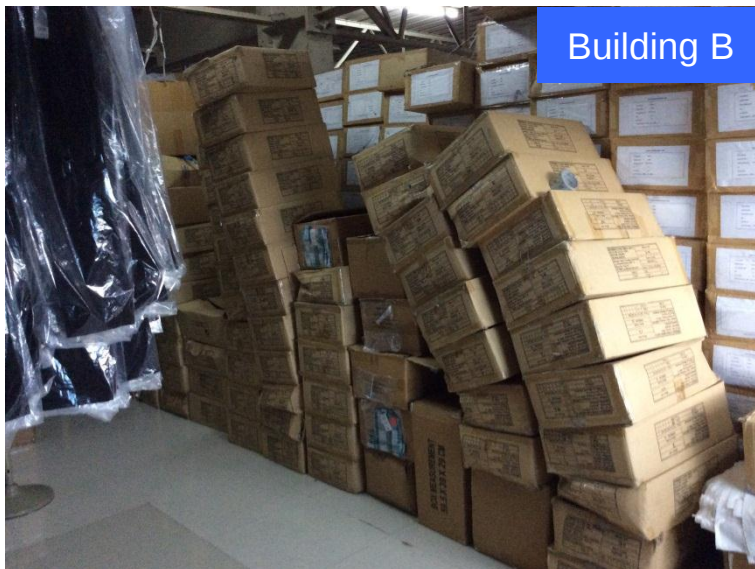
Uncontrolled heavy storage loading was found on 3<sup>rd</sup> floor at Building B. We believed the loading on storage area to be 5.0 kPa (11 kg per box, 0.60 x 0.40 m footprint, 11 boxes per stack). Loading in these area should be reduced to 2.0 kPa. We require that these items be investigated in a Detailed Engineering Assessment. Loading plans should be displayed in these areas.

| Item No. | Observation | Recommended Action Plan | Recommended Timeline |
|---|---|---|---|
| 4 | Priority 1 - Uncontrolled heavy storage loading on 3rd floor of Building B. | Reduce stacking height to ensure total load does not exceed 2.0 kPa.<br>A Detailed Engineering Assessment is required to review the design and loads.<br>Factory Engineer to state the maximum weight that is allowed per square meter. Suggest that state the value on notice boards in these areas. (Loading Plans). | Immediate – Now |
| 5 | Priority 1 - Uncontrolled heavy storage loading on 3rd floor of Building B. | Adopt some sort of signage/staff guidance to ensure that the maximum weight of storage is not exceeded. (Loading Plans). | 6-weeks |
| 6 | Priority 1 - Uncontrolled heavy storage loading on 3rd floor of Building B. | Maintain standards of quality control to ensure that storage procedures are correctly followed so that overloading problems do not arise in the future.<br>Maintain and implement Loading Plans. | 6-months |

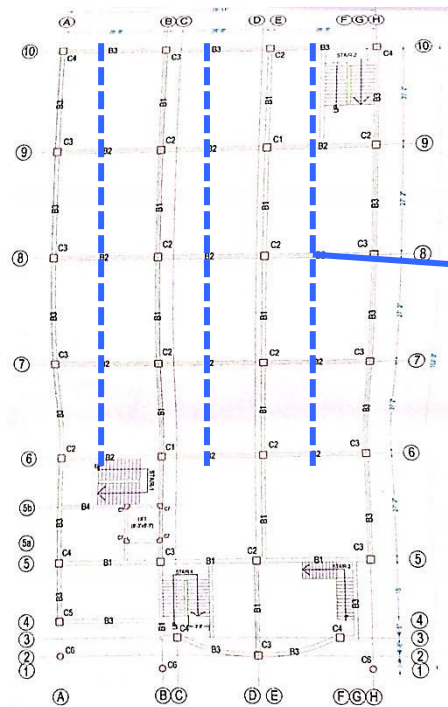
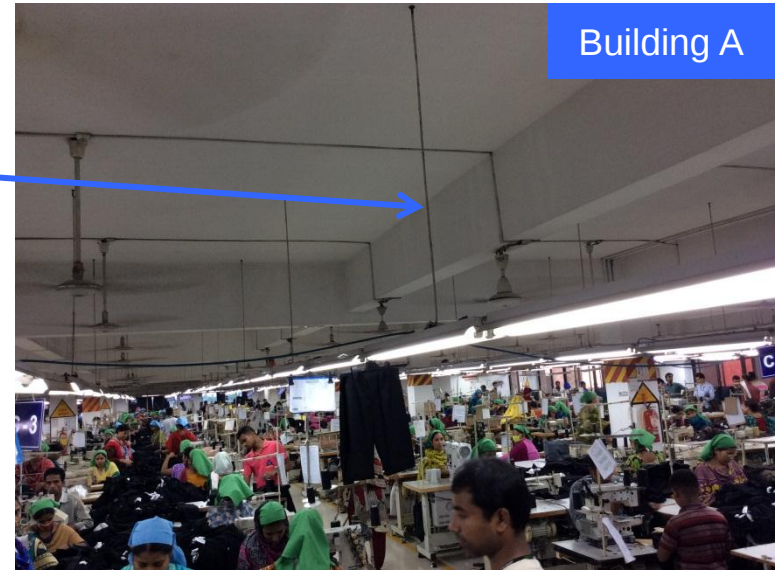
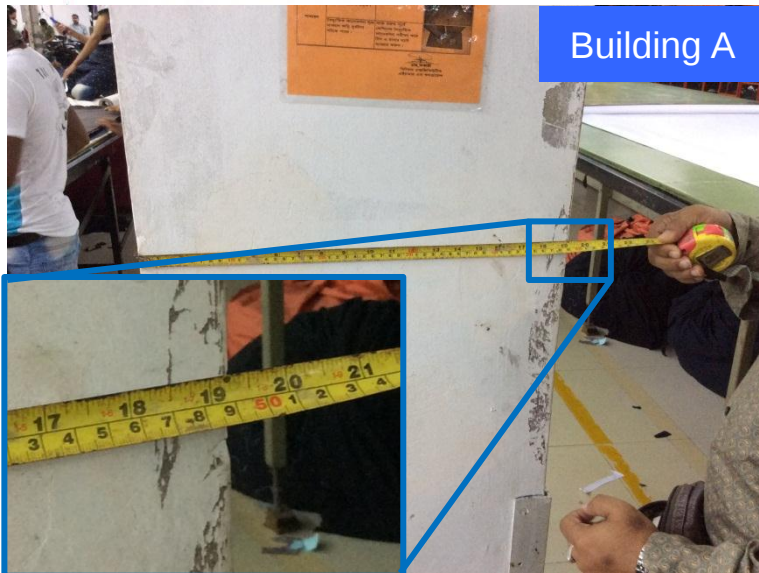
There are sub beams noted at mid span at Building A as shown.

The size of columns and beams measured in situ do not match those specified in the structural drawings of Building A.

There is no yield strength of steel or steel grade specified in the structural drawings of Building B.

The structural drawings of Building A and Building B need to be revised.

| Item No. | Observation | Recommended Action Plan | Recommended Timeline |
|---|---|---|---|
| 7 | Priority 2 - Inadequacies between the drawings and the actual as-built conditions. | Factory Engineer to survey the actual conditions and revise the drawings.<br>Any results of the Detailed Engineering Assessment which affect the structure should be taken on board. | 6-weeks |

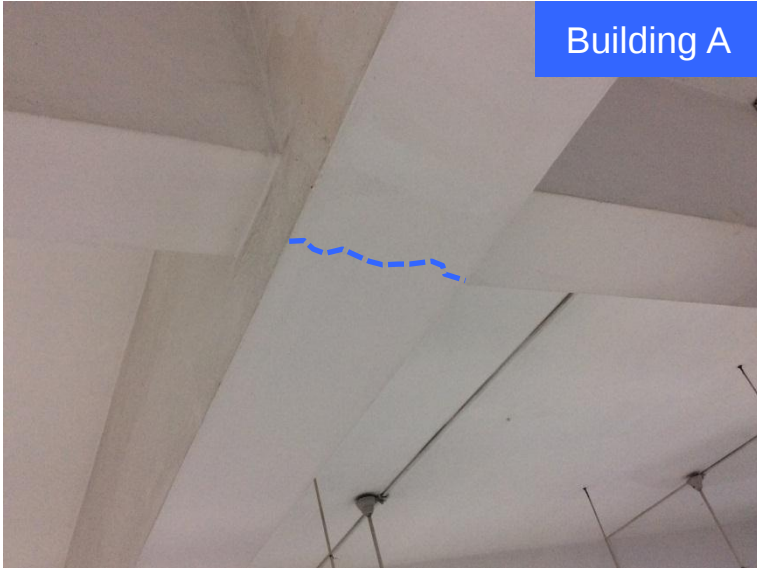
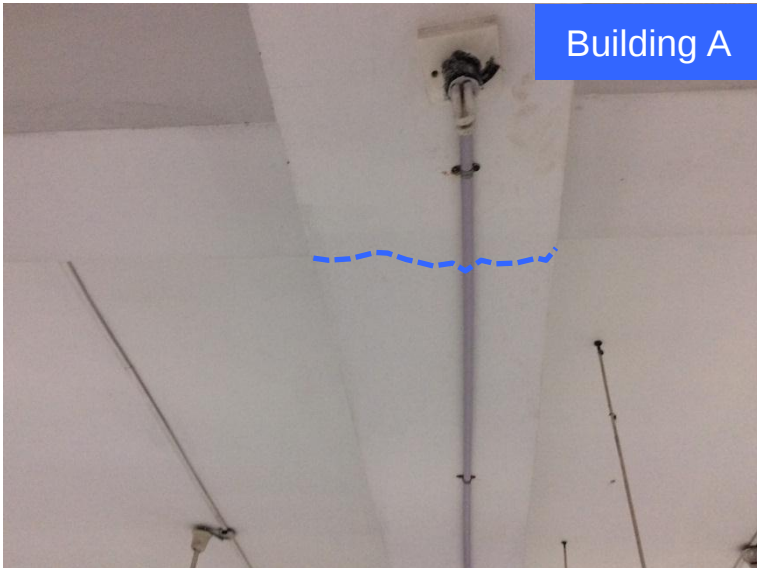
Cracks on 3<sup>rd</sup> floor beams at Building A. The cause of cracks should be investigated by appropriate methods and then repaired.

| Item No. | Observation | Recommended Action Plan | Recommended Timeline |
|---|---|---|---|
| 9 | Priority 2 - Cracks on 3rd floor beams of Building A. | The Factory Engineer to investigate the cause of cracks by appropriate methods.<br>The distress found is to be suitably rectified and then repaired. | 6-weeks |

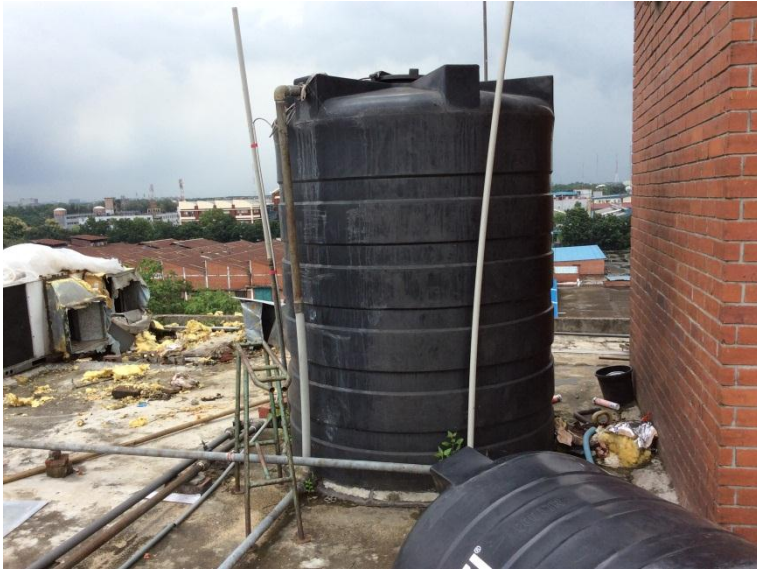
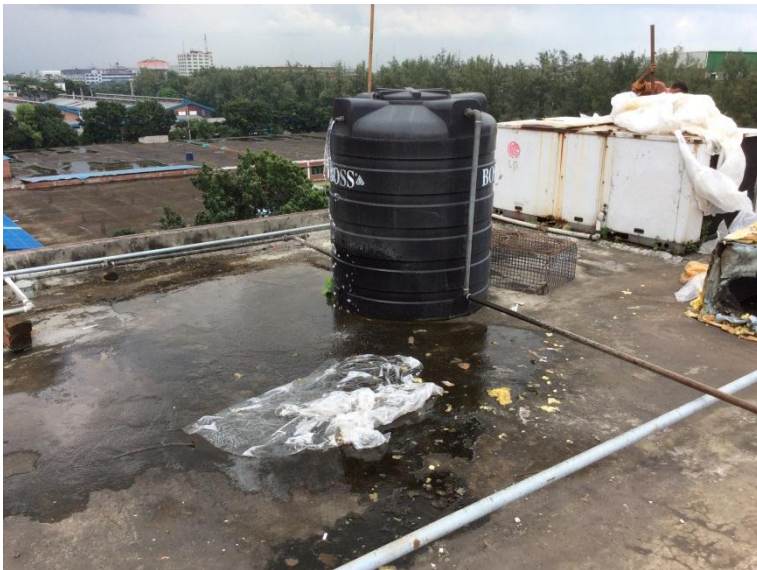
Concerns on the roof slab supporting water tanks. A capacity check of these slabs and all related elements need to be carried out.

| Item No. | Observation | Recommended Action Plan | Recommended Timeline |
|---|---|---|---|
| 10 | Priority 2 - Capacity check of roof slab supporting water tanks in Building A. | Factory Engineer to review design, loads and related elements in area identified above to confirm capacity for these items.<br>Or<br>The items in the area identified above should be removed. | 6-weeks |

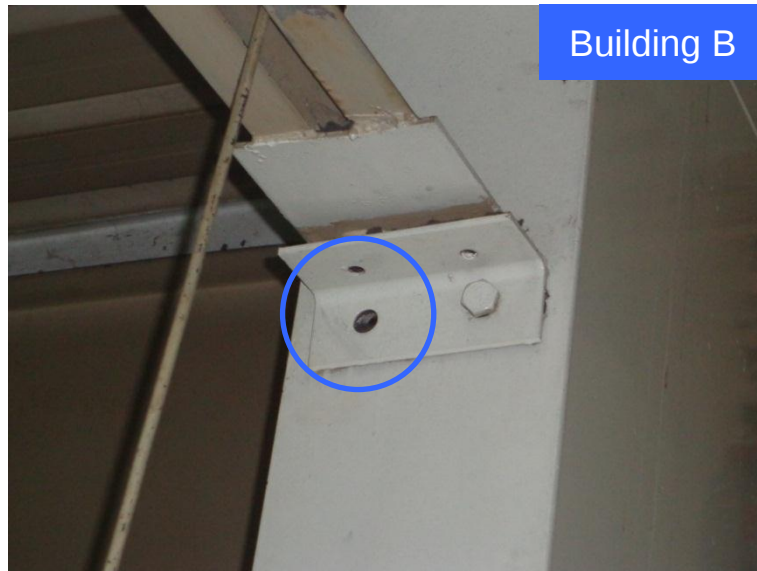
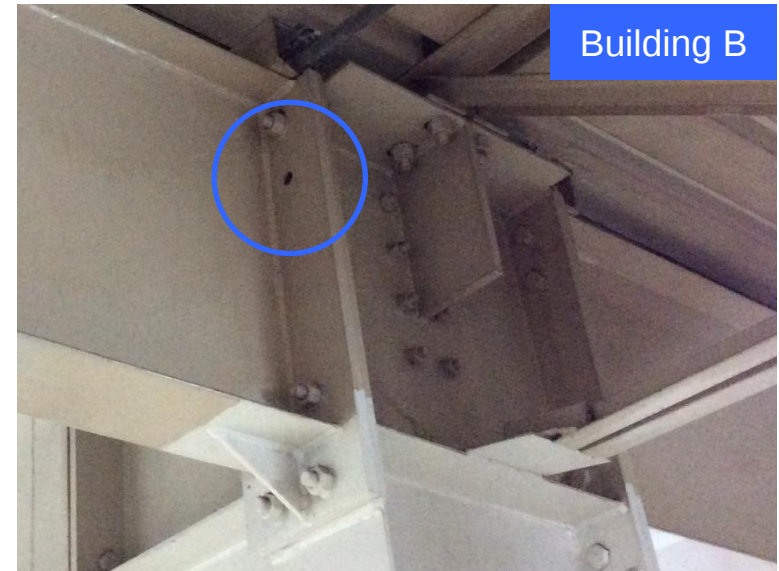
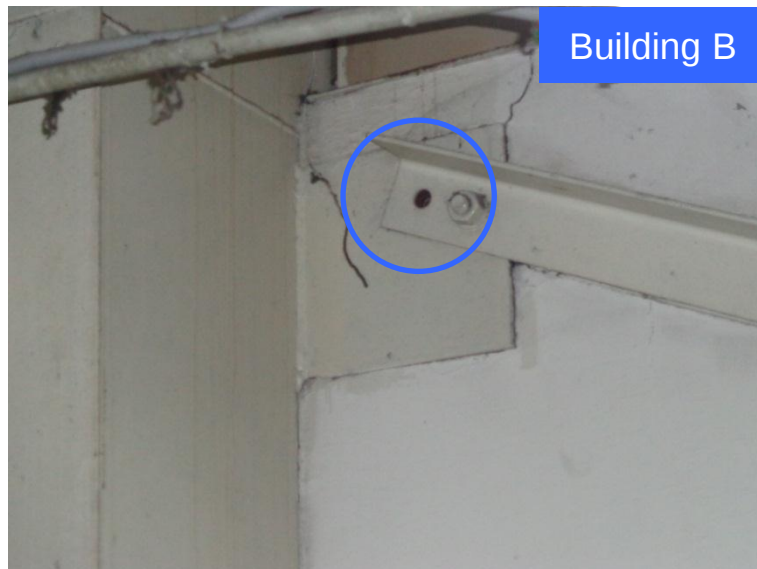
Concern on structural steel connections at Building B. Some bolts were missing at the connections. These items need to be checked and rectified.

| Item No. | Observation | Recommended Action Plan | Recommended Timeline |
|---|---|---|---|
| 11 | Priority 2 - Concern with structural steel connections of Building B. | Factory Engineer to check these items in the area identified above and rectify with a suitable methods. | 6-weeks |

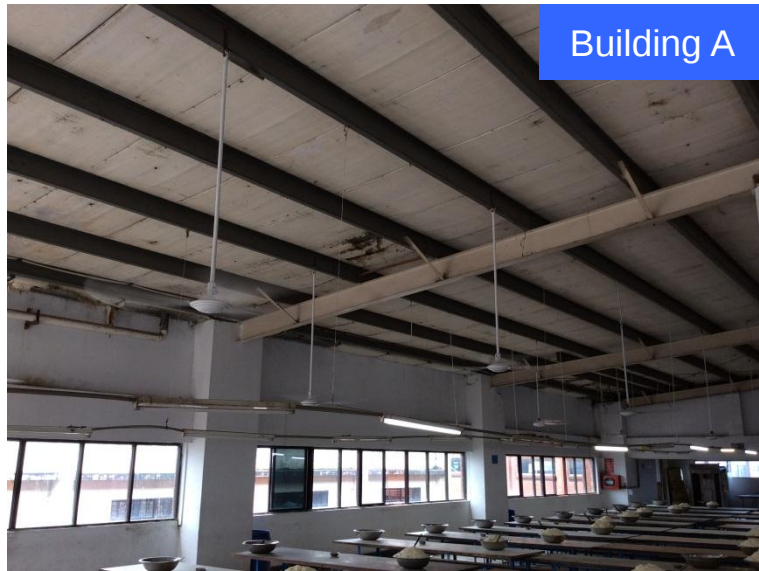
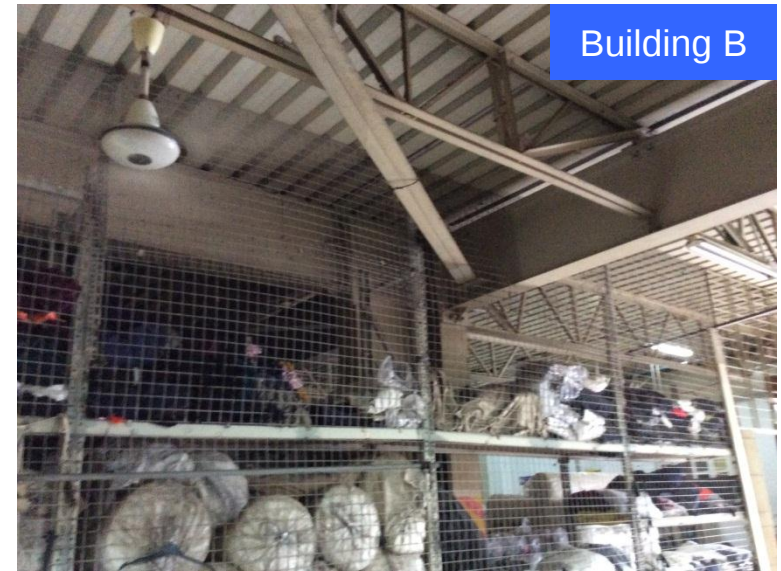
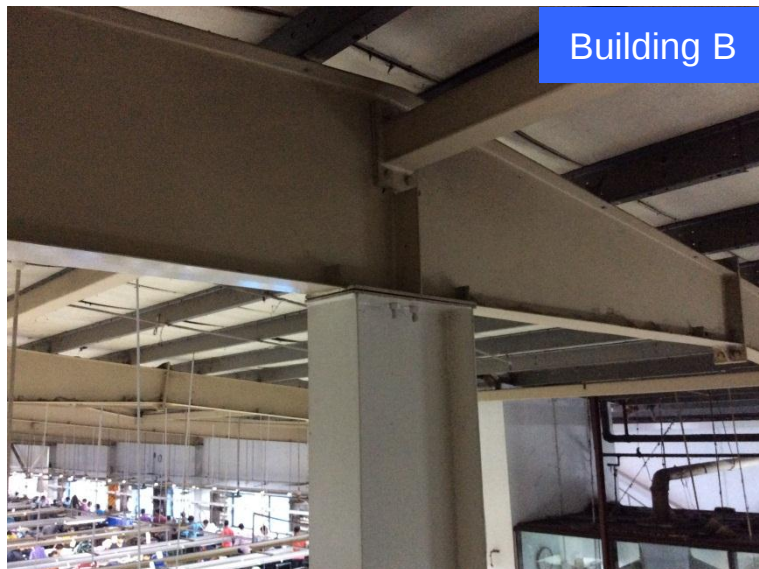
No fireproofing material was noted on structural steel elements (if required).

| Item No. | Observation | Recommended Action Plan | Recommended Timeline |
|---|---|---|---|
| 12 | Priority 2 - No fireproofing material on any structural steel elements (if required). | Fireproofing material for structural steel element is recommended as suggested in BNBC Codes.<br>Maintain standard of quality control and protection of the fire protection. | 6-weeks |

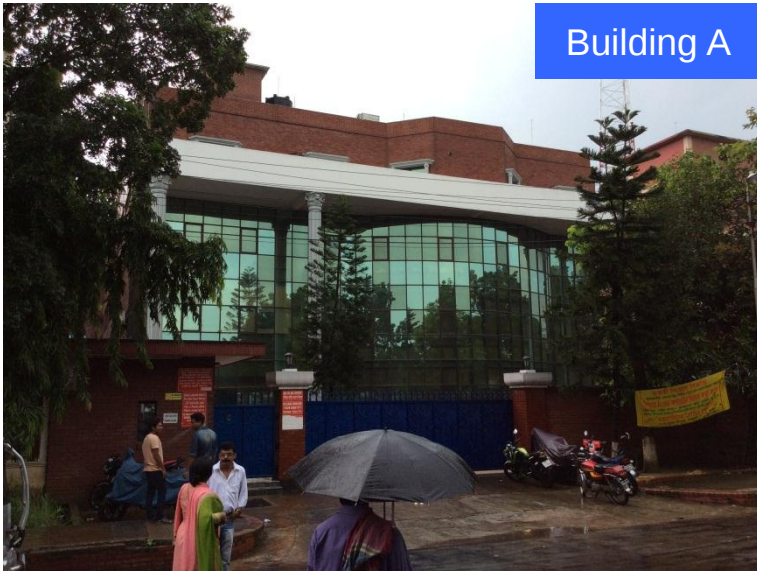
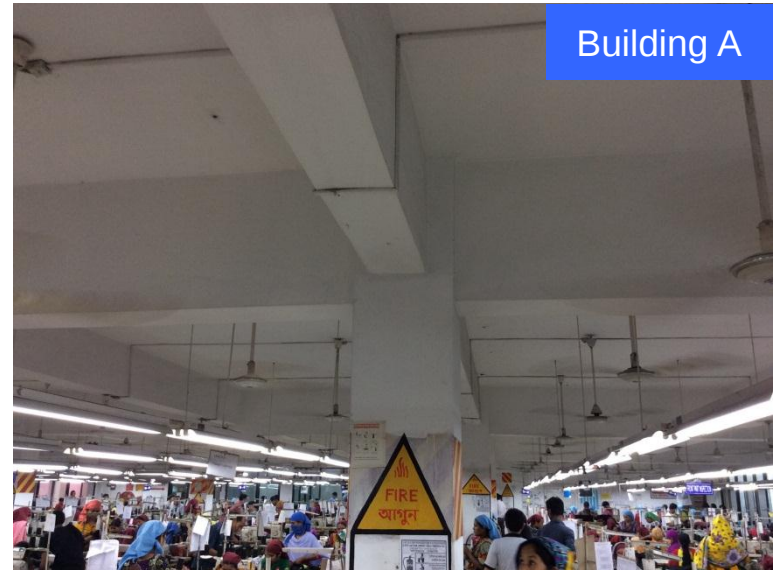
The lateral loading resistance for Building 1, a 5-storey building is provided by moment frame action without any shear wall and the façade brickwork walls lack moment capacity due to their poor connections with the surrounding columns and beams.

We require that the stability of Building A is investigated as part of a Detailed Engineering Assessment.

| Item No. | Observation | Recommended Action Plan | Recommended Timeline |
|---|---|---|---|
| 13 | Priority 2 - Overall stability system. | A Detailed Engineering Assessment of the overall building to be carried out and in particular, stability and foundation aspects should be investigated in detail. | 6-weeks |
| 14 | Priority 2 - Overall stability system. | Any recommendations of the DEA are to be completed fully. | 6-months |

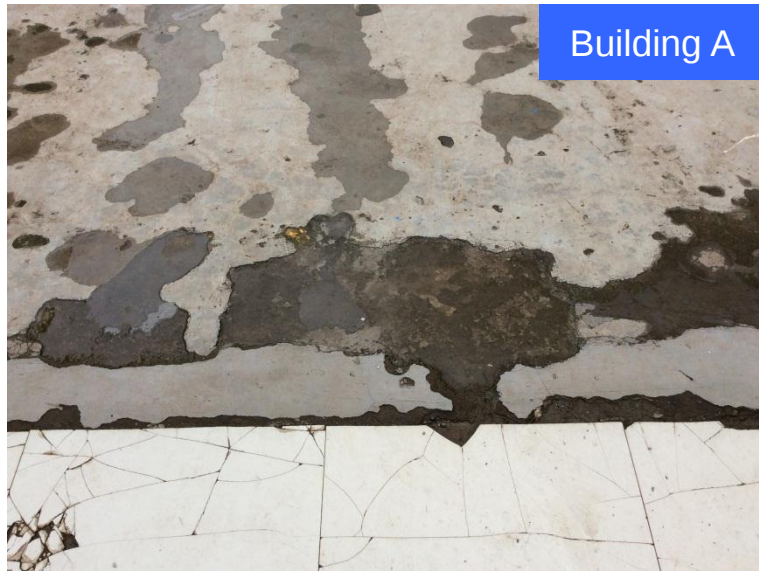
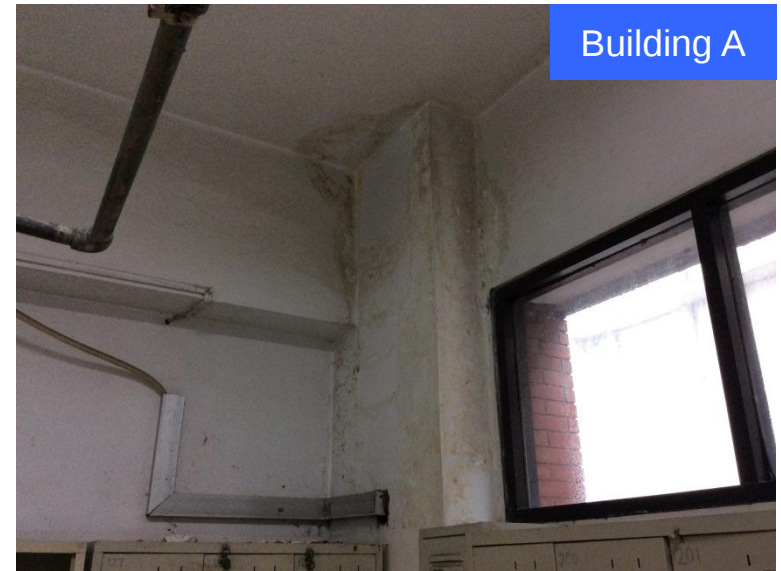
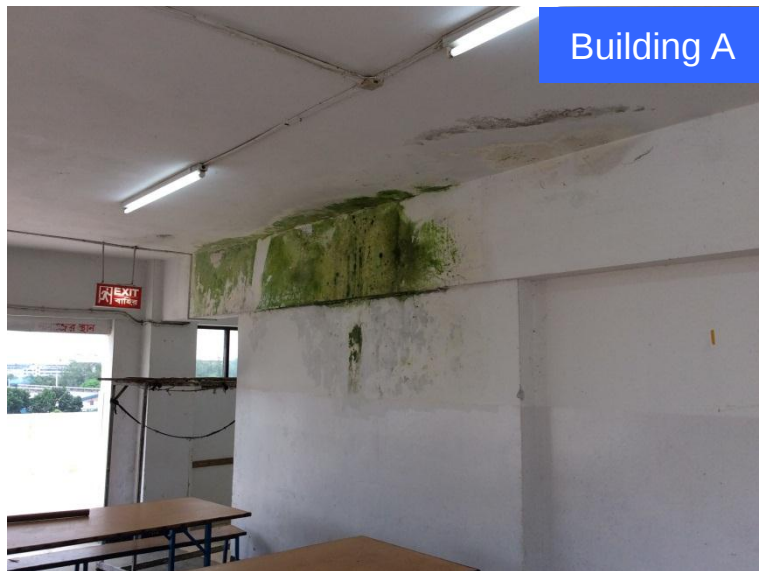
Water distress was noted on slabs, beams, columns and walls at Building A. Water ponding were also found on the top level of Building A.

| Item No. | Observation | Recommended Action Plan | Recommended Timeline |
|---|---|---|---|
| 15 | Priority 3 - Distress due to water ingress. | Factory Engineer to inspect water damaged structures and repair with a suitable methods.<br>Waterproofing on the roof slab is to be applied. Moreover the roof slab drainage system should be investigated and improved. | 6-months |
