# Snowtex Outerwear Ltd. (11803)

27.August.2014

# Identified Priority 1 Concerns

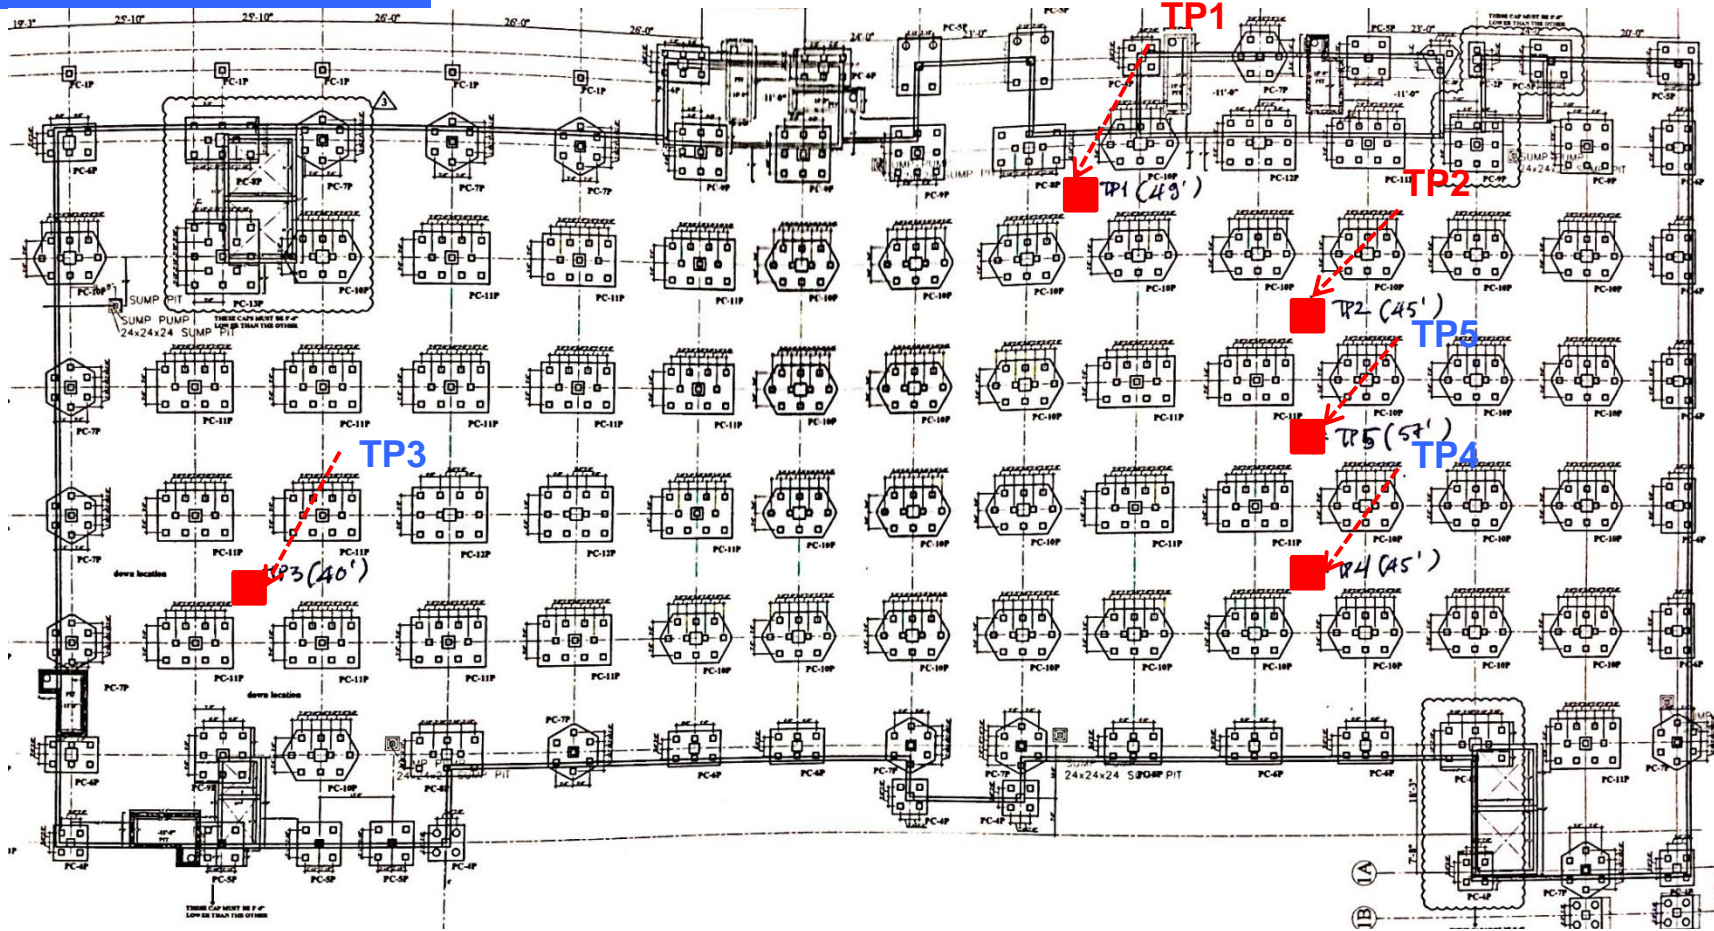
■ Test pile location

The foundations appear to be under designed with a pile capacity problem. See next page for details.

According to the Building Engineer and the Structural drawing, all the piles were driven to 13.7m. Therefore according to the soil report the pile design capacity is 55 Ton.

There are several problems with the soil report:

1. The test piles are not evenly spread over the building footprint.
2. The test piles are of different lengths.
3. The pile design loading does not consider the change in ground conditions throughout the site.
4. Test data was only provided for 3 piles.

We suggest that the pile foundation should be carefully reviewed and checked again using the existing pile capacity at a 13.7m length.

The Building Engineer should then revise the foundation capacities and determine any implications on floor loading, or number of floors.

We require that these items be investigated in an Engineering Assessment

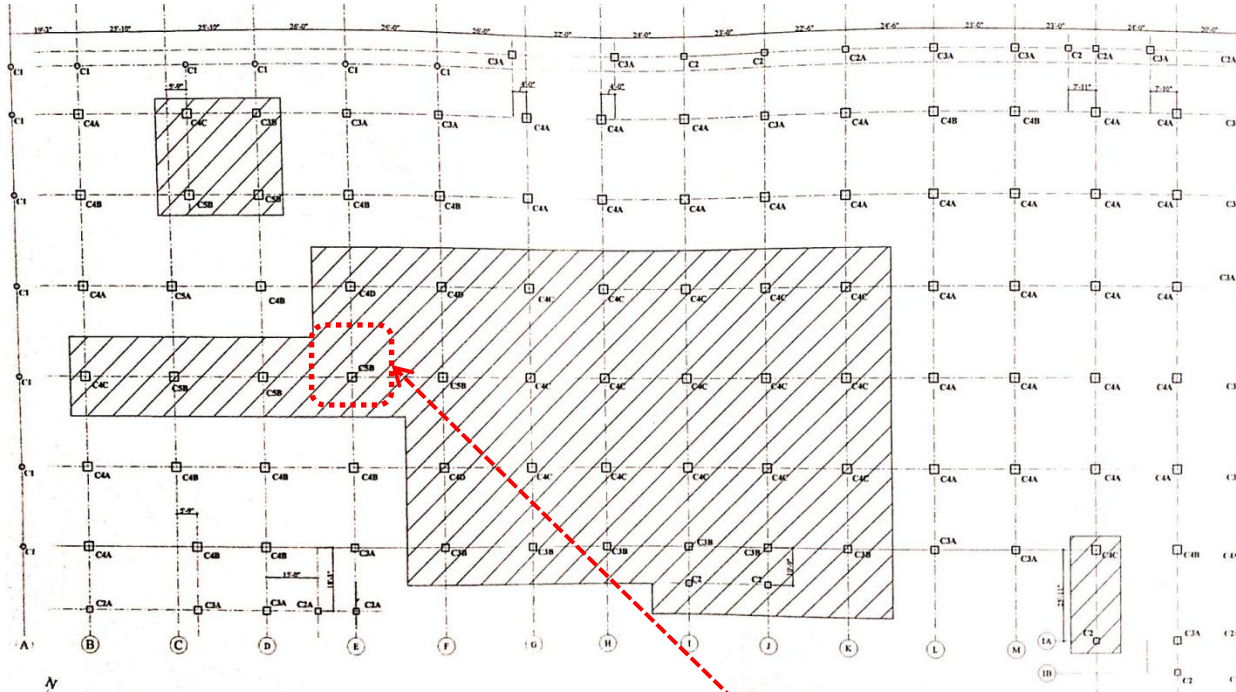
Column Layout Plan

Column to be checked

Based on the load rundown analysis of column C4D in the building with live load 120psf (6.0kPa) as the Building Engineer advised, the column appears to be overstressed.

**NOTE:** We were advised that the imposed loadings for each floor are 120psf (6kPa)

6	Priority 2 - The columns would appear to be overstressed if the floor loads were the actual suggested design loads of 120psf.	Once the re-analysis is complete re-confirm the actual allowable floor loadings.	6-months
7	Priority 2 - The exact floor loads are unknown and need to be verified.	Produce loading plans for each floor of the building as per design live load based on the findings from items 2 & 3.	6-weeks

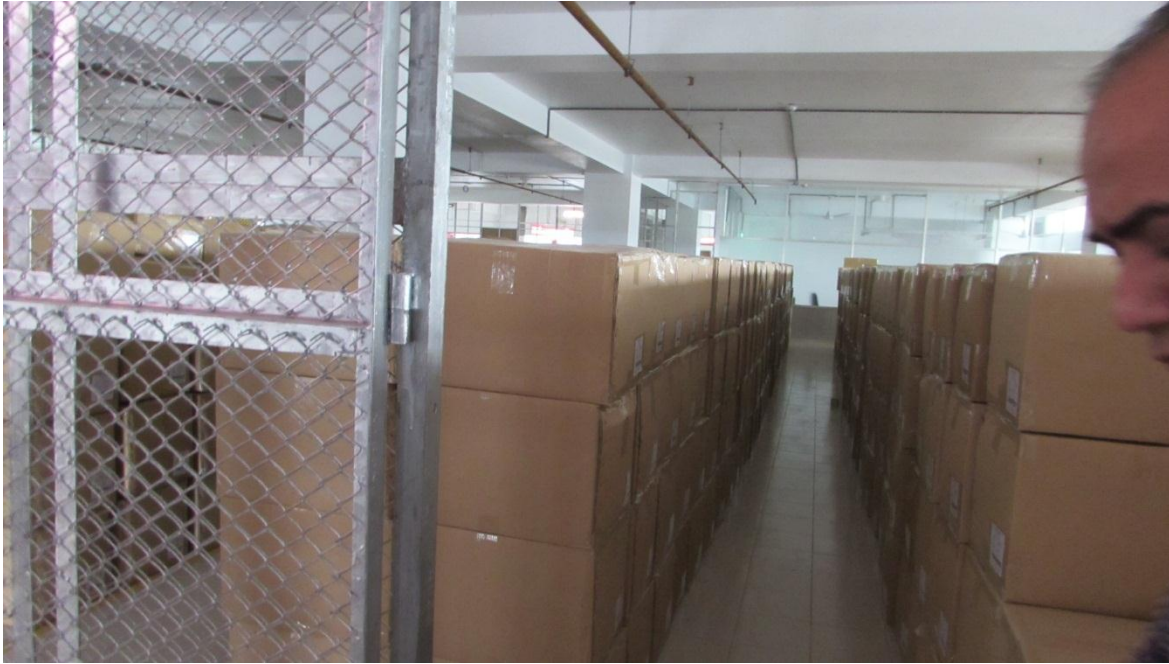
The exact floor loads are unknown and need to be verified.

Produce loading plans for each floor to make sure of no overloading.

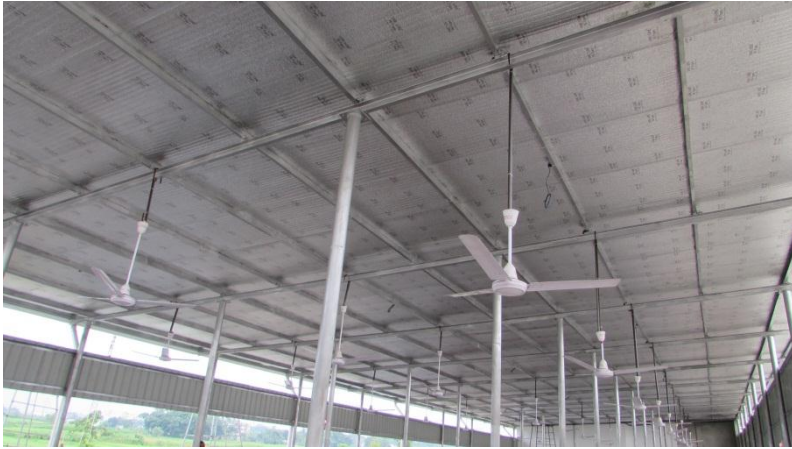
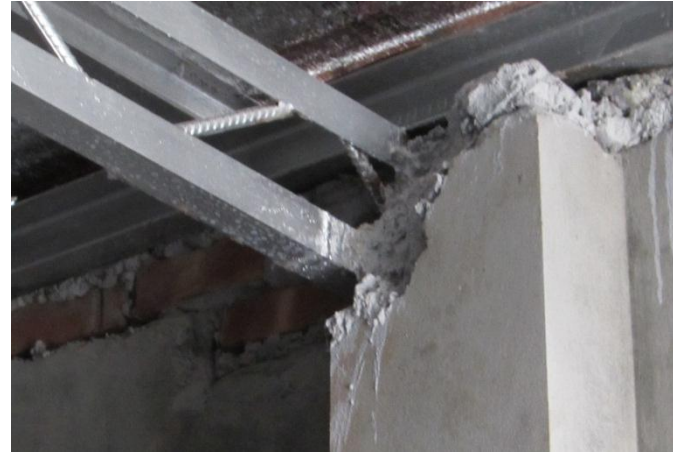
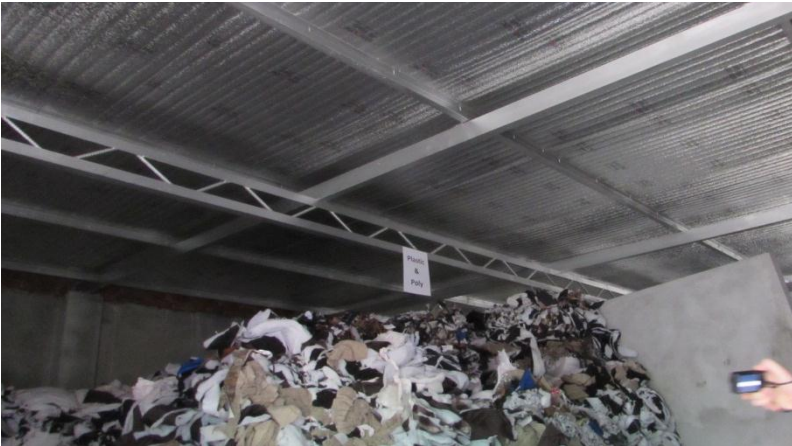
Inadequate steel detailing to any of the shed buildings.

Item No.	Observation	Recommended Action Plan	Recommended Timeline
8	Priority 2 - Inadequate steel detailing to any of the shed buildings.	Building Engineer to review and check the stability structure of the building under wind load and the steel to masonry connections.	6-weeks
9	Priority 2 - Inadequate steel detailing to any of the shed buildings.	A bracing system needs to be provided and the connections need to be repaired properly. Steel – masonry connections to be strengthened accordingly.	6-months
10	Priority 2 - Several temporary buildings around the complex.	Building Engineer to inspect all “Temporary Buildings” to establish present condition. Demolish or repair “Temporary Buildings” as necessary.	6-weeks
11	Priority 2 - There are errors in the sections on the building permission drawings with the number of storeys.	One section of the drawing needs to be revised to show 6 storeys throughout to avoid any misunderstanding in the construction process.	6-weeks

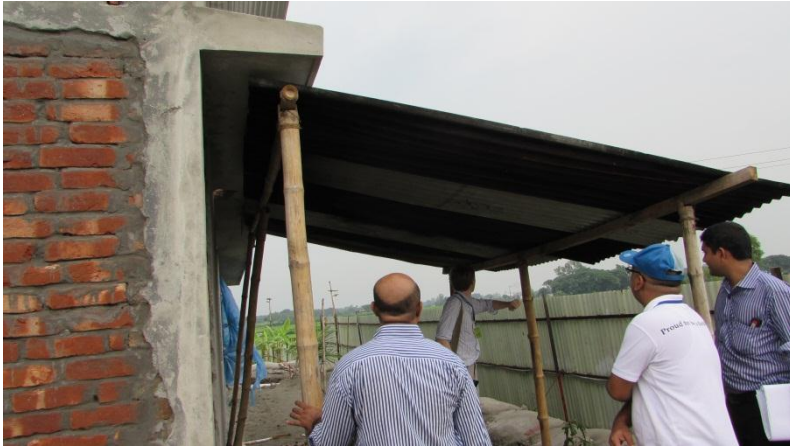
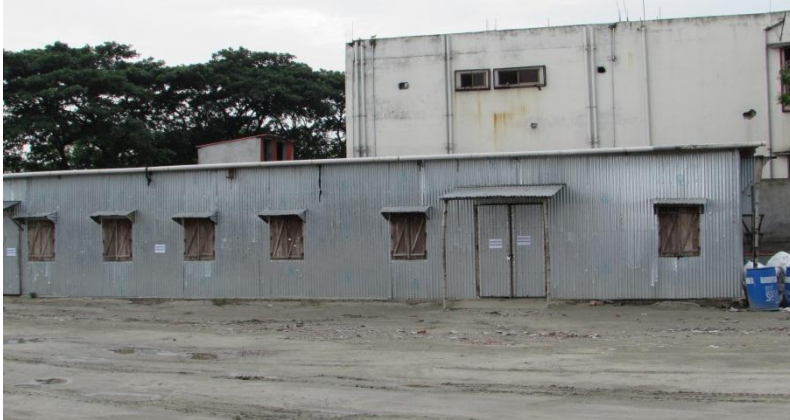
Several temporary buildings around the complex.

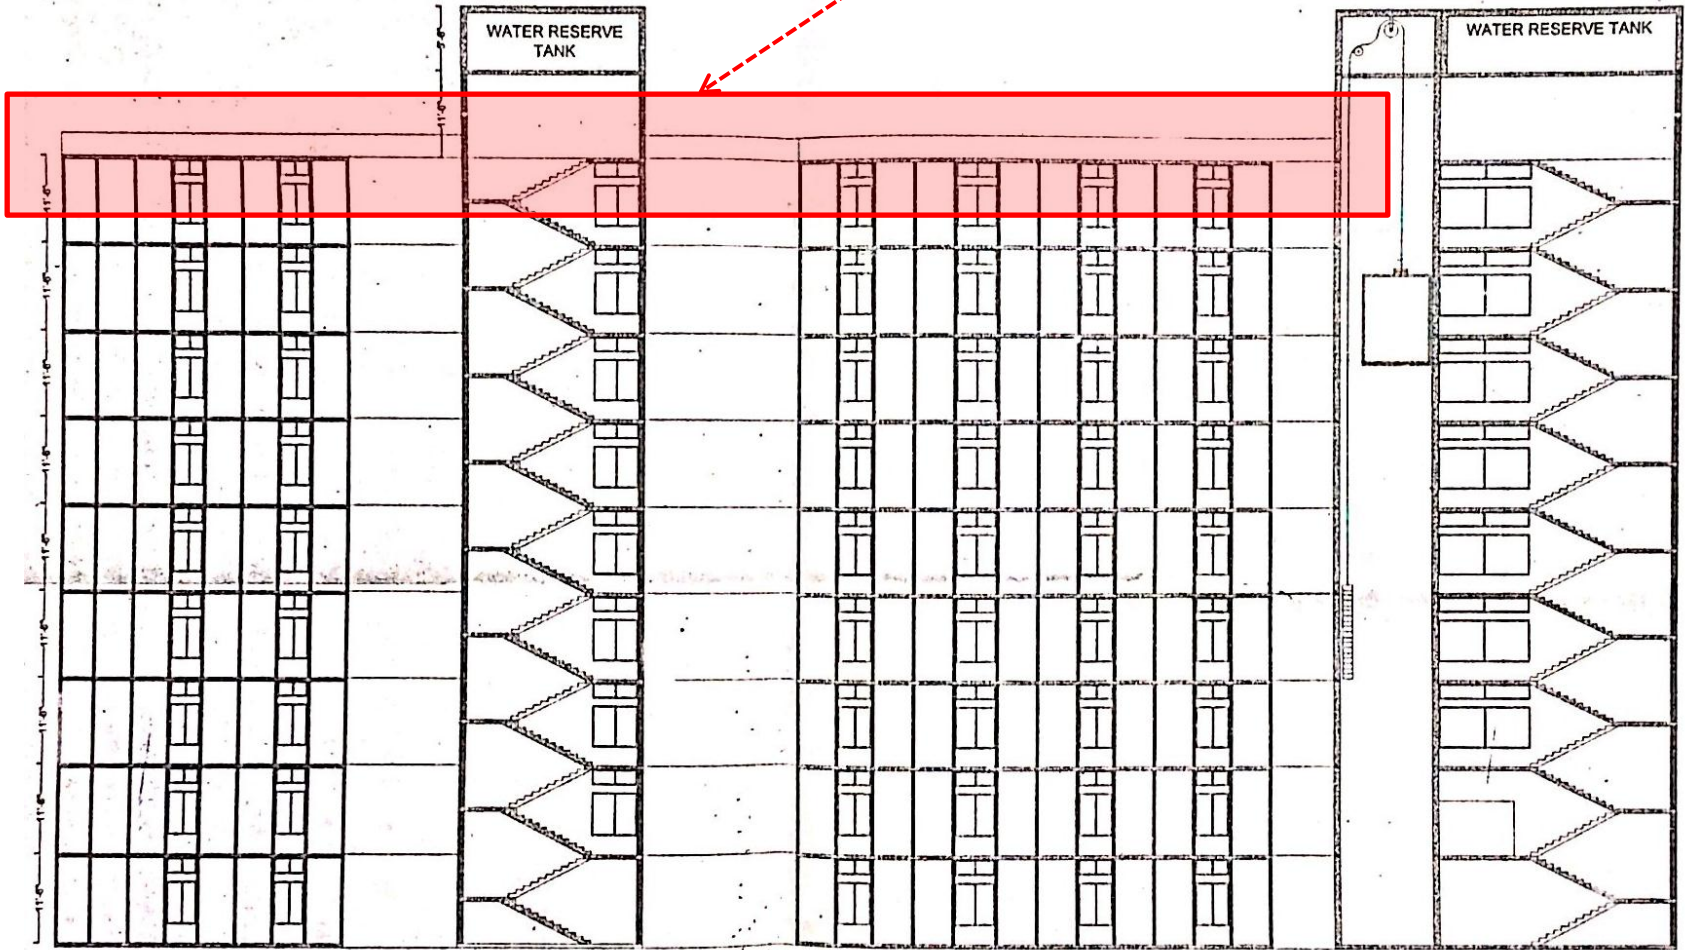
SECTION DD  
SCALE 3" = 32' 0"

Additional storey shown on section D-D

There are errors in the sections on the building permission drawings with the number of storeys.

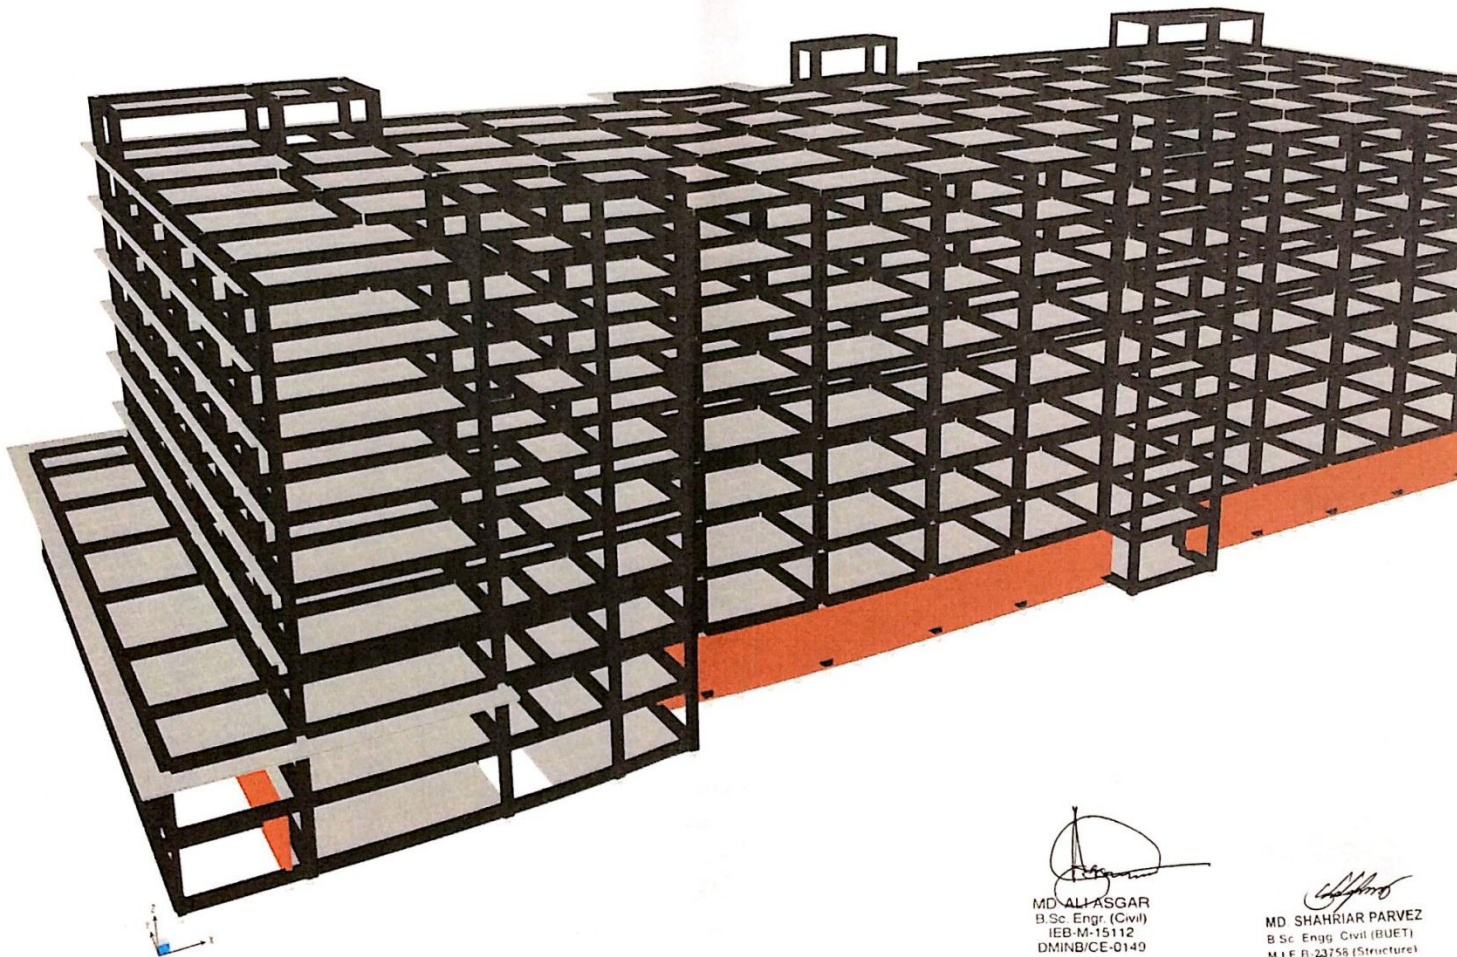
The building did not feature any core or shear walls. Stability was achieved through sway action between beams and columns and masonry infill walls.

A 3D analysis has been carried out however, we were shown no concrete frame design based on this analysis.

We require that this item is investigated in an Engineering Assessment

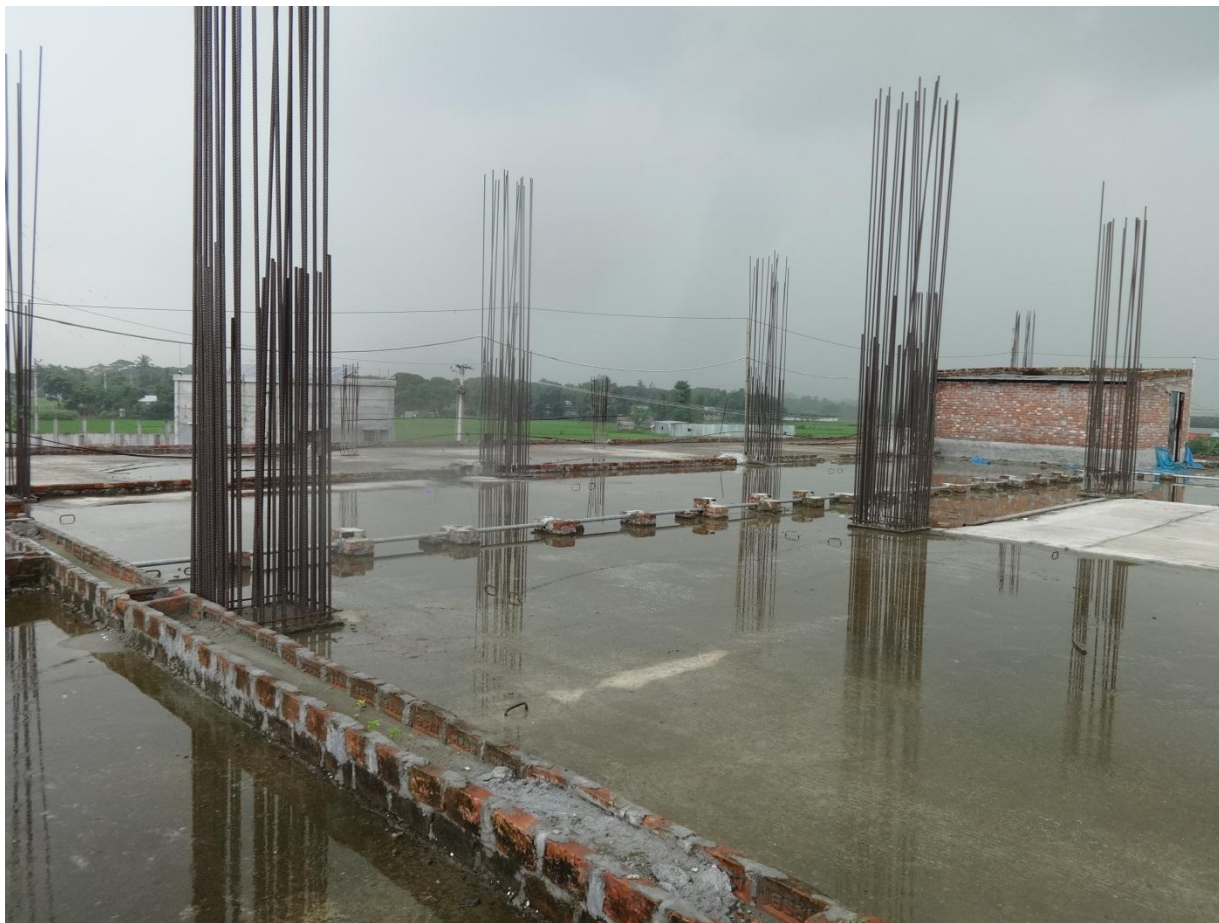
No permanent roof currently exists as construction is ongoing, therefore no waterproofing membrane exists on the upper floor of the building. This means that any cracks in the surface finishes on the roof will allow water to seep into the concrete slab beneath the finishes, and cause corrosion of the reinforcing steel. We would recommend a waterproof membrane is applied to the roof of the building at the end of construction, or an upper level if construction is to stop for more than one year.

12	Priority 3 - No waterproofing membrane to the roof.	A waterproof membrane needs to be applied to the roof of the building at the end of construction, or an upper level if construction is to stop for more than one year.	6-months
