# MZM (CEPZ) Ltd. (11782)

Plot # 8-9, Sector # 2/A, CEPZ, Chittagong-4223

30.August.2014

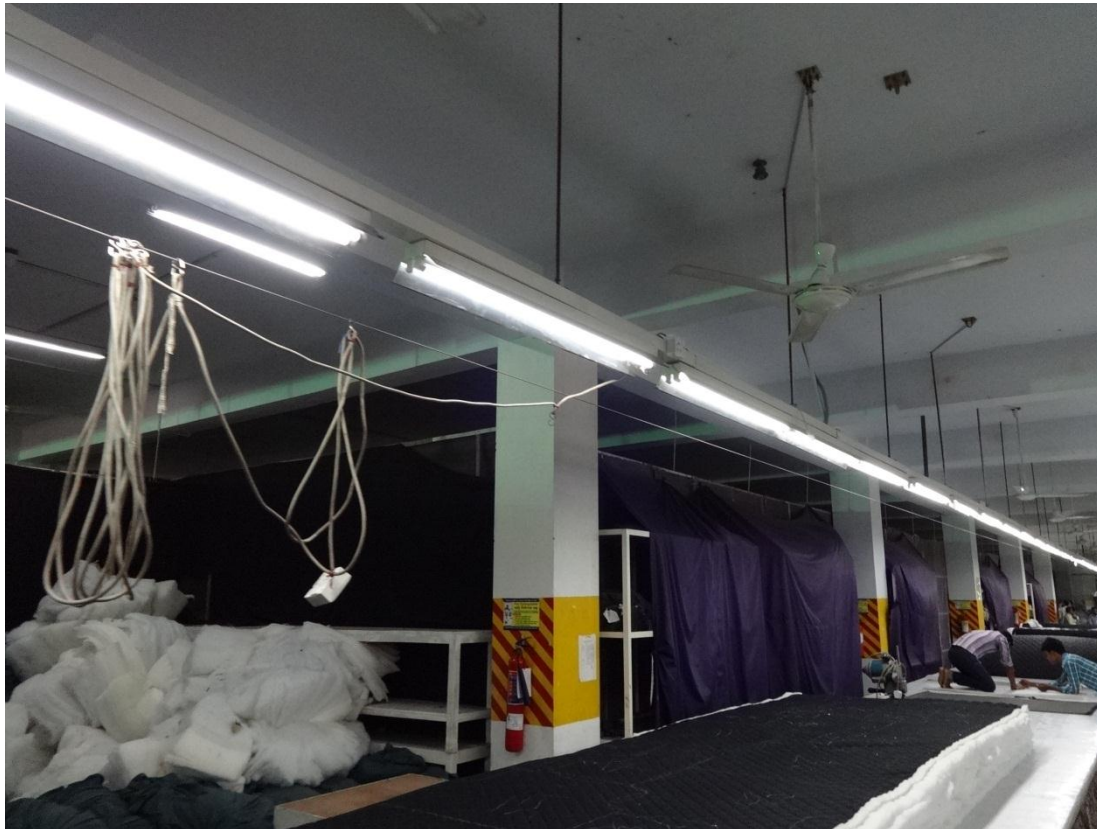
## 1<sup>st</sup> Priority 1 Concern

High column stresses to all internal column. The factor of safety was found to be between 1.25 & 1.5 for C2 columns and between 1.86 & 1.5 for C1 columns by calculation based on existing loadings.

| Item No. | Observation | Recommended Action Plan | Recommended Timeline |
|---|---|---|---|
| 1 | Priority 1 - High column stresses to all internal columns. | Remove any stored yarn / cloth from the upper slabs.<br>Ensure that the load on the upper slabs does not exceed 40psf (2.0kPa) | Immediate – Now |
| 2 | Priority 1 - High column stresses to all internal columns. | Carry out a Detailed Engineering Assessment on the building, involving all actions described in the slide at the end of the report. | 6-weeks |
| 3 | Priority 1 - High column stresses to all internal columns. | Carry out the recommendations highlighted in the Detailed Engineering Assessment. | 6-months |

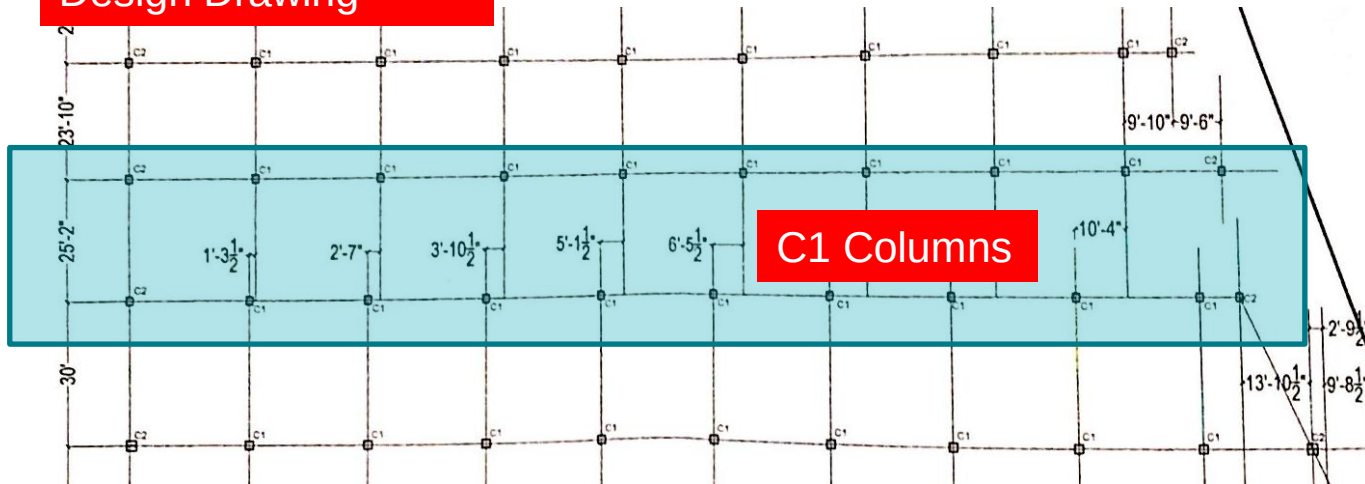
### Design Drawing

The column types changes between the Design Drawings and the “As Built” drawings along the central section of the building.

| Item No. | Observation | Recommended Action Plan | Recommended Timeline |
|---|---|---|---|
| 4 | Priority 1 - Structural design drawings do not match structural as built drawings and neither match the “As Built” condition of the building. | Re survey the building as part of a Detailed Engineering Assessment and revise the drawings to match the site conditions. | Immediate – Now |

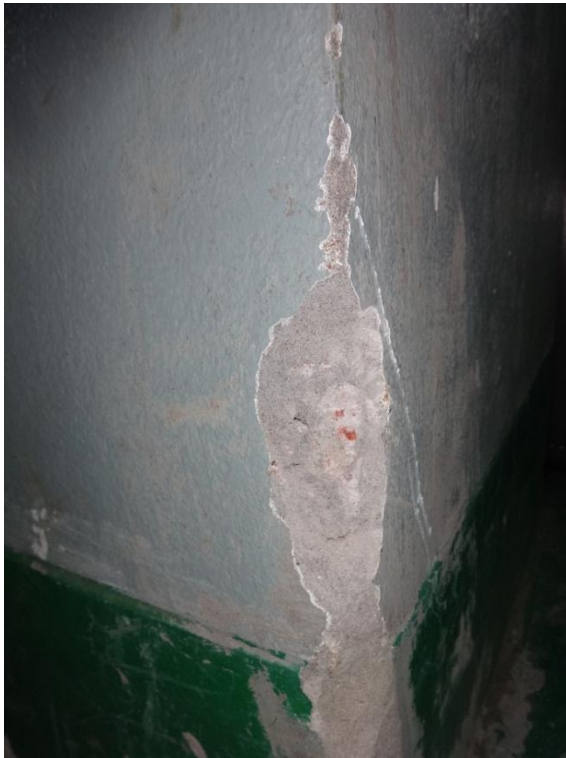
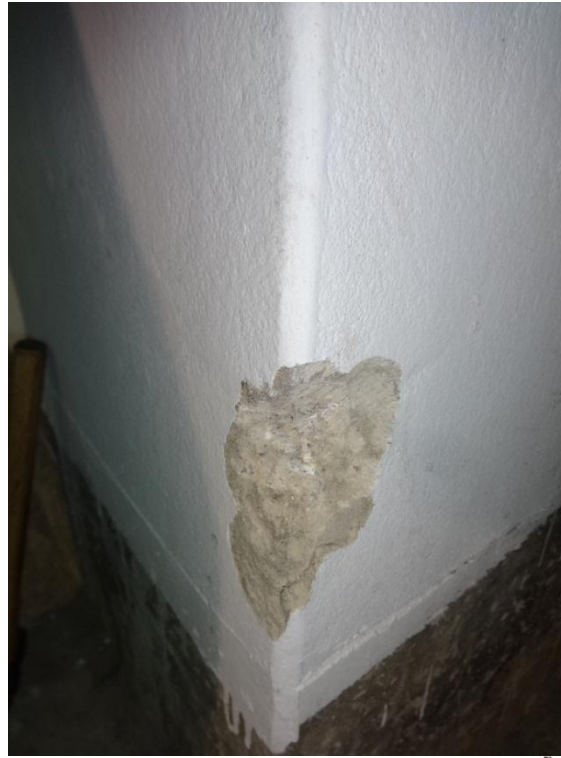
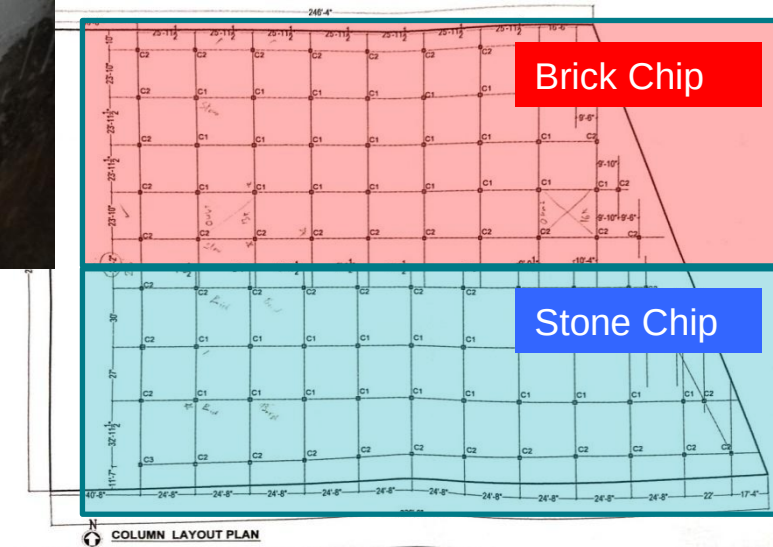
The coarse aggregate in the columns differs from brick to stone throughout the building.

The drawings detail stone chip to all columns.

It would appear that the North part of the building uses brick chips and the South part uses stone chips based on our limited intrusive survey. It would be necessary to check more columns at all levels to determine which columns use brick aggregate.

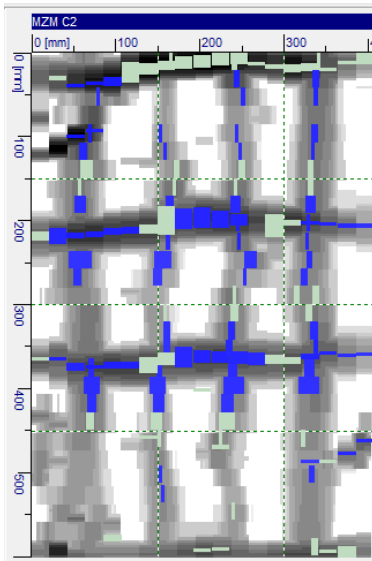
The reinforcement discovered during the Ferro-scanning did not match the structural “As Built” drawings.

The scans for the C2 column (left) clearly show 12N° 25mmØ bars. While the drawings show 14 N° 25mmØ bars.

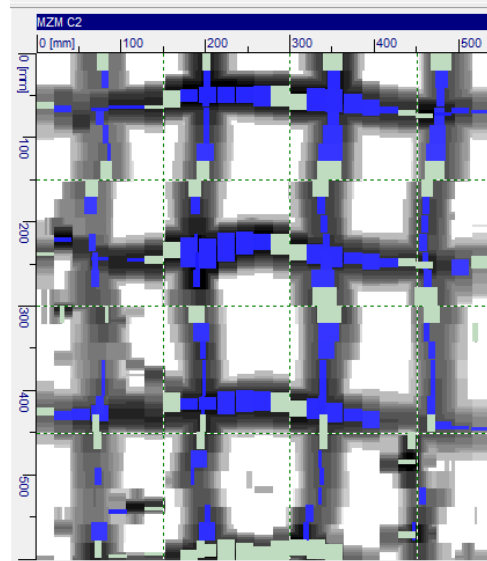
The scans for the C2 column shows 16N° 25mmØ bars. While the drawings show 24N° 25mmØ bars.

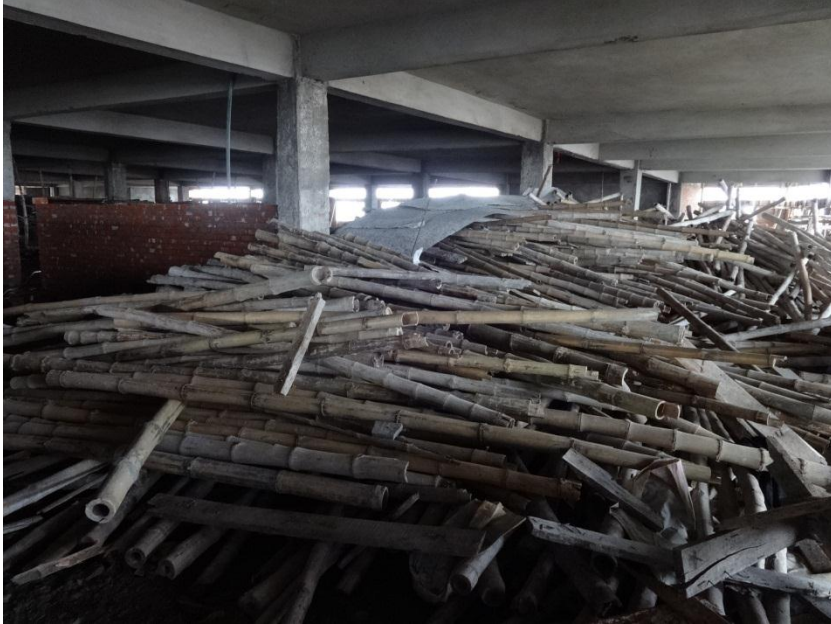
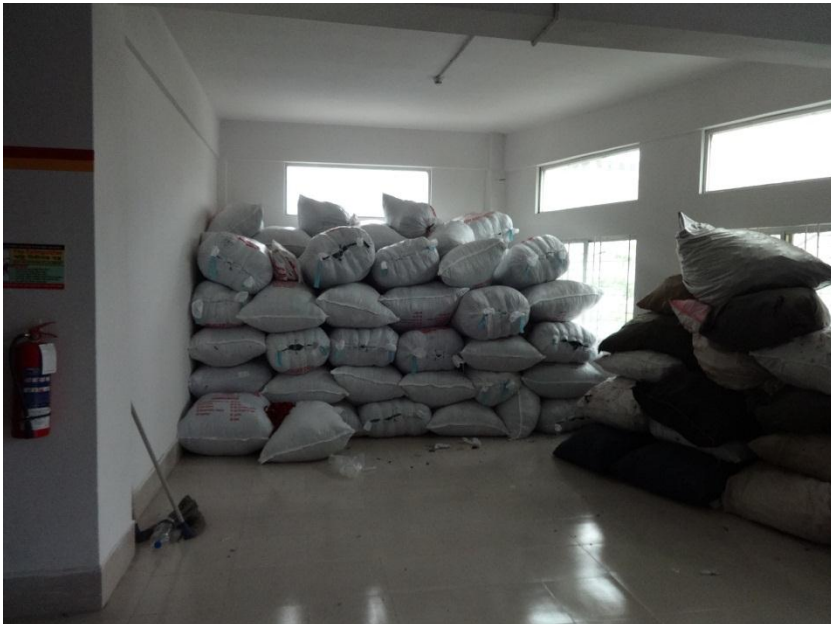
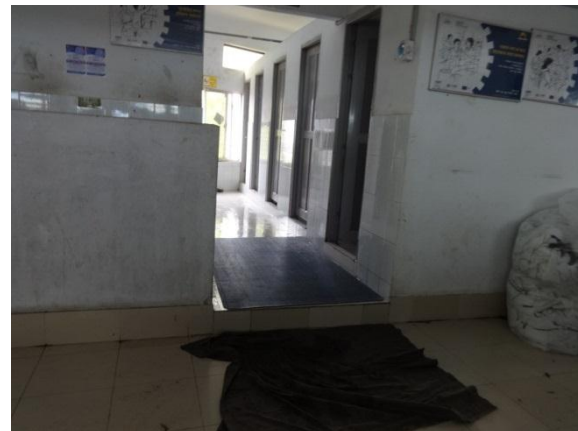
The allowable loading for the building is unknown

We were advised that the floors were designed for 80psf. Given the columns have been constructed considerably smaller than the original design the allowable loading will be greatly reduced.

Plinths have been constructed around the toilets at 1<sup>st</sup> floor, we recommend that the increase in dead load is also checked as part of the Detailed Engineering Assessment.

We would advise that the suspended floors are not loaded above 40psf (2.0kPa) until a Detailed Engineering Assessment is undertaken.

| Item No. | Observation | Recommended Action Plan | Recommended Timeline |
|---|---|---|---|
| 7 | Priority 1 - The allowable loading for the building is unknown. | Ensure that the load on the upper slabs does not exceed 40psf (2.0kPa)<br>Carry out a Detailed Engineering Assessment on the building to verify the allowable imposed load for each level. | Immediate – Now |
| 8 | Priority 1 - The allowable loading for the building is unknown. | Produce loading plans for each level.<br>Ensure these are displayed and actively managed. | 6-weeks |

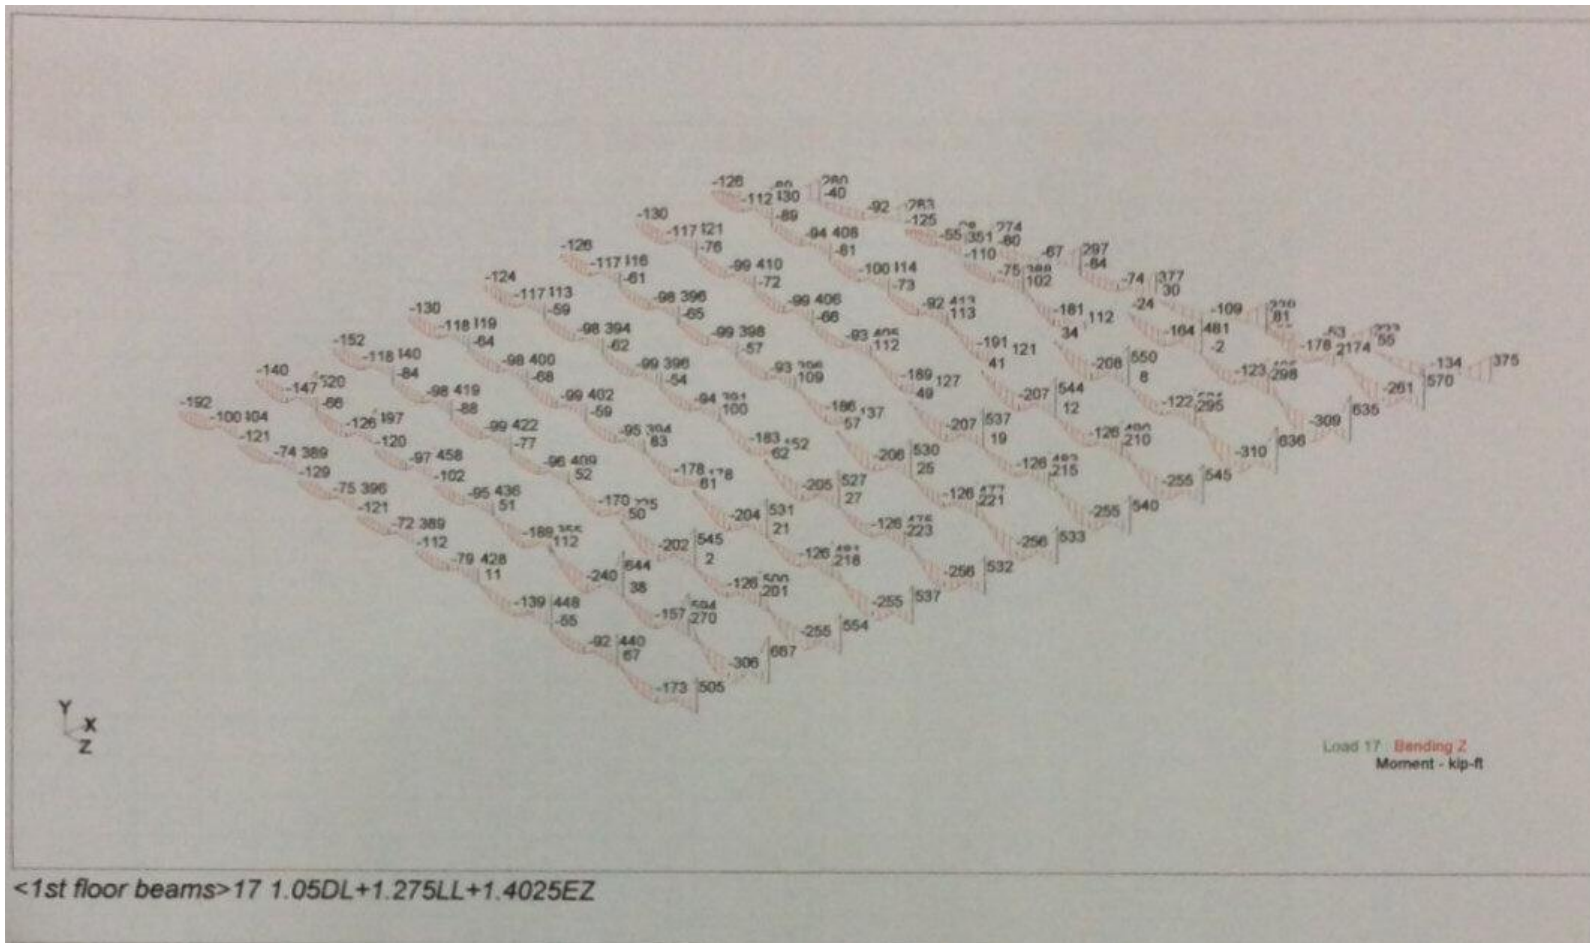
# Overall Stability System

The building did not feature any core or shear walls. Stability was achieved through sway action between beams and columns and masonry infill walls.

A analysis has been carried out however, we were not shown any concrete design based on this analysis.

We require that these items are investigated in a Detail Engineering Assessment

| Item No. | Observation | Recommended Action Plan | Recommended Timeline |
|---|---|---|---|
| 5 | Priority 1 - Unknown stability system. | Carry out a Detailed Engineering Assessment on the building to verify that it is stable under lateral loading. | 6-weeks |
| 6 | Priority 1 - Unknown stability system. | Carry out all recommendations of the Detailed Engineering Assessment. | 6-months |

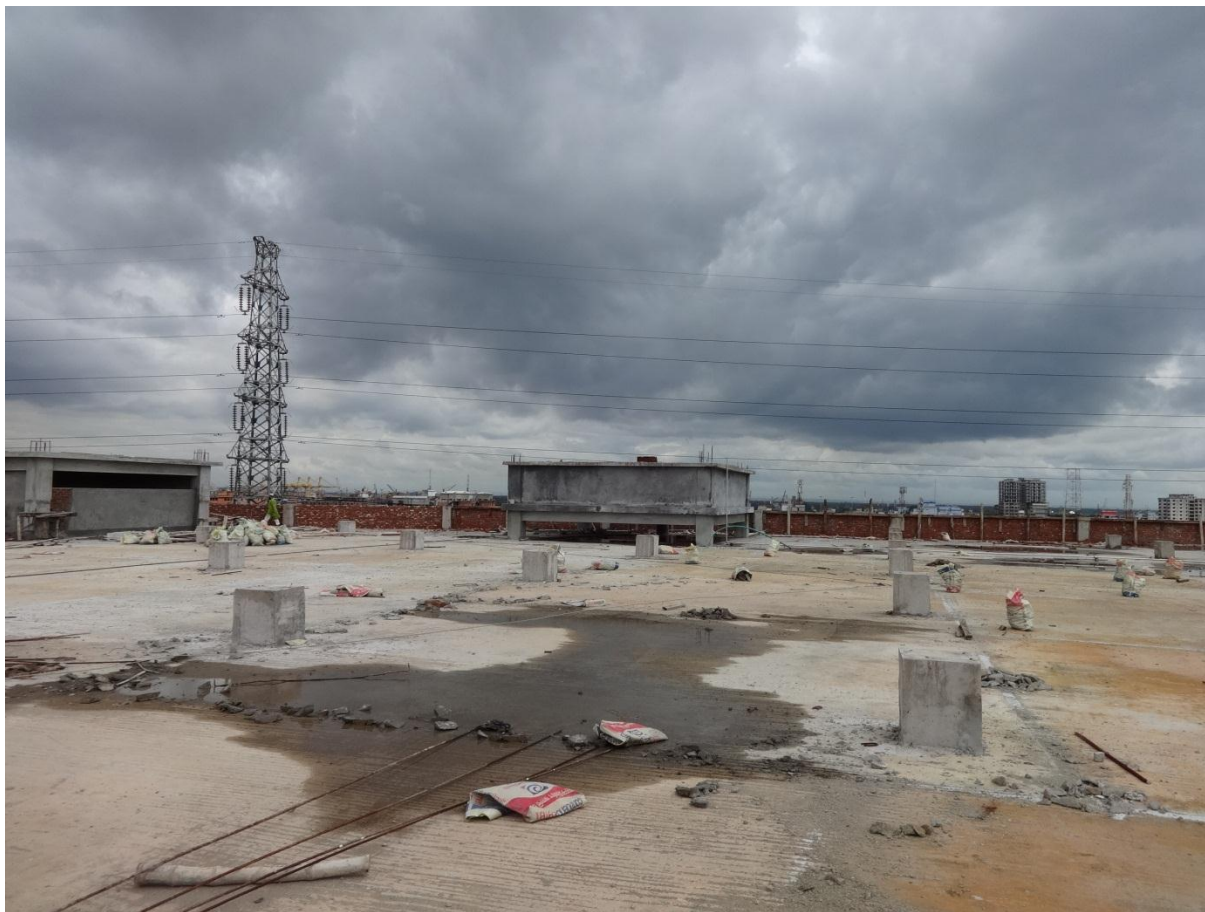
# Water Ingress at Roof Level

No permanent roof currently exists as construction is ongoing, therefore no waterproofing membrane exists on the upper floor of the building. This means that any cracks in the surface finishes on the roof will allow water to seep into the concrete slab beneath the finishes and cause corrosion of the reinforcing steel. We would recommend a waterproof membrane is applied to the roof of the building at the end of construction, or to an upper level, if construction is to stop for more than one year.

| Item No. | Observation | Recommended Action Plan | Recommended Timeline |
|---|---|---|---|
| 9 | Priority 3 - No waterproof membrane to the roof. | Apply a suitable waterproofing membrane to the roof once construction has finished. | 6-months |
