Rising Fashions Ltd.

Plot 16, Block-k, Rupnagar I/A, Mirpur-2, Dhaka-1216

17 September 2013

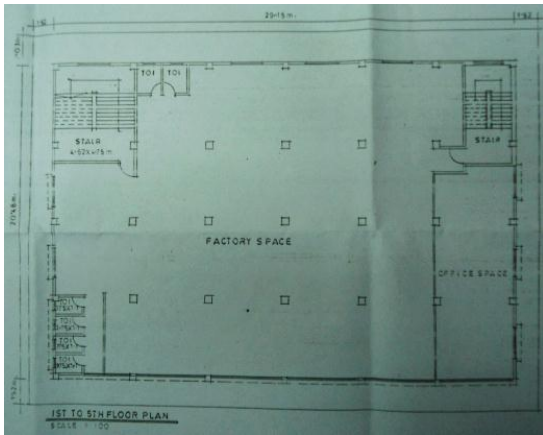
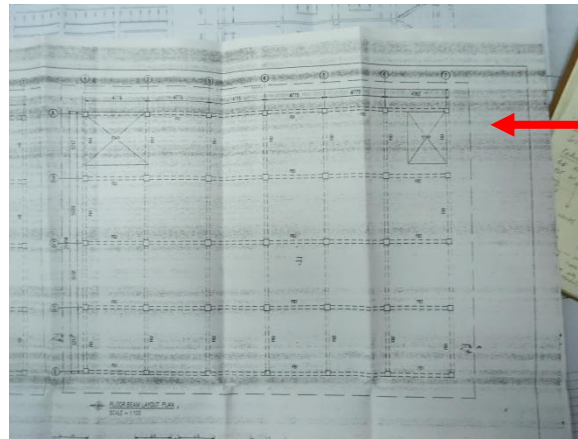
Architecture, Structure, Industrial drawings agree with the building

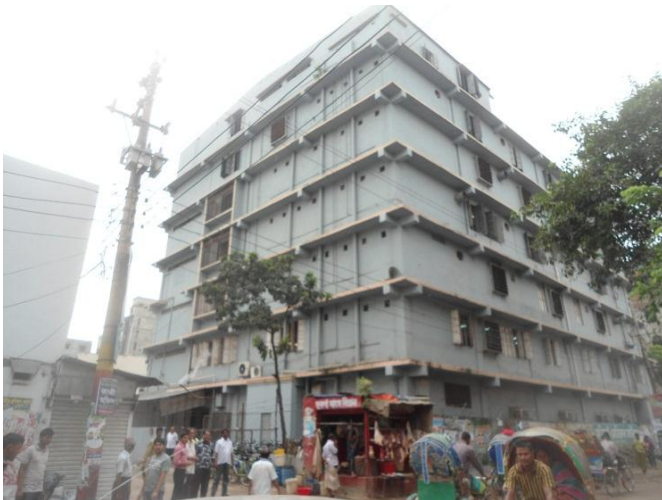
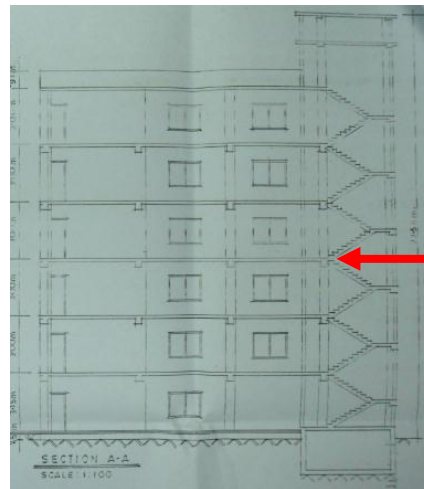
Column grid and column sizes agree with structural drawings

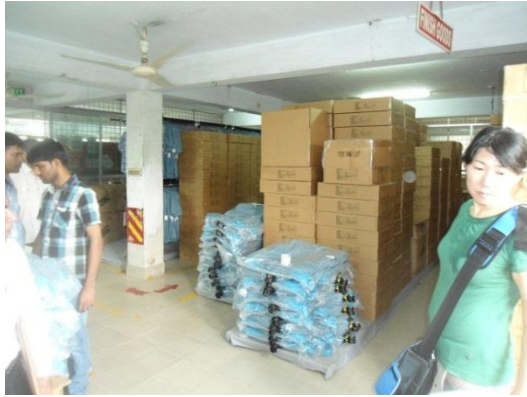
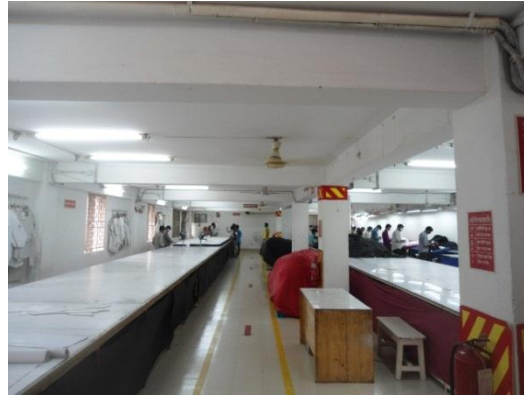
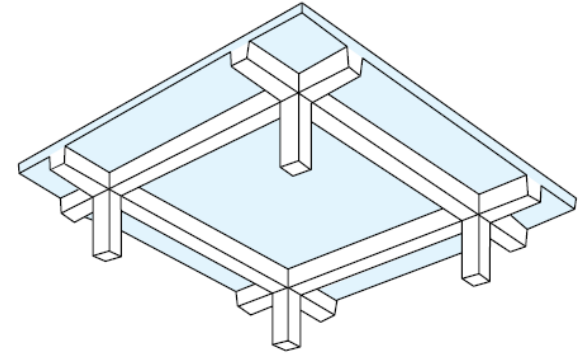
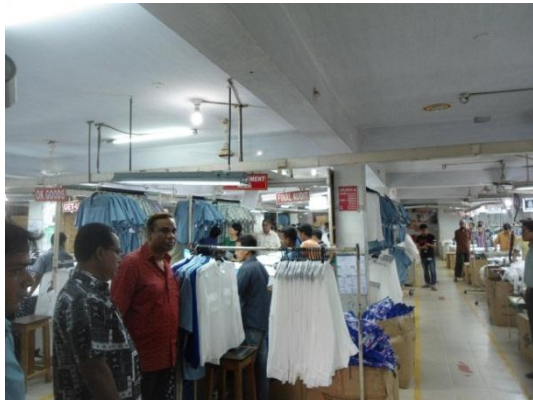
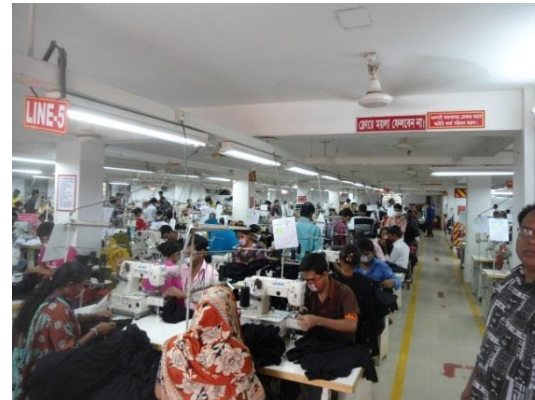
Permit Drawing for six floor agrees with observed building. No extensions. No refurbishment

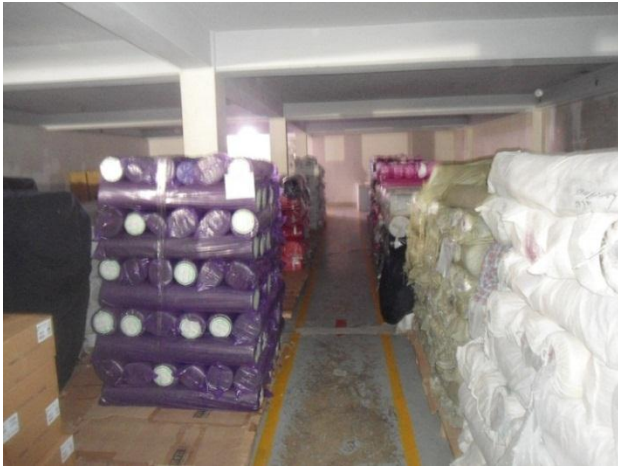
Loads in Bonded/Storage areas

Super imposed design load 3.0 kN/m^2

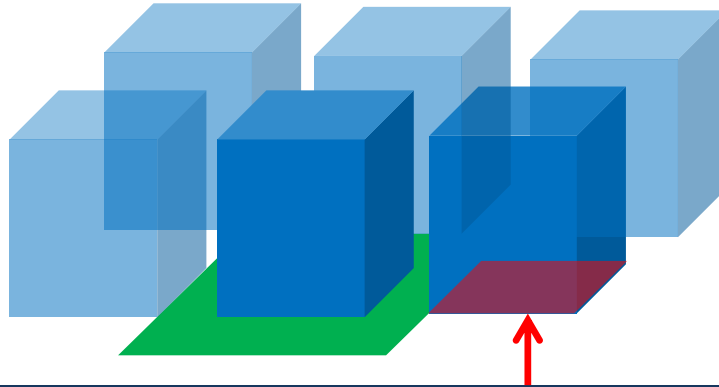
Stacks ($1.50 \times 1.50 \times 1.80 \text{ m}$ high) produce an equivalent load of 6.0 kN/m^2
Keeping 0.50 m cleared strip all sides, equivalent area load 3.0 kN/m^2

ITEM 4: Control loading in Bonded/Storage areas.

6	Materials stacked close to ceiling in densely spaced piles	Create controlled loading plans for all floors designating where storage can be placed and can not be placed. Designated areas must be posted and communicated to the factory management	6-months

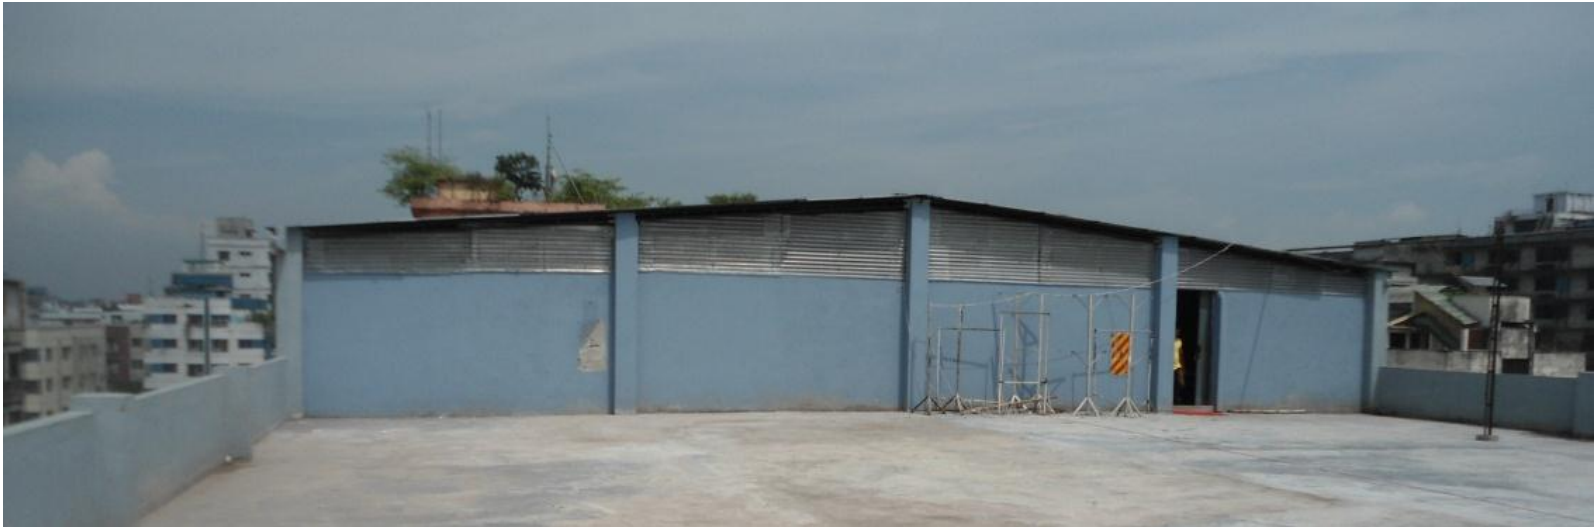
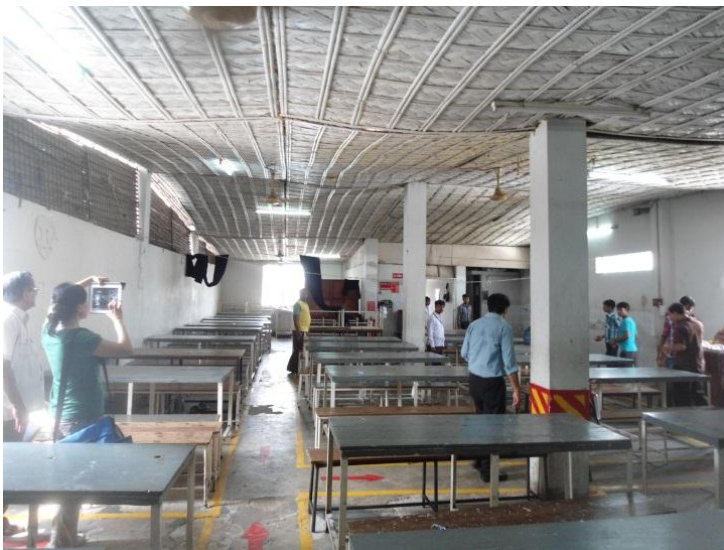
Top roof structure

Canteen:

Lightweight steel roof on concrete columns. Masonry walls. No permission for temporary structure on the top roof. They are moving canteen to the ground floor and removing the structure due local authority requirement.

ITEM 2: Light steel roof structure on top roof (canteen) to be removed. Factory has no permit for this extension. Plans to remove the structure.

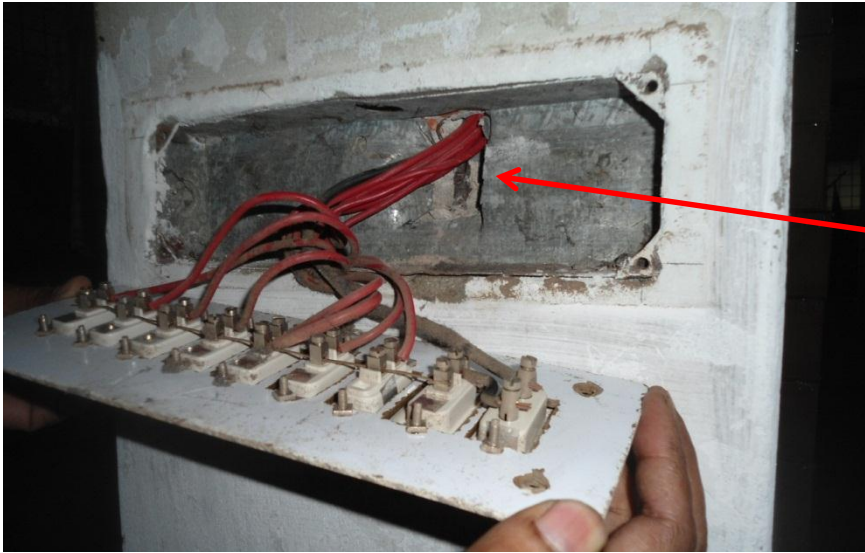
Minor local damage in columns

Minor damages :

Embedded electric boxes and wire duct cause local spalling of the concrete cover.

Reinforcement bar exposed.

Remaining concrete cover 20 mm. Box depth 50 mm. No relevant column size reduction.

Other minor local damages on columns concrete cover.

The building Engineer to inspect these areas. If required specify remediation treatment system for these damaged areas.

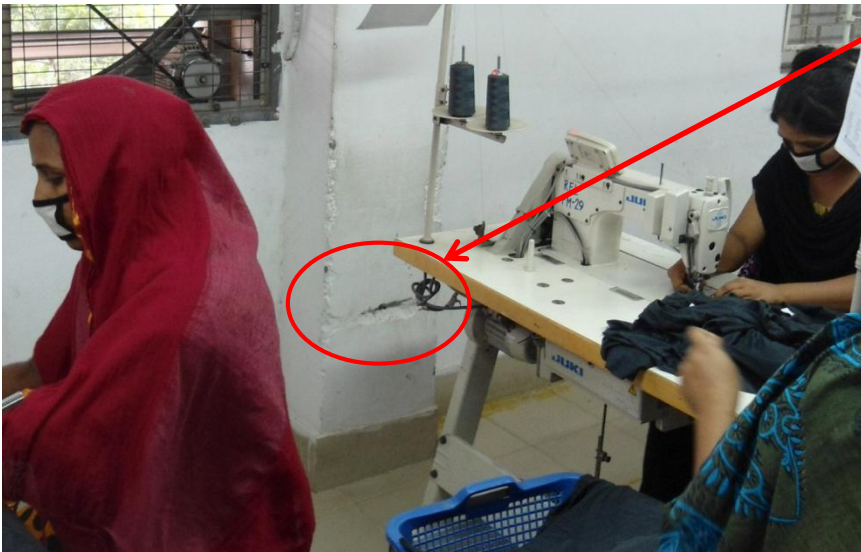
Minor repairs in columns required

ITEM 3: Embedded electrical boxes and wire duct produce local spalling of the concrete cover. Minor local damages in columns. To be repaired as maintenance activity.
