# Divine Intimates Ltd

Khowaznagar, Azimpara, Karnafuli, Chittagong

10<sup>th</sup> January 2018

# Paucity of details in As-Built drawings

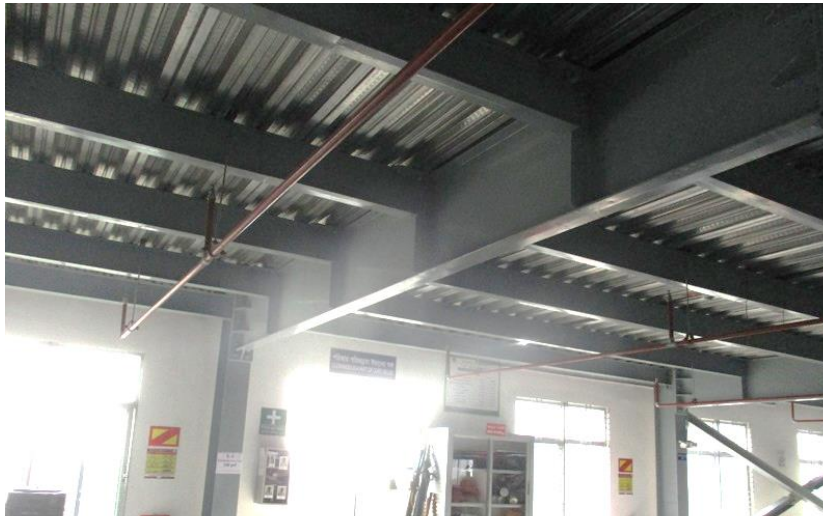
Sub-beam at 5<sup>th</sup> floor are not similar with typical floor. Sub-beam layout for 5<sup>th</sup> floor was not found in as built drawings. Also Sectional details of grid 13 was not available in provided drawings .

| Item No. | Observation | Recommended Action Plan | Recommended Timeline |
|---|---|---|---|
| 1 | Paucity of details in As-Built drawings | Building Engineer to survey as-built structure and prepare accurate as-built survey information with connection details for the building. | 6-weeks |

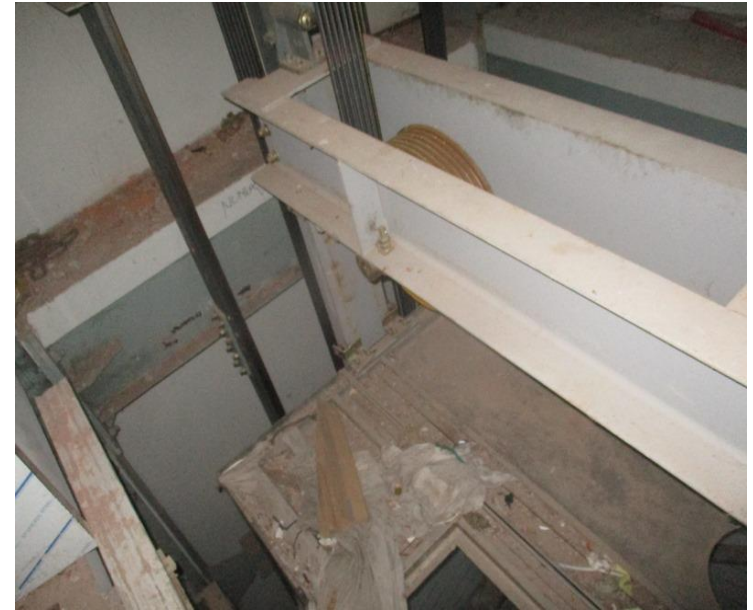
Details information were not found for section 13 (Lift core)

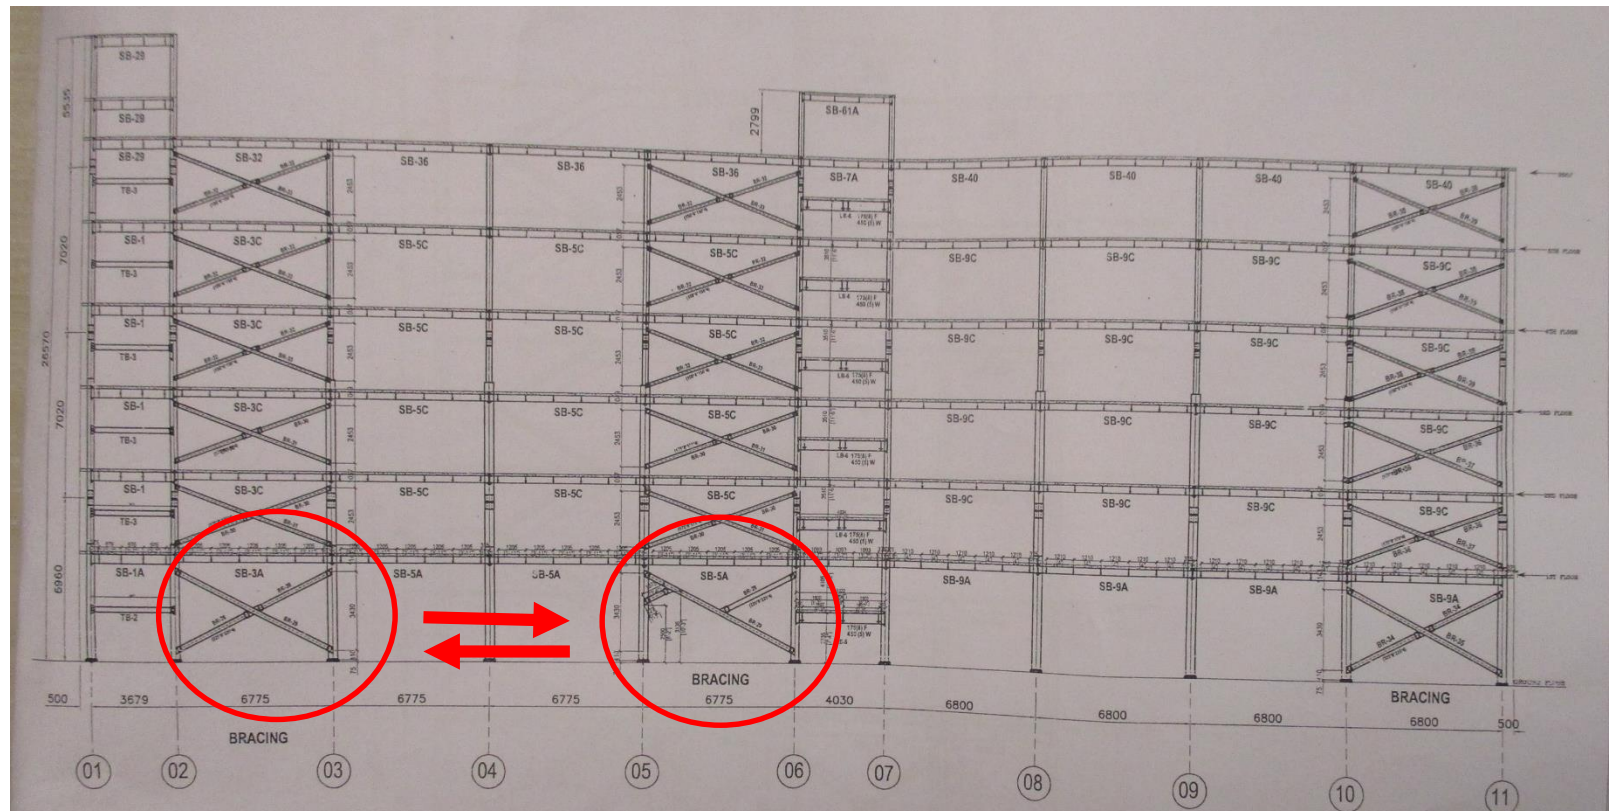
Cross section of Grid-A

Bracing pattern of marked two location was interchanged on site.

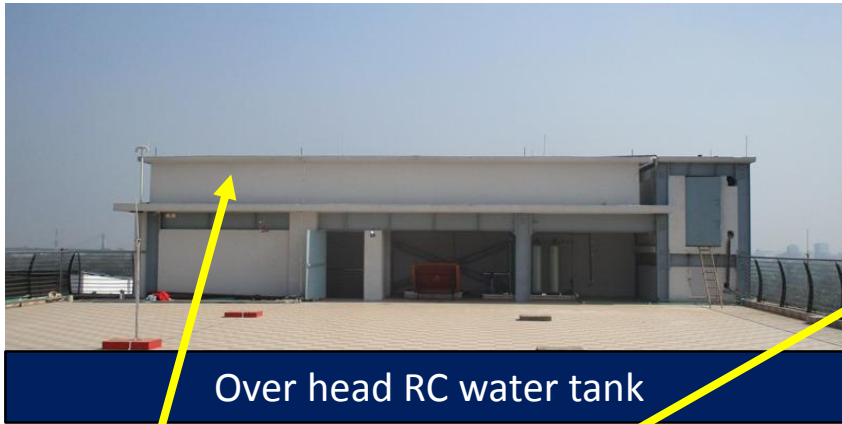
Over head RC water tank

No structural details were available on provided drawings for over head water tanks

| Item No. | Observation | Recommended Action Plan | Recommended Timeline |
|---|---|---|---|
| 2 | Paucity of details in As-Built drawings | Provide details information for over head water tanks. | 6-weeks |
