# Kimberly Fashions Ltd.

South Panishail, Zirani Bazar, Kashimpur, Gazipur  
(23.992269, 90.260299)

15<sup>th</sup> January 2018

# Discrepancies between drawings and on site condition

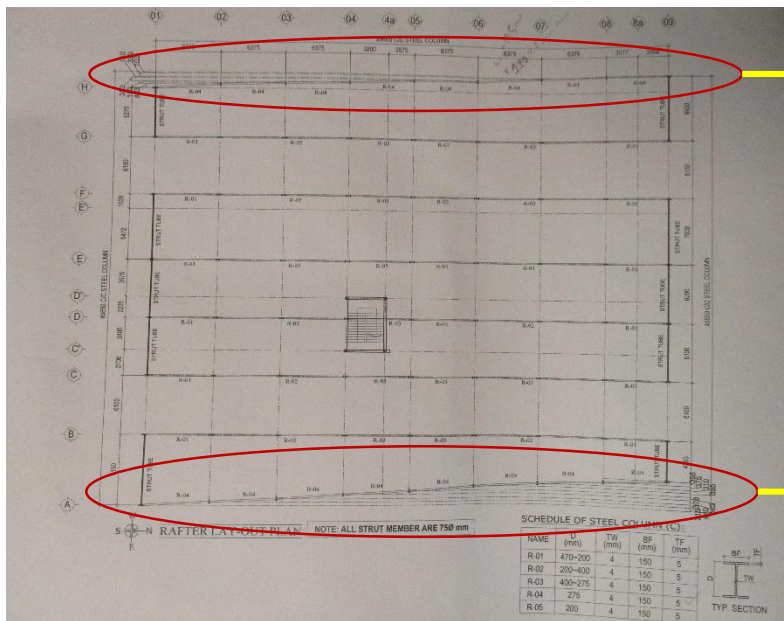
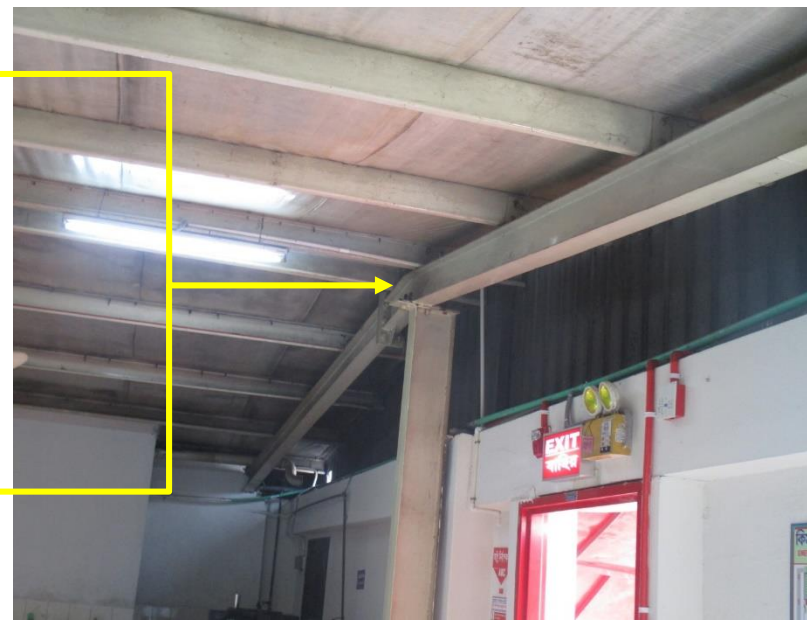
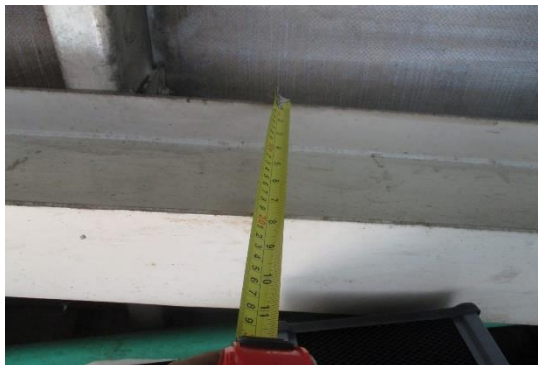
In as built drawings rafter R-04 is mentioned as W:275x4 mm; F:150x5 mm but existing rafter size were found W: 195 mm; F: 120 x 5 mm.

| Item No. | Observation | Recommended Action Plan | Recommended Timeline |
|---|---|---|---|
| 1 | Discrepancies between drawings and on site condition | Building Engineer to survey as-built structure and prepare accurate as-built survey information with connection details for the building. | 6-weeks |

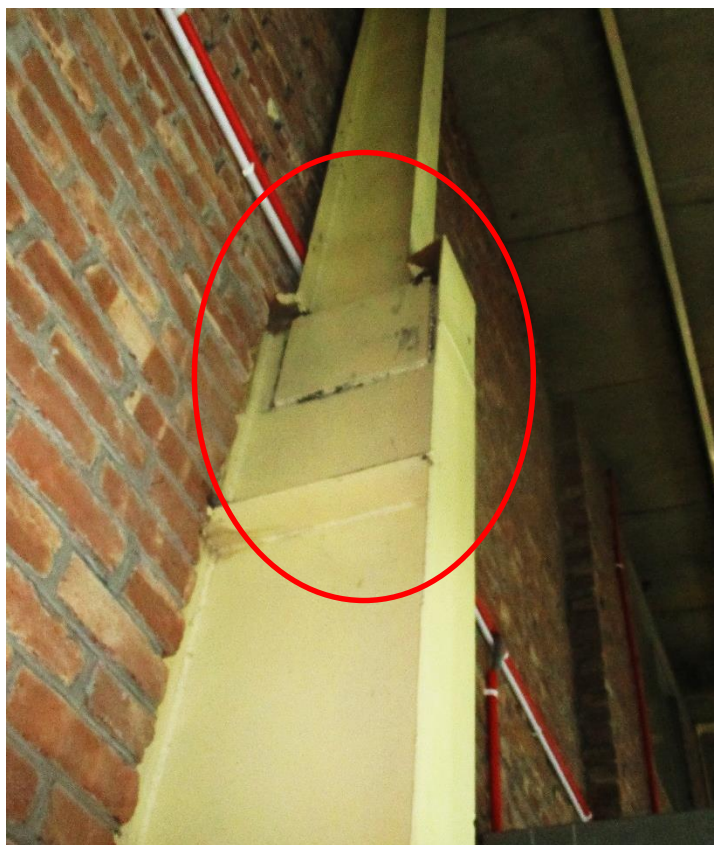
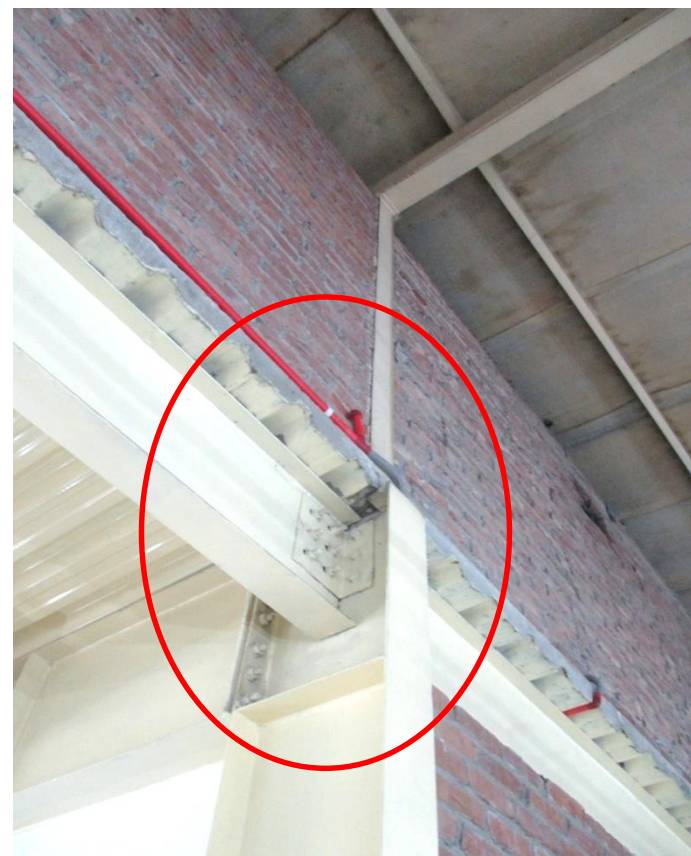
Smaller sectioned columns have been welded with steel columns for extension. But the joint details was not available in provided drawings.

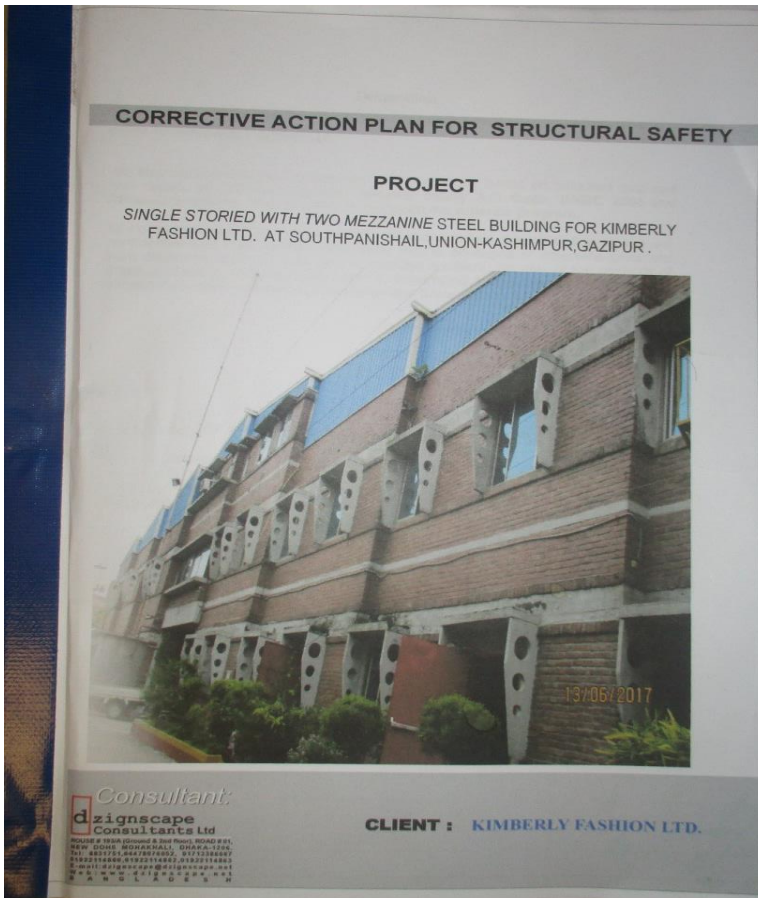
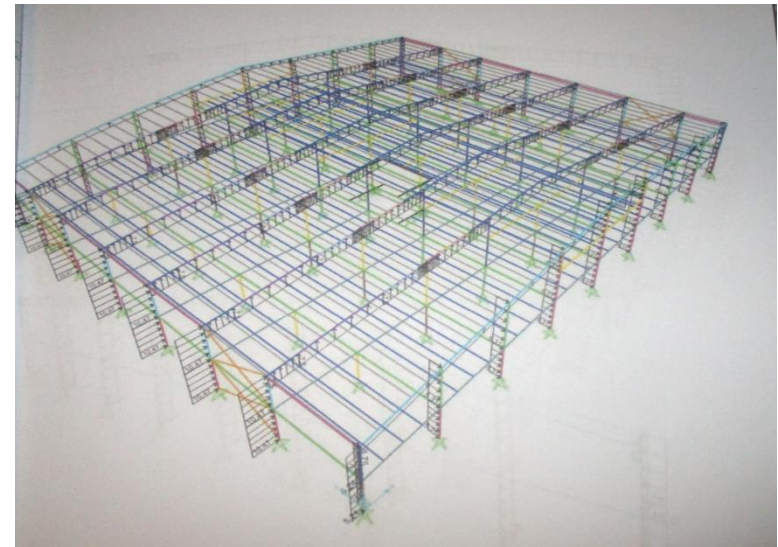
# Incomplete assessment report

An assessment report was prepared but computer based analysis file was not available for verification. Factory is required to submit complete Design report including software based analysis file to Accord for further review.

| Item No. | Observation | Recommended Action Plan | Recommended Timeline |
|---|---|---|---|
| 2 | Incomplete assessment report | Factory is required to submit complete assessment report including software based analysis file to Accord for further review. | 6-weeks |
| 3 | Incomplete assessment report | Implement remedial works as outcome of design report if required. | 6-months |

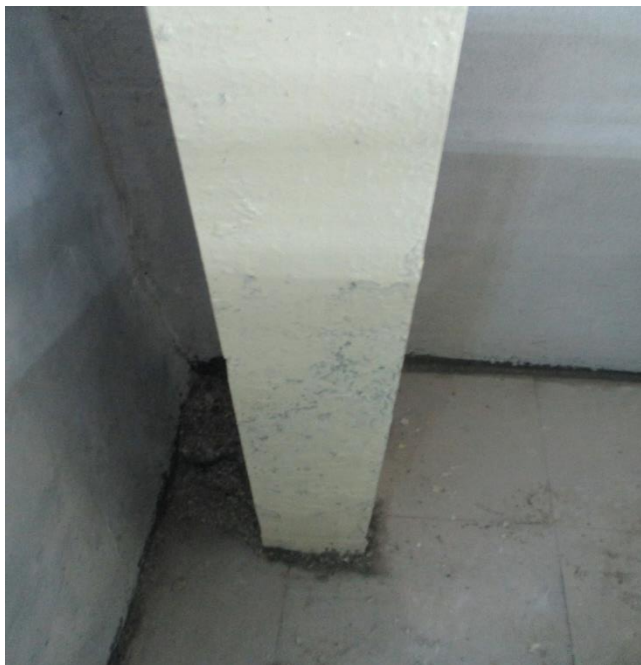
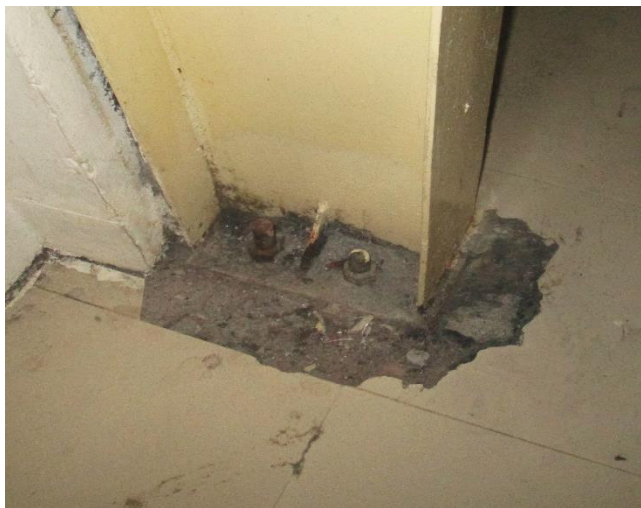
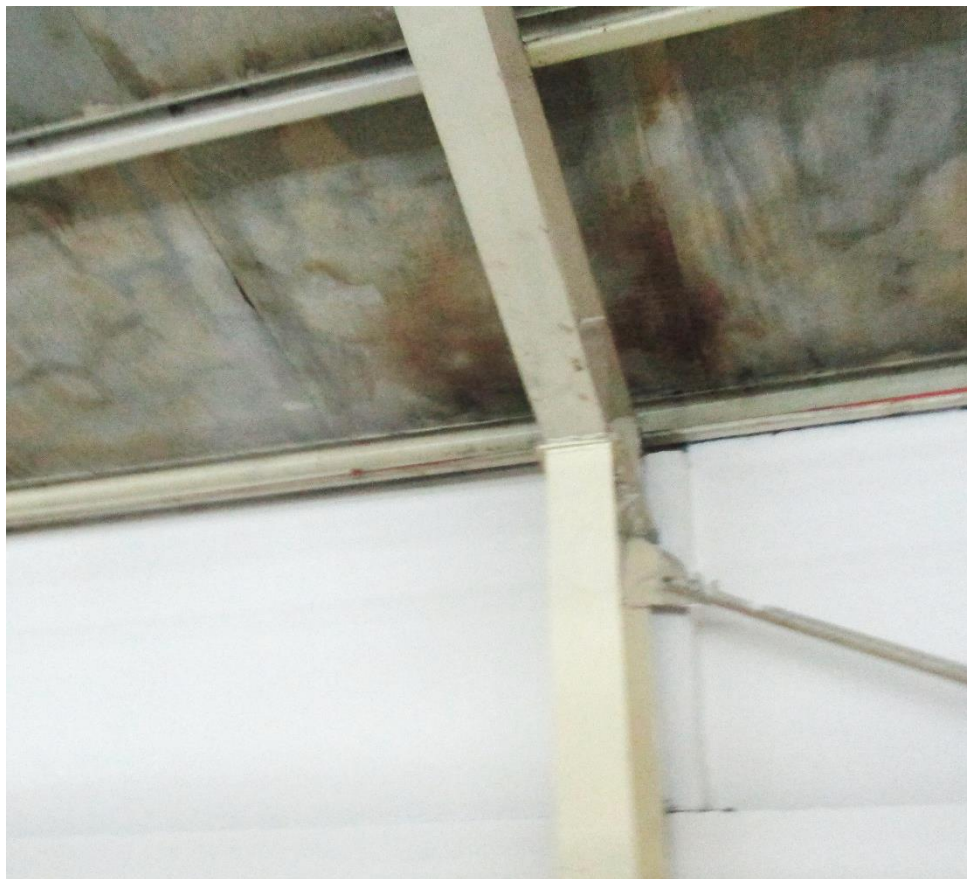
# Corrosion in steel members

Corrosion on several steel members was observed.

| Item No. | Observation | Recommended Action Plan | Recommended Timeline |
|---|---|---|---|
| 4 | Corrosion in steel members | Apply suitable method to protect the steel members. | 6-weeks |

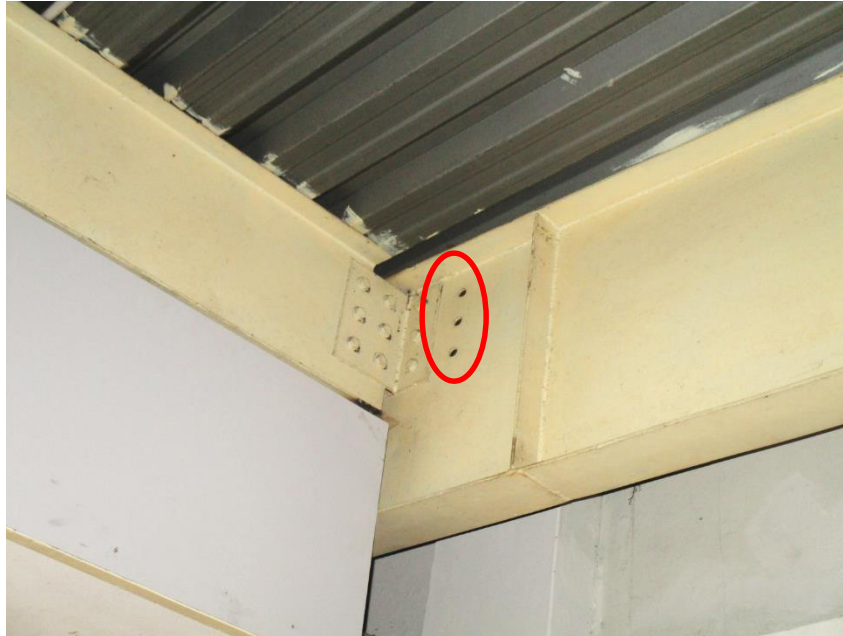
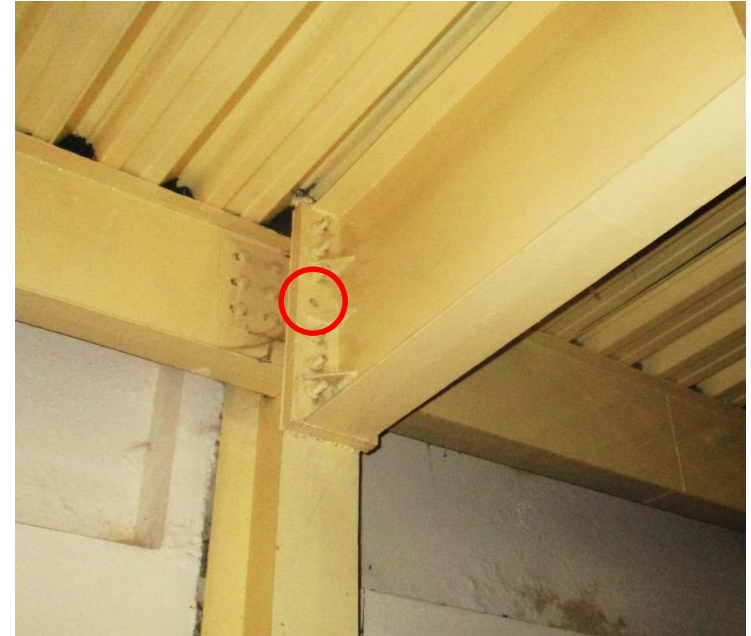
**Bolt missing from several joints**

Some bolts were missing in several beam-column joints.

| Item No. | Observation | Recommended Action Plan | Recommended Timeline |
|---|---|---|---|
| 5 | Bolt missing from several joints | Install missing bolts where required. | 6-weeks |
