**Dazzling Dresses Ltd.(10285)  
Astex Garment Ltd.  
Alpine Apparels Ltd.**

51/52, Ismail Plaza, Shah Kabir Mazar rd. Chalabon, Dakkin Khan Uttara, Dhaka  
(+23.869385N, +90.419827E)

28.APRIL.2014

**ACCORD**  
on Fire and Building Safety in Bangladesh

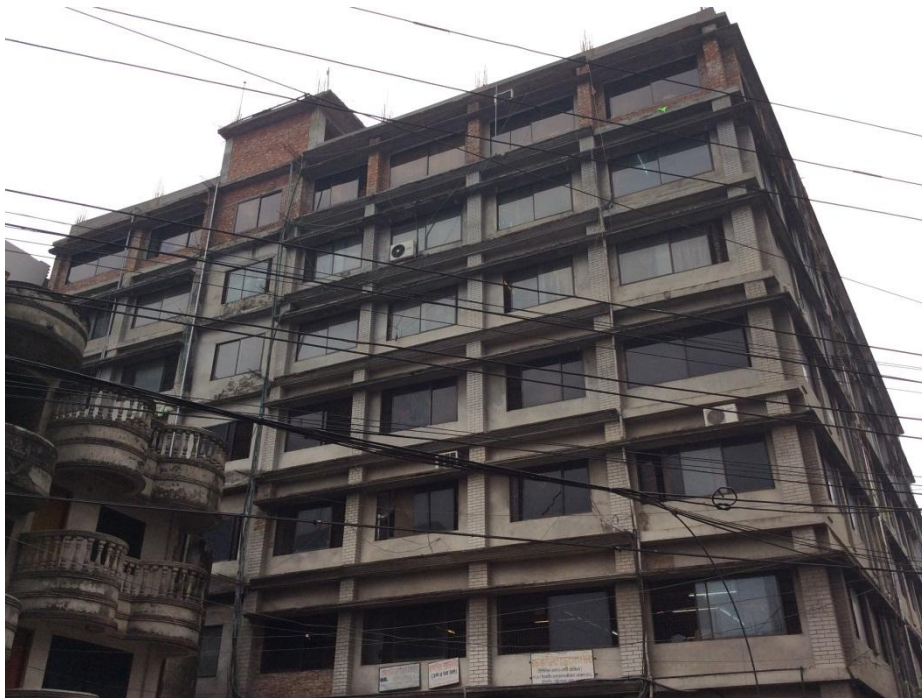
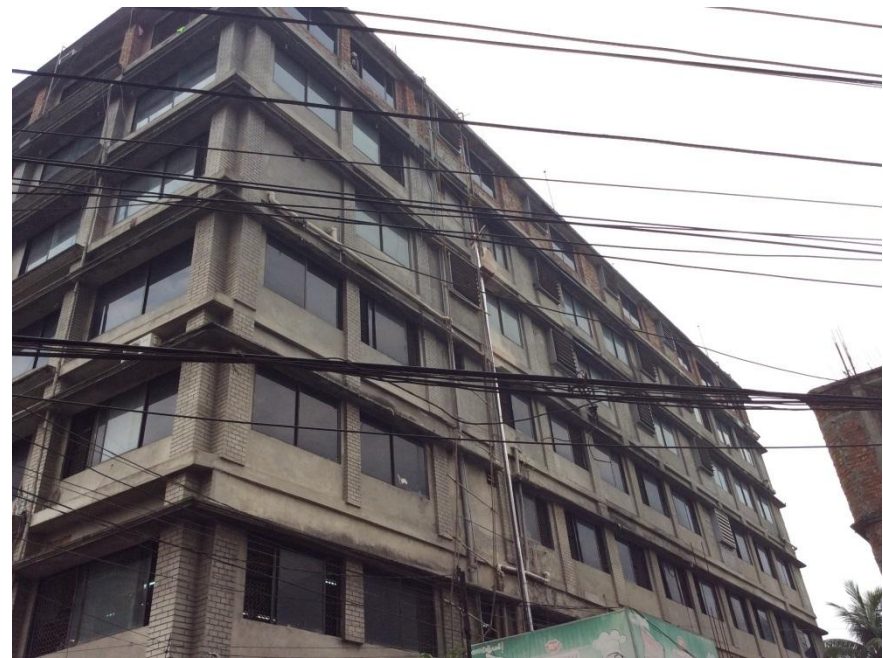
## 1<sup>st</sup> Priority 2 Concern

Concerns with the lateral load stability system. The façade brickwork walls lack any real form of connection with the surrounding columns and flat slab and therefore contributes very little.

Although a seismic and wind design report certificate has been provided by BUET, we still require that these items be investigated as part of a Detailed Engineering Assessment.

- Carry out a Detailed Engineering Assessment of the building which should investigate in particular, stability and foundation aspects.
- Seismic and wind load calculations are required.

- Implement any actions or recommendations of the DEA.

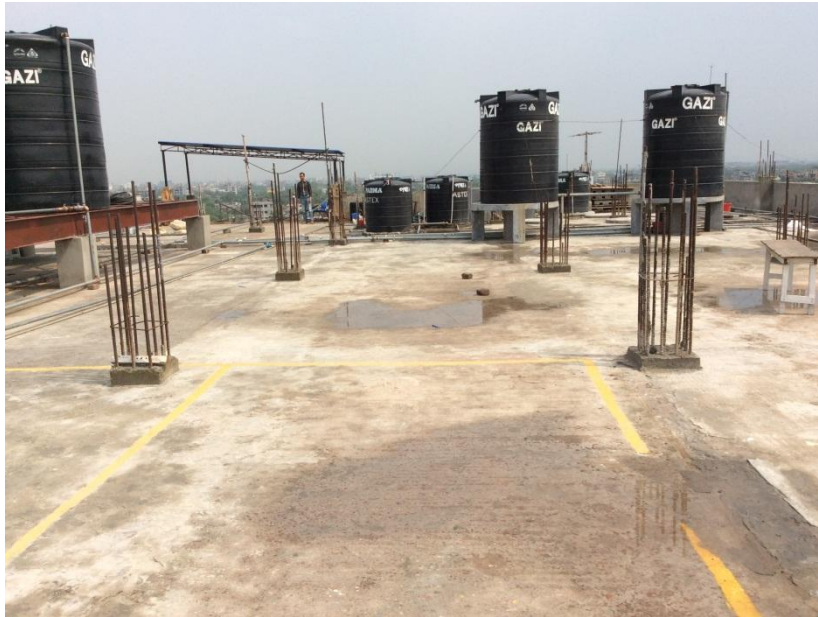
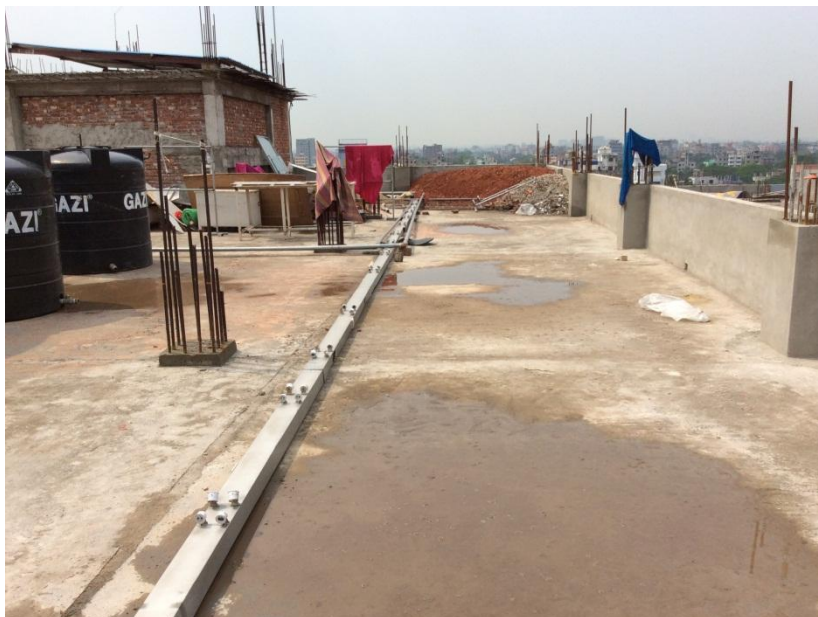
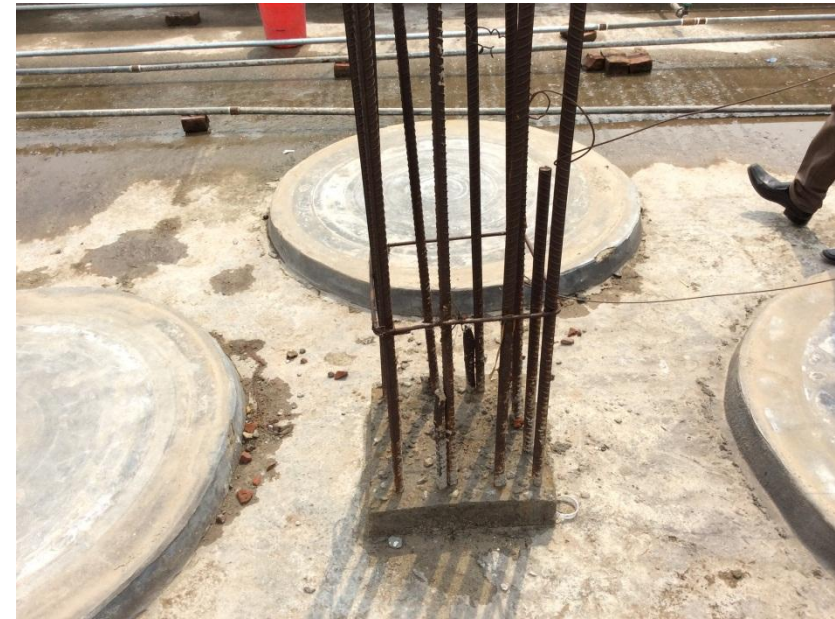
## 1<sup>st</sup> Priority 3 Concern

- No waterproofing for roof level and reinforcement left exposed.

No waterproofing applied on the roof slab and reinforcement exposed.

An appropriate layer of waterproofing needs to be applied including anti-rust paint for the exposed reinforcement.

- Waterproofing material to be applied including rust-proof paint for the exposed reinforcement..
