# Interstoff Apparels Ltd. (9493)

Chandra, Kaliakor, Gazipur

29.April.2014

ACCORD  
on Fire and Building Safety in Bangladesh

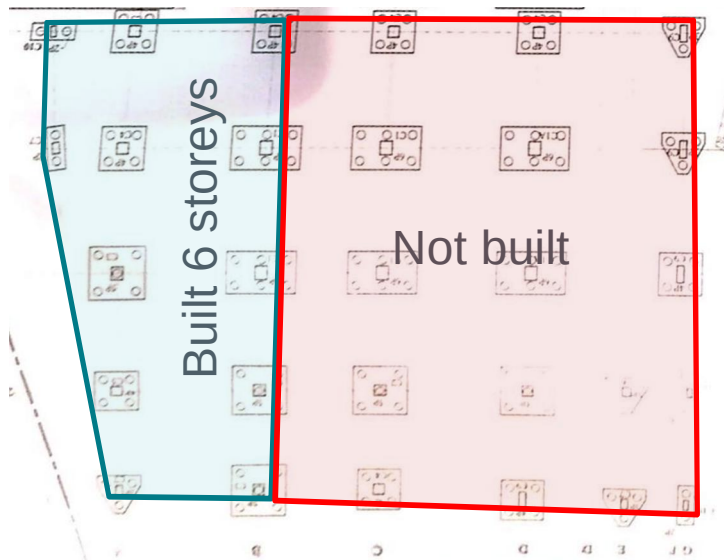
Building 2. During our visit, we found that a section of the new proposed 11 storey building (currently built to 6 and 9 storeys) had only one bay built and was currently being used. This building section has currently minimal overturning resistance and we have reasonable doubt that the piles can take the increased uplift forces due to the full wind load. This building needs to be braced or otherwise stabilised as quickly as possible.

For all the other buildings, sway stability of the structures could probably be expected from a rigid frame system (beam and column participation) although no ductile detailing is provided in structural plans. Masonry infill is unrestrained and cannot be considered.

We require that these items be investigated in a Detailed Engineering Assessment immediately.

- Commence immediate Detailed Engineering Assessment that evaluates the lateral stability of the building in its current state.
- Temporarily brace the building.

- Carry out all recommendations of the DEA.

- Complete all recommendations of the DEA.

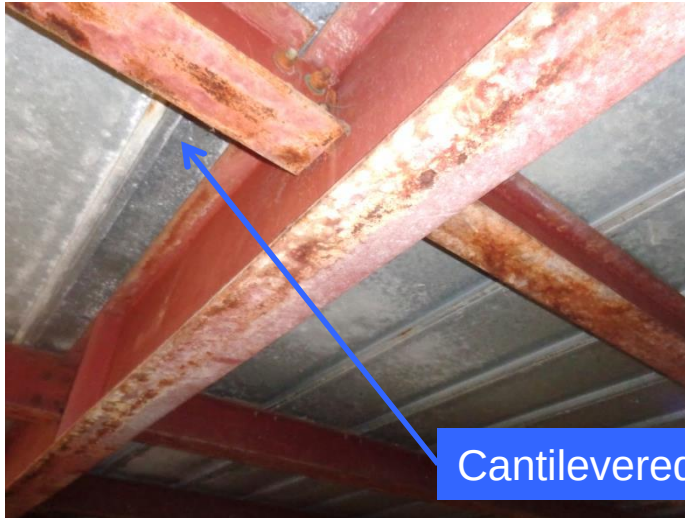
Cantilevered section

Building 1. On the top floor of the 6 storey building, there are some cantilevered beam sections fixed to a perpendicular beam.

We've found localised cracking in the receiving beam.

The receiving beam should be verified for its torsional resistance.

- A Detailed Engineering Assessment should be carried out with regard to the torsional resistance of the receiving beam.

- Carry out and complete all recommendations of the completed DEA.

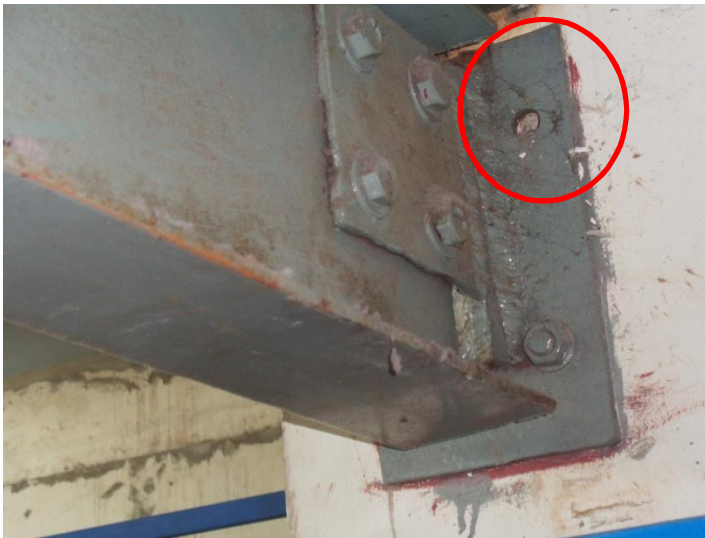
Multiple mezzanines in the main building were visually inspected during our survey and we found elements that caused concern.

1. Main mezzanine at ground floor of 6 storey building

1 Main mezzanine at top floor of 6 storey building

Notable elements:

1. Poor rigid connection detailing.
2. Poor weld quality.
3. Missing anchor bolts.
4. Unrestrained compression flanges.

We require a full Detailed Engineering Assessment of all of the steel work.

- Carry out a full Detailed Engineering Assessment of the steel mezzanine taking into account the actual site conditions.

- Carry out and complete all recommendations of the completed DEA.

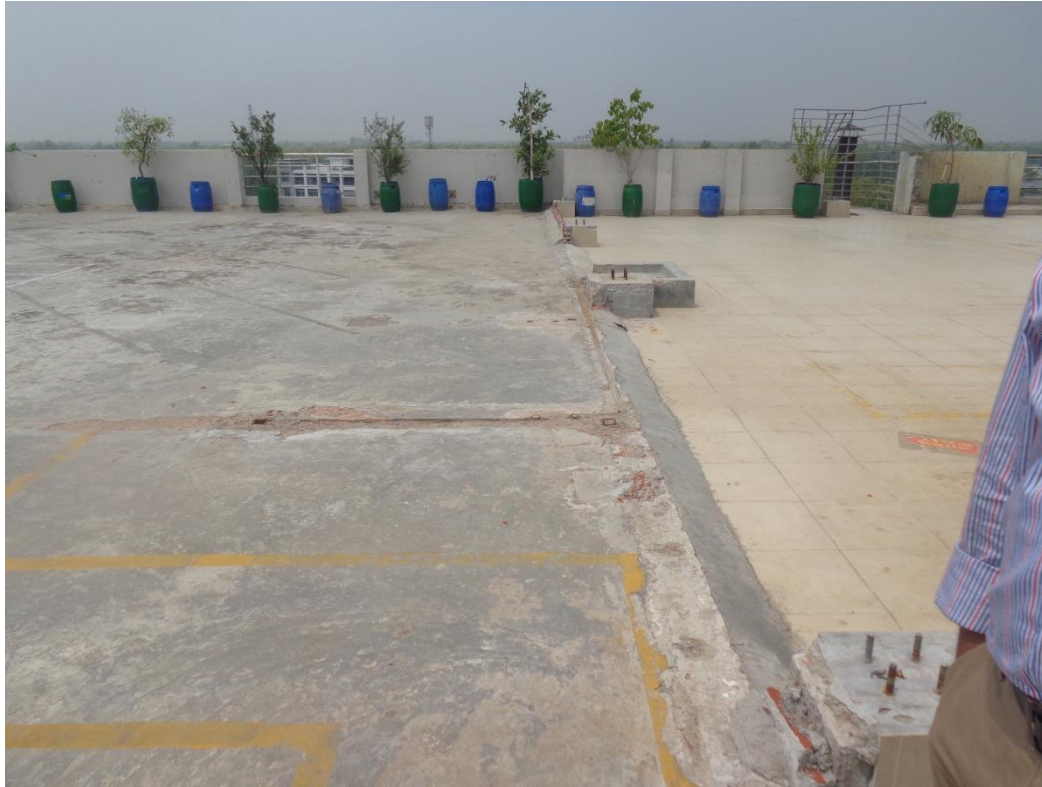
No waterproofing membrane was visible on the roof of the building. This means that any cracks in the surface finishes on the roof will allow water to seep into the concrete slab beneath the finishes, and cause long-term soaking of the slab.

Certain areas had floor finishes but they were cracked and do not represent an efficient water barrier system

- Apply a new waterproofing membrane.
