# Big Boss Corporation Ltd. (NEW)

Holding#30 Sharabo, Kasimpur, Gazipur

23<sup>th</sup> January 2018

# Observations

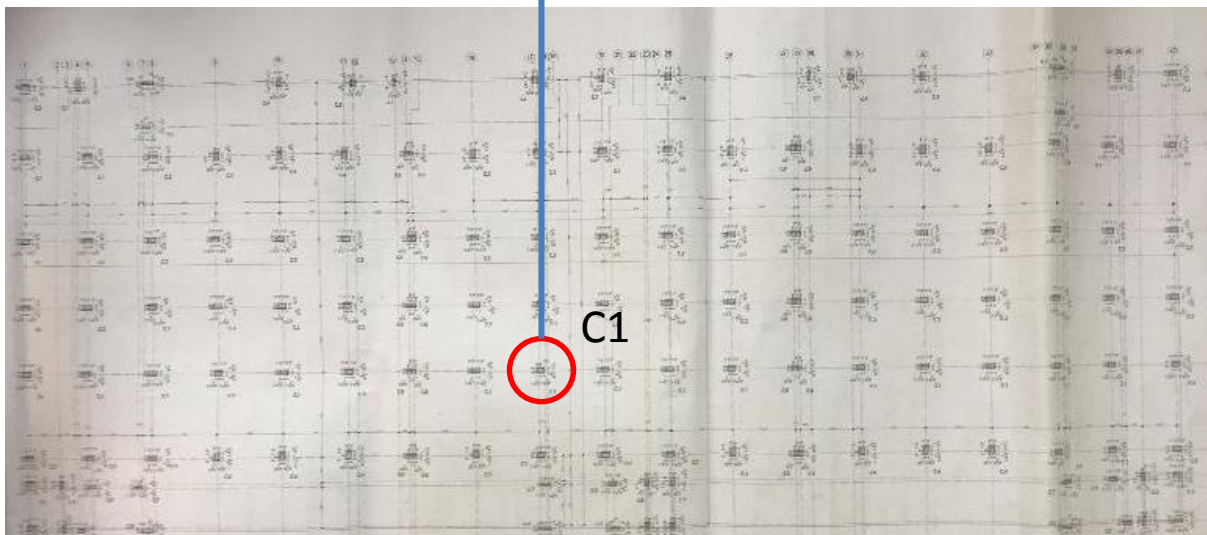
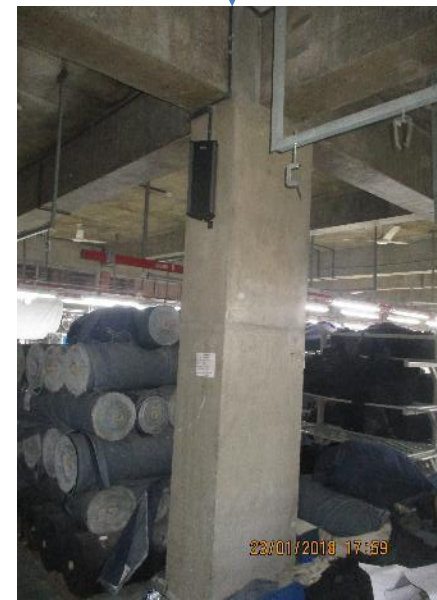
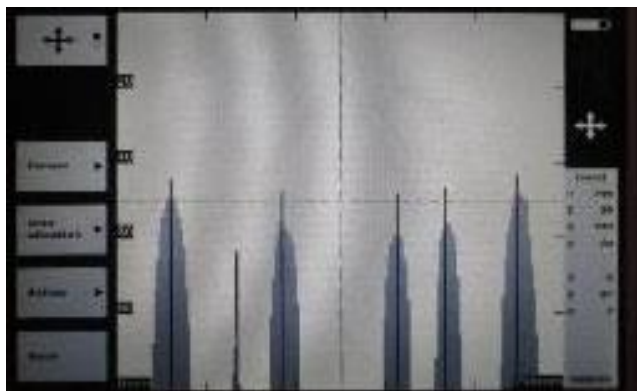
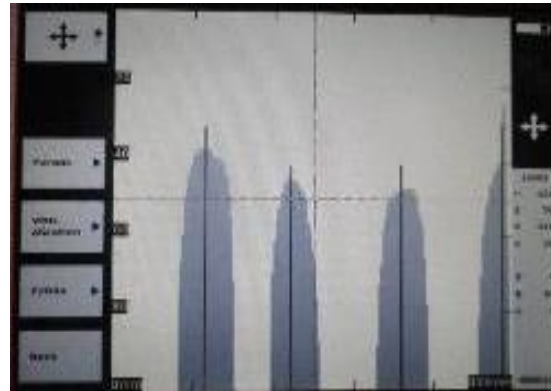
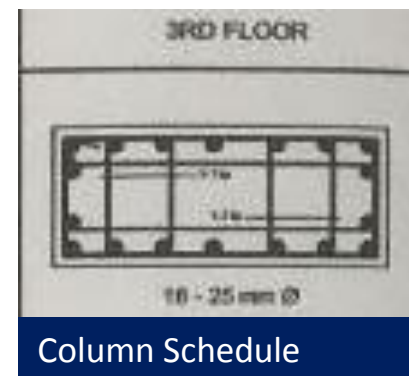
Column Layout Plan

18 rebars are shown on the drawing in C-1 type column but during inspection 16 rebars were found by ferro scanning.

| Item No. | Observation | Recommended Action Plan | Recommended Timeline |
|---|---|---|---|
| 1 | Discrepancies between drawings and on-site observation (Sewing Building) | Factory engineer is required to survey all the structural elements properly and produce correct as built drawings. | 6-weeks |

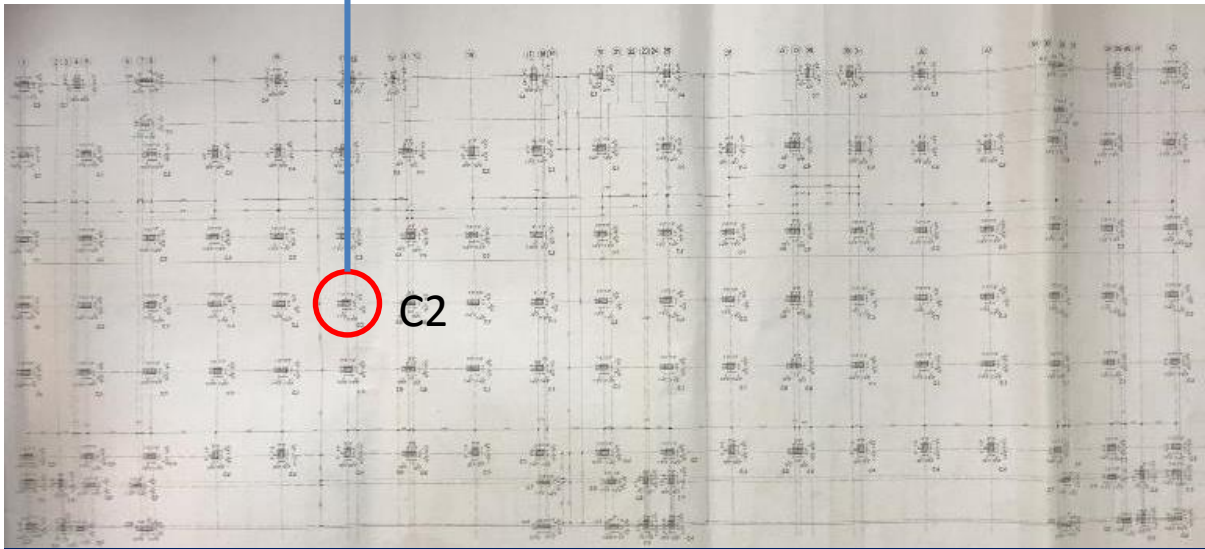
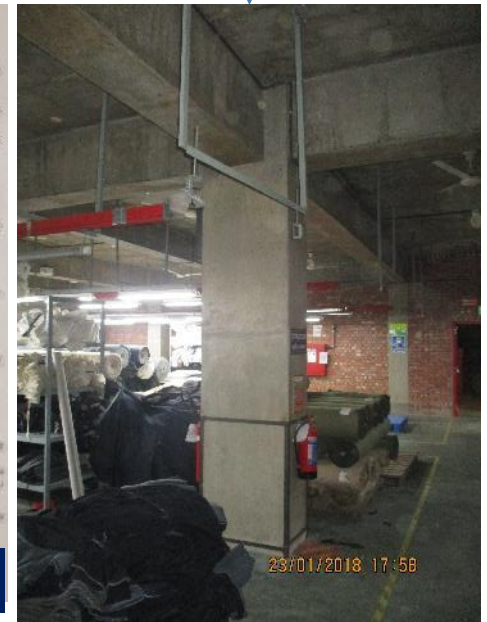
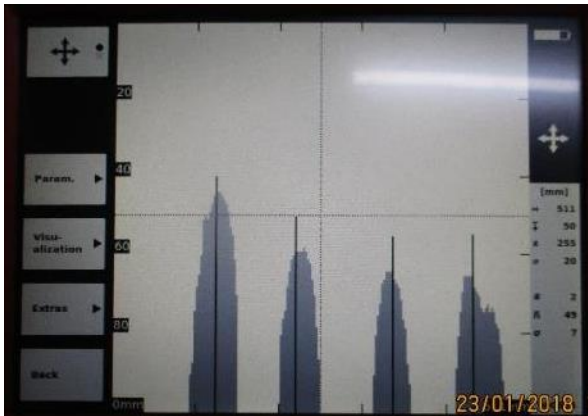
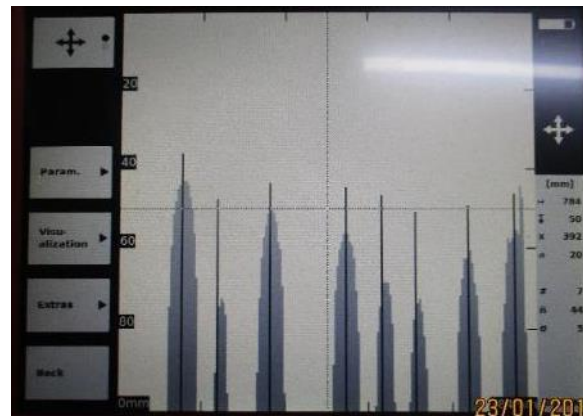
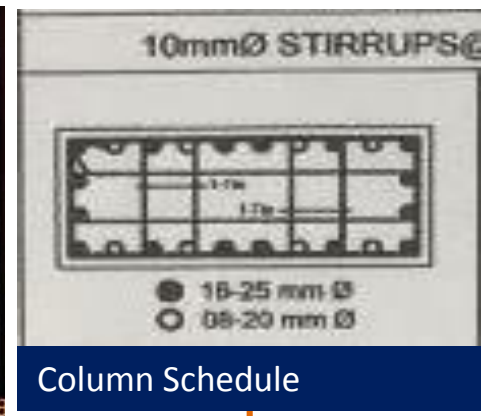
Column Layout Plan

24 rebars are shown on the drawing in C-2 type column but during inspection 20 rebars were found by ferro scanning at 2<sup>nd</sup> floor.

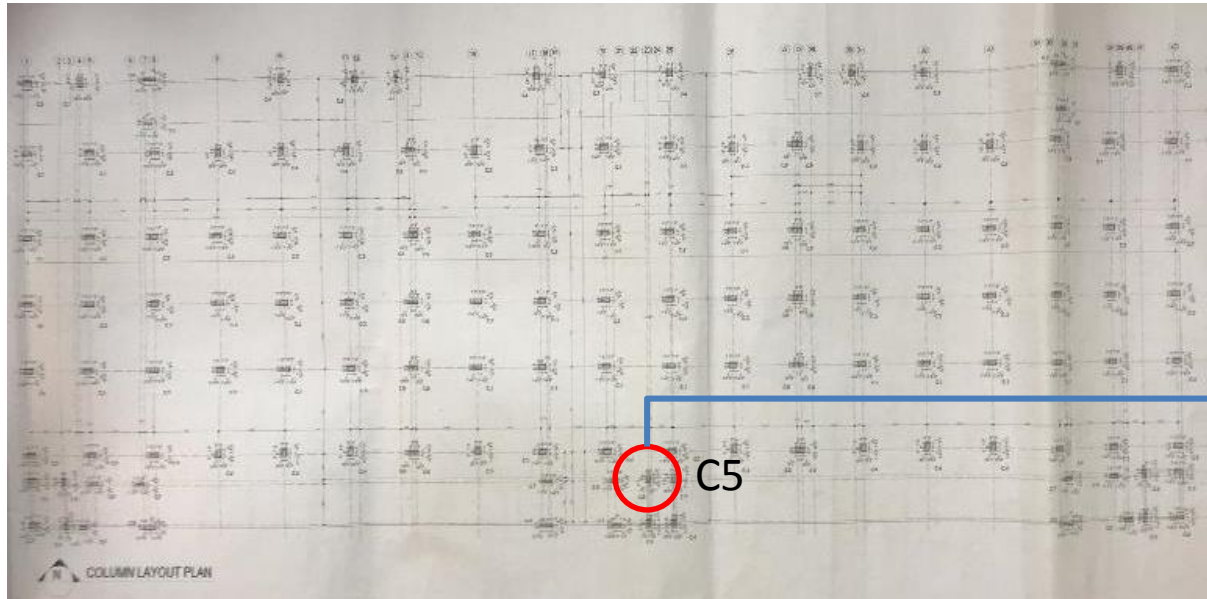
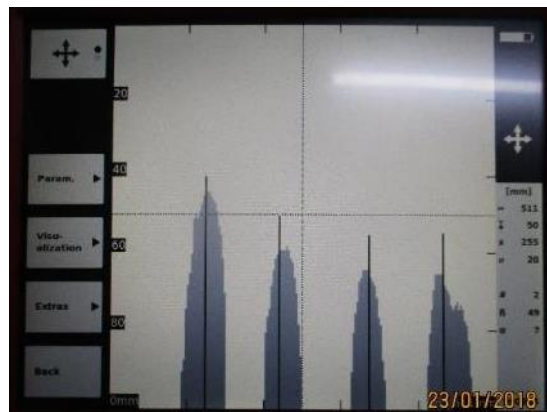
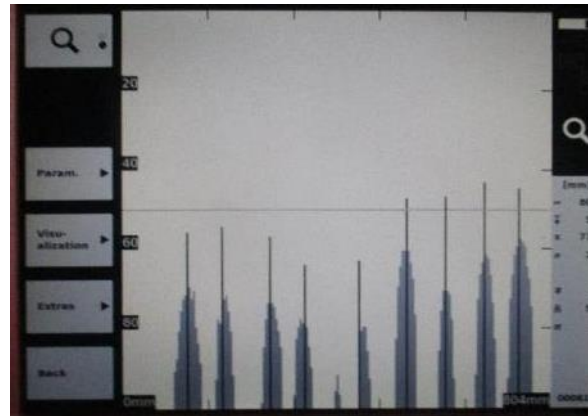
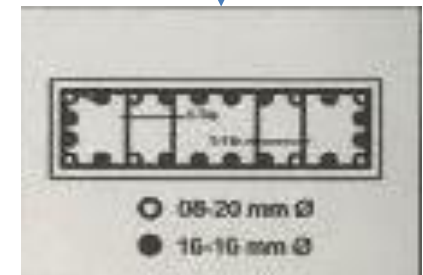
24 rebars are shown on the drawing in C-5 type column but during inspection 22 rebars were found by ferro scanning at 3<sup>rd</sup> floor.

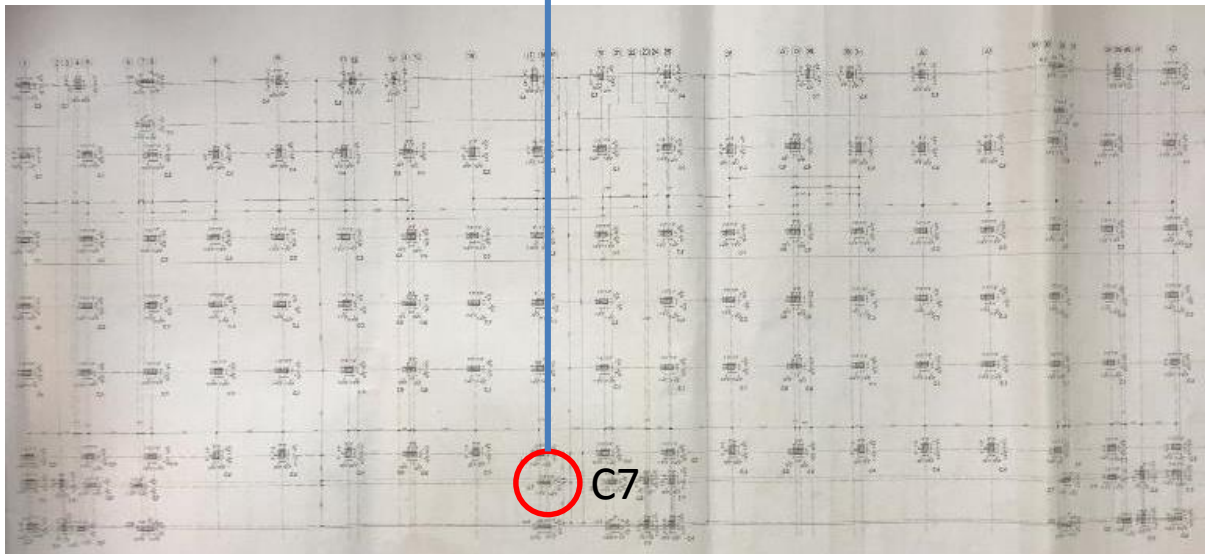
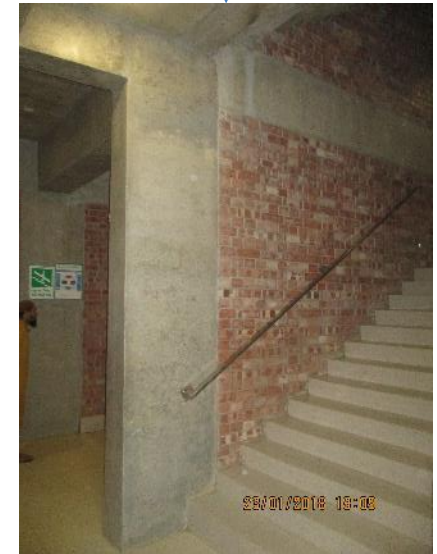
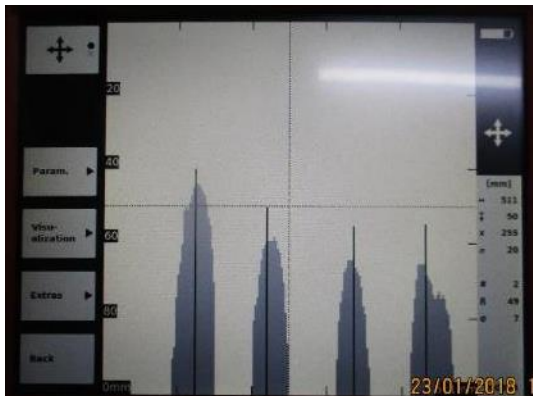
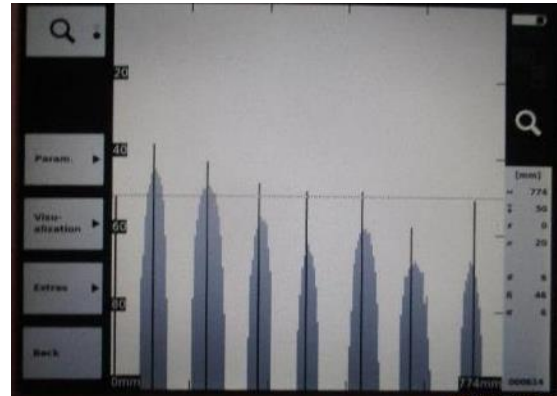
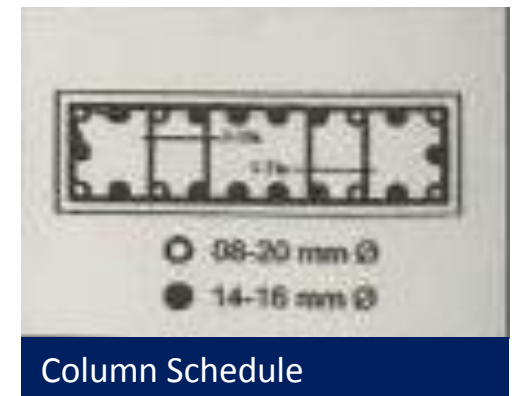
Column Layout Plan

22 rebars are shown on the drawing in C-7 type column but during inspection 16 rebars were found by ferro scanning at 3<sup>rd</sup> floor.

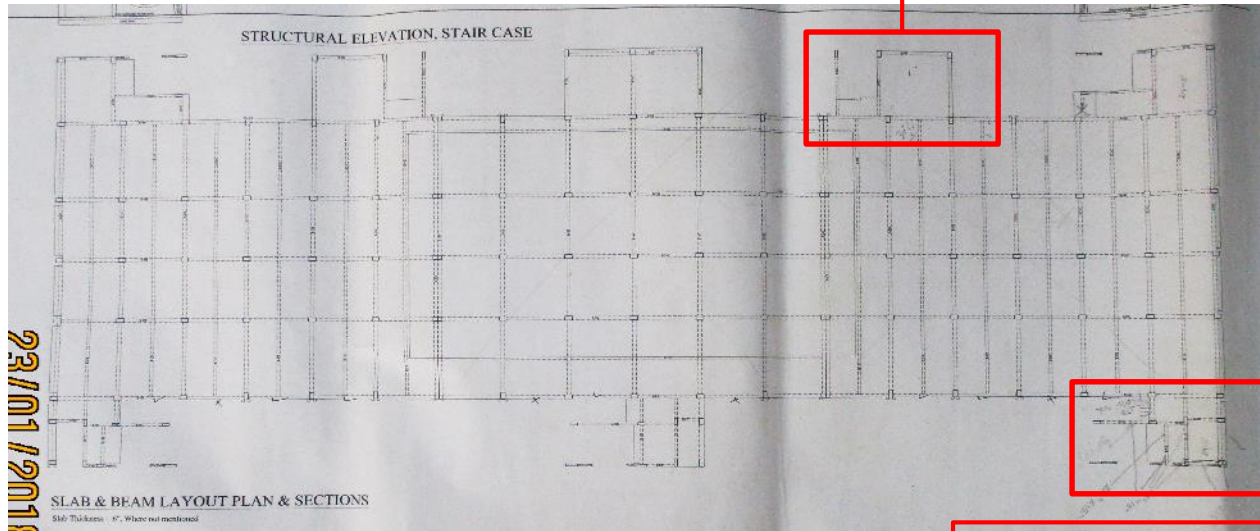
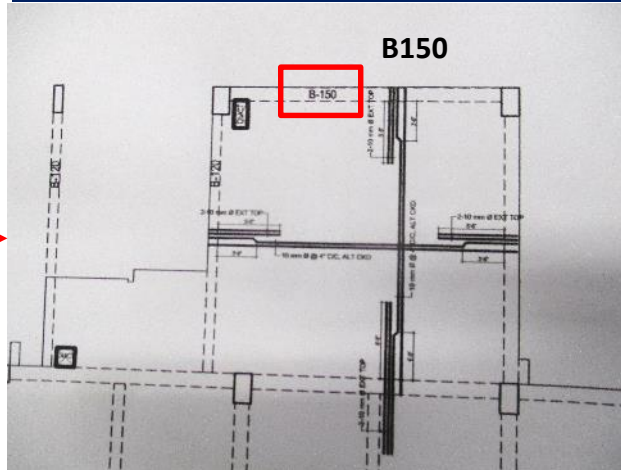
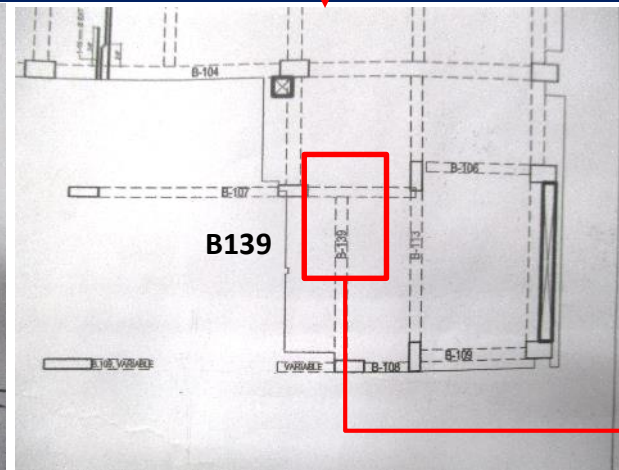
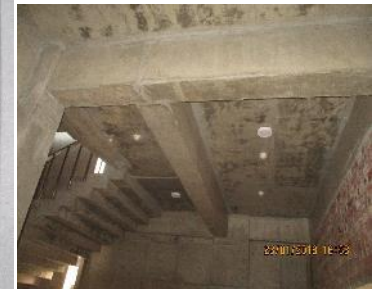
Beam Layout Plan

In beam layout plan, B-139 and B-150 type beams are shown but no section size and detail was found for these beams in provided drawing.

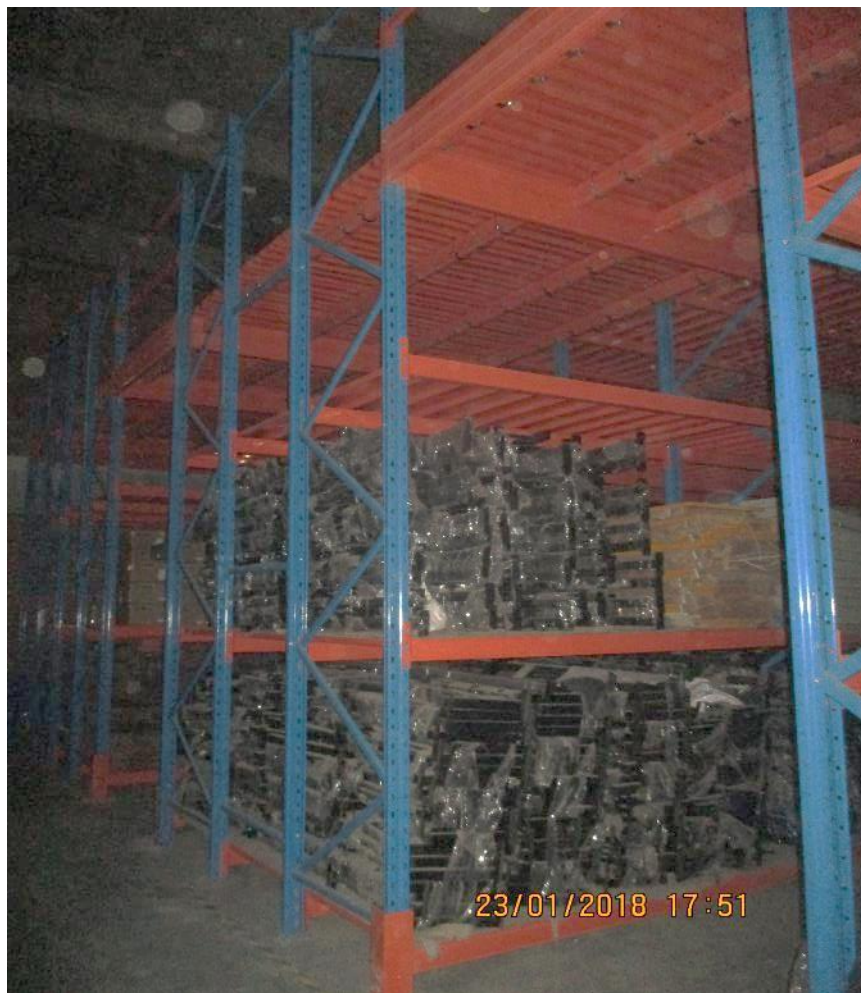
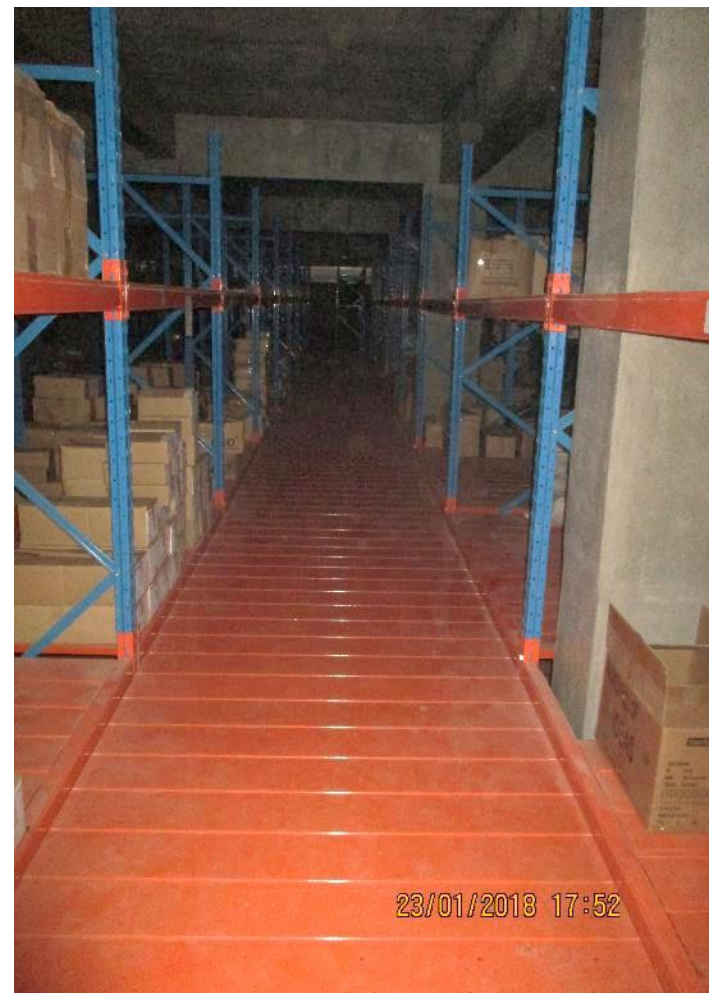
Customized steel racking system is used for storage with an upper platform over the double heighted area. A capacity check of steel members is required to be carried out.

| Item No. | Observation | Recommended Action Plan | Recommended Timeline |
|---|---|---|---|
| 3 | Capacity Check for the customized steel racks (Sewing Building) | Factory is required to carry out the capacity check of the ground floor's racks and maintain loading according to the calculation result. | 6-weeks |

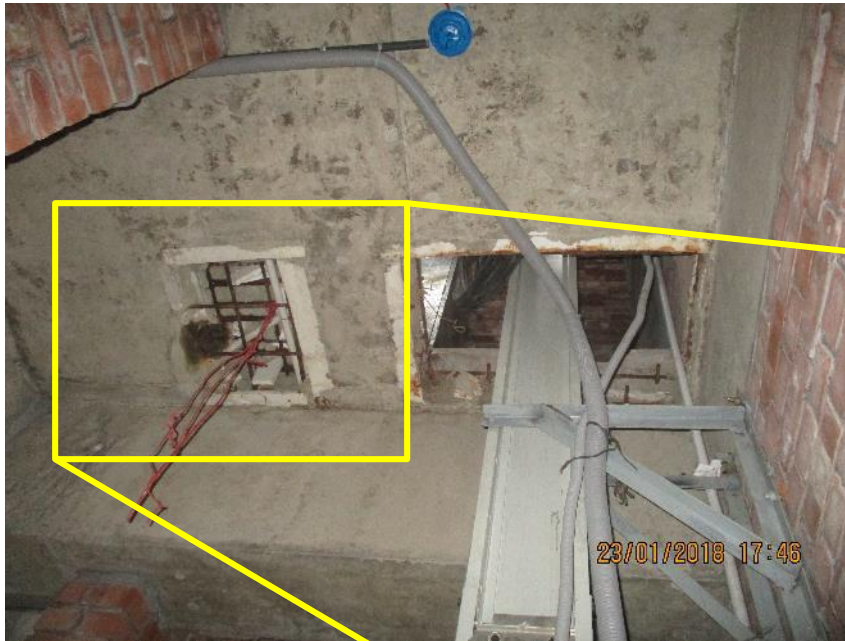
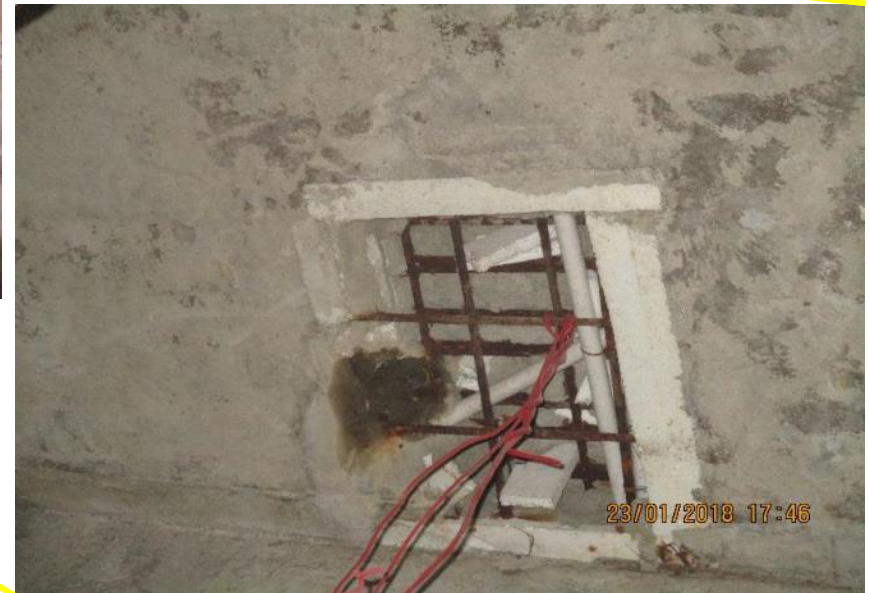
Exposed rebar was found on electric duct in every floor and most of the re-bars were subjected to corrosion. Factory is required to take proper remedial measures for preventing the corrosion.

| Item No. | Observation | Recommended Action Plan | Recommended Timeline |
|---|---|---|---|
| 5 | Corrosion on exposed slab reinforcements (Sewing Building) | Factory engineer is required to take proper remedial measures to protect rebar from corrosion. | 6-weeks |

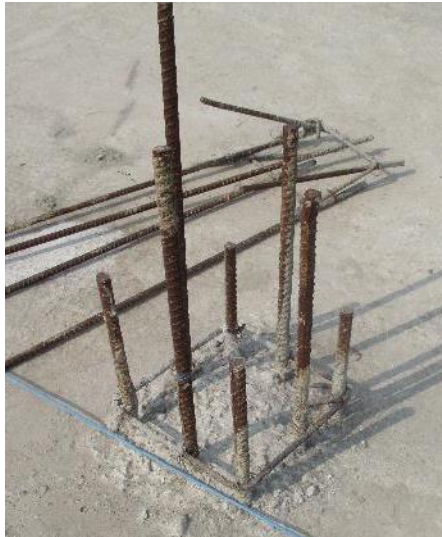
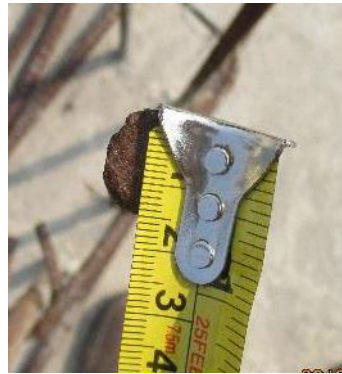
Exposed  
reinforcements on  
the roof

In as built drawing the reinforcement size was not matched with on-site condition. For C4 type columns 8-20mm rebars was shown but 4-16mm and 4-20mm rebars were found during on site.

| Item No. | Observation | Recommended Action Plan | Recommended Timeline |
|---|---|---|---|
| 6 | Discrepancies between drawings and on-site observation (Utility Building) | Factory engineer is required to survey all the structural elements properly and produce correct as built drawings. | 6-weeks |

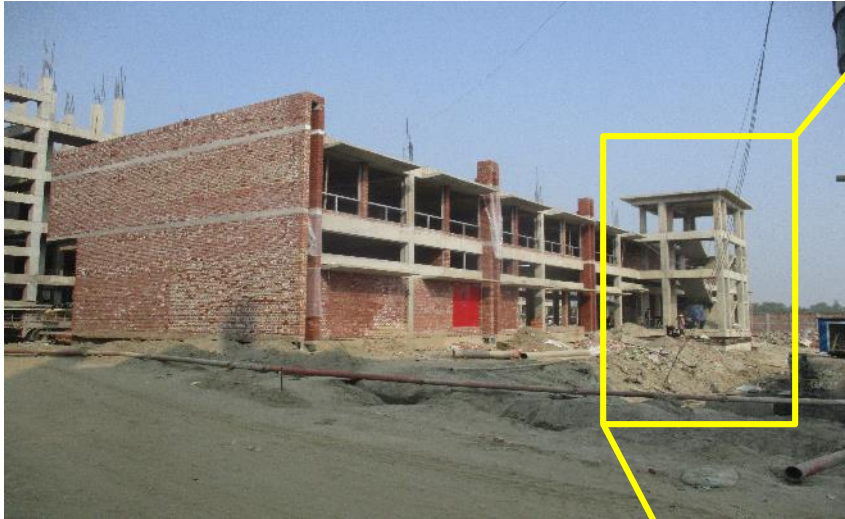
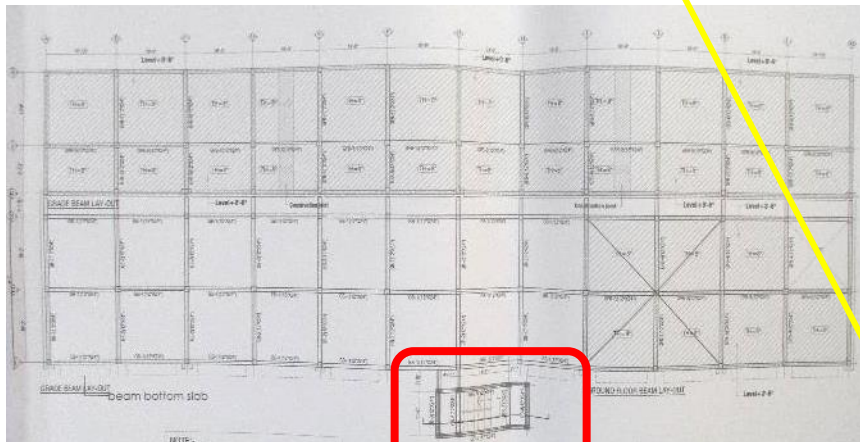
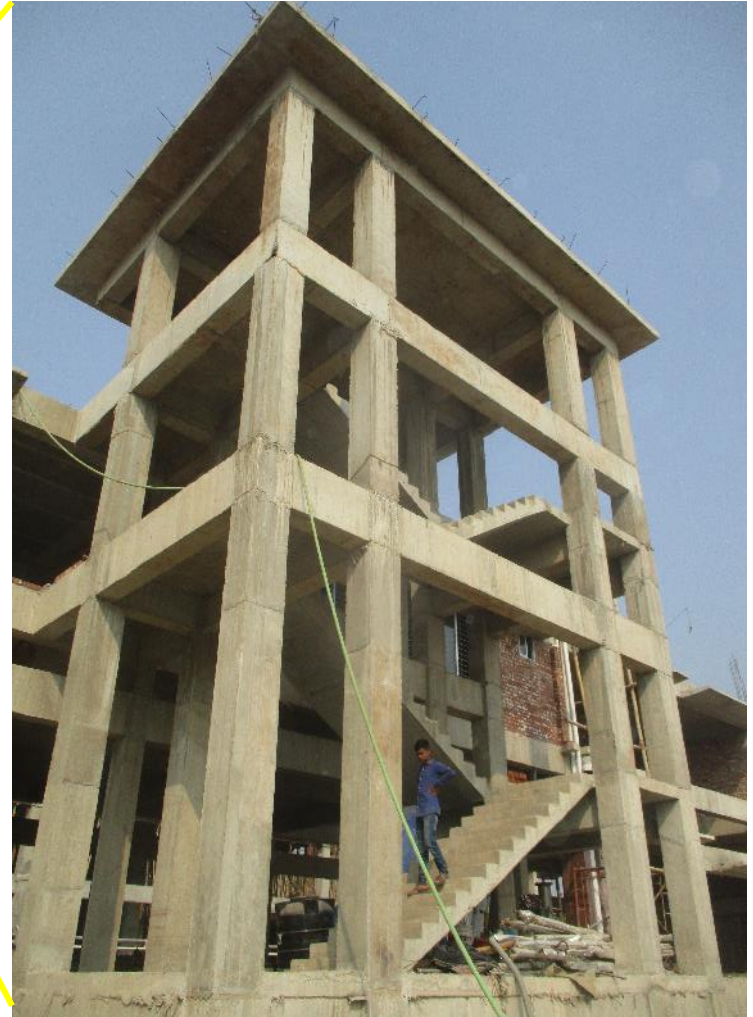
There is a staircase on the southern face of the utility building. Complete structural drawing of this staircase was not available in the provided drawing.

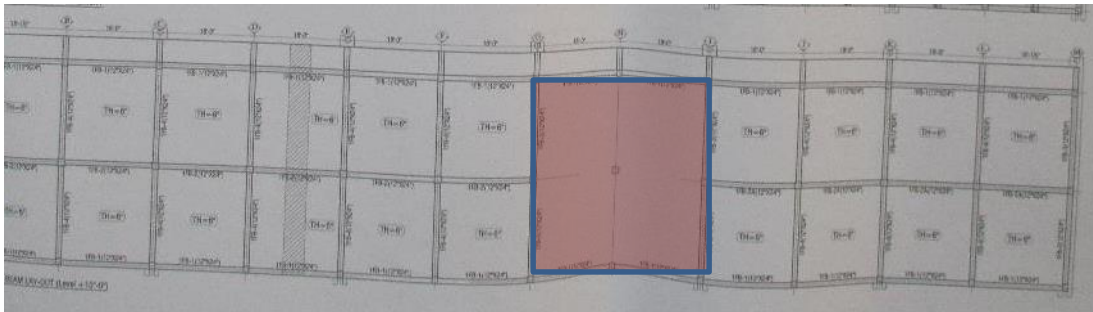
Double height ground floor location in as built drawings

The location of double height column was not matched with the provided drawing.

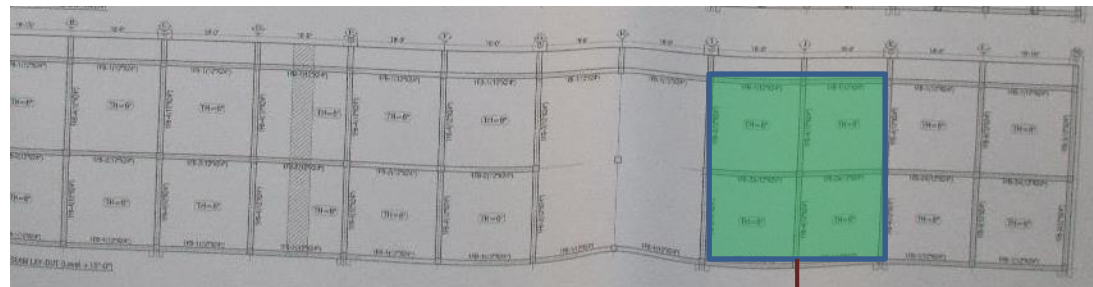
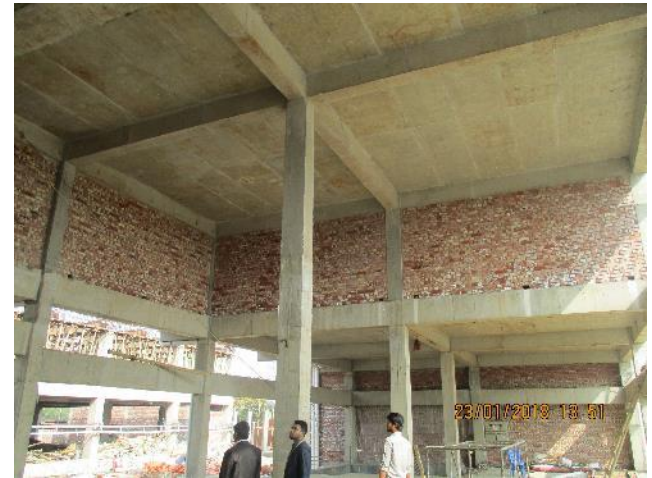
Real location of double height ground floor

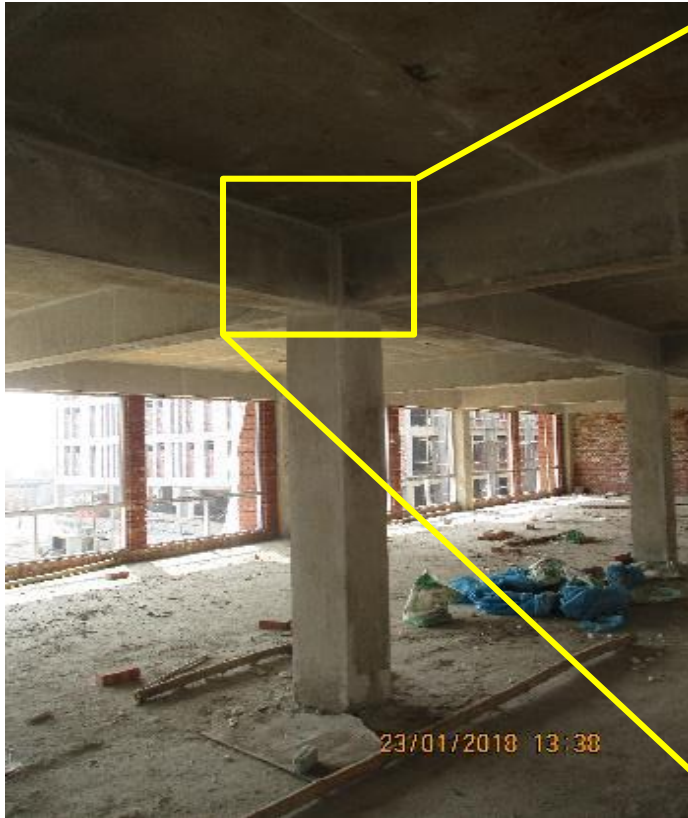
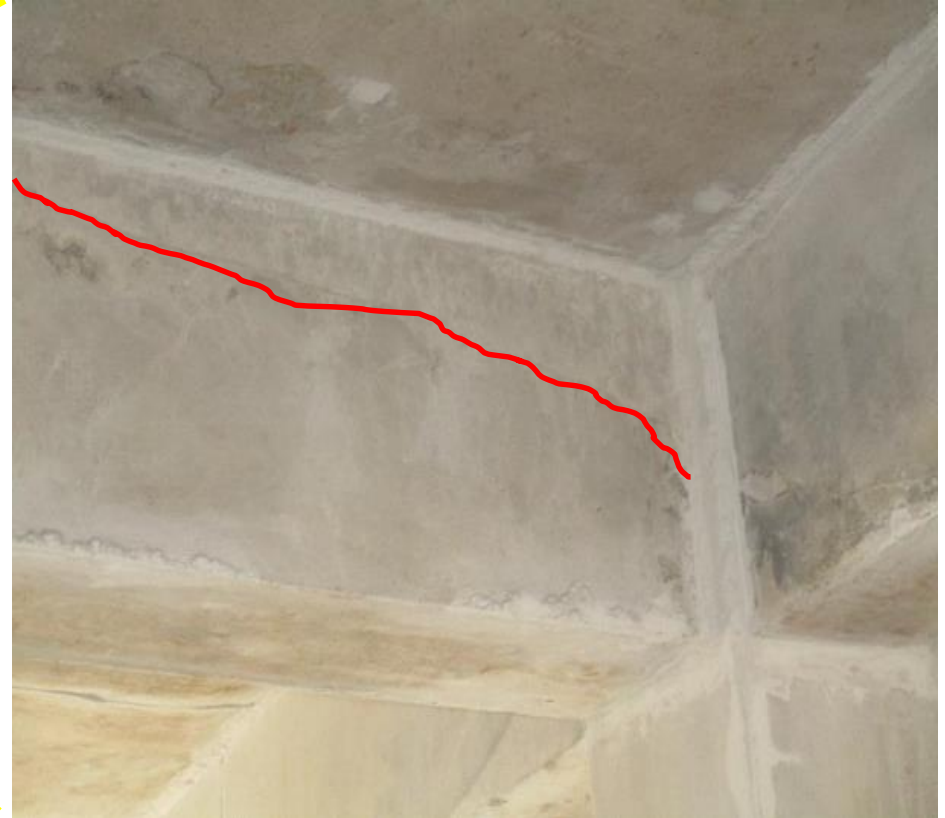
Crack was observed on beam in Utility Building. The reason of crack is required to be investigated and take proper remedial measures.

| Item No. | Observation | Recommended Action Plan | Recommended Timeline |
|---|---|---|---|
| 7 | Appearance of crack on beam (Utility Building) | The reason of cracking is required to be investigated and take proper remedial measures. | 6-weeks |
| 8 | Appearance of crack on beam (Utility Building) | Carry out remedial works as per engineer's advice. | 6-months |

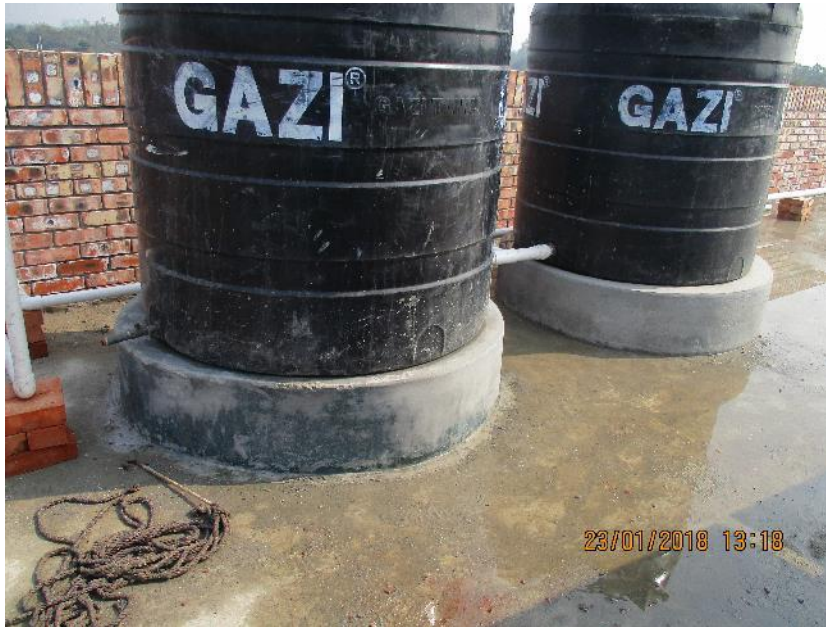
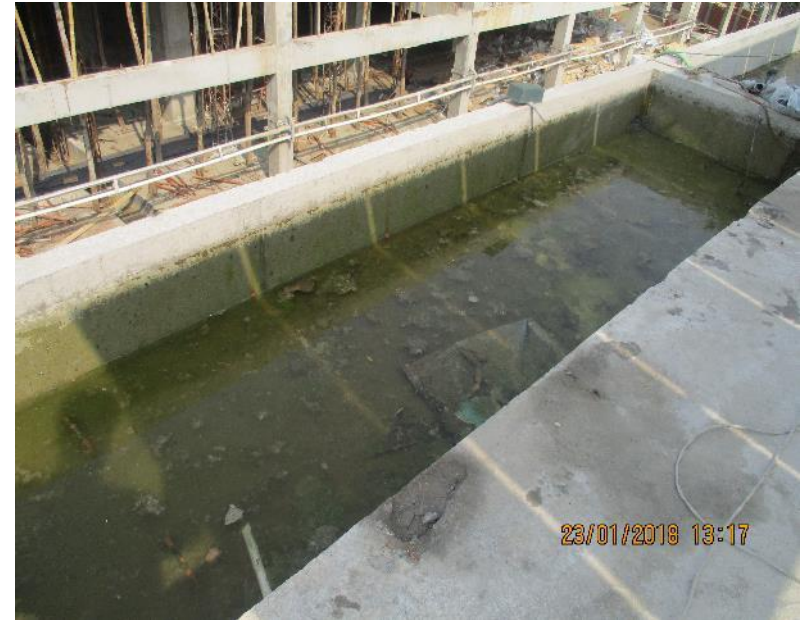
Water clogging was observed on rooftop near water tanks position. Also there are several places on roof top for gardening which is responsible for water clogging. A proper drainage system is required to install for preventing the water clogging in future.

| Item No. | Observation | Recommended Action Plan | Recommended Timeline |
|---|---|---|---|
| 9 | Water clogging on roof top (Utility Building) | Factory is required to implement proper drainage system and other remedial measures to prevent water clogging. | 6-weeks |

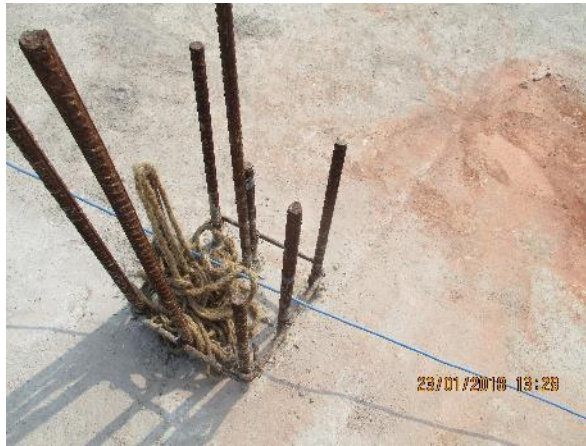
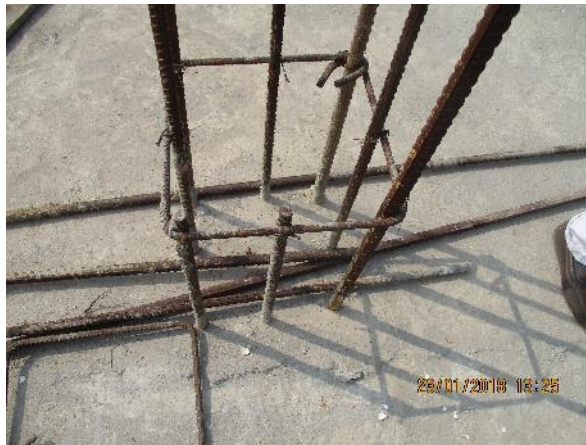
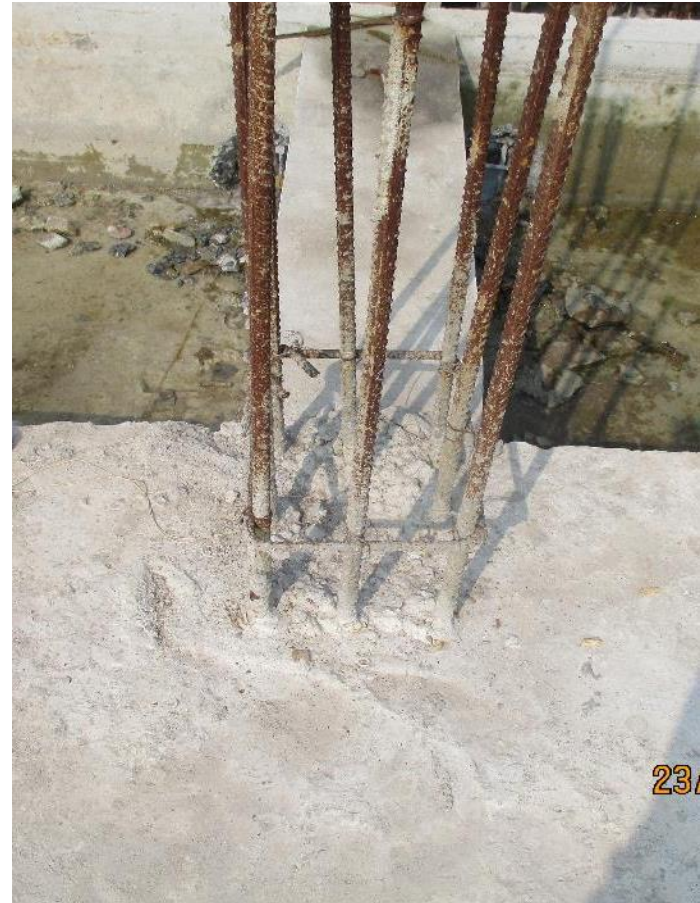
Corrosion was observed on almost all exposed reinforcement of column on roof top. Factory is required to take proper measures to protect rebars from corrosion.

| Item No. | Observation | Recommended Action Plan | Recommended Timeline |
|---|---|---|---|
| 10 | Corrosion on roof top exposed reinforcement (Utility Building) | Factory engineer is required to take proper remedial measures to protect rebar from corrosion. | 6-weeks |
