Vintage Denim Apparels Ltd. (Wet Processing)

Boherarchala, Sreepur, Gazipur.
(24.190945N , 90.405580E)
5th February, 2018

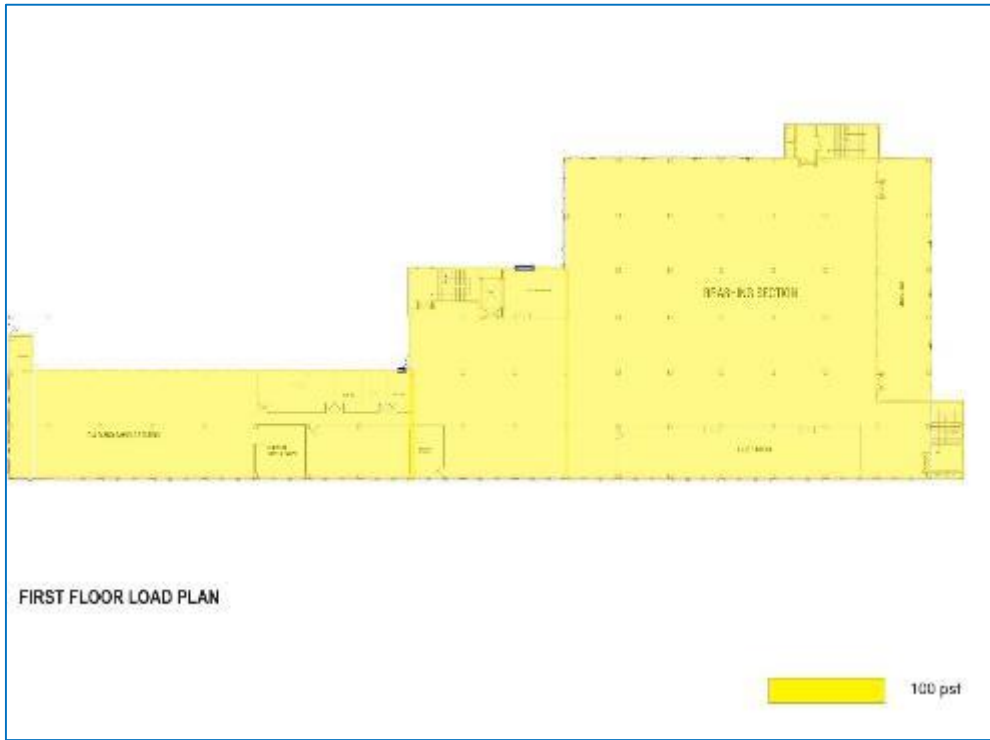
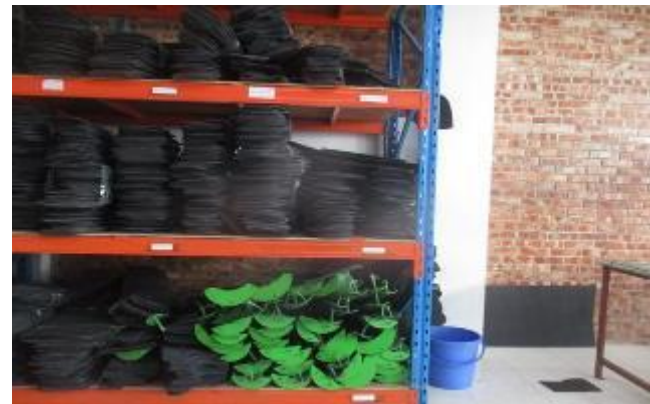
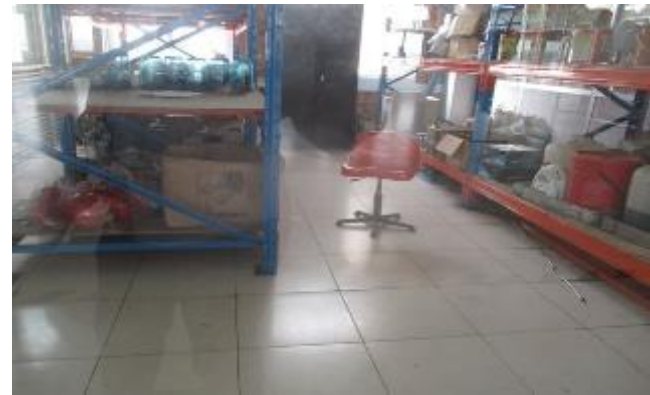
Prepared load plan required to be verified

Factory engineer has prepared a load plan considering 5kpa allowable floor loading. Design report is required if the factory management intends to implement the load plan.

During inspection no over loading was observed and FoS calculation for internal column was found satisfactory considering 3 kpa allowable floor live loading.

Factory is required to maintain the floor live load 3 kpa until prepared load plan reviewed by design engineer.

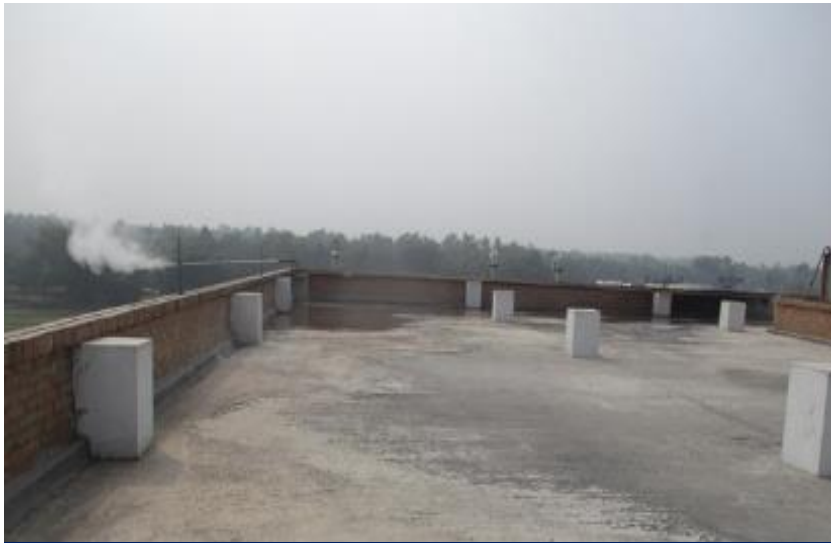
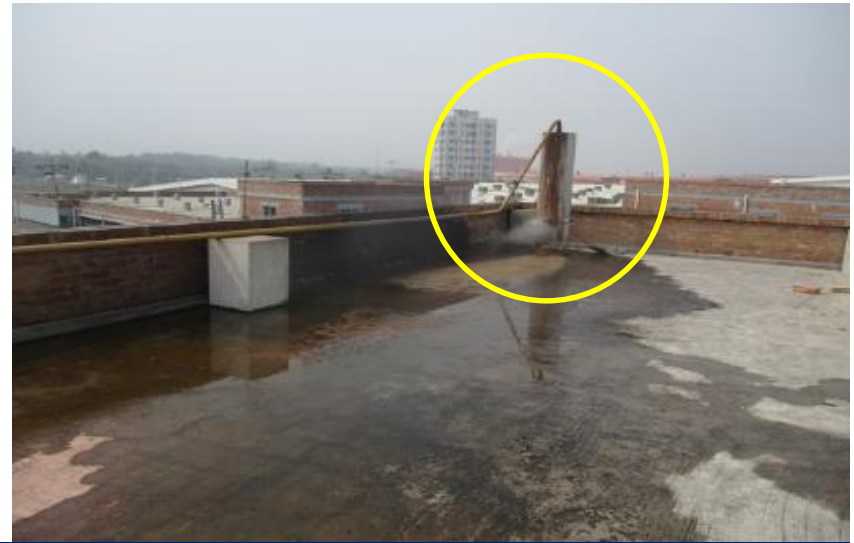
Water causing damage

Steam rejection causing constant wetting. Unmanaged roof drainage causing corrosion to façade and structure.

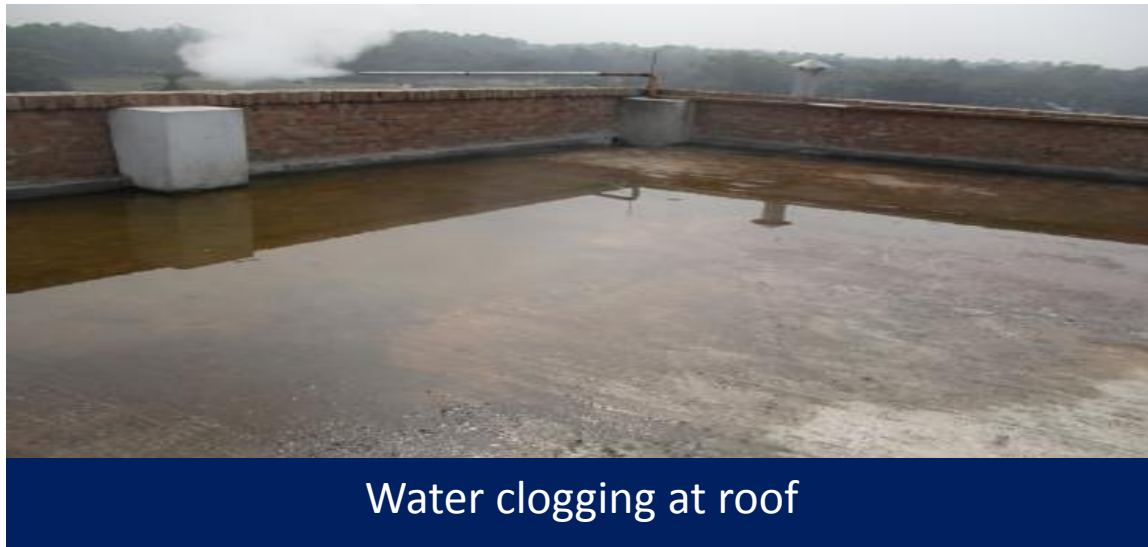
Water clogging at roof

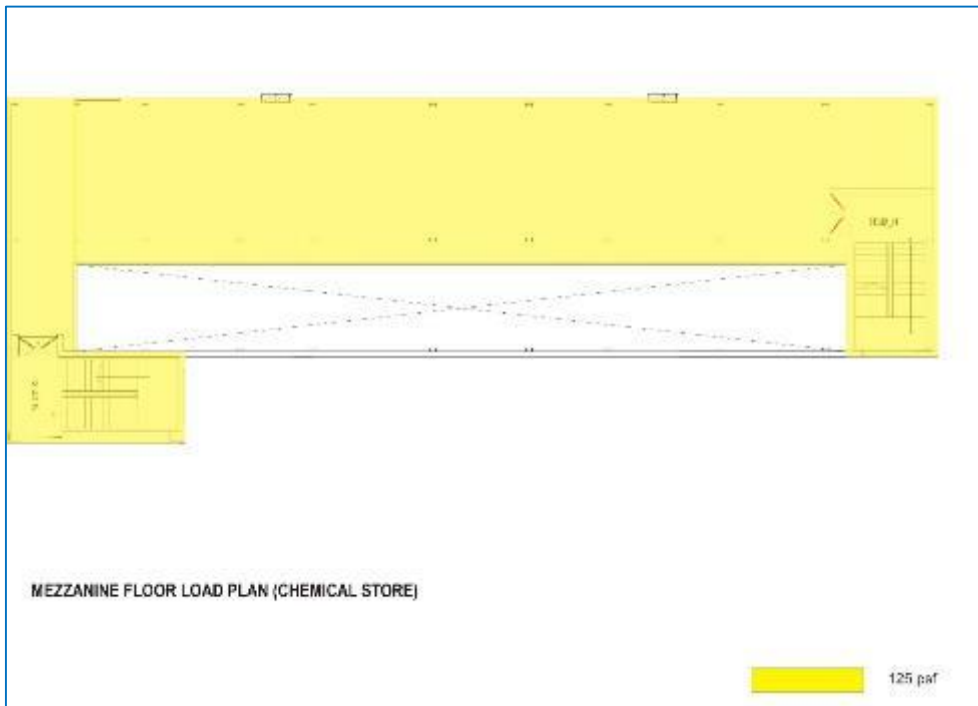
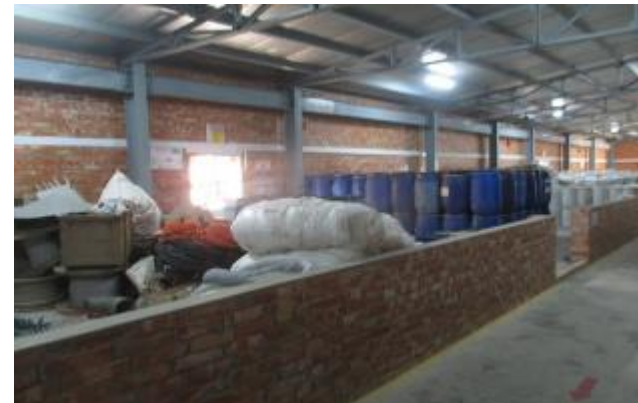
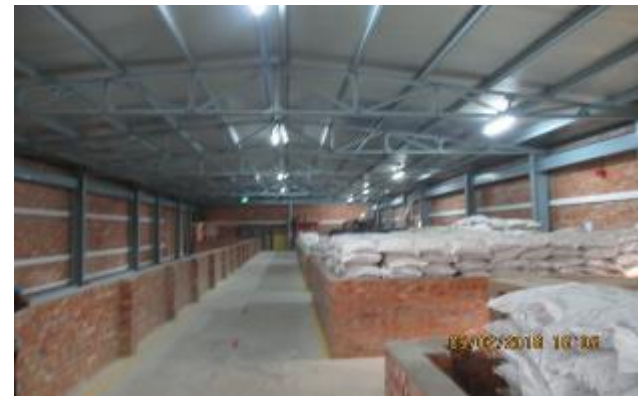
Prepared load plan required to be verified

Factory engineer has prepared a load plan considering 6 kpa allowable floor loading. Design report is required if the factory management intends to implement the load plan.

During inspection no over loading was observed and FOS calculation for internal column was found satisfactory considering 3 kpa allowable floor live loading.

Factory is required to maintain the floor live load 3 kpa until further verification by design engineer.

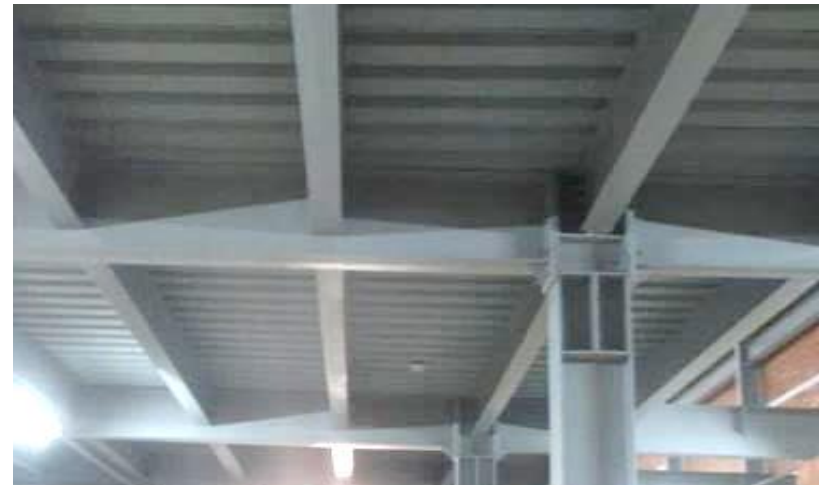
Typical beam-column connection

Purlin layout and connection details were not available on provided drawings. On the other hand, truss pattern did not match with as-built condition.

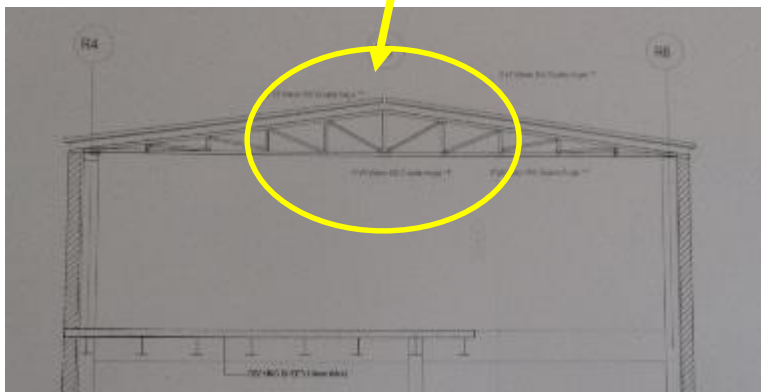
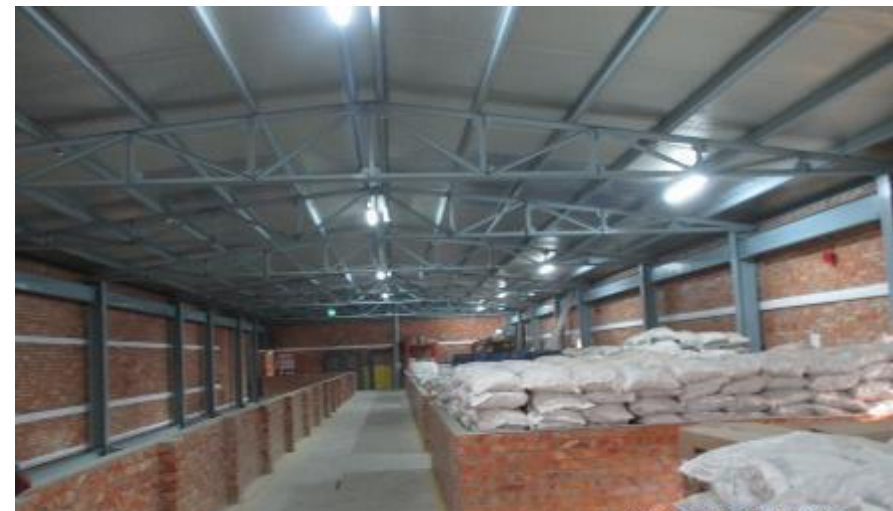
Truss section

Connection details were not available on provided drawings. Truss patterns did not match with as-built condition. Single truss member were found in as-built condition whereas double angle truss member were shown on drawings.
