# S.Suhi Industrial Park Ltd. (New Building)

Hazi Liakat Mir Sarak, Zamgora, Savar.

4<sup>th</sup> February 2018

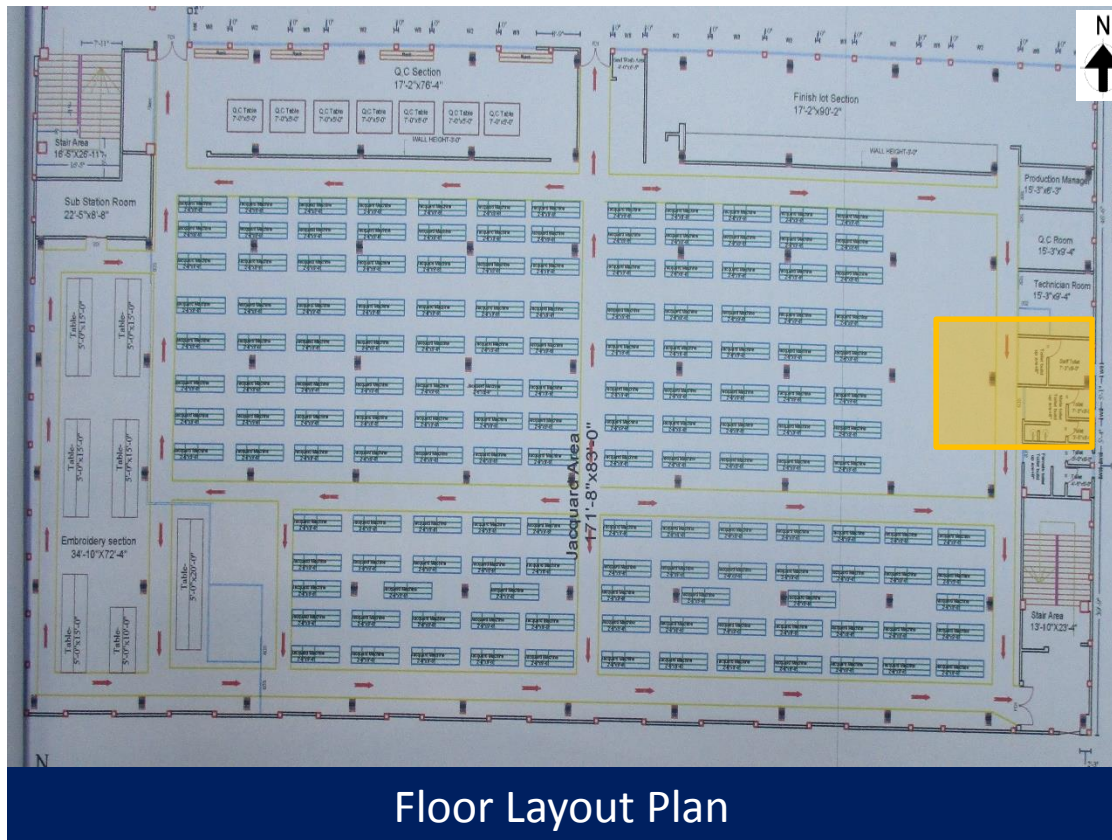
Floor Layout Plan

# Steel columns to be stressed above normal design limits

Cursory calculations indicate that the working stress of the highlighted columns at ground floor level appear to be stressed in excess of normal design limits.

| Item No. | Observation | Recommended Action Plan | Recommended Timeline |
|---|---|---|---|
| 1 | (Sweater Building)<br>Steel columns to be stressed above normal design limits | Building engineer to review design, loads and column stresses of the existing steel columns. | 6-weeks |

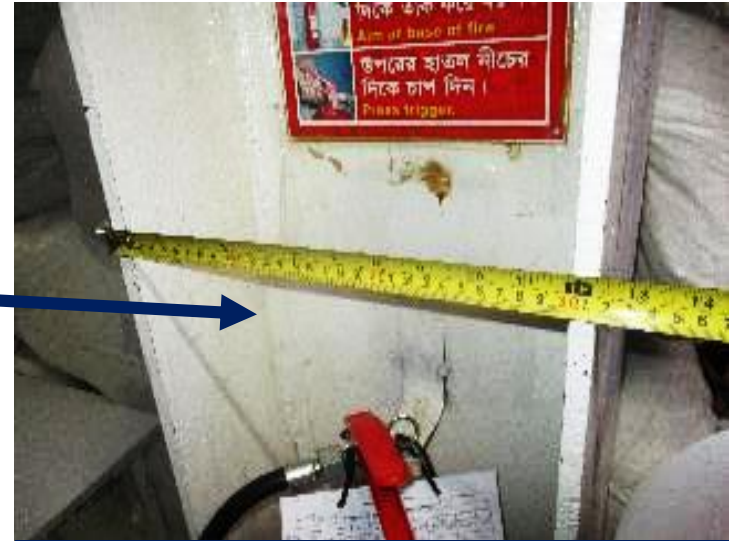
Depth of web was observed 315 mm instead of 325 mm

During inspection, Steel section of the highlighted columns were found undersized at ground floor and 1<sup>st</sup> floor level.

| Item No. | Observation | Recommended Action Plan | Recommended Timeline |
|---|---|---|---|
| 5 | (Sweater Building)<br>Discrepancies between provided drawings and on site condition | Building Engineer to survey as-built structure and prepare accurate as-built survey information for the building | 6-weeks |

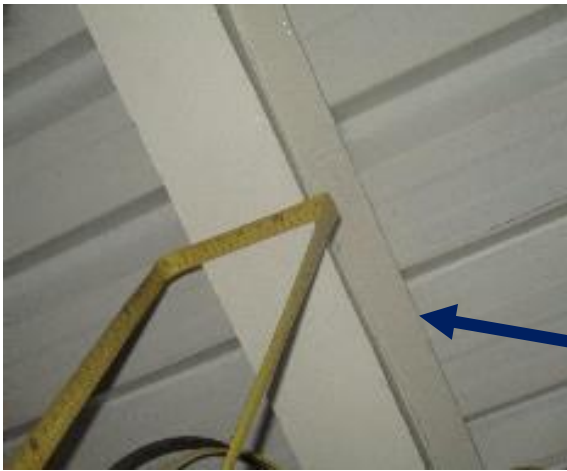
Width of flange of the highlighted portion was observed 150 mm instead of 175 mm.

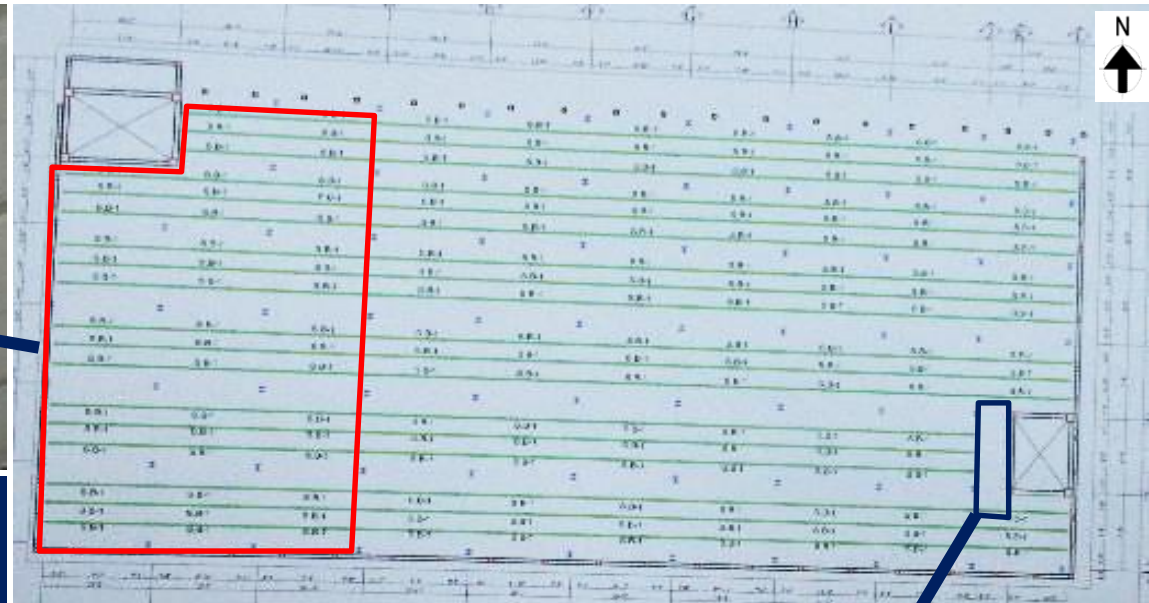
Sub- Beam Layout Plan

During inspection, Steel main beam and sub-beam were found under-sized of the highlighted portion at 1<sup>st</sup> floor and 2<sup>nd</sup> floor level. Also some sub-beams near north-east staircase were not indicated in sub-beam layout plan.

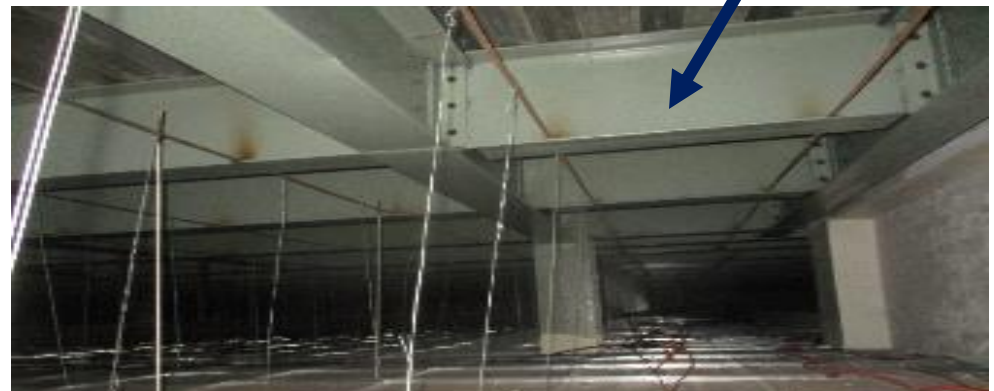
Steel Sub Beam was observed on the highlighted portion at ground floor roof which was not included in As -Built drawing.

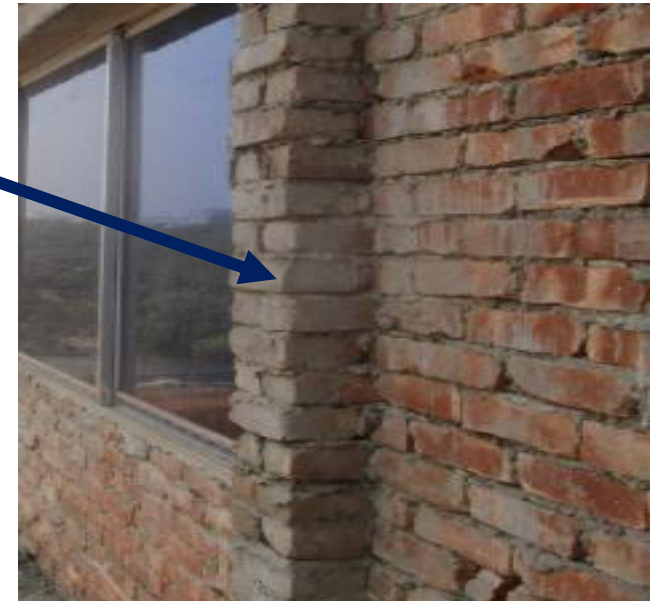
In drawing, RCC columns were mentioned on ground floor for the highlighted portion. But Brick columns were observed on site.

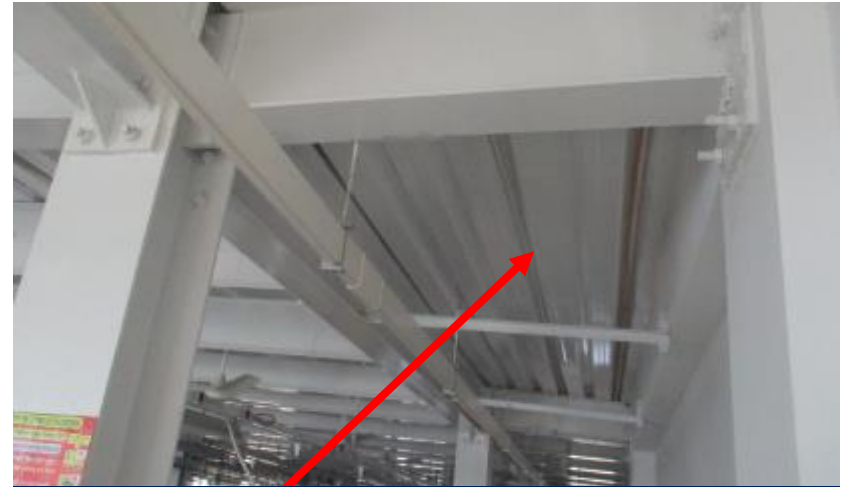
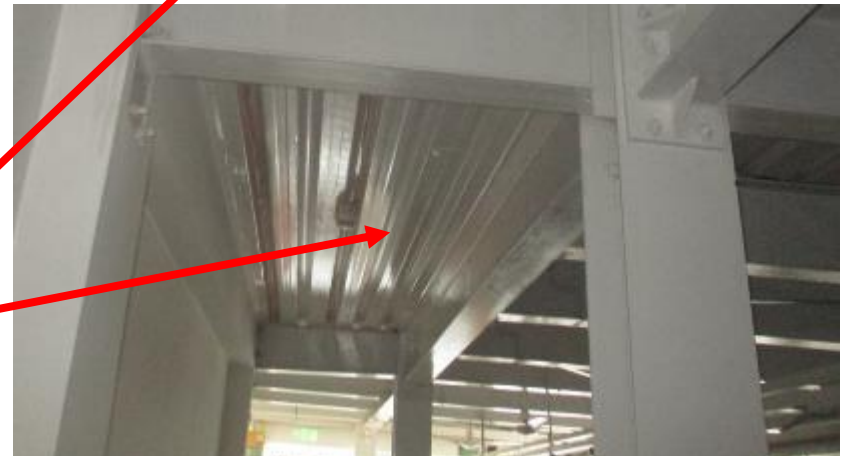
Almost 5 feet width deck slab found near Eastside stair without sub-beam on 1<sup>st</sup>, 2<sup>nd</sup> and 3<sup>rd</sup> floor. Factory engineer is required to confirm that deck has adequate capacity to take the floor load otherwise provide additional beams.

Deck without sub-beam

| Item No. | Observation | Recommended Action Plan | Recommended Timeline |
|---|---|---|---|
| 6 | (Sweater Building)<br>Deck slab with out sub-beam | Factory engineer is required to confirm that deck has adequate capacity to take the floor load otherwise provide additional sub-beams. | 6-weeks |

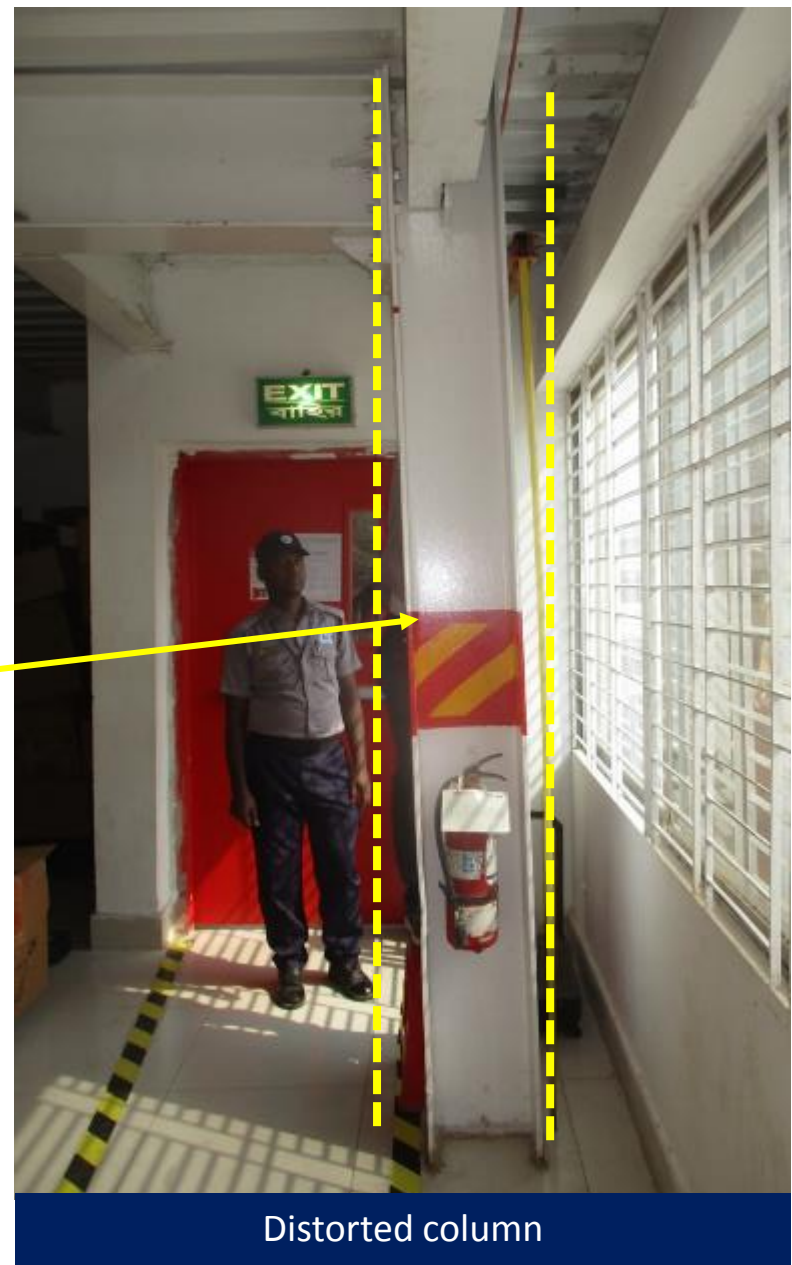
A distorted steel column found on 2<sup>nd</sup> & 3<sup>rd</sup> floor of the main production building. Stability for the distorted columns and related elements need to be checked. Factory Engineer to review design, loads and column stress in the area identified above.

Distorted column

| Item No. | Observation | Recommended Action Plan | Recommended Timeline |
|---|---|---|---|
| 7 | (Sweater Building)<br>Distorted column | Building Engineer to review design of distorted steel column taking into account the as-built condition of the column. | 6-weeks |

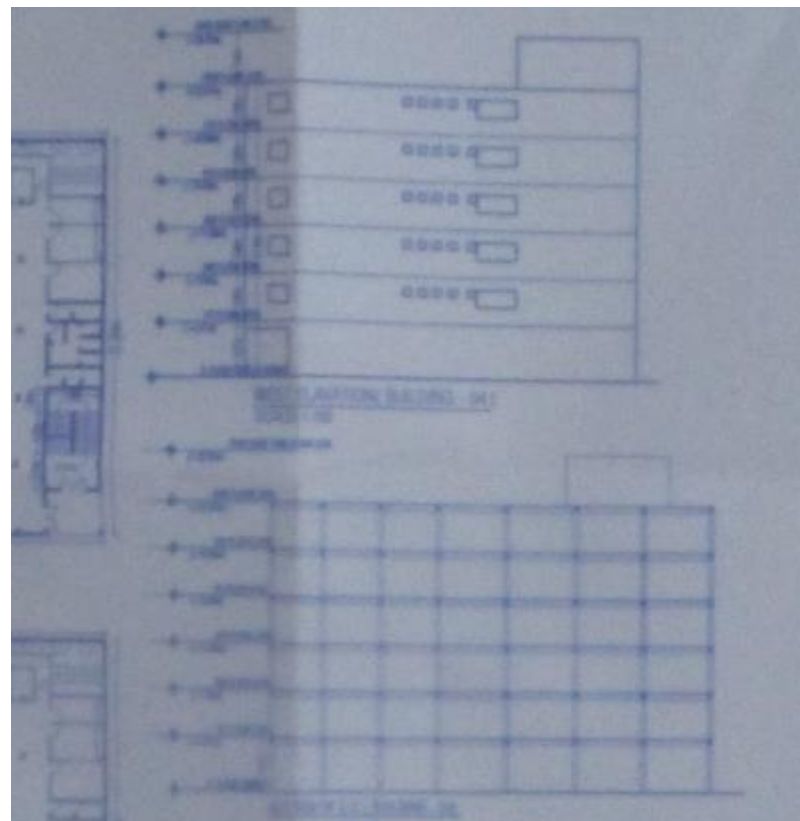
Currently the building is 4 storied. There is a possibility of one storey extension in future. Factory engineer is required to carried out a Detail Engineering Assessment considering BNBC provision prior to commencement of any extension work.

Local authority Permit drawing shown 6 storied

| Item No. | Observation | Recommended Action Plan | Recommended Timeline |
|---|---|---|---|
| 8 | (Sweater Building)<br>Future extension to be carried out | Prior to commencement of any extension, factory engineer to be carried out further analysis and update design report following BNBC requirement. | 6-weeks |

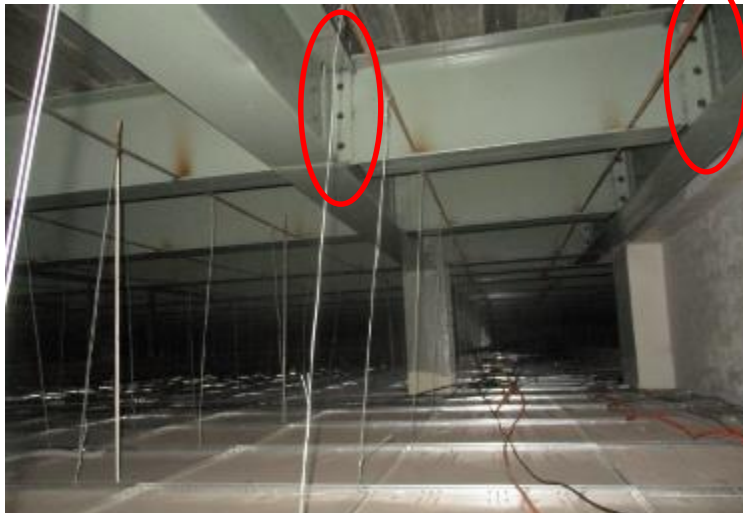
Welded joints instead of bolt joints

| Item No. | Observation | Recommended Action Plan | Recommended Timeline |
|---|---|---|---|
| 9 | (Sweater Building)<br>Bolt missing and light connection | Factory Engineer to check the member joints and install missing Bolts. | 6-weeks |

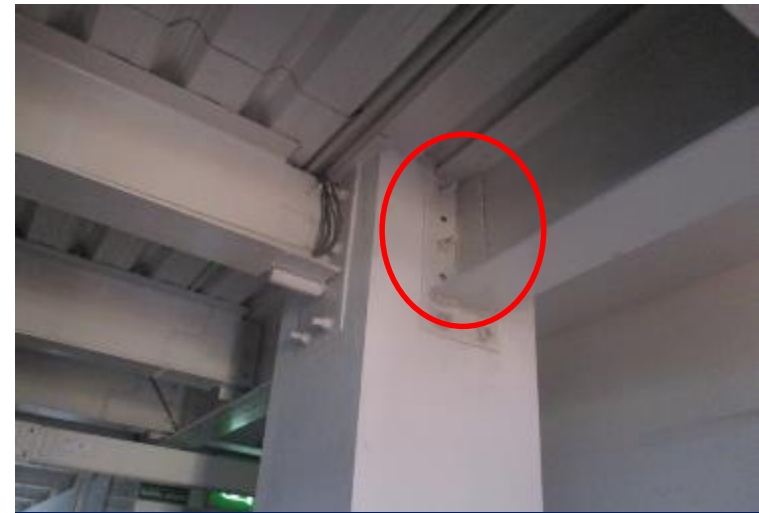
Missing bolt

Missing bolts and loose nuts found on several bolted joints. Factory Engineer to check the member joints and install missing bolts.

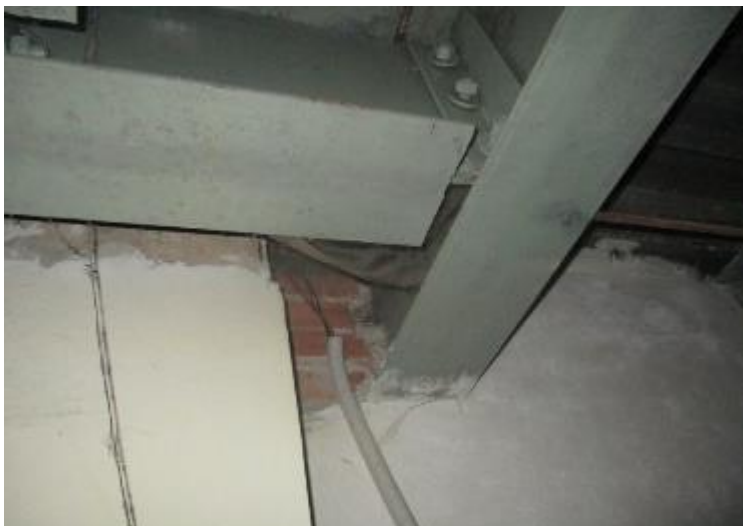
Loose nuts on some bolted joints

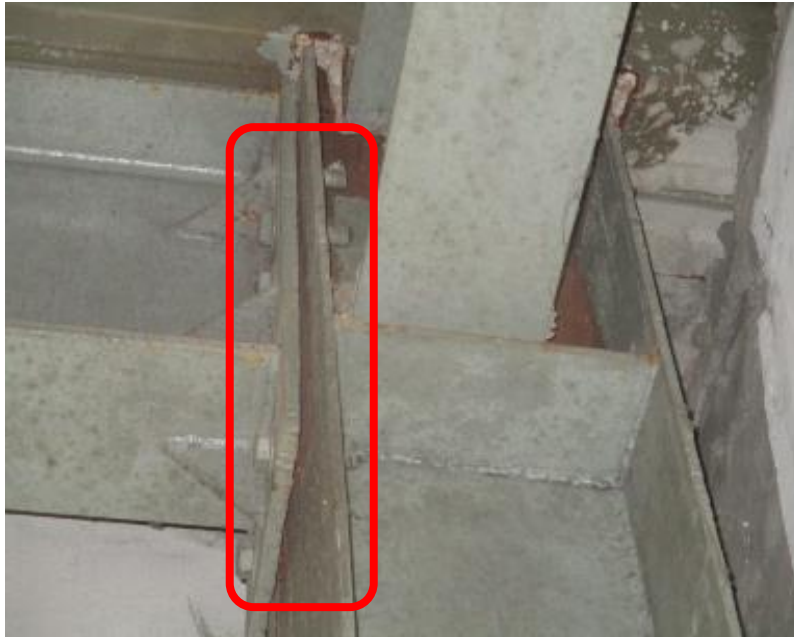
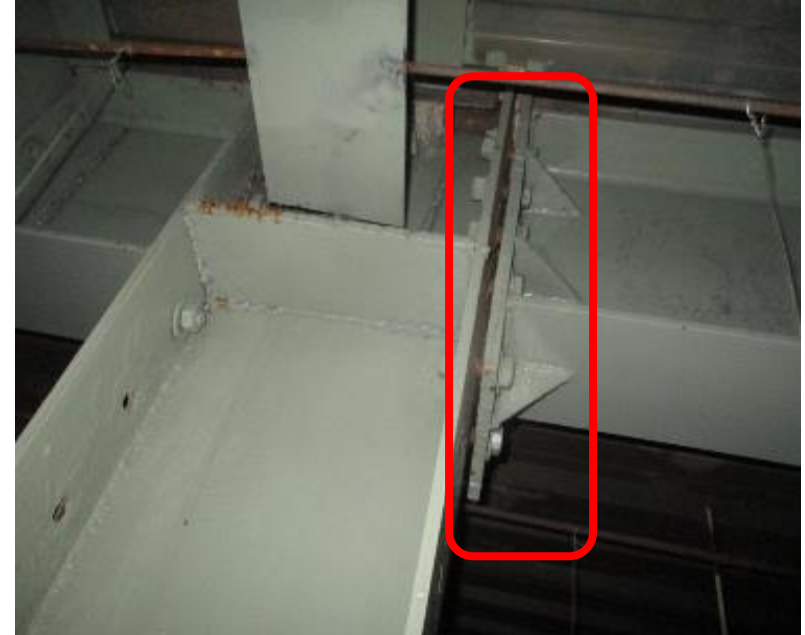
Gap found at ground floor beam-column joint. Factory Engineer to take remedial actions for repairing the connections where required.

Gap in between beam-column joint

| Item No. | Observation | Recommended Action Plan | Recommended Timeline |
|---|---|---|---|
| 10 | (Sweater Building)<br>Bolt missing and light connection | Factory Engineer to take remedial actions where required. | 6-weeks |

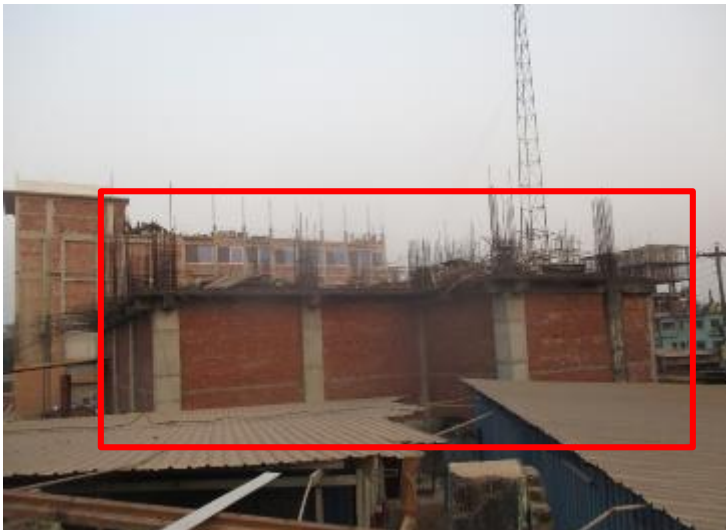
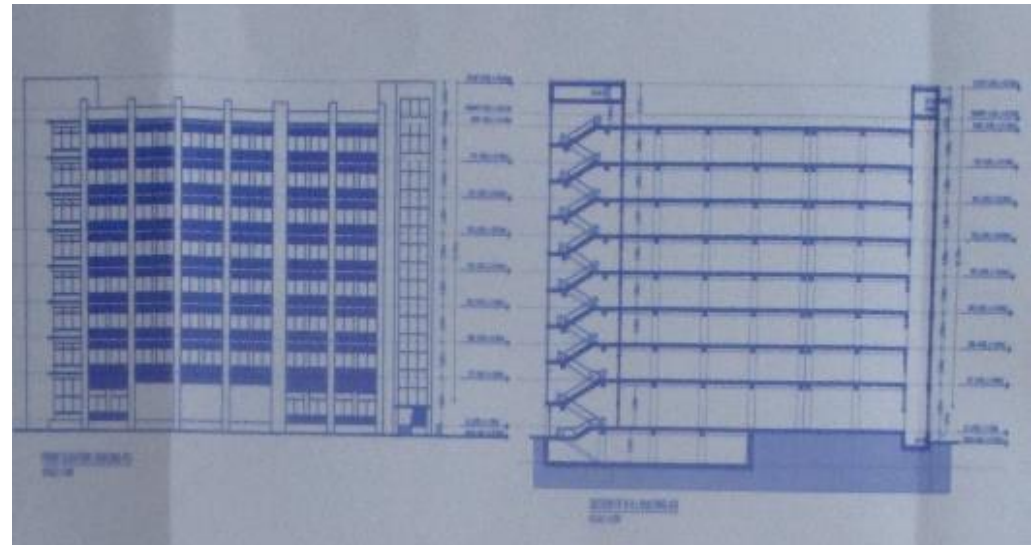
This building is permitted for 8 storeys with a basement (B+G+7) from local authority. Currently the building is partially single (B+G) storied. Factory owner has a plan to extend the building both vertically and horizontally up to 7<sup>th</sup> floor in future. Factory engineer is required to carry out a Detail Engineering Assessment considering BNBC provision prior to commencement of any extension work.

Current condition of the building

Local authority Permit drawing shows (B+G+7)

| Item No. | Observation | Recommended Action Plan | Recommended Timeline |
|---|---|---|---|
| 11 | (Dining & Ware house Building)<br>Future extension to be carried out | Prior to commencement of any extension, factory engineer to be carried out further analysis and update design report following BNBC requirement. | 6-weeks |

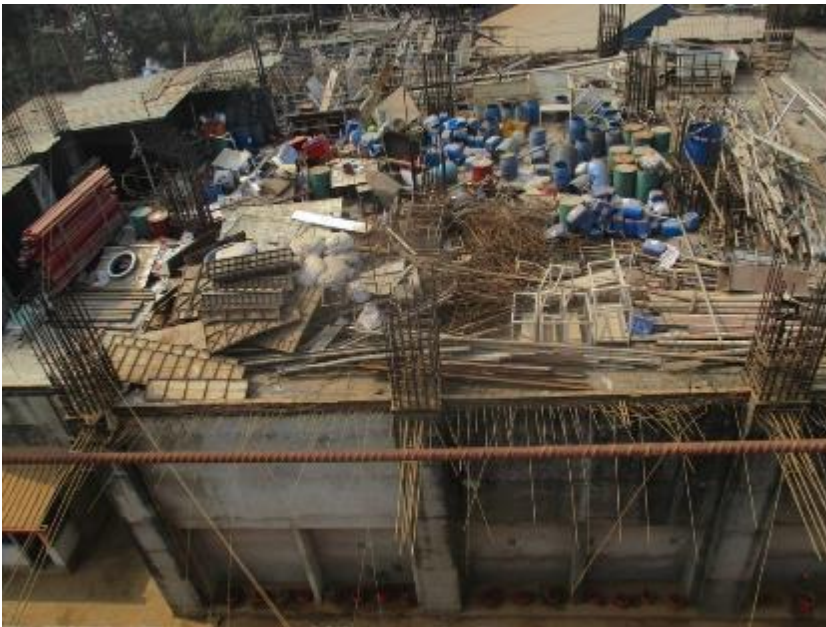
Currently the exposed reinforcement is prone to corrosion. All exposed reinforcement must have adequate protection. There is no parapet on first floor which may cause falling hazard. Also, stacked materials need to be removed from roof and develop proper drainage system.

Ground floor roof.

| Item No. | Observation | Recommended Action Plan | Recommended Timeline |
|---|---|---|---|
| 12 | (Dining & Ware house Building)<br>Exposed rebar and stacking of construction material at roof | All exposed reinforcement is to be protected from corrosion which may cause degradation of the concrete. | <b>6-weeks</b> |

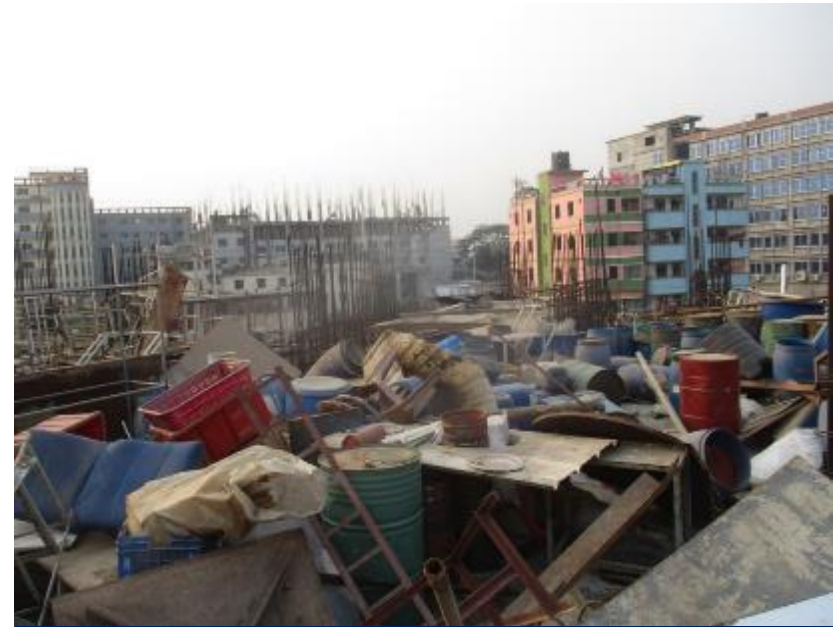
Stacked materials.

| Item No. | Observation | Recommended Action Plan | Recommended Timeline |
|---|---|---|---|
| 13 | (Dining & Ware house Building)<br>Exposed rebar and stacking of construction material at roof | Stacked materials need to be removed. | <b>6-weeks</b> |

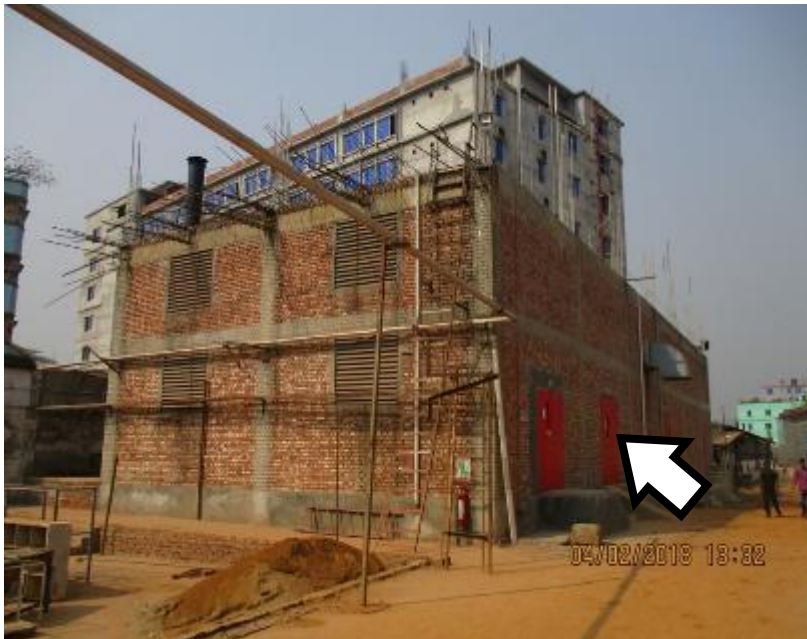
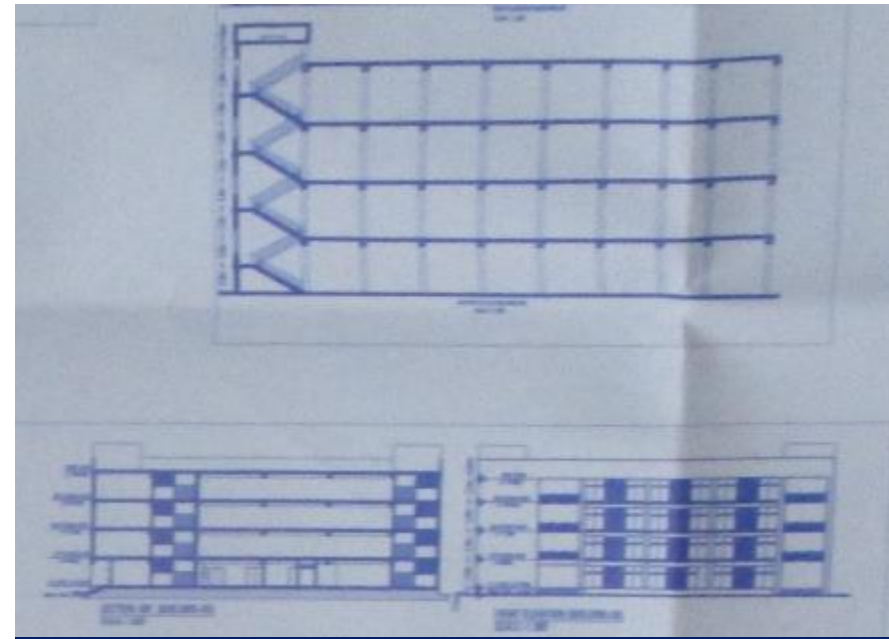
This building is permitted for 4 storied from local authority. Currently the building is single storied. Factory owner has a plan to extend the building both vertically and horizontally up to 4 storey in future. Factory engineer is required to carried out a Detail Engineering Assessment considering BNBC provision prior to commencement of any extension work.

Current condition of utility building

Local authority Permit drawing shown 4 storeys

| Item No. | Observation | Recommended Action Plan | Recommended Timeline |
|---|---|---|---|
| 15 | (Utility Building)<br>Future extension to be carried out | Prior to commencement of any extension, factory engineer to be carried out further analysis and update design report following BNBC requirement. | <b>6-weeks</b> |

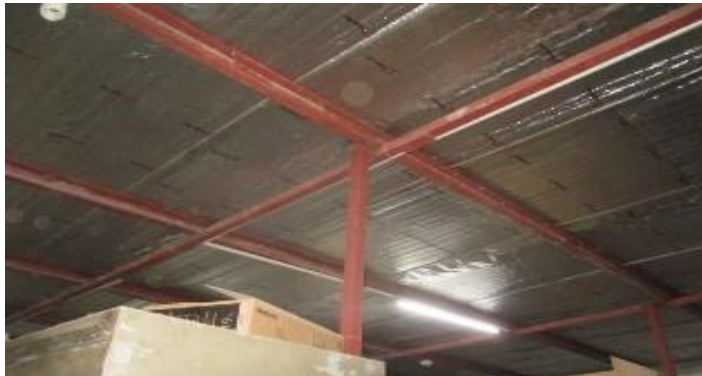
Soft Winding Shed

Poor connection between steel members was observed in the non-engineered ancillary sheds. Building engineer to check the stability of the lightweight steel roofs against uplift forces due to lateral loading. Otherwise demolish/replace with engineered shed.

| Item No. | Observation | Recommended Action Plan | Recommended Timeline |
|---|---|---|---|
| 16 | (Ancillary Sheds)<br>Apparently non-engineered ancillary sheds | Ancillary sheds should be designed and upgraded to support code vertical and wind loads by the building Engineer, or they should be replaced/removed. | <b>6-weeks</b> |
