# **FIRE SAFETY INSPECTION REPORT**

**Factory Name: Sublime Greentex Limited**

**ACCORD ID: 23102**

**Date: 25 February, 2018.**

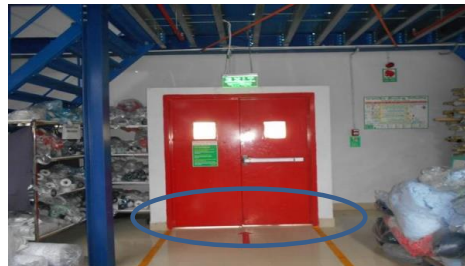
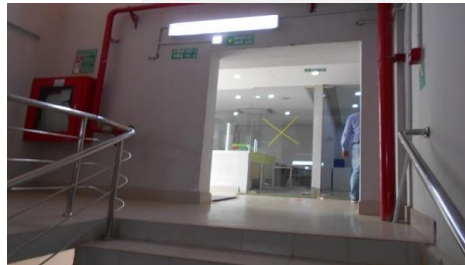
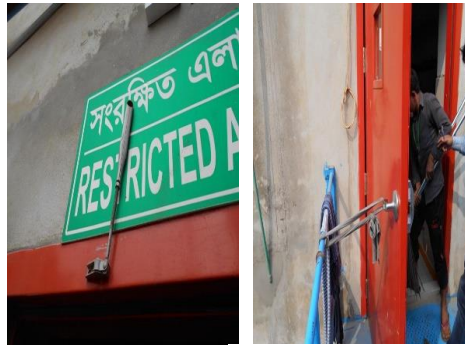
| Sl No. | Category | Findings | Required Action | Remediation Time Frame | Pictorial Evidence |
|---|---|---|---|---|---|
| 1 | Fire Rated Construction | <p>The exit stairs are not separated from [work areas, other spaces] on each floor by fire-rated construction.</p> <p>Location: Building 1 &amp; Building 2.</p> | <p>Stair shall be enclosed with a minimum 2-hr fire-rated construction. Seal all unprotected openings and provide minimum 2-hr fire rated doors to separate the exit stairs from work areas and other building spaces on all floor levels. Ensure that the fire doors are self-closing, positive latching and that they are provided with fire exit (panic) hardware where serving production floors.</p> <p>If fire doors are required to be held open for functional reasons, provide automatic-closing devices tied to the fire alarm system.</p> <p>Note: The gap between floor level and fire door was not found as per standard, door co-ordinator &amp; door closure was found missing during inspection. Also, fire door was found held open by external forces.</p> | Within 3 months | |

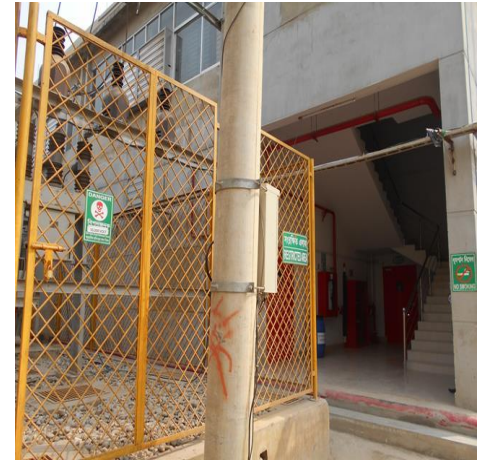
| 2 | Fire Rated Construction | <p>The exit discharge path serving west exit stair is less than 10 ft. wide and is not separated from the transformer.</p> <p>Location: building 2.</p> | <p>Seal all penetrations and openings to the interior of the building along the discharge path, up to a height of 10 ft. to provide a minimum 1-hr fire separation.</p> <p>Alternatively, provide a second remote discharge path to the public way (only include this if feasible).</p> | Within 3 months |

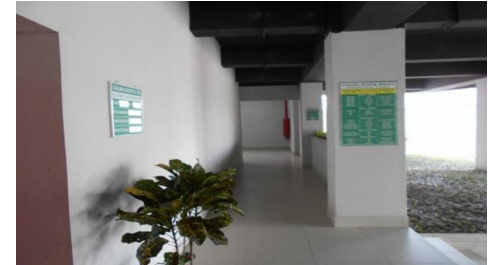
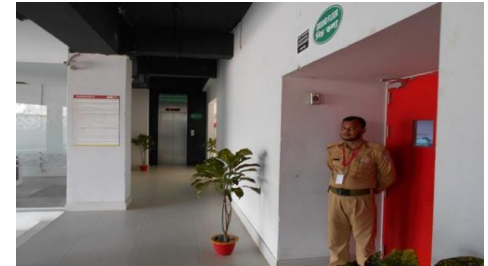
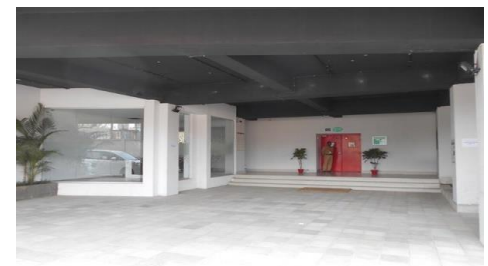
The exit stairs discharge inside the building to the ground floor.  
Location: Building 1.

Modify the stairs to discharge directly outside.  
Alternately, provide 2-hr fire rated exit passageway leading directly outside (vestibules to separate any storage areas).

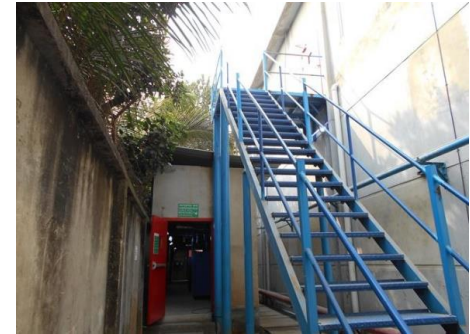
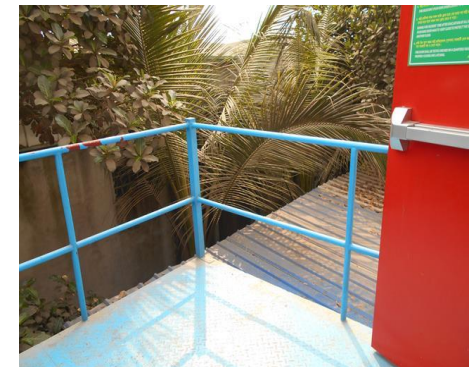
The secondary exit stair is not separated from the compressor shed.  
Location: Dinning at 1st floor of Building-2.

Secondary exit stair shall be separated by minimum 2-hr fire-rated construction and The rating of the exterior wall shall extend 3.05 m (10 ft.) beyond the ends of the stair structure. Provide minimum 2-hr fire rated doors to separate the exit stairs from work areas and other building spaces on all floor levels. Ensure that the fire doors are self-closing, positive latching and that they are provided with fire exit (panic) hardware where serving production floors.

If fire doors are required to be held open for functional reasons, provide automatic-closing devices tied to the fire alarm system.

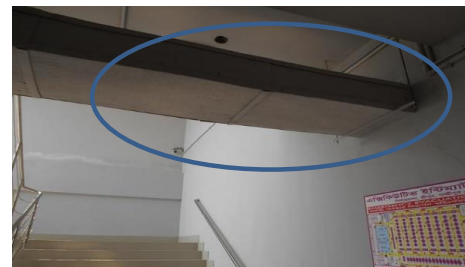
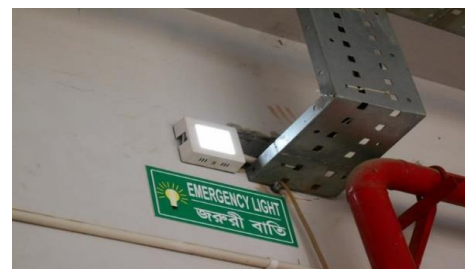
| 5 | Fire Rated Construction | <p>Unsealed penetrations and openings are located in exit stair enclosures.</p> <p>Location: Building 1 &amp; Building 2.</p> | <p>Seal all penetrations and openings in the wall of exit enclosure walls (full thickness of the wall) by fire rated materials to maintain the fire resistance rating.</p> | Within 1 month | |

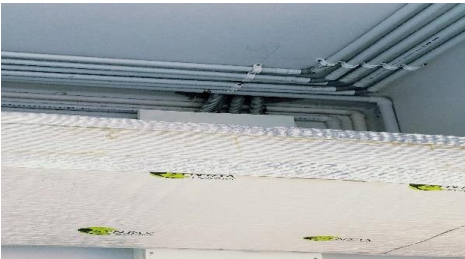
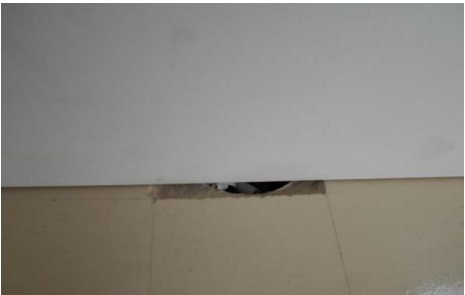
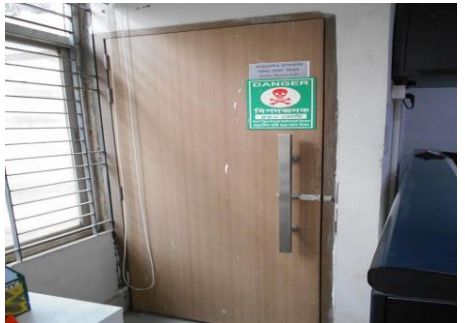
| 6 | Fire Rated Construction | Penetrations through floor/ceiling assemblies are found unsealed. (Electrical Riser) | Seal all penetrations and openings in floor/ceiling (full thickness of the floor/ceiling) assemblies by fire rated materials to maintain the fire resistance rating. | Within 3 months | |
| | | Location: Building 1 & Building 2. | Provide a minimum 2-hr fire rated shaft to separate the utility risers from each floor if required. | | |

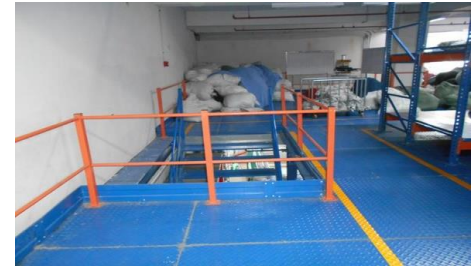
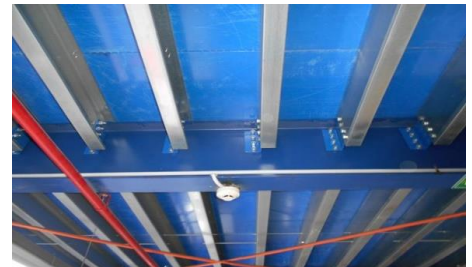
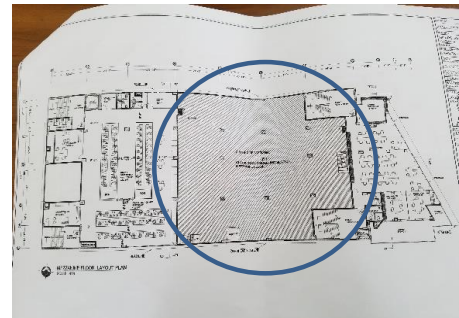
1st floor of Building-1 has 3 parts. One part (Middle Part of the floor) is Pre-fabricated steel (Part-1) which is non-rated structure and another 2 parts is RCC frame (Part-2 & 3). Part-1, Part 2 and Part-3 are not physically separate buildings but have a structurally independent fire wall separating them. From visual inspection all those structural members were found free of damage during assessment.

Since the structure is steel-composite type and all the RCC panels are resting on the steel beams and slab. Hence, ground & 1st floor of the building is not separated by a fire resistive rated protection construction barriers.

Provide fire-resistive rated construction barriers between floors following Section 4.4 and Table 4.4.1 of the Accord Standard or Table 3.3.1 and Table 4.1.1 from BNBC Part 4. Consult a qualified fire protection engineer to design the rated construction barriers.

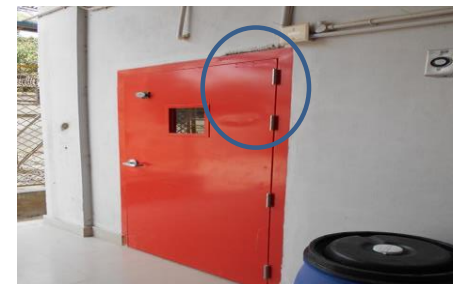
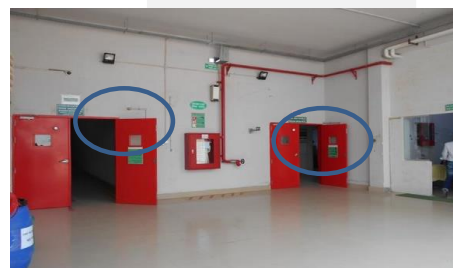
| 8 | Fire Rated Construction | <p>Rooms used for storage of combustible materials are not separated from the surrounding occupancy/areas.</p> <p>Location: Building 2.</p> | <p>Rooms used for storage of combustible materials shall be separated from the surrounding occupancy with a minimum 1 hour construction.</p> <p>Note: The gap between floor level and fire door was not found as per standard, door co-coordinator &amp; door closure was found missing during inspection.</p> |

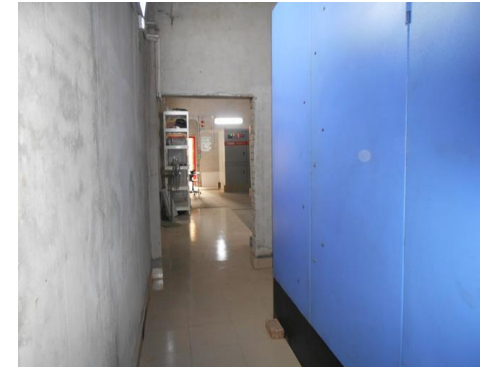
| 9 | Fire Rated Construction | <p>Generator &amp; Sub-Station room is not properly separated by fire rated construction with each other.</p> <p>Location: Building 3</p> | <p>Generator &amp; Boiler room shall be separated from other occupancies by a minimum 2-hr fire rated construction (wall, floor, slab etc.). Seal all penetrations and openings (door, window etc.) should be protected by 1.5-hr fire rated materials to maintain the fire separation if required. All exhaust systems shall discharge to the exterior of the building in a safe location.</p> <p>Or</p> <p>Relocate it to exterior of the building and maintain a minimum 3m (10 ft.) spatial separation distance from the building.</p> | Within 3 months | |

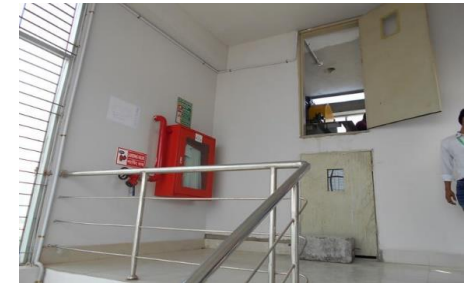
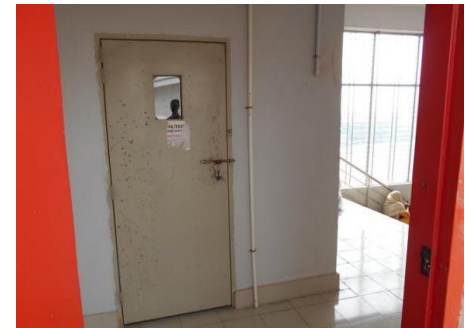
All elevator machine rooms were not separated by fire rated construction. The elevator machine rooms in Building 1 was not provided with fire rated doors and was open with exit stair enclosure.

Separate the elevator machine rooms. by a minimum 2-hr fire rated construction. Seal and/or protected all openings to maintain the required fire separations

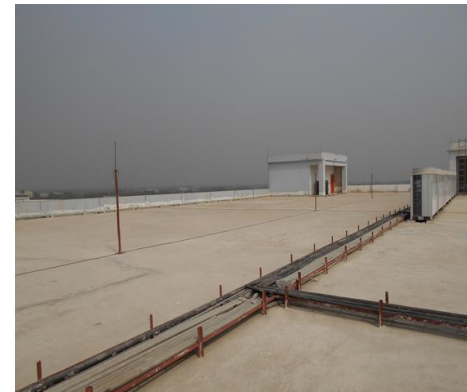
| 11 | Egress | Handrails are not provided in the exit stair.<br>Location: Building 1. | Provide handrails on both sides of the exit stair.<br>New handrails shall have a minimum height of 865 mm (34 in.) and a maximum height of 965 mm (38 in.) as measured from the leading edge of the tread. Intermediate handrails shall be provided when the stair width exceeds 2.2 m (87 in.) | Within 3 months | |

| 12 | Egress | Parapets or guards are not provide in Occupiable roof.<br>Location: Building 1 & Building 2. | Provide parapets or guards with a minimum height of 1067mm (42 inch.). | Within 3 months | |

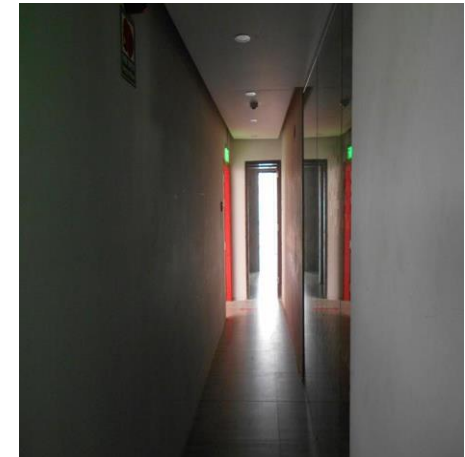
| 18 | Egress Lighting | <p>Based on the number and location of emergency lights observed, adequate illumination levels are not anticipated along egress routes.</p> <p>Location: Building 1, Building 2.</p> | <p>Test the emergency lighting system on each floor and provide additional emergency fixtures to provide adequate illumination along the means of egress. Provide a minimum illumination of 10 lux at the floor level within exit stairs and exit discharge paths and minimum 2.5 lux along exit access aisles.</p> | Within 3 months | |
