Kentucky Knit Composite Ltd. (12907)

Ratondi, Baranagar, Sonargaon, Narayangonj, Bangladesh

12 December 2017

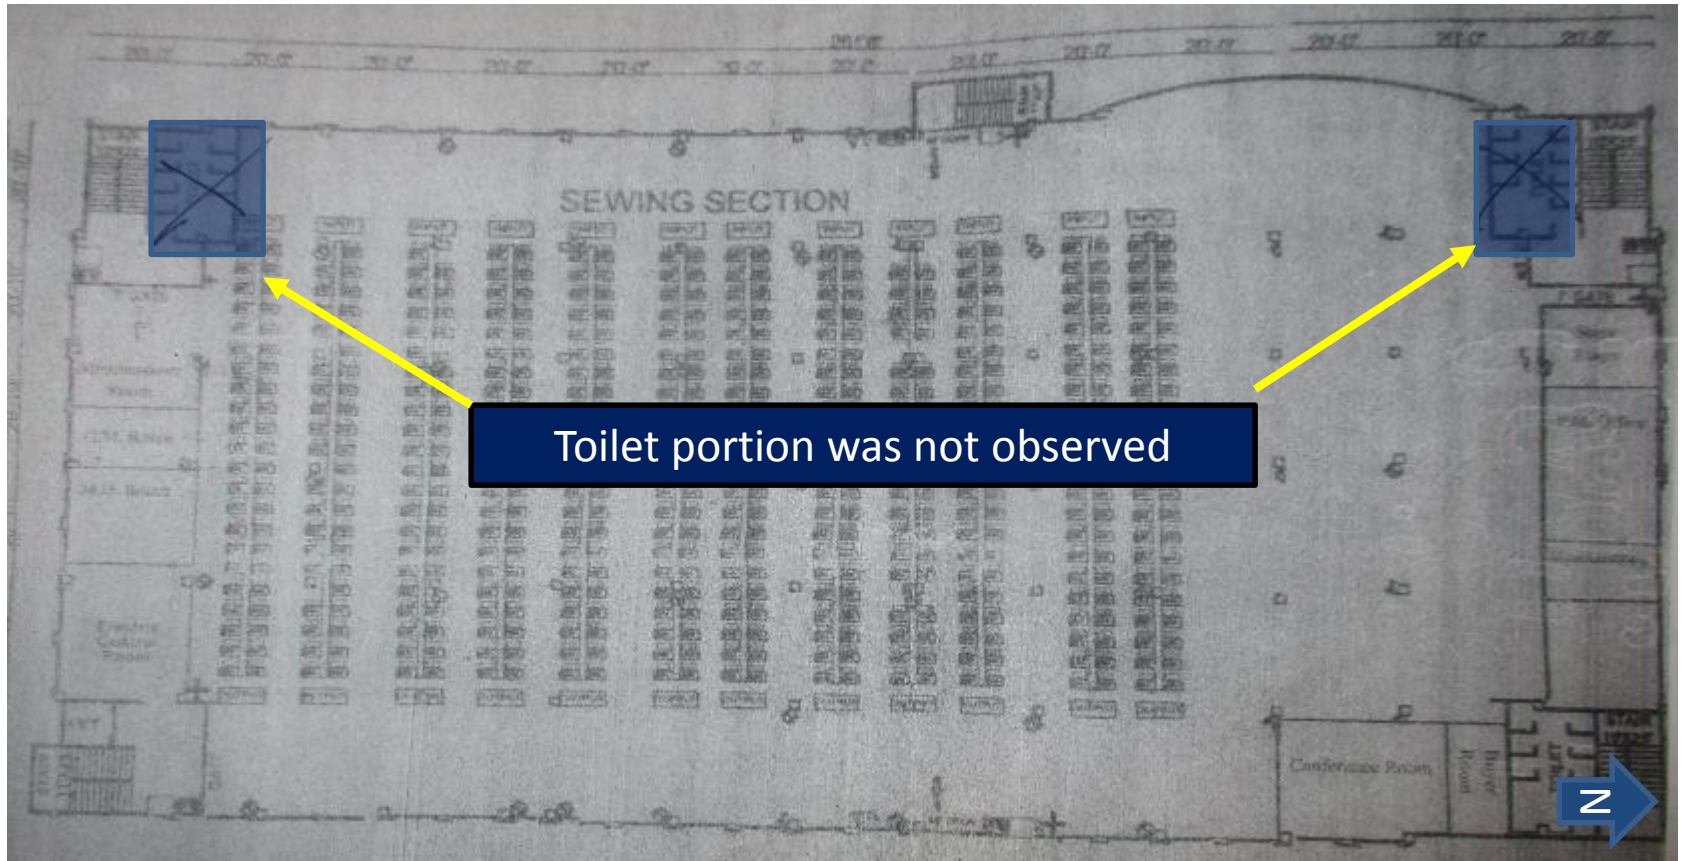
Machine Layout Plan (2nd Floor)

Toilet portion was not observed

No Architectural drawing was observed. However, discrepancy was observed on machine layout plan. The mentioned toilet portion was not built. Factory is required to produce as built drawing accurately as per on site condition.

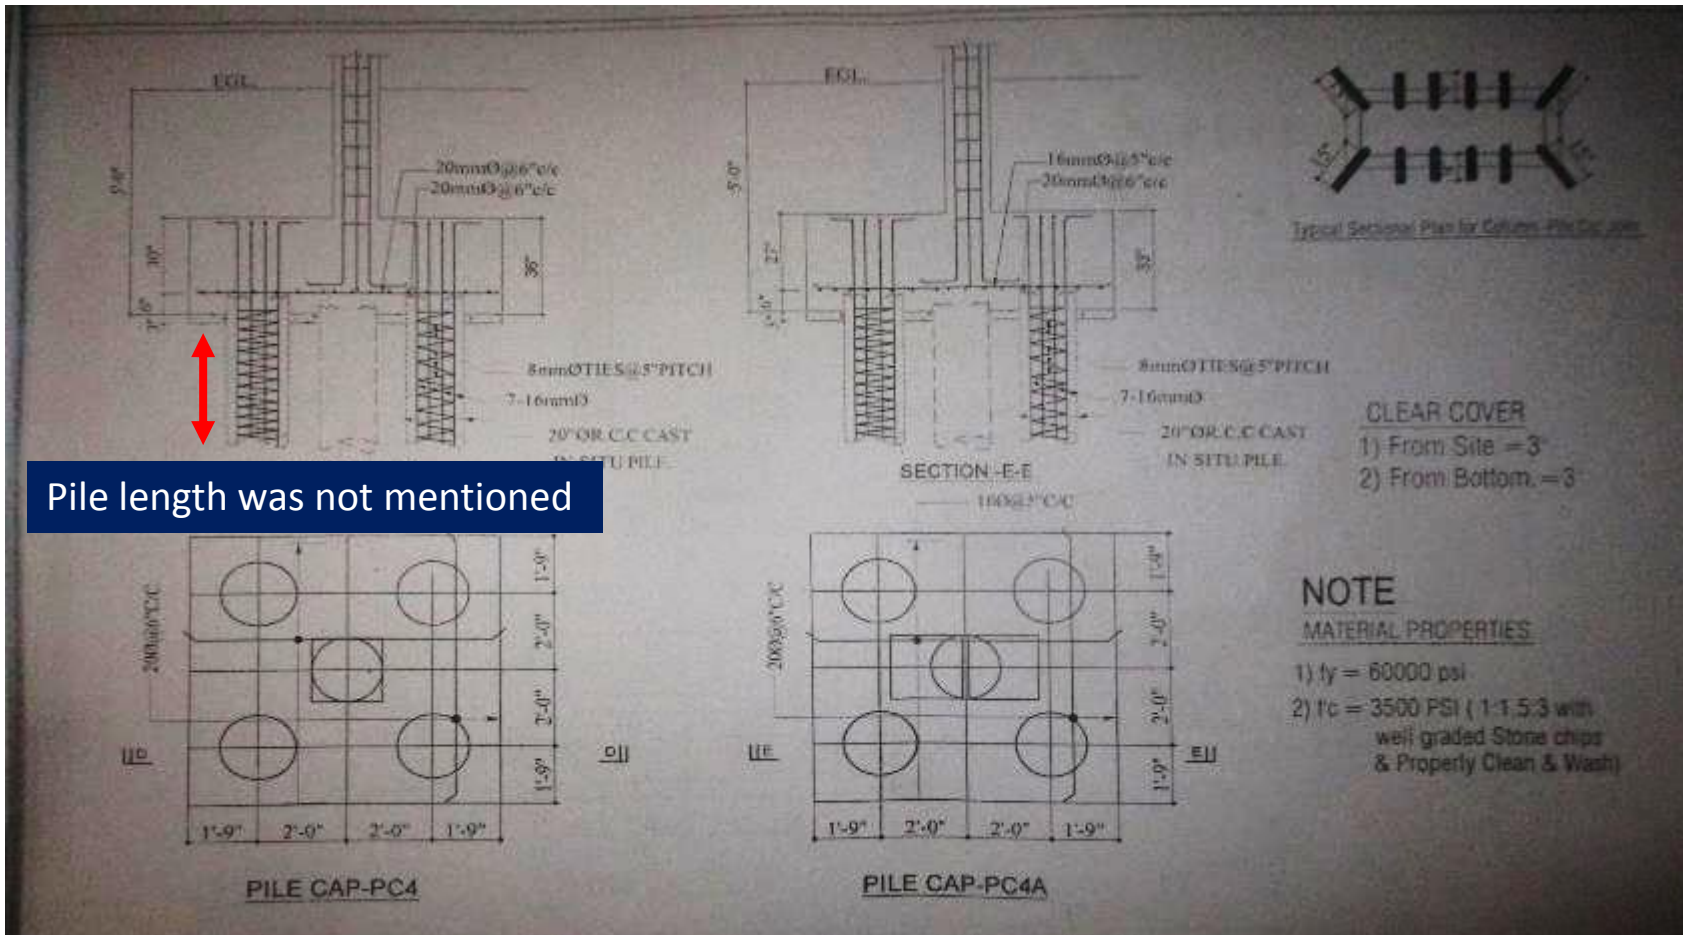
Pile length was not mentioned

As per the provided structural drawing of the main building, footing type is pile foundation. But pile length is not mentioned on the structural drawing. Building Engineer is required to confirm the length of the pile and check the adequacy of the foundation system.

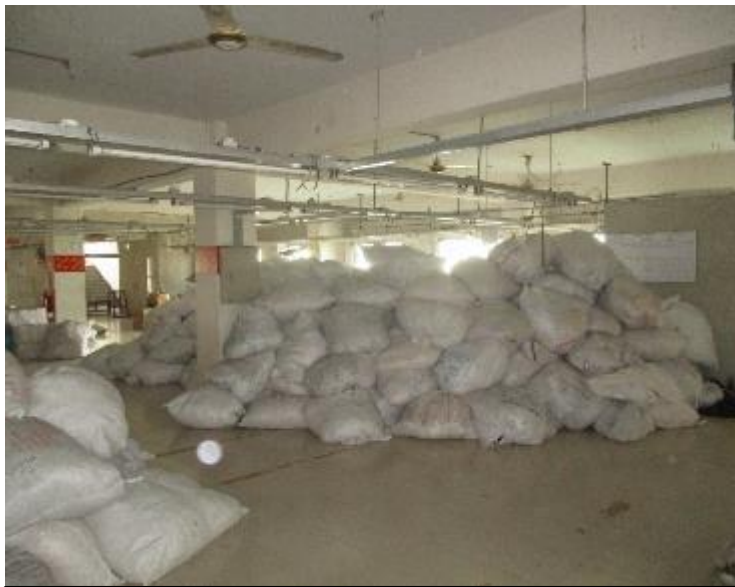
Loading at 3rd floor

During inspection, no load plan was observed for the main building. Factory is required to produce load plan with respect to floor, beam, column and footing capacity.

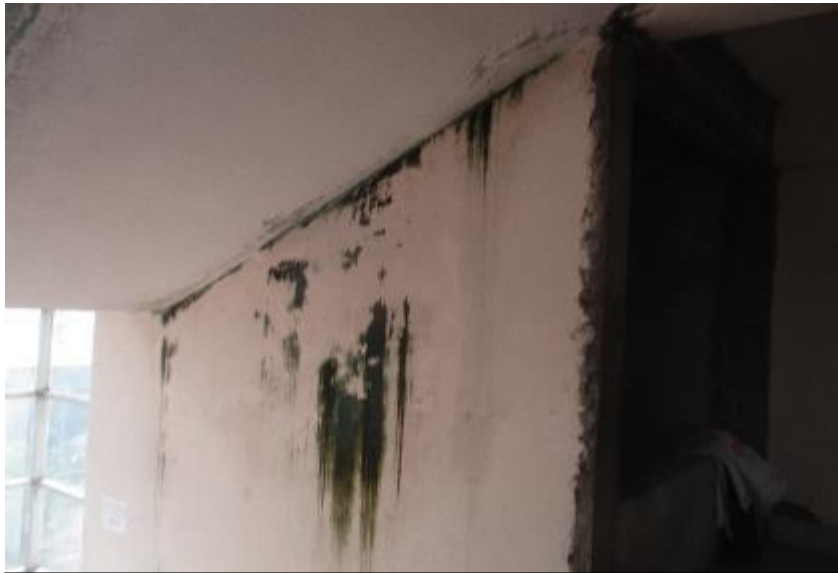
Dampness on wall at lift core portion

Dampness was observed on different places on façade wall. Factory is required to investigate the cause of dampness and take necessary remedial action.

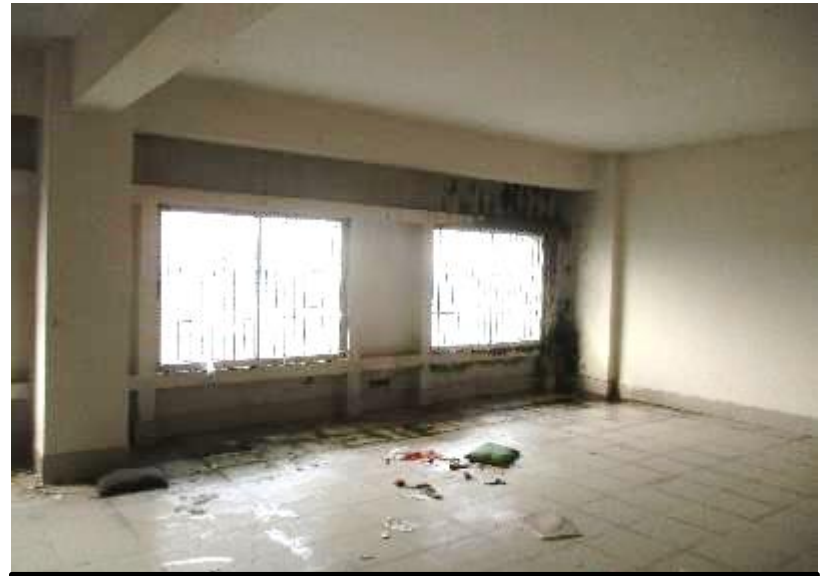
Dampness on wall at inner façade wall

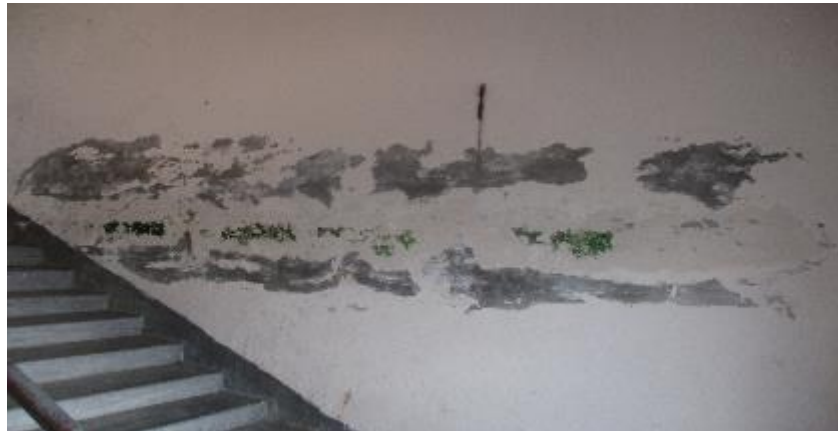
Dampness on wall between stair and toilet portion

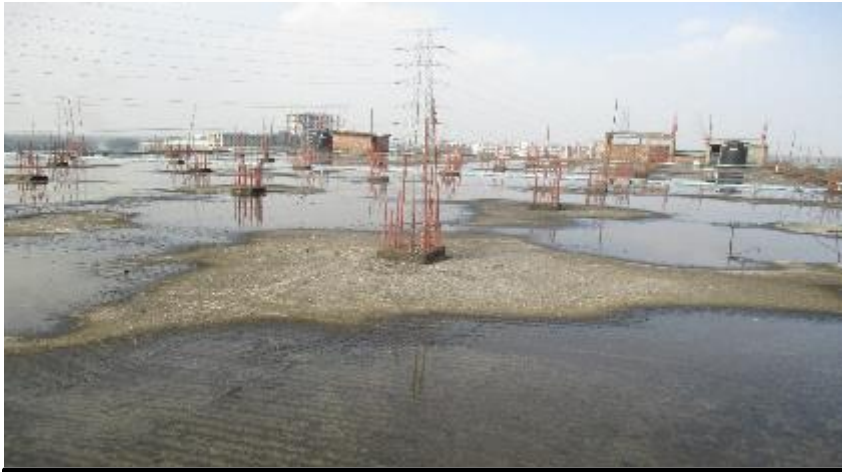
Water ponding on roof

No water proofing layer was observed on roof. Besides, water clogging was observed everywhere on roof. Added with that, water found penetrated through slab. Investigation of damage due to water ingress is required . Remedial action is required based on the investigation.

8	Water ingress at roof level (Main Building)	Building Engineer is to investigate the extent of damaged slab due to water ingress.	6-weeks
9	Water ingress at roof level (Main Building)	Carry out remedial action for the damaged slab.	6-months

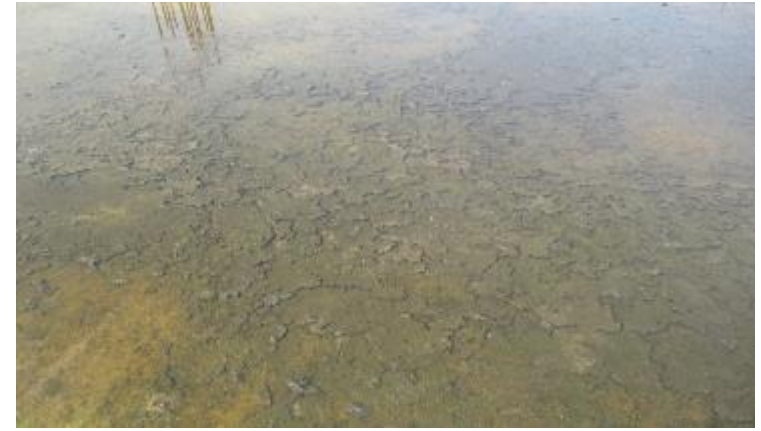
Vegetation growth due to water clogging

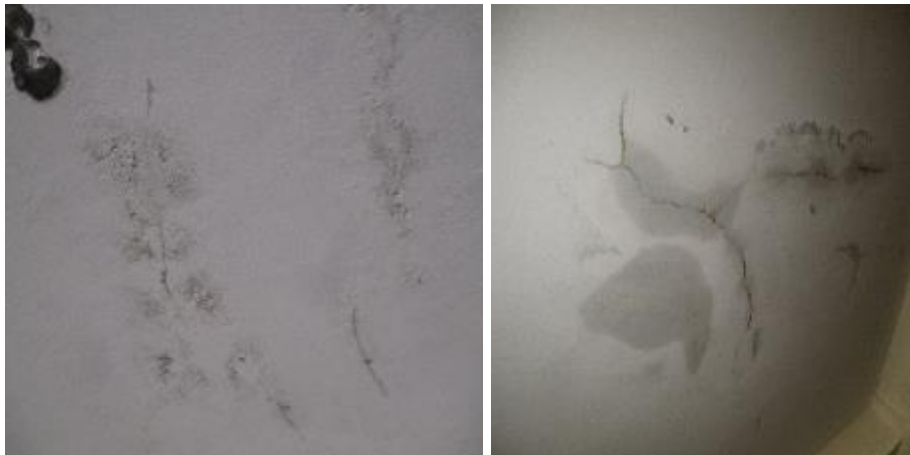
Dampness observed on roof slab soffit due to water ingress .

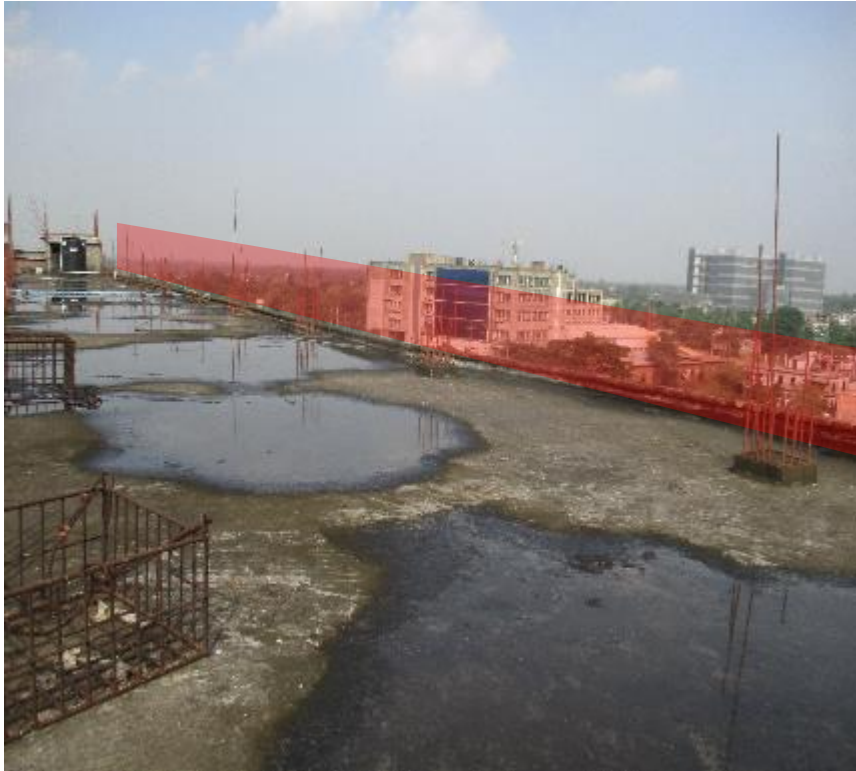
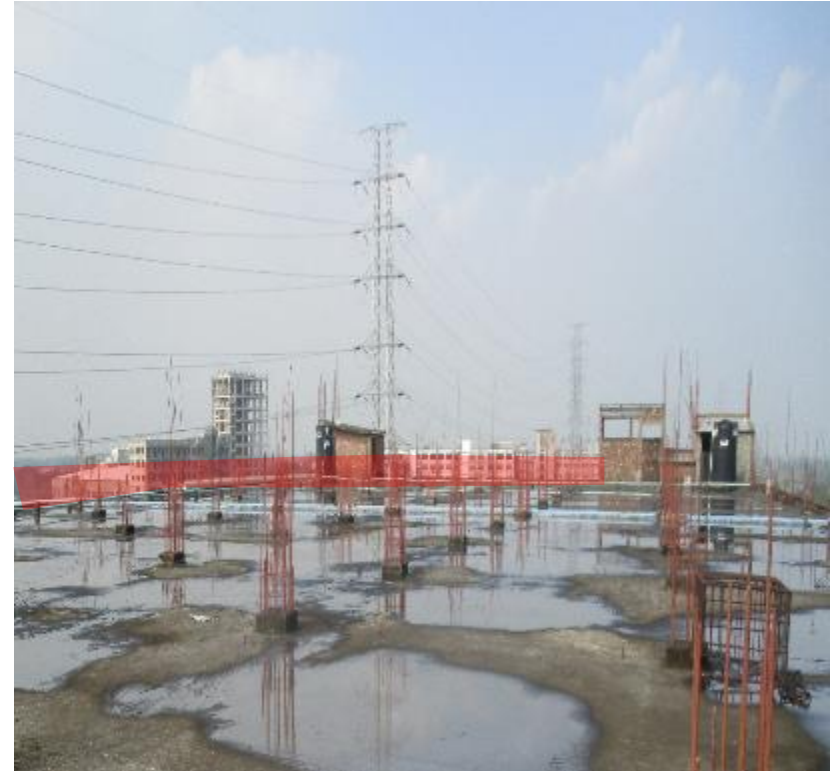
Lack of edge protection at roof

During inspection, Edge protection (Parapet wall/Railing) was not observed on roof. Factory is required to provide edge protection to avoid falling hazard.

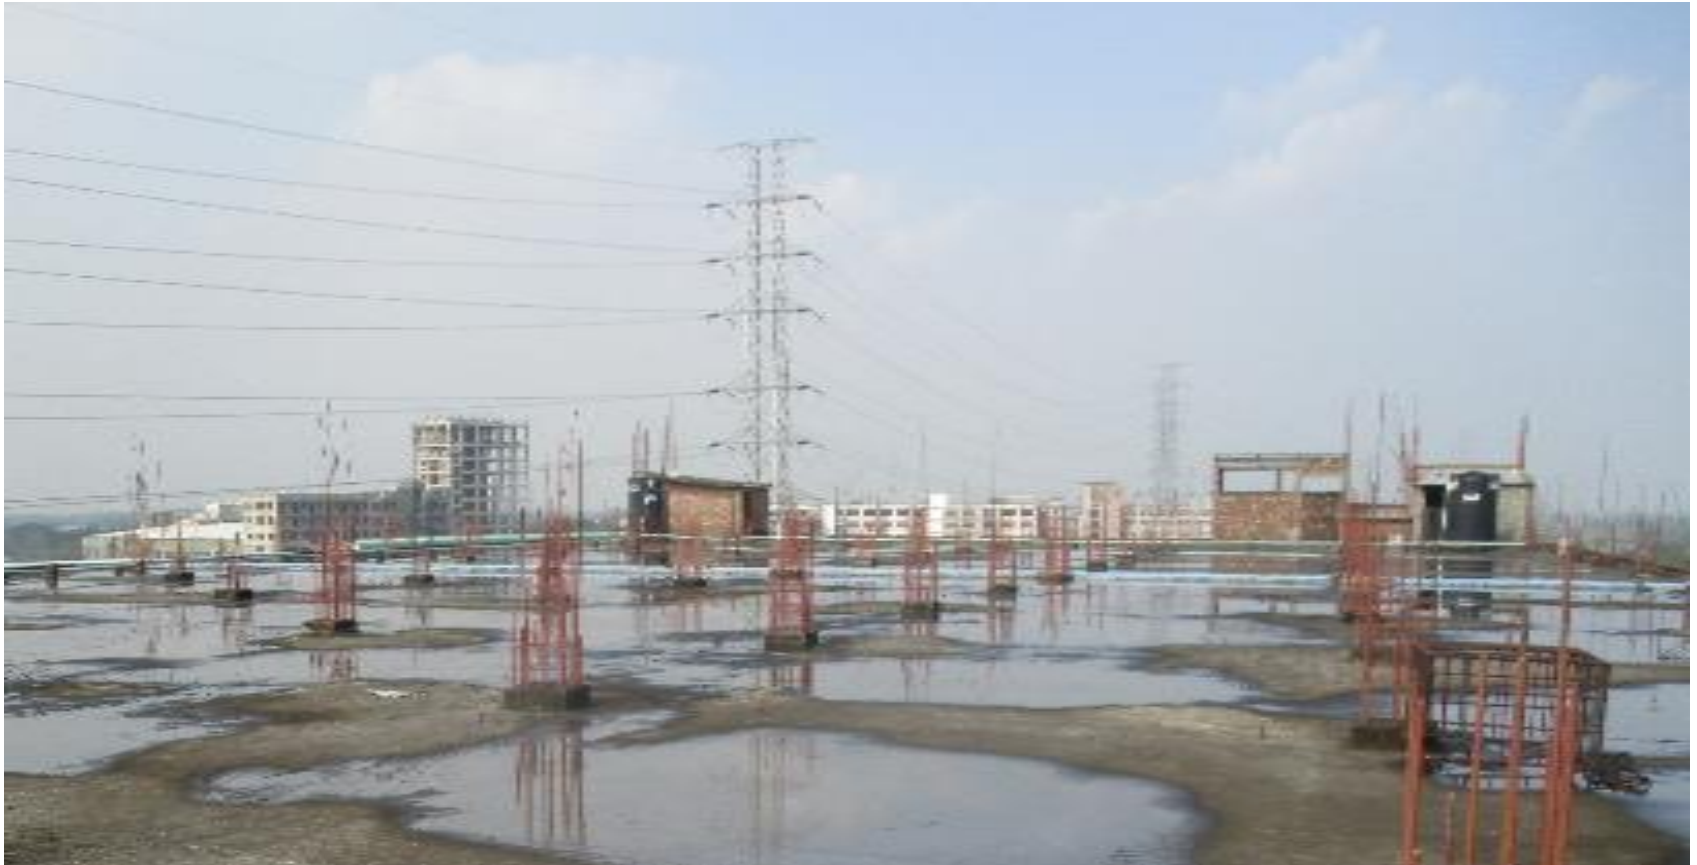
Column to be stressed above normal stress limit in fully completed main building

Cursory calculation shows that the column stress exceeds normal stress limit in fully completed main building. Prior to extension, Building Engineer is required to do Detailed Engineering Assessment for the main building as per BNBC.

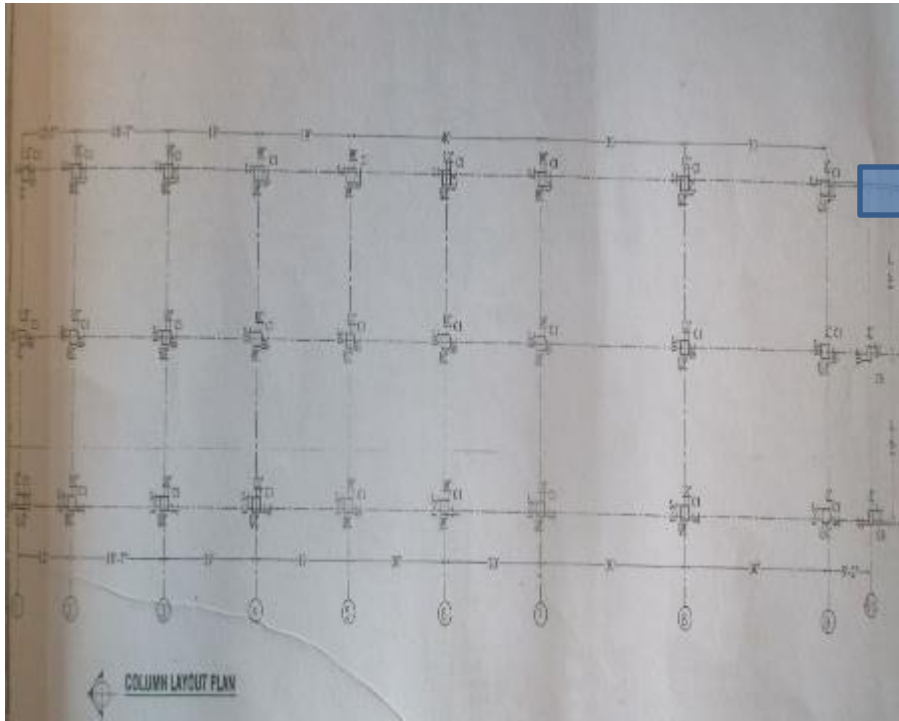
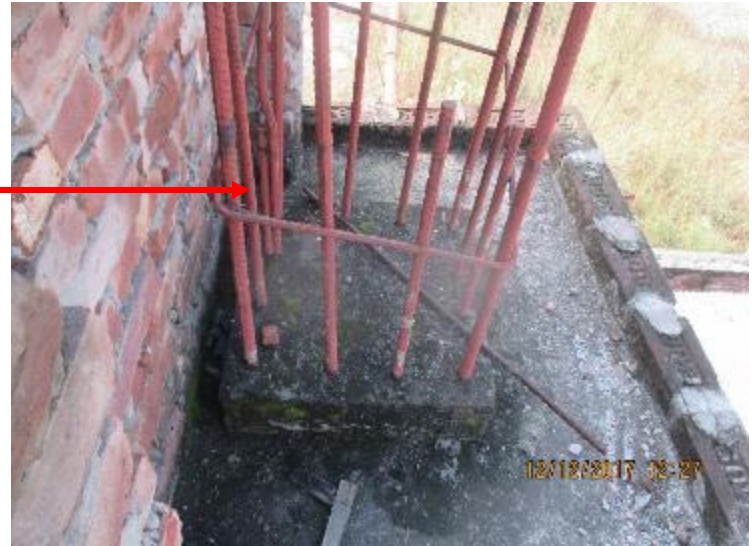
During inspection, A RCC column of 475mm x 500mm was found in the marked location which was not mentioned in the as built drawing.

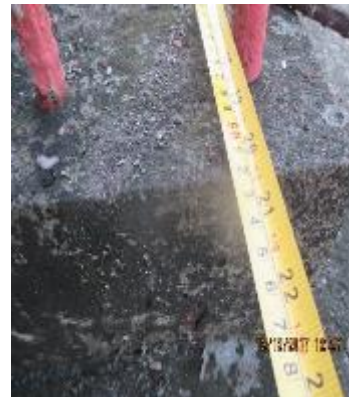
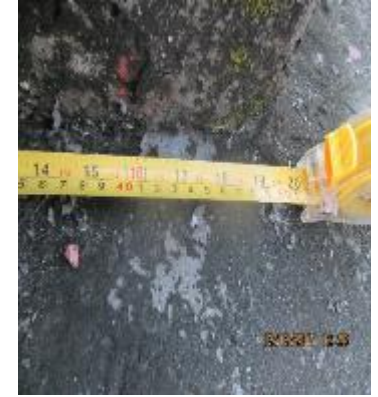
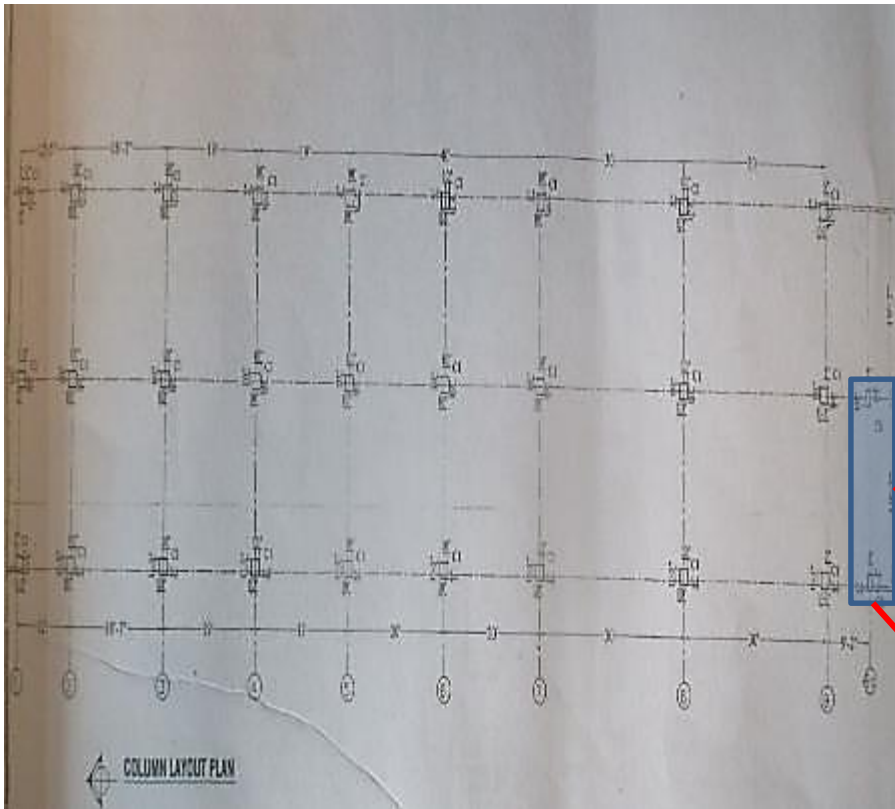
Steel columns are mentioned in the marked location. Instead of that, two 475mm x500mm RC columns are found on site. Added with that, wooden pile is mentioned in that location. Building is required to confirm the actual footing type in the Location.

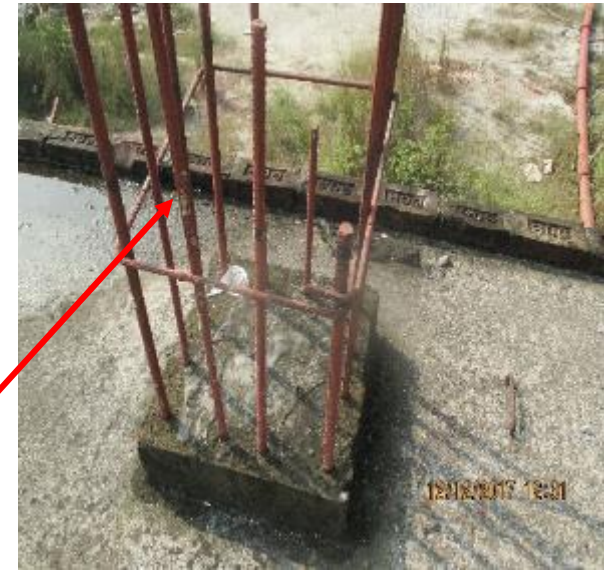
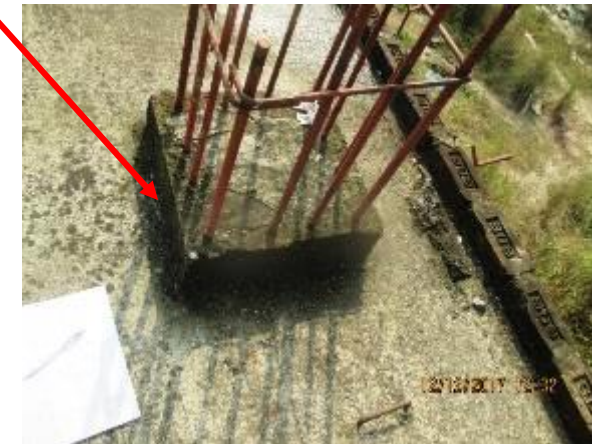
No layout was found for this marked tie beam. The beam size was found 300mm x 550mm in size.

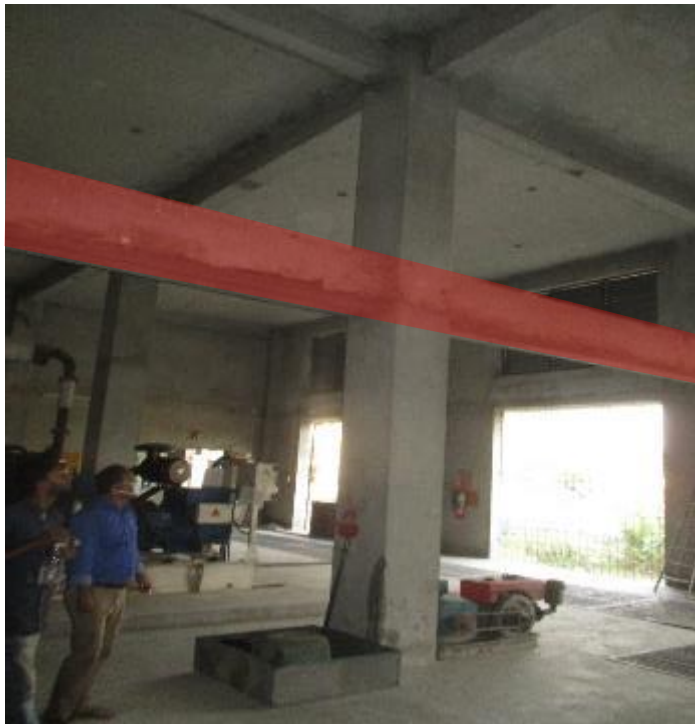
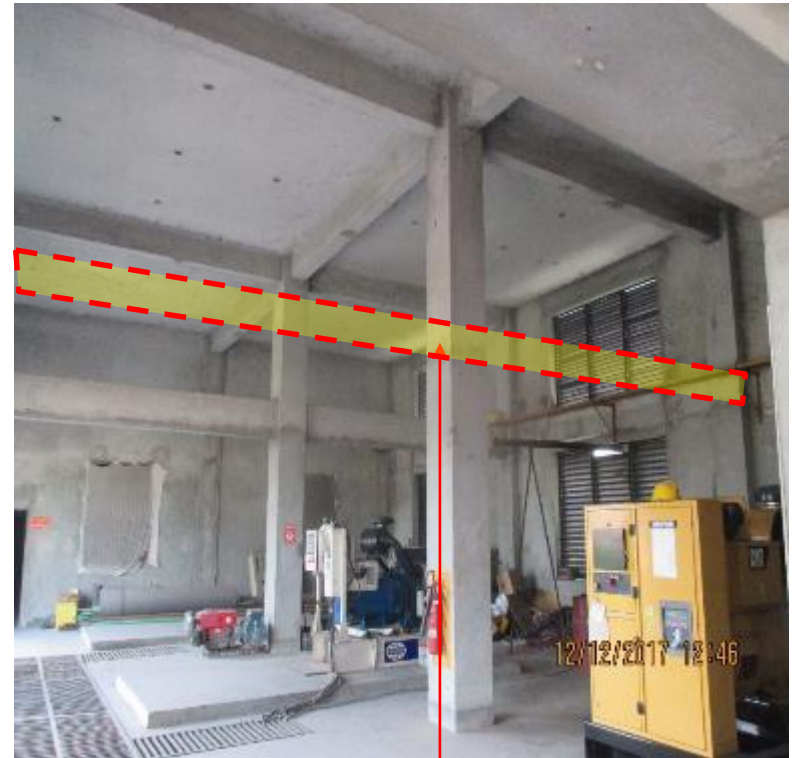
Also in the marked location, tie beam was found missing. Building Engineer is required to update the beam layout accurately.

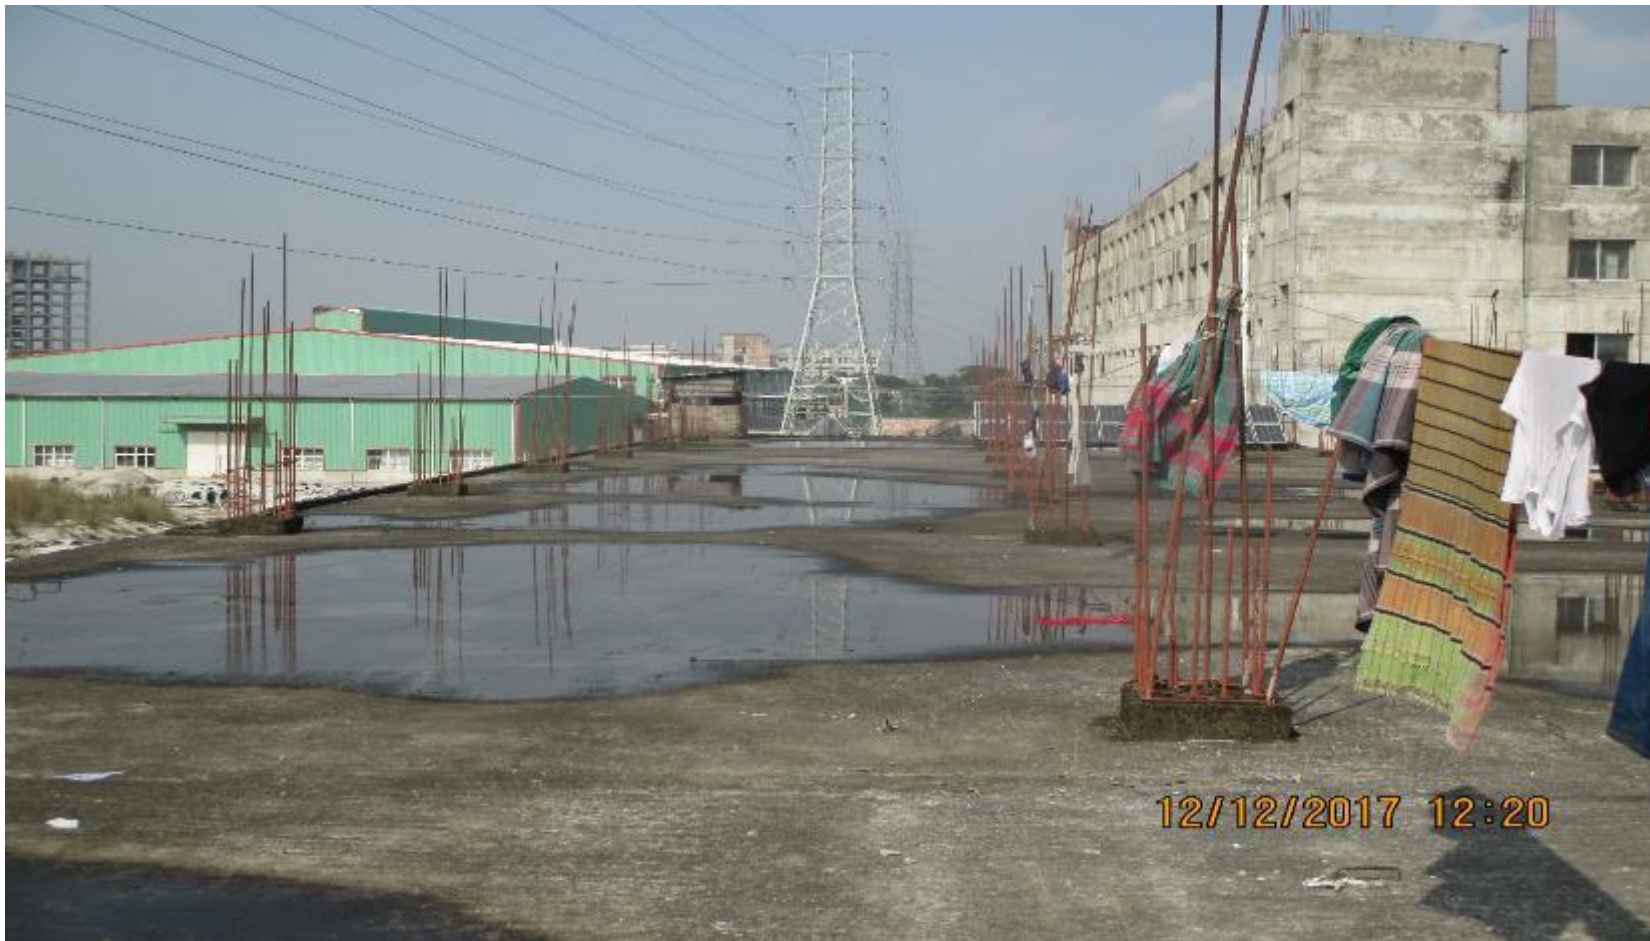
No water proofing and drainage at the roof top

The roof top slab has been found exposed. No water proofing and drainage action is provided. Building Engineer is required to implement action to stop the water accumulation at the roof top.

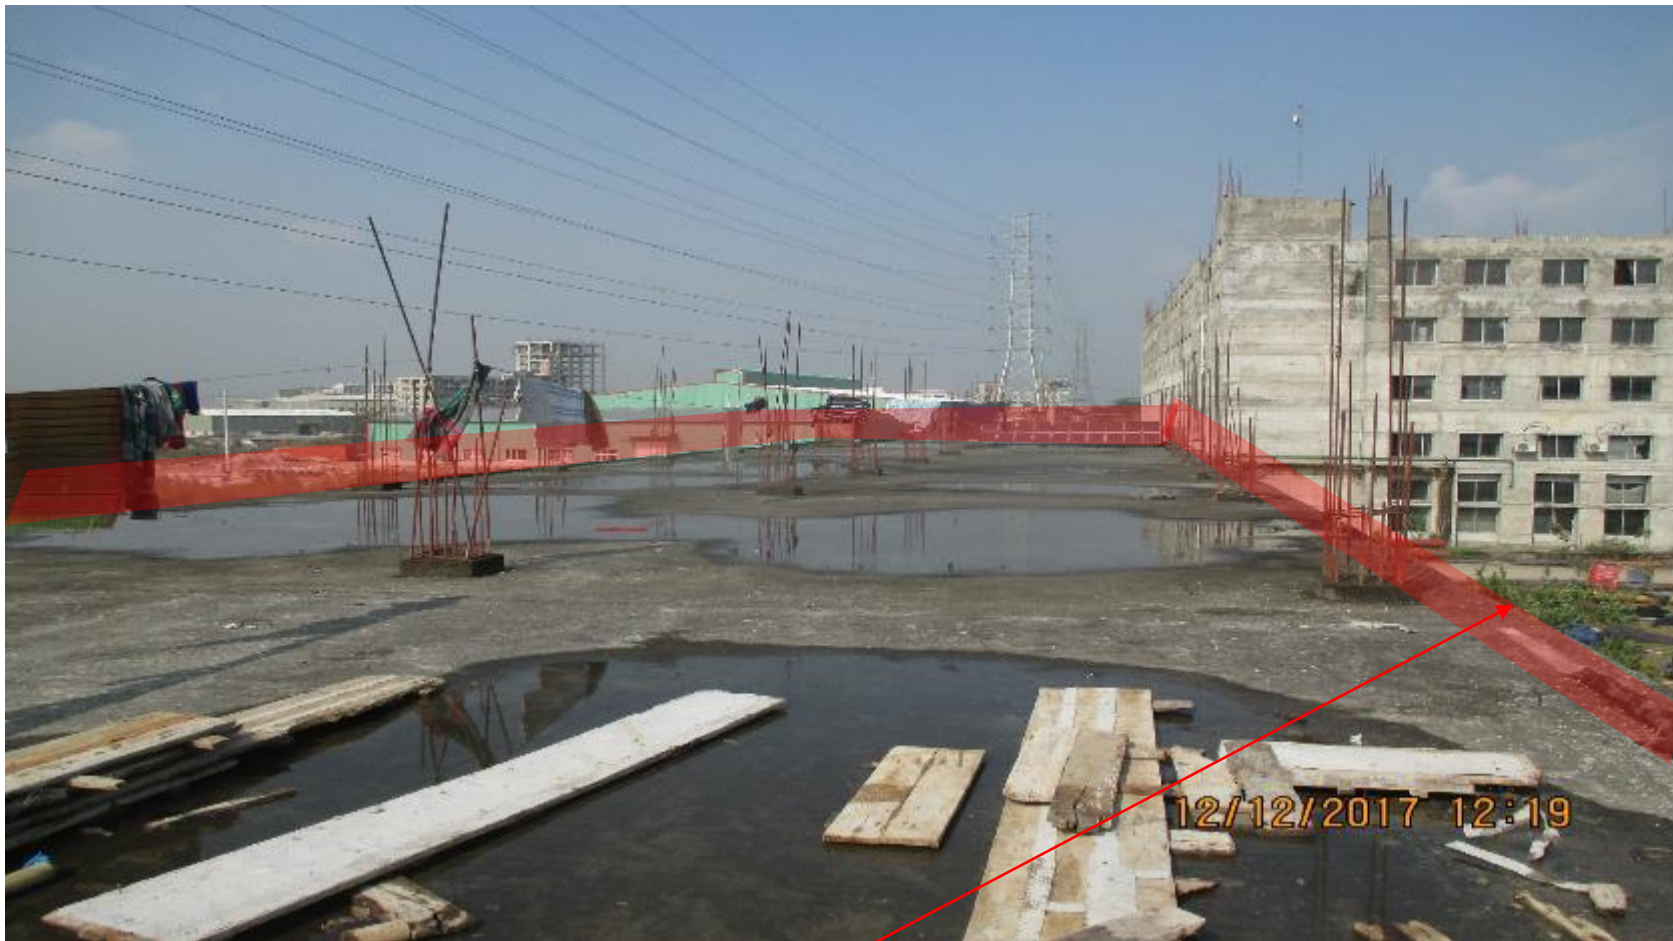
No edge protection at the roof top

No railing or safety guard is provided at the roof top . Building Engineer is required to provide safety around the periphery of the roof top to ensure protection against falling.

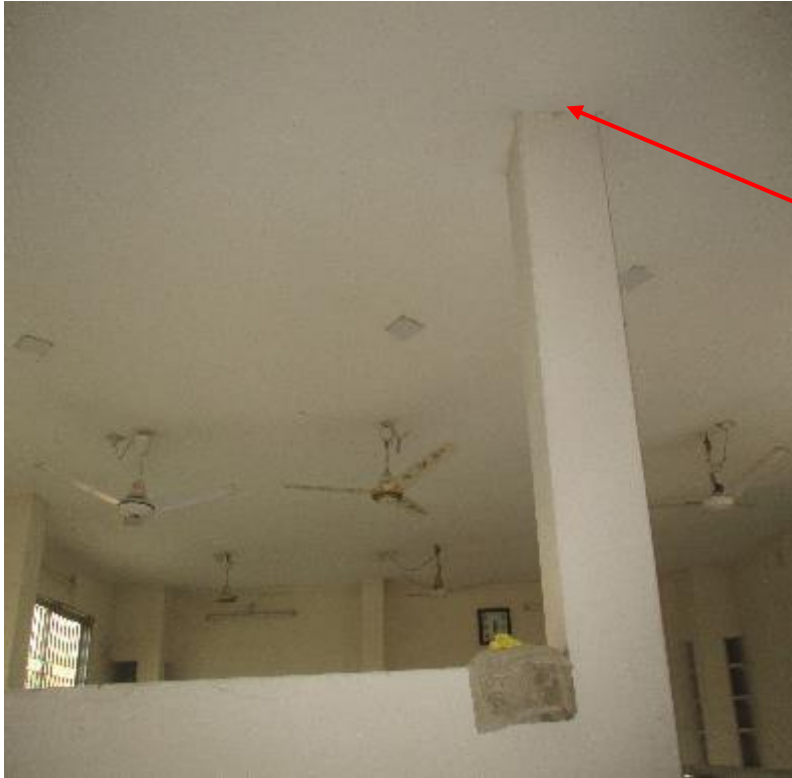
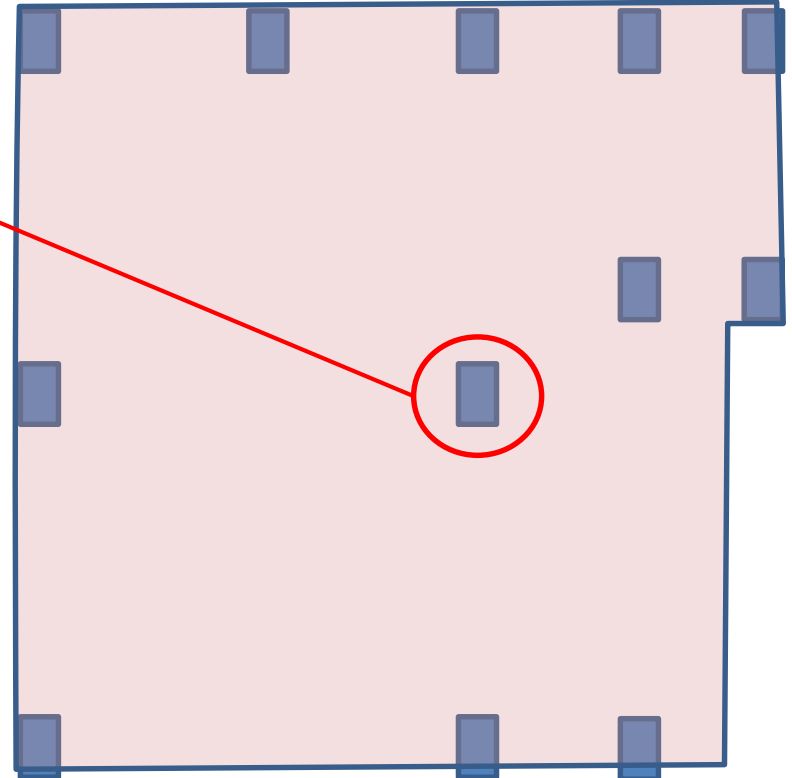
Check the adequacy of the slab

Cursory calculation indicates that the slab is in critical zone for high punching shear in the marked column. Factory engineer is required to check the adequacy of the slab.

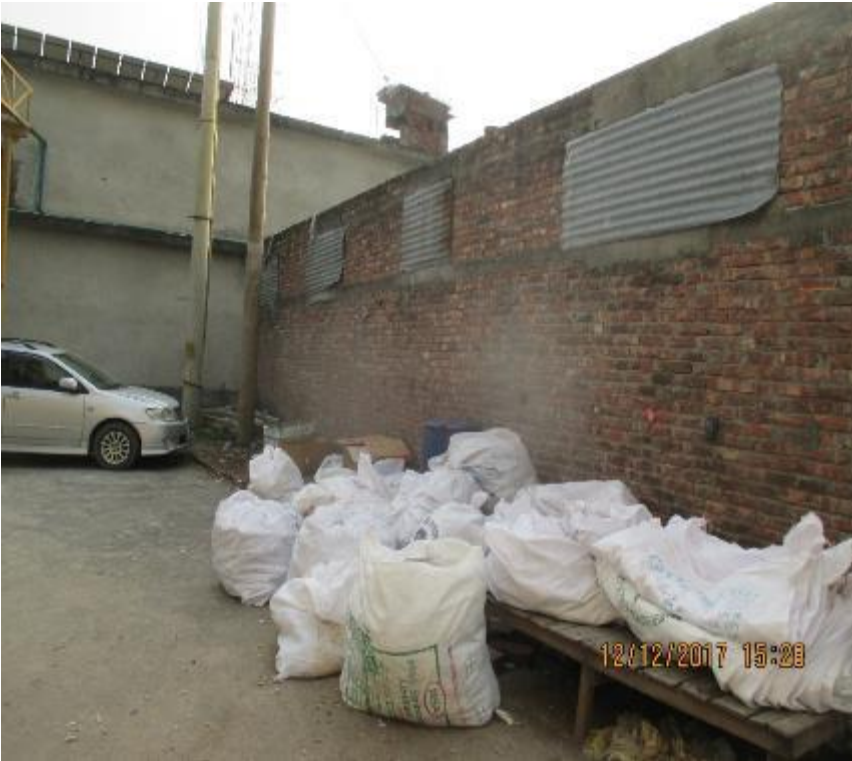
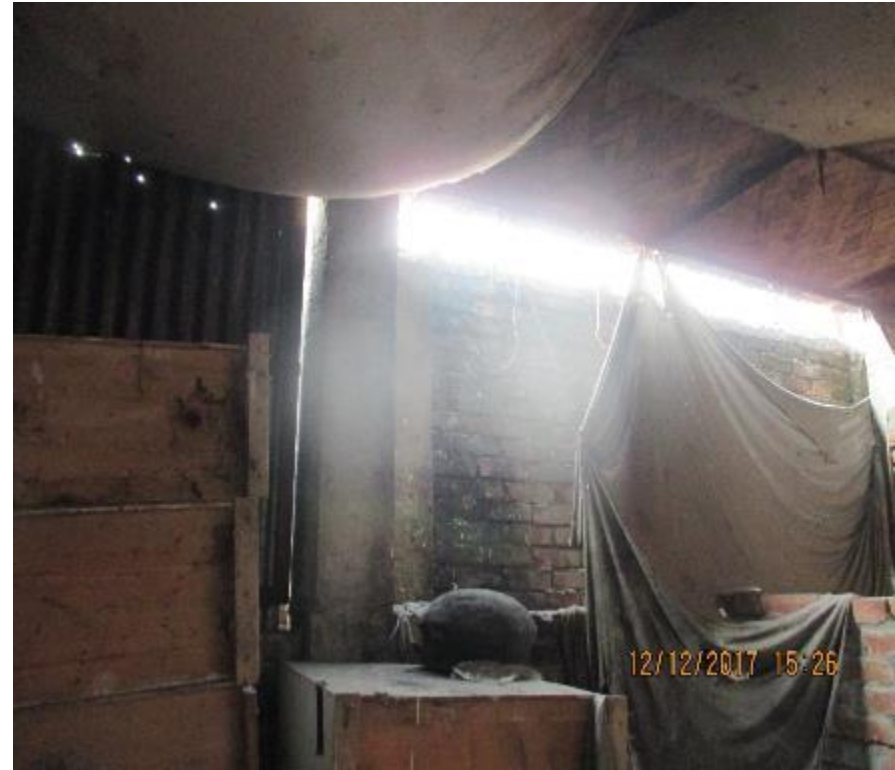
Observation: Ansar Dormitories

No visible stability system is present in those brick buildings. Roof Top shed has been found resting on the brick columns. Some RCC columns are present inconsistently in the west part of one of the two Ansar dormitories. Building engineer is required to investigate the stability of the structures for the lateral load.

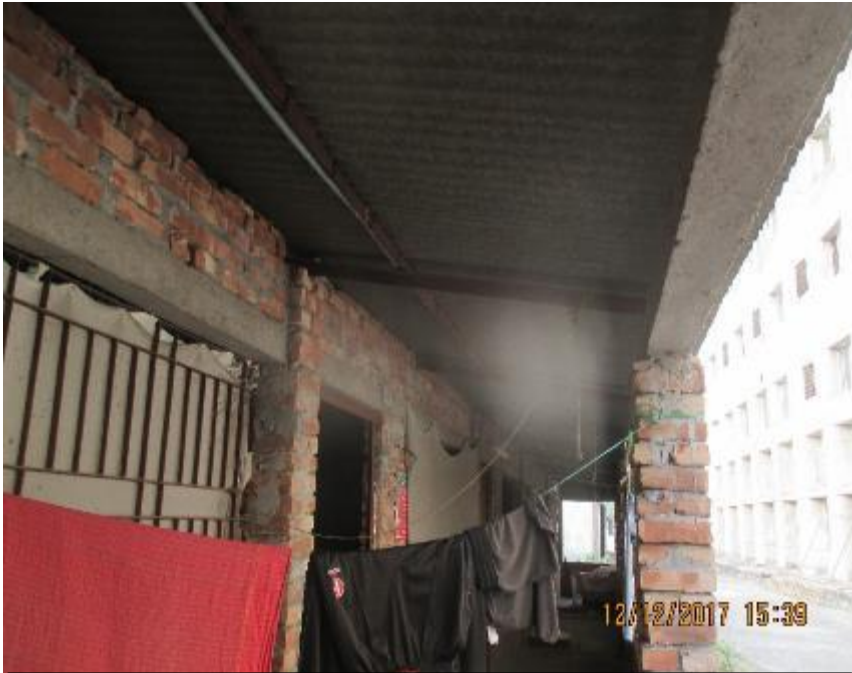
Staff Dormitory

Connection is not clear for the boiler shed, storage and staff quarter. Tin shed resting on the angle is supported by masonry pier and masonry wall. Building Engineer is required to investigate the stability against lateral load.

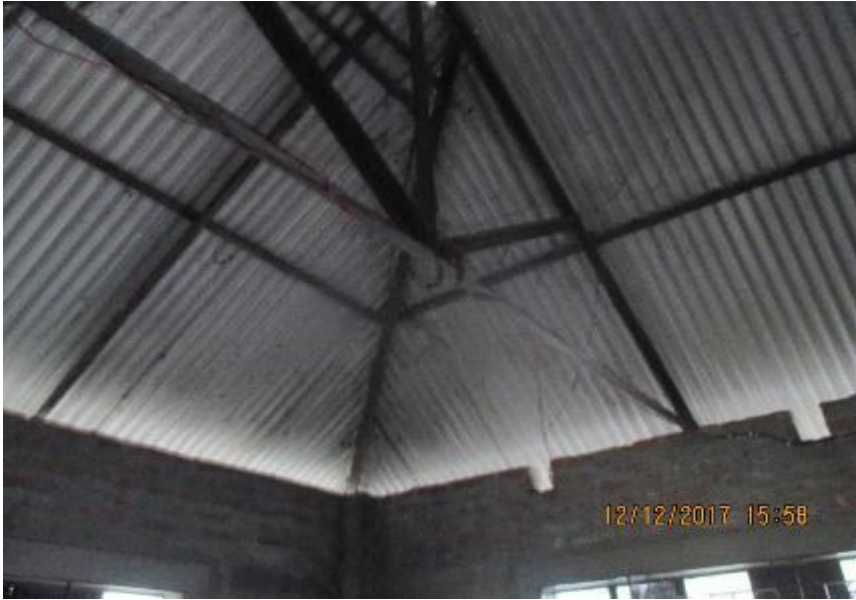
Truss Shed resting on the brick wall in staff canteen

In the Staff canteen, truss shed is supported by masonry pier and masonry wall with non engineered connections. Building Engineer is required to investigate the stability of the canteen shed. In inclusion to this, The wastage storage also is a non engineered shed resting on the bamboo frame. Stability of the structure is required to be investigated.

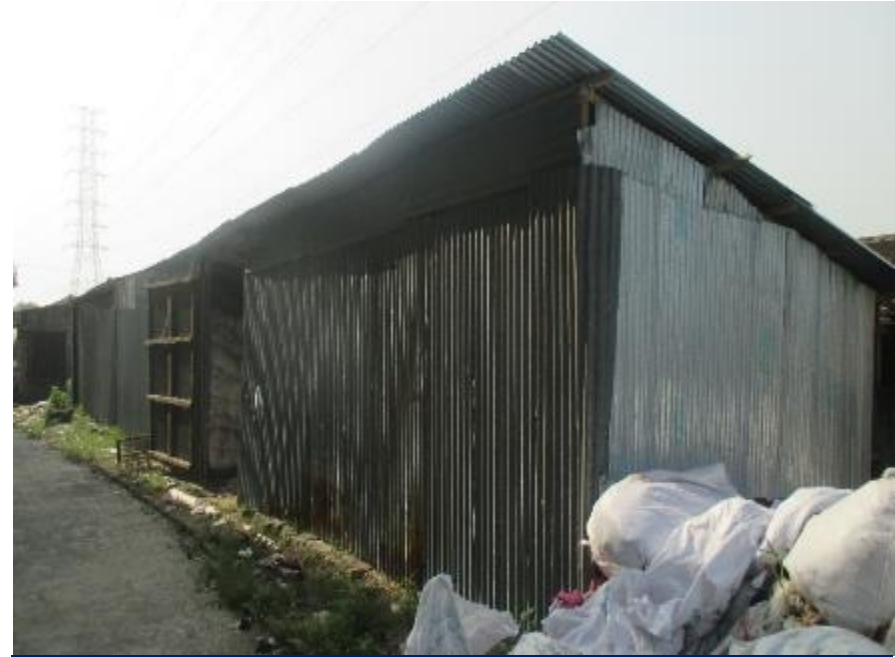
Non engineered shed in Wastage Store
