PNG (BD) LTD

Korerhat, Shattaroa, Jorargonj, Mirsharai, Chittagong, Bangladesh

9th January, 2018

Observations

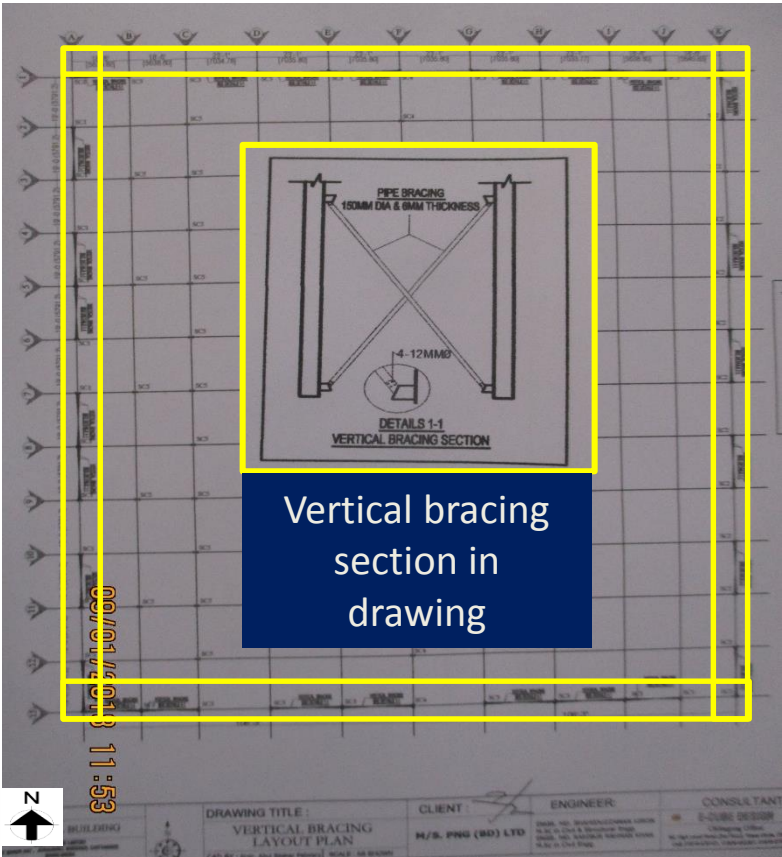
Vertical bracing section in drawing

Vertical bracings have designed as stability system against lateral loading. On site no vertical bracings were installed.

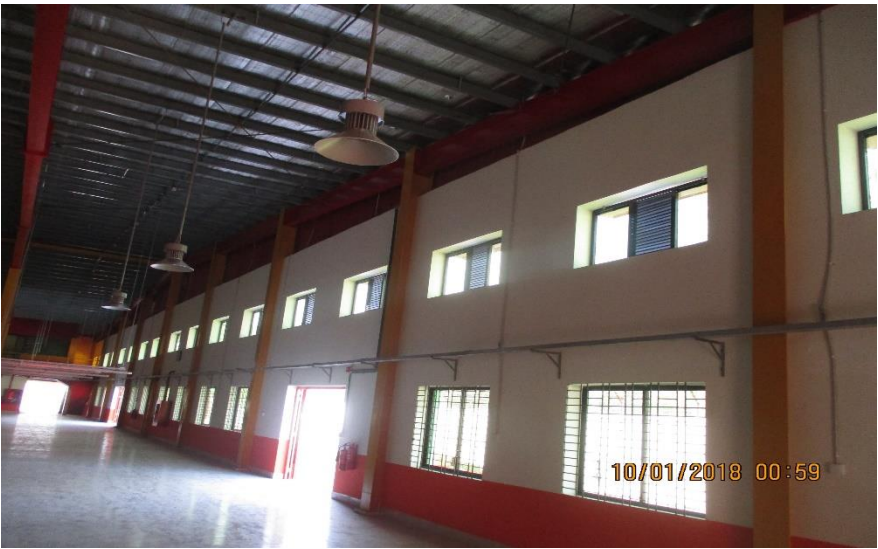
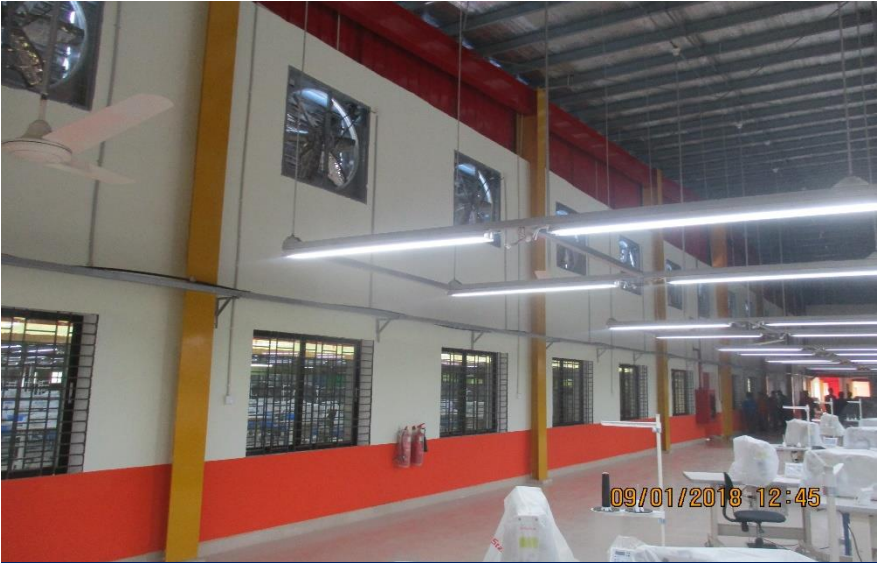
No vertical bracing on site

Item No.	Observation	Recommended Action Plan	Recommended Timeline
1	Lateral stability of Main Production Shed. (Shed#1 - Main Production Shed)	Factory engineer need to check stability system against lateral load and install bracing where required as per calculation.	6-weeks
2	Lateral stability of Main Production Shed. (Shed#1 - Main Production Shed)	Carry out remedial works where necessary.	6-months
3	Significant gaps and missing bolts at several connections. (Shed#1 - Main Production Shed)	Identify all the location and carryout suitable repair works where necessary.	6-weeks
4	Mismatched in as built drawings. (Shed#1 - Main Production Shed)	Building Engineer to survey as-built structure and prepare accurate as-built survey information with connection details for the building.	6-weeks
5	Lateral Stability of Finishing Shed. (Shed#2 – Finishing Shed)	Factory engineer need to check stability system against lateral load and install bracing where required as per calculation.	6-weeks

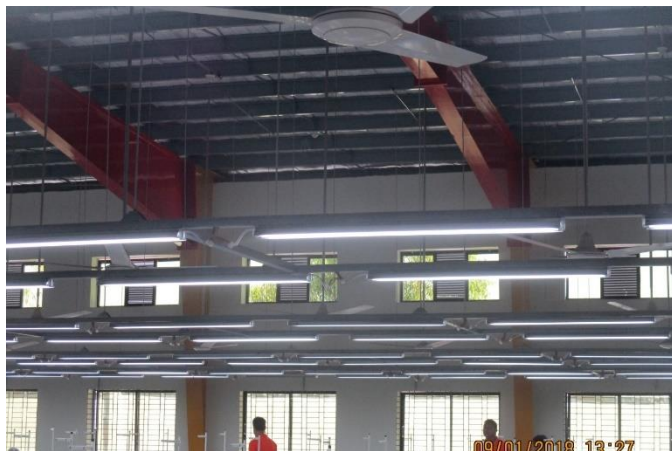
Missing strut member in eave level

Vertical bracings and struts members are part of lateral stability system. Vertical bracings and strut member at eave points were not installed as per drawing. Building engineer is required to check the lateral stability of the shed considering lateral forces as per BNBC provision.

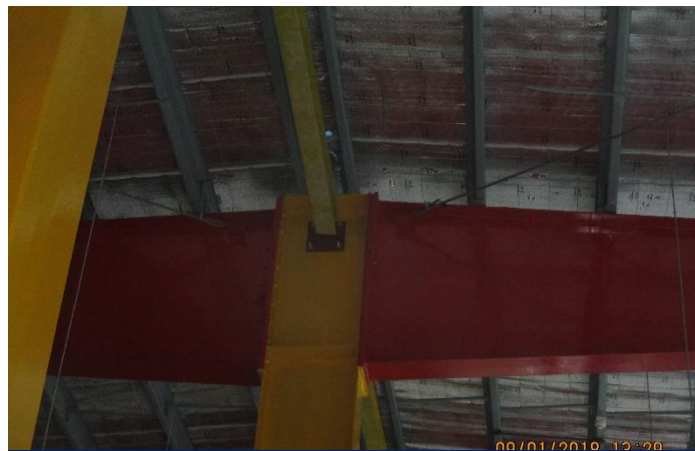
Strut member in ridge level

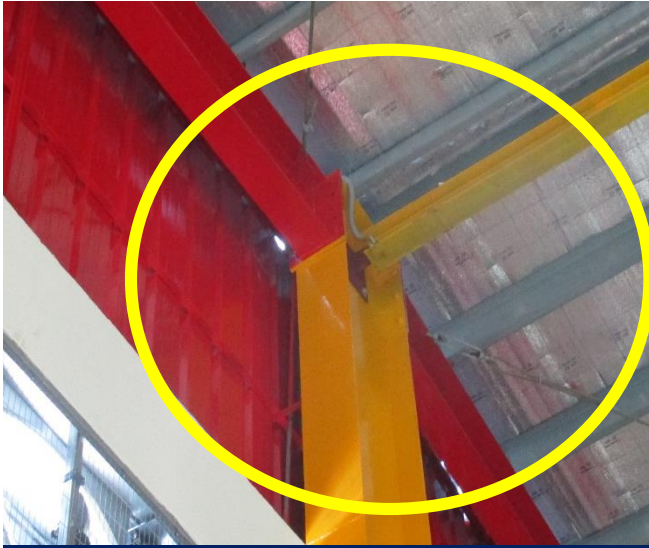
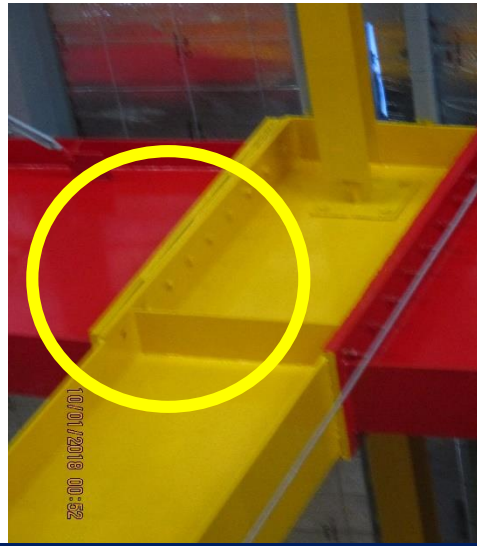
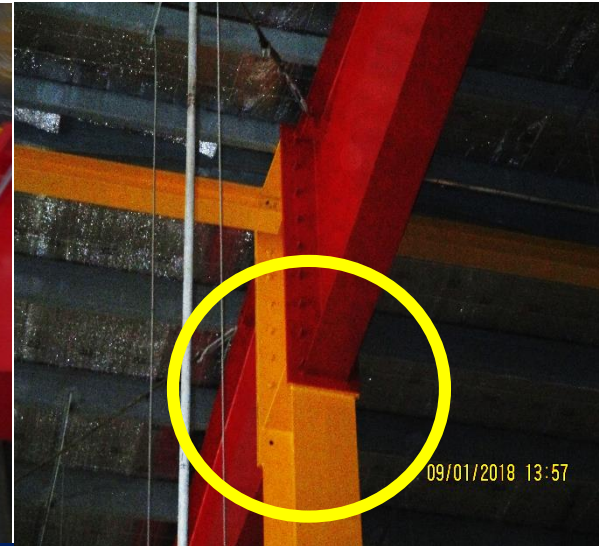
Bolts missing in several location

Significant gaps and bolts missing were observed in column rafter joint at several location. Building engineer is required to carry out suitable remedial works.

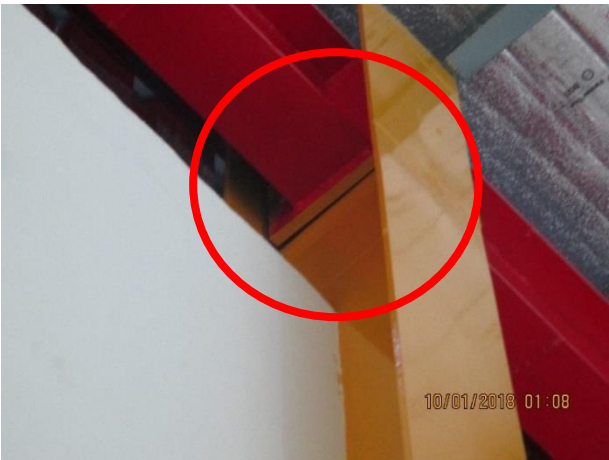
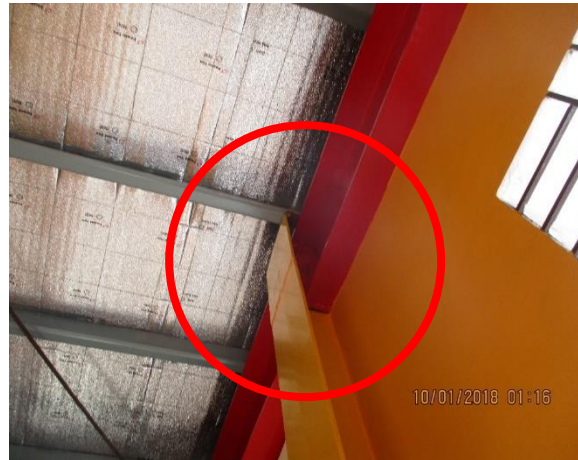
Existence of significant gap at connection

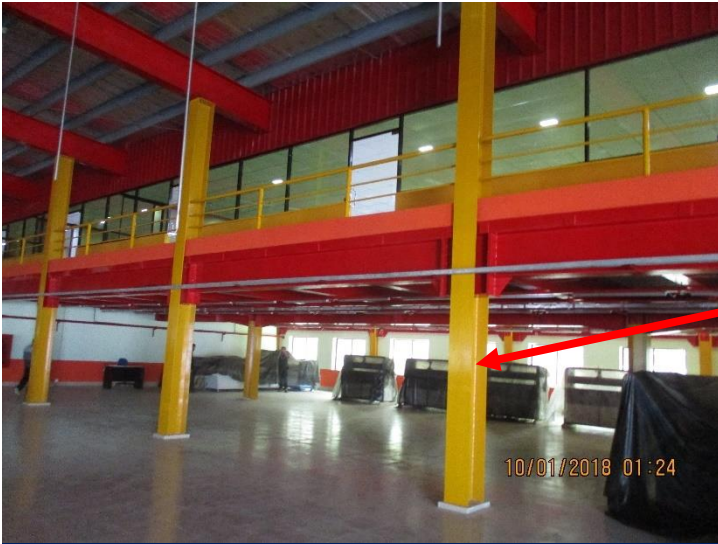
Column extended up to rafter with pin head not shown on drawing.

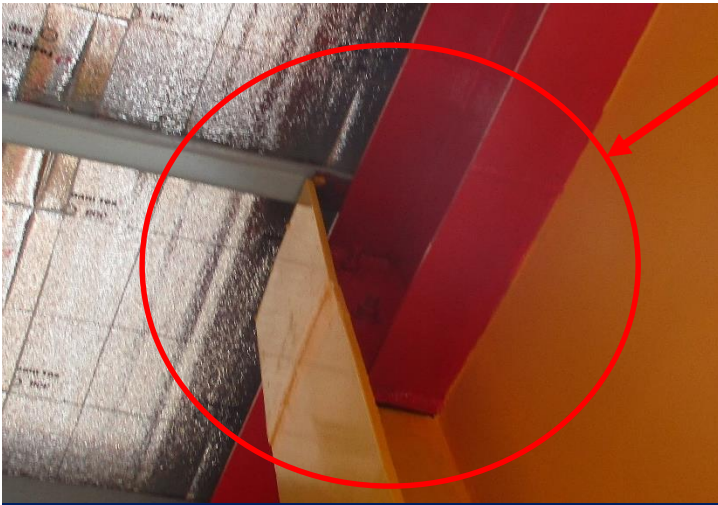
Connection of end frames are moment connection as per drawing. Onsite pin connection observed.

Change of connection type

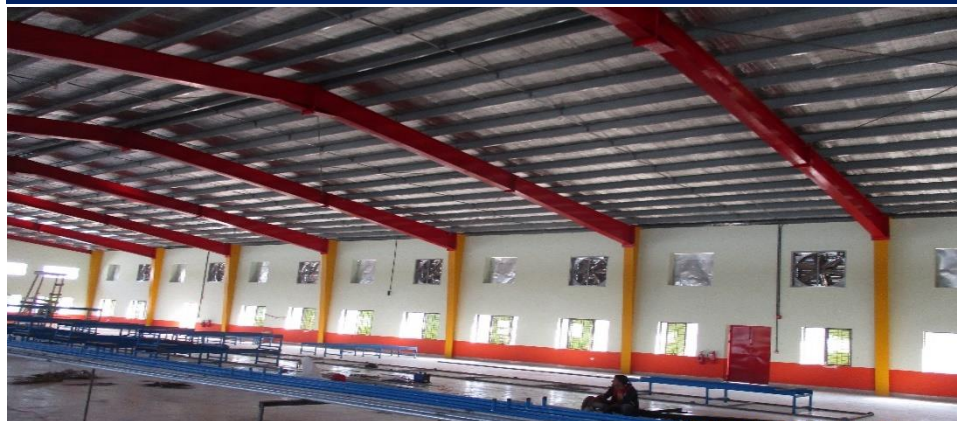
Vertical bracings have designed as stability system against lateral loading. On site no vertical bracings were installed.

6	Lateral Stability of Finishing Shed. (Shed#2 – Finishing Shed)	Carry out remedial works where necessary.	6-months

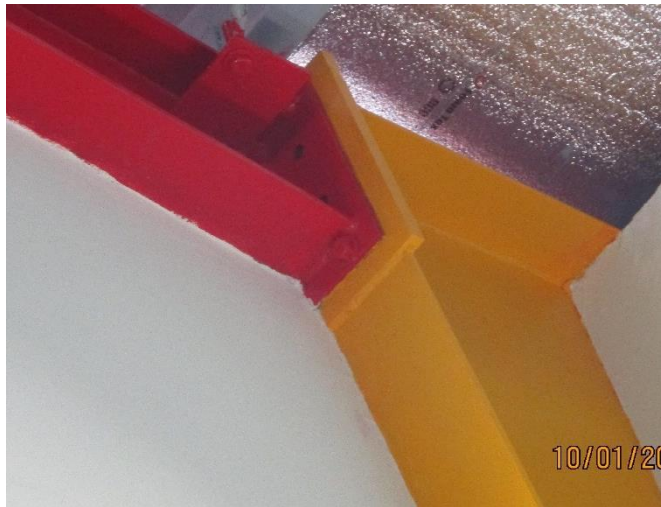
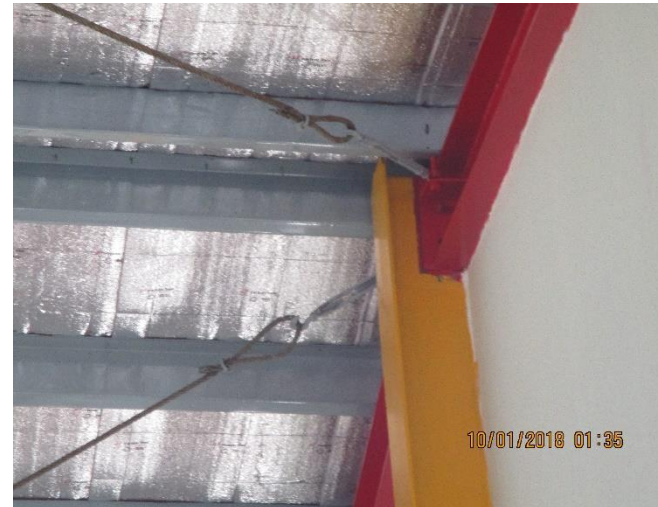
Bolts missing in several location

Significant gaps and bolts missing were observed in column rafter joint at several location. Building engineer is required to carry out suitable remedial works.

Item No.	Observation	Recommended Action Plan	Recommended Timeline
7	Significant gaps and missing bolts at several connections. (Shed#2 – Finishing Shed)	Identify all the location and carryout suitable repair works where necessary.	6-weeks
8	No apparent lateral stability system. (Shed#3 – Canteen Shed)	Building engineer is required to check the lateral stability system against lateral loading.	6-weeks
9	No apparent lateral stability system. (Shed#3 – Canteen Shed)	Carry out remedial works where necessary.	6-months
10	Update as built drawings for all ancillary buildings. (All ancillary buildings)	Building Engineer to survey as-built structure and prepare accurate as-built survey information with connection details for the building.	6-weeks

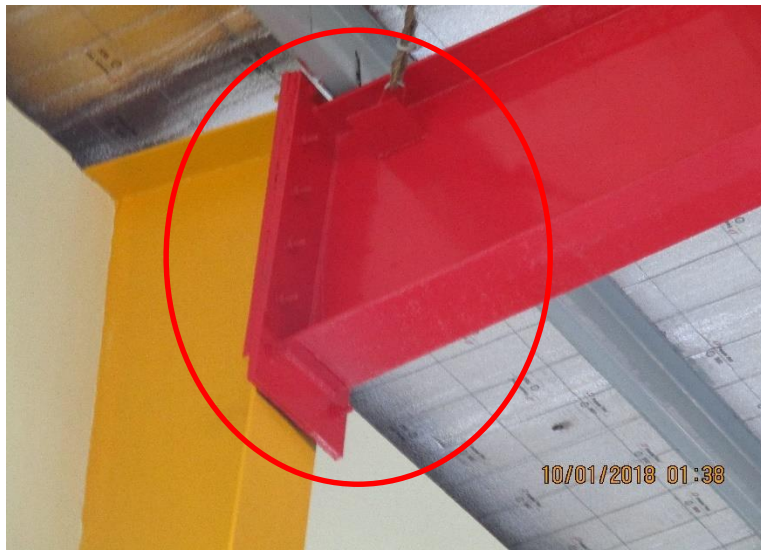
Existence of significant gap at connection

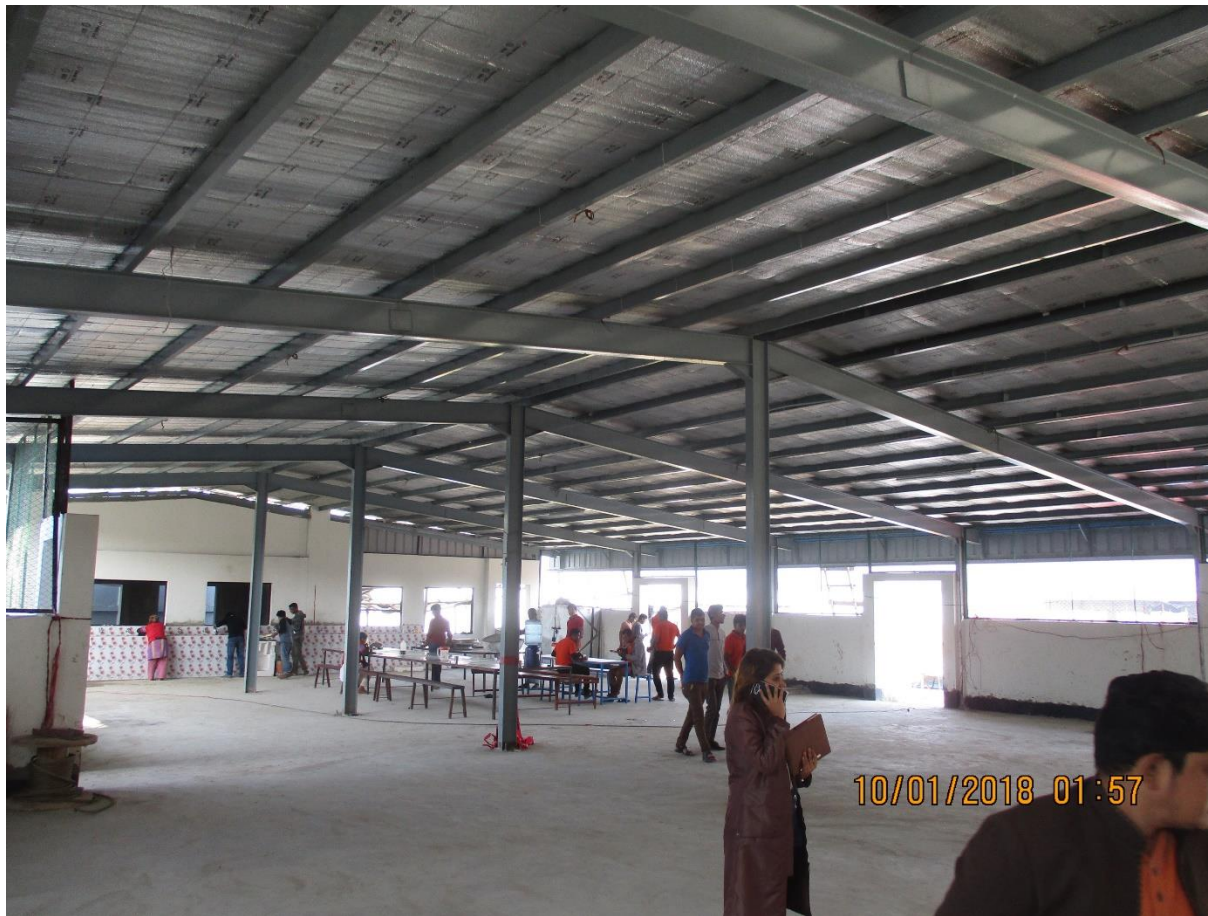
No bracing system was installed.

No structural drawings were available.

Apparently no lateral load resisting system was observed on canteen shed. Building engineer is required to check the lateral stability of this shed.

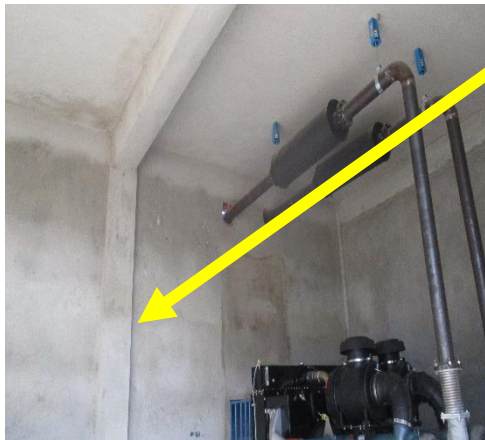
Extra Column

Column layout, number of rebar in column and grid dimension did not match with drawings. Red marked columns are not shown in drawings. 8 nos. of rebar were found in each column instead of 10. on drawings.

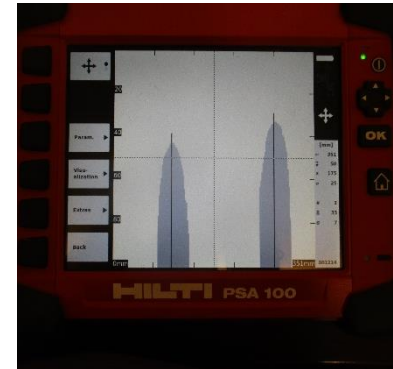
Scan result

Nos of rebar in column and grid dimension did not match with provided drawings. 6 nos. of rebar were found by Ferro scanning in each column instead of 10.

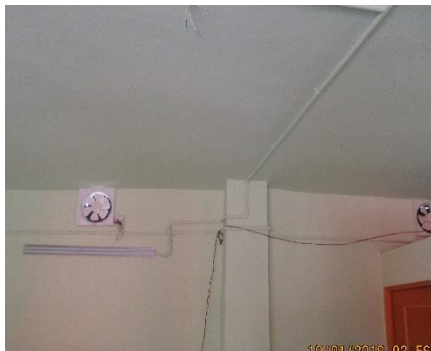
Slab layout did not match with drawing. At west extended portions are not shown in drawing. Also, beam slab are shown in drawings whereas flat slab was found.

Flat slab

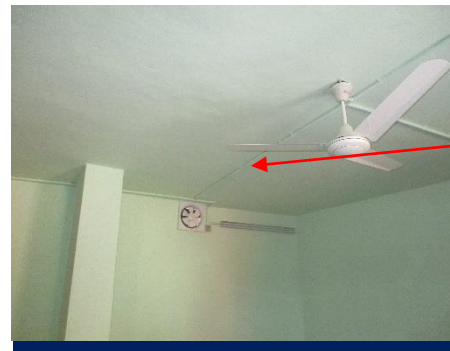
Extended slab

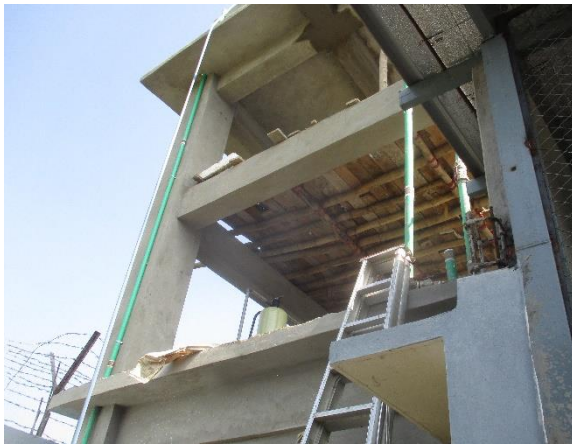
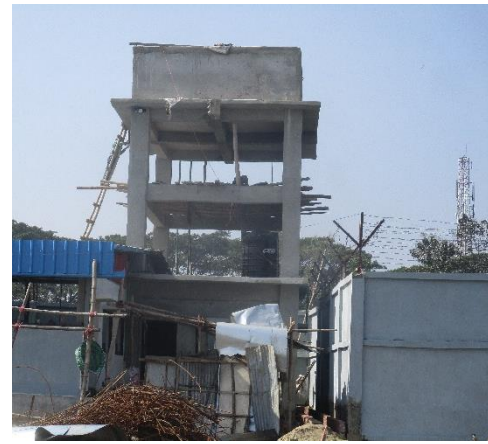
Orientation of column and grid dimension did not match with drawing. Also no over head RC water tank details were found.
