# **FIRE SAFETY INSPECTION REPORT**

**S. Suhi Industrial Park Ltd.(New Building)**

**ACCORD ID: 23153**

**Date: 04 February, 2018**

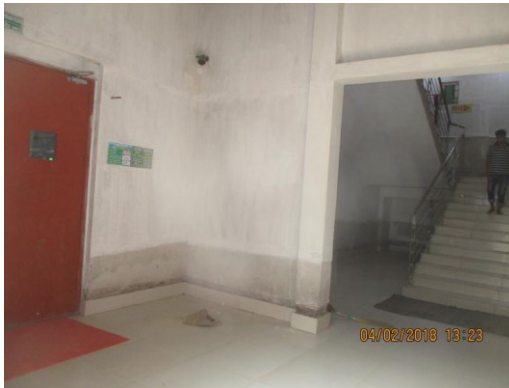
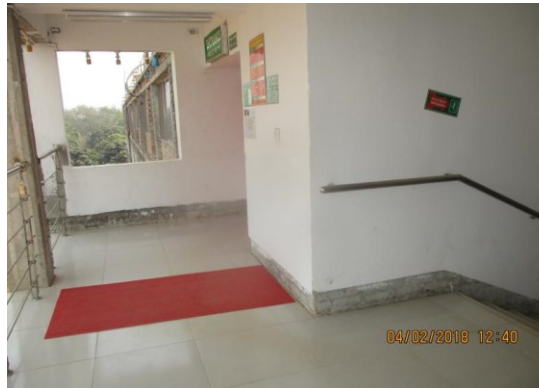
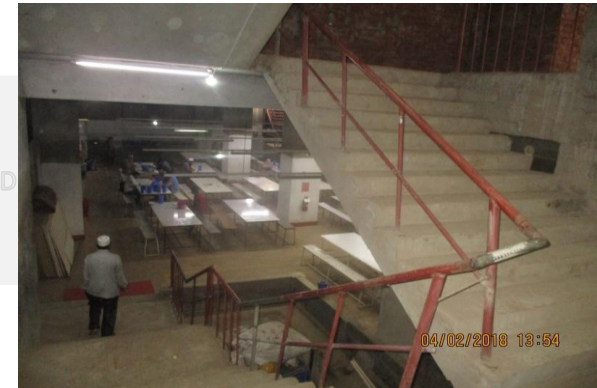
| Sl No. | Category | Findings | Required Action | Remediation Time Frame |
|---|---|---|---|---|
| 1 | Fire Rated Construction | Exit stairs are not separated from work areas & other spaces on each floor by fire-rated construction due to unprotected openings and penetrations.<br>Location: Building-1 (Sweater Building), Building-2 (Dining & Wearhouse) | Separate the exit stairs from work areas and other building spaces on all floor levels by minimum 2- hr fire-rated construction. Provide minimum 1.5- hr fire rated doors and seal all unprotected openings and penetrations to maintain the fire separation. Ensure that all fire doors are self-closing and positive latching, and are provided with fire exit (panic) hardware where serving production floors or assembly occupancies. If fire doors are required to be held open for functional reasons, provide automatic-closing devices tied to the fire alarm system. Once fire doors are installed, every door in a stair enclosure serving more than 5 stories shall be provided with re-entry unless it meets ACCORD standard 6.8.3.1. | Within 3 months |

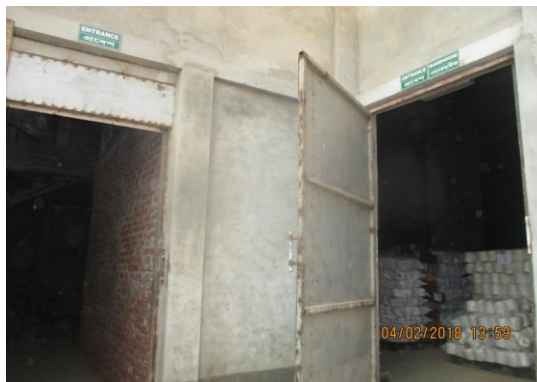
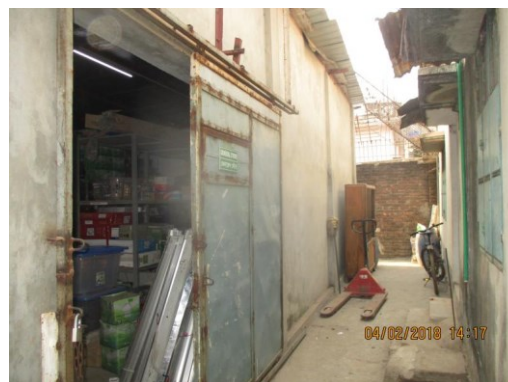
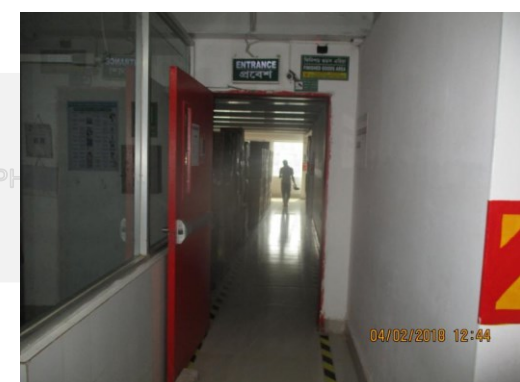
| 2 | Fire Rated Construction | Rooms used for combustible storage are not separated by fire rated construction properly. Location: Ground Floor (Building-1 &2, Shed-general store, embroidery store), 3rd floor (Building-1) | Provide dedicated storage room separated by minimum 1-hr fire-rated construction. | Within 3 months |

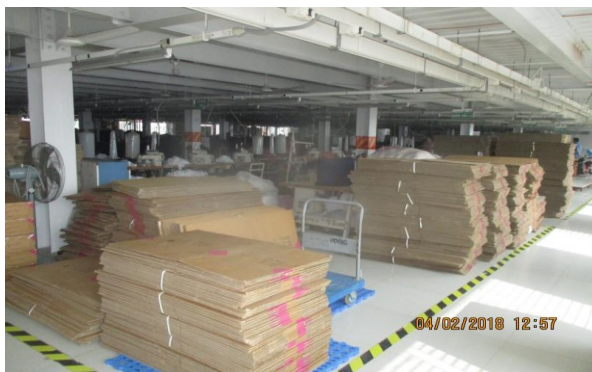
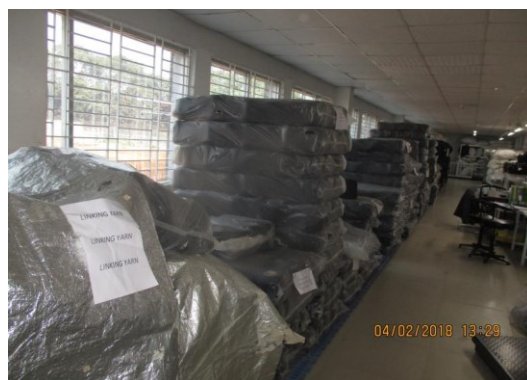
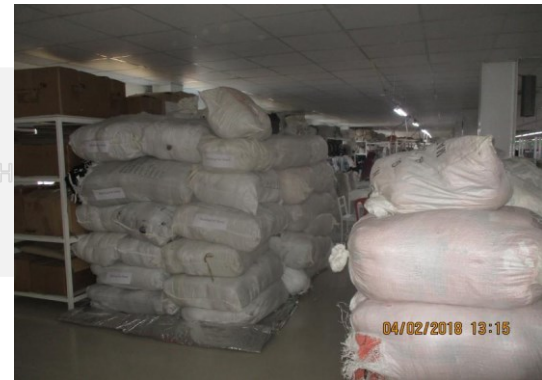
| 3 | Fire Rated Construction | <p>Areas used for combustible storage are not separated by fire rated construction.</p> <p>Location: Building-1 (Sweater Building-All Floor)</p> | <p>Provide dedicated storage rooms separated by minimum 1-hr fire-rated construction.</p> <p>Where separate storage rooms are not feasible, provide defined storage areas and limit the storage arrangement as follows:</p> <ul style="list-style-type: none"> <li>- Maximum height of 2.4m and maximum area of 23m2</li> <li>- If sprinkler protected: maximum height of 3.66m and maximum area of 93m2</li> </ul> <p>Separate areas of unenclosed combustible storage by a minimum clear distance of 3m.</p> | Within 3 months |

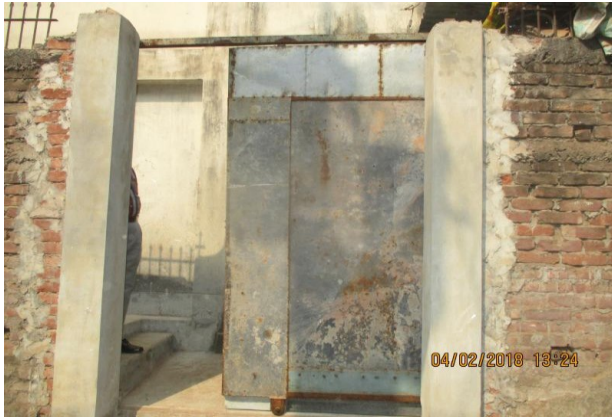
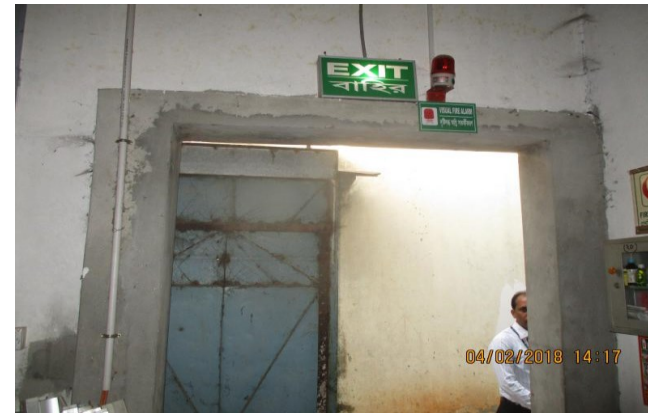
| 4 | Egress | <p>Collapsible gates/sliding doors/rolling shutter doors are provided at [building exits, exit stairs, along egress routes, exit discharge]</p> | <p>Replace all collapsible gates/ sliding doors/ rolling shutter doors along the means of egress with side-hinged, swinging egress doors.</p> <p>If locks are required for security reasons, utilize specialized door locking features complying with NFPA101.</p> | Within 1 month |

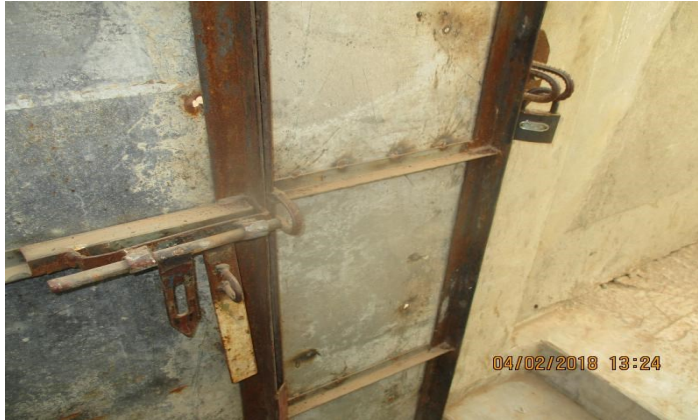
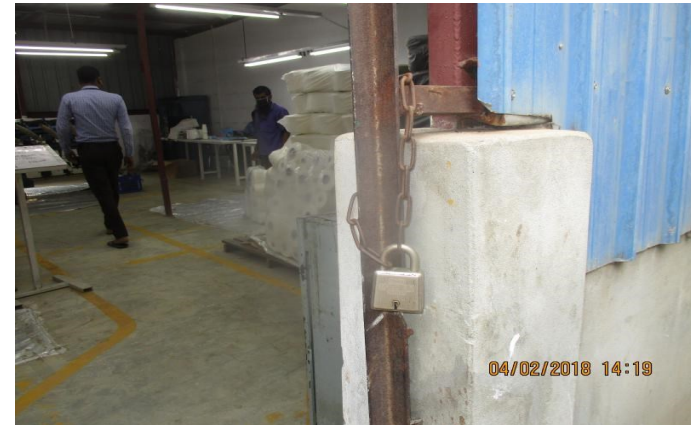
| 5 | Egress | Egress doors/gates with locking features not complying with NFPA101 are provided at [ building exits, exit stairs, along egress routes, exit discharge] | <p>Remove locking features from all egress doors/gates. If locks are required for security reasons, utilize specialized door locking features complying with NFPA101.</p> <p>OR</p> <ol style="list-style-type: none"> <li>1. Remove all non compliant locking features from egress doors.</li> <li>2. If locks are required for security reasons, utilize special door locking features complying with NFPA 101.</li> <li>3. Doors may be locked where the latch and lock are disengaged with one motion where the occupant load does not exceed 49 persons.</li> <li>4. Doors may be provided with locking hardware from the ingress side provided that a panic bar is installed on any door with an occupant load exceeding 49 persons.</li> </ol> | Immediate |

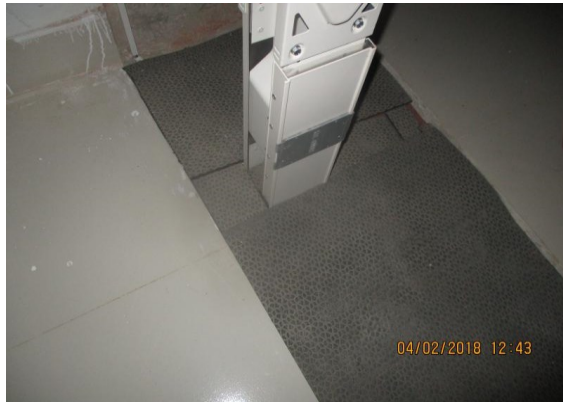
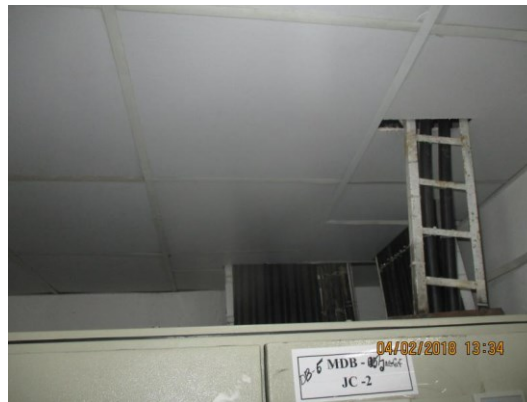
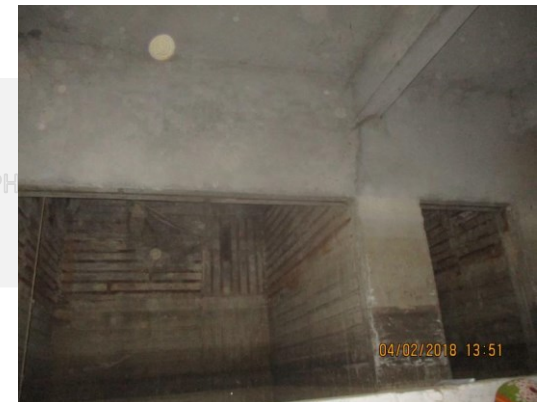
| 6 | Fire Rated Construction | Unsealed penetrations and openings are located in the fire rated floor/ceiling assemblies.<br>Location: Building-1(Sweater) & Building-2 (Dining/Wearhouse). | Seal all penetrations and openings in floors/ceiling assemblies to maintain the fire separation. | Within 3 months |

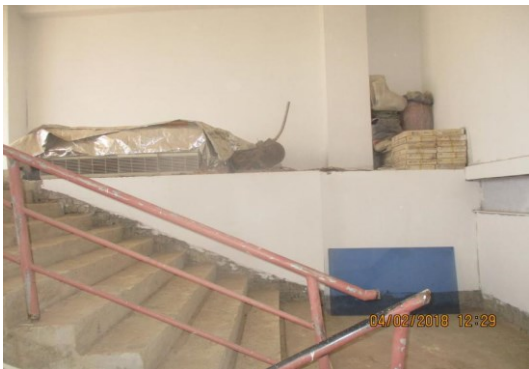
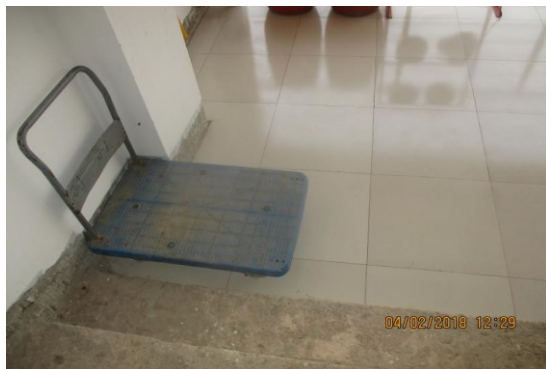
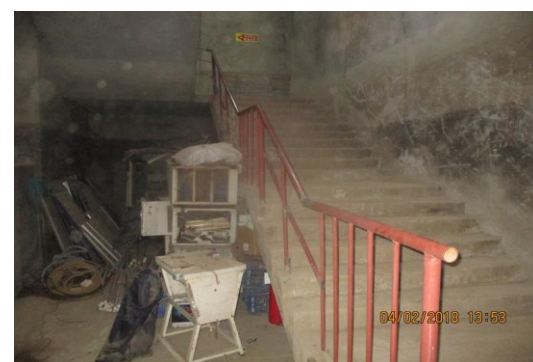
| 8 | Egress | Storage was located in exit stairs. | Remove storage from the exit stairs and egress path | Immediate |

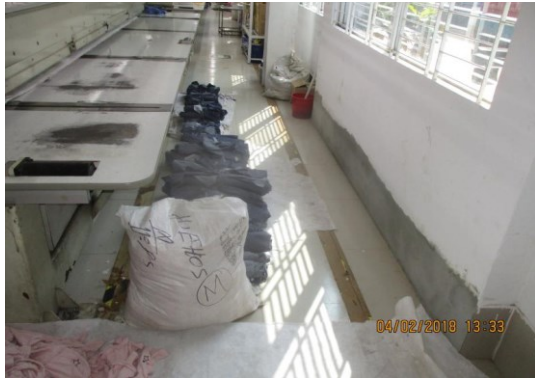
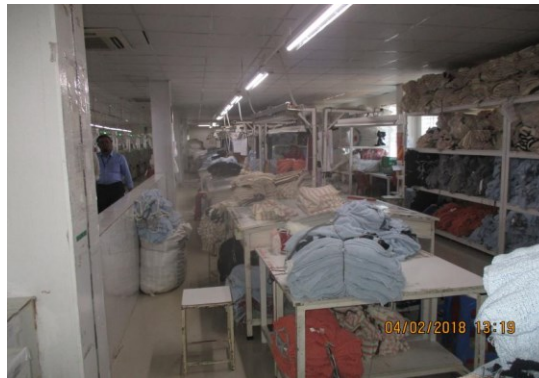
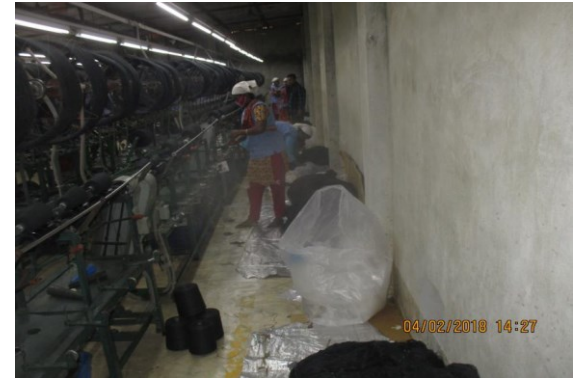
| 9 | Egress | Storage was located in the egress path.<br>Location: Sweater Building: 1st & 3rd floors. | Keep egress path and stair clear of storage. | Immediate |

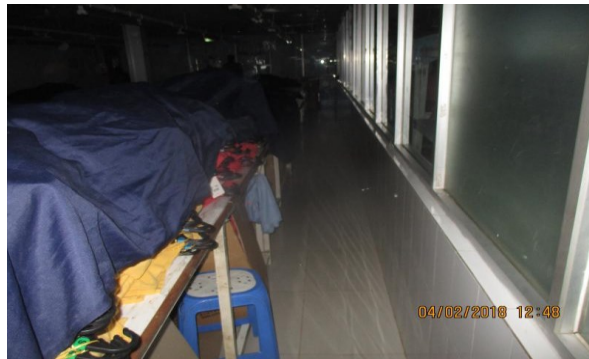
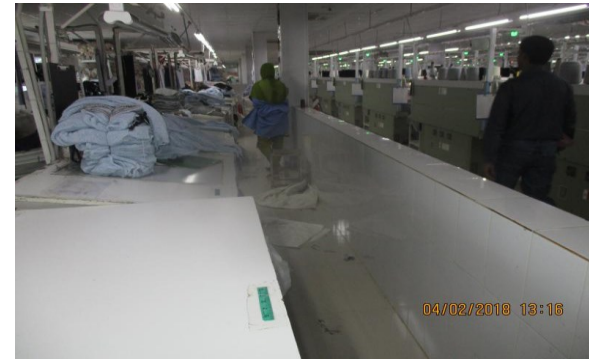
| 10 | Egress | The width of egress aisles is less than 36-in.<br>Locations: Sweater Building: Ground, 1st & 3rd floors. | Provide minimum aisle widths of 36-in. | Within 3 months |

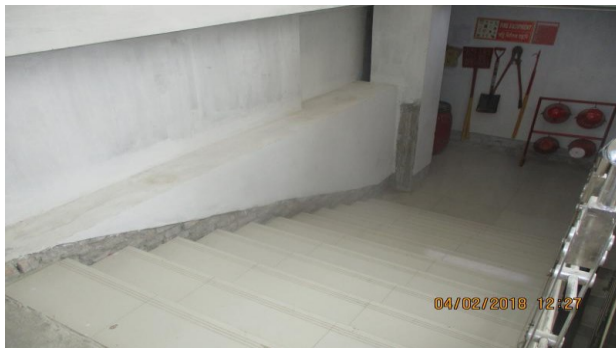
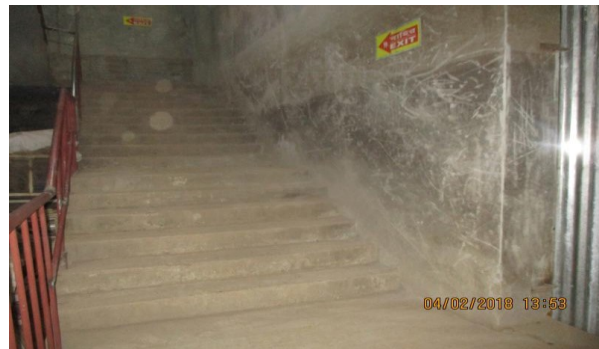
| 11 | Egress | Handrails are not provided on both sides of each exit stairs on all floors. Having handrails on one side of said staircase, may pose as a falling hazard during evacuation.<br>Or, Handrails are not provided at exit stairs.<br>Locations: Building-1 (Sweater Building) & Building-2 (Dining & Warehouse) | Provide handrails on both sides of the exit stair. New handrails shall have a minimum height of 865 mm (34 in.) and a maximum height of 965 mm (38 in.) as measured from the leading edge of the tread.<br>Intermediate handrails shall be provided when the stair width exceeds 2.2 m (87 in.) | Within 3 months |

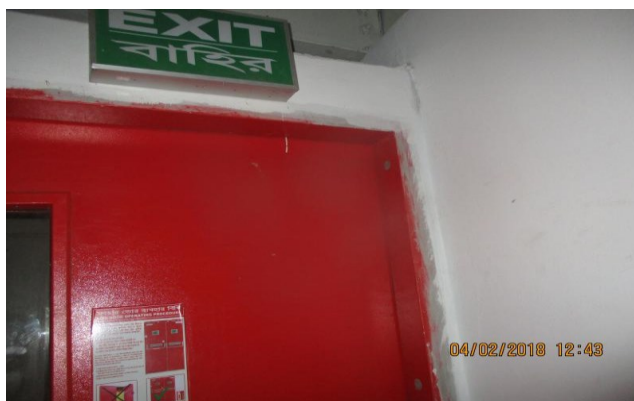
| 17 | Egress Lighting | Exit signage not illuminated (burned out, broken, etc.). | Regularly inspect all exit signage and replace/install lights as needed to illuminate signs | Within 1 month |

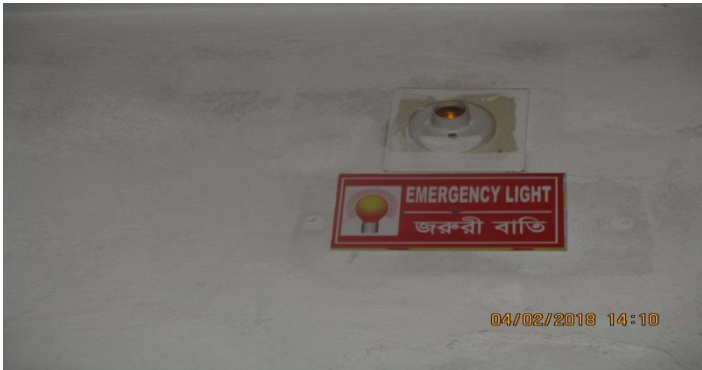
| 18 | Egress Lighting | Emergency lighting did not function in test mode (burned out, broken, etc.). | Regularly test the emergency lighting system on each floor and replace/repair lights as needed | Within 1 month |

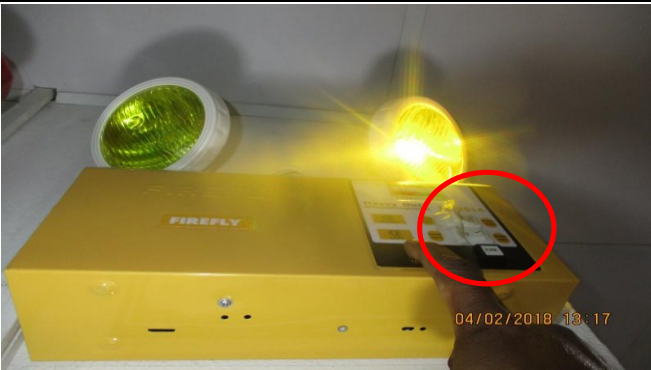
| 19 | Egress Lighting | Manual on-off switch facility available for emergency lights/exit signs. | Remove manual on/off switches from emergency lighting units/ exit signs to prevent them from being switched off. | Within 1 month |

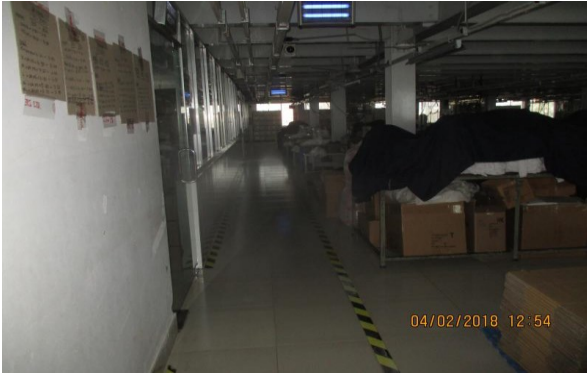
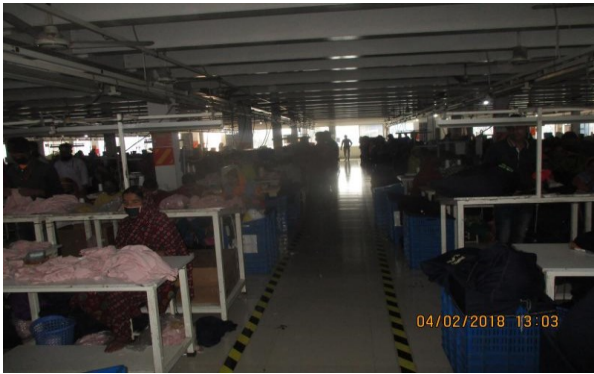
| 20 | Egress Lighting | Based on the number and location of emergency lights/exit signs observed, adequate illumination levels are not anticipated along egress routes. | Test the emergency lighting system on each floor and provide additional emergency fixtures to provide adequate illumination along the means of egress. Provide a minimum illumination of 10 lux at the floor level within exit stairs and exit discharge paths and minimum 2.5 lux along exit access aisles. | Within 3 months |
