# **FIRE SAFETY INITIAL INSPECTION REPORT**

**Factory Name: Dynasty Sweater(BD) Ltd (Extension Building)**

**ACCORD ID: 23066**

**Date: 01 April, 2018.**

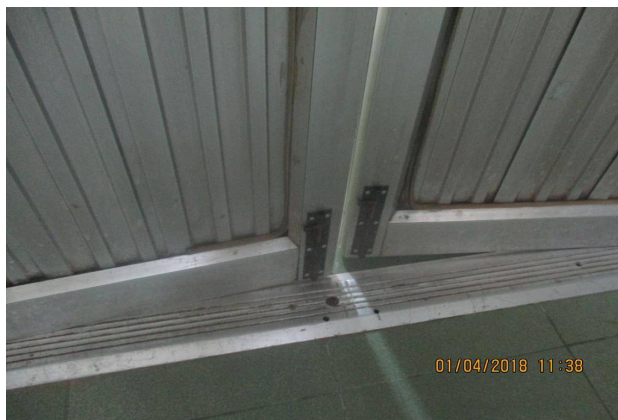
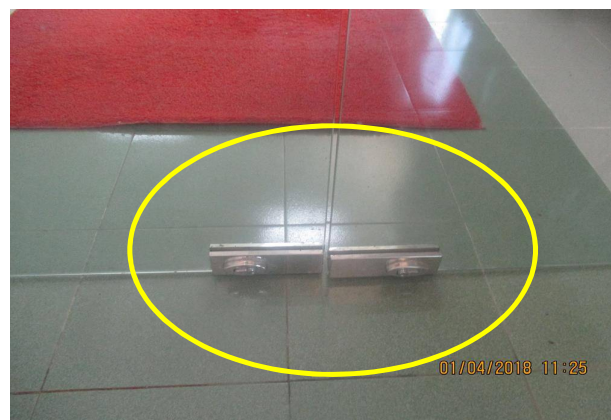
| 2 | Locking system of egress doors | Doors along means of egress are provided with non compliant locking system. | <ol style="list-style-type: none"> <li>1. Remove all non compliant locking features from egress doors.</li> <li>2. If locks are required for security reasons, utilize special door locking features complying with NFPA 101.</li> <li>3. Doors may be locked where the latch and lock are disengaged with one motion where the occupant load does not exceed 49 persons.</li> <li>4. Doors may be provided with locking hardware from the ingress side provided that a panic bar is installed on any door with an occupant load exceeding 49 persons.</li> </ol> | Immediate |

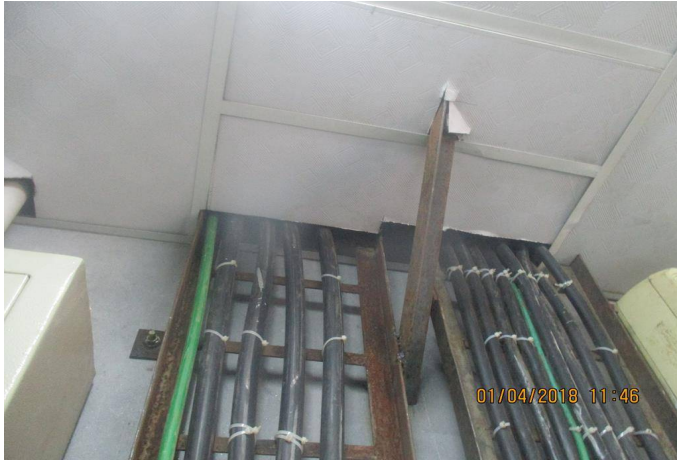
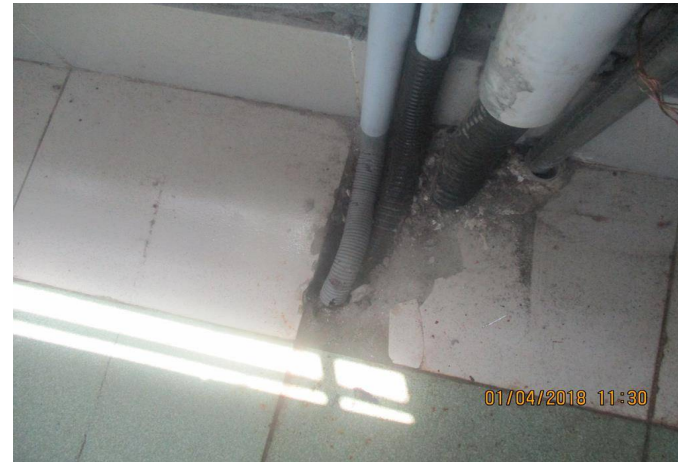
| 3 | Fire separation | Penetrations through floor/ceiling assemblies are found unsealed. | <p>Seal all penetrations and openings in floor/ceiling (full thickness of the floor/ceiling) assemblies by fire rated materials to maintain the fire resistance rating. Provide a minimum 2-hr fire rated shaft to separate the utility risers from each floor if required.</p> | within 3 months |

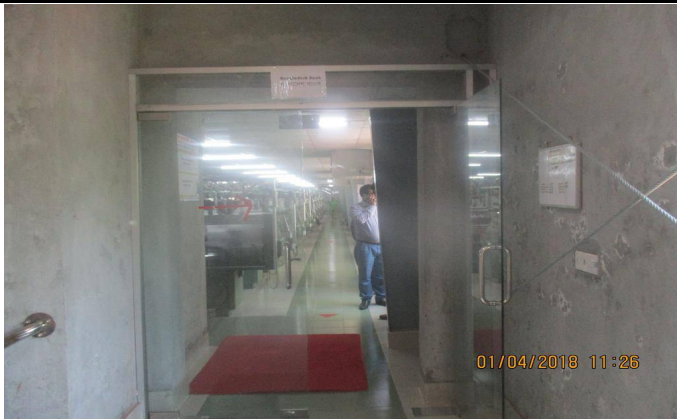
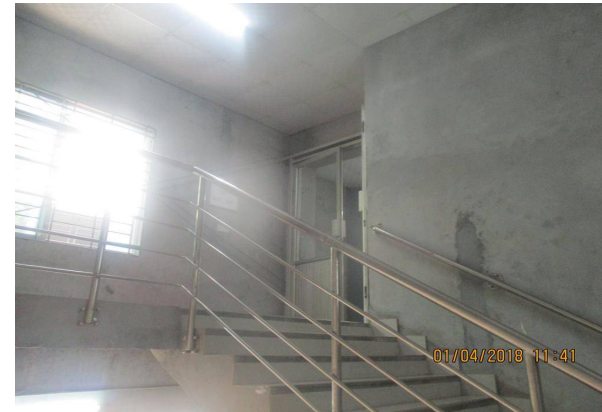
| 4 | Fire Separation | <p>The exit stairs are not separated from [work areas, other spaces] on each floor by fire-rated construction.</p> | <p>Stair shall be enclosed with a minimum 1-hr fire-rated construction. Seal all unprotected openings and provide minimum 1-hr fire rated doors to separate the exit stairs from work areas and other building spaces on all floor levels. Ensure that the fire doors are self-closing, positive latching and that they are provided with fire exit (panic) hardware where serving production floors.</p> <p>If fire doors are required to be held open for functional reasons, provide automatic-closing devices tied to the fire alarm system.</p> | within 3 months |

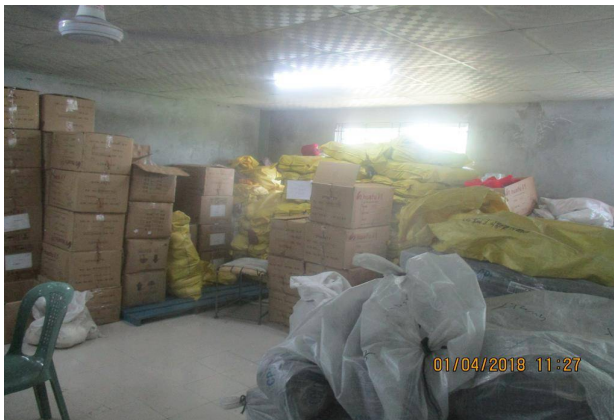
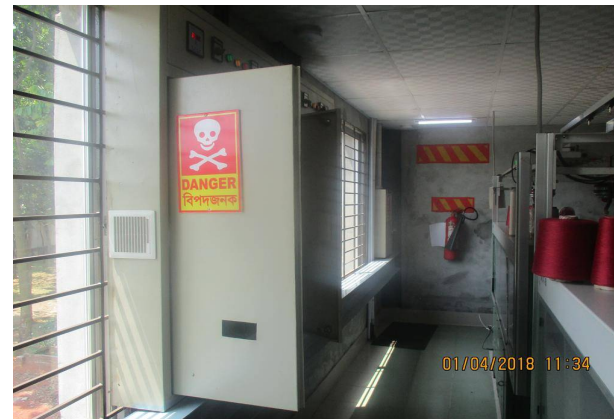
| 5 | Means of egress | <p>The egress path along means of egress has interrupted by obstruction/storage.</p> <p><b>Note:</b> DB Pannel's door creating obstruction.</p> | <p>Means of egress shall be maintained continuously free and clear of all obstructions/storage.</p> <p>Or</p> <p>Keep egress paths and stairs clear of storage.</p> | Within 1 month |

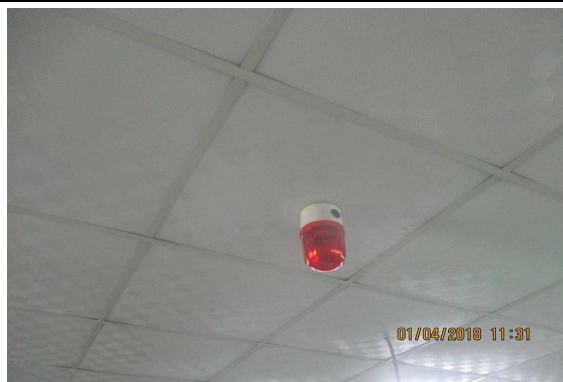
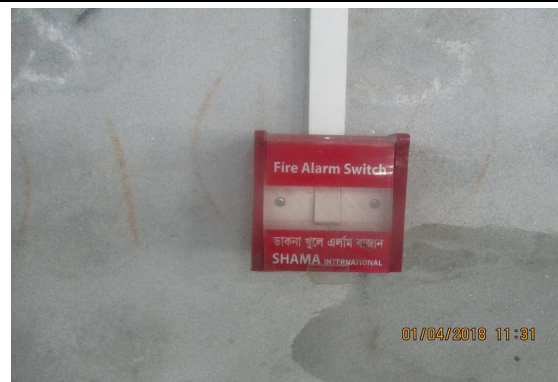
| 7 | Fire Alarm System | The existing fire alarm system is not a listed system and does not provide automatic alarm and notification features consistent with acceptable standards. | Replace the Fire Alarm system with a new, listed, addressable fire alarm system in accordance with NFPA 72. | Design within 4 months, installation within 6 months after drawing review |
