# Epyllion Knitwears Ltd (10294)

Plot #1/6. Road #6, Sections #7, Mirpur 1/A

27.APRIL.2014

# Identified Priority 1 Concerns

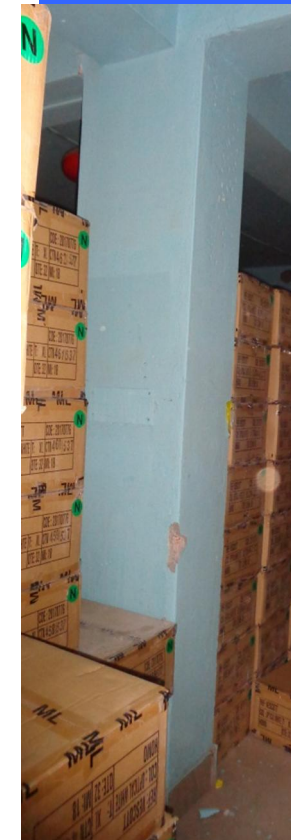
Based upon observed loadings in combination with material strengths assumed for brick aggregate concrete and steel reinforcing procured prior to 2005, the column stresses developed within the columns of Building 1 are much higher than allowable.

**ITEM 1: Priority 1 – Building 1 - Concrete stress levels, checked under current guidelines, indicate that the columns have Factors of Safety much lower than required.**

- Limit live loads (workers, equipment & storage) within Building 1 to a maximum of 2.0 kPa per floor level.
- Verify in-situ material properties by testing 100mm dia. concrete cores of at least 4 columns.

- Commence a Detailed Engineering Assessment of the entire structure.
- Create and actively manage loading plans for all floors

- Maintain and enforce the loading plans.

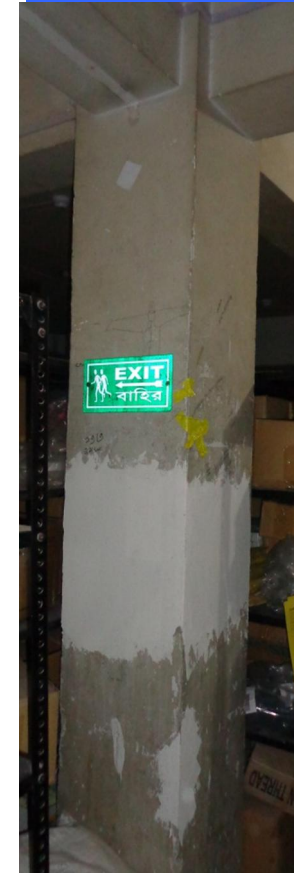
Based upon observed loadings in combination with material strengths assumed for brick aggregate concrete and steel reinforcing procured prior to 2005, the column stresses developed within the columns of Building 3 are slightly higher than allowable.

**ITEM 2: Priority 2 – Building 3 – Concrete stress levels checked under current guidelines, indicate that the columns have Factors of Safety slightly lower than required.**

- Factory Engineer to review design, loads and column stresses.

- Complete implementation of any works deemed necessary by Factory Engineer's review.

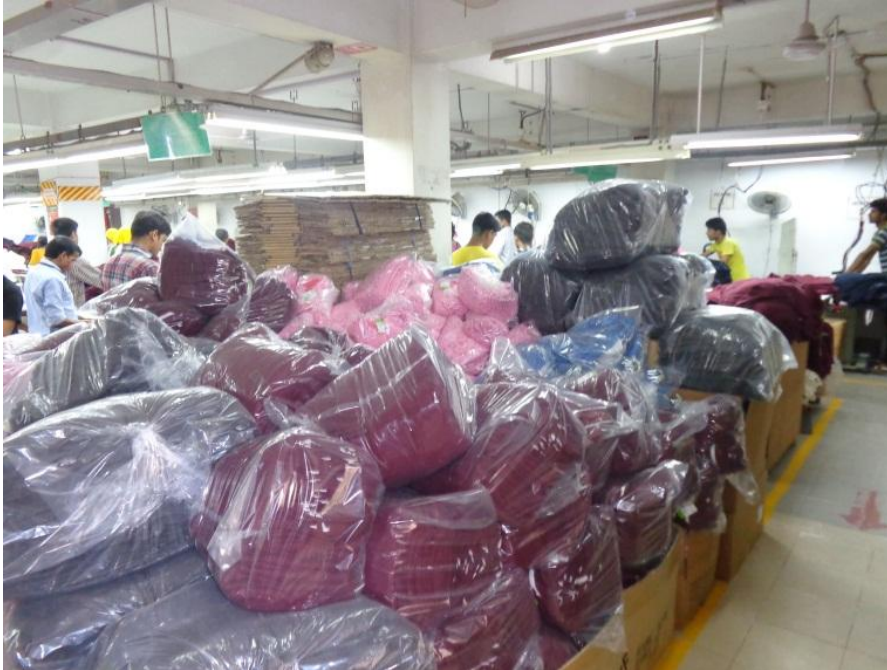
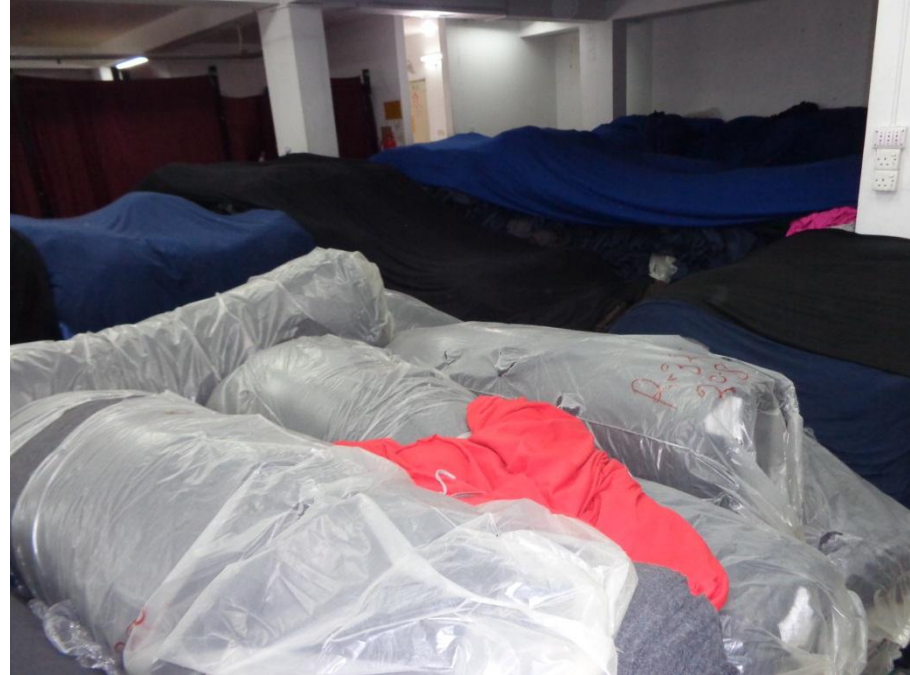
Building 1, 2 & 3

Storage loading was observed to be generally light throughout the factory buildings. However, in some instances excessive storage loads were observed. A loading plan of 'existing' loads was available. However, no loading plan was provided which encompassed the maximum allowable loads for the floors within the factory. Additionally, no load monitoring appeared to be in effect.

**ITEM 3: Priority 2 – Buildings 1, 2 & 3 – Although an ‘existing’ loading plan was provided there was no loading plan developed from a structural capacity perspective. Some storage loads were present at the time of inspection, however, there did not appear to be any load monitoring in effect.**

- Limit storage loads throughout the factory.

- Factory Engineer to review and revise the existing loading plans for all floor plates giving consideration to slab, beam and column capacities.

- Maintain and actively monitor the revised loading plan.

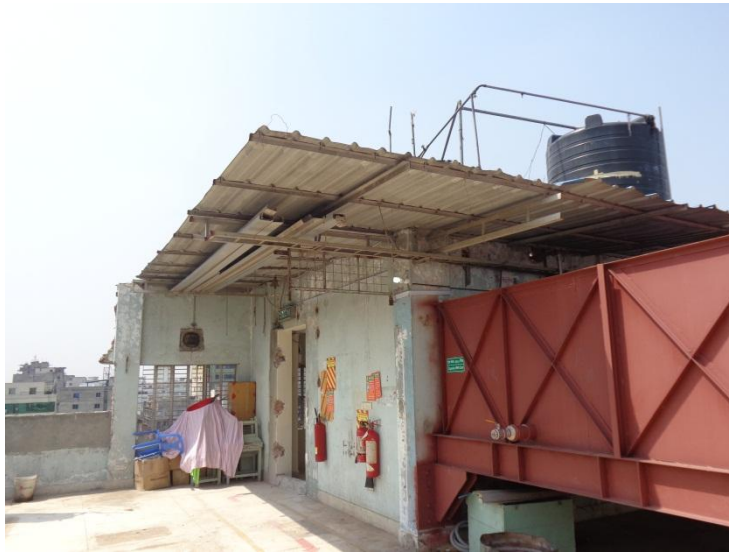
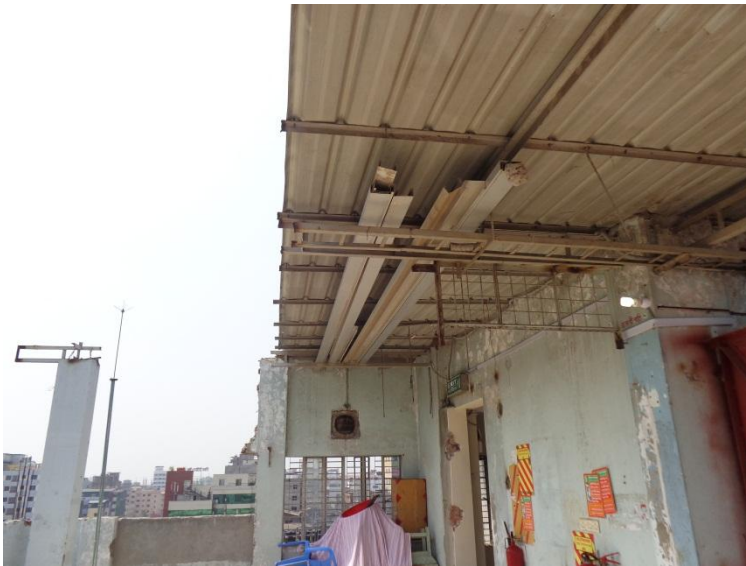
Building 1, 2 & 3

At the roof level of each building, stair core extensions typically had a poorly framed steel canopy around their perimeter.

Poorly Framed Steel Canopies

**ITEM 4: Priority 3 – Buildings 1, 2 and 3 – Structural steel canopies at the roof level were poorly framed.**

- Factory Engineer to review the steel canopy construction and assess adequacy for wind loads.

- Carry out any remedial works deemed necessary by the Factory Engineer.

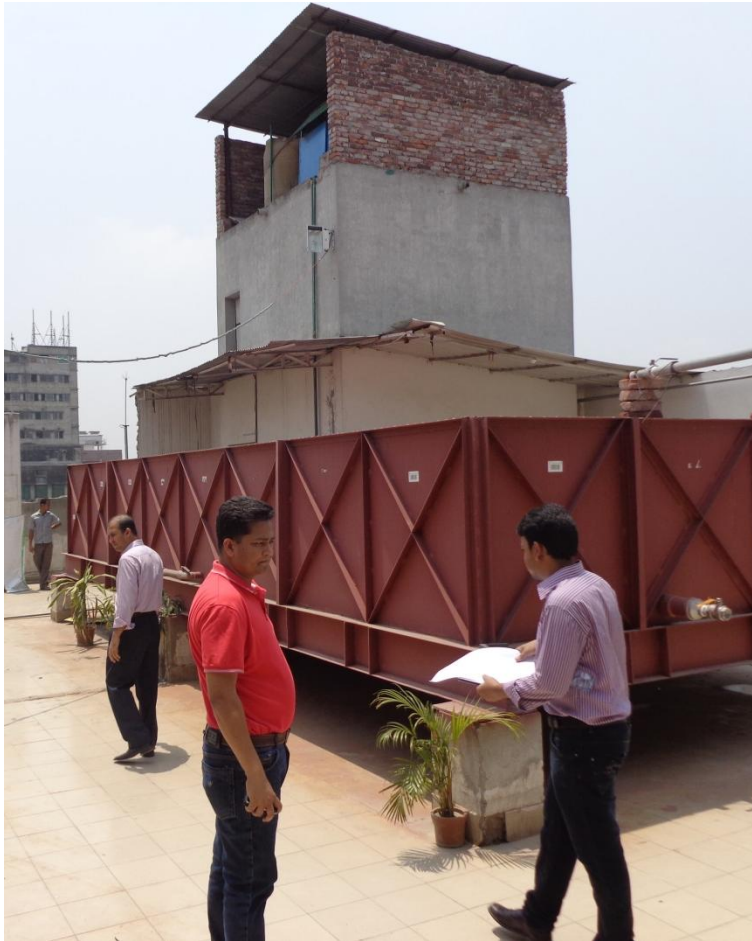
Building # 3

At Building #3 the stair/elevator core has been extended above the top of the roof level stair to accommodate the elevator machine room. However, there has been no elevator installed.

**Stair/Elevator Core Extension**

**ITEM 5: Priority 3 – Building 3 – The elevator/stair core at the front of the building has been extended by at least one additional storey.**

- Remove additional Stair/Elevator core levels above the roof-level stair enclosure.

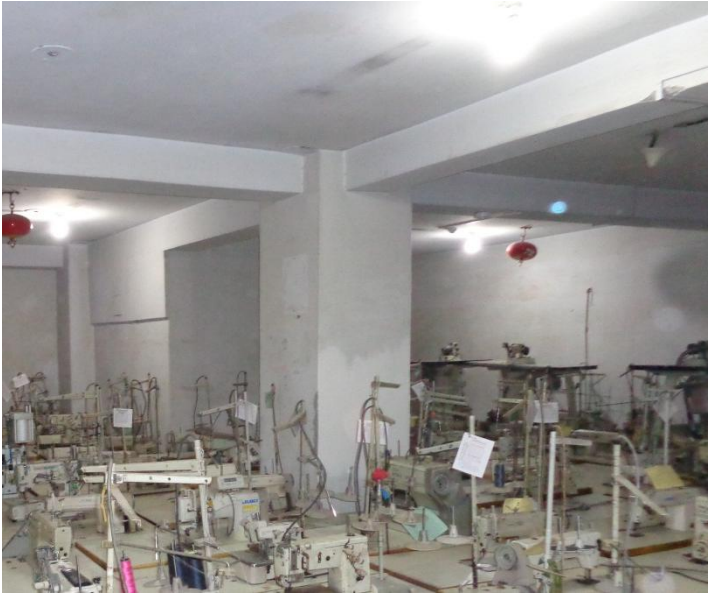
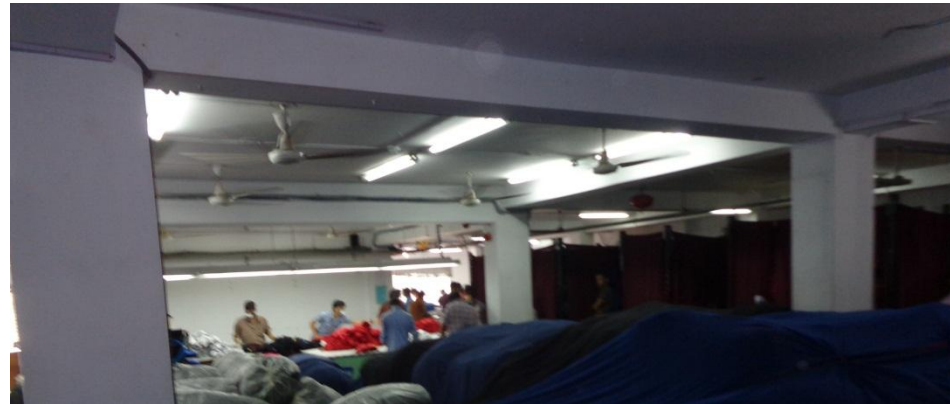
All buildings within the Epyllion complex were constructed using R.C. beam/column frames. This construction is considered to provide at least a measure of lateral stability. But there was no other lateral support system observed.

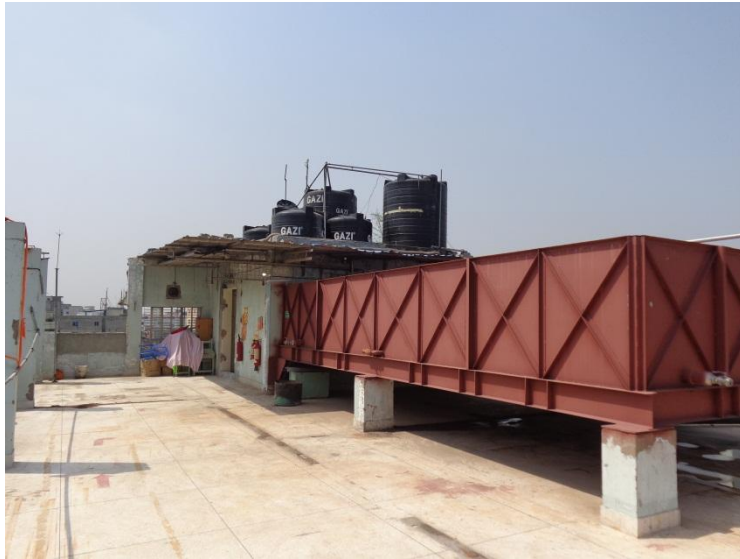
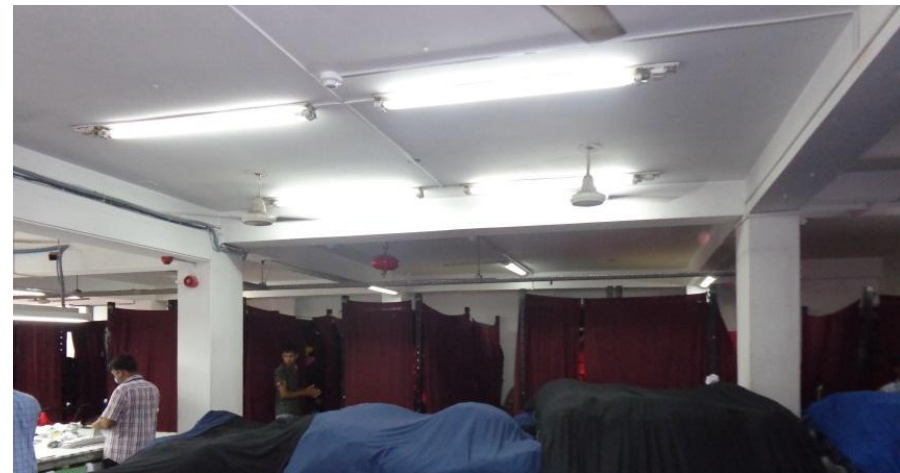
The exposed portion of roof slab had no waterproofing protection. However, no evidence of water ingress was observed at the underside of the roof slab.
