# Shanta Denims Ltd (10180)

Plot #156 & 177, D.E.P.Z., Ganakbari, Savar

28.APRIL.2014

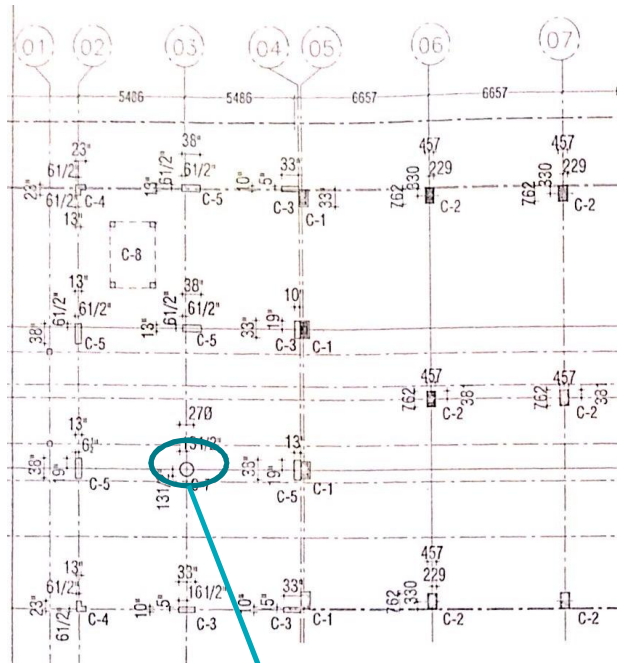
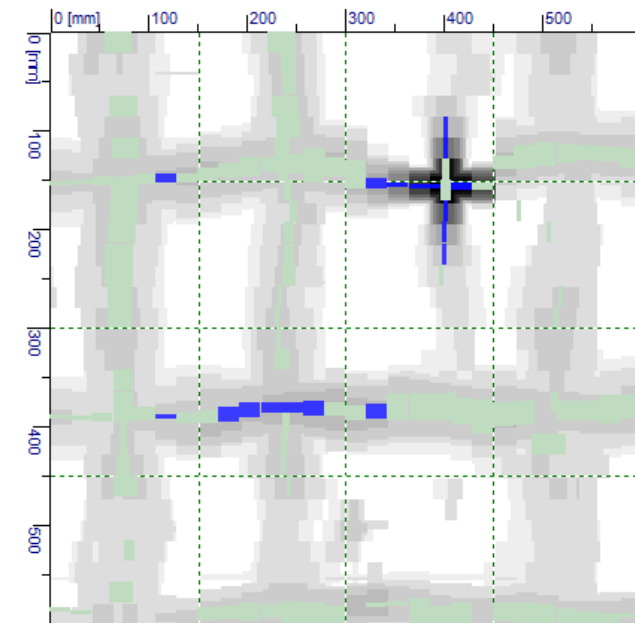
## Discrepancy Between Construction and Structural Documents

Small square column in place of larger circular column & deficient reinforcing

Priority 1 Concern

Numerous discrepancies between the construction and the structural plans were observed. Specifically concerning columns, we found in several instances, one 19" x 19" column with 12 vertical bars instead of the specified circular 24" dia column with 16 vertical bars. Regarding slabs, we measured 254 mm flat slabs at each level instead of 165 mm typical floor beam/slab shown by the drawings. The large degree of deviation from design drawings instills a great degree of uncertainty regarding the adequacy of construction to support the imposed loads.

**ITEM 1: (Priority 1)** At both the West and East buildings, we find discrepancies between drawings and the observed construction. Column sizes, column reinforcing, number of stories and slab construction were all observed to deviate from the design documents.

- A Detailed Engineering Assessment (DEA) is to be commenced to assess the adequacy of the as-built construction of the East and West concrete buildings.

- The Detailed Engineering Assessment is to be completed and its actions and recommendations carried out.

- Complete the implementation of any works deemed necessary by the DEA.

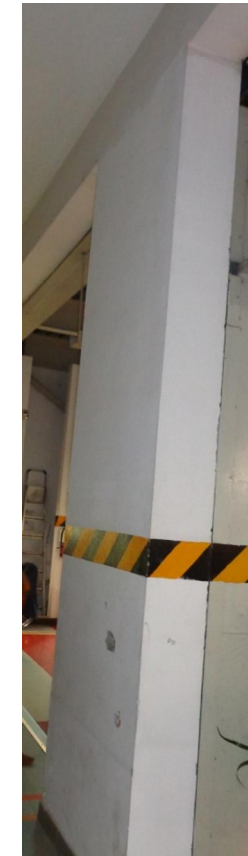
High Column Stresses

Priority 2 Concern

Based upon the column sizes and reinforcing observed on-site (which differ from the drawings) the concrete column stresses are slightly higher than desirable.

**ITEM 2: (Priority 2)** High Columns Stresses. Although not definitive, Ferroscanning indicates reinforcement in the verified columns is less than shown on the Structural drawings. This in combination with the deviation in column size from the column schedule and the increased load imposed by the thickened slabs causes high column stresses.

- As part of the Detailed Engineering Assessment verify column size, reinforcing and concrete strength.
- Complete a detailed column design check based upon the as-built construction.

- Implement recommendations of the DEA.

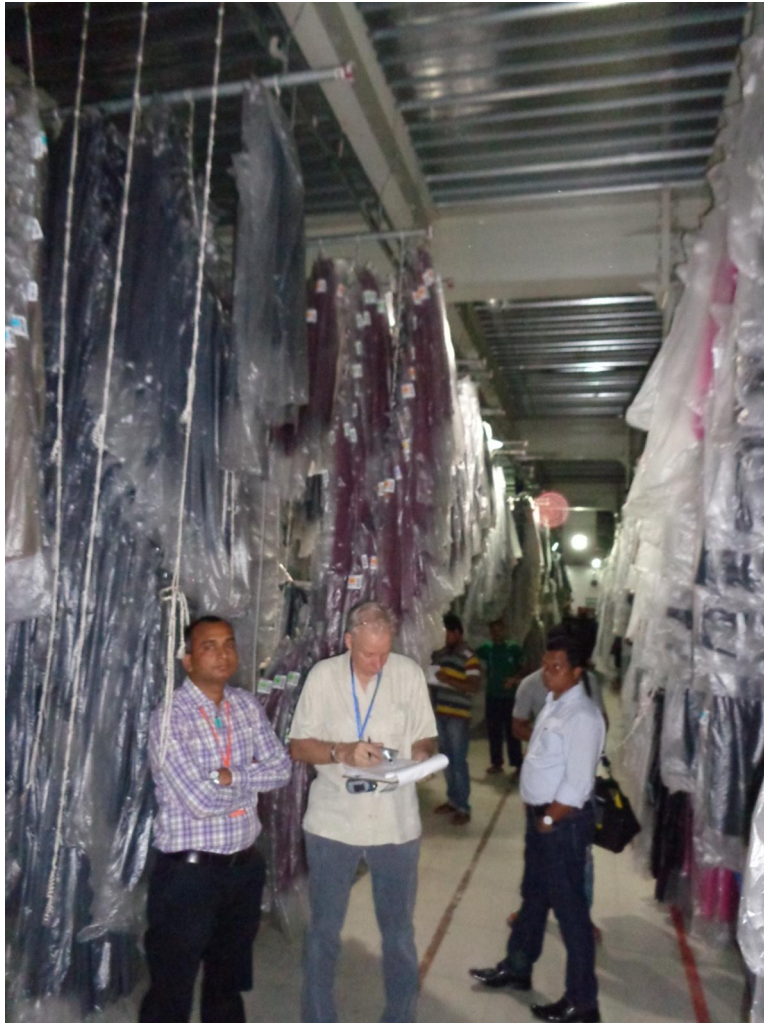
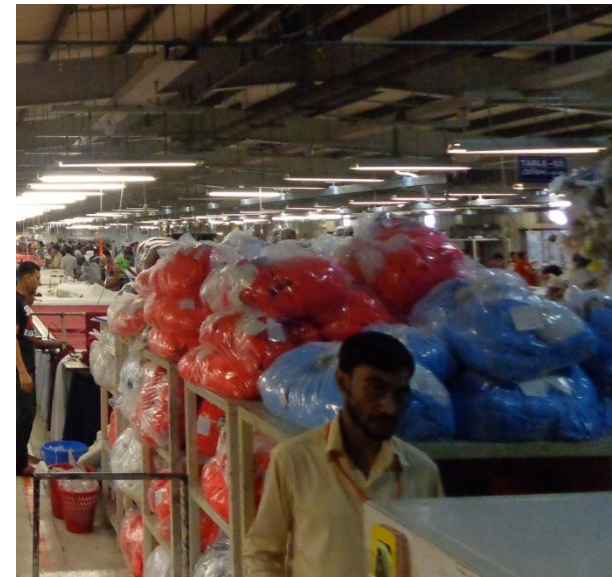
### No Loading Plan or Storage Monitoring

Although slab loading was in general very light, there was some sporadic storage throughout the factory. There was no loading plan provided nor was there any evidence that load monitoring was taking place.

**ITEM 3: (Priority 3)** No loading plans were provided nor were there any signs of ongoing load monitoring

- Detailed Engineering Assessment to include evaluation of allowable floor live loads.
- Based upon Detailed Engineering Assessment and structural steel design documentation, formulate and begin the implementation of a floor loading plan for all floors within the factory complex.

- Actively monitor and enforce the loading plans.

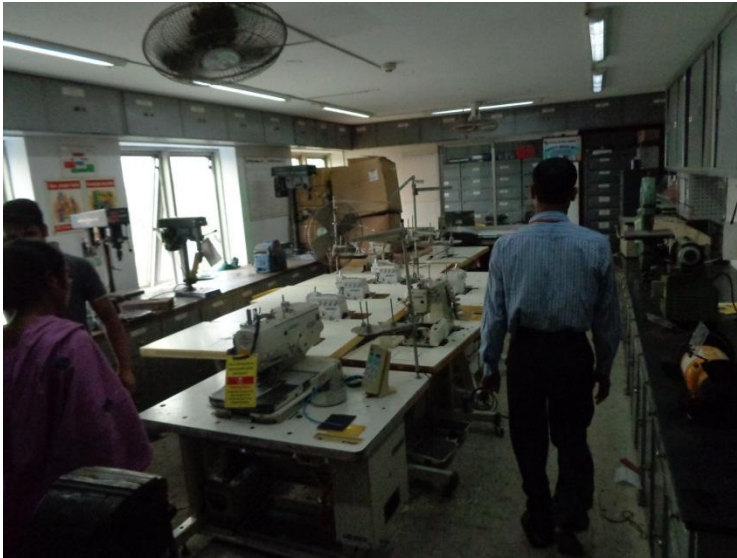
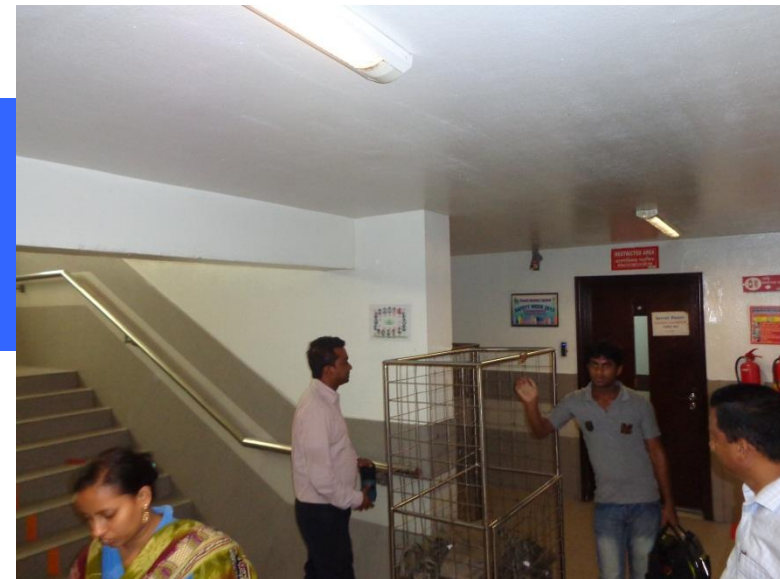
**Lateral Restraint System**

For all floor levels above the Ground Floor, the majority of the slabs were constructed as a flat slabs. A proper lateral restraint system was not observed.

We require that the lateral stability of the structure be further investigated through a Detailed Engineering Assessment.

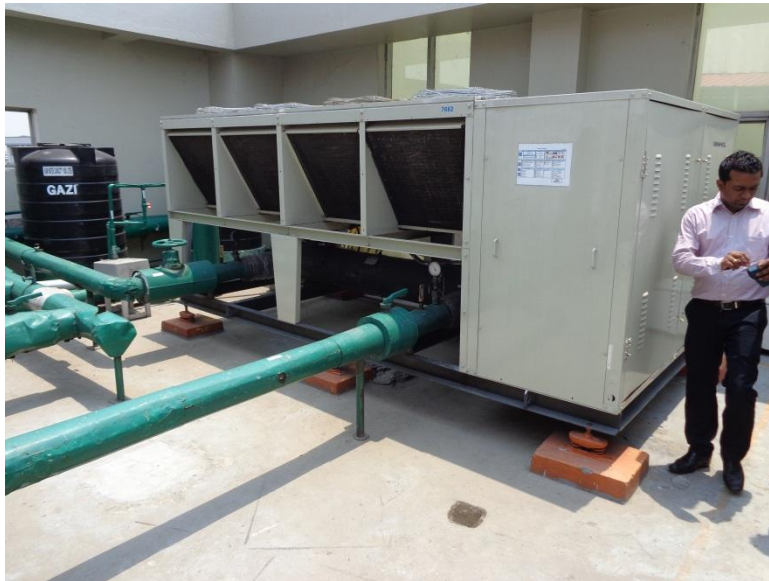
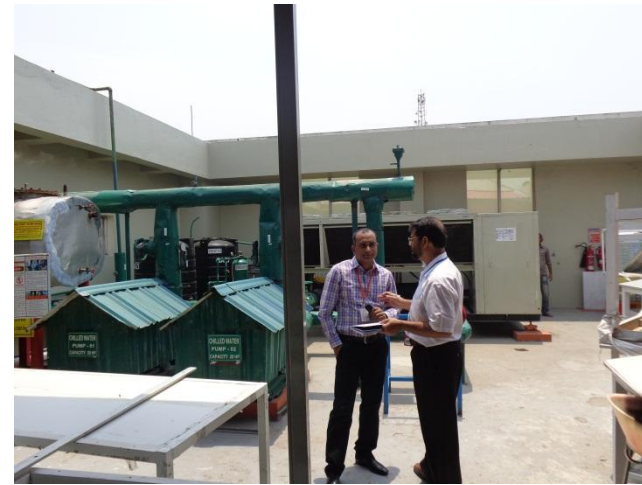
## Roof Waterproofing System

The exposed portion of roof slab contained no waterproofing. However, no evidence of water infiltration was observed at the underside of the roof slab.
