# **FIRE SAFETY INSPECTION REPORT**

**Factory Name: AR Jeans Producer Ltd.**

**ACCORD ID: 23156**

**Inspected By: Md. Zahidul Islam , Kazi Raian Mahmood  
Date: 20 March, 2018.**

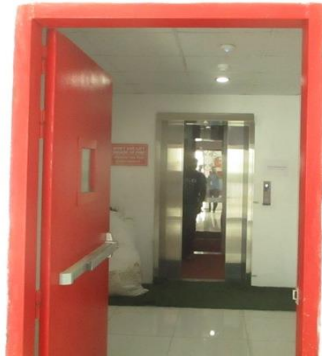
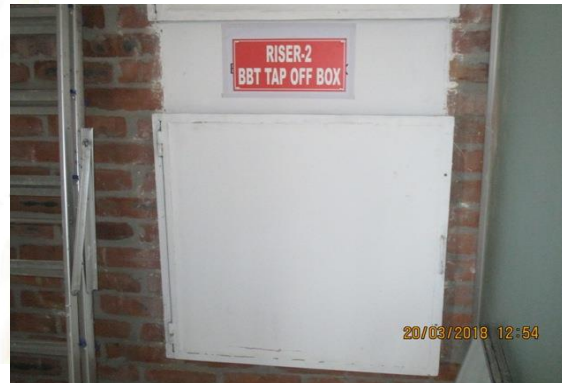
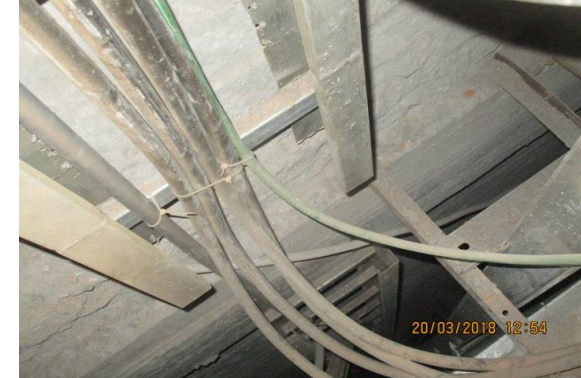
| Sl No. | Category | Findings | Required Action | Remediation Time Frame |
|---|---|---|---|---|
| 1 | Fire separation | Penetrations through floor/ceiling assemblies are found unsealed.<br>Electrical Shaft & elevator shaft are open to the floor near to exit stair 1 & 3. Fire rated material without proper documentation has been used to separate the electrical shaft. | Seal all penetrations and openings in floor/ceiling (full thickness of the floor/ceiling) assemblies by fire rated materials to maintain the fire resistance rating.<br>Provide a minimum 2-hr fire rated shaft to separate the utility risers from each floor if required. | 3 months |

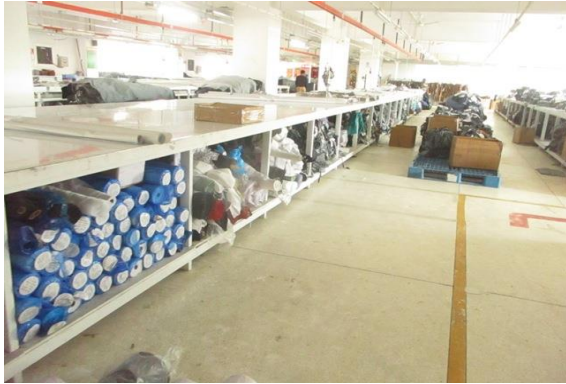
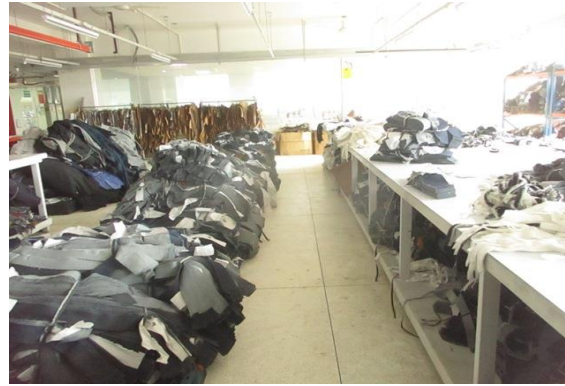
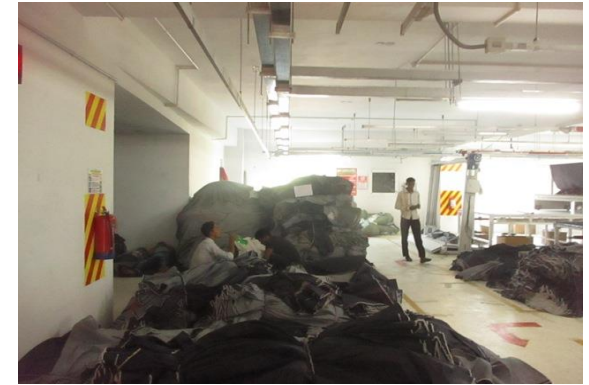
| 2 | Fire separation | Areas used for in-process storage of combustible materials are open to the surrounding occupancy & combustible goods are found under the cutting table. | <p>Provide defined storage areas and limit the storage arrangement as follows:-</p> <ol style="list-style-type: none"> <li><b>General Condition:</b> Maximum height of 2.4m and maximum area of 23m<sup>2</sup>. Separate areas of unenclosed combustible storage by a minimum clear distance of 3m.</li> <li><b>If sprinkler protected:</b> maximum height of 3.66m and maximum area of 93m<sup>2</sup>. Separate areas of unenclosed combustible storage by a minimum clear distance of 3m.</li> </ol> <p>or</p> <ol style="list-style-type: none"> <li>Enclose the storage area from the surrounding occupancy with a minimum 1 hour construction.</li> </ol> | within two month |

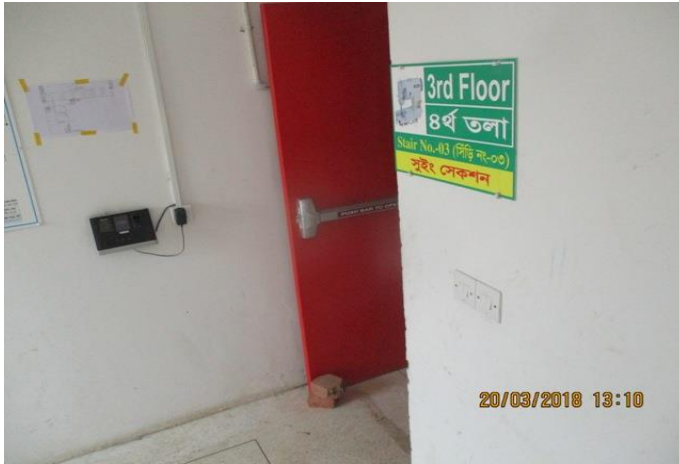
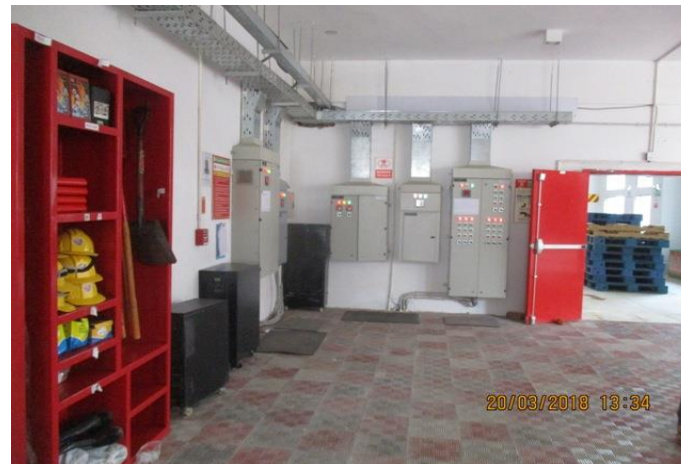
| 3 | Fire Separation | <p>The exit stairs are not separated from [work areas, other spaces] on each floor by fire-rated construction.</p> <p>Stair-3 discharge to a passage having DB board at ground floor.</p> <p>Stair-2 with admin HR room at ground floor has non listed fire door.</p> <p>Fire door install at all exits at all floors are held open with the help of external sources (laces, bricks etc.) those are not interfaced with fire alarm system.</p> | <p>Stair shall be enclosed with a minimum 2-hr fire-rated construction. Seal all unprotected openings and provide minimum 2-hr fire rated doors to separate the exit stairs from work areas and other building spaces on all floor levels. Ensure that the fire doors are self-closing, positive latching and that they are provided with fire exit (panic) hardware where serving production floors.</p> <p>If fire doors are required to be held open for functional reasons, provide automatic-closing devices tied to the fire alarm system.</p> | within 3 months |

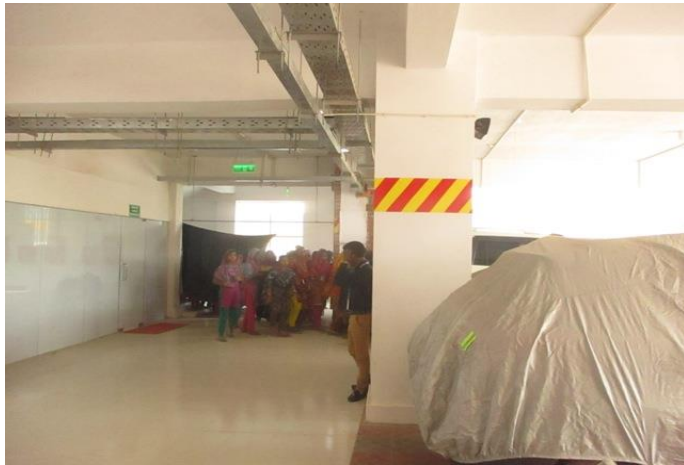
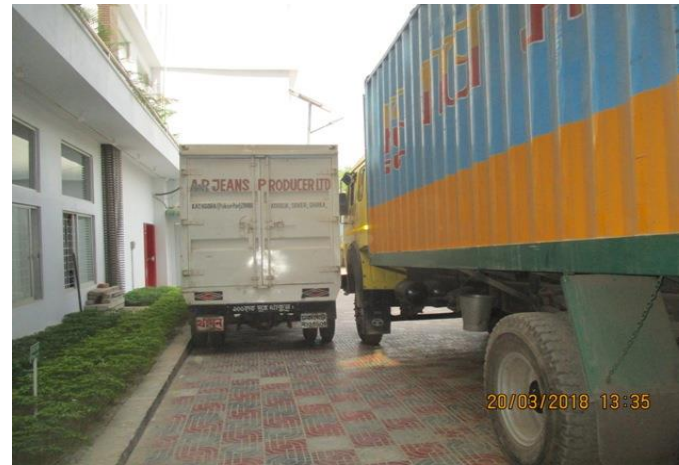
| 6 | Egress | Exit capacity is not adequate for the occupant load at building-1 4th floor. | 1. Reduce occupant load to not more than available exit capacity.<br>Or<br>2. Provide additional exits to increase exit capacity. | 3 months |

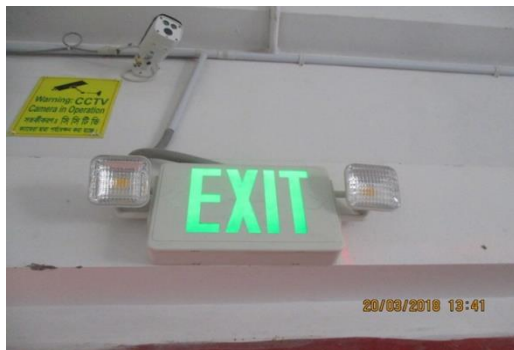
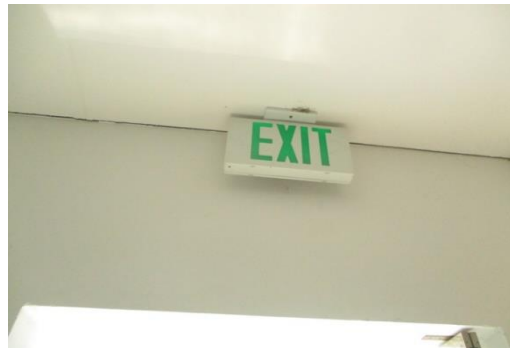
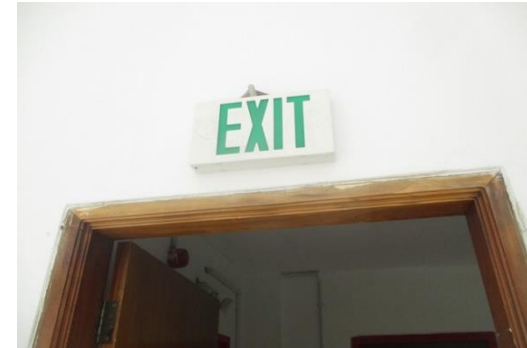
7 Egress lighting

Exit signs are not in dual language.

Provide both local and international language to all exit sign

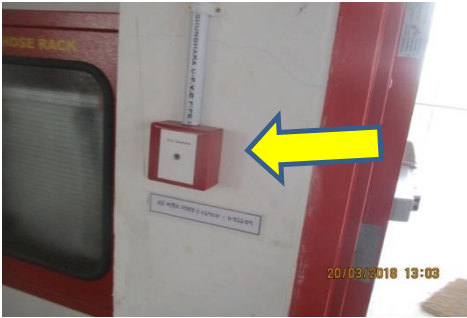
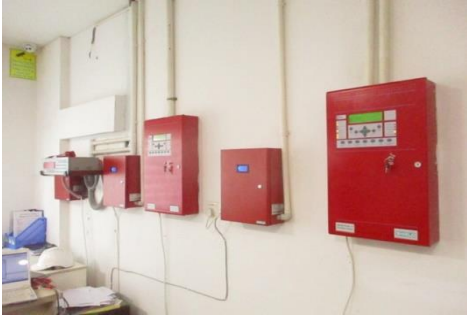
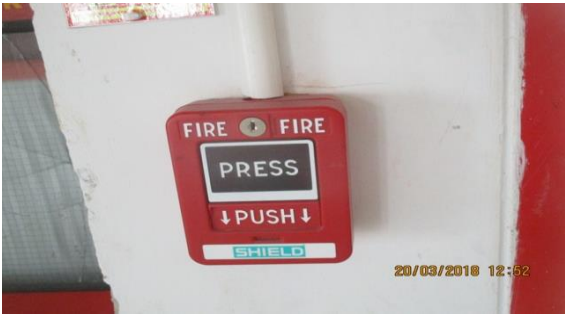
| 8 | Fire Alarm Syatem | <p>The factory has designed &amp; installed the addressable fire alarm system without having approval from AHJ. An old non-listed system has also been observed along with the new listed system.</p> | <p>Submit the drawing to ACCORD and Modify the system (if required) as per NFPA 72 upon reviwed by ACCORD. Remove the old non-listed system.</p> | <p>Design within 4 months, installation/ modification within 6 months after drawing review</p> |

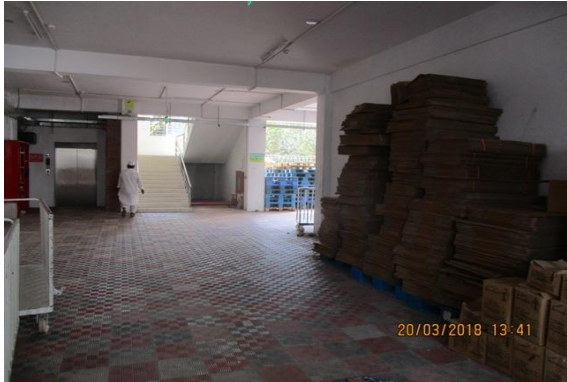
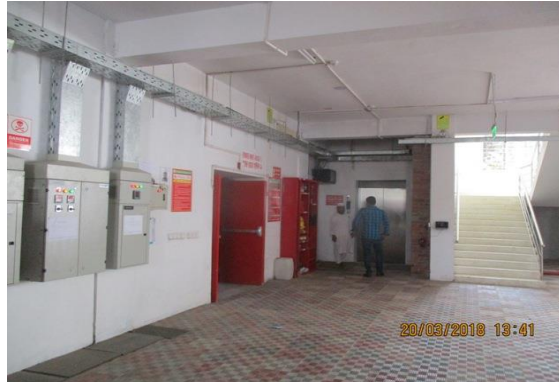
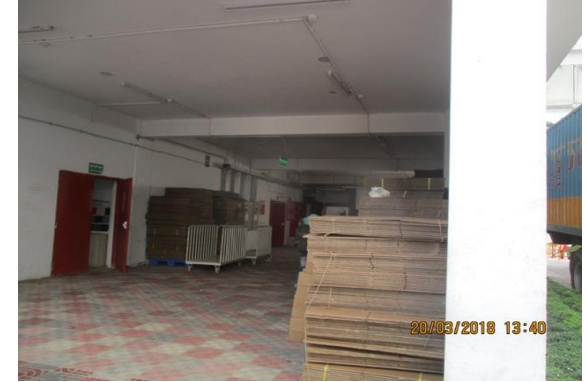
| Sl No. | Category | Findings | Required Action | Remediation Time Frame |
|---|---|---|---|---|
| 1 | Fire Separation | <p>The exit stairs are not separated from [work areas, other spaces] on each floor by fire-rated construction.</p> <p>The loading unloading area is open with stair 1. Fire doors install at all exits through out the building are kept open through external sources (brick, laces etc.) not interfaced with FACP.</p> | <p>Stair shall be enclosed with a minimum 2-hr fire-rated construction. Seal all unprotected openings and provide minimum 2-hr fire rated doors to separate the exit stairs from work areas and other building spaces on all floor levels. Ensure that the fire doors are self-closing, positive latching and that they are provided with fire exit (panic) hardware where serving production floors.</p> <p>If fire doors are required to be held open for functional reasons, provide automatic-closing devices tied to the fire alarm system.</p> | within 3 months |

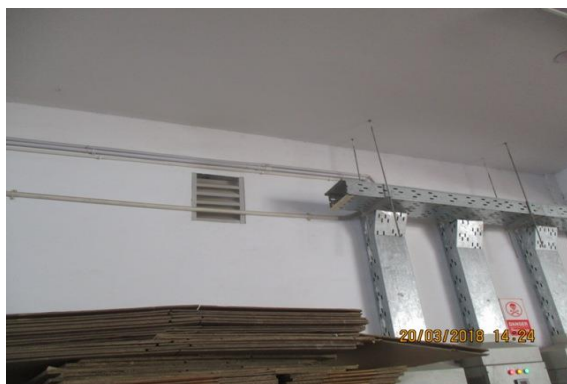
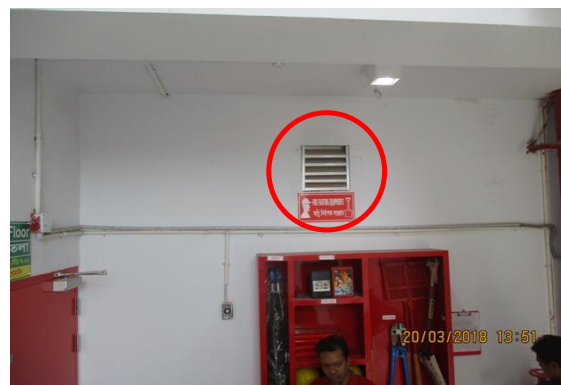
| 2 | Fire Separation | Horizontal penetrations at stair-2 at ground and 2nd floor are found unsealed. | Seal all penetrations and openings in floor/ceiling (full thickness of the floor/ceiling) assemblies by fire rated materials to maintain the fire resistance rating. Provide a minimum 2-hr fire rated shaft to separate the utility risers from each floor if required. | 3 month |

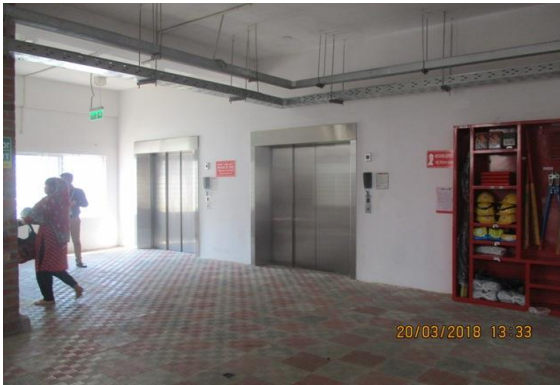
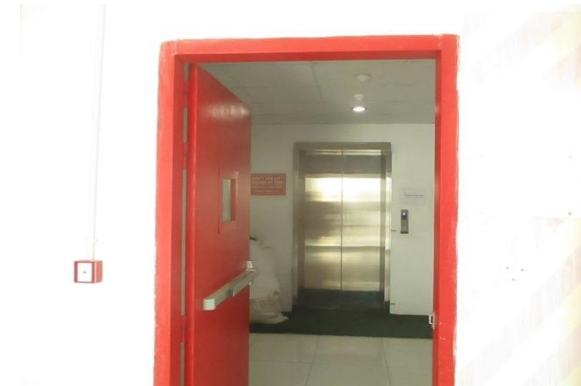
| 3 | Fire separation | <p>Elevator shaft is not separated by proper fire rated construction (openings, non-rated doors, penetrations)</p> <p>Lift open to floor and elevator shaft near stair 1 &amp; 2.</p> | <p>Provide a minimum 2-hr fire rated elevator shaft to separate it from each floor. Seal and/or protect all openings to maintain fire separations</p> | 3 months |

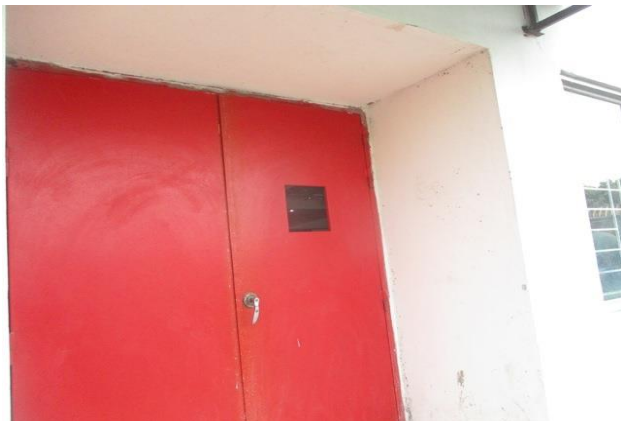
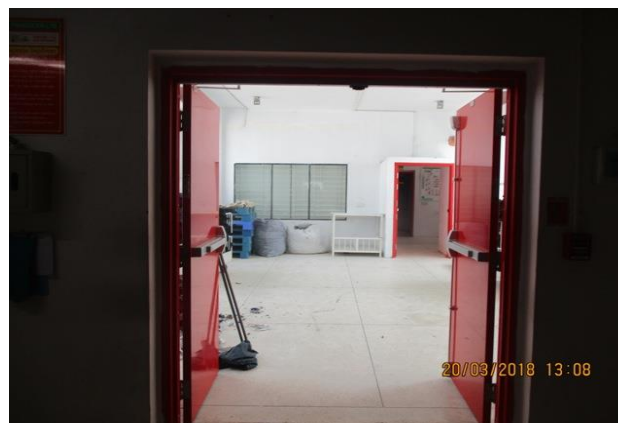
| 4 | Fire separation | Building 1 & 2 are not separated at 5th floor, non listed door at connecting bridge was observed. | Provide minimum 2 hour fire rated separation in between two buildings. | 3 months |

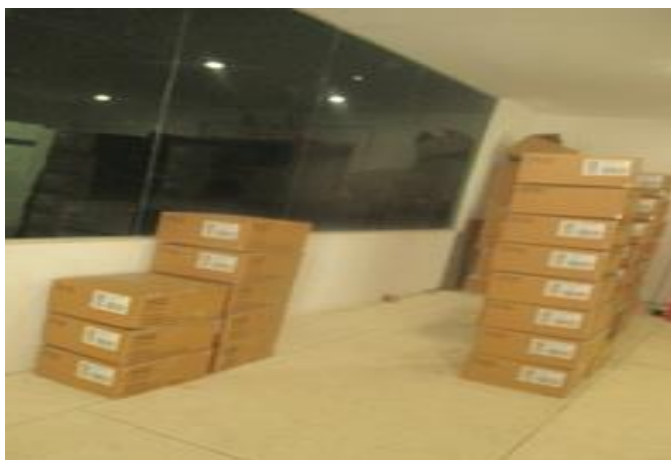
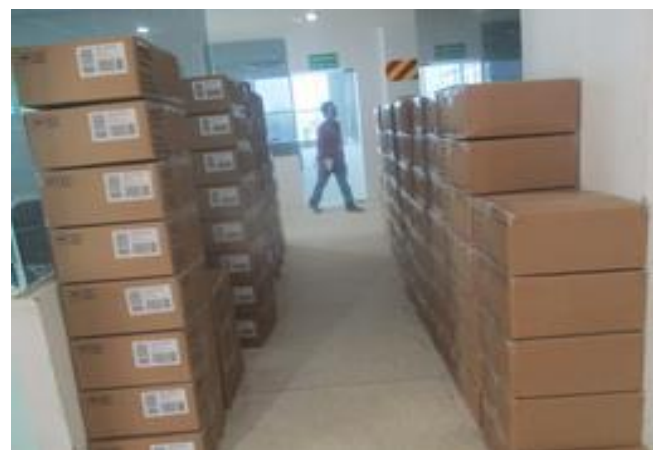
| 5 | Fire separation | Inspection room at second floor has secondary exit through bonded warehouse. | Provide a secondary exit opens directly to the exit stair or provide a 2-hr fire rated corridor at the secondary exit discharge. | Within 3 months |

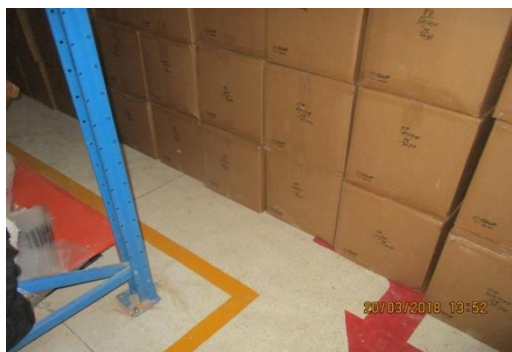
| 6 | means of egress | <p>The egress path along means of egress has interrupted by obstruction/storage. Storage on aisles on finished goods area.</p> | <p>Means of egress shall be maintained continuously free and clear of all obstructions/storage.<br/>Or<br/>Keep egress paths and stairs clear of storage.</p> | Immediately |

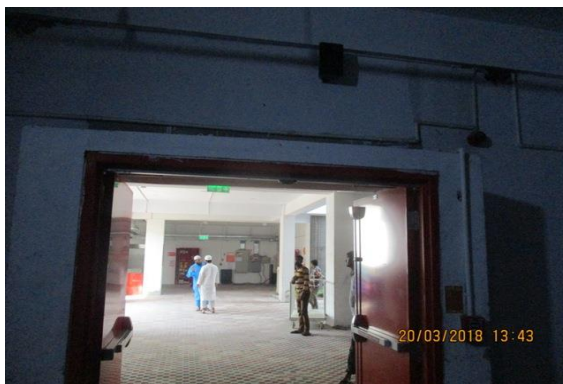
| 8 | Egress Lighting | Exit sign not provided at exit at bonded warehouse (ground floor). | <p>Lighted exit signs shall be placed at entrance to an exit. Additional exit signs shall be placed throughout the facility anywhere the continuation of the egress is not obvious.</p> <p>Lighted exit signs shall be provided with either battery backup or uninterruptable power supply systems and shall be continuously illuminated.</p> | 2 months |
