# Southeast Sweaters Ltd. (New)

278/A, Mehernagar, Dobadia, Uttarkhan, Dhaka.

19<sup>th</sup> February 2018

# Observation

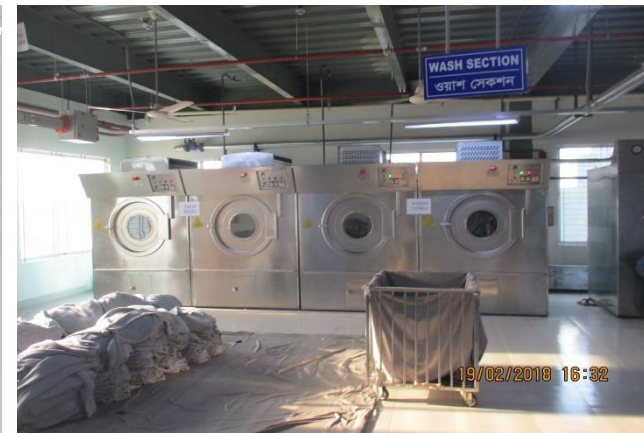
1<sup>st</sup> floor washing area

Load was measured below 2Kpa on every floor and FOS calculation for internal column was found satisfactory considering 3kPa allowable floor live loading.

Factory engineer prepared a load plan for 1<sup>st</sup> to 3<sup>rd</sup> floor considering 5 kPa as allowable load and 3Kpa for 4<sup>th</sup> floor dining area. Factory is required to verify the load plan by ACCORD if factory management intends to maintain the load plan.

Factory is required to maintain the floor live load 3 kPa until further verification by ACCORD.

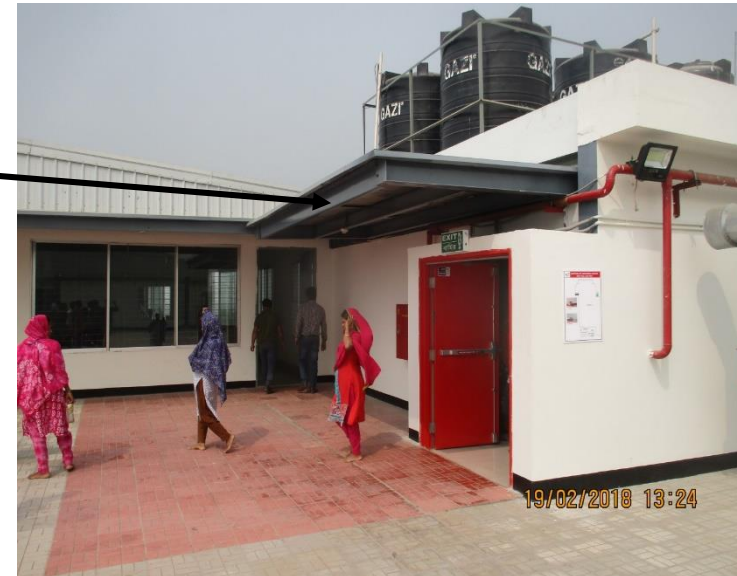
Extended canopy in front of the stair case did not shown in drawing

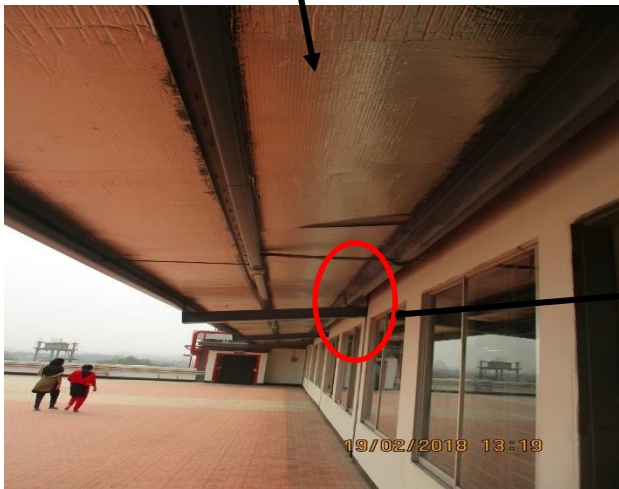
Extended beam of roof top shed was shown as CR-201 section but detail of the beam was not available

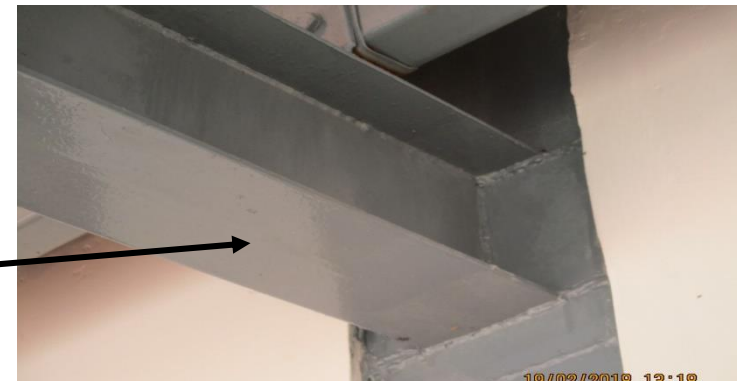
The extended beam is welded with the steel column

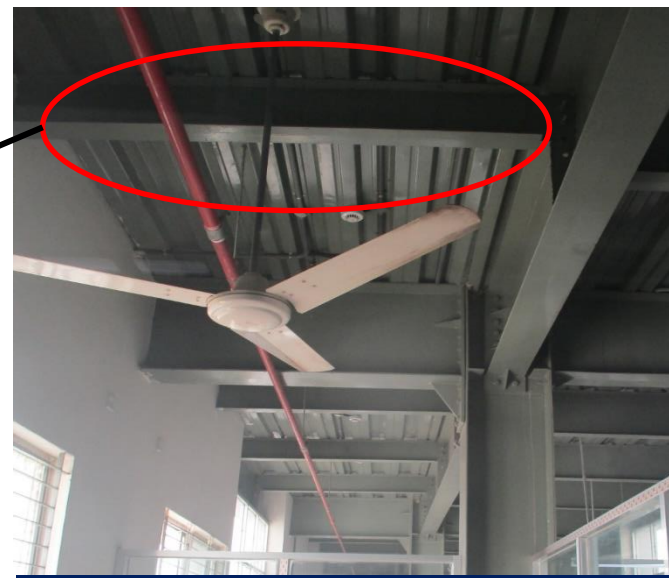
Detail of SB-3 type sub-beam was absent in drawing

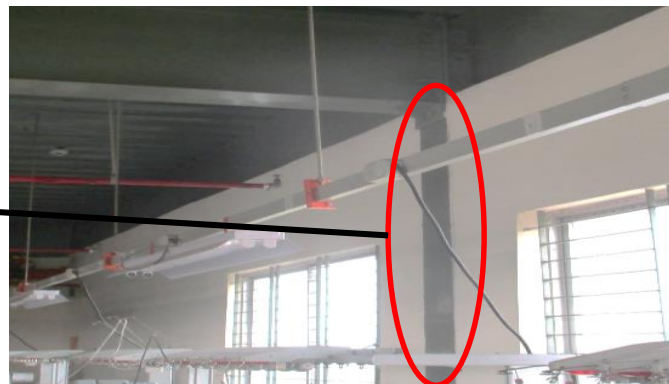
On south side, some non load bearing steel strut was observed and no detail was found in drawing

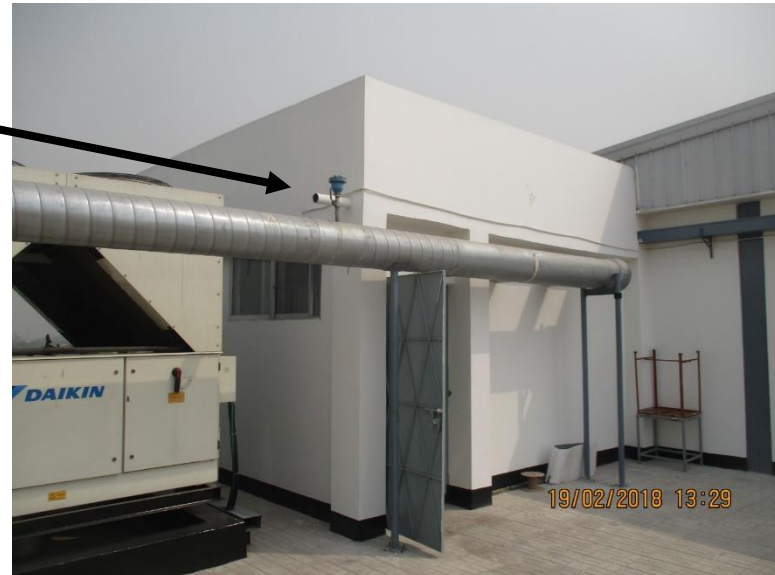
The undocumented lightweight shed

The support condition of roof top shed was vulnerable and non engineered due to poor detailing. The stability system is required to be verified under lateral loads.

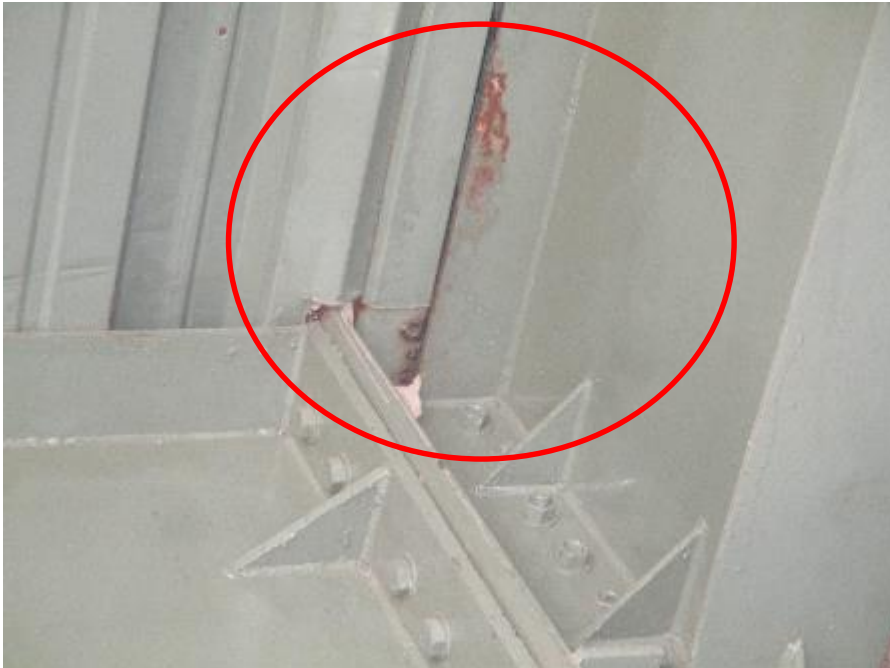
Corrosion observed at main beam under deck slab.

Corrosion was observed on steel beam and columns on different locations of 1st and 2nd floor areas. Factory is required to identify the corroded locations and take proper remedial measures.

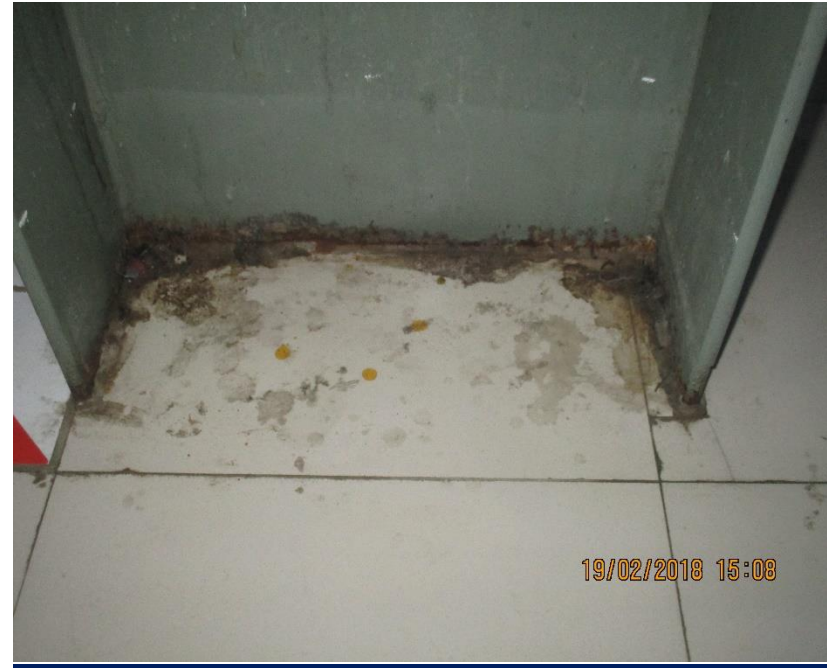
Corrosion was observed at joint of deck slab and steel column of 2nd floor production areas.

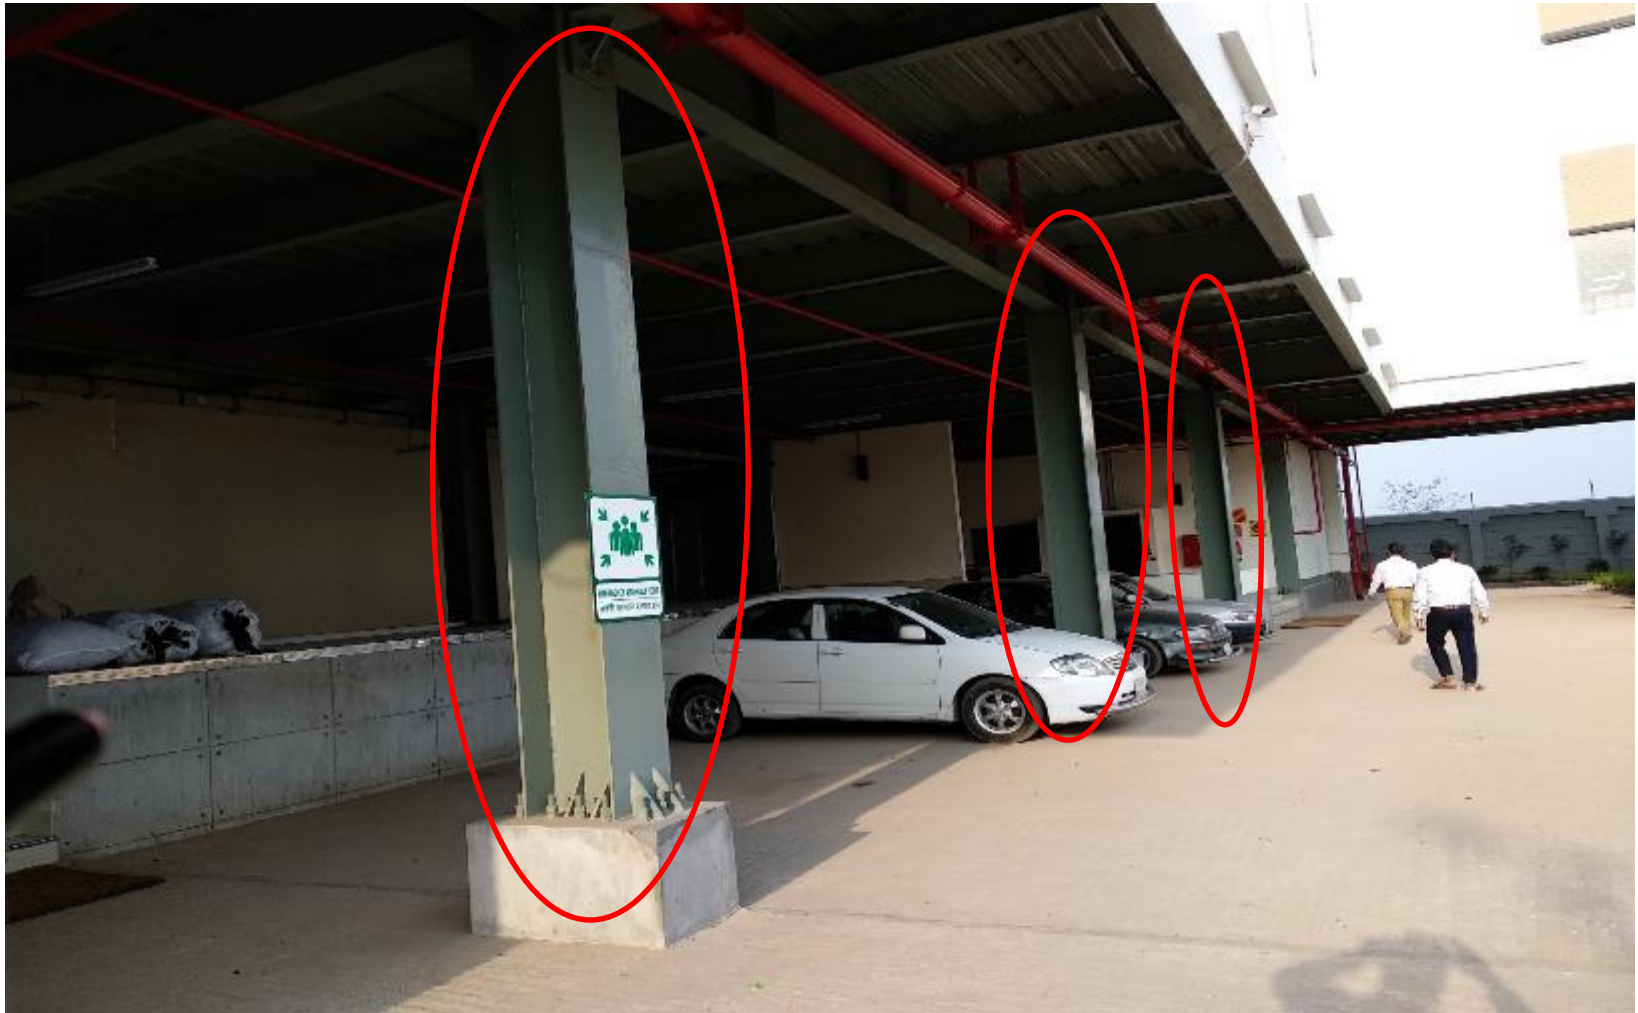
The highlighted columns are susceptible to vehicle impact. Factory is required to take necessary steps to protect the columns from vehicle impact.

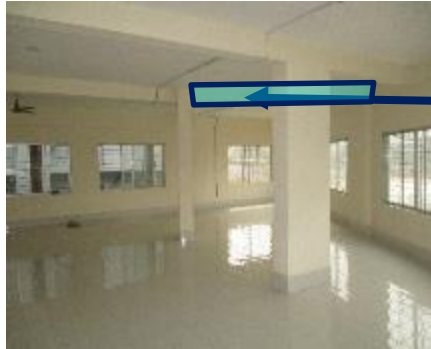
Beam found on the marked location

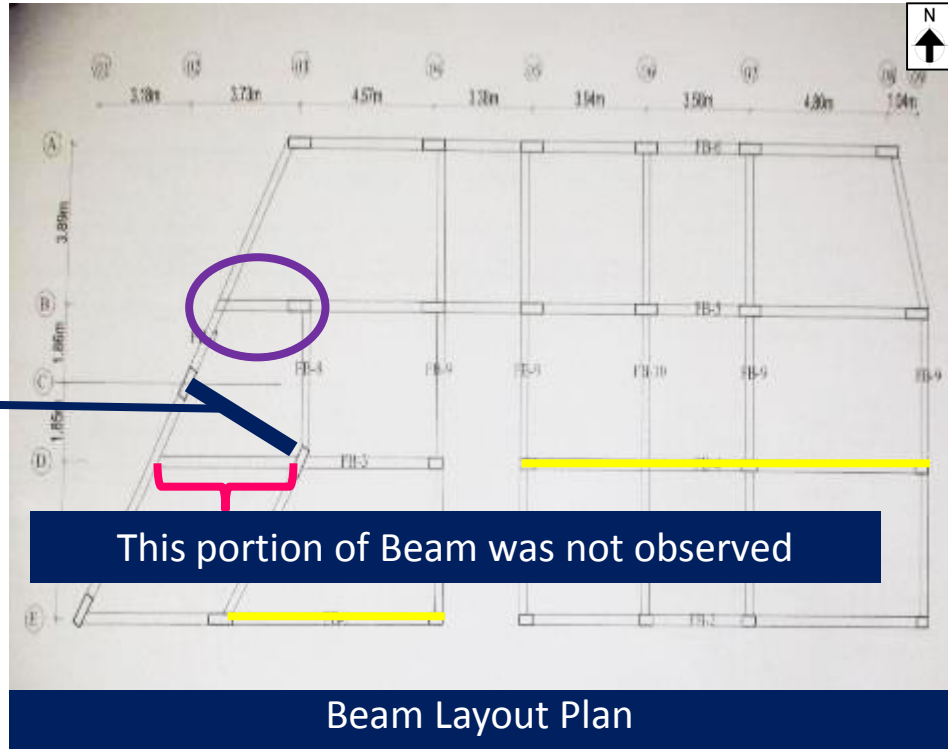
This portion of Beam was not observed

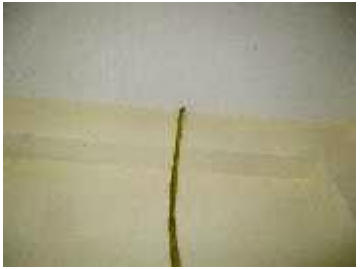
Down stand observed 250 mm instead of 325 mm

During inspection, Down stand of the all the beams (except the mentioned) was observed 250 mm instead of 325 mm. Factory is required to revise As – Built drawing as per actual condition.

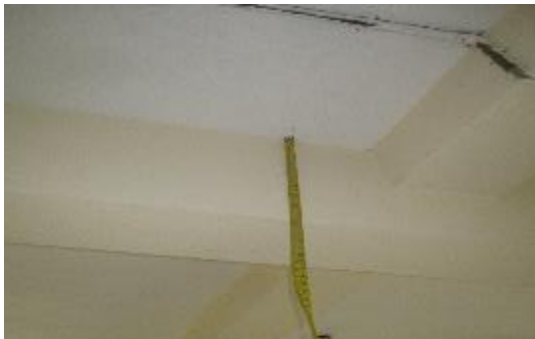
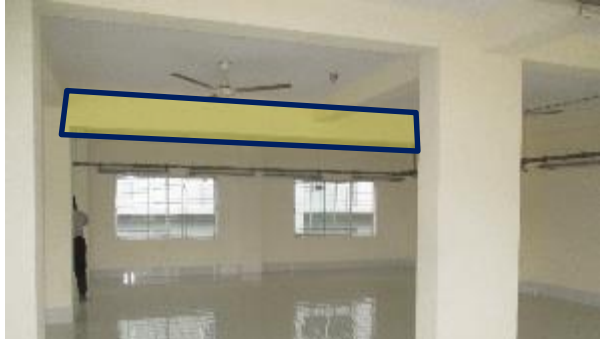
Down Stand of the highlighted (yellow marked) beam was observed 450 mm instead of 325 mm on GF and 1st Floor

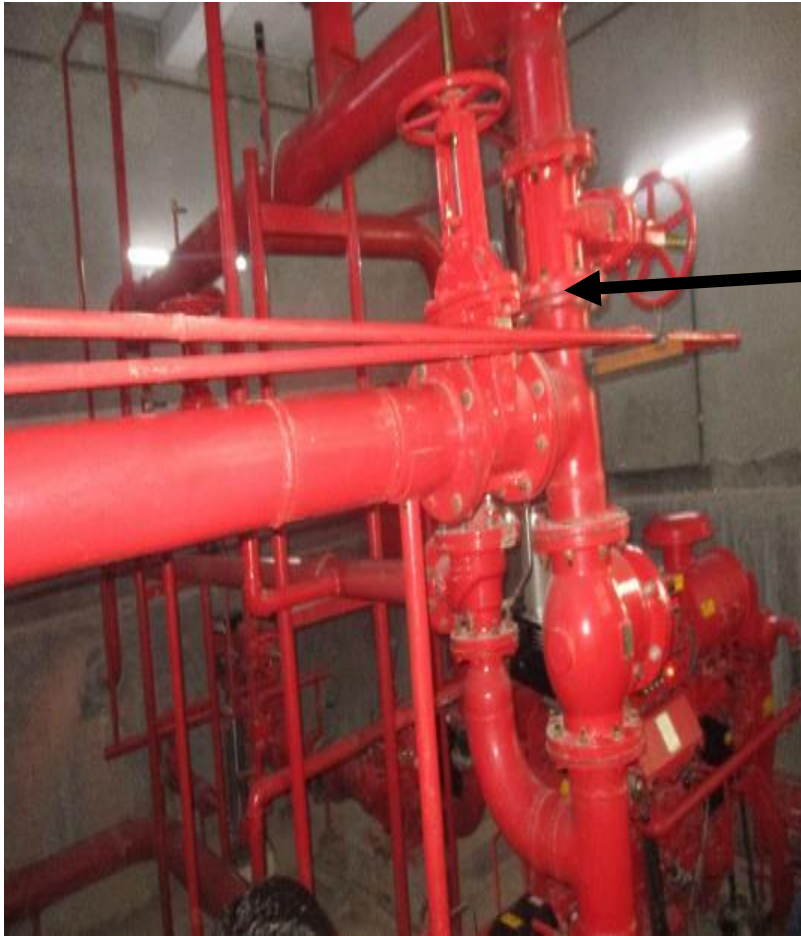
Pump Room below Ground Floor

During inspection, a pump room was observed on the marked position below ground floor level of the utility Building which was not included in As-Built drawing. Factory is required to update the As-Built drawing as per actual condition.

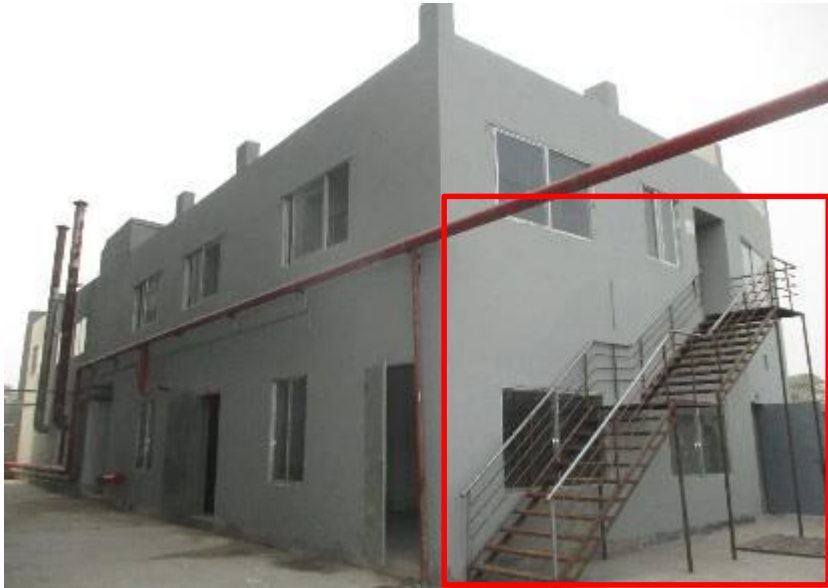
Steel Stair outside of the utility building

The support condition of the steel stair at the east side of the utility Building was appeared to be non-engineered due to poor implementation of connection and slender steel column support. Factory is required to replace the steel stair with a engineered steel stair.

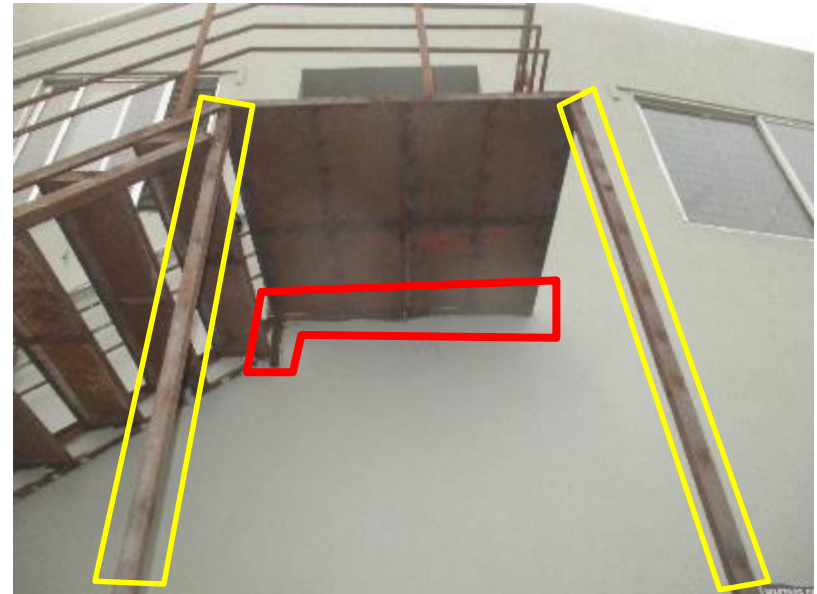
Non- engineered connections and slender columns

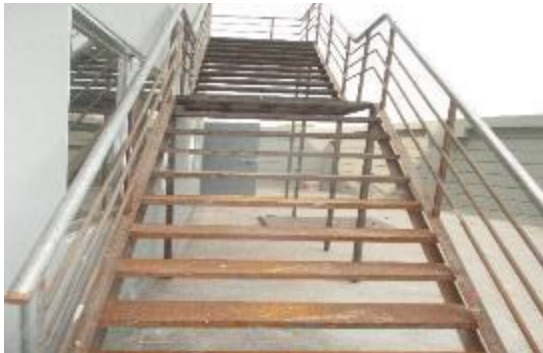
Corrosion observed on the stair

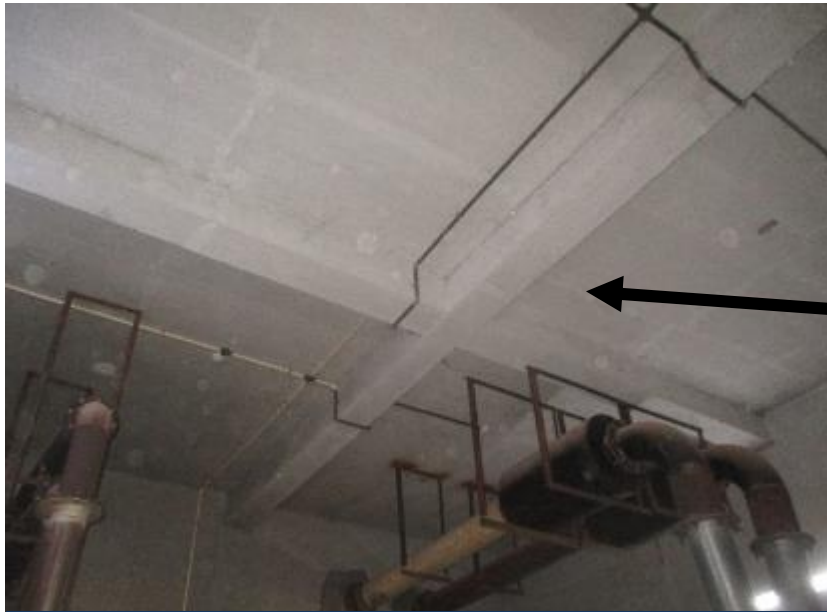
Structural System of Generator room

Down stand of the roof beam on generator room was observed 300 mm instead of 475 mm. Factory is required to revise the As-Built drawing as per actual condition.

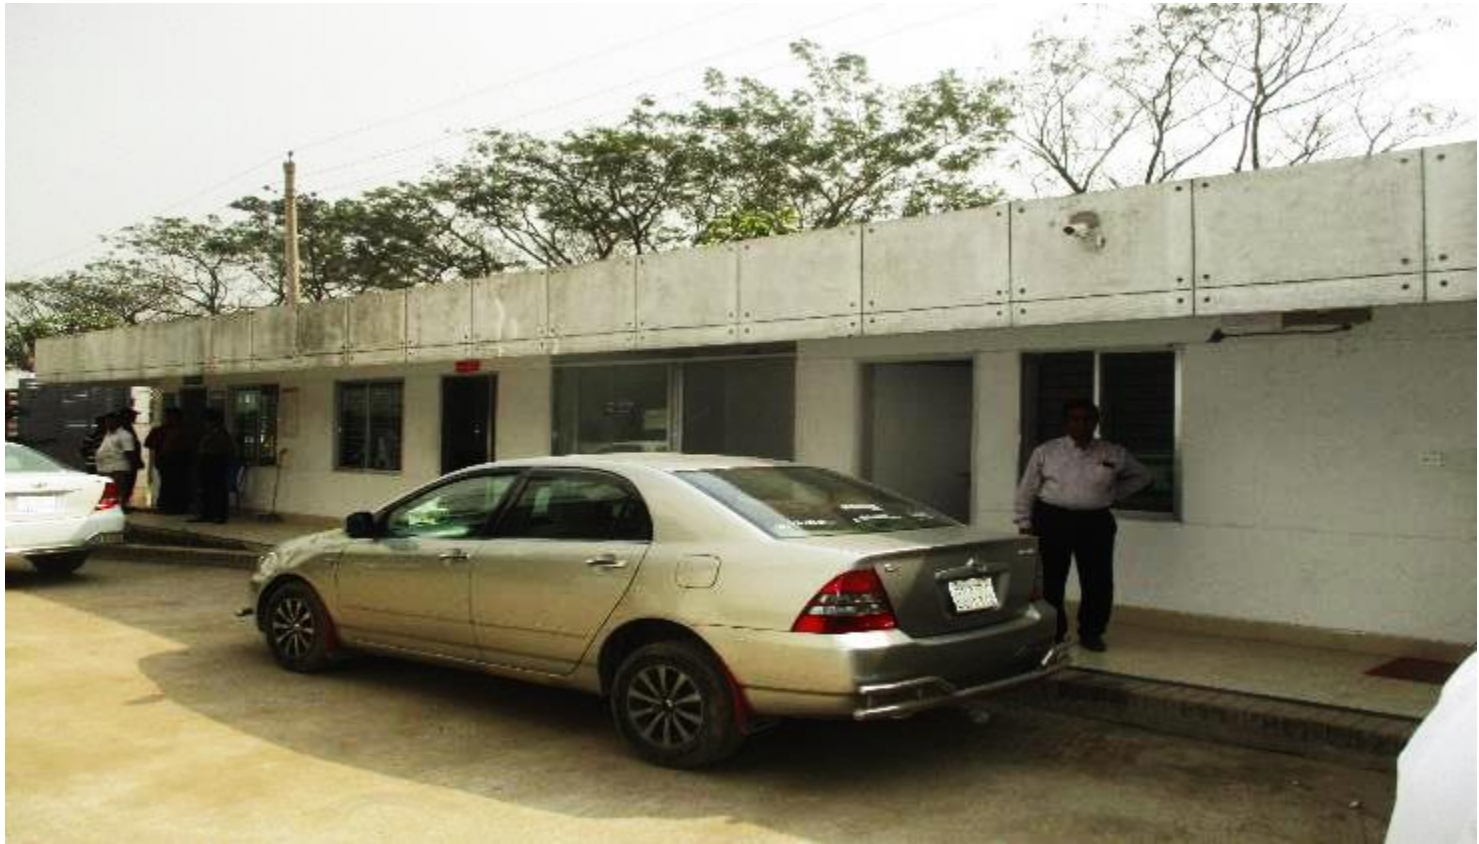
No as-built drawing was observed for the security Building. Factory is required to produce as-built drawing which reflects the actual condition.

13	(Security Building) Lack of as-built drawing	Factory required to produce As Built drawings which reflect the actual condition.	6-weeks
