# Radial International Ltd. Array International Ltd.

Zirani Bazar, Kashmirpur, Gazipur Sadar.  
(23.997823, 90.254950)  
20<sup>th</sup> April 2014

# Observations

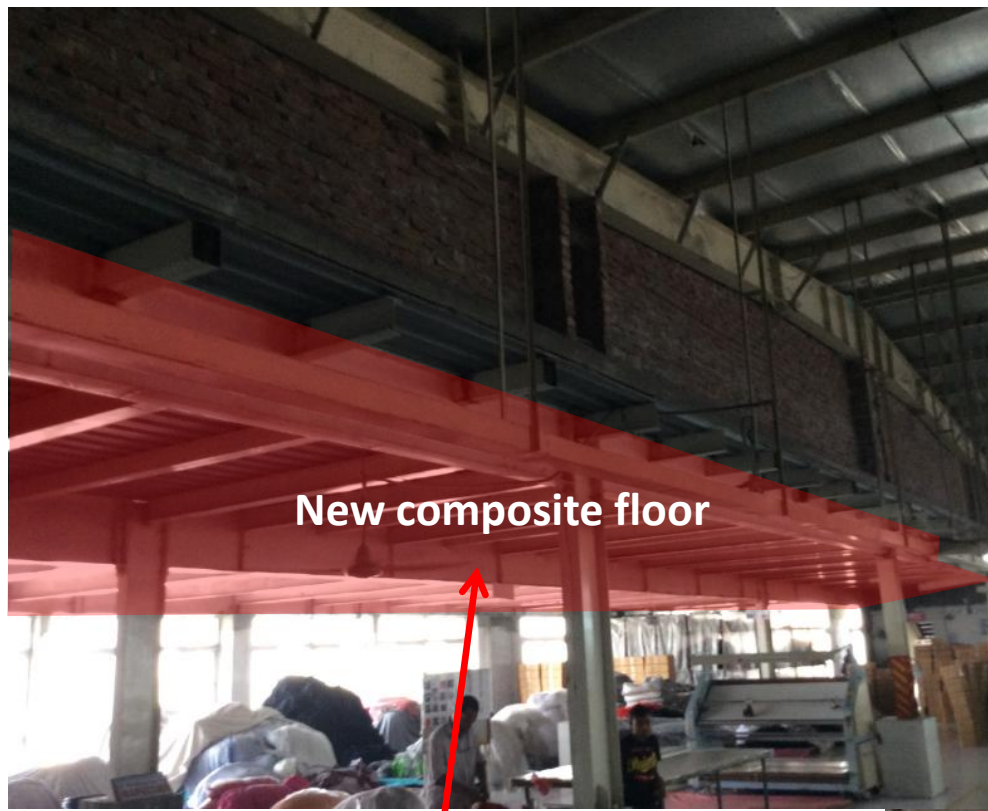
**New composite floor**

**Changes have been made to the structure with part of the portal frame removed and replaced with a composite deck for fire safety reasons. This modification has removed an entire bay of roof bracing.**

**Some bracing elements are slack and should be tightened to ensure they are functioning properly.**

| Item No. | Observation | Recommended Action Plan | Recommended Timeline |
|---|---|---|---|
| 6 | Main Building Steel Roof Structures over Fifth Floor | Diagonal bracing, removed to construct new concrete flat roof, to be replaced | 6-weeks |
| 8 | Main Building Steel Roof Structures over Fifth Floor | Tension in all cross-bracing to be restored | 6-weeks |

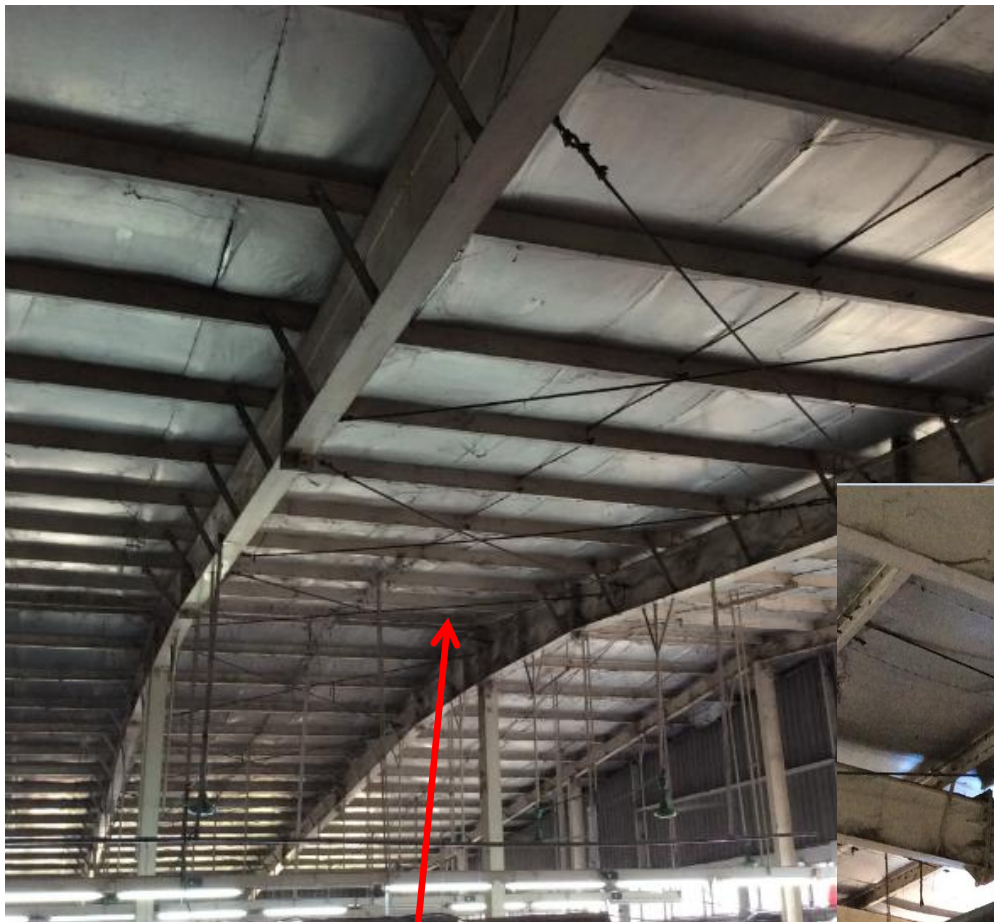
**Bracing in steel roof for lateral restraint.**

**Bracing elements missing on elevation both sides (north and south).**

| Item No. | Observation | Recommended Action Plan | Recommended Timeline |
|---|---|---|---|
| 7 | Main Building Steel Roof Structures over Fifth Floor | Missing diagonal bracing (walls and roof) to be installed | 6-weeks |

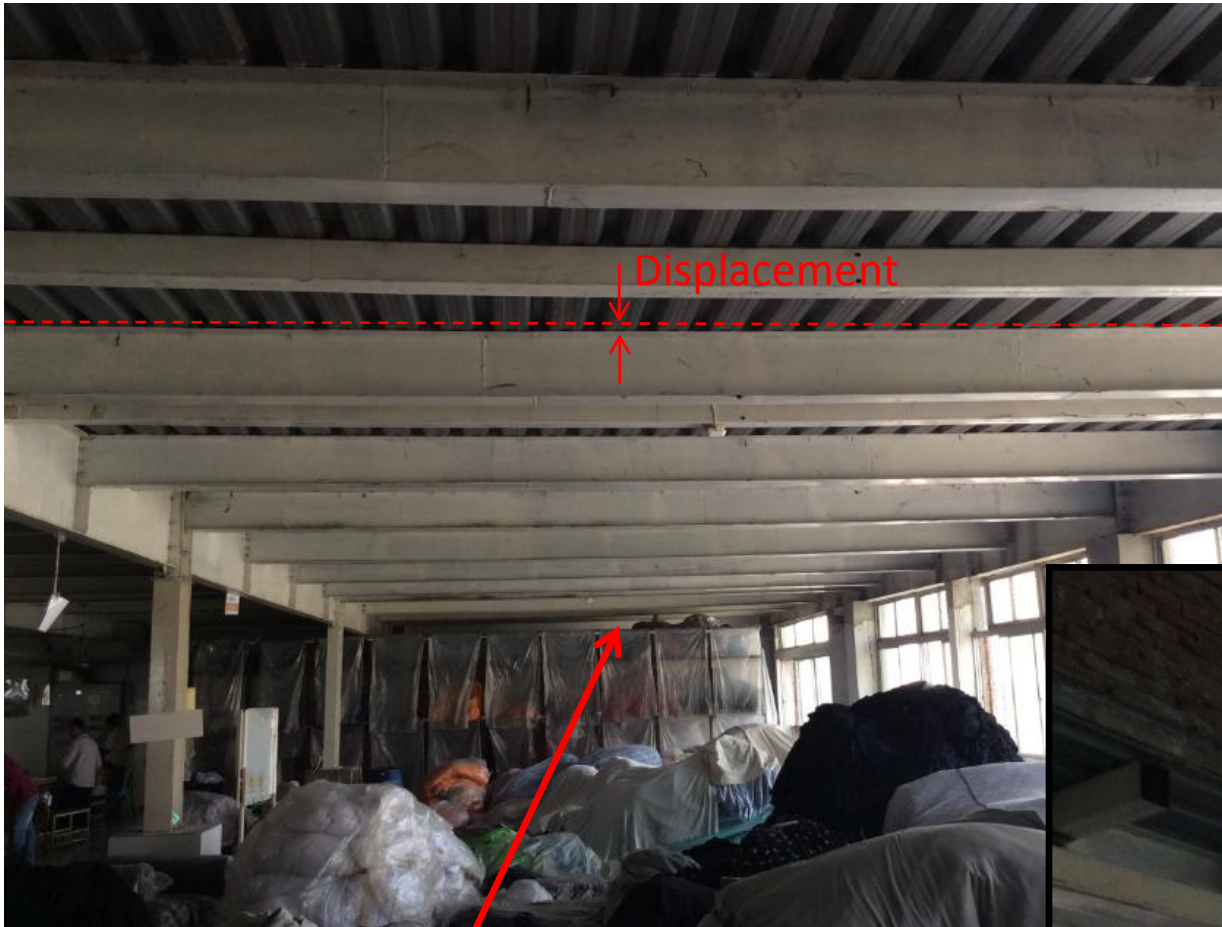
Displacement

Deck is constructed from a mixture of welded box/channel sections and I-Sections.

New composite deck above the 5<sup>th</sup> Floor appears to be deflecting slightly.

| Item No. | Observation | Recommended Action Plan | Recommended Timeline |
|---|---|---|---|
| 4 | Main Building Steel Roof Structures over Fifth Floor | Slight sagging in beams under new concrete roof (West side) to be assessed | Immediate - Now |

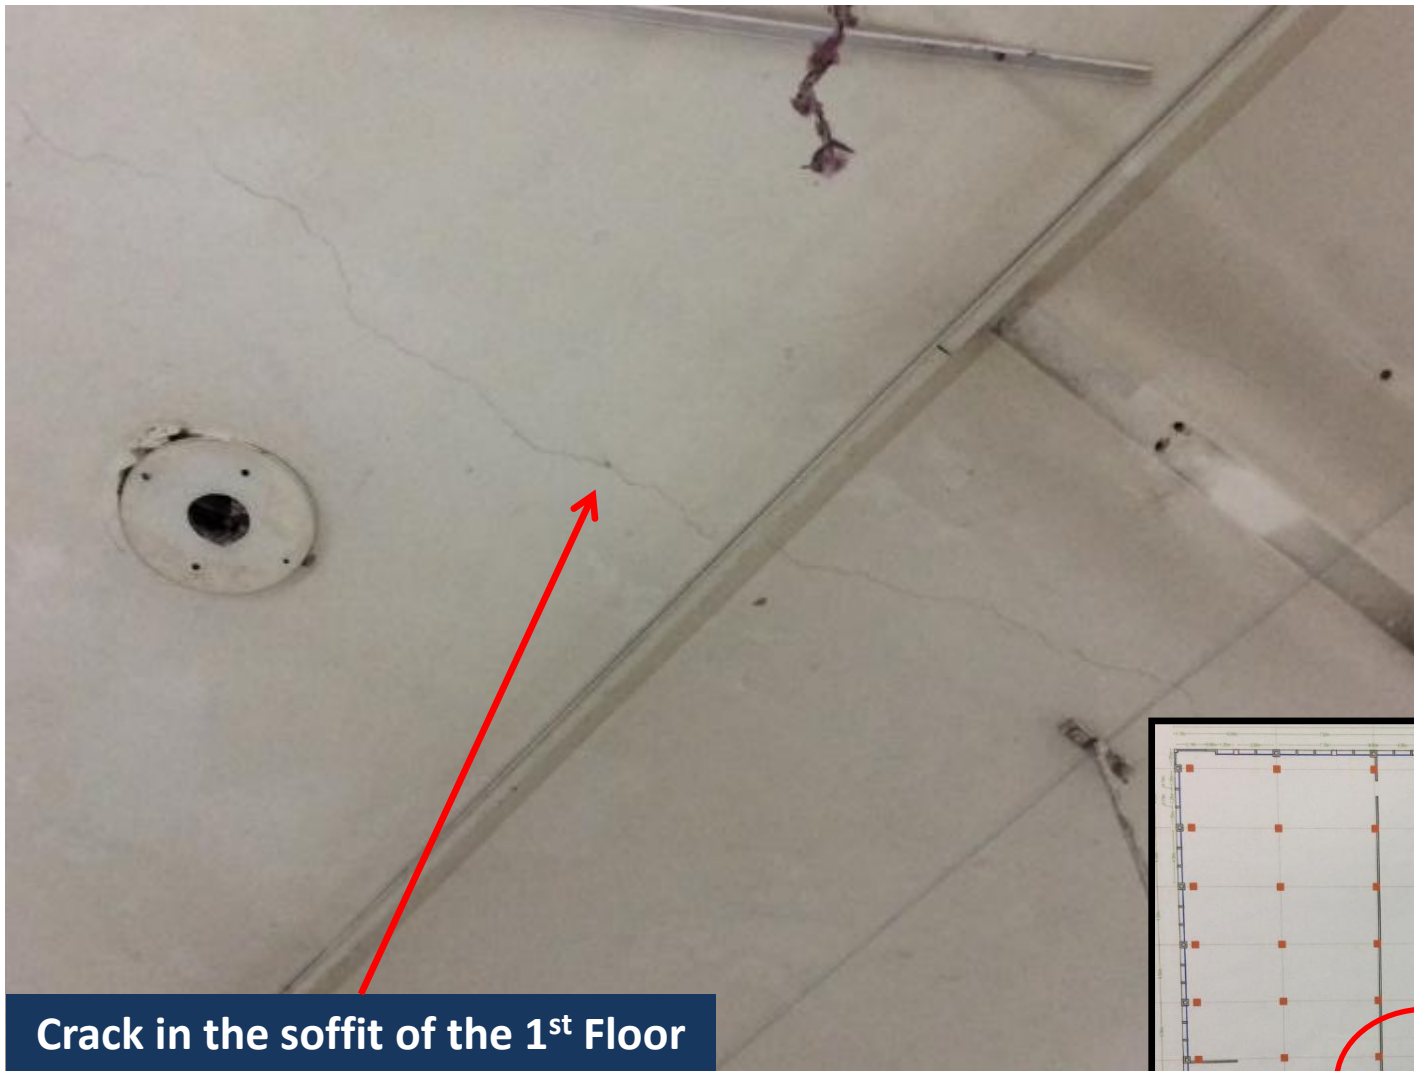
**Crack in the soffit of the 1<sup>st</sup> Floor**

| Item No. | Observation | Recommended Action Plan | Recommended Timeline |
|---|---|---|---|
| 11 | Cracking to the soffit of 1st Floor in Main Production Building | Sections of plaster finish to the soffit of the 1st floor of the Main Production Building to be removed to investigate if cracks are reflected in the building structure. | 6-weeks |
| 12 | Cracking to the soffit of 1st Floor in Main Production Building | Building Engineer to carry out design check on the slab to confirm that these cracks are within normal structural behaviour | 6-weeks |
| 13 | Cracking to the soffit of 1st Floor in Main Production Building | Strengthening measures installed if required. | 6-months |

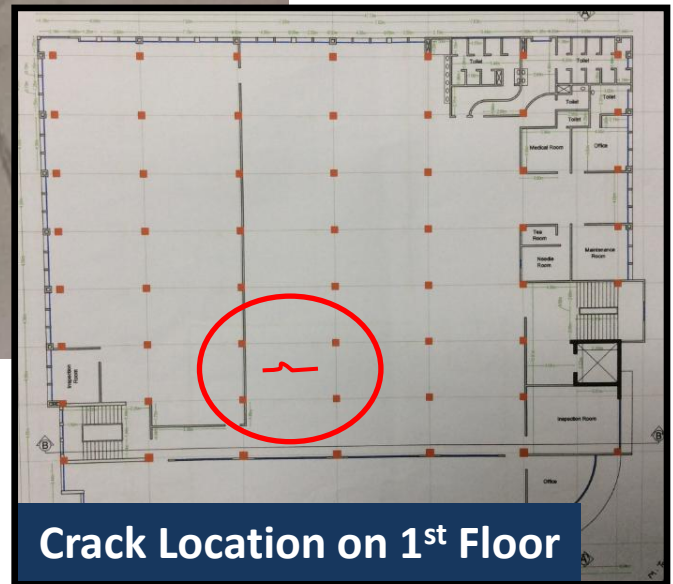
**Crack Location on 1<sup>st</sup> Floor**

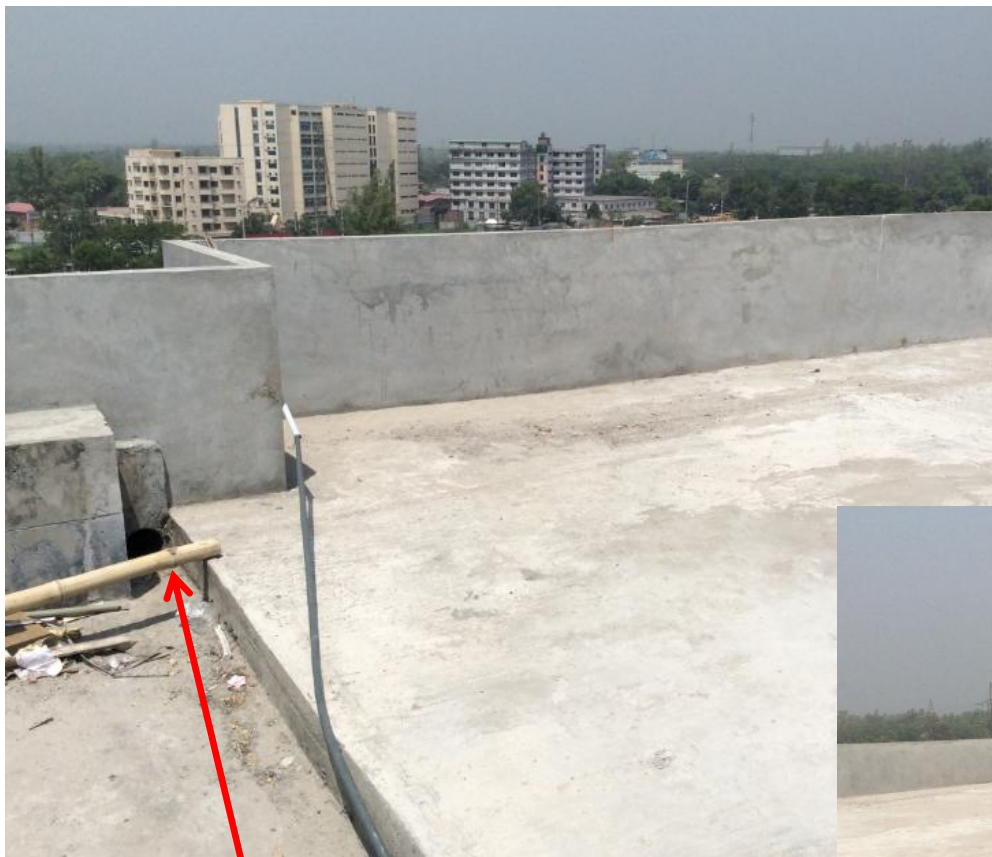
**No other drainage routes provided to the roof.  
New concrete parapet walls.**

**Only one drainage route on the roof to let water escape.  
Surrounding debris can block this one route and can cause an accumulation of water in a severe weather event.**

| Item No. | Observation | Recommended Action Plan | Recommended Timeline |
|---|---|---|---|
| 14 | Drainage to flat roof of Main Production Building. | Clear all rubbish and building materials from roof area | Immediate - Now |
| 16 | Drainage to flat roof of Main Production Building. | Install additional rainwater outlets from roof to ensure no build-up of water is possible, which could potentially overload the structure | 6-weeks |

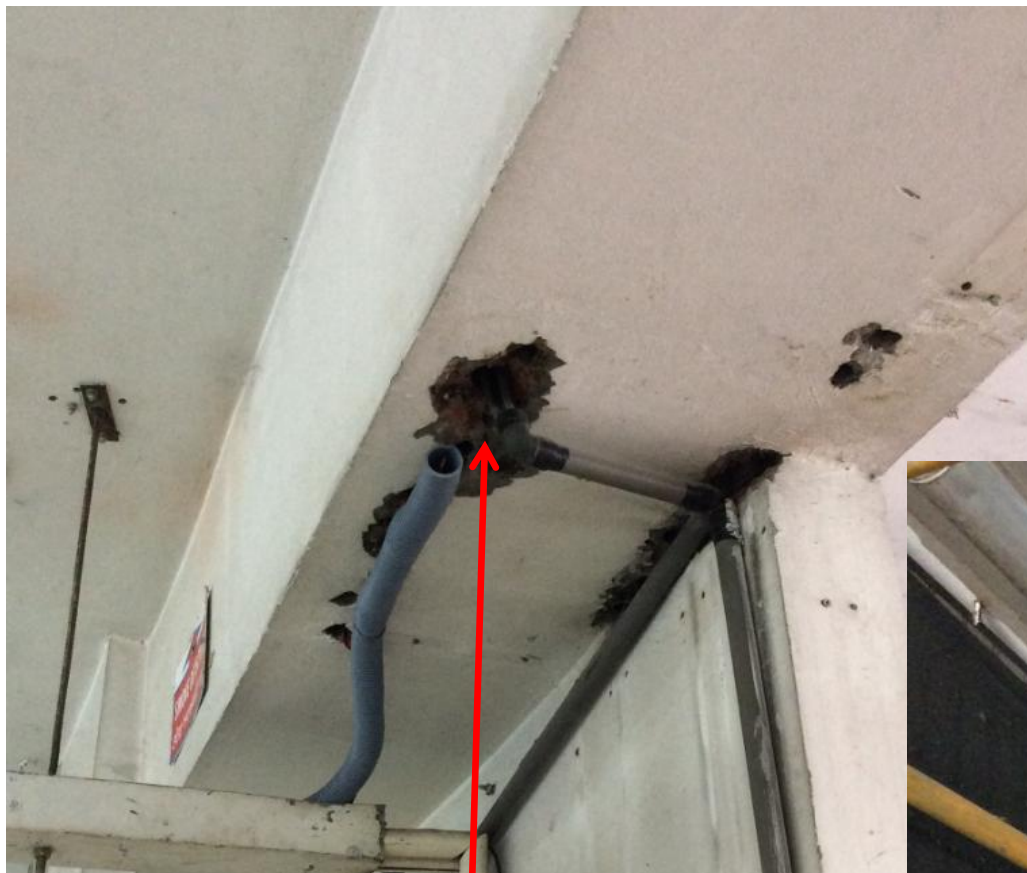
**New service opening broken in slab at toilet block to allow for pipes to pass through. Not good practice but has not compromised strength here.**

**New service openings broken/drilled in beams to allow electric cables to pass through. Not good practice but has not compromised strength here.**

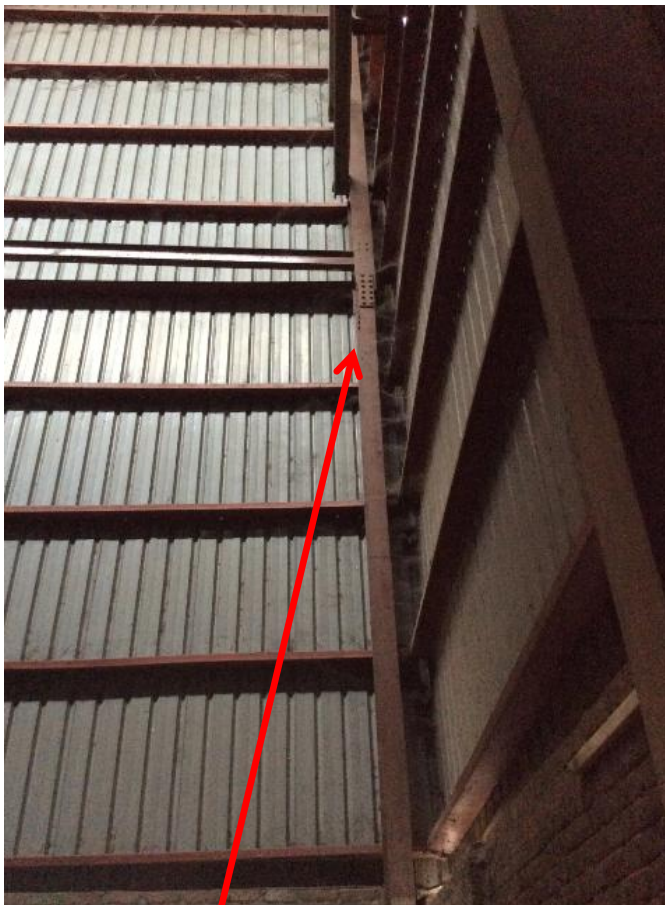
**Boiler house columns are larger section at higher levels than at lower levels. Bolted connection at mid-height is poorly aligned.**

**Boiler house steel structure is tall without the benefit of floors or effective bracing.**

| Item No. | Observation | Recommended Action Plan | Recommended Timeline |
|---|---|---|---|
| 18 | Single-Storey Buildings: Boiler House Steelwork | Full survey and structural analysis of the Boiler House steel structure to be carried out by the Factory Building Engineer to assess section sizes, connection details and lateral stability. | <b>Immediate - Now</b> |
| 19 | Single-Storey Buildings: Boiler House Steelwork | Additional steelwork and strengthening measures to be designed by the Factory Building Engineer. | <b>6-weeks</b> |
| 20 | Single-Storey Buildings: Boiler House Steelwork | Strengthening works to be implemented before the cyclone season to ensure the building is laterally stable against wind loads. | <b>6-months</b> |

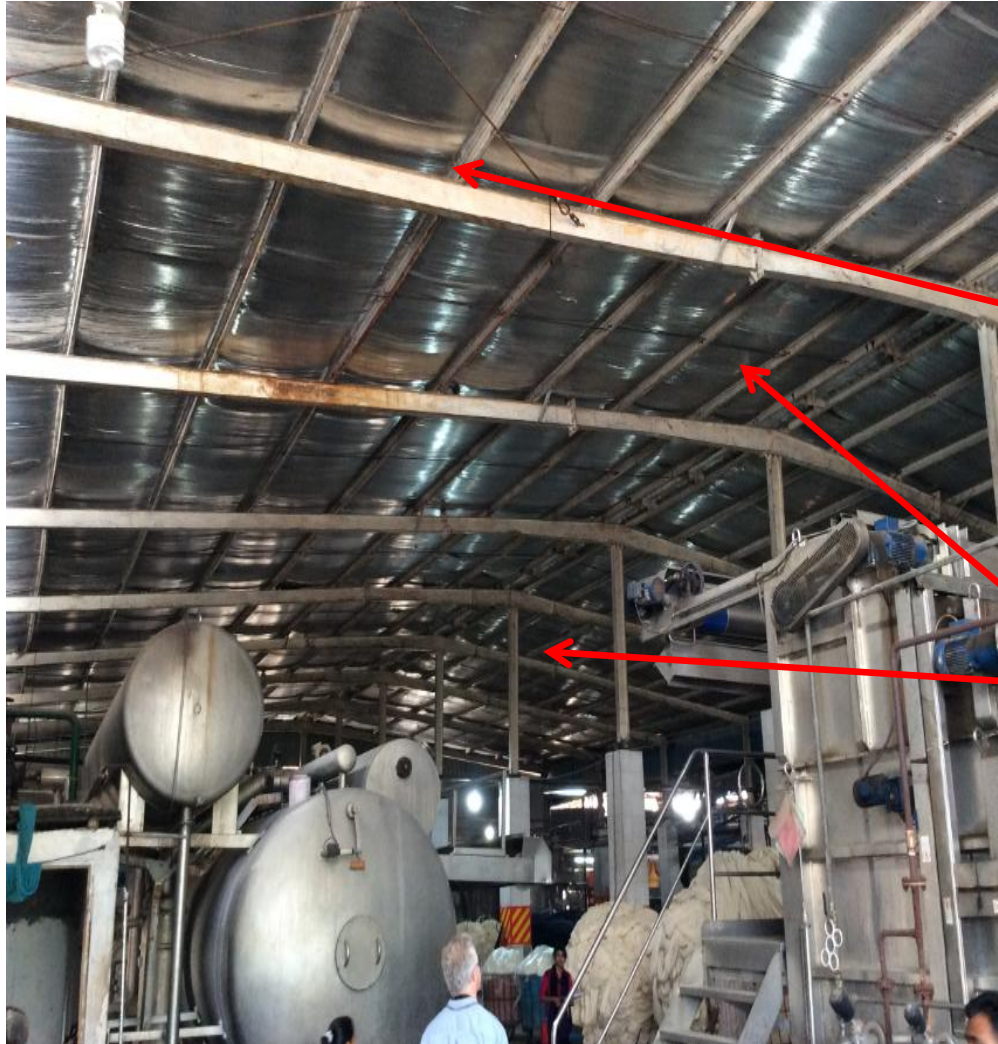
The steel sections in the portal frame in the dyeing shed appear extremely lightweight for the large span.

No lateral stability cross-bracing observed in roof structure of the portal frame in Dyeing shed.

| Item No. | Observation | Recommended Action Plan | Recommended Timeline |
|---|---|---|---|
| 21 | Single-Storey Buildings: Dyeing Shed Steelwork Roof | Full survey and structural analysis of the Dyeing Shed roof steel structures to be carried out by the Factory Building Engineer to assess section sizes, connection details and lateral stability. | <b>Immediate - Now</b> |
| 23 | Single-Storey Buildings: Dyeing Shed Steelwork Roof | Additional lateral stability elements to be designed by the Factory Building Engineer. | <b>6-weeks</b> |

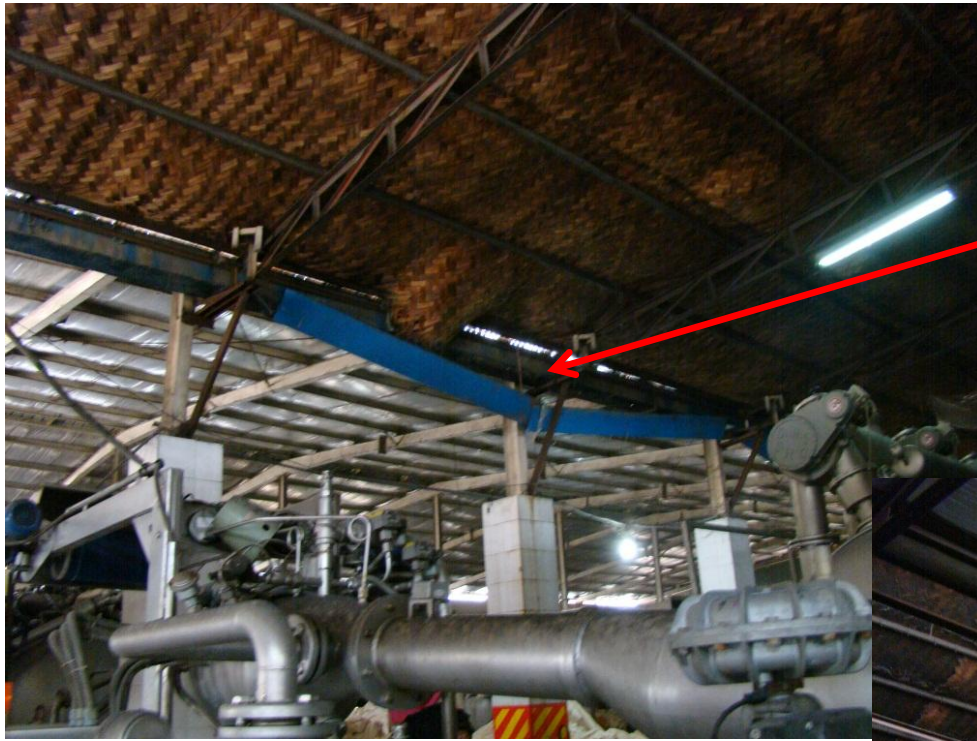
**Gutter and part roof collapse –  
Dyeing Shed**

**Lightweight steel roof over part  
of Dyeing Shed**

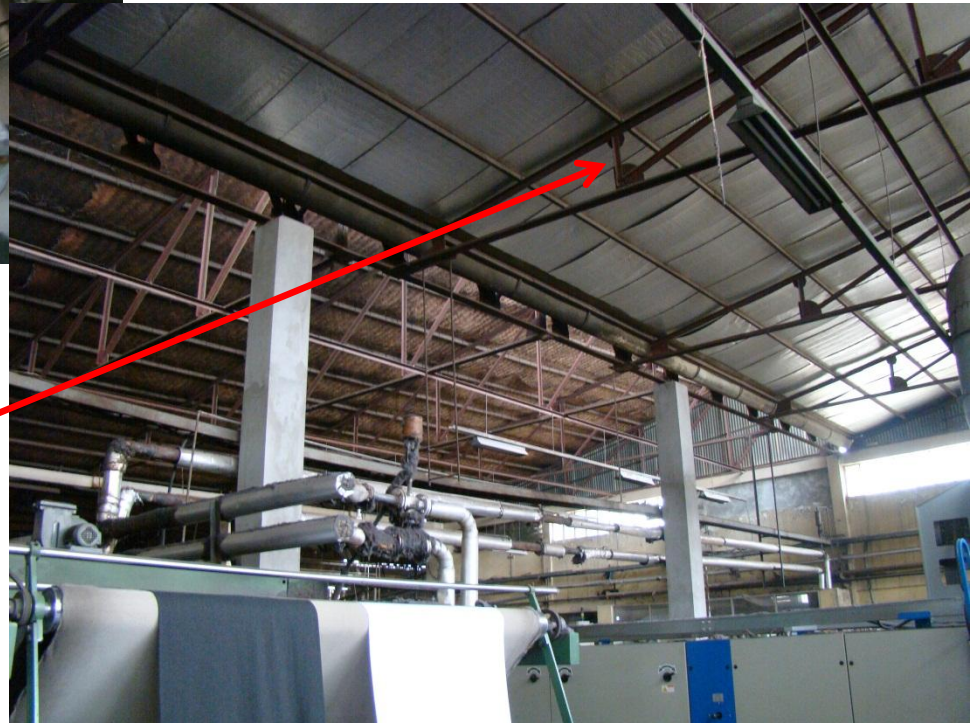
**Steel purlins in roof  
of Dyeing Shed are  
deflecting heavily.**

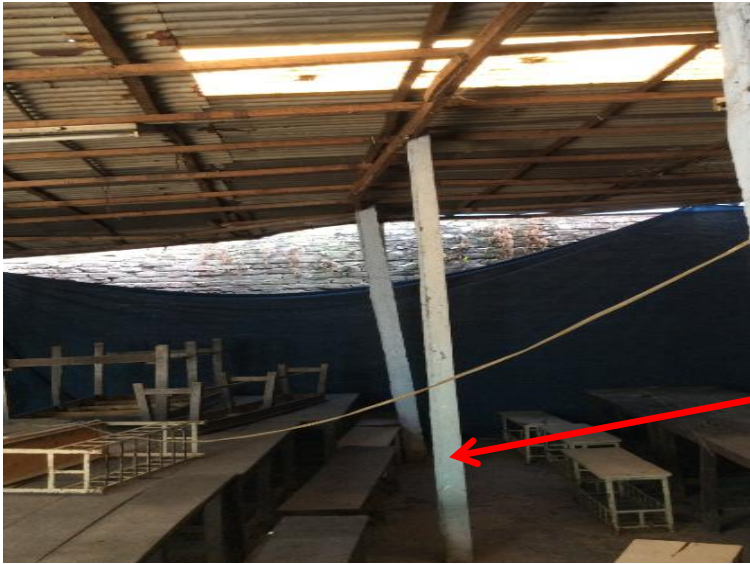
Ad-hoc  
bamboo/timber/steel roof  
on concrete posts arranged  
haphazardly over canteen  
area used by approx. 300  
workers.

| Item No. | Observation | Recommended Action Plan | Recommended Timeline |
|---|---|---|---|
| 25 | Single-Storey Buildings:<br>Dining Area Shed | Provide alternative dining accommodation which is safe and structurally sound until the existing roof structure is properly strengthened or replaced | <b>Immediate - Now</b> |
| 26 | Single-Storey Buildings:<br>Dining Area Shed | Provide a safe and structurally sound Dining Area for employees | <b>6-weeks</b> |

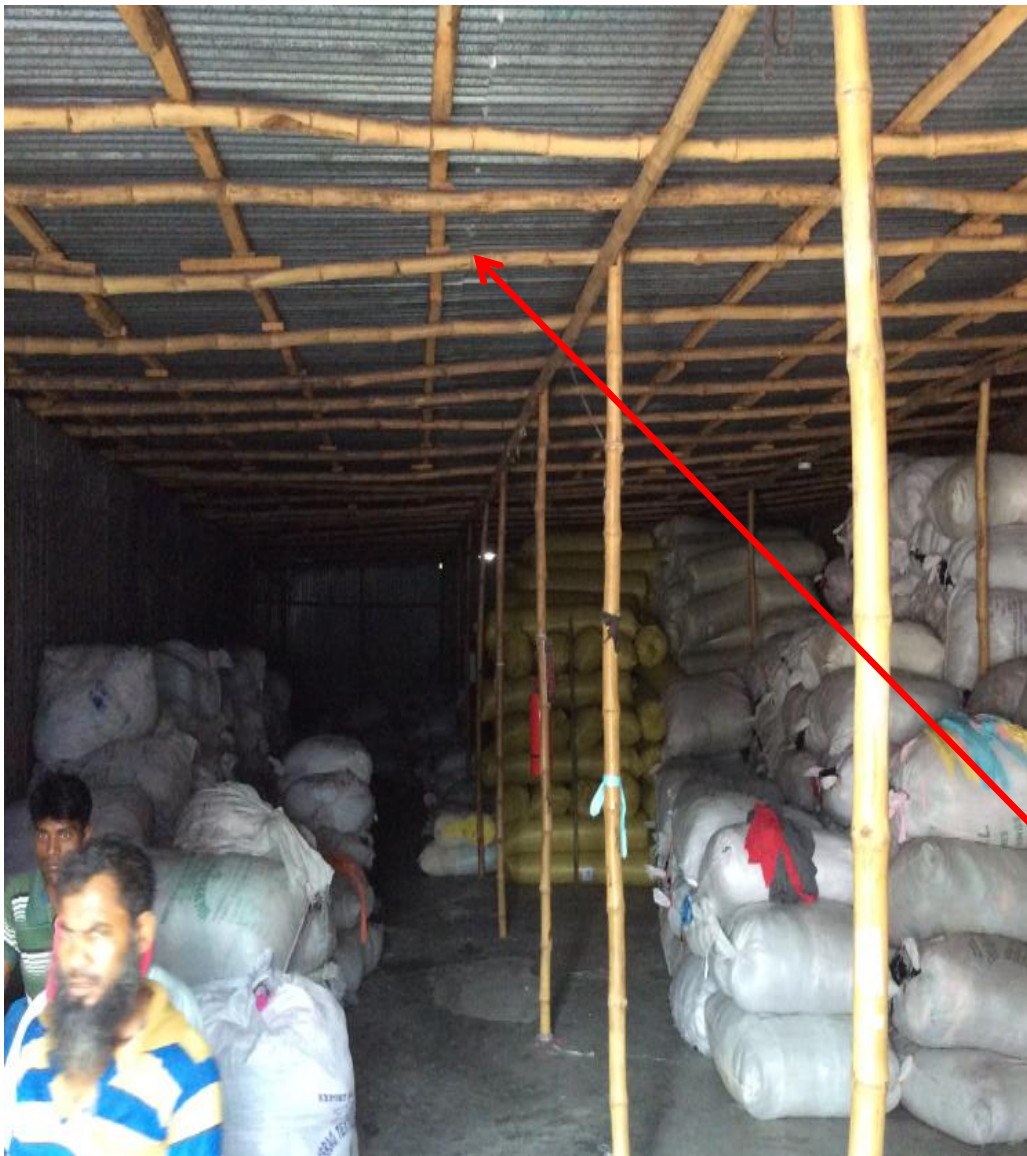
Bamboo/timber/steel/concrete used randomly and ad-hoc in single-storey miscellaneous structures. Stability of structures very questionable.

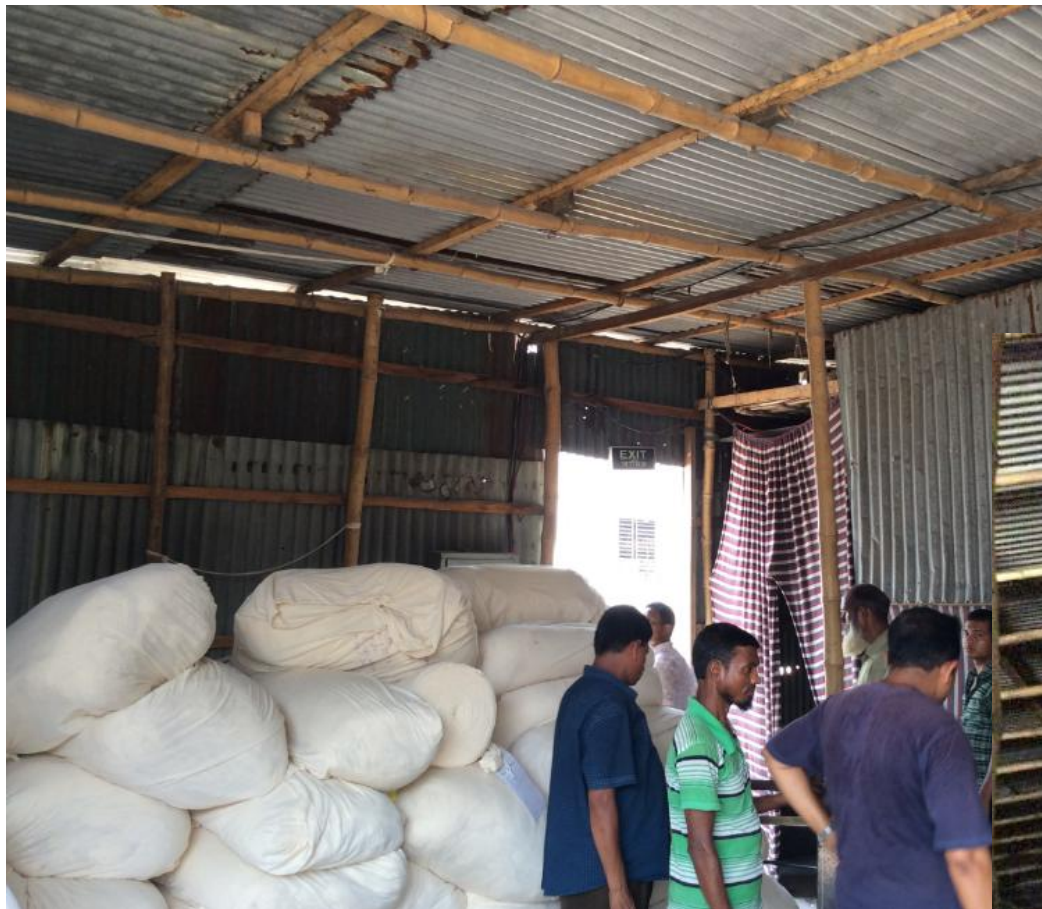
No lateral stability in the second raw material storage shed.

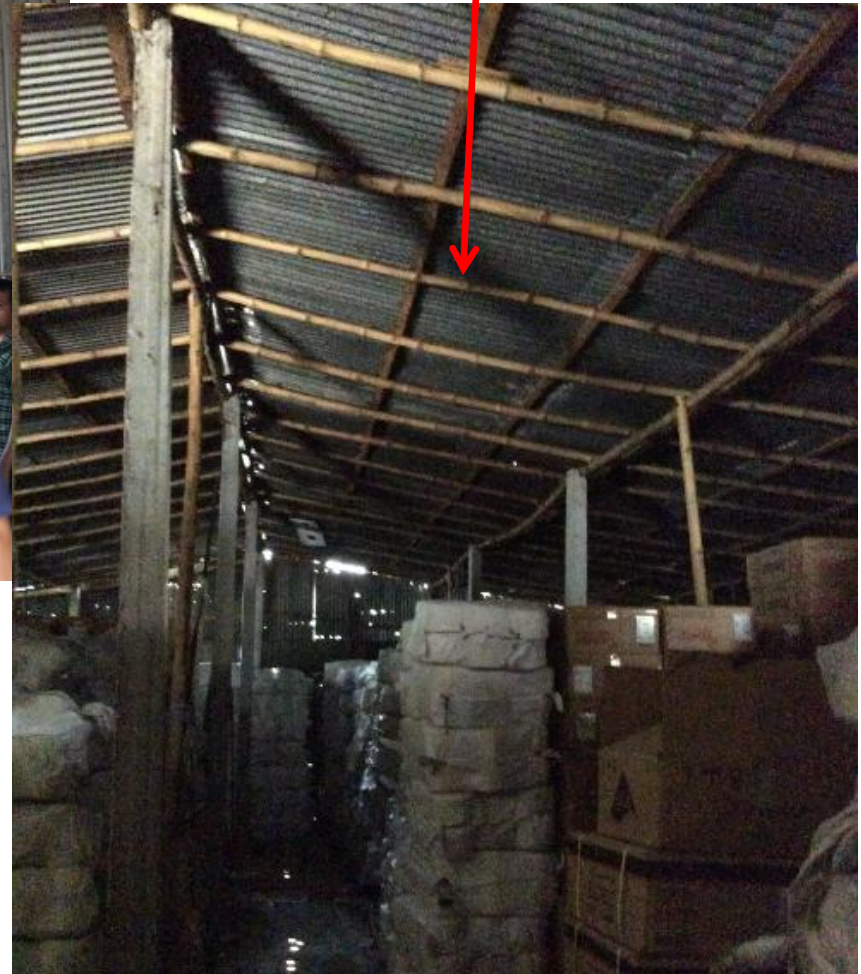
No lateral stability in both directions is a common issue across all non-engineered single-storey structures.

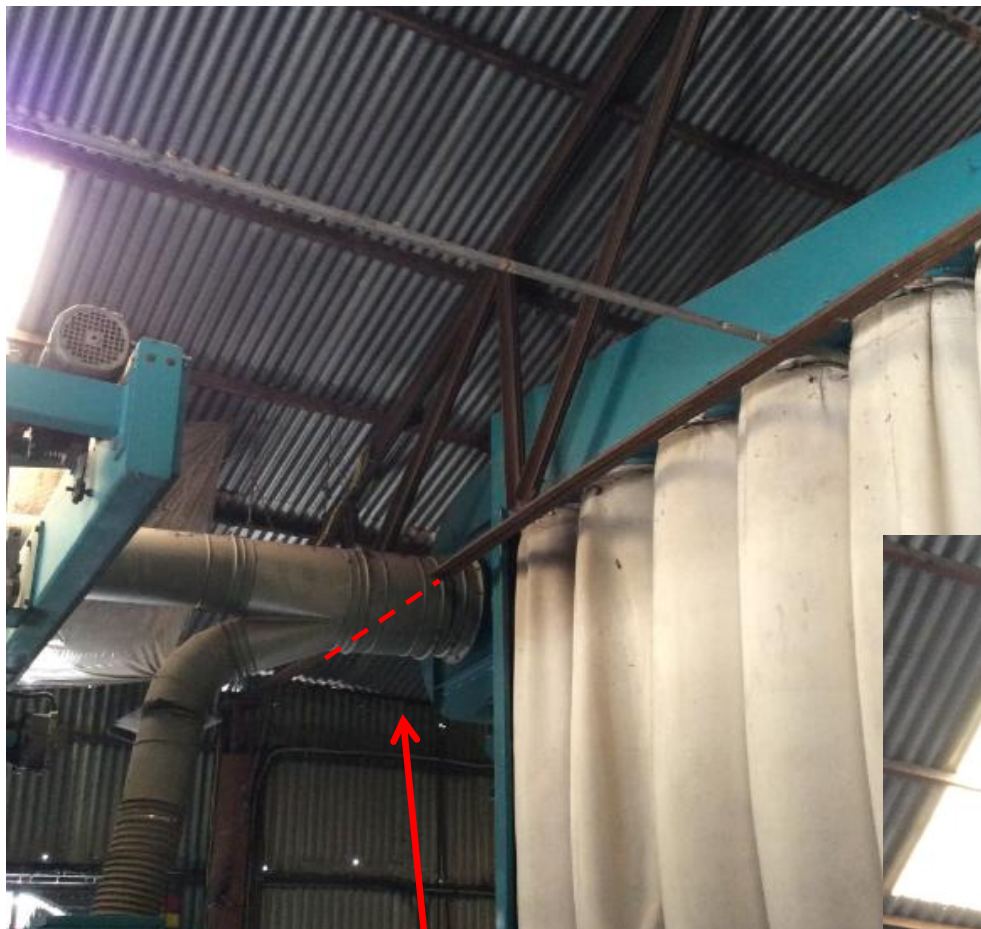
**Bottom section of truss removed to make way for machinery piping.**

**Bottom section of the truss has either been removed or has failed locally. Bamboo currently in place to support section.**

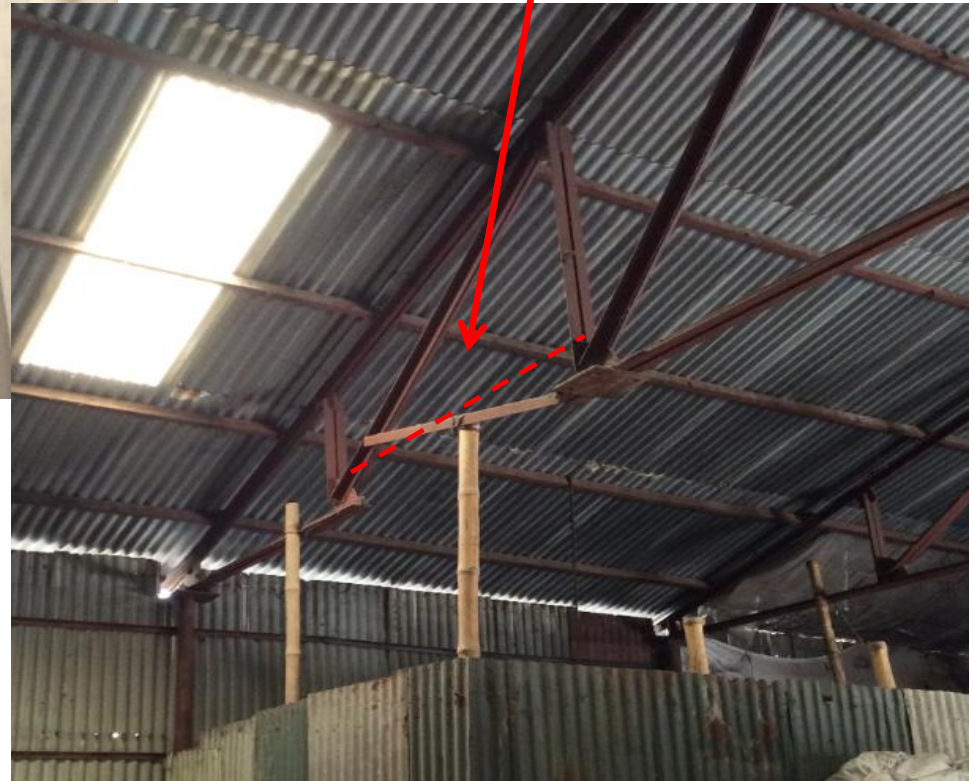
**Angle section supporting roof has either buckled or has been hit by a vehicle**

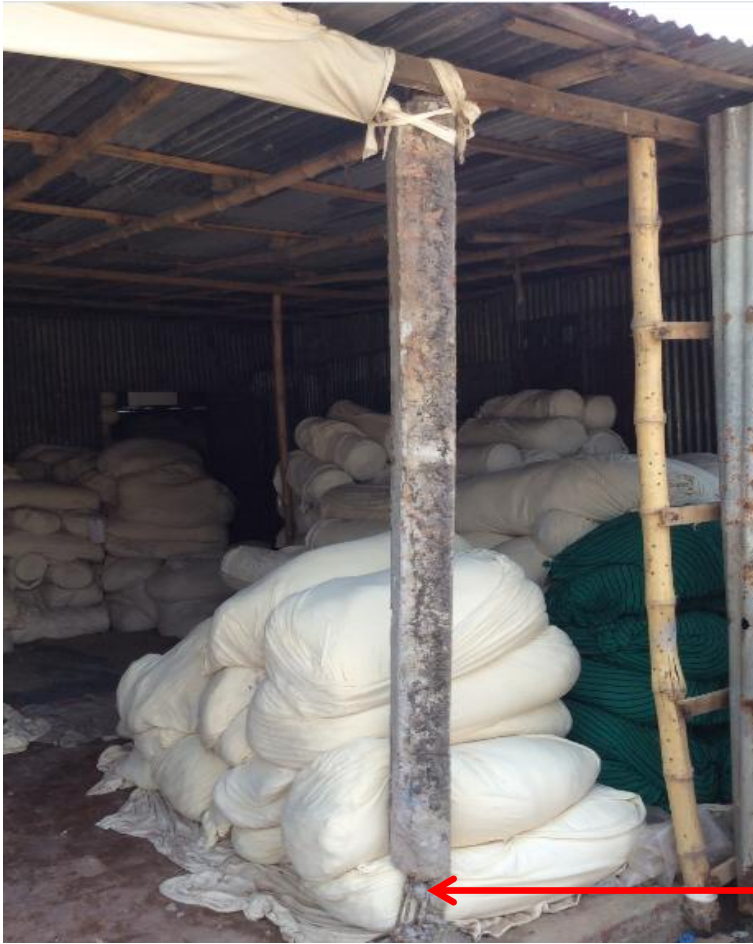
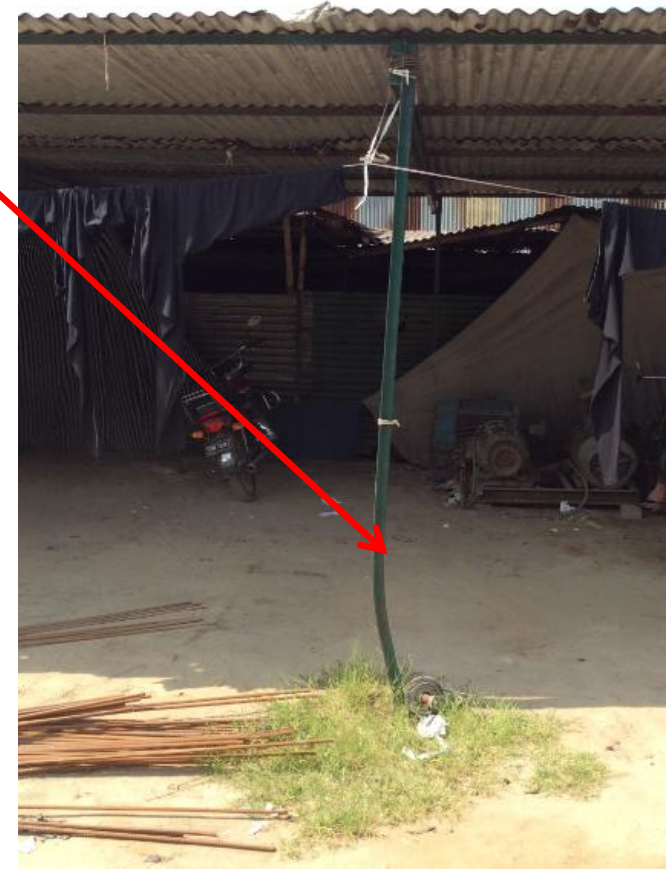
**Concrete removed at base and column base and is in danger of collapse.**
