# Windy Apparels Ltd Hollywood Garments

140, Baron, Diakhali, DEPZ Road, Ashulia, Savar, Dhaka  
(+23.936500N, 90.29647222E)

24 September 2013

# Building Observations

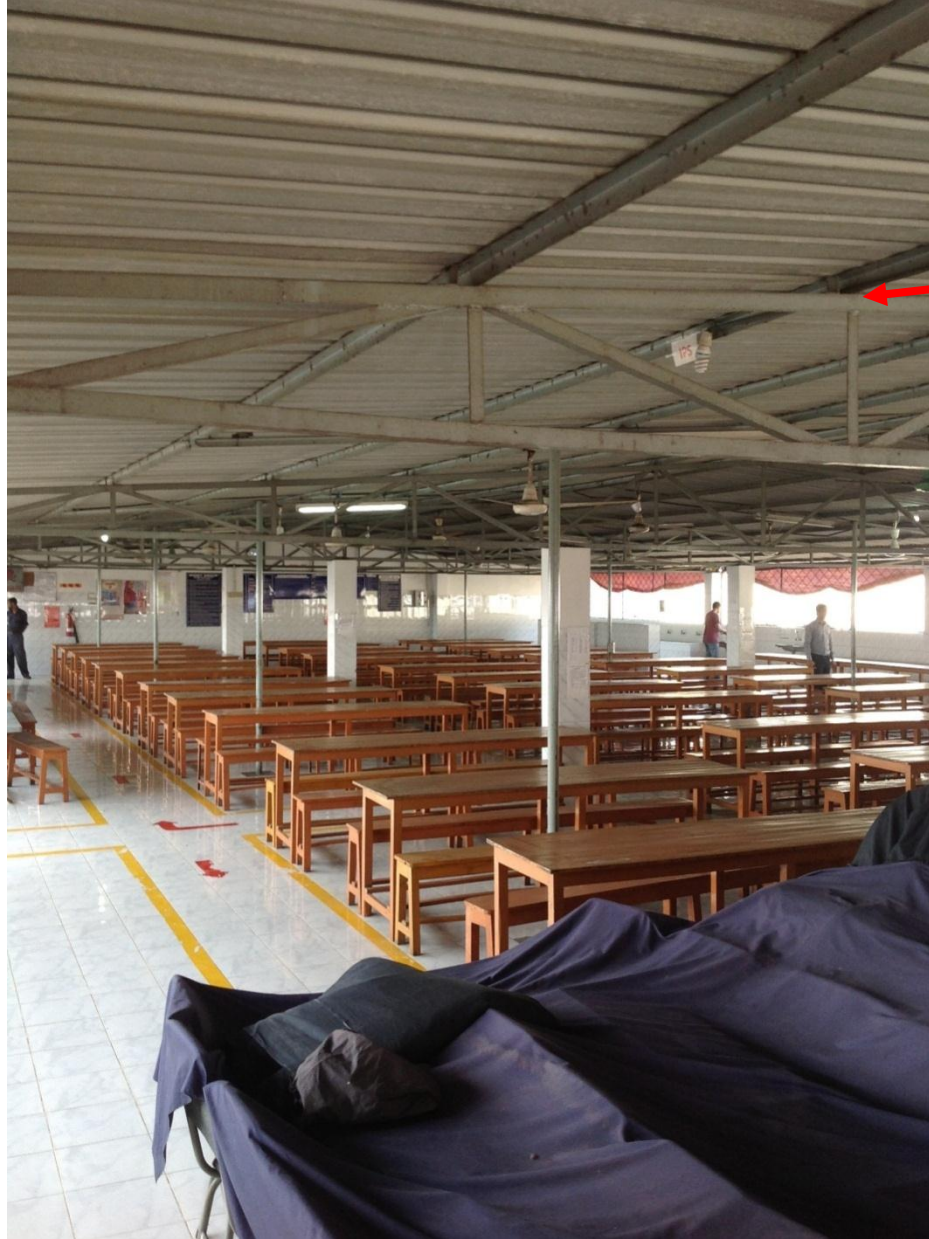
**The clad steel framed structure supported on the concrete roof slab has no obvious horizontal bracing system in the plane of the steel roof to resist high wind loads. Localised extensions to this steel frame are currently being constructed.**

Roof system has no obvious horizontal bracing to provide stability in high winds.

| Item No. | Observation | Recommended Action Plan | Recommended Timeline |
|---|---|---|---|
| 1 | The steel structure supported on the concrete roof slab has no obvious horizontal bracing system in the plane of the steel roof to resist high wind loads. In addition, localised extensions to this steel frame are currently being constructed. | Steel frame stability system and localised extensions to be designed by the Building Engineer to support code vertical and wind loads. | 6-months |

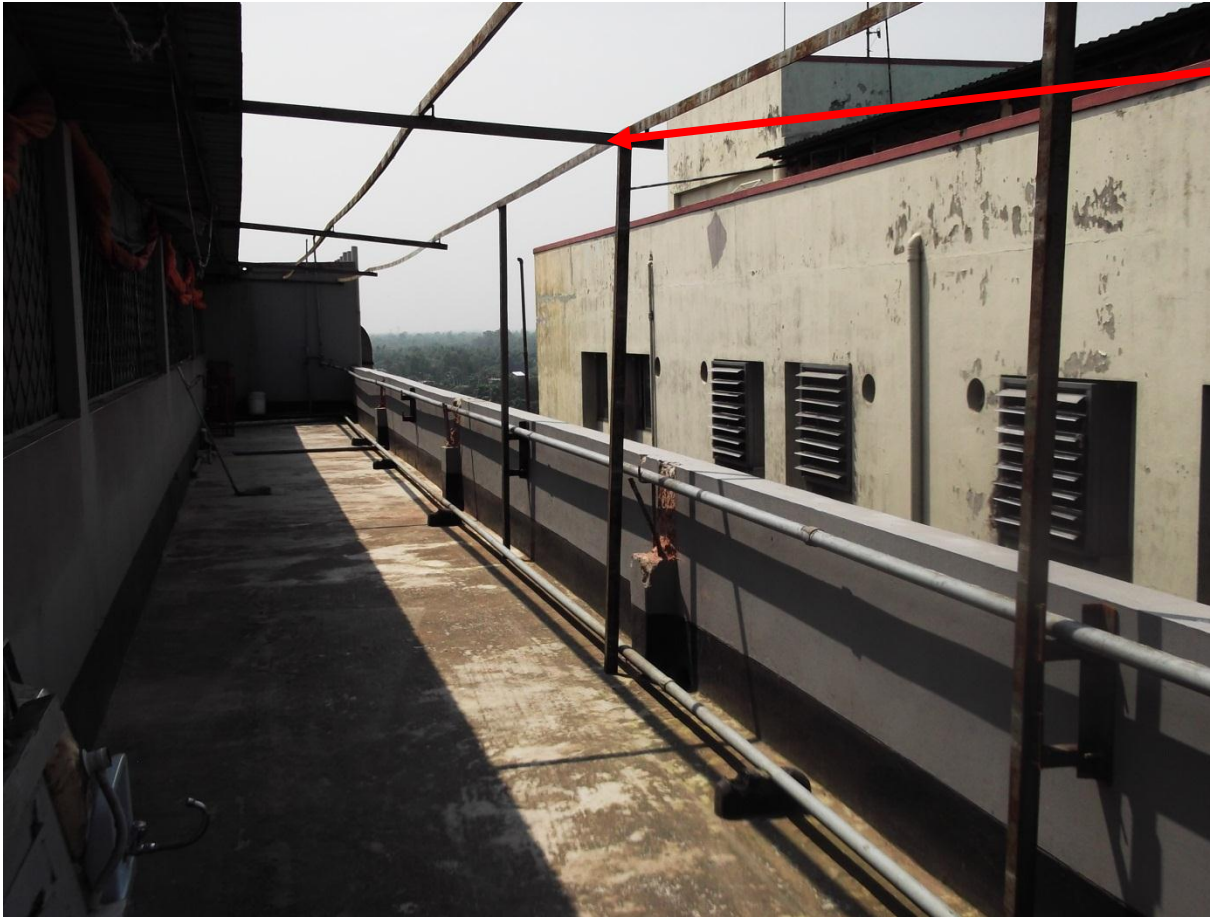
## Steel Roof Stability System

**Additions to roof steel frame – Building Engineer to confirm that these have been designed for code specified loads.**

**Check on roof additions required**

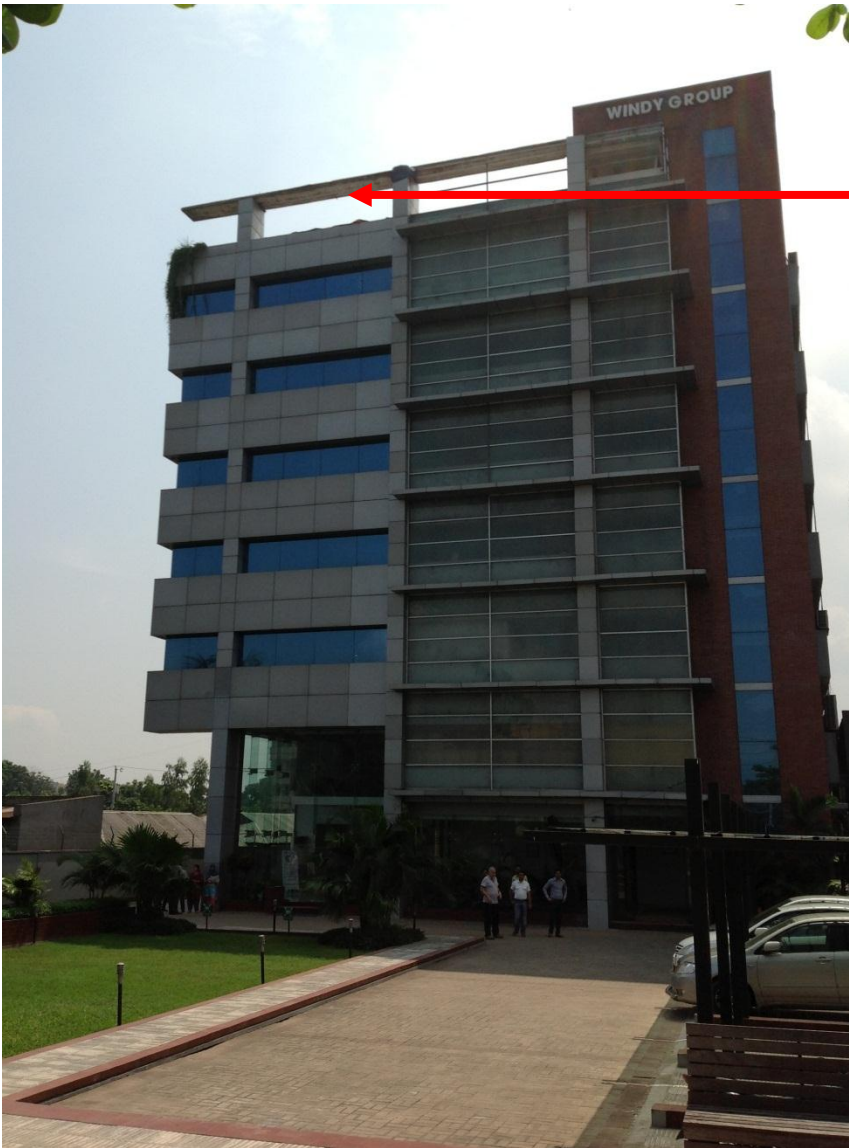
Area at roof level where structure has been removed following instruction from Fire Brigade.

# **Ensure drainage and waterproofing of recently exposed roof slab**

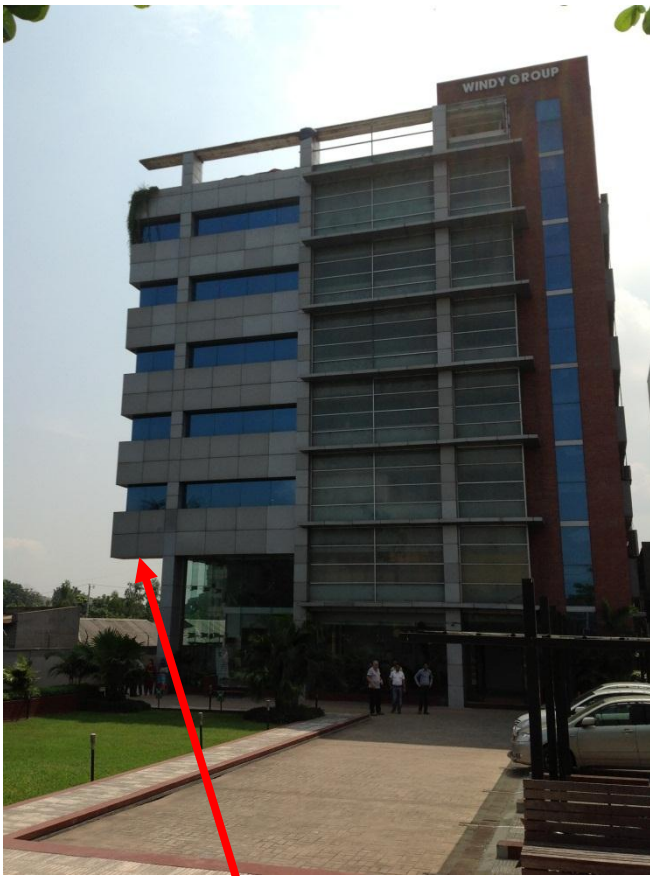
**Approx 2.75m cantilever on building perimeter**

**Check on allowable cantilever loads and monitoring.**

| Item No. | Observation | Recommended Action Plan | Recommended Timeline |
|---|---|---|---|
| 3 | Establish allowable load on cantilever floor slab and monitor floor loading. | Building Engineer to advise allowable loading for cantilever floor slab. Controlled loading plans to be prepared for cantilever slabs and floor loads to be monitored accordingly. | 6-months |

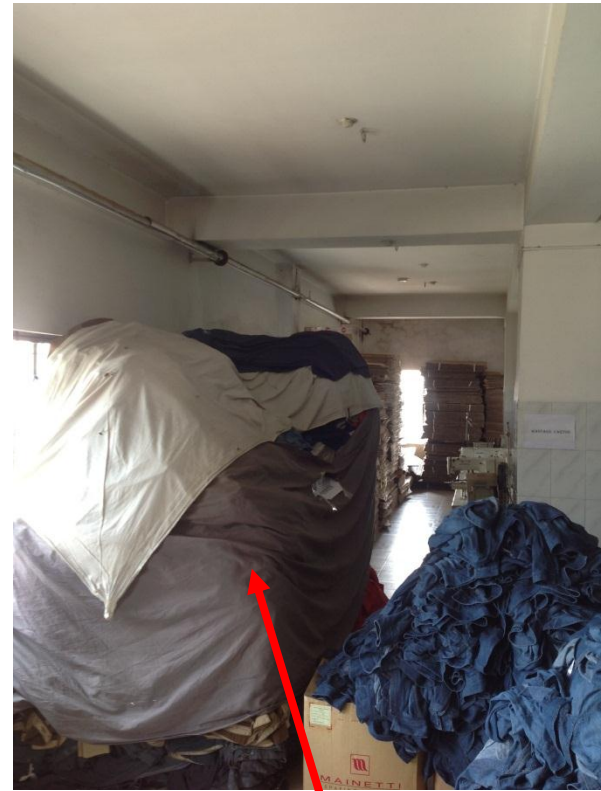
**Cantilever loading to be assessed and monitored**
