# **FIRE SAFETY INSPECTION REPORT**

**BASIC APPARELS LTD**  
**135\_138, ABDULLAHPUR, UTTARA**

**ACCORD**  
on Fire and Building Safety in Bangladesh

April 15, 2014

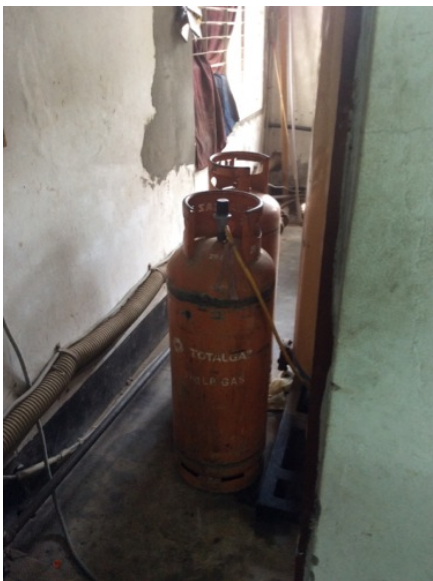
| No. | Category | Finding | Recommendation | Remediation Timeframe |
|---|---|---|---|---|
| F-1 | Fire Rated Construction | Hazardous materials storage area is not separated by fire-rated construction openings, non-rated doors and penetrations all present. | Separate the hazardous materials / flammable liquid storage room by a minimum 2-hr fire-rated construction. Seal and/or protected all openings to maintain the required fire separations. | Within 3 months |

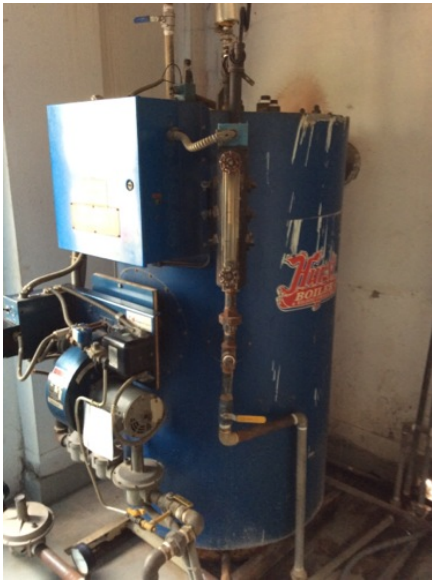
| No. | Category | Finding | Recommendation | Remediation Timeframe |
|---|---|---|---|---|
| F-2 | Fire Rated Construction | The boiler room is not adequately separated by fire-rated construction (openings, non-rated doors, penetrations all present on the first floor only. | Separate the boiler room by a minimum 2-hr fire-rated construction. Seal and/or protected all openings to maintain the required fire separations | Within 3 months |

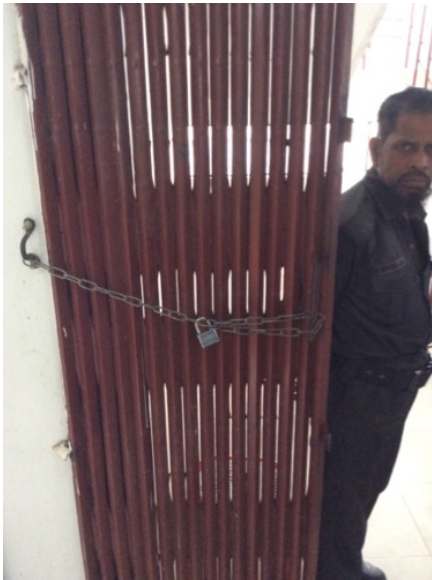
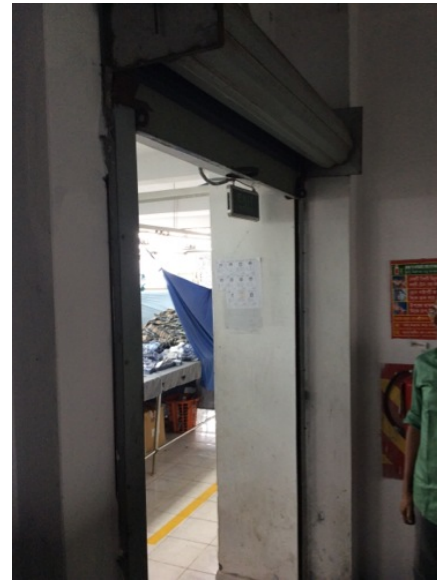
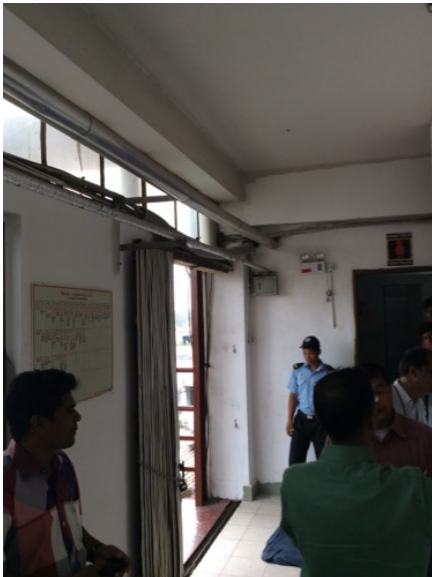
| F-3 | Fire Rated Construction | The exit stairs are not separated from work areas on each floor by fire-rated construction. | <p>Provide minimum 1.5-hr fire rated doors and seal all unprotected openings to separate the exit stairs from work areas and other building spaces on all floor levels. Ensure that the fire doors are self-closing and positive latching and that they are provided with fire exit (panic) hardware where serving production floors.</p> <p>If fire doors are required to be held open for functional reasons, provide automatic-closing devices tied to the fire alarm system.</p> | Within 3 months |

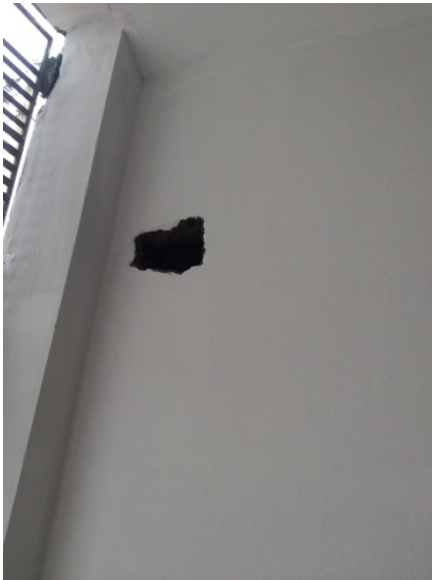
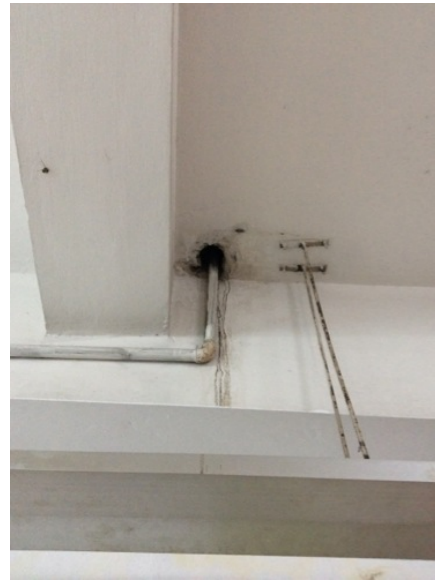
| F-4 | Fire Rated Construction | Unsealed penetrations and openings are located in exit stair enclosures. | Seal all penetrations and openings in exit stair enclosure walls and floors to maintain the fire separation. | Within 3 months |

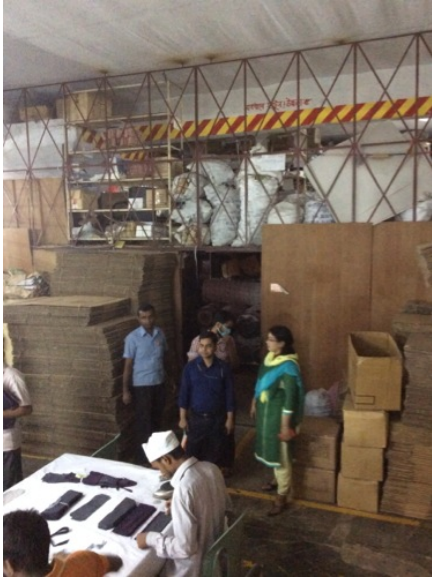
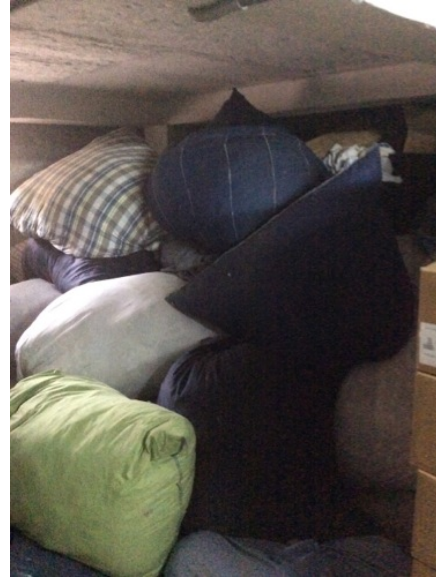
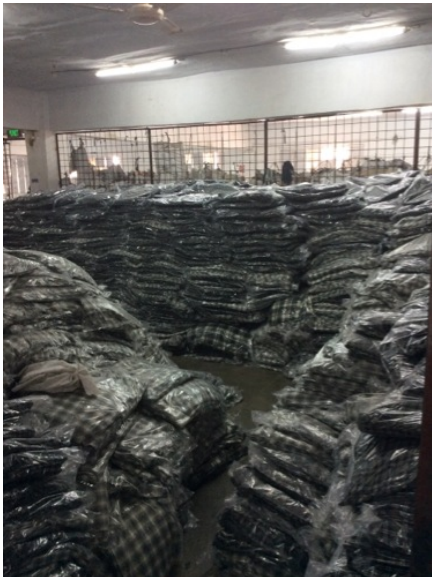
| F-5 | Fire Rated Construction | Floors 1 and 2, combustible storage is not separated by fire-rated construction throughout factory. | <p>Provide dedicated storage rooms separated by minimum 1-hr fire-rated construction.</p> <p>Where separate storage rooms are not feasible, provide defined storage areas and limit the storage arrangement as follows:</p> <ul style="list-style-type: none"> <li>- Maximum height of 2.4m and maximum area of 23m<sup>2</sup></li> <li>- If sprinkler protected: maximum height of 3.66m and maximum area of 93m<sup>2</sup></li> </ul> <p>Separate areas of unenclosed combustible storage by a minimum clear distance of 3m.</p> | Within 3 months |

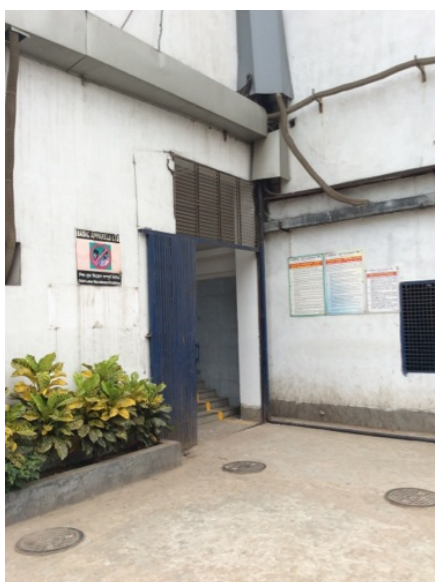
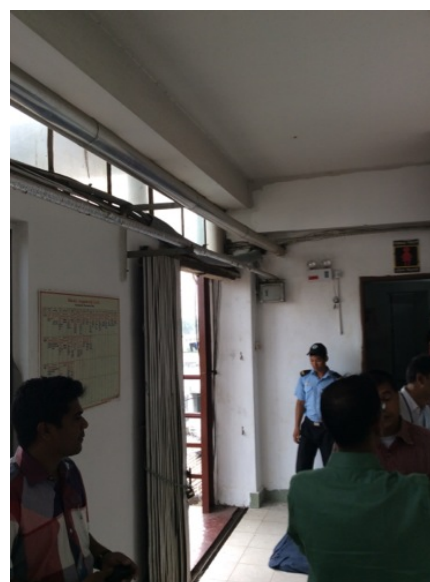
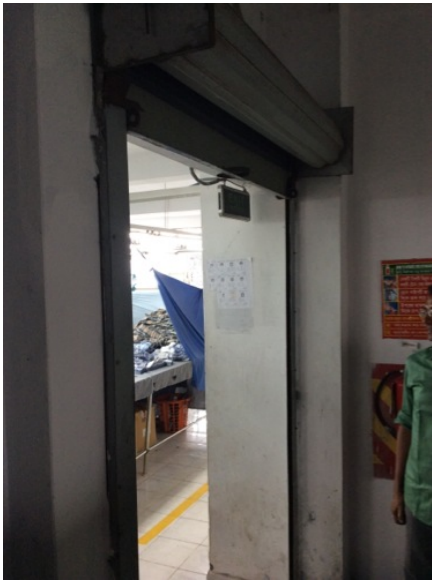
| F-7 | Egress | <p>Collapsible steel sliding gated doors are provided at building exits, exit stairs, along egress routes on the first floor and main exit discharge at ground level. All egress doors were open with locks in sealed position.</p> | <p>Replace all gates / sliding doors along the means of egress with side-hinged, swinging egress doors.</p> <p>If locks are required for security reasons, utilize special door locking features complying with NFPA 101.</p> | Within 1 month |

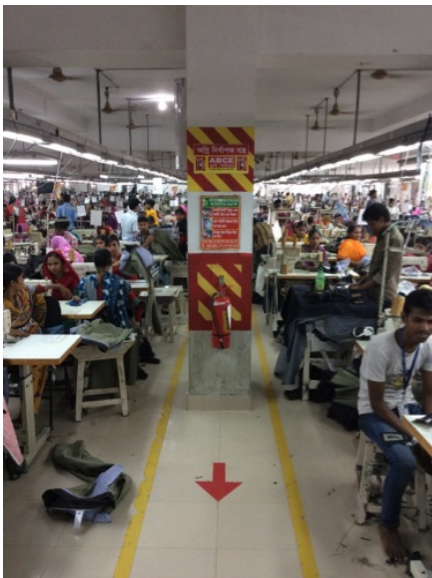
| F-8 | Egress | The width of egress aisles is less than 36-in on the first and second floor due to structural column layout and design of sewing machine productions. | Provide minimum aisle widths of 36-in. | Within 3 months |

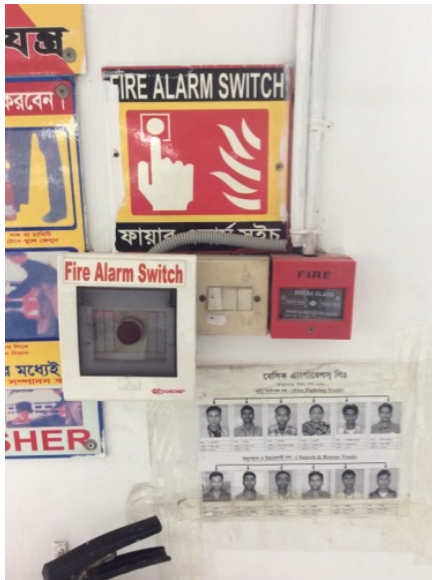
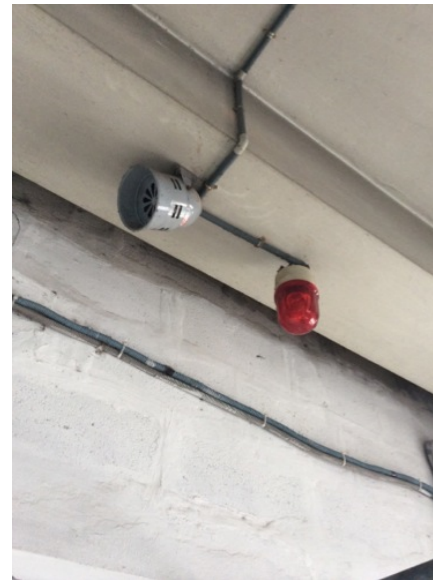
| F-9 | Fire Protection | The fire alarm system is antiquated, not a listed system, and does not provide alarm and notification features consistent with acceptable standards. | Replace the fire alarm system with a new, listed addressable fire alarm system in accordance with NFPA 72. | Design within 4 months, install within 9 months |

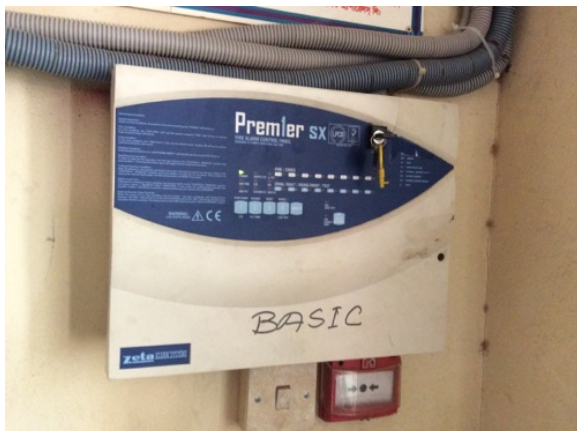
| F-10 | Fire Protection | Inspection, testing, and maintenance for the fire alarm system was not in accordance with NFPA 72. | Inspect, test and maintain the fire alarm system, and keep written records on-site, in accordance with NFPA 72. | Within 3 months |

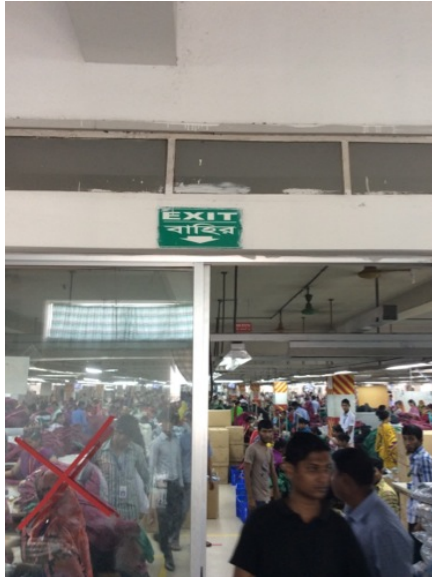
| F-11 | Egress Lighting | Exit signage was not adequately illuminated in line with Bangladesh national building code. Located on the Second floor finishing section. | Provide illuminated signage above all egress exit door points. | Within 3 months |
