# Energypac Fashions Ltd-2

Hotapara Bokran Monipur; Bhabanipur; Gazipur, Dhaka

23<sup>th</sup> January 2018

# Observations

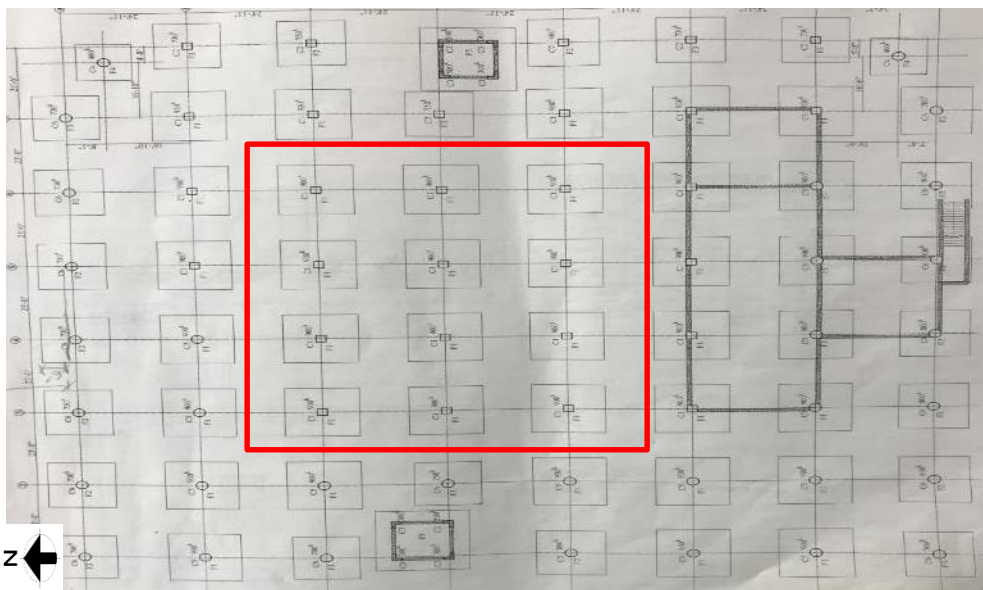
Foundation layout plan

Cursory calculation indicates that footing appears to be stressed above normal design limits in marked zone. Factory engineer is required to review the adequacy of footings considering actual depth of footing and comply with BNBC.

| Item No. | Observation | Recommended Action Plan | Recommended Timeline |
|---|---|---|---|
| 1 | Design check required for the foundation system | Factory Engineer to review design, loads and stresses of foundation system. | 6-weeks |
| 3 | Design check required for the foundation system | Carry out remedial works where necessary. | 6-months |

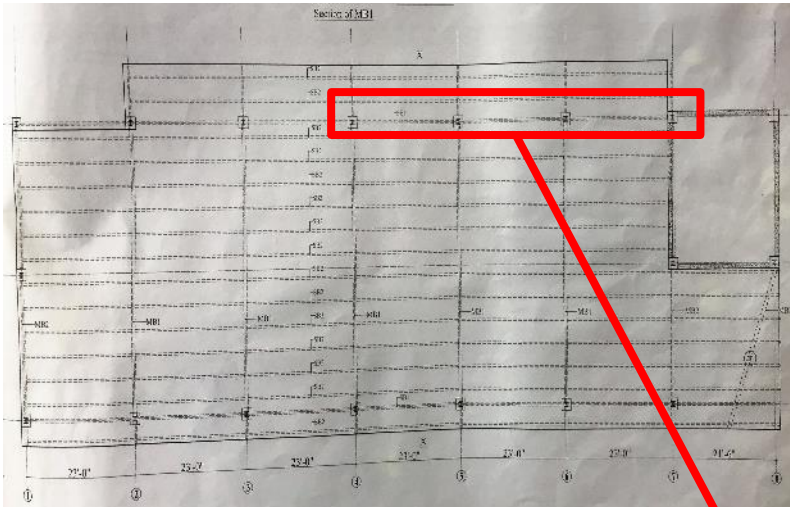
Beam layout plan of roof top shed

In place of box knee bracing, pipe knee bracing has been installed.

In place of 100mm X 100mm box section, 200mm X 100mm I-section has been provided as beam adjacent to the knee bracing.

Also, column Section were found to be tapered in stead of regular I-section shown in provided drawing

| Item No. | Observation | Recommended Action Plan | Recommended Timeline |
|---|---|---|---|
| 4 | Discrepancies between drawings and on-site observation | Factory required to produce As Built drawings which reflect the actual condition. | 6-weeks |

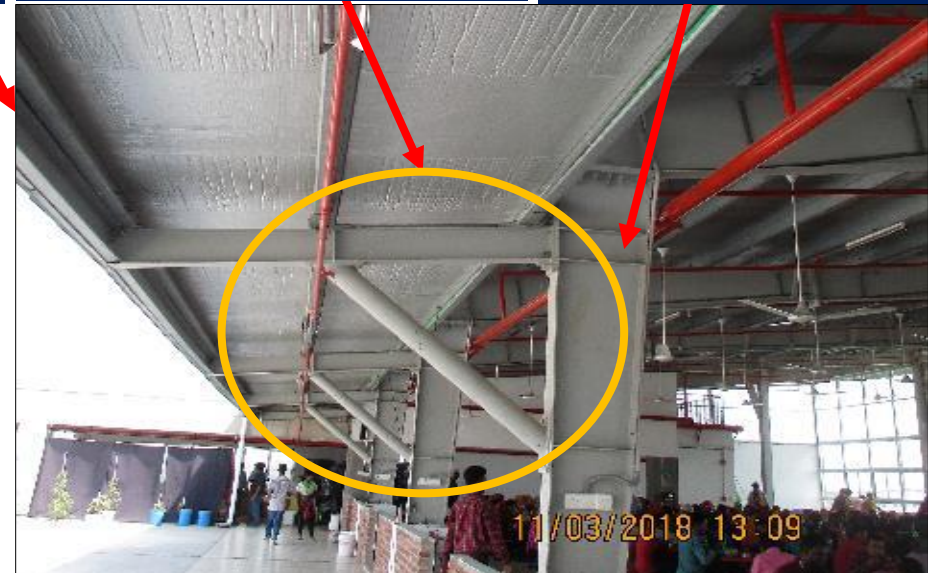
Columns in north side with knee bracing

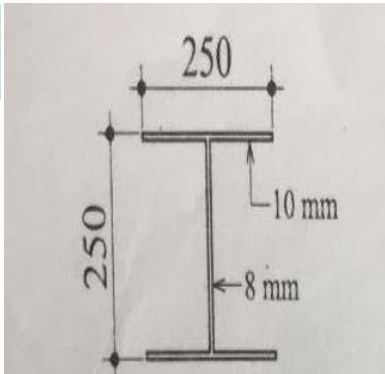
Uniform Steel  
column section

All the columns installed in the roof shed were found to be tapered sections where as uniform I-section is shown in the provided drawing

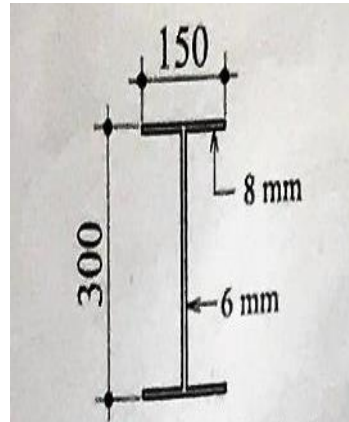
Beam section SB1

In place of SB1 beam, pipe  
Compression Strut was installed

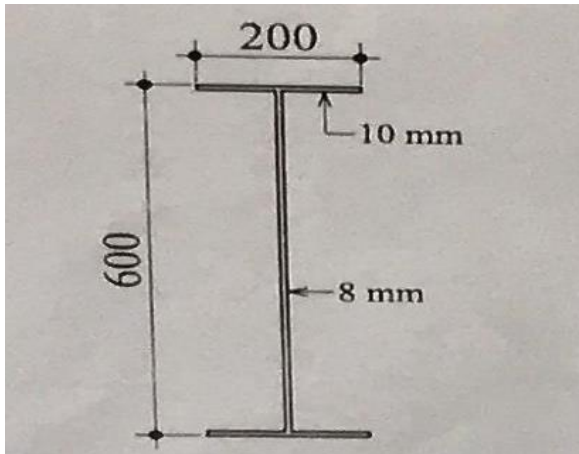
Beam section MB1

All the rafters are in three parts connected by bolts. Two end sections of rafters are tapered sections which were shown as uniform I-section in the provided drawing.

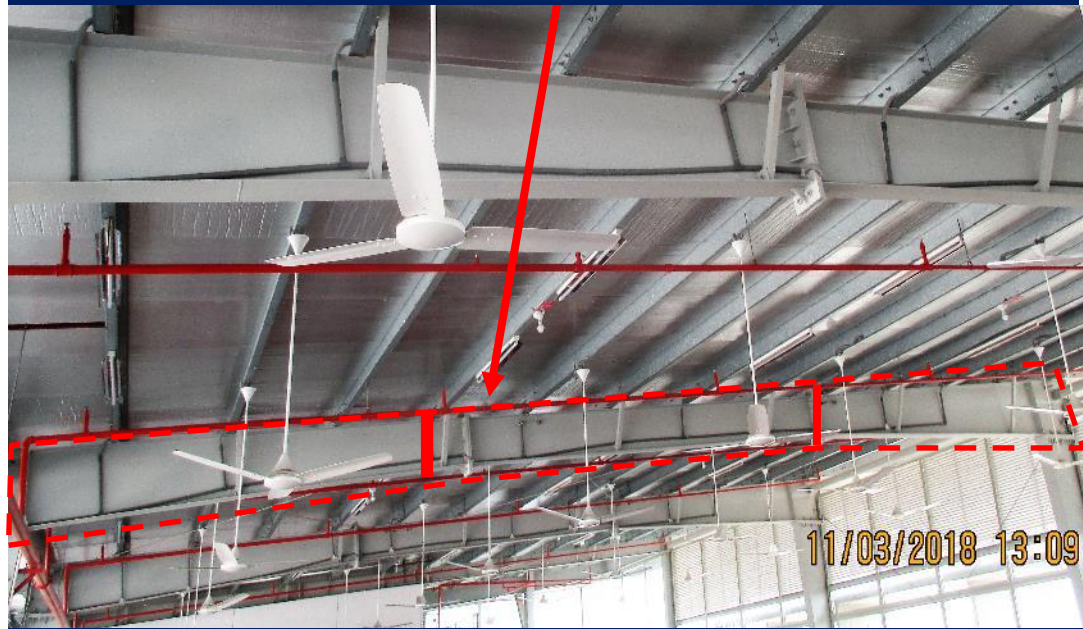
Internal view of roof top shed

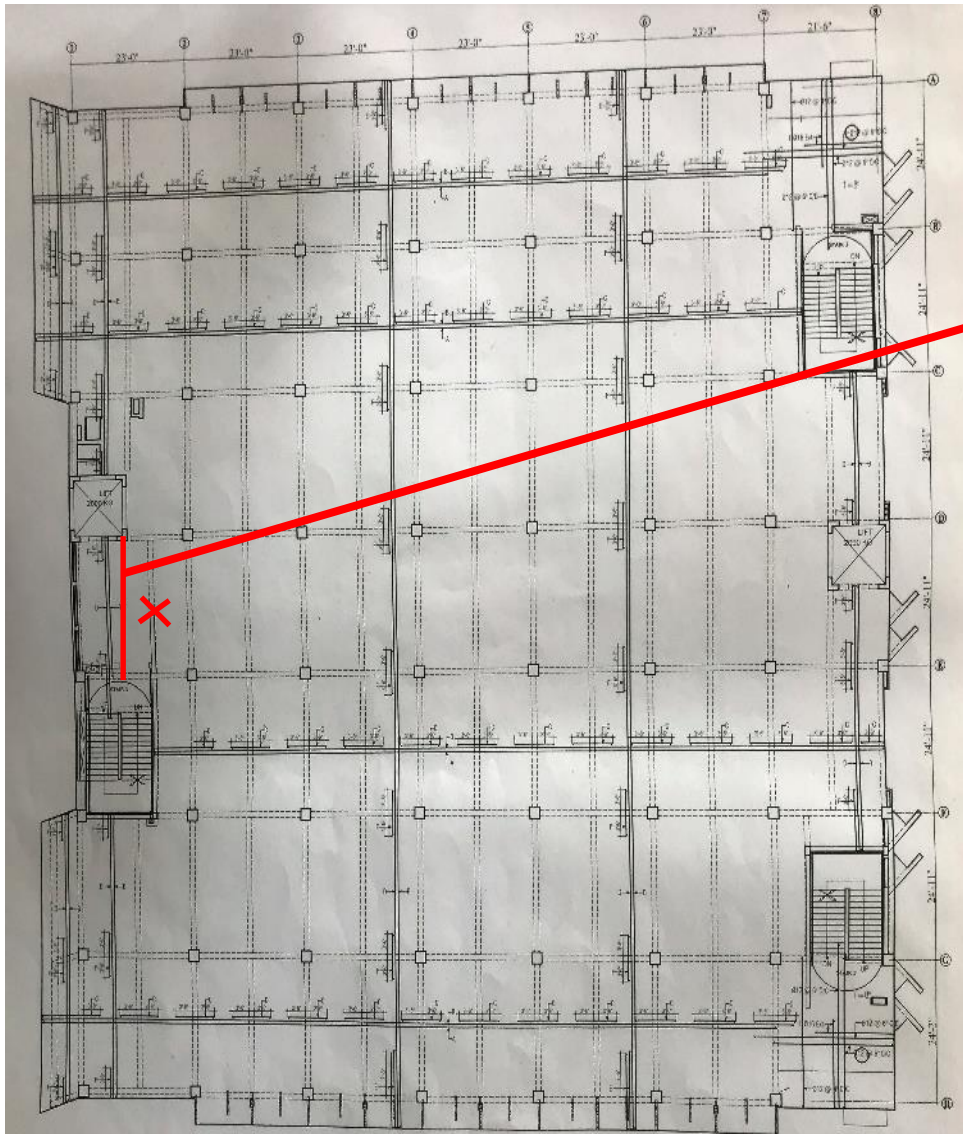
5<sup>th</sup> Floor Beam Layout Plan

Location of B5 (at grid 2-DE)  
shown in provided drawing

Location of B5  
found on site

5<sup>th</sup> Floor beam layout does not match  
with provided beam layout plan. Beam  
B5 was found 2.3 m offset towards west  
from grid 2-DE which is showed in  
provided drawing

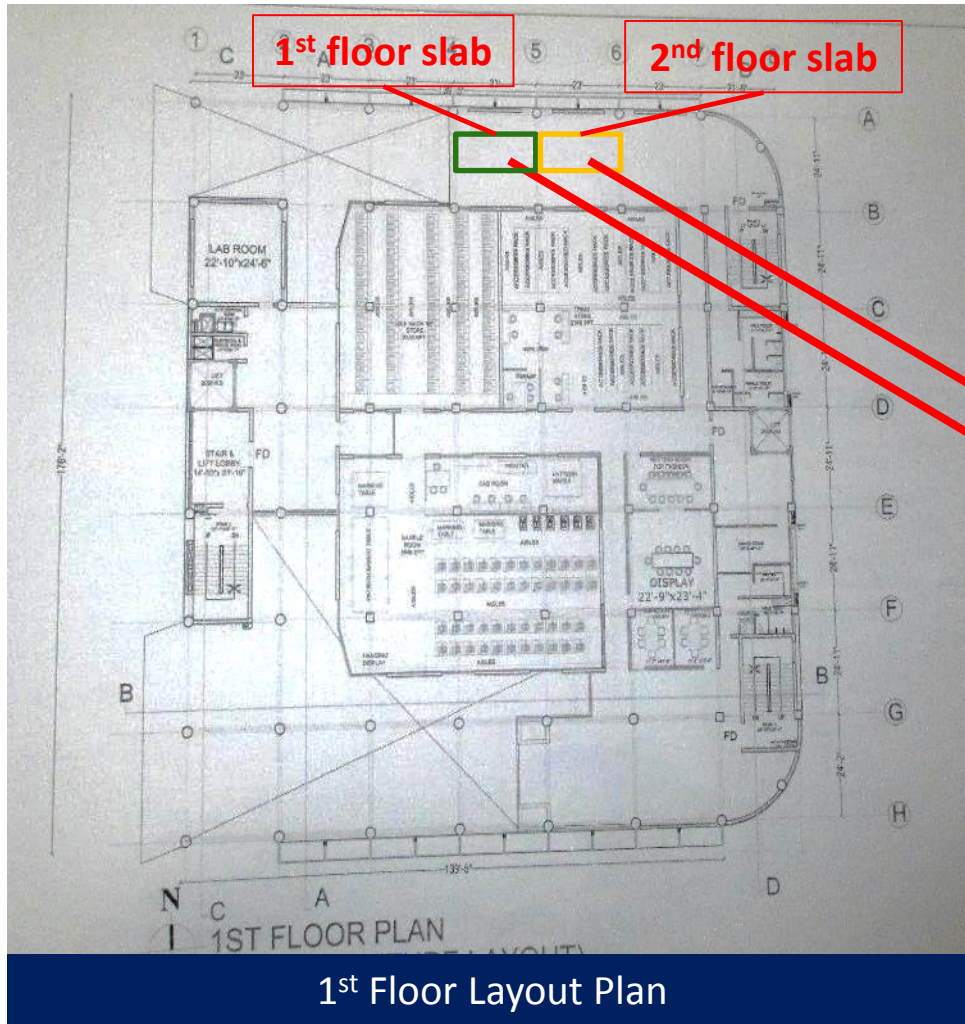
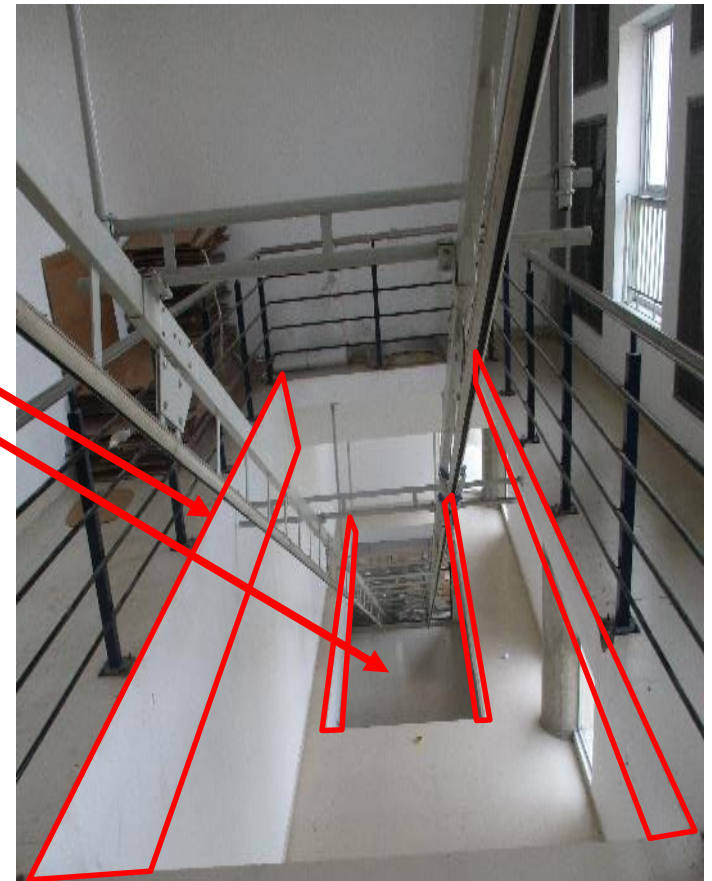
Opening in slab due to conveyor facilities

There are openings on 1<sup>st</sup> (Grid A-B & 4-5) and 2<sup>nd</sup> (Grid A-B & 5-6) floor slabs for accommodating conveyor which are not shown in floor layout. Also, there are two beams on either side of the void which are not shown in beam layout.

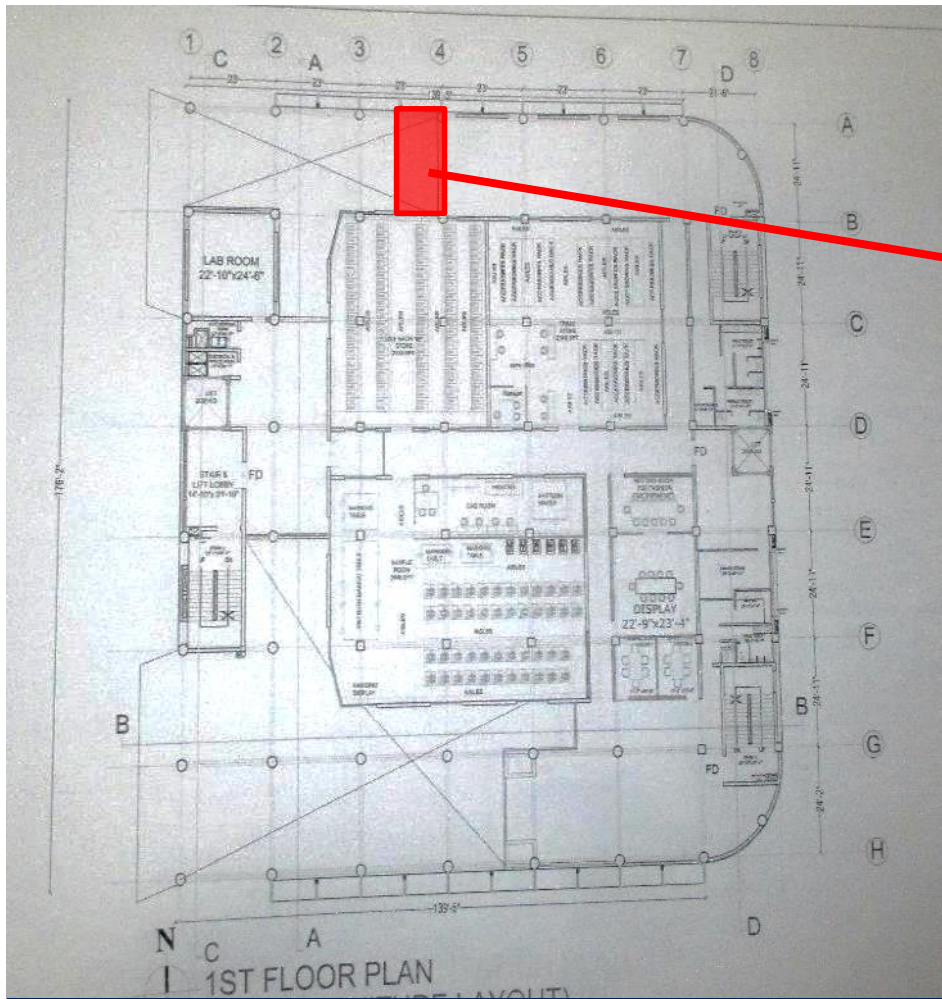
1<sup>st</sup> Floor Layout Plan

1<sup>st</sup> floor slab was extended by 7.5 m x 3.3 m in between grid A-B & 3-4.

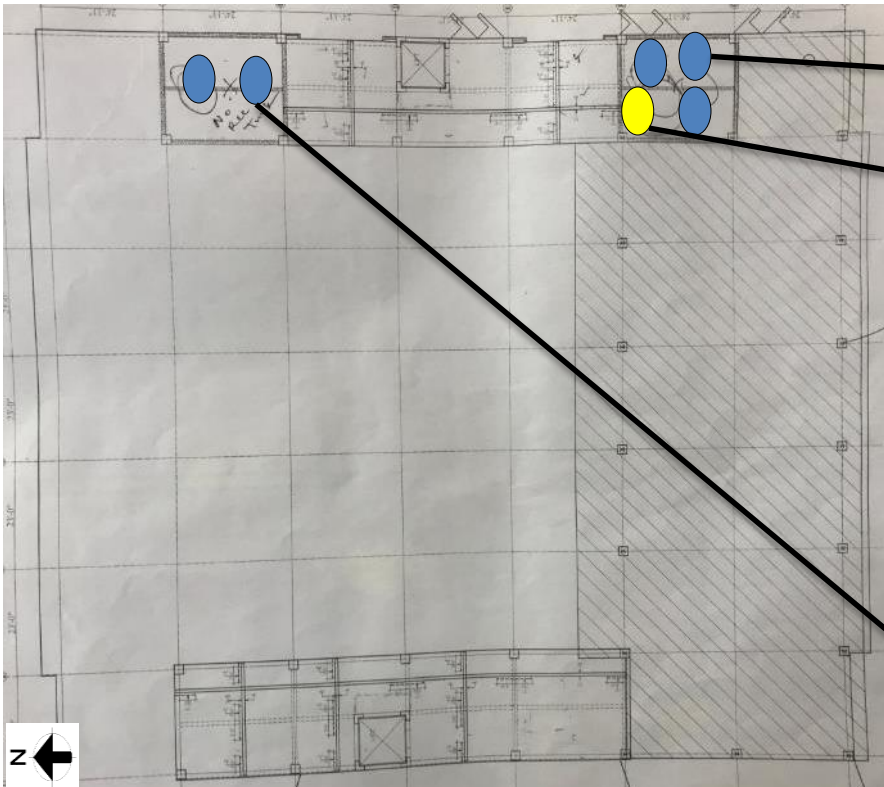
Roof plan layout

Concerns on the roof slab supporting 10000 Liter water tanks. A capacity check of these slabs and all related elements need to be carried out.

| Item No. | Observation | Recommended Action Plan | Recommended Timeline |
|---|---|---|---|
| 5 | Capacity check of roof slab supporting water tanks | Factory Engineer to review design, loads and related elements in area identified above to confirm capacity for the tanks. | 6-weeks |
| 6 | Capacity check of roof slab supporting water tanks | Carry out remedial works where necessary. | 6-months |

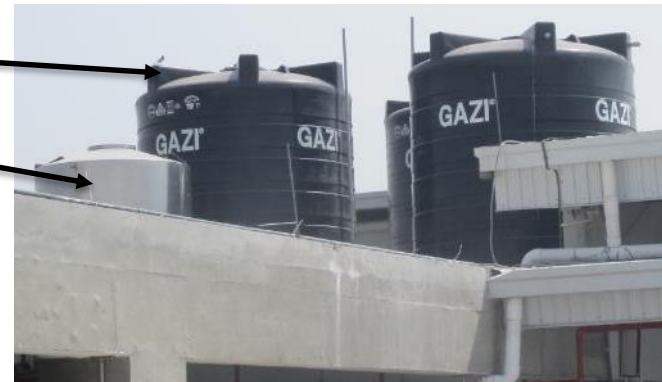
Three nos. 10000 liter and single 5000 liter water tank on stair case roof slab

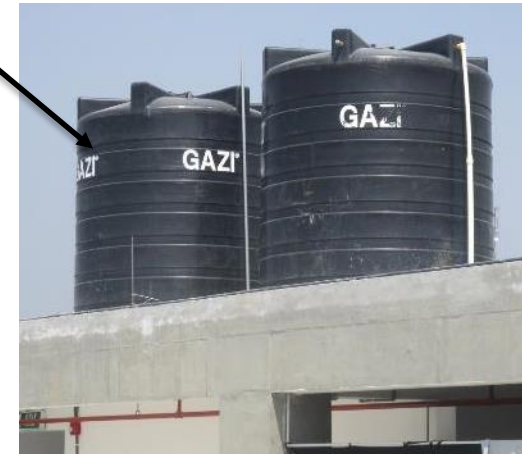
Two nos. 10000 liter water tank on stair case roof slab

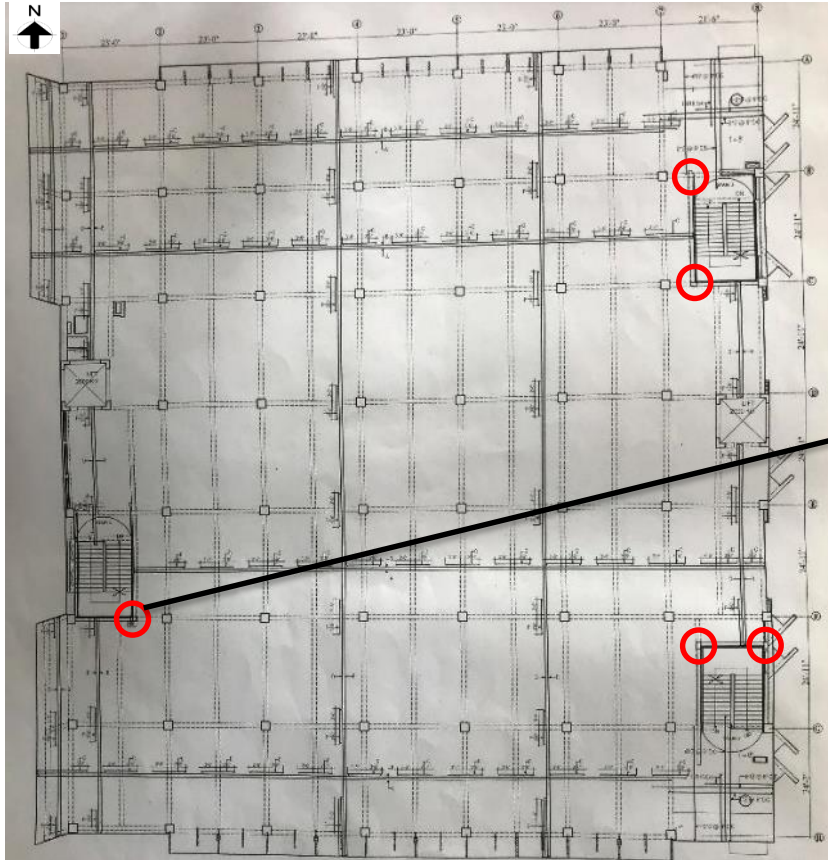
Typical Beam column layout

Short columns were only found between landing beam and main beam but not continue to the floor's roof slab in typical floor

Check the redundancy of the short column load to main beam at stair zone

| Item No. | Observation | Recommended Action Plan | Recommended Timeline |
|---|---|---|---|
| 7 | Capacity check for the beam of stair case | Check the redundancy of the short column load to main beam at stair zone. | 6-weeks |

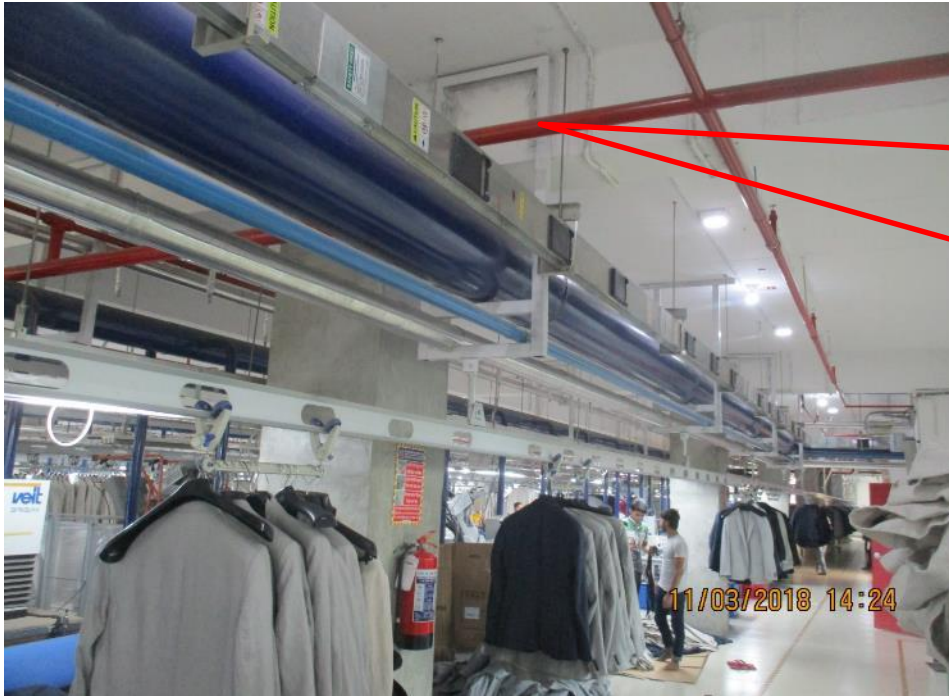
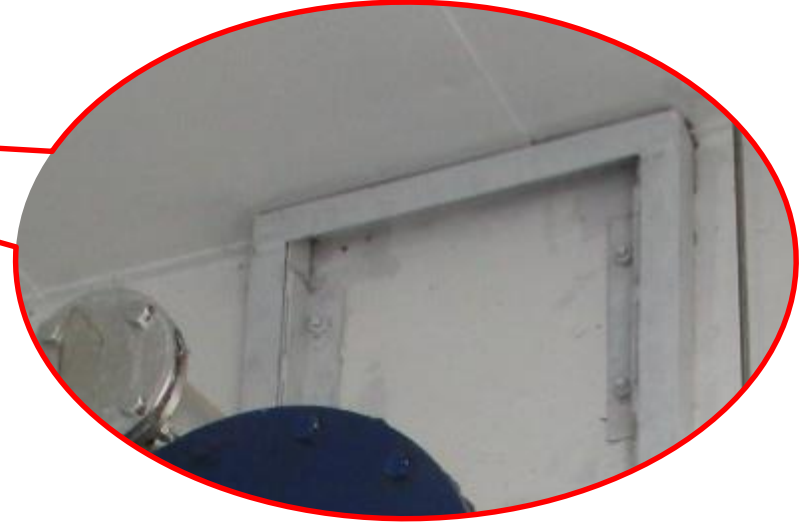
Iron steam pipe was observed in 3<sup>rd</sup> floor and 2<sup>nd</sup> floor which were hanging from beam. The joint was bolted. Factory engineer is required to check the capacity of the support system.

| Item No. | Observation | Recommended Action Plan | Recommended Timeline |
|---|---|---|---|
| 9 | Adequacy check for the support condition of the steam pipe | Factory engineer is required to check the capacity of the supported system. | 6-weeks |
| 10 | Adequacy check for the support condition of the steam pipe | Carry out remedial works where necessary. | 6-months |
