# Base Fashions Ltd. - New Unit

93 Sataish Road, Tongi, Gazipur

31<sup>st</sup> December 2017

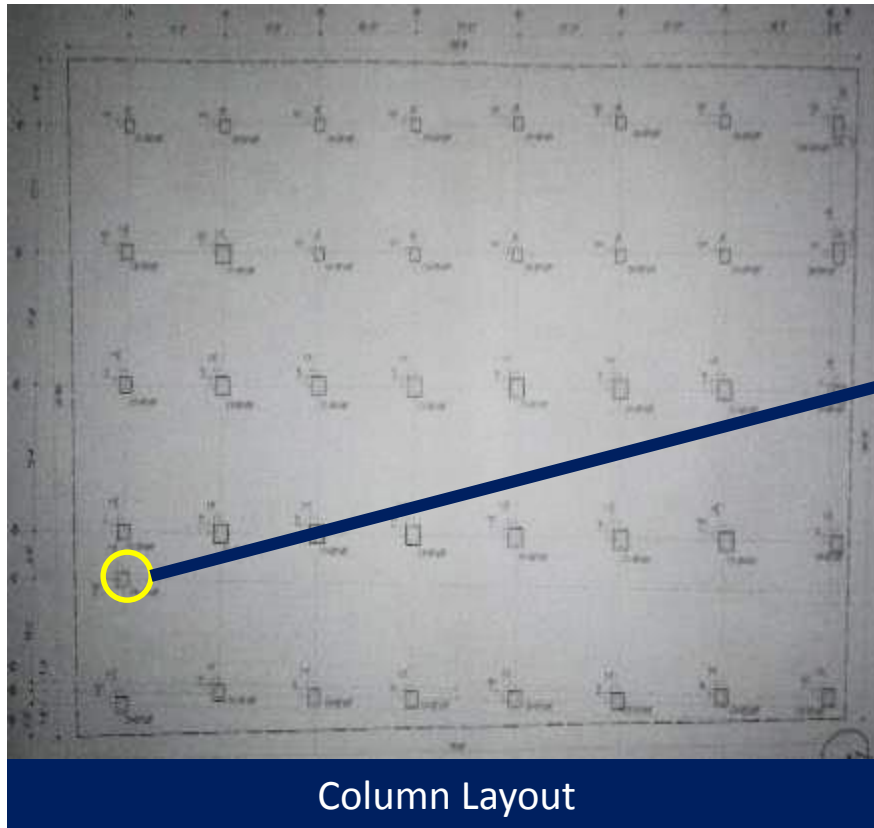
Column Layout

In the provided as-built drawing, the highlighted column was shown as strengthened by concrete jacking but that was not strengthened on site.

| Item No. | Observation | Recommended Action Plan | Recommended Timeline |
|---|---|---|---|
| 1 | Discrepancy between as-built drawings and on site condition | Building Engineer to survey the structure and update as-built drawings to the as-constructed status. | 6-weeks |

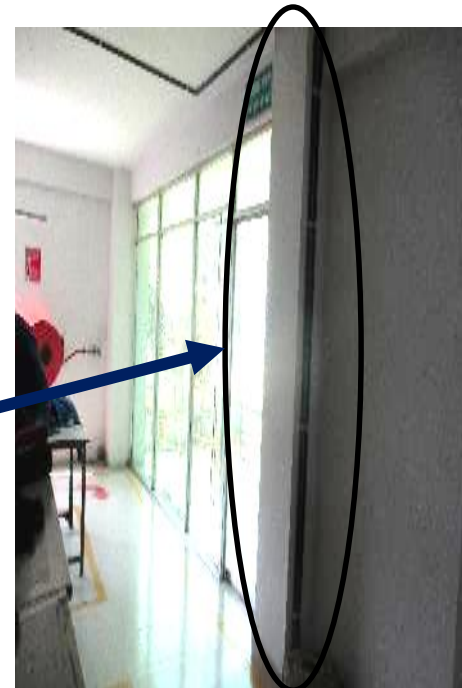
Existing column section was observed (375mm X 375mm) instead of retrofitting column (625mm x 625mm)

8 rebar observed on roof

8 rebar (3x3) were observed in the existing column section.

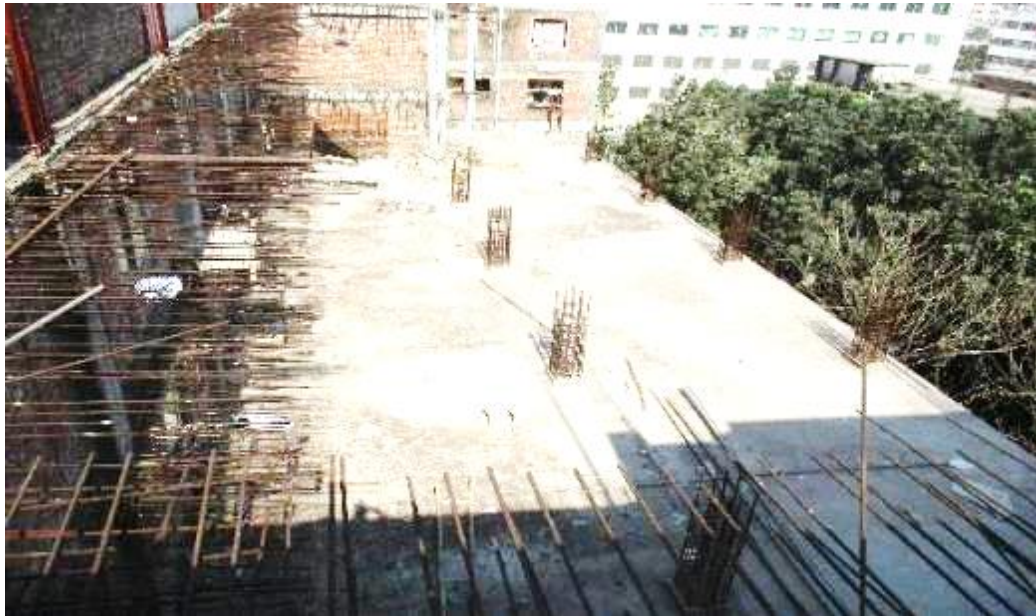
Exposed rebar on column and slab

Factory has permit drawing for the 6-storey building and exposed reinforcement in roof indicates the possibility of further extension of the building. For any future extension, a significant increase in column loads may cause. So, design report to be verified for concrete strength as part of Details Engineering Assessment before the commencement of construction additional floor above present condition (5-storey and 3-storey).

| Item No. | Observation | Recommended Action Plan | Recommended Timeline |
|---|---|---|---|
| 2 | DEA report to be verified | Building Engineer to survey the structure and revise the prepared design report including software based analysis. | 6-weeks |

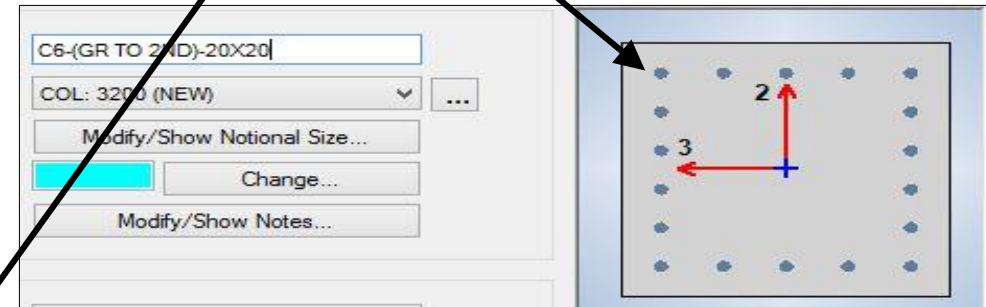
18 rebars found in FEA instead of 16 for C6 column

The column layout did not match with provided Finite Element Analysis (FEA) model. Also, the reinforcement of C6 column; size & retrofitting scheme of C5 column did not match. Factory engineer is required to check the drawings and update the FEA accordingly.

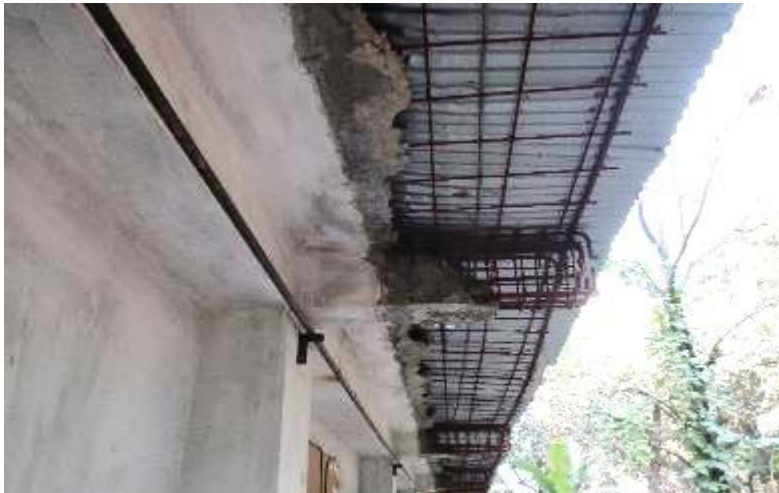
Exposed rebar on 1<sup>st</sup> floor slab

Corrosion on exposed rebar was observed on both 5 & 3 storied portions. Necessary steps to be taken to protect the rebars from corrosion. Also drainage system to be improved.

| Item No. | Observation | Recommended Action Plan | Recommended Timeline |
|---|---|---|---|
| 5 | Corrosion observed on exposed rebar and lack of drainage system on roof | Building engineer needs to check the ingress of corrosion and suggest proper remedial action accordingly. | 6-weeks |
| 6 | Corrosion observed on exposed rebar and lack of drainage system on roof | Implement repair works suggested by the engineer. | 6-weeks |

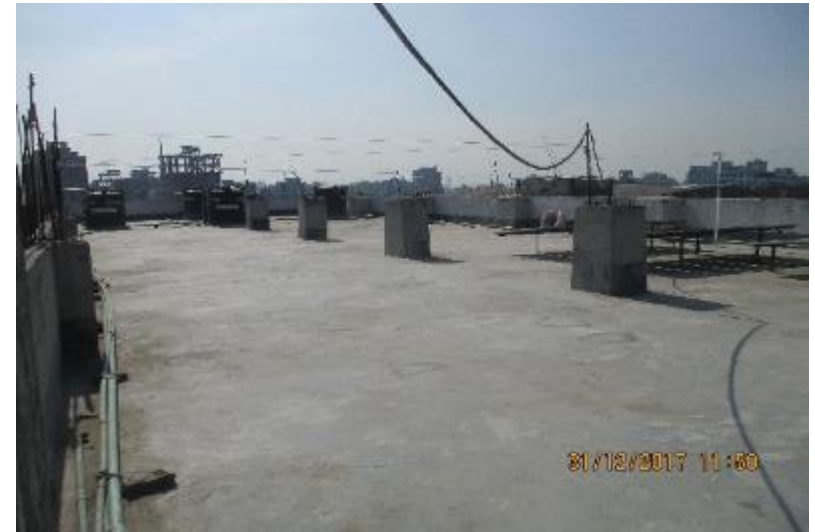
No obvious drainage system was observed

| Item No. | Observation | Recommended Action Plan | Recommended Timeline |
|---|---|---|---|
| 7 | Corrosion observed on exposed rebar and lack of drainage system on roof | Develop proper slopping and provide necessary outlets to improve drainage system on roofs. | 6-months |

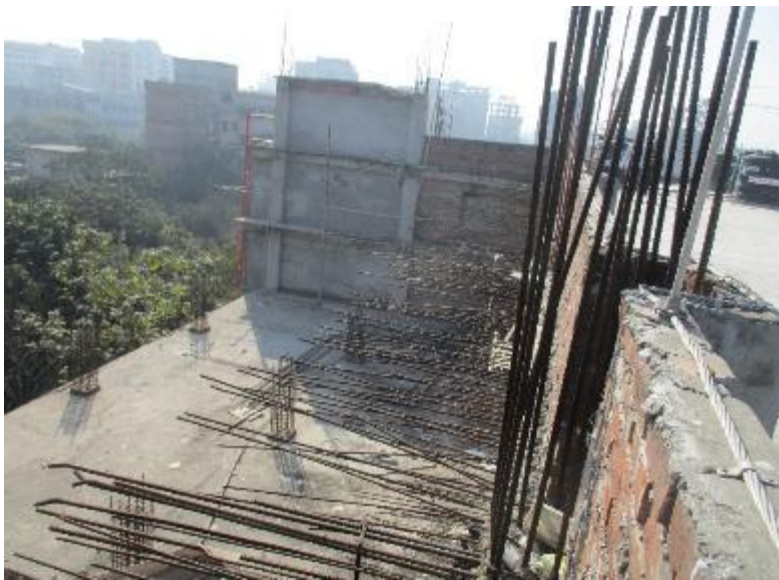
Exposed rebar on roof

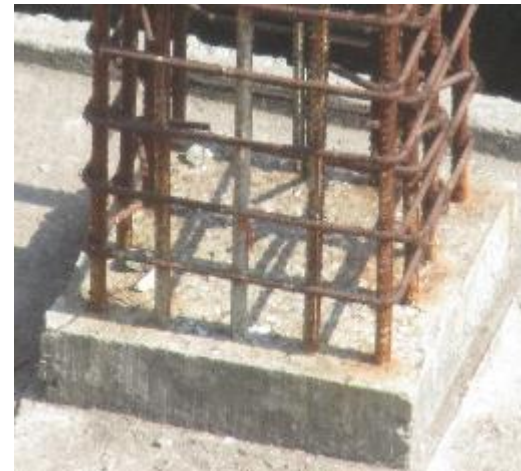
Corrosion observed on exposed rebar

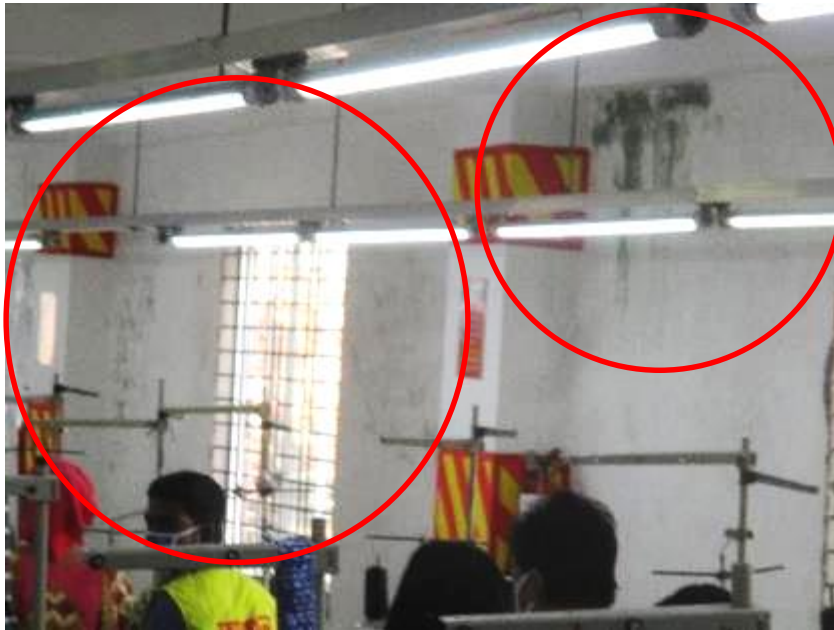
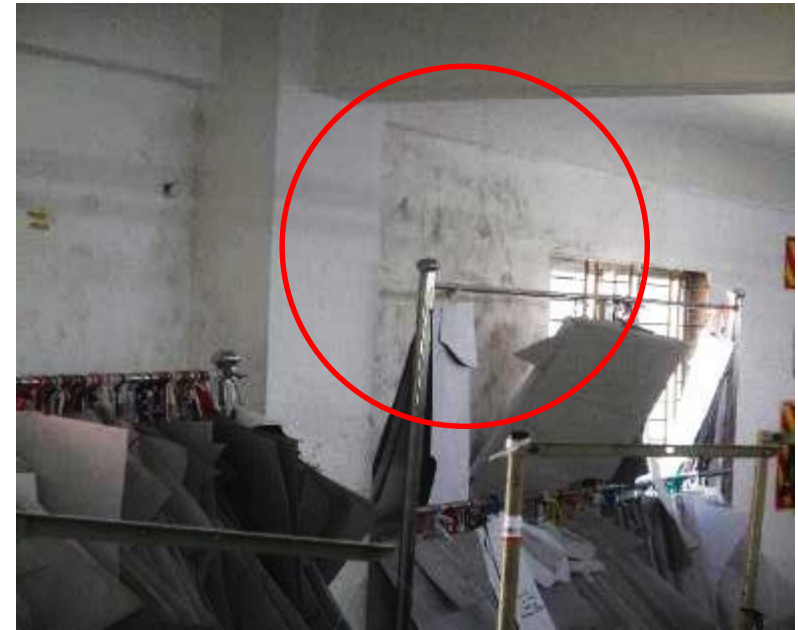
Dampness on periphery wall of 5-storied portion

Dampness was found in several areas of the peripheral brick walls. The factory is required to identify the reason and repair following an appropriate method.

| Item No. | Observation | Recommended Action Plan | Recommended Timeline |
|---|---|---|---|
| 8 | Dampness observed on periphery wall | Building engineer needs to check the reasons for dampness and suggest proper remedial action accordingly. | 6-weeks |
| 9 | Dampness observed on periphery wall | Implement repair works suggested by the factory engineer. | 6-months |

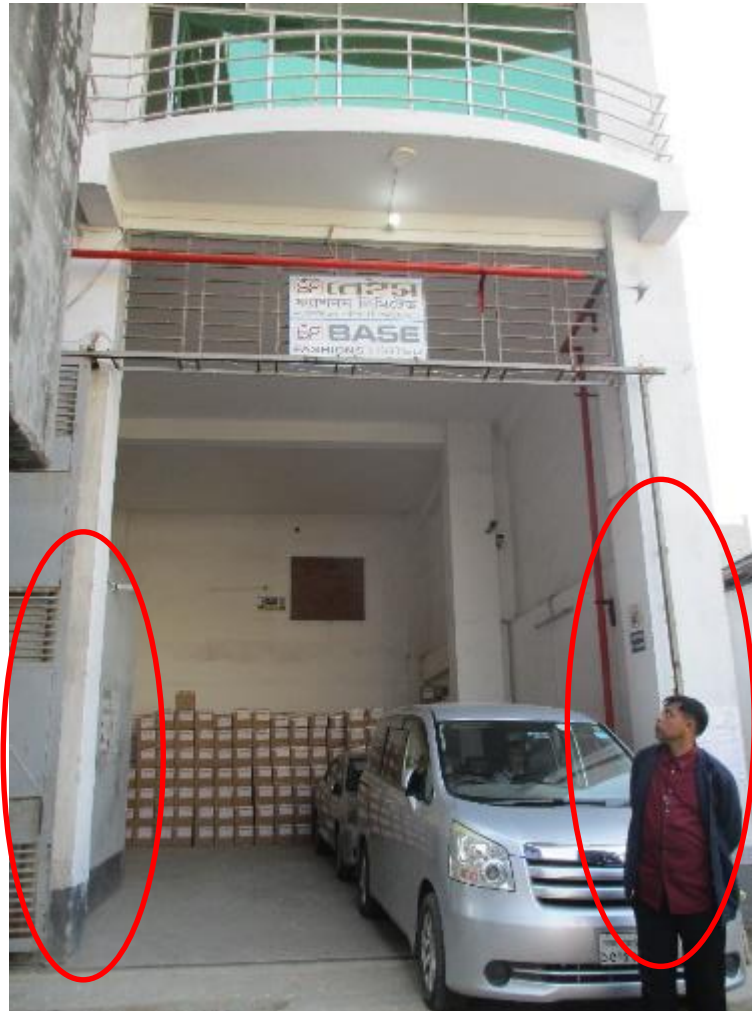
The highlighted columns are susceptible to vehicle impact. The factory is required to provide a barrier to protect the columns from vehicle impact.

| Item No. | Observation | Recommended Action Plan | Recommended Timeline |
|---|---|---|---|
| 10 | Columns susceptible to vehicle impact | A barrier to be installed around the exterior columns. | 6-months |

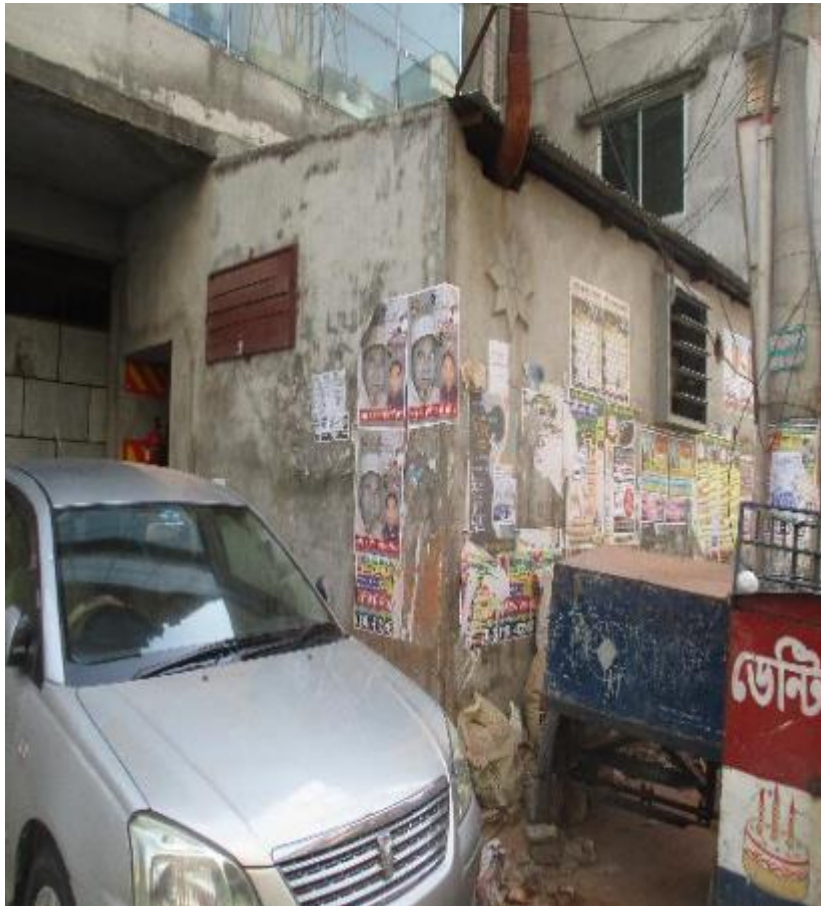
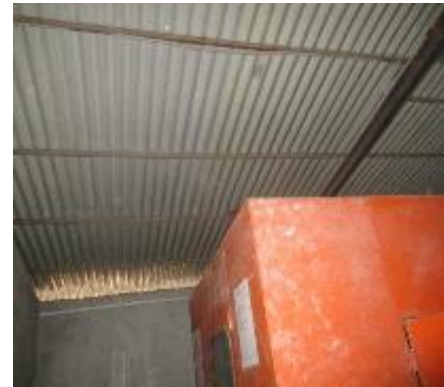
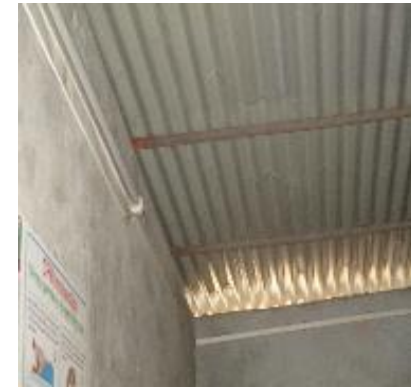
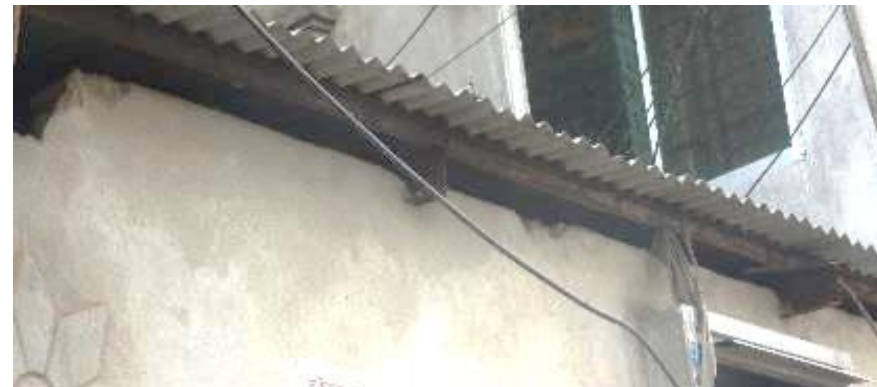
Lightweight steel roof rested on the brick walls

The as-built drawing was not available for generator shed. As-built drawings for the shed to be prepared. Besides, No stability system was observed and the shed seems to be non-engineered. Factory is required to check the adequacy of roof against uplift forces.

| Item No. | Observation | Recommended Action Plan | Recommended Timeline |
|---|---|---|---|
| 11 | Lack of as-built documents of generator shed | Building Engineer to survey the structure and prepare as-built drawings. | 6-weeks |
| 12 | Lack of as-built documents of generator shed | Building Engineer is required to check the capacity of the roof anchorage against uplift forces. | 6-weeks |
| 13 | Lack of as-built documents of generator shed | Implement remedial works suggested by the Building Engineer. | 6-months |

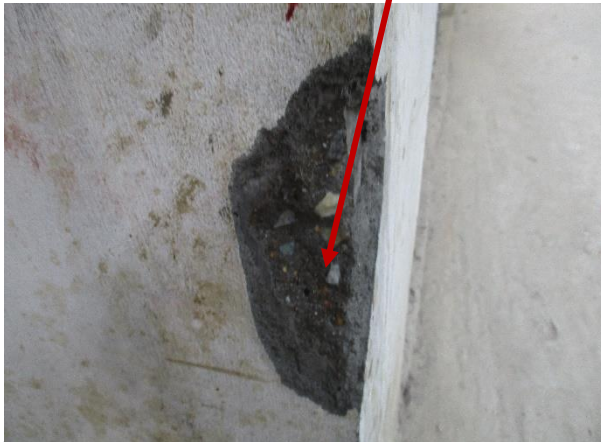
Stone chips aggregate at strengthened column

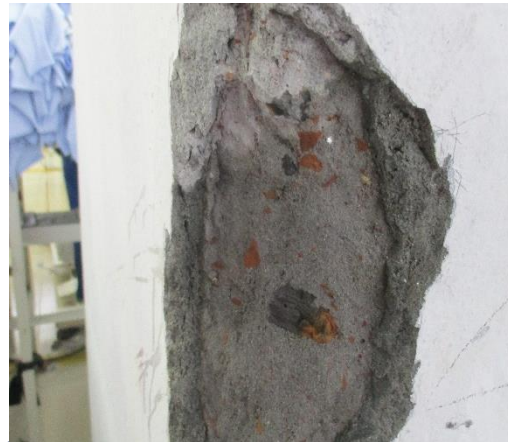
Brick chips aggregate at existing column
