# Mega Dyeing Ltd.

Shardagonj, Gabindabari, Joydevpur, Gazipur, Dhaka  
(+23.965735N, 90.285605E)

13 & 26 April 2014

# Observations

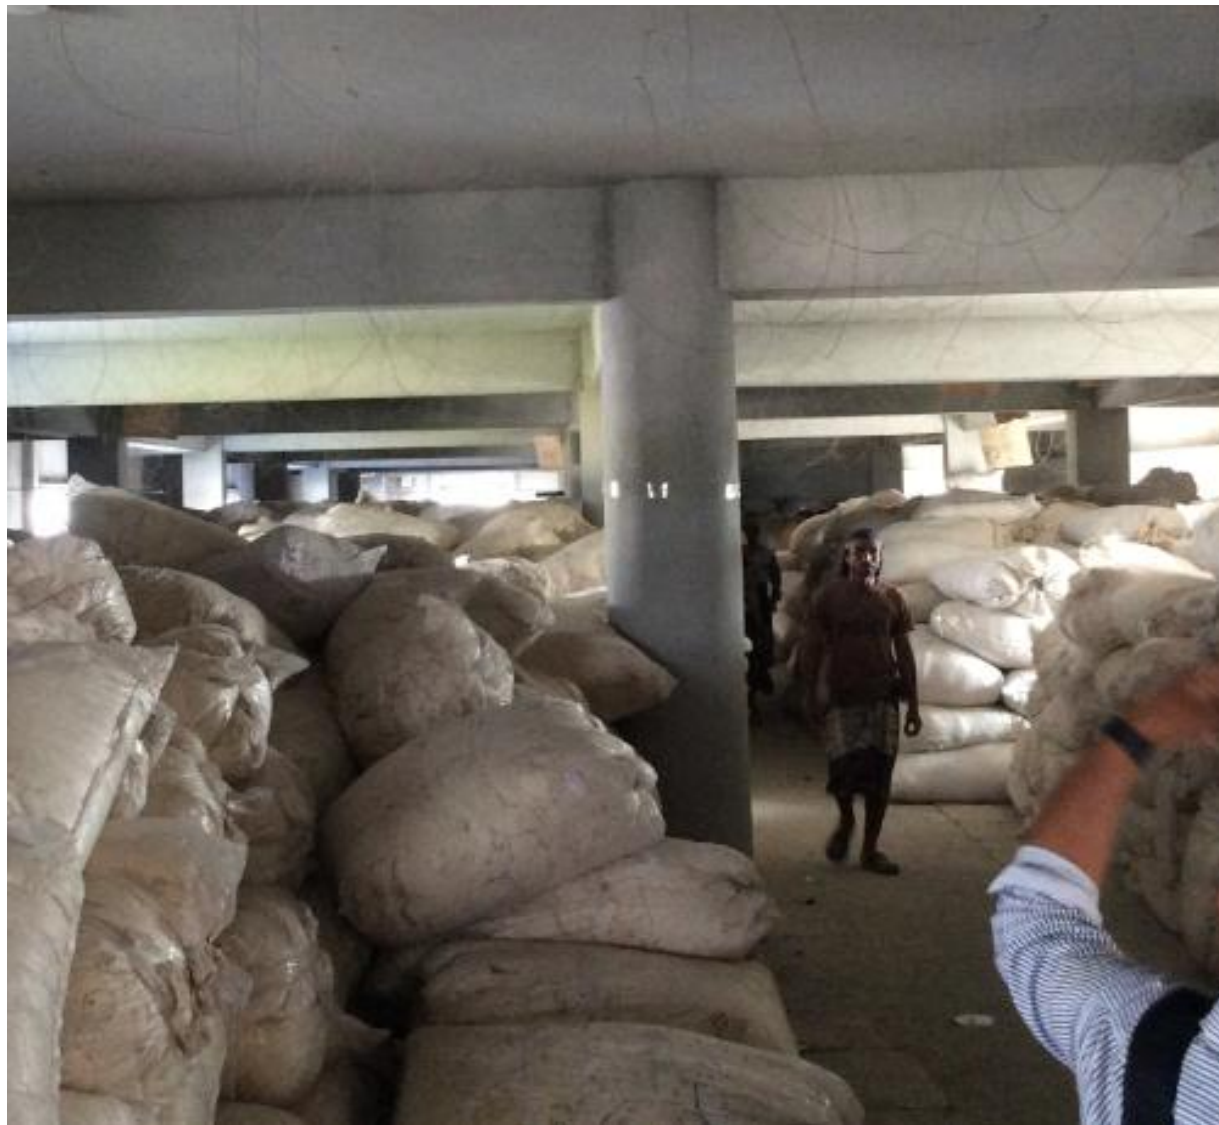
**Building 4- High stress in columns**

# **Building 4 - High stress in columns requires immediate review and the preparation of a Detail Engineering Assessment**

Cursory calculations indicate that columns within Building 4 are highly stressed and require immediate review.

A Detail Engineering Assessment of Building 4 is required (See attached Scope). Building Engineer is to perform detailed calculations based on as constructed dimensions and concrete tests to prove column size and (if required) :

- Reduce loads by vacating floors and removing additional structures
- Reinforce columns

Item No.	Observation	Recommended Action Plan	Recommended Timeline
1	Building 4 - High stress in columns requires immediate review and the preparation of a Detail Engineering Assessment	Building Engineer to review design, loads and column stresses in production Building 4.	<b>Immediate - Now</b>
2	Building 4 - High stress in columns requires immediate review and the preparation of a Detail Engineering Assessment	Verify in-situ concrete strengths either by cores or existing cylinder strength data for ground floor columns or by taking cores from 4 columns in Building 4.	<b>Immediate - Now</b>
3	Building 4 - High stress in columns requires immediate review and the preparation of a Detail Engineering Assessment	A Detail Engineering Assessment of Building 4 only to be commenced, see attached Scope.	<b>Immediate - Now</b>
4	Building 4 - High stress in columns requires immediate review and the preparation of a Detail Engineering Assessment	Produce and actively manage a loading plan for all floor plates within the factory giving consideration to floor capacity and column capacity.	<b>6-weeks</b>

5	Building 4 - High stress in columns requires immediate review and the preparation of a Detail Engineering Assessment	Detail Engineering Assessment to be completed for Building 4.	<b>6-weeks</b>
6	Building 4 - High stress in columns requires immediate review and the preparation of a Detail Engineering Assessment	Continue o implement load plan	<b>6-months</b>

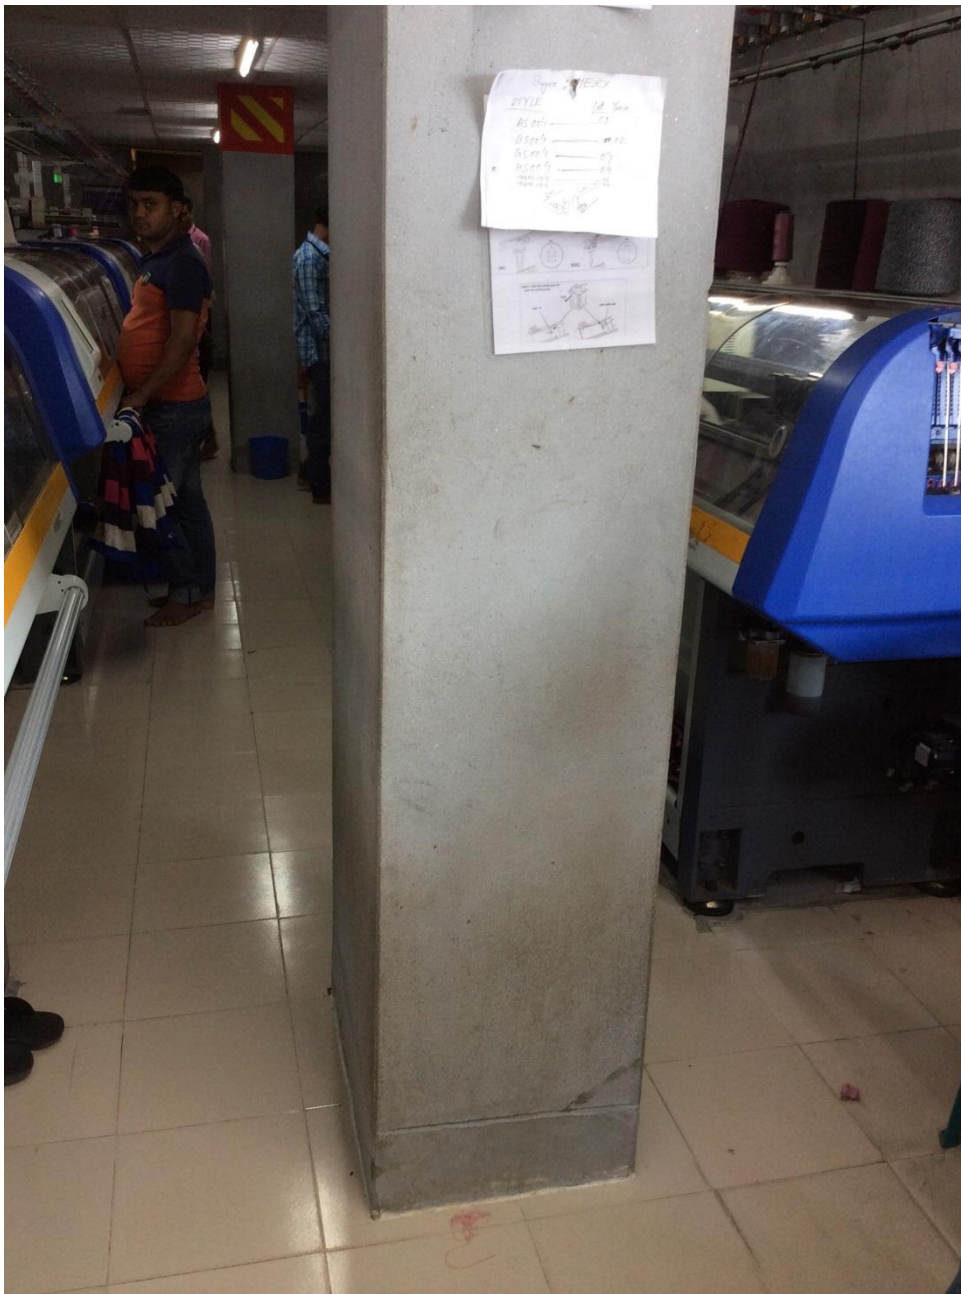
**Building 3- Column Stresses**

# **Building 3 – Columns are stressed in excess of normal design levels**

Outline calculations indicate that columns within Building 3 are stressed in excess of the normal design levels. Building Engineer is to perform detailed calculations based on as constructed dimensions and concrete tests to prove column size and (if required) :

- Reduce loads by vacating floors and removing additional structures
- Reinforce columns

Item No.	Observation	Recommended Action Plan	Recommended Timeline
7	Building 3 – Columns are stressed in excess of normal design levels	Factory Engineer to review design, loads and column stresses in Building 3 as identified above.	6-weeks
8	Building 3 – Columns are stressed in excess of normal design levels	Verify in-situ concrete strengths either by cores or existing cylinder strength data for ground floor columns or by taking cores from 4 columns in Building 3.	6-weeks
9	Building 3 – Columns are stressed in excess of normal design levels	Produce and actively manage a loading plan for all floor plates within the factory giving consideration to floor capacity and column capacity.	6-months
10	Building 2 - High stress in columns	Factory Engineer to review design, loads and columns stresses in area identified above.	6-weeks
11	Building 2 - High stress in columns	Verify insitu concrete stresses either by existing cylinder strength data for by 100mm dia. cores from 4 columns.	6-weeks

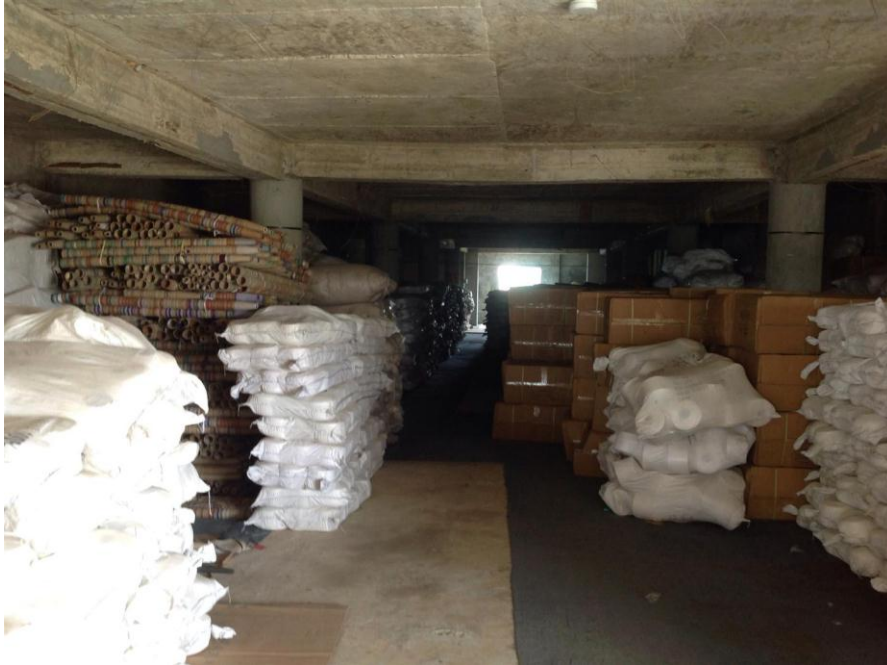
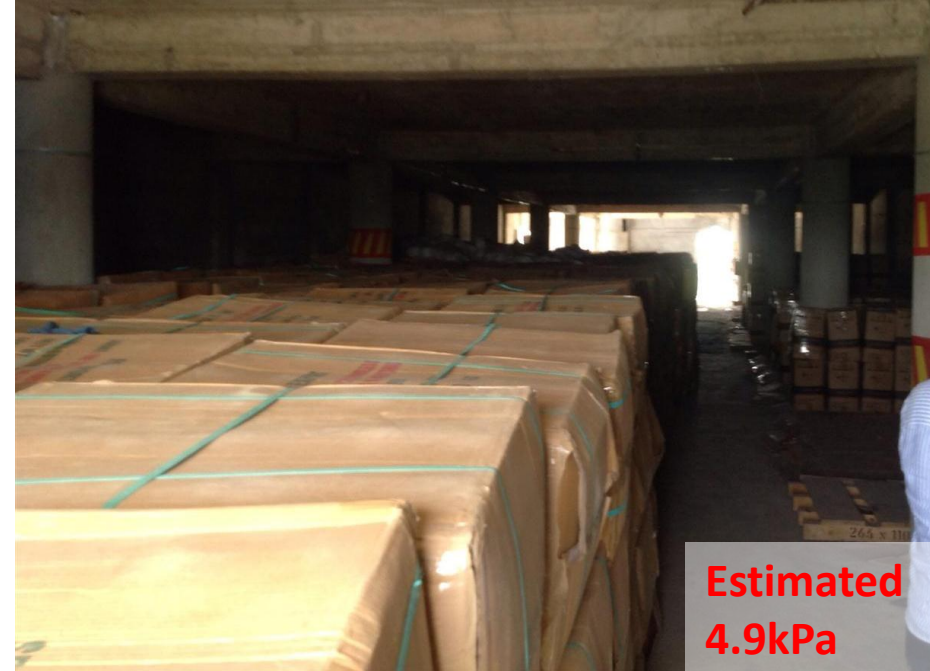
# Building 2 - High stress in columns

Storage loading within Building 2 on upper floors. Estimated loading in areas up to 4.9kPa. Cursory calculations indicate that column stresses are fairly high.

12	Building 2 - High stress in columns	Produce and actively manage a loading plan for all floor plates within the factory giving consideration to floor capacity and column capacity.	6-months
13	Inadequacy of steel stairs around and within buildings	All steel stair structures within the complex to be reviewed and assessed for adequacy by Building Engineers. Strength, stability and detailing of connections to other structures to be considered.	6-weeks
14	Inadequacy of steel stairs around and within buildings	A fire evacuation scenario to be used to determine loading requirements on all stairs.	6-weeks
15	Inadequacy of steel stairs around and within buildings	Strengthening works to steel stair structures as required by Building Engineer assessment to be completed.	6-months

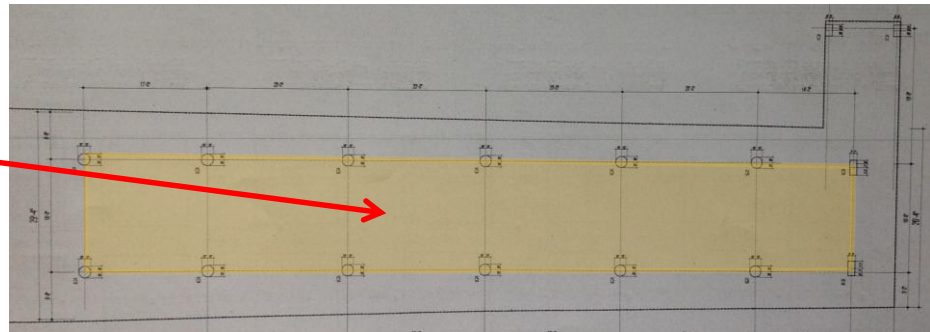
Large water tank on roof of Building 2 (currently empty). Factory management indicate no intention to fill this tank. Tank should remain empty until checks completed.

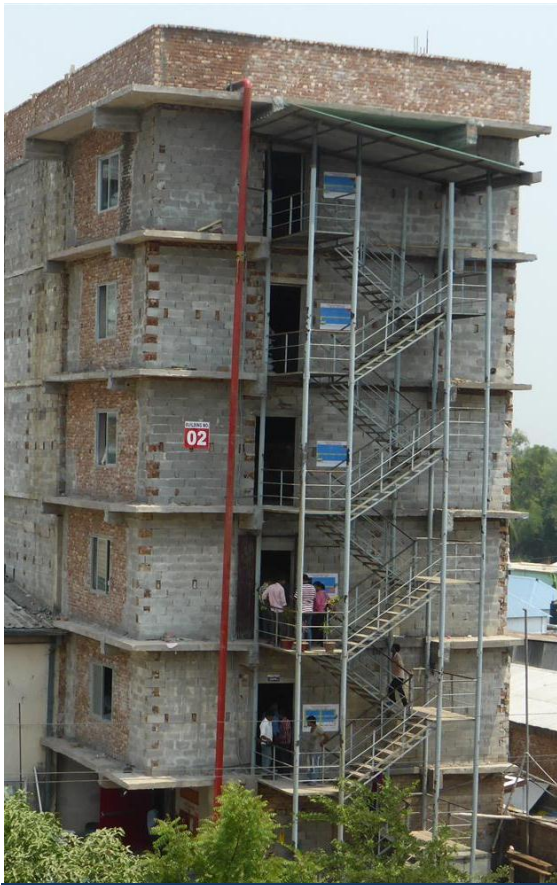
**Escape stairs to Building 2**

**Numerous steel stairs around and within buildings which appear to be non-engineered.**

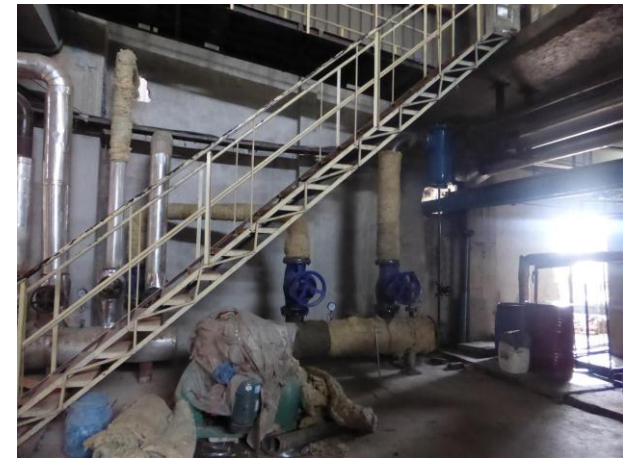
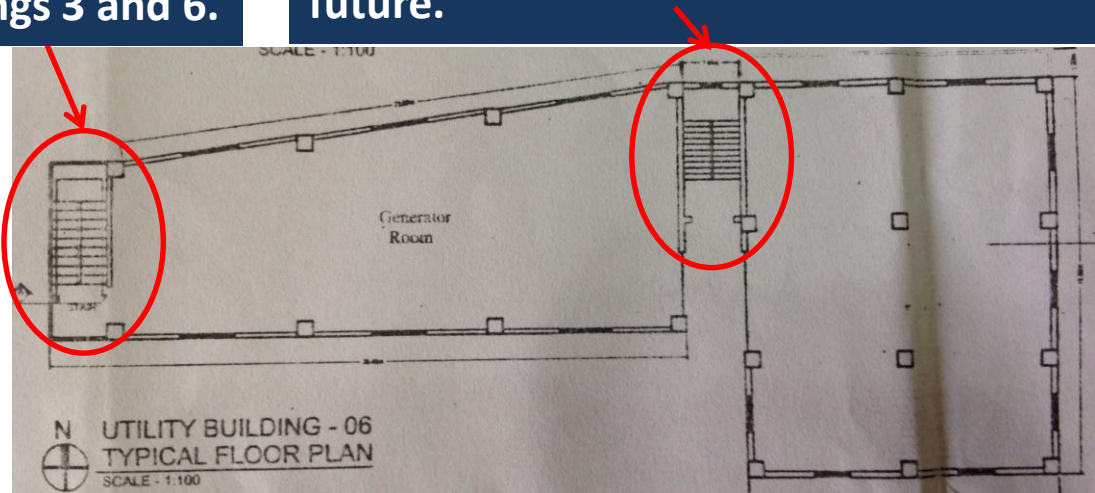
**Steel escape stairs provided between Buildings 3 and 6.**

**Stairs within Building 6 not constructed. Factory management indicate this will be constructed in future.**

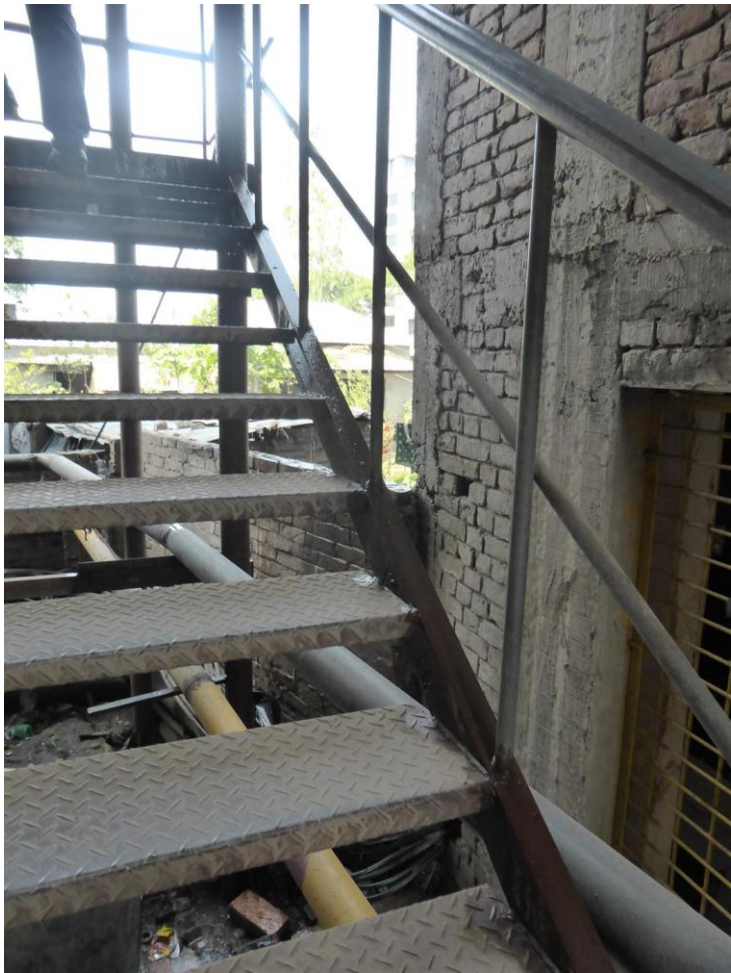
Some evidence of minor corrosion to steelwork. Water flowing down stairs between Building 3 and Building 6.

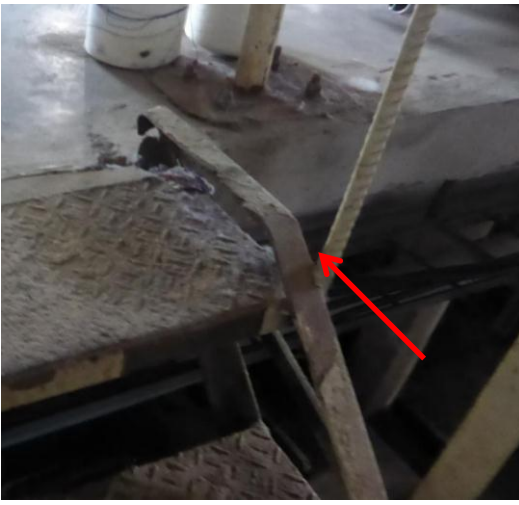
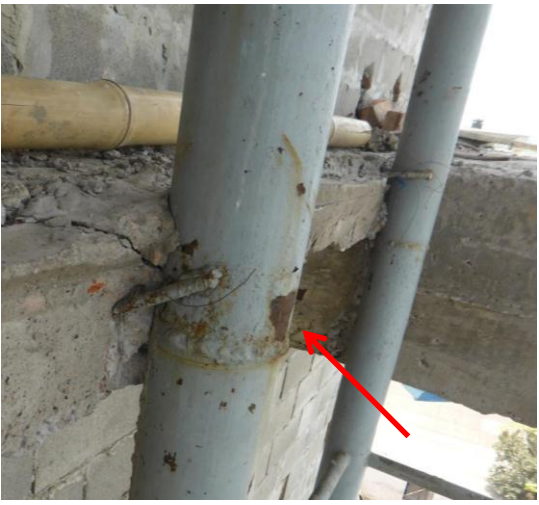
Stairs have limited independent lateral stability systems and poor connections to neighbouring buildings.

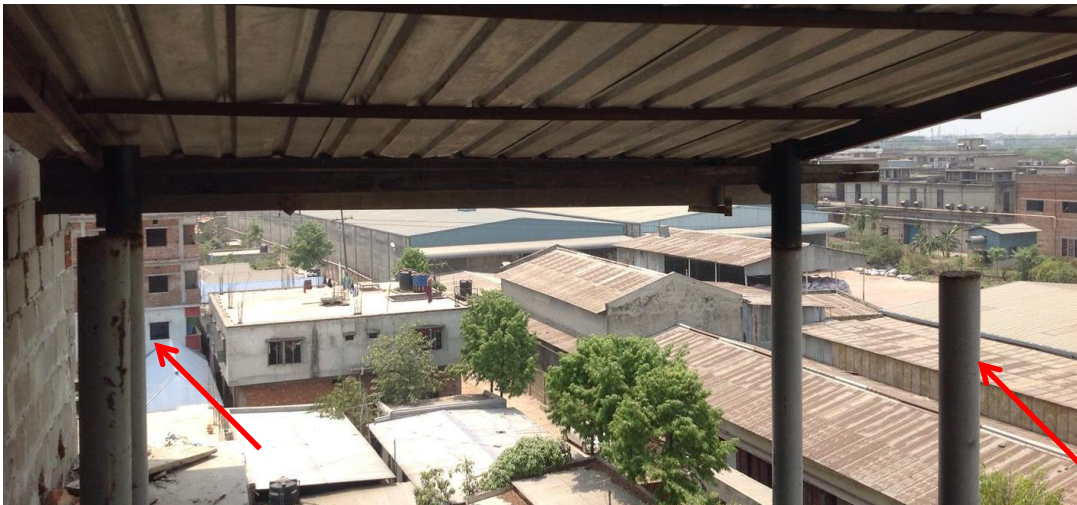
Fire escape stairs adjacent to Building 3 has no apparent lateral stability system and is not tied into the Building 3 structure.

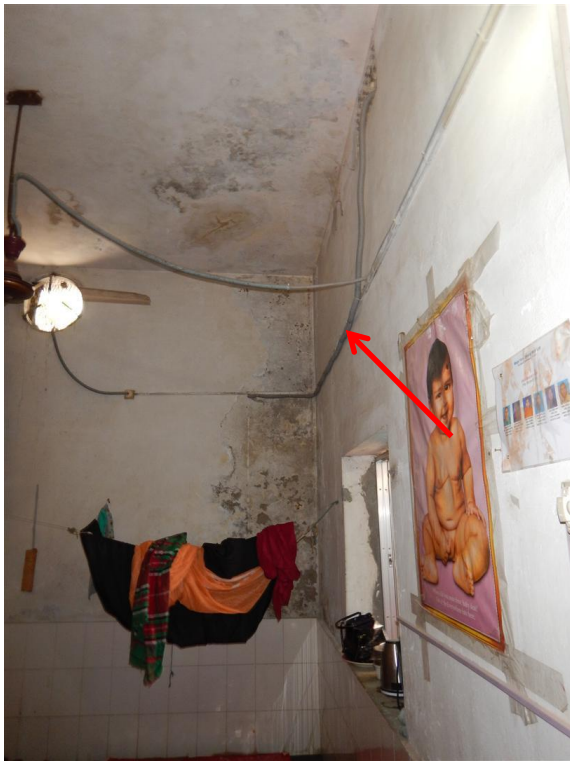
Areas of dampness observed on walls and ceiling of Crèche/Doctor's Room. Solid concrete water tank located directly above.

Item No.	Observation	Recommended Action Plan	Recommended Timeline
16	Structural cracking in Doctor's Room and Crèche	Empty water tank above and do not use until Building Engineer has reviewed the building and any strengthening works are complete.	6-weeks
17	Structural cracking in Doctor's Room and Crèche	Building Engineer to identify all cases of cracking and distress of structural elements in the Doctor's Room and Crèche. Strength and integrity of existing structural elements to be assessed.	6-weeks
18	Structural cracking in Doctor's Room and Crèche	Strengthening works and crack repairs to be implemented, as necessary, to Building Engineer's details.	6-weeks
19	Structural cracking in Doctor's Room and Crèche	Strengthening works and crack repairs to be completed.	6-months
20	Structural cracking in Doctor's Room and Crèche	Continue to monitor cracking and signs of element distress in this area.	6-months

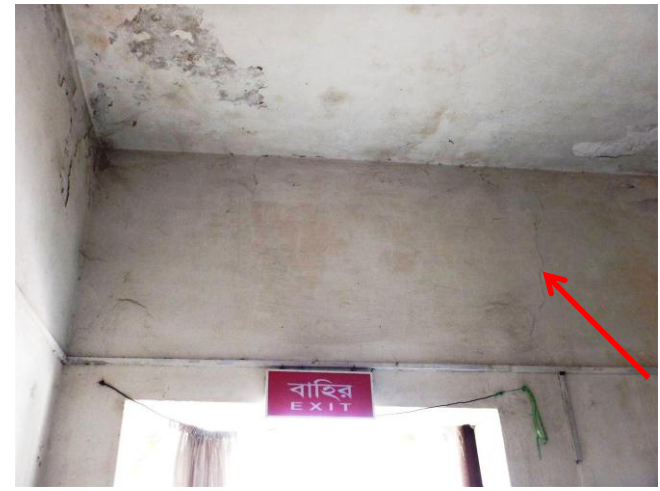
Structural cracking observed in beam in Doctor's Room.

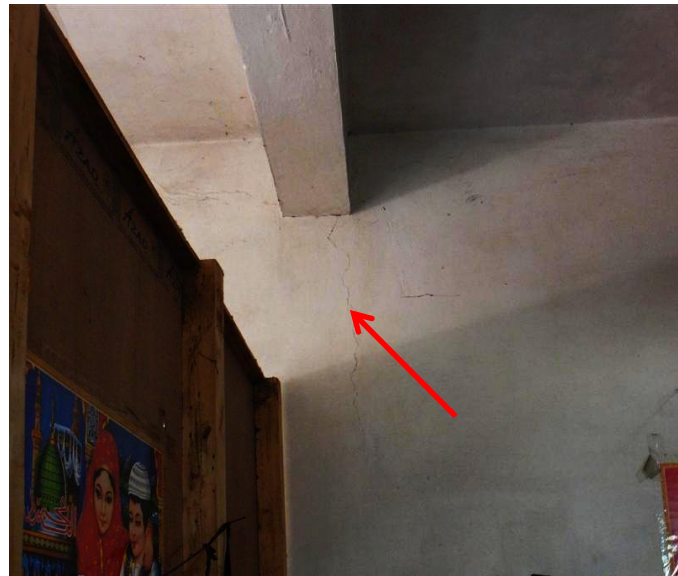
Structural cracking observed in column in Crèche/Doctor's Room.

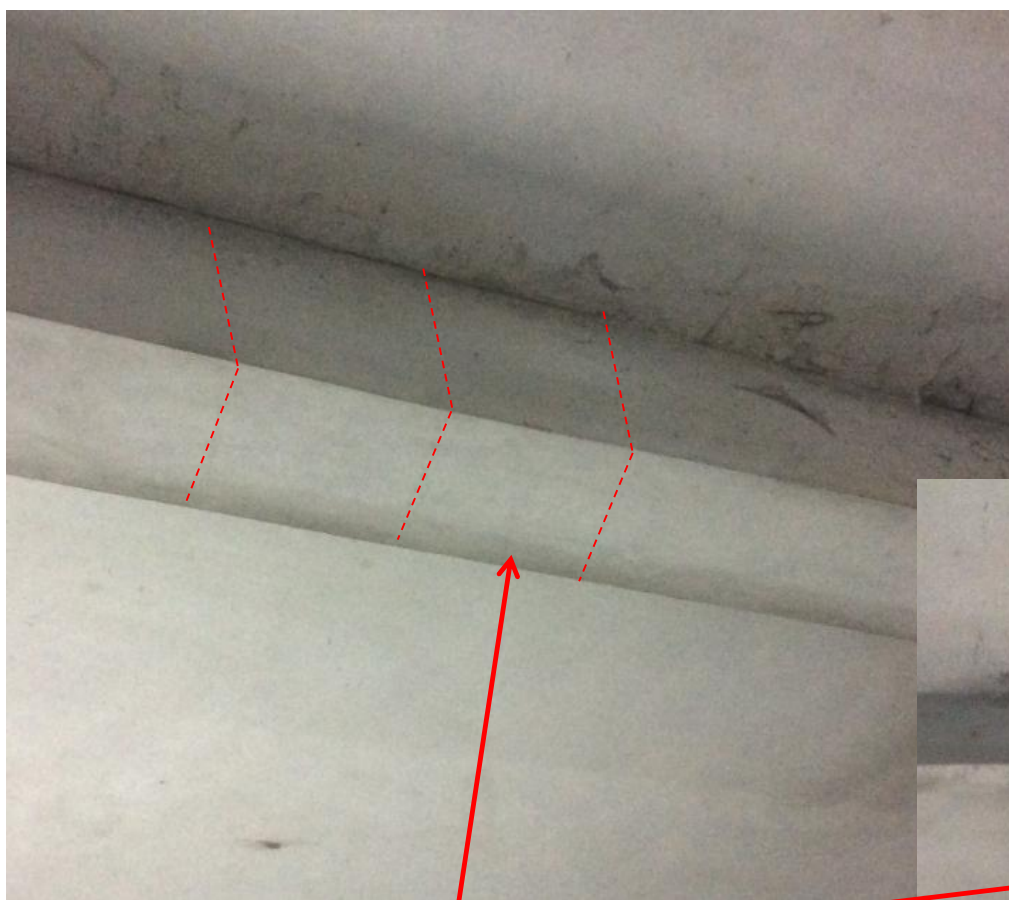
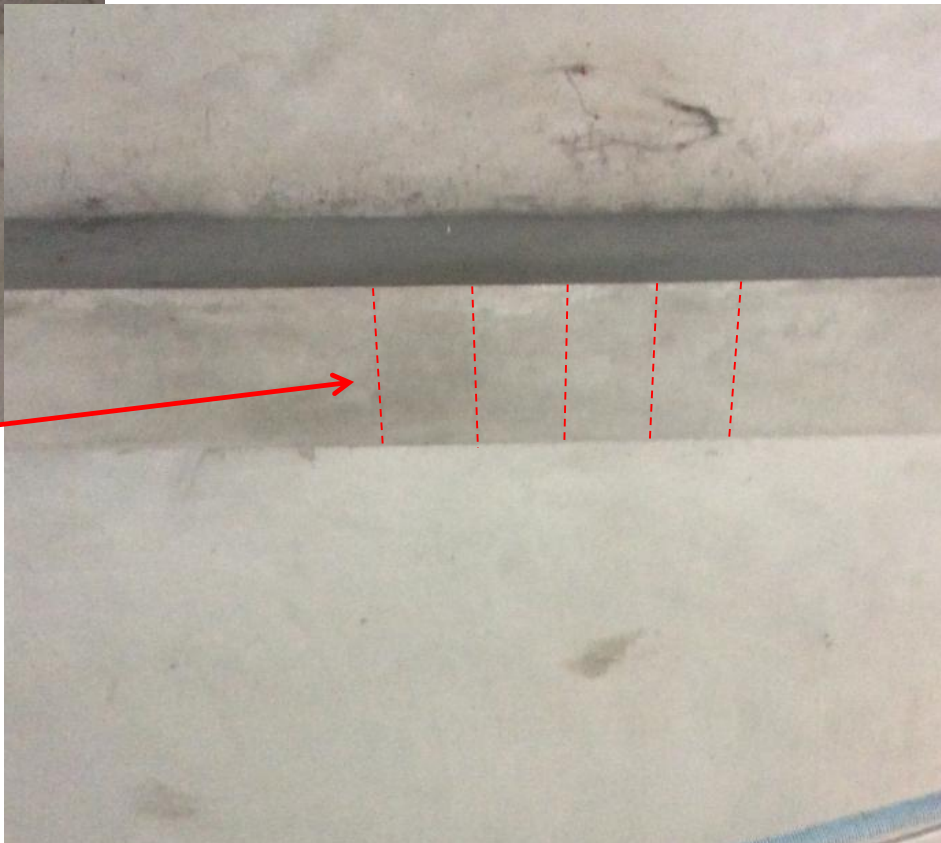
## **Cracking in Beams**

# **Building 4 - Cracking of beams on the underside of 1<sup>st</sup> floor**

**Cracking at mid-span in beams in Building 4 at underside of 1<sup>st</sup> floor. Building Engineer to investigate cause of cracks and to inspect if cracks go through plaster to the structure.**

21	Building 4 - Cracking of beams on the underside of 1st floor	Monitor cracks in beams. Conduct regular inspection of cracks. Investigate if cracks are only in the plastering.	6-months
22	Building 4 - Cracking of beams on the underside of 1st floor	If cracks grow larger, remove all items above the beams and close working areas below the affected areas. Engage an engineer to investigate, repair and strengthen the beam.	6-months
23	Building Engineer to inspect the columns under the ground floor of Building 3 once the reservoir has been drained.	Reservoir to be drained to undertake annual inspections to satisfy the Building Engineer that corrosion is not occurring. After this time, if no corrosion is present, inspections to be at a less frequent period of 3-5 years.	6-months
24	Building Engineer to inspect the columns under the ground floor of Building 3 once the reservoir has been drained.	Due attention to safety of inspection when undertaking assessment of reservoir columns in confined space.	6-months

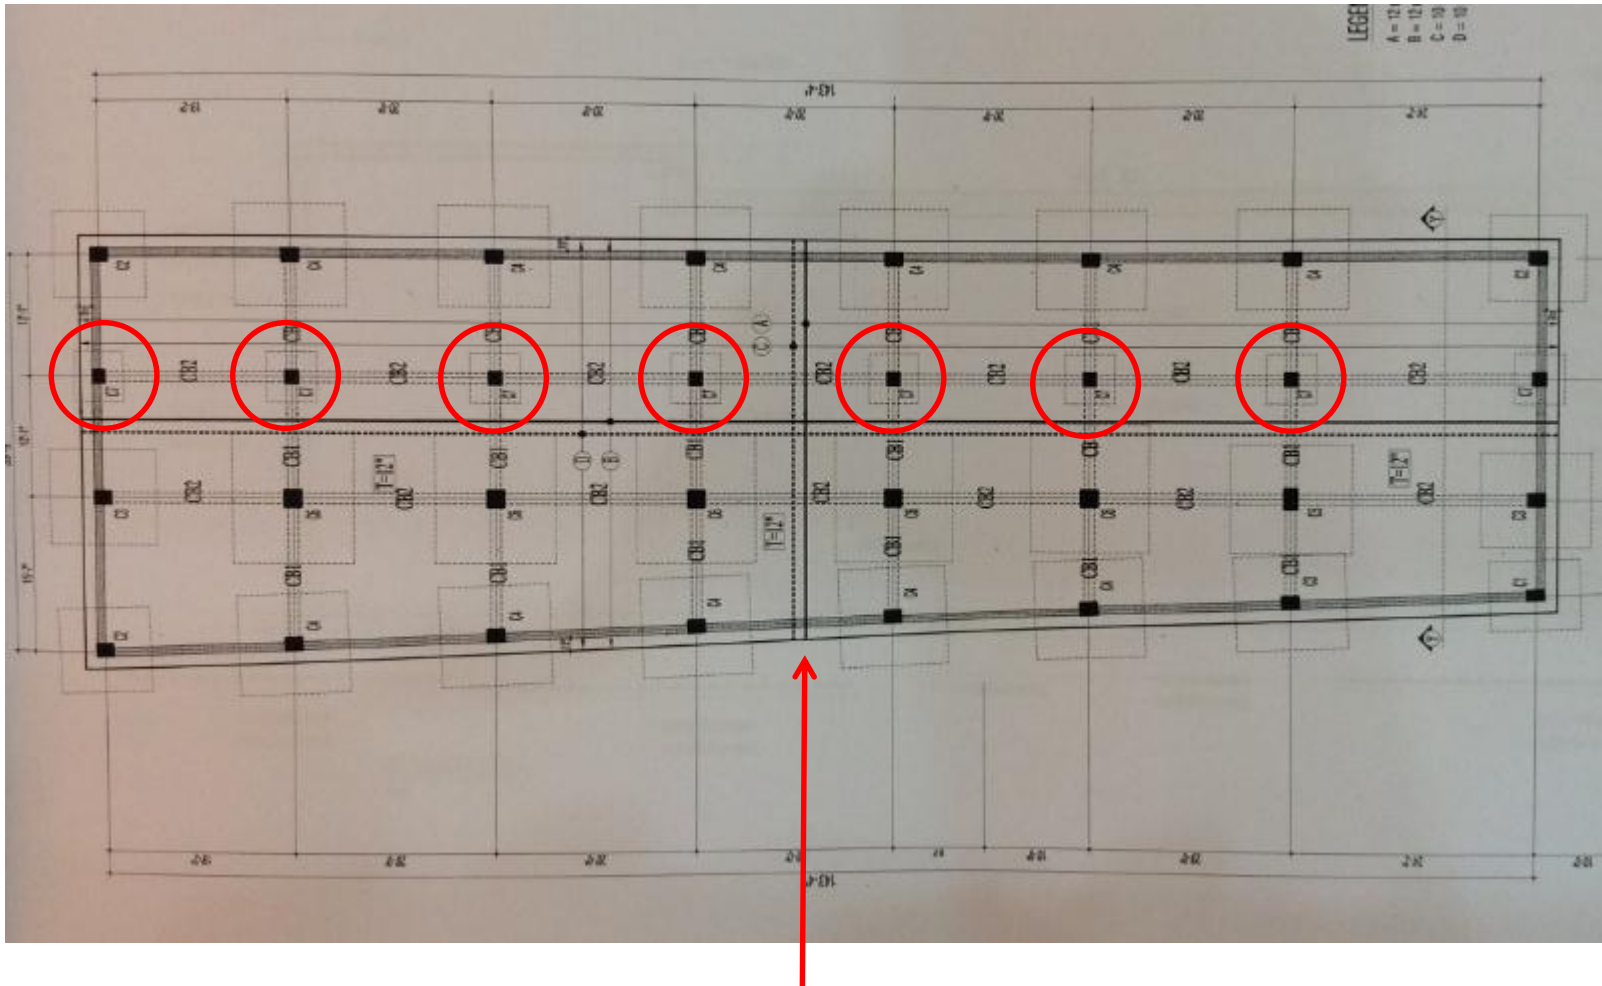
# **Building 3 – No access for inspection of columns within reservoir below ground floor level**

Large reservoir located under the entire footprint of the ground floor. Additional columns to support the slab below ground floor noted in red. This reservoir was concreted over, by the ground floor slab, so no access was available to inspect. We recommend that the reservoir is periodically drained for a Building Engineer to inspect these columns

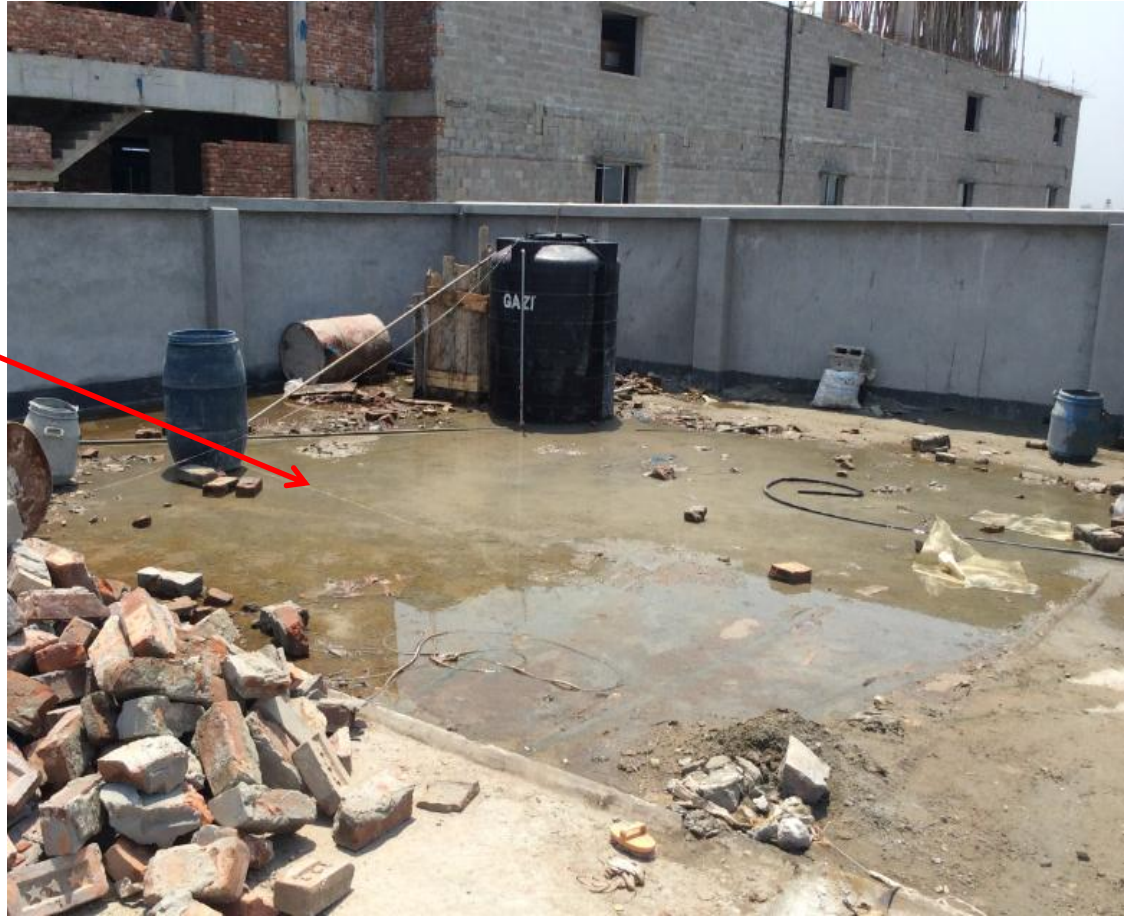
**Building 3 – Water pooling on roof**

**Water pooling on roof due to lack of drainage routes and leak in water tank.**

**Building Engineer to review and ensure that**

- Debris is cleared from roof
- Roof weatherproofing is provided
- A roof drainage system is provided

Item No.	Observation	Recommended Action Plan	Recommended Timeline
25	Roof of Building 3: Water accumulation and leaking with potential to cause corrosion and lasting damage to roof slab. Parapet wall works to be completed.	Repair leaks in water tanks.	6-months
26	Roof of Building 3: Water accumulation and leaking with potential to cause corrosion and lasting damage to roof slab. Parapet wall works to be completed.	Roof weatherproofing to be provided	6-months
27	Roof of Building 3: Water accumulation and leaking with potential to cause corrosion and lasting damage to roof slab. Parapet wall works to be completed.	Building Engineer to inspect drainage routes to ensure they are functioning properly.	6-months
28	Roof of Building 3: Water accumulation and leaking with potential to cause corrosion and lasting damage to roof slab. Parapet wall works to be completed.	Parapet wall works to be completed	6-months

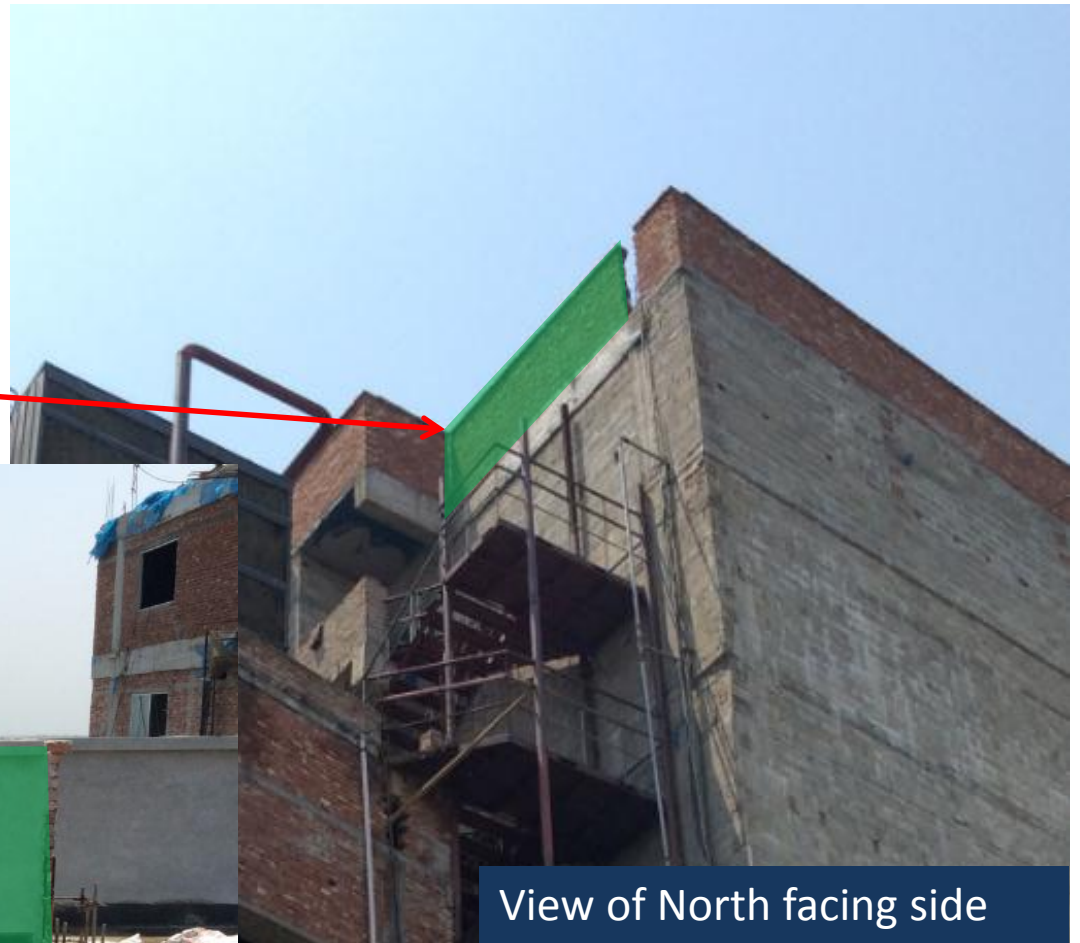
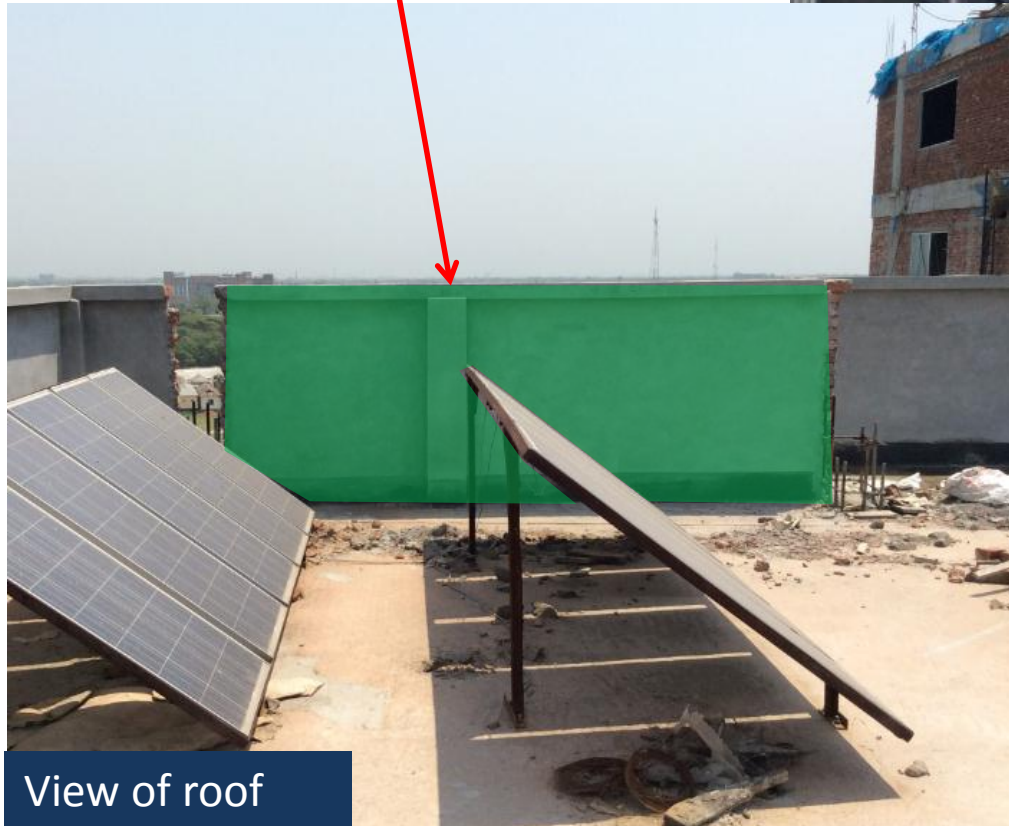
## Building 3 - Parapet wall

Work to parapet wall to be completed by removing highlighted area to give access to roof from stairs.

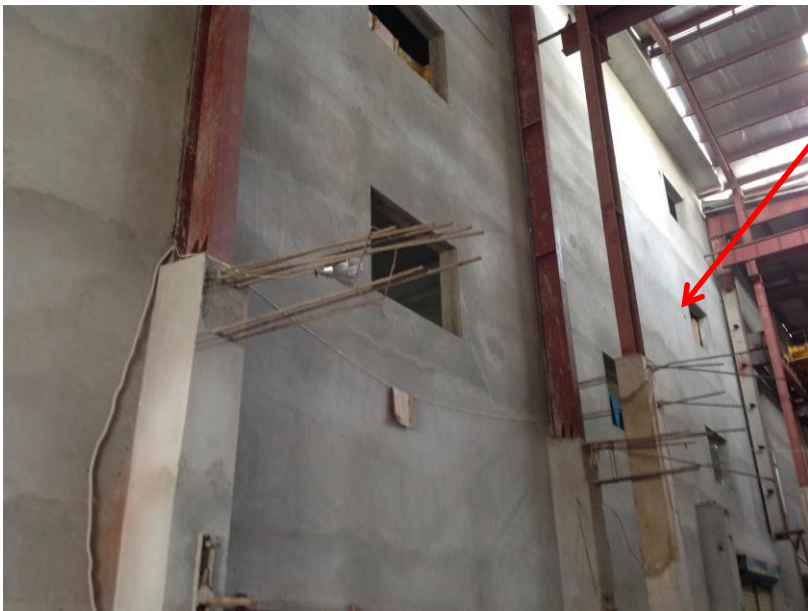
Building 5 steelwork supported on Building 4 columns, but do not appeared to be tied in. Concrete beams have not been cast.

29	Unclear lateral stability systems in Building 5 and Building 9	Building Engineer to review overall building stability systems in Building 5 and Building 9.	6-months
30	Unclear lateral stability systems in Building 5 and Building 9	Strengthening works for buildings to be implemented as necessary, to Building Engineer's details.	6-months

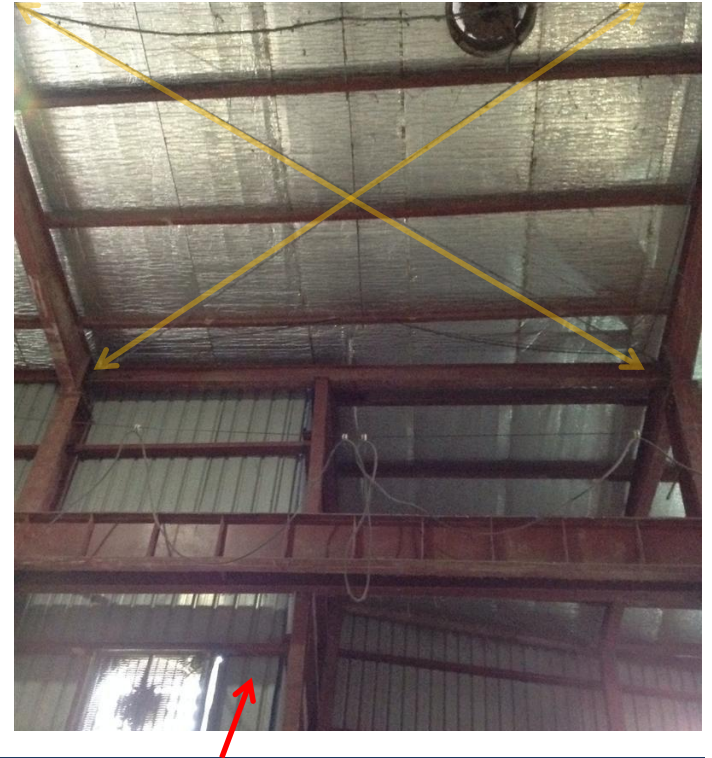
Unclear lateral stability system in Building 5 (dyeing shed). Plan bracing does not coincide with vertical braced bay. Generally well engineered steelwork otherwise.

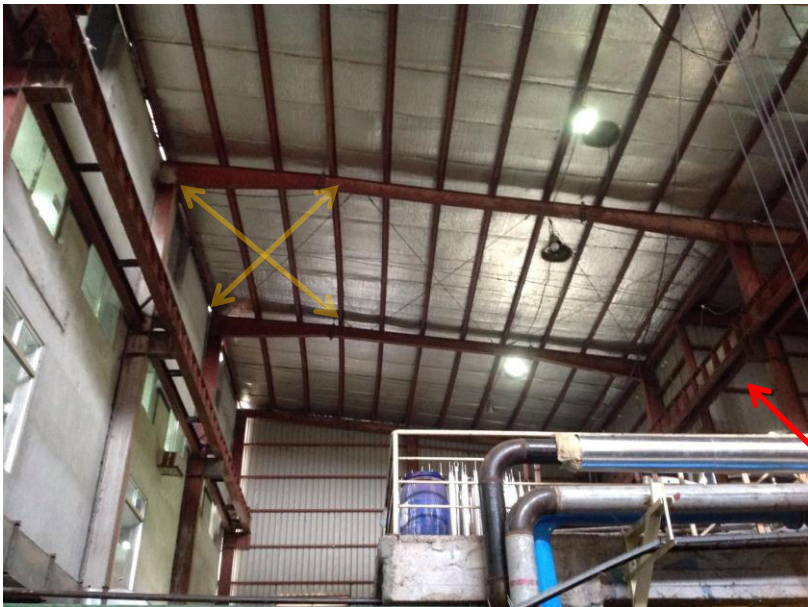
Unclear lateral stability system in Building 5

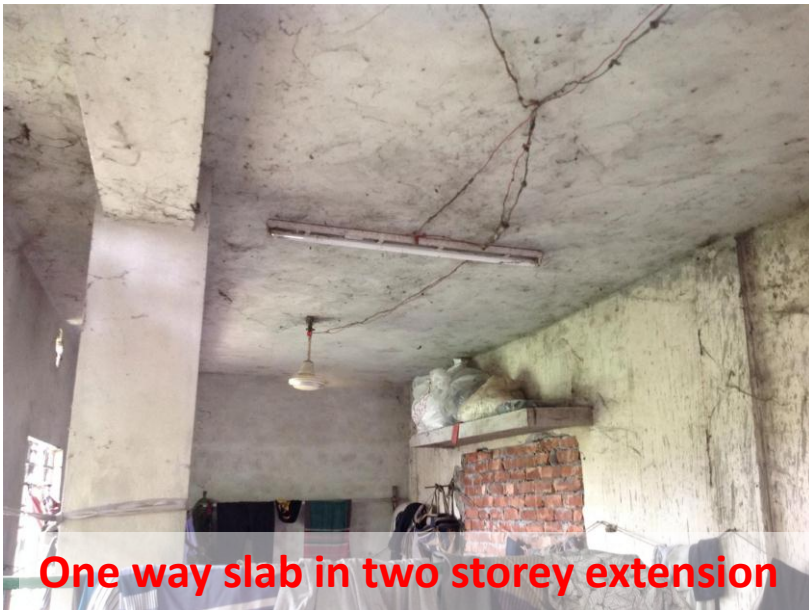
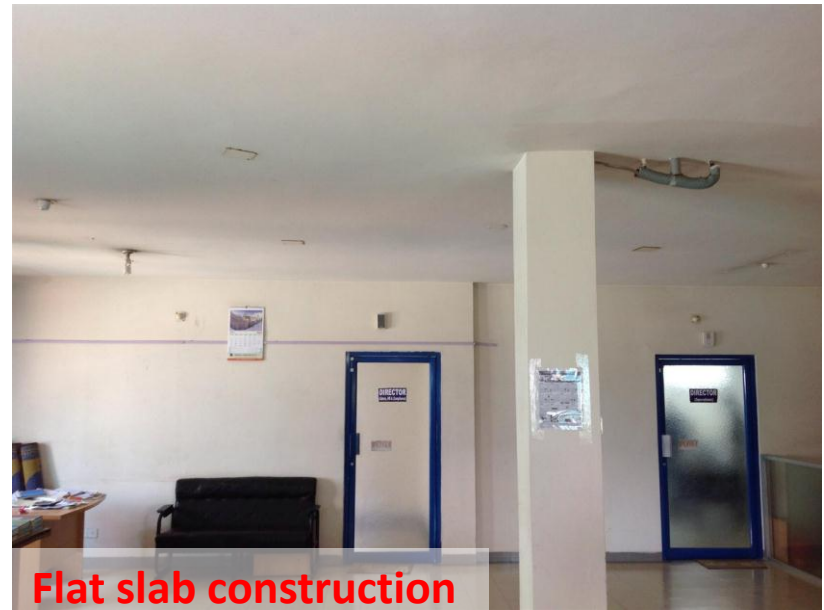
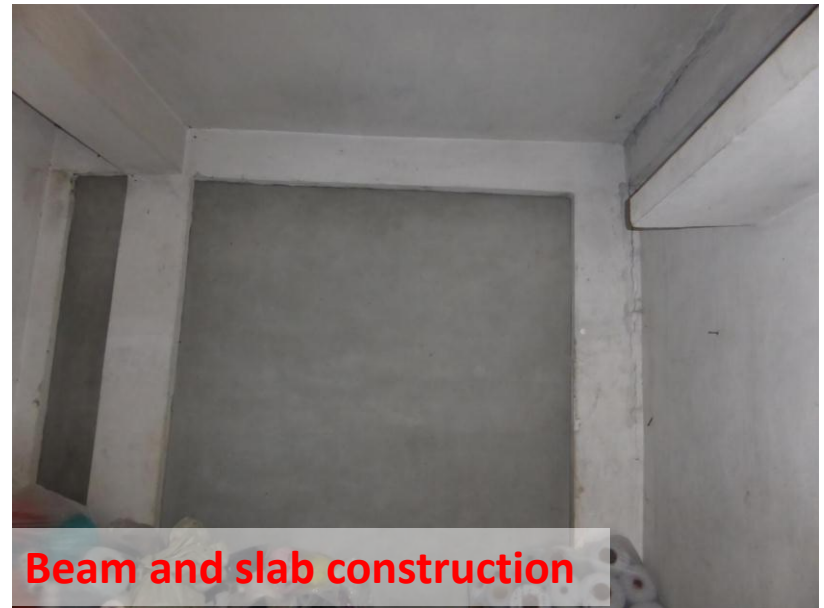
**Unclear lateral stability system in Building 9 (office) for mix of 'beam and slab' and 'flat slab' construction for main building and 'one way slab' for two storey extension.**

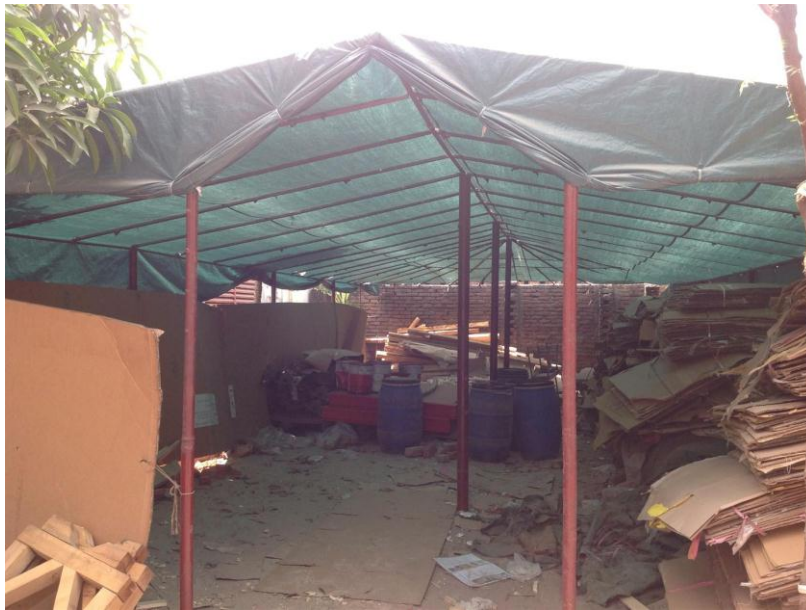
**Fabric roof with no plan bracing. No apparent stability system for storage building.**

Item No.	Observation	Recommended Action Plan	Recommended Timeline
31	Non-engineered structures within the complex	Building Engineer to undertake structural assessment of all sheds and outbuildings within complex and specify upgrades as required to meet code vertical and wind loading.	6-months
32	Non-engineered structures within the complex	All sheds and outbuildings connected to factory buildings to be documented on as built drawings.	6-months
33	Settlement of office building and ETP tank	Trial pit to be dug to establish footing of extensions to office building and ETP tank and Building Engineer to assess whether foundation is adequate	6-months
34	Settlement of office building and ETP tank	Remedial works to foundations and/or cracking, where required, to be developed to Building Engineer's details.	6-months
35	Settlement of office building and ETP tank	Continue to monitor settlement and cracking in and around Building 9 and ETP as required.	6-months

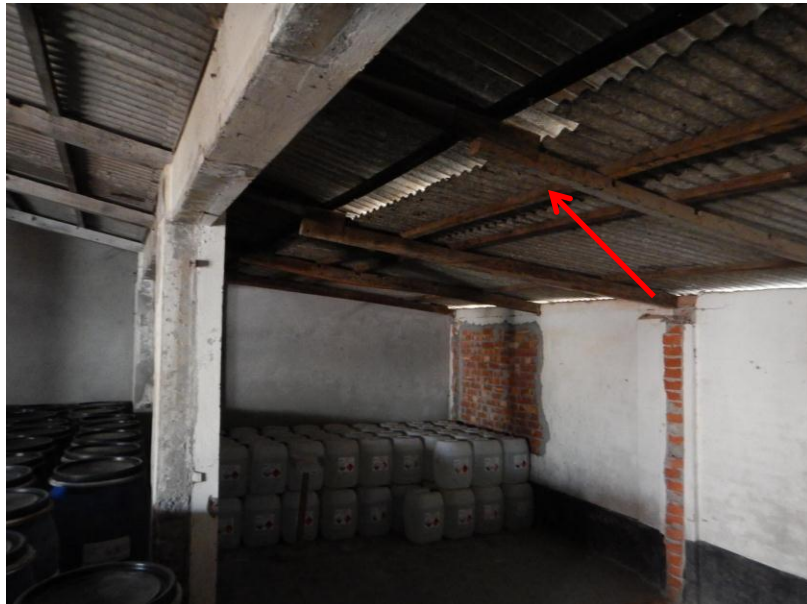
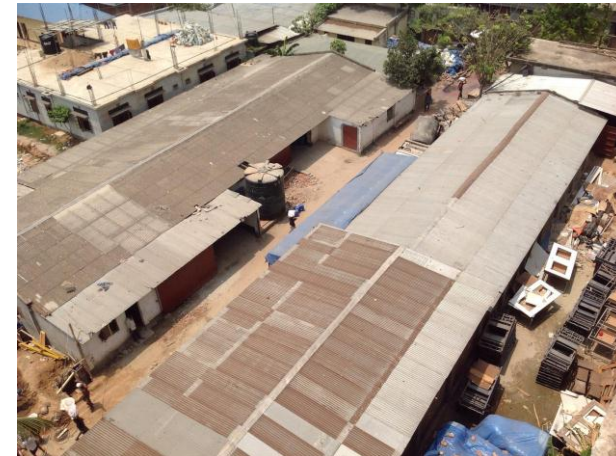
**Lightweight roofs with no apparent stability system. Roofs susceptible to wind uplift due to inadequate holding down connections.**

**Numerous non-engineered sheds and outbuildings observed within the complex. Generally to south of site.**

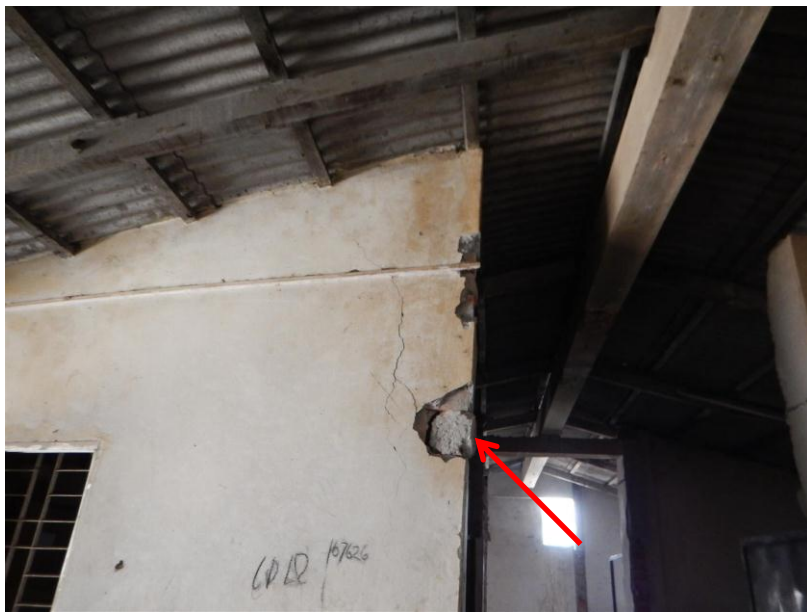
Masonry piers used to support concrete beams.
