# Mega Dyeing Ltd.

Shardagonj, Gabindabari, Joydevpur, Gazipur, Dhaka  
(+23.965735N, 90.285605E)

13 & 26 April 2014

# Observations

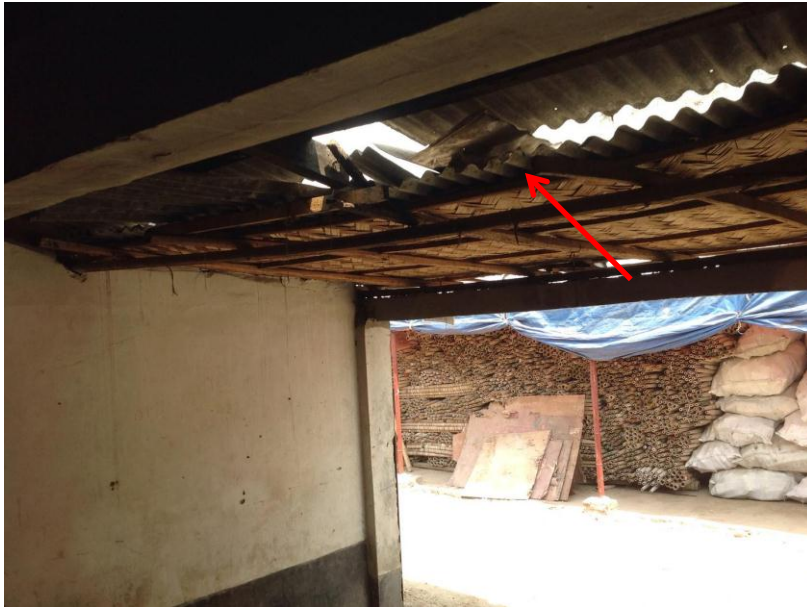
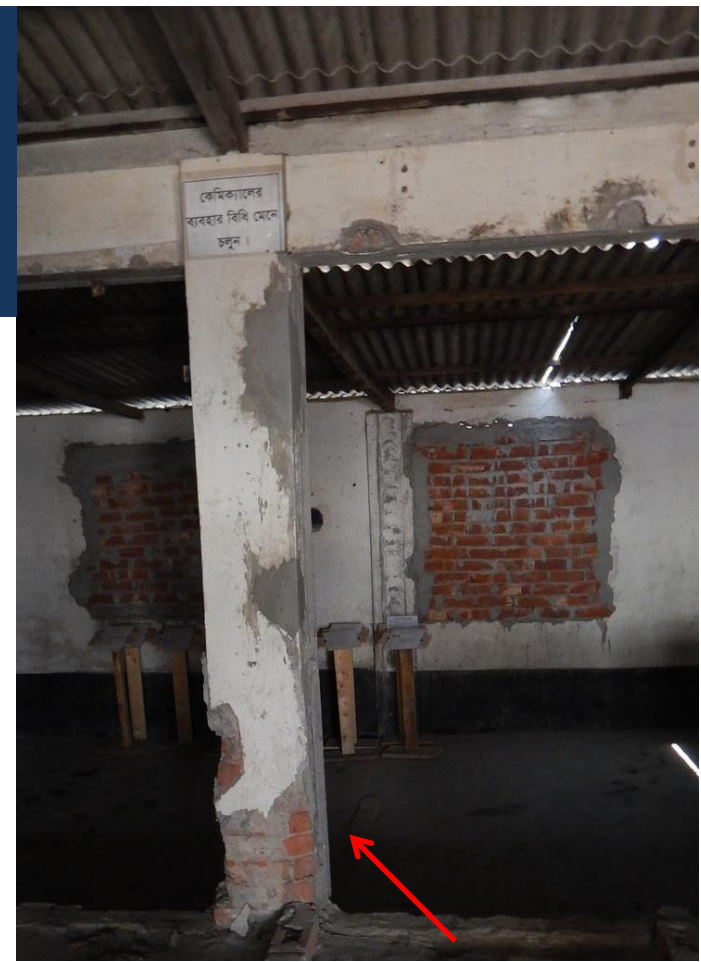
Poor maintenance to buildings within the complex.

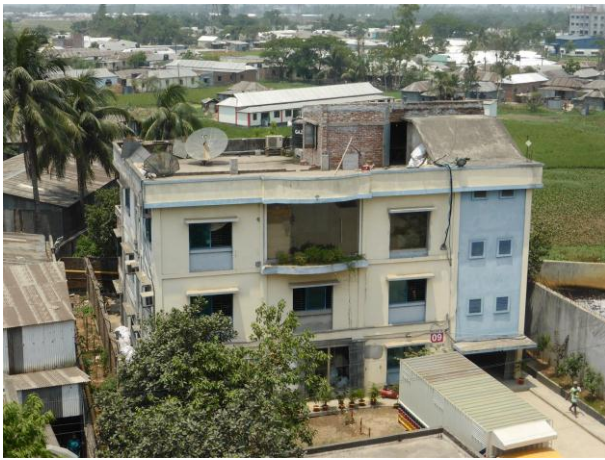
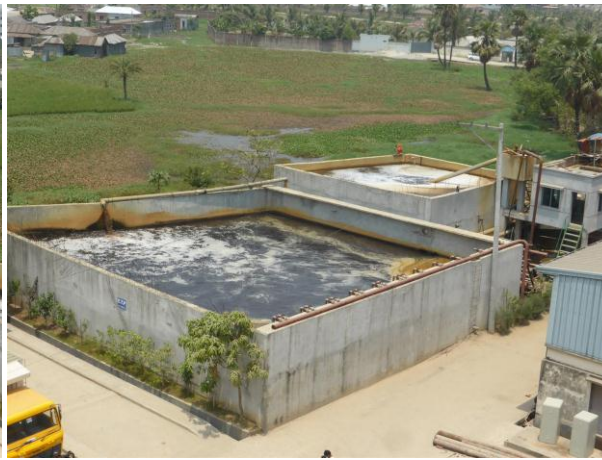
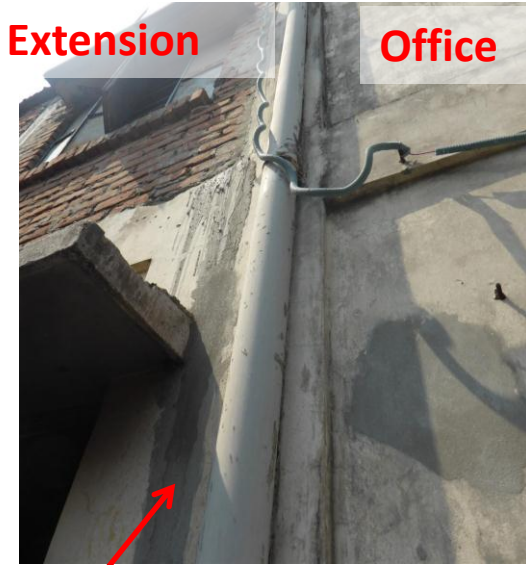
Marsh land observed to rear of office and ETP.

Evidence of settlement of outbuildings at rear of office building and of ETP tank. Cracking at joints between structures.

Item No.	Observation	Recommended Action Plan	Recommended Timeline
31	Non-engineered structures within the complex	Building Engineer to undertake structural assessment of all sheds and outbuildings within complex and specify upgrades as required to meet code vertical and wind loading.	6-months
32	Non-engineered structures within the complex	All sheds and outbuildings connected to factory buildings to be documented on as built drawings.	6-months
33	Settlement of office building and ETP tank	Trial pit to be dug to establish footing of extensions to office building and ETP tank and Building Engineer to assess whether foundation is adequate	6-months
34	Settlement of office building and ETP tank	Remedial works to foundations and/or cracking, where required, to be developed to Building Engineer's details.	6-months
35	Settlement of office building and ETP tank	Continue to monitor settlement and cracking in and around Building 9 and ETP as required.	6-months

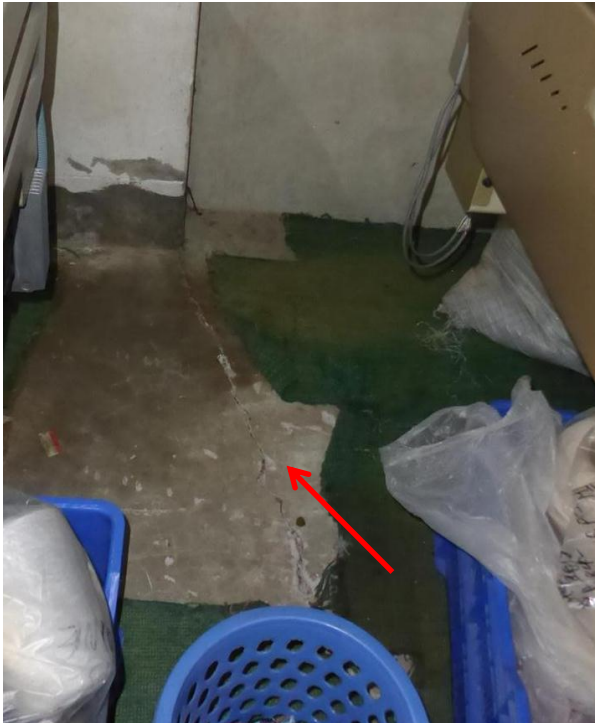
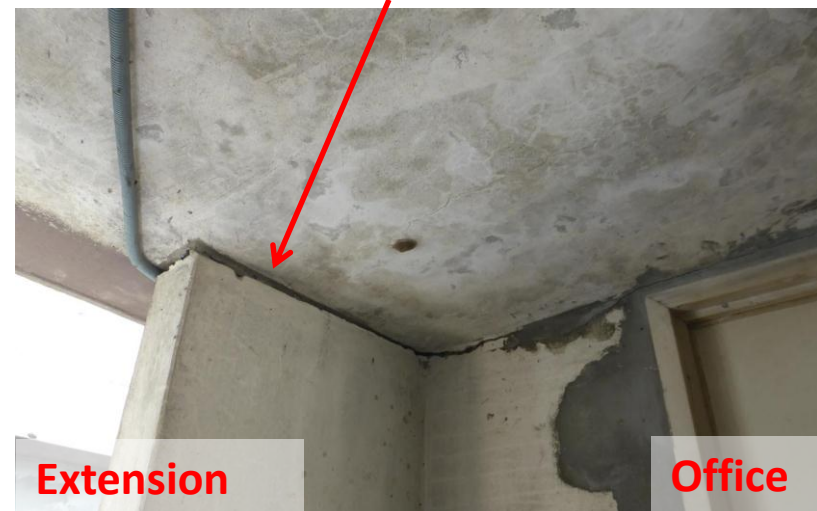
Cracking to ground bearing slabs observed in Building 9 (office) and noticeable deflections in ground floor slab.

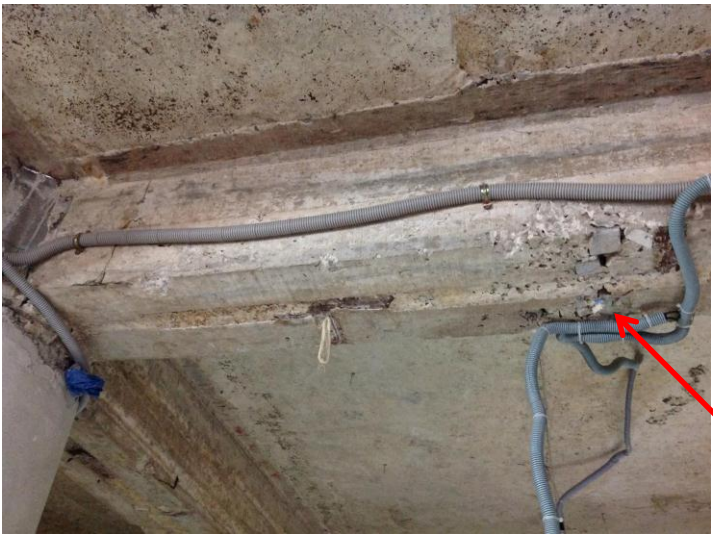
**Rough finish to concrete – slab soffits, beams and columns. Rust staining on soffits.**

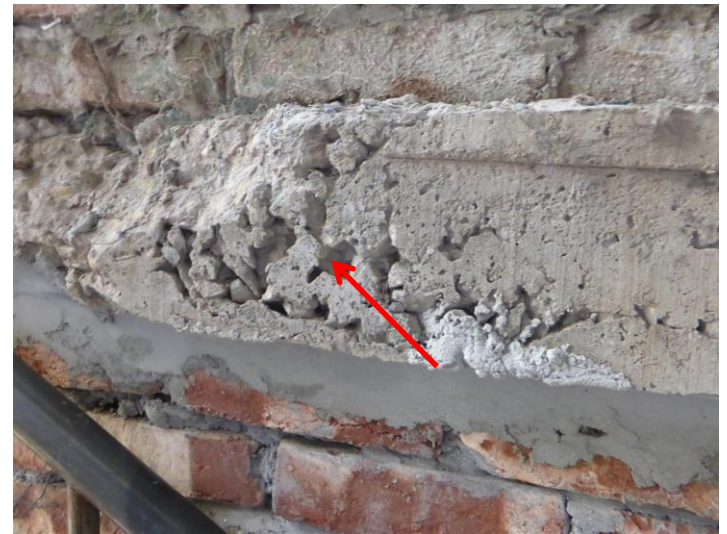
**Poor compaction of concrete in columns and other structural elements observed.**

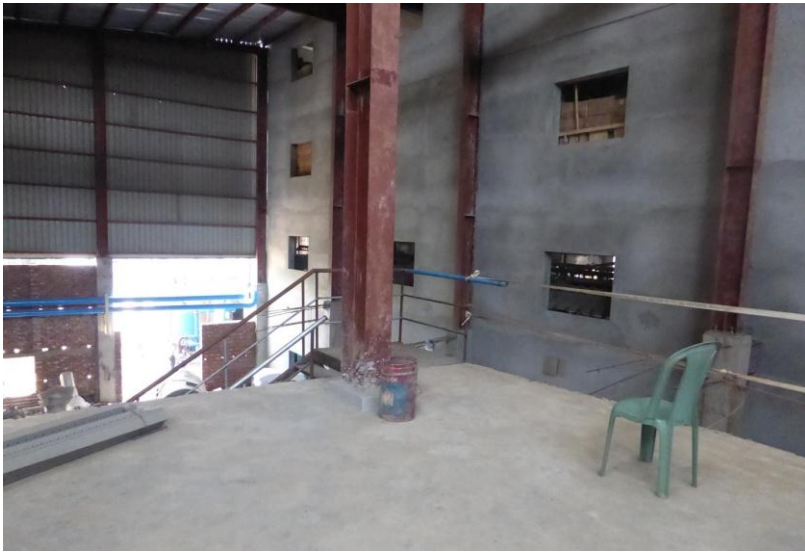
**Unprotected open edges at mezzanine level in Building 5.**

36	Non-structural observations	All open edges around mezzanines and on walkway structures to be provided with edge protection – kick plates and handrails to Building Engineer's specifications.	6-months
37	Non-structural observations	All open gulleys, channels and excavations to be covered or enclosed. Alternatively, handrails to be provided around all openings.	6-months

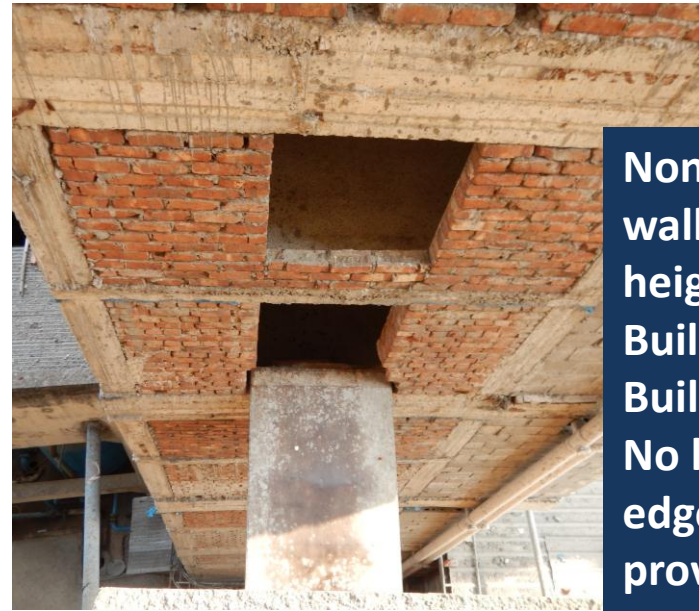
**Non-engineered walkway at height between Building 2 and Building 4. No handrails or edge protection provided.**

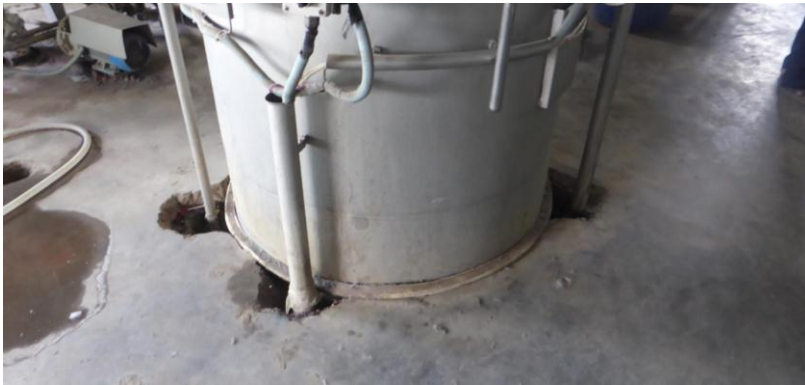
**Numerous undocumented openings within Building 5 mezzanine slab.**

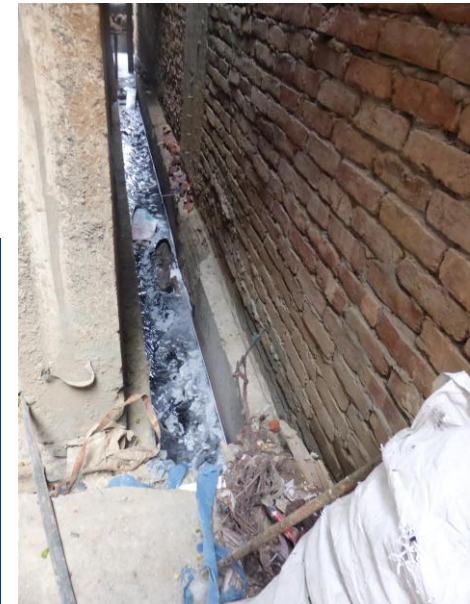
**Many open drains, gulleys and large excavations throughout the factory complex – both within and around buildings.**
