# Divine Textiles Ltd

Pollibiddut, Shafipur, Gazipur, Dhaka  
(24.03977N, 90.25669E)

22 March 2014

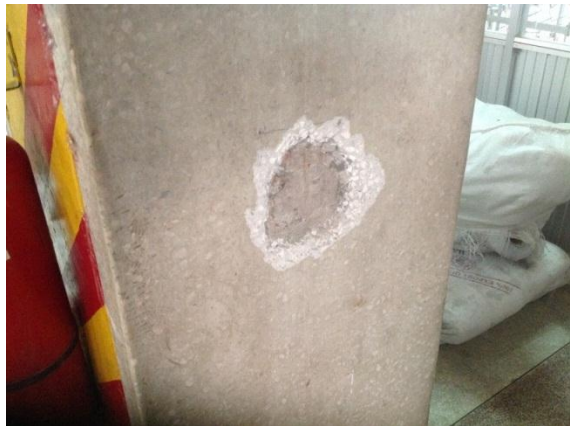
Stone chips were found in the columns of the 6 and 8 storey buildings, while brick chips were found in the columns for the 4 storey building

Tested Basement Column 8 Storey Building – Stone Chips

Cursory calculations indicate that column working stress is at a high level in the columns in all three factory buildings. An outline of each building is given below.

While our calculations show that the column working stresses are not critical, they are still in excess of normal levels. Therefore, the Building Engineer is to perform detailed calculations and concrete tests to ascertain the adequacy of the columns and (if required):

- Reduce loads
- Reinforce columns

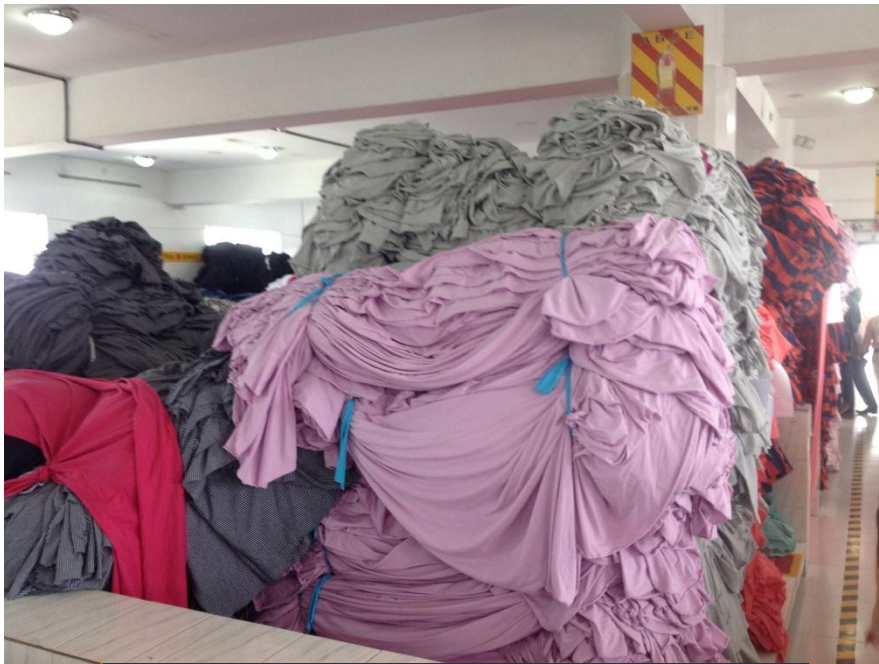
8 storey building - 4<sup>th</sup> Floor Storage Area

Uncontrolled stacking of material

Building Engineer to prepare controlled loading plans for all floors which will designate where storage can be placed.

13	Management of storage loads	Produce and actively manage a loading plan for all floor plates within the factory giving consideration to floor capacity and column capacity	<b>6-weeks</b>
14	Management of storage loads	Continue to implement load management plan	<b>6-months</b>

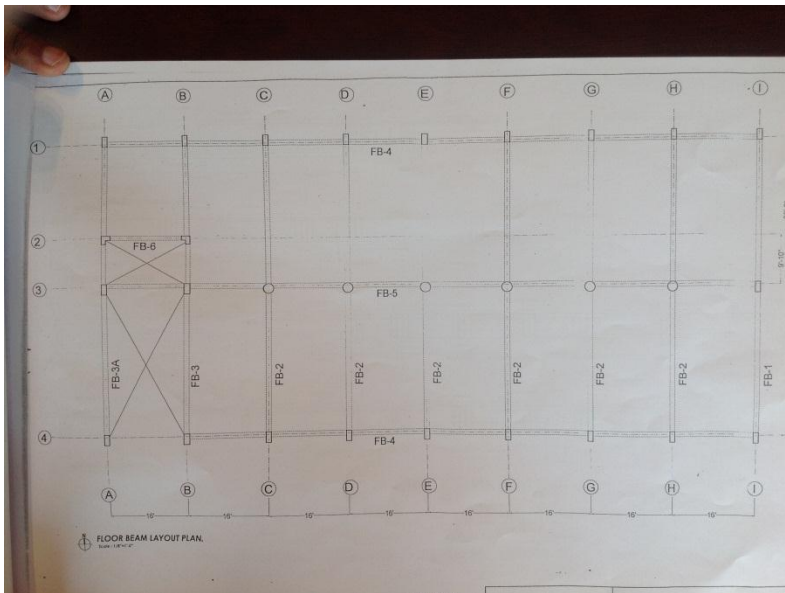
8 storey building typical plan

Longer grid dimension is 8.9 m (29' 2'') and not 8.53 m (28')

Building Engineer to survey as-built structure and update drawings.

Item No.	Observation	Recommended Action Plan	Recommended Timeline
15	Inconsistencies between structural drawings and the as-constructed arrangement of the factory	Building Engineer to survey as-constructed buildings. Updated drawings to be prepared showing the correct as-constructed layout	6-weeks
16	Inconsistencies between structural drawings and the as-constructed arrangement of the factory	Prepare/update calculations showing the structural adequacy of the building structure taking into account the factory design imposed loading and the as-built structure	6-months
17	Inconsistencies between structural drawings and the as-constructed arrangement of the factory	Prepare controlled loading plans for all floors designating where storage can / cannot be placed (see Item 3)	6-months
18	Water ingress through structure	Building engineer to access extent and cause of water ingress and implement preventative measures to protect the structure from any further damage	6-weeks

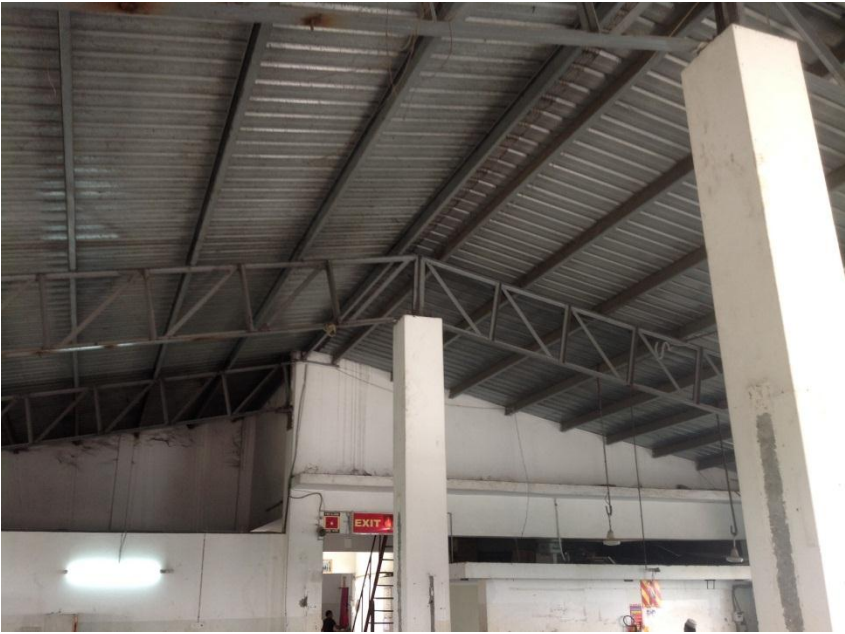
Steel structures at roof level on 4 and 6 storey buildings are not shown on structural drawings.

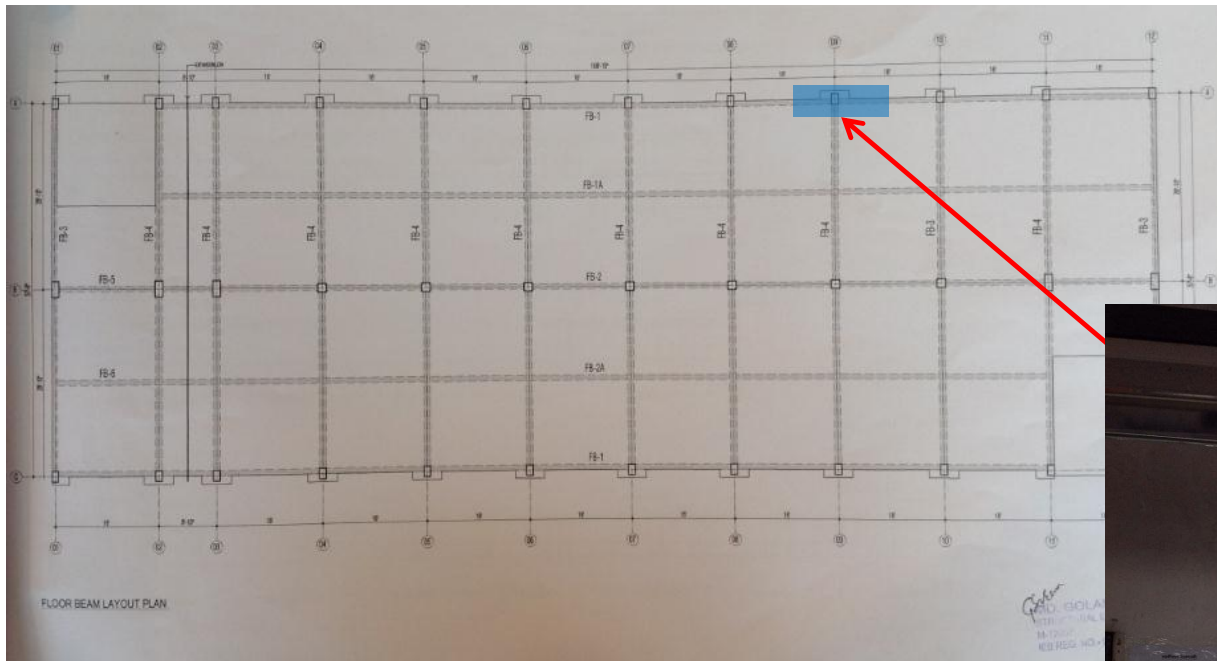
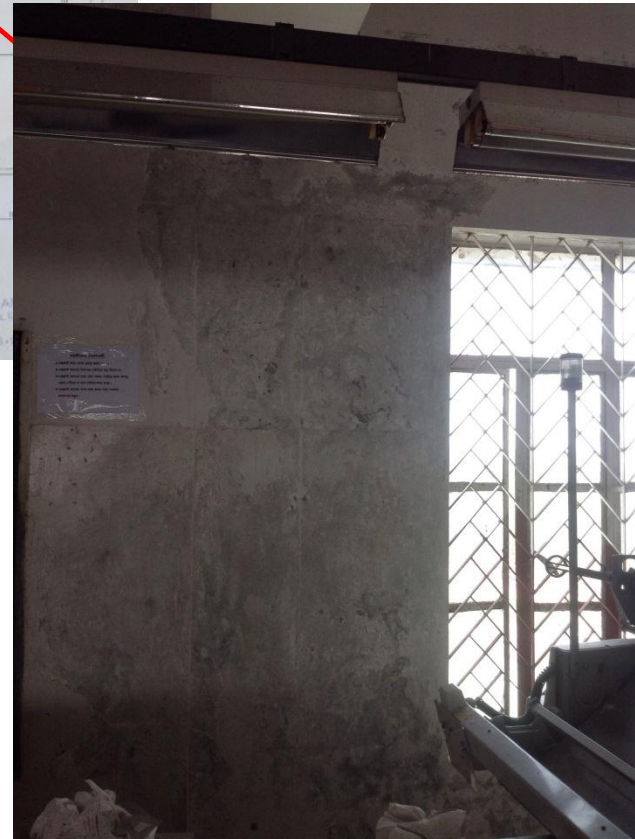
Water ingress on 4<sup>th</sup> floor of 6 storey building

**Areas where water ingress is evident should be investigated and the cause of such should be remedied.**

19	Water ingress through structure	Continue to monitor structure for water ingress on an on-going basis	6-months
20	Hairline cracking of beams	Sections of plaster finish to beams to be removed to investigate if cracks penetrate the building structure. Building Engineer to review further if cracks are found to penetrate into building structure	6-weeks
21	Hairline cracking of beams	Carry out repair remedial works as required	6-weeks
22	Hairline cracking of beams	Continue to monitor for cracking on an on-going basis	6-months

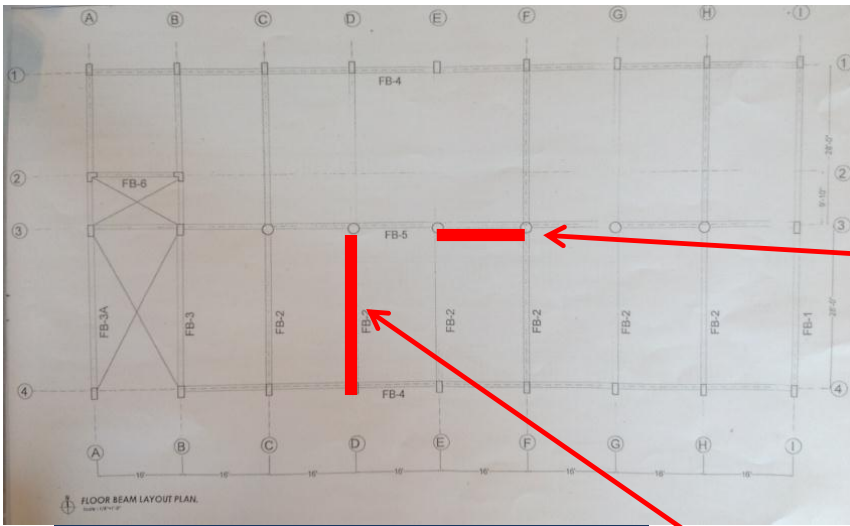
8 storey building – Typical floor plan

Crack Locations

All beam cracks to be reviewed by removing plaster to confirm that cracks do not extend into structure.

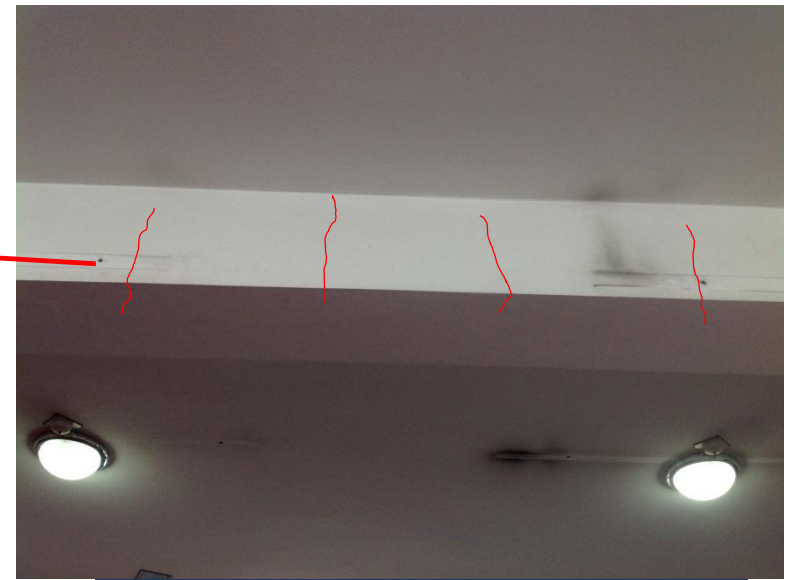
Cracking in beam supporting 5<sup>th</sup> floor

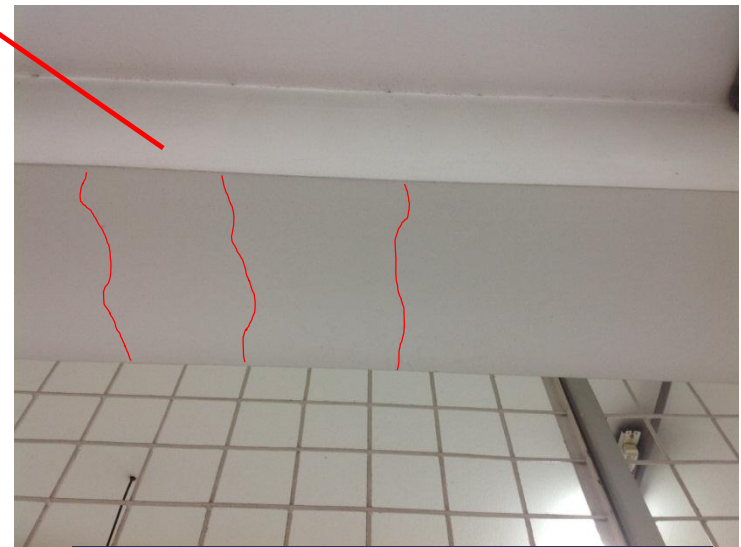
Cracking in beam supporting 2<sup>nd</sup> floor
