# Mondol Knit Tex Ltd (9959)

## Alim Knit (BD) (11273)

13.April.2014

ACCORD  
on Fire and Building Safety in Bangladesh

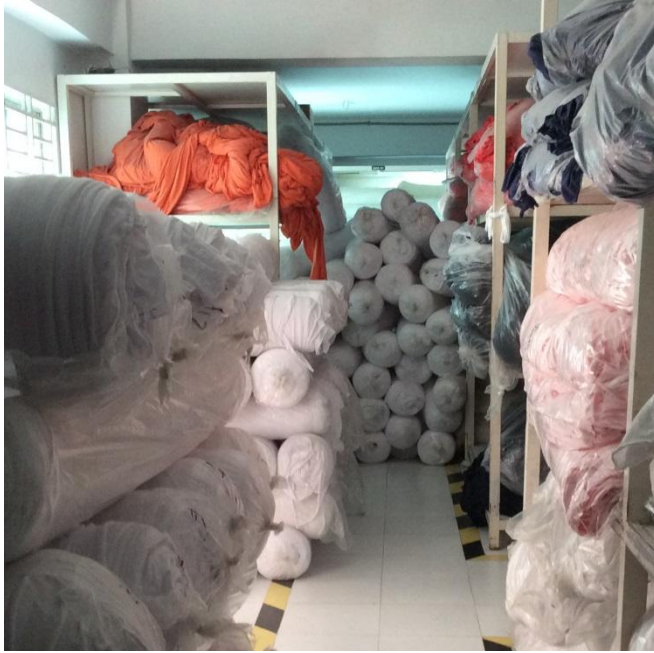
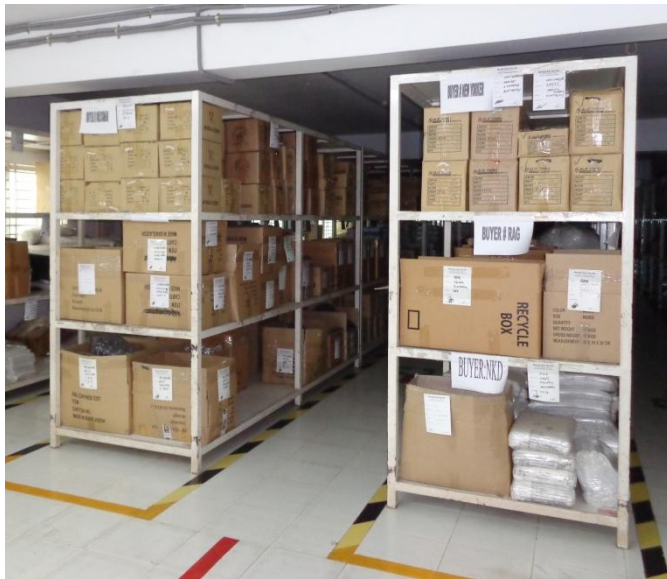
## 1<sup>st</sup> Priority 1 Concern

Loading to be reduced for both buildings as storage areas surpass the prescribed limits displayed on signs on the walls.

During our visit, we found that floors used for storage were loaded above the prescribed limits indicated on signs a few columns.

We also noticed that loading varied in weight density. A loading plan would be more appropriate for each floor level.

This concern is applicable for both buildings.

- Verify insitu concrete stresses either by 100mm dia. cores or existing cylinder strength data from 4 columns.
- Detail Engineering Assessment of Factory to be commenced, see attached scope

- Factory engineer to produce and actively monitor a loading plan for all floor plates within the factory complex, with consideration given to slab, column and foundation capacity

- Maintain and enforce the loading plans.

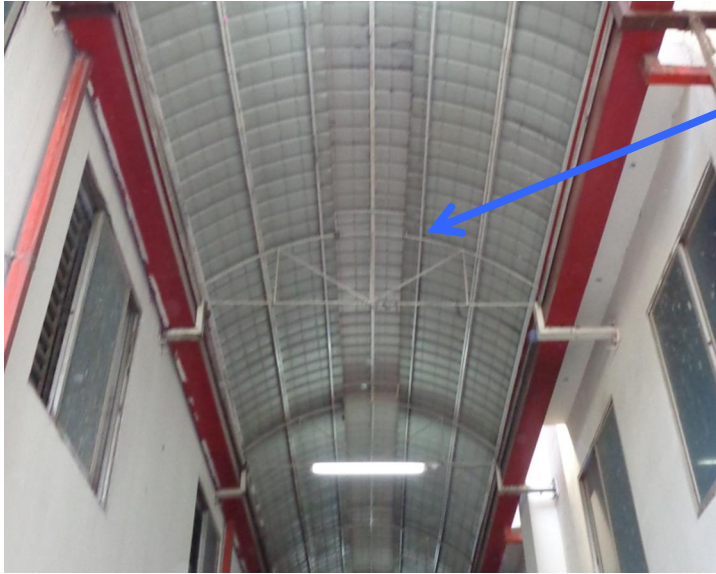
Steel trusses with large tributary areas

During our survey, we found that some steelwork structural framing elements were built and used in an unorthodox way. We require a full detailed engineering assessment of all of the various steel roofs around the 2 buildings.

- Include in a Detailed Engineering Assessment of the Factory, see attached scope. Assess capacity of connections and steel members of roofs to resist wind forces (down force & uplift)

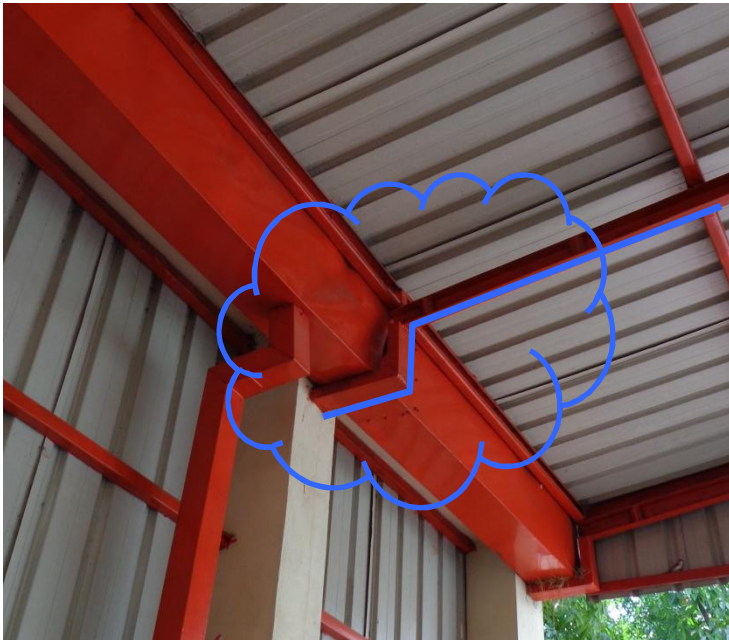
Supporting member redirected for gutter

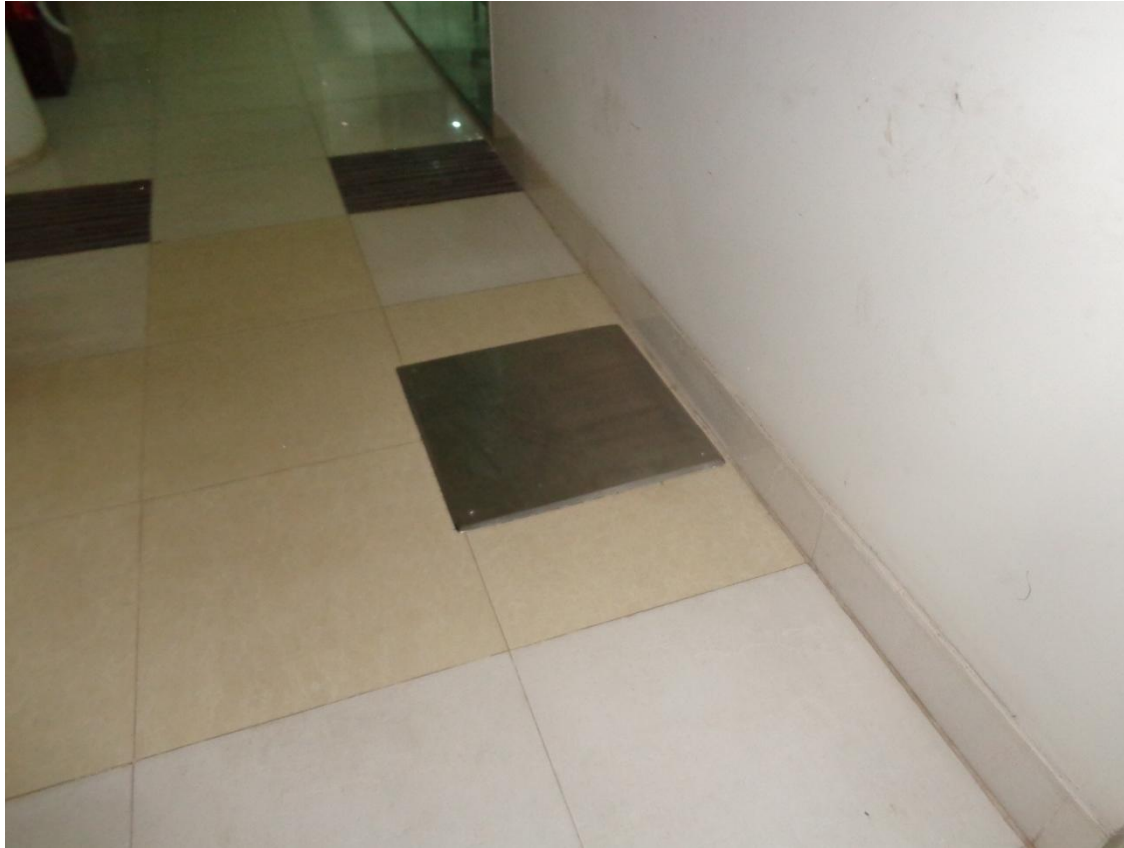
### 1<sup>st</sup> Priority 3 Concern

In certain areas of all floors, mainly in office spaces, we found old floor openings covered by flimsy aluminium plates.

- Replace with thicker panels designed for 3 kPa floor load. Securely fasten to floor.

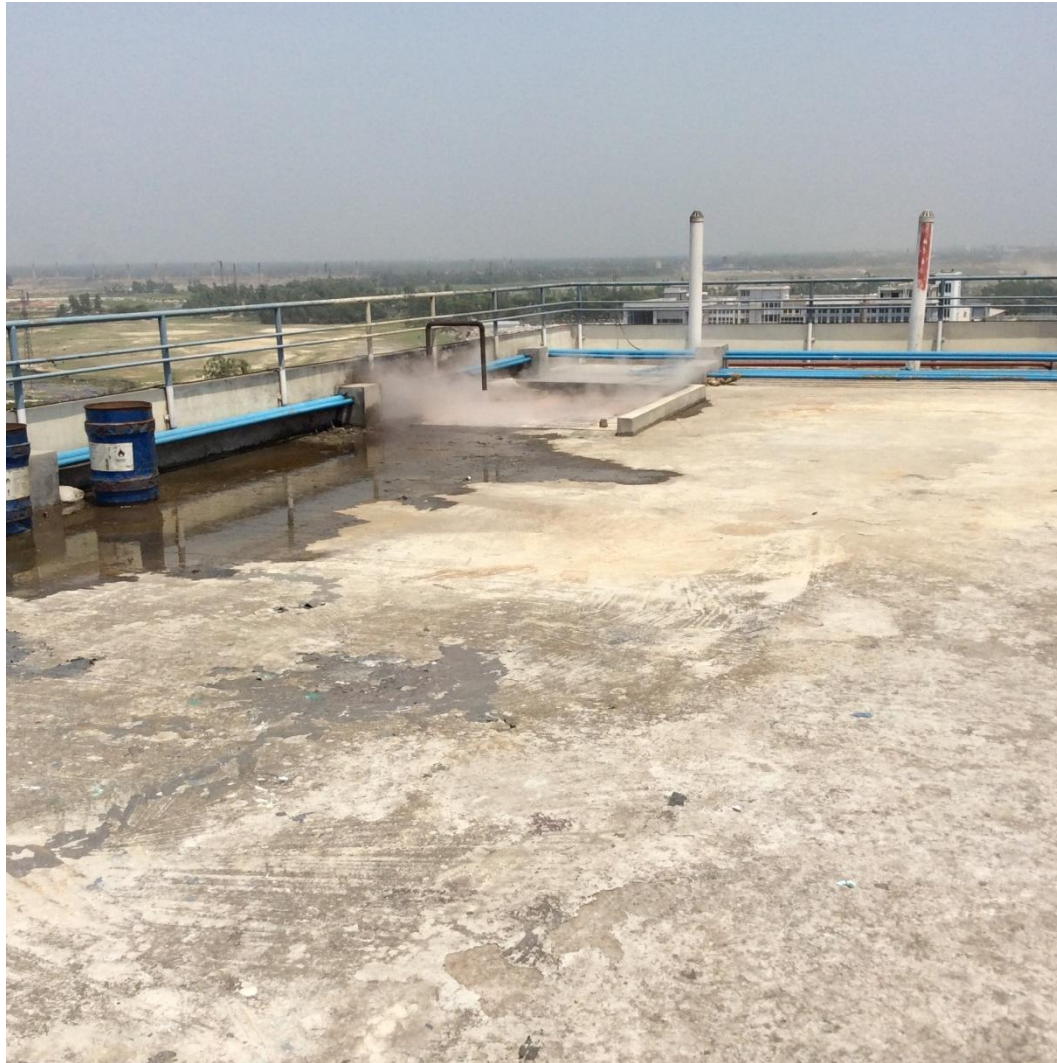
## 2<sup>nd</sup> & 3<sup>rd</sup> Priority 3 Concerns

No waterproofing membrane was visible on the roof of the buildings. This means that any cracks in the surface finishes on the roof will allow water to seep into the concrete slab beneath the finishes, and cause long-term soaking of the slab. The same applies to the water tanks at roof level.

We can also noted steam from an ironing process being directed across the surface of the roof slab.

- Apply a new waterproofing membrane.

- Redirect and collect steam via a different system which provides water/heat protection to slab

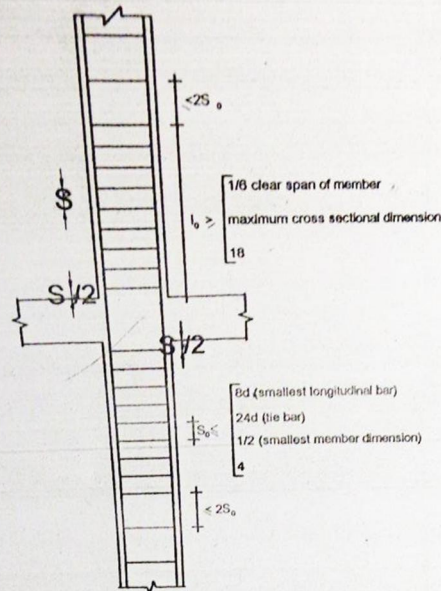
28. CONFINEMENT REQUIREMENTS OF COLUMN AT JOINTS  
FOR EARTHQUAKE LOADING

The overall stability of both buildings is provided by a moment frame action which requires special detailing at the beam to column connections. Such details were included on the construction drawings.

We have 2 concerns with regards to the surveyed system. The first one is the fact that both buildings are connected in one bay and do not have a movement joint. This can alter load distribution. The second concern is with regard to the height of the first floor being close to 6m as opposed to 3.4m. This makes for a fairly flexible moment frame system.

A Detail Engineering Assessment should be carried out to assess both systems.
