# Dynasty Sweaters (BD) Ltd (Extended Building)

1<sup>st</sup> April, 2018

# Observation

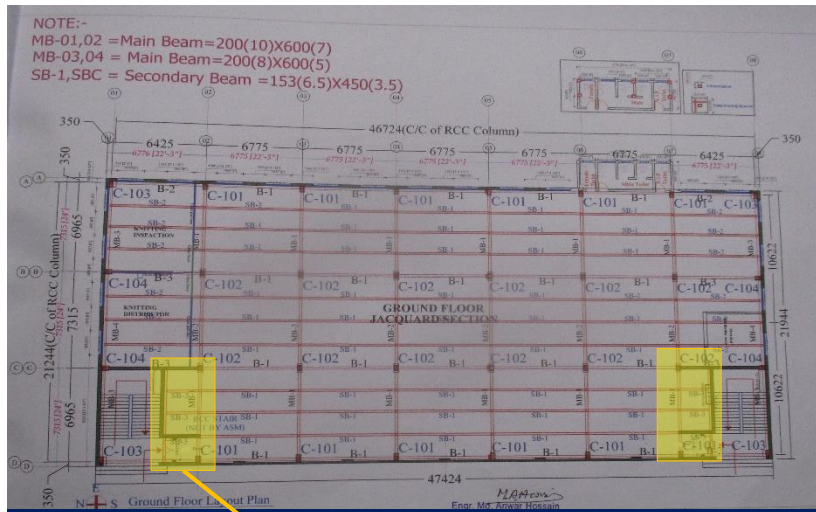
Beam Layout

# Mismatch in as-built drawings

13mm dia cable bracings were found whereas as-built drawing shows 16 mm. Also no details were provided in as-built drawings for sub-beam near stair.

| Item No. | Observation | Recommended Action Plan | Recommended Timeline |
|---|---|---|---|
| 1 | Mismatch in as-built drawings | Building Engineer to survey the as-built structure and update the as-built drawings accordingly. | 6-weeks |

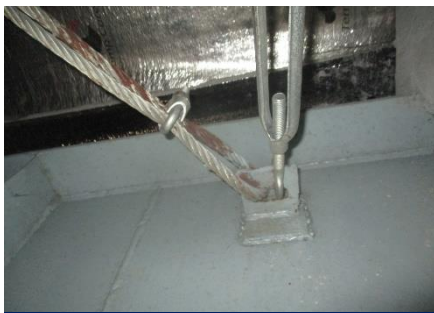
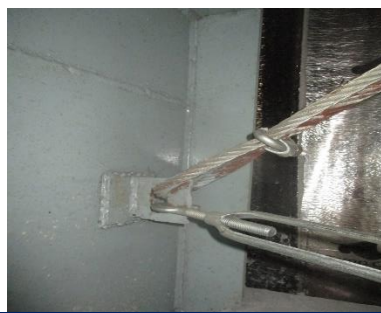
**Gable Frame @ Grid :01&08**

# Missing Knee bracing & loose cable bracing

| Item No. | Observation | Recommended Action Plan | Recommended Timeline |
|---|---|---|---|
| 2 | Missing Knee bracing & loose cable bracing | Building engineer is required to check the adequacy of the structure for the missing knee bracing and also check the connection of the cable bracing. | 6-weeks |
| 3 | Missing Knee bracing & loose cable bracing | Building engineer to check and tighten all loose bracings. | 6-weeks |
| 4 | Missing Knee bracing & loose cable bracing | Complete remedial works if required in assessment report. | 6-months |

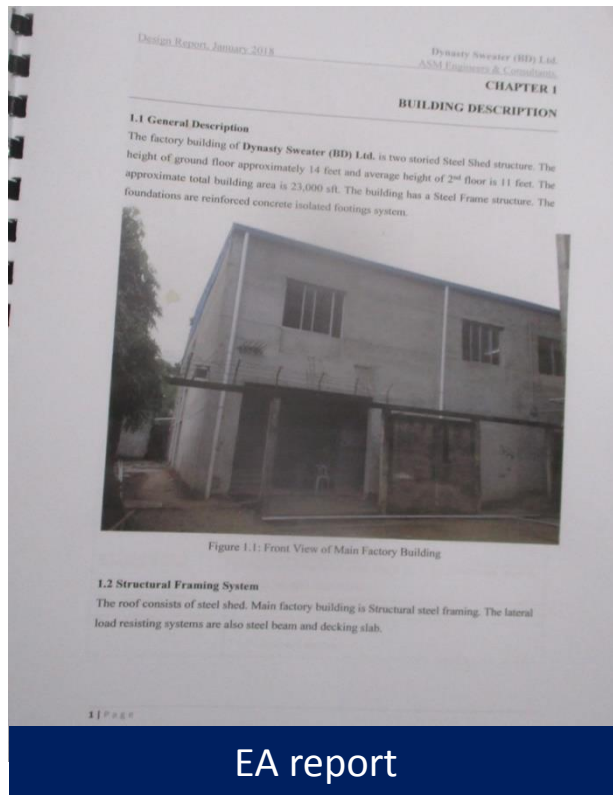
EA report

**Prepared engineering assessment  
to be verified**

An Engineering Assessment (EA) has been prepared following BNBC for the two storied steel building. Some members are found over stressed in the FEM model. Also, EQ load combination wasn't considered. Factory is required to submit the revised EA to Accord for further review.

| Item No. | Observation | Recommended Action Plan | Recommended Timeline |
|---|---|---|---|
| 5 | Prepared engineering assessment to be verified | Complete the review of Engineering Assessment with Accord. | 6-weeks |
| 6 | Prepared engineering assessment to be verified | Complete remedial works arising from engineering assessment after reviewed by Accord. | 6-months |
