# Tanzila New building, extension

Baroypara, Ashulia, Savar, Dhaka

12<sup>th</sup> March 2018

# Observations

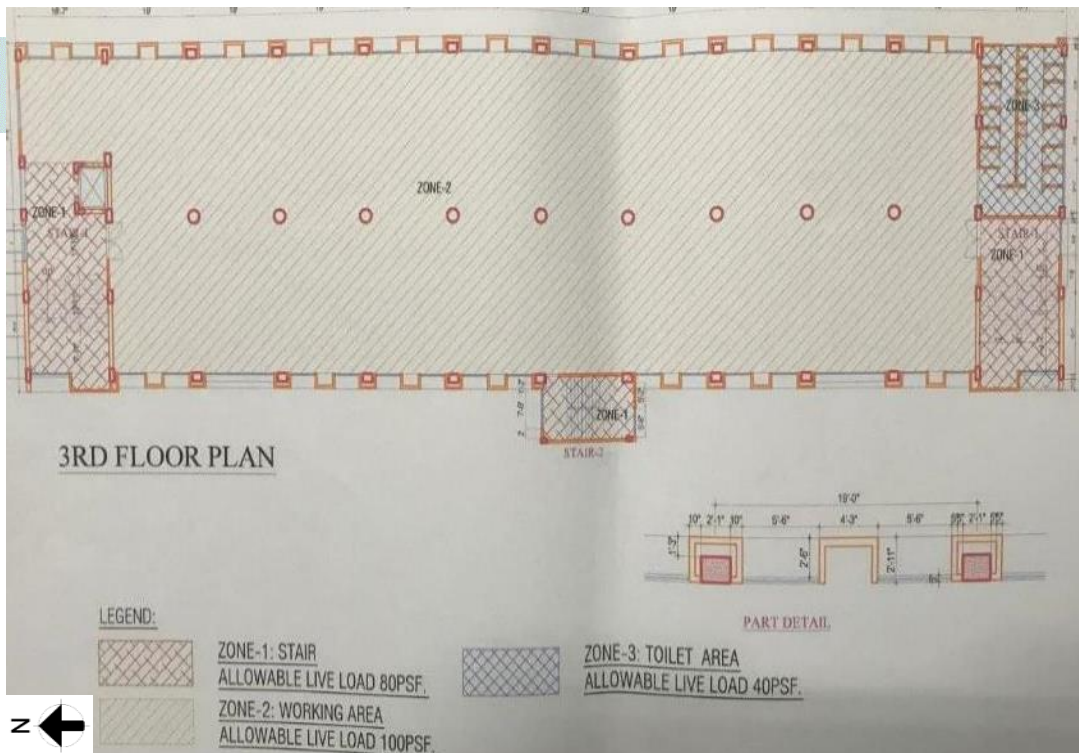
Load was measured below 3Kpa on every floor and FoS calculation for columns were found satisfactory. For 5kPa column stresses exceed normal design limit.

Factory is required to maintain the floor live load 3 kPa until further verification by design engineer.

| Item No. | Observation | Recommended Action Plan | Recommended Timeline |
|---|---|---|---|
| 1 | (Main production building)<br>Prepared load plan required to be verified | Maintain 3 Kpa load on all floors. | 6-weeks |
| 2 | (Main production building)<br>Prepared load plan required to be verified | Factory engineer is required to review design, load and the column stresses if factory intended to implement live loading 5 kPa. | 6-weeks |

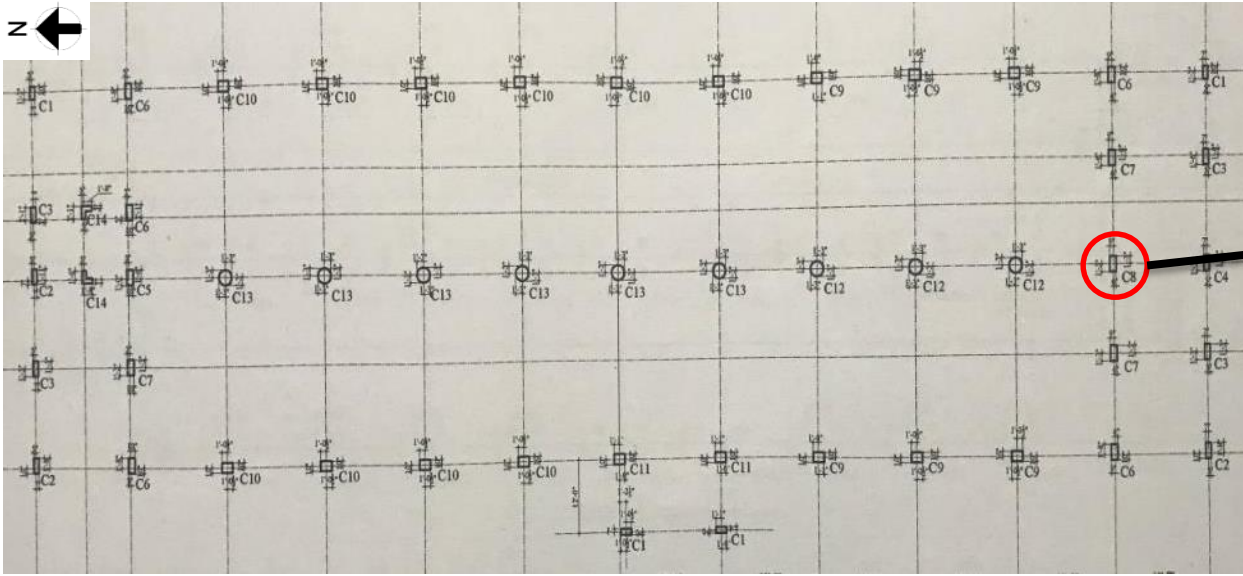
Column Layout Plan

20 nos. rebars were shown on the drawing in C-8 type column but during inspection 16 rebars were found by ferro scanning in ground floor.

| Item No. | Observation | Recommended Action Plan | Recommended Timeline |
|---|---|---|---|
| 4 | (Main production building)<br>Discrepancies between drawings and on-site observation | Factory engineer is required to survey the structural elements properly and produce correct as built drawings. | 6-weeks |

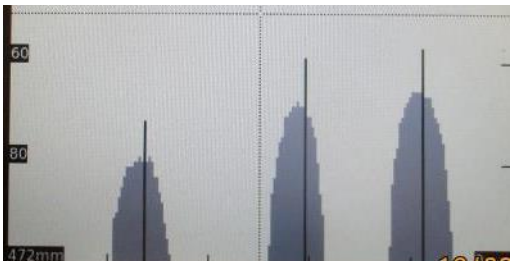
16 nos. rebar were found by ferro scanning in C-8 type column

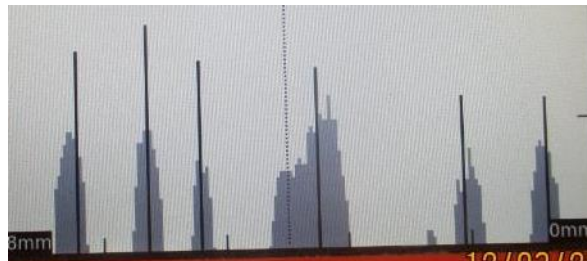
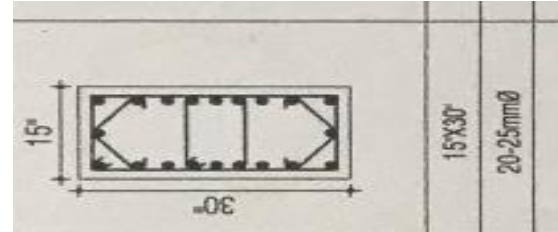
20 nos. rebar were shown in column schedule for C-8 type column in ground floor

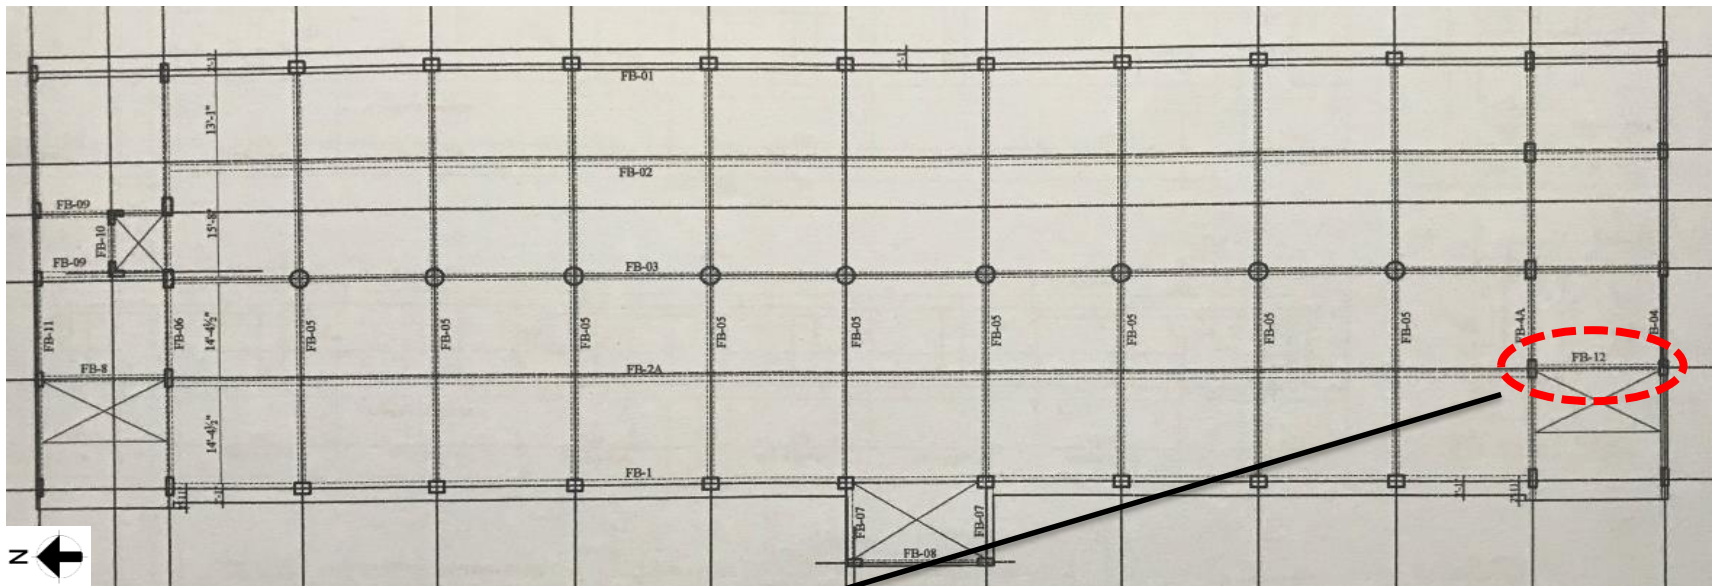
Typical Beam Layout Plan

In beam layout plan, FB-12 type beam was shown but no section size and detail was found for that beam in provided drawing.

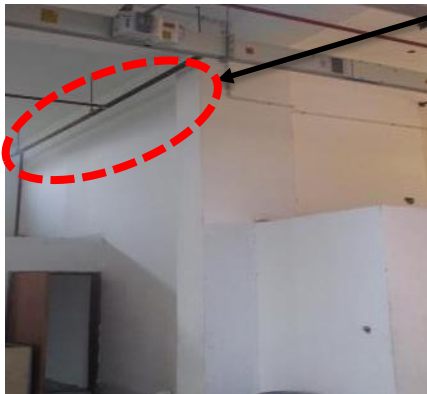
Size was measured for  
FB-12 type beam in  
stair case

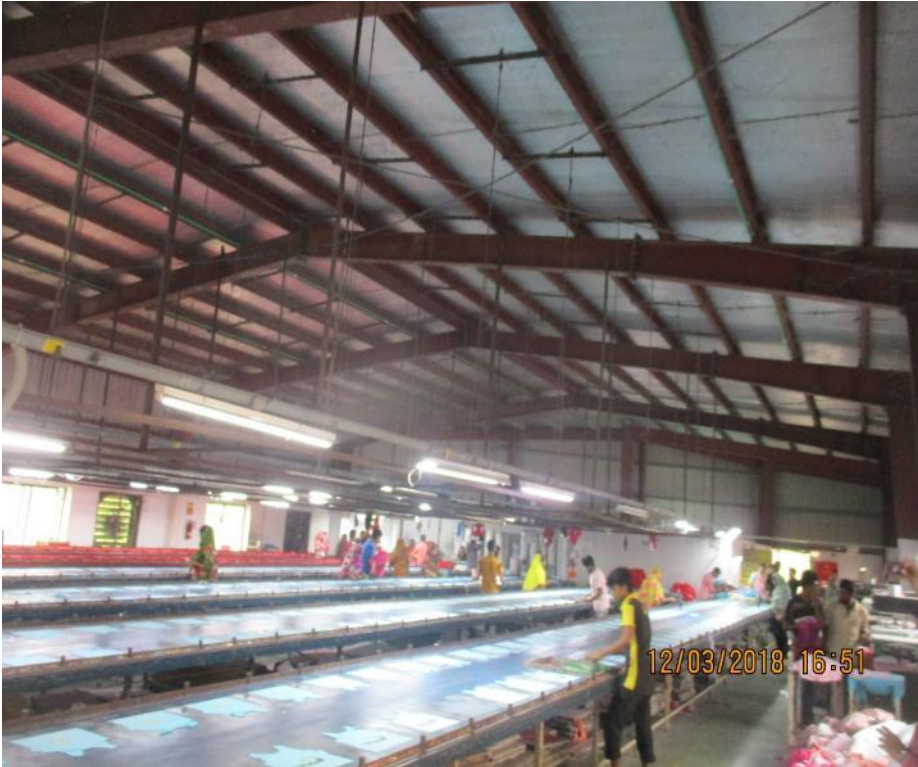
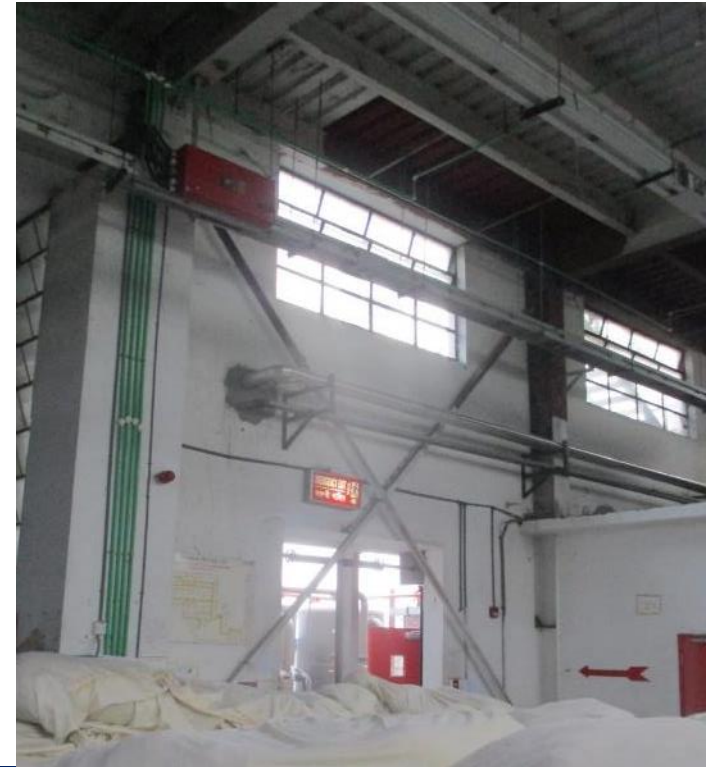
No vertical bracing or compression strut was observed on 1<sup>st</sup> floor. Only vertical bracing was observed in ground floor.

Factory could not provide any structural document of the shed. Factory Engineer is required to produce a full set of as-built drawing reflecting actual condition. Lateral stability of the shed need to verified against lateral loading.

| Item No. | Observation | Recommended Action Plan | Recommended Timeline |
|---|---|---|---|
| 5 | (Dyeing shed building)<br>Lack of as-built documentation | Factory engineer to survey the shed and produce as-built documentation reflecting the as constructed condition. | 6-weeks |
| 6 | (Dyeing shed building)<br>Lack of as-built documentation | Factory engineer to check the lateral stability of the shed against lateral loading. | 6-weeks |
| 7 | (Dyeing shed building)<br>Lack of as-built documentation | Carry out remedial works resulting from engineering assessment where necessary. | 6-months |

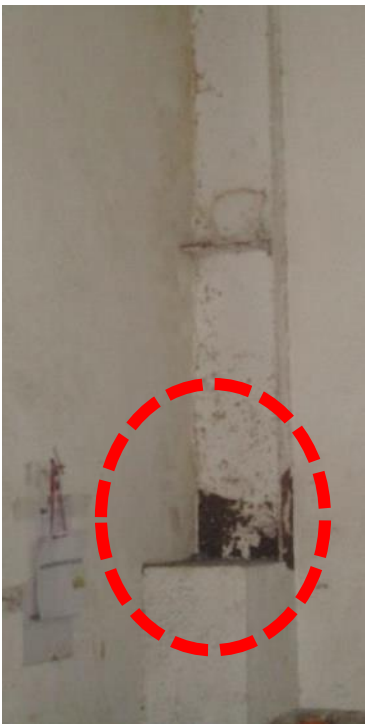
Corrosion was observed on steel column in ground floor at chemical store

Corrosion was observed on various location at 1<sup>st</sup> floor and ground floor on steel columns. Factory is required to identify all the corroded locations and take proper remedial measures.

| Item No. | Observation | Recommended Action Plan | Recommended Timeline |
|---|---|---|---|
| 8 | (Dyeing shed building)<br>Corrosion observed at steel sections | Factory Engineer to suggest and implement proper remedial measures to protect steel sections from corrosion. | 6-weeks |

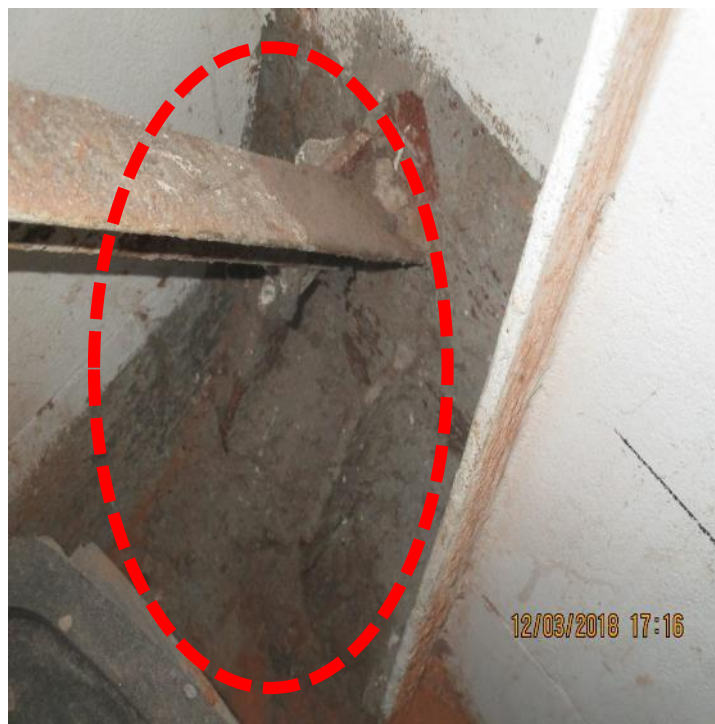
Corrosion was observed at joint of angle bracing and column in ground floor

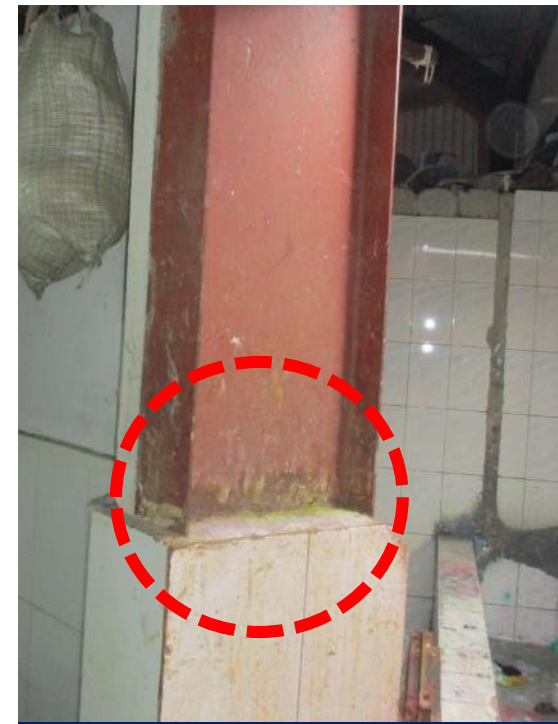
Corrosion was observed on steel column in 1<sup>st</sup> floor's printing section

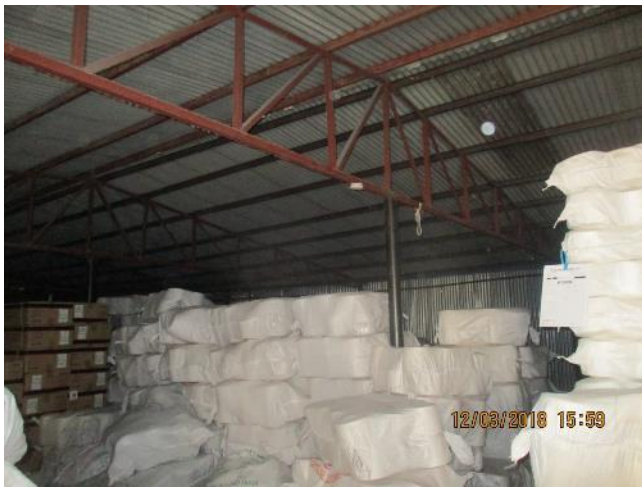
Typical truss frame with out any horizontal or vertical bracing system in Grey fabric store

The support condition of the steel trusses were not clear and apparently non engineered. In addition, factory could not provide any structural document of the sheds. Factory Engineer is required to produce a full set of as-built drawing reflecting actual condition. Lateral stability of those sheds need to be verified against lateral loading.

| Item No. | Observation | Recommended Action Plan | Recommended Timeline |
|---|---|---|---|
| 9 | (Grey fabric store and Jhut store)<br>Lack of as-built documentation | Factory engineer to survey the shed and produce as-built documentation reflecting the as constructed condition. | 6-weeks |
| 10 | (Grey fabric store and Jhut store)<br>Lack of as-built documentation | Factory engineer to check the lateral stability of the shed against lateral loading. | 6-weeks |
| 11 | (Grey fabric store and Jhut store)<br>Lack of as-built documentation | Carry out remedial works resulting from engineering assessment where necessary. | 6-months |

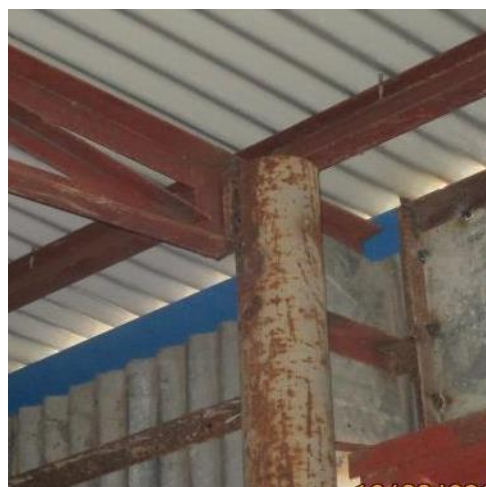
Truss were poorly welded with steel pipe column in Grey fabric store

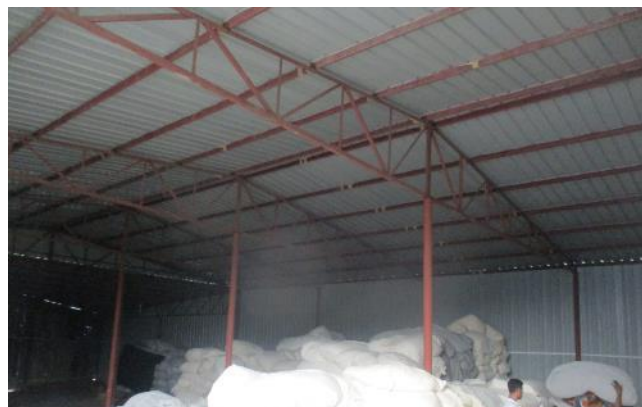
Typical truss frame with out any horizontal or vertical bracing system in Jhut store

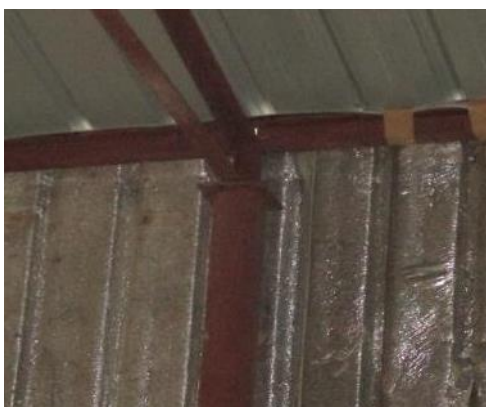
Truss were poorly welded with steel pipe column in Jhut store
