# FIRE SAFETY INSPECTION REPORT

**CHORKA TEXTILE LIMITED (NEW BUILDING)**

**ACCORD ID: 22933**

**Date: 28 September, 2017**

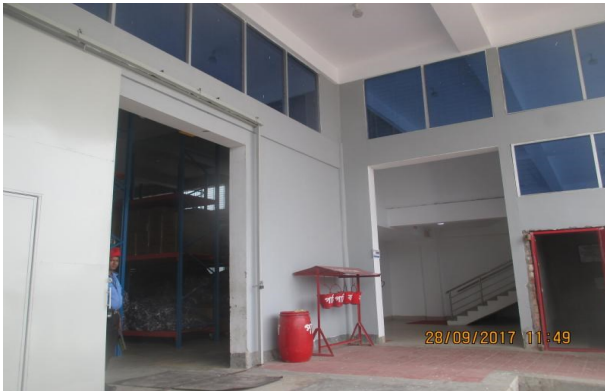
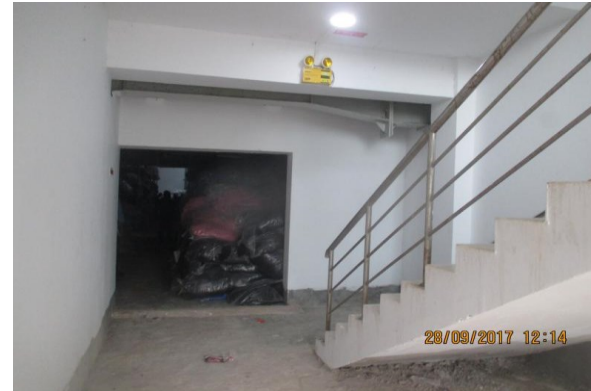
| Sl No. | Category | Findings | Required Action | Remediation Time Frame |
|---|---|---|---|---|
| 1 | Fire Rated Construction | The exit stairs enclosures are not separated from work areas and other spaces on each floor by fire-rated construction(Non rated doors, unsealed penetrations and openings etc.). | Provide minimum 1-hr rated doors for buildings with 3 or fewer stories and 1.5-hr fire rated doors for buildings that are 4 or more stories. Seal all unprotected openings to separate the exit stairs from work areas and other building spaces on all floor levels. Ensure that the fire doors are self-closing and positive latching and that they are provided with fire exit (panic) hardware where serving production floors. If fire doors are required to be held open for functional reasons, provide automatic closing devices tied to the fire alarm system. Once fire doors are installed, every door in a stair enclosure serving more than 5 stories shall be provided with re-entry unless it meets. | Within 3 months |

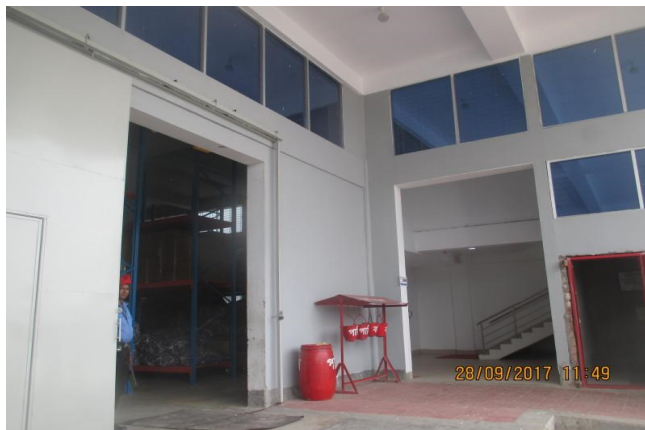
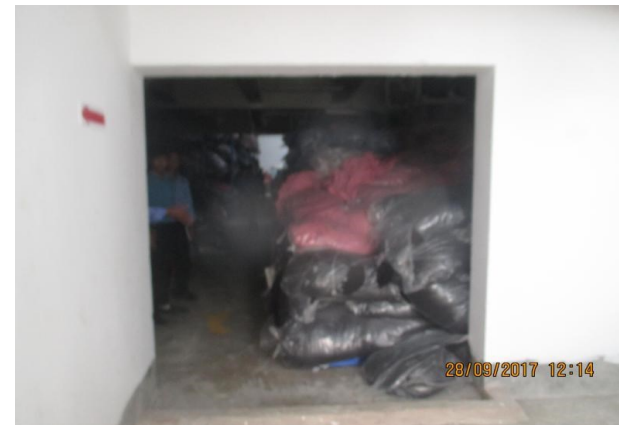
| 2 | Fire Rated Construction | Rooms used for combustible storage are not separated by fire rated construction properly.<br><b>Location: Ground Floor.</b> | Provide dedicated storage room separated by minimum 1-hr fire-rated construction. | Within 3 months |

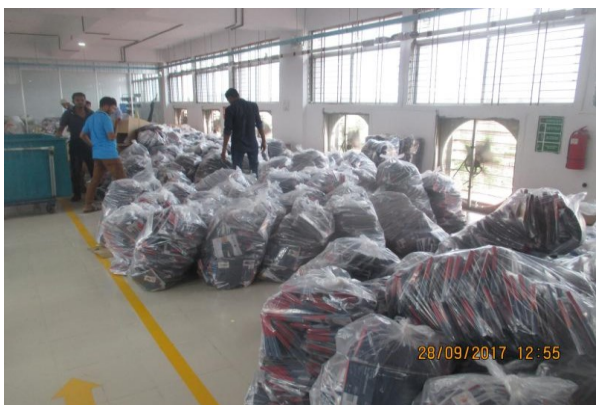
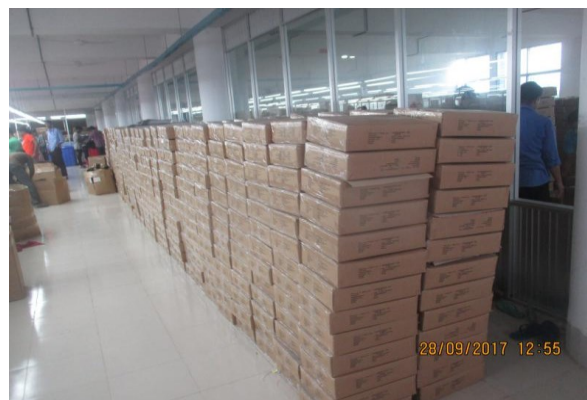
| 3 | Fire Rated Construction | Areas used for combustible storage are not separated by fire rated construction in several floors. | <p>Provide dedicated storage rooms separated by minimum 1-hr fire-rated construction.</p> <p>Where separate storage rooms are not feasible, provide defined storage areas and limit the storage arrangement as follows:</p> <ul style="list-style-type: none"> <li>- Maximum height of 2.4m and maximum area of 23m<sup>2</sup></li> <li>- If sprinkler protected: maximum height of 3.66m and maximum area of 93m<sup>2</sup></li> </ul> <p>Separate areas of unenclosed combustible storage by a minimum clear distance of 3m.</p> | Within 3 months |

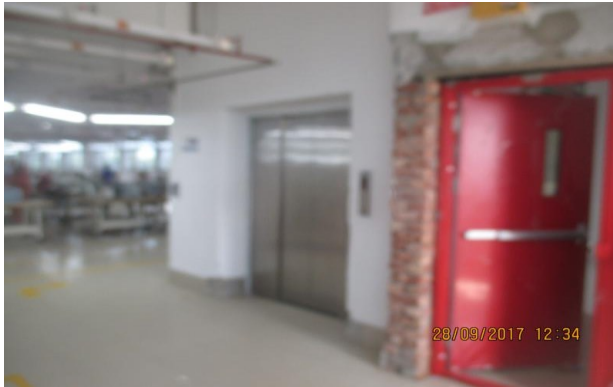
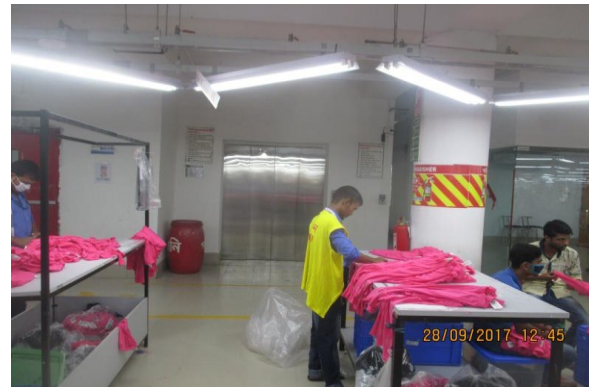
| 4 | Fire Rated Construction | <p>The elevators are discharges inside the production floor. [Unsealed penetrations &amp; openings]</p> <p>Location: All floors except ground.</p> | <p>Provide a minimum 2-hr fire rated construction to separate the elevator shaft from each floor level.</p> <p>Seal all penetrations and openings in floors/ceiling assemblies to maintain the fire separation.</p> | Within 3 months |

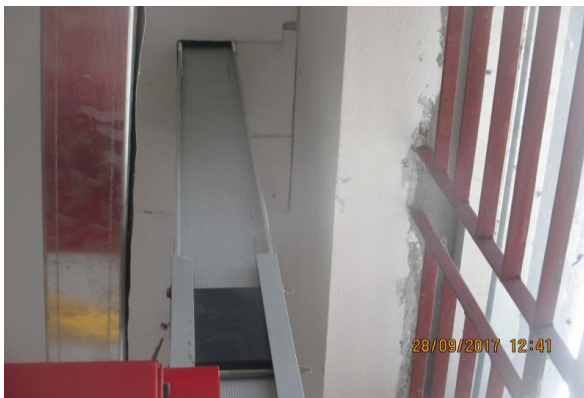
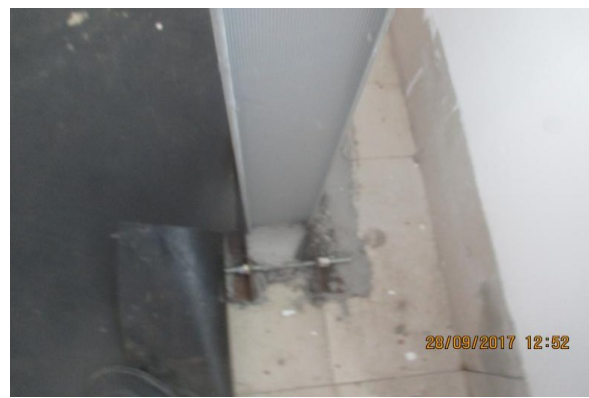
| 5 | Fire Rated Construction | Unsealed penetrations and openings are located in the fire rated floor/ceiling assemblies.<br><b>Location:</b> Electrical riser for all floor. | Seal all penetrations and openings in floors/ceiling assemblies to maintain the fire separation. | Within 3 months |

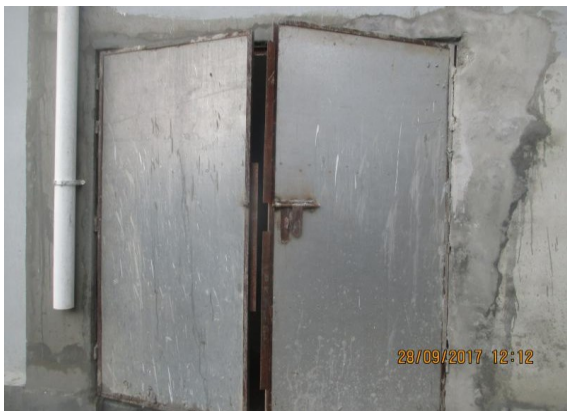
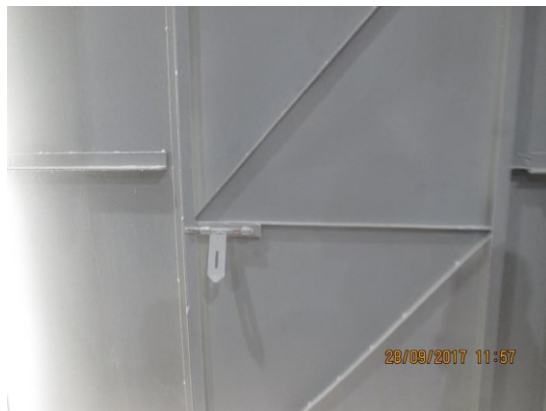
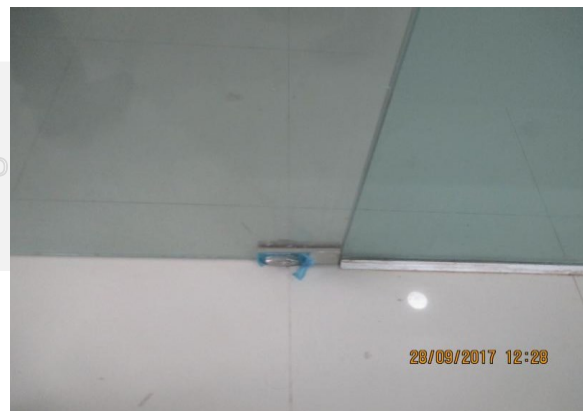
| 6 | Egress | Egress doors/gates with locking features not complying with NFPA101 are provided at various building exists. | Remove locking features from all egress doors/gates. If locks are required for security reasons, utilize specialized door locking features complying with NFPA101. | Immediate |

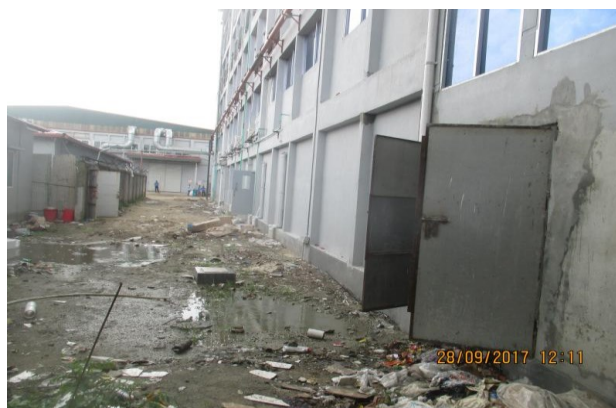
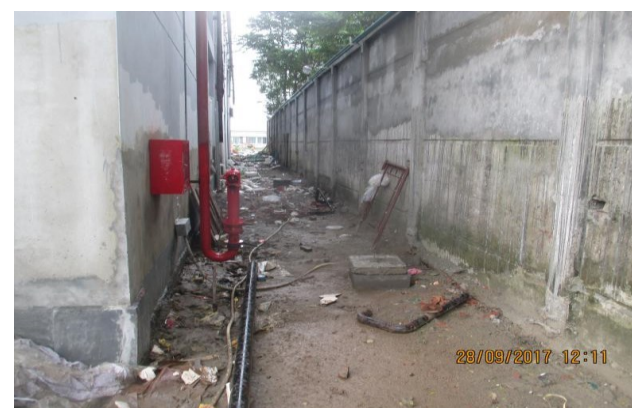
| 7 | Egress | Uneven path of travel and blockage in exit access.<br><b>Location:</b> Ground floor North & East Side. | Remove unnecessary items and level exit path to the public way. | Within 3 months |

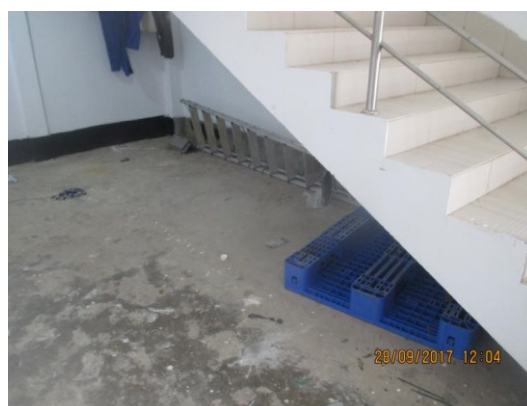
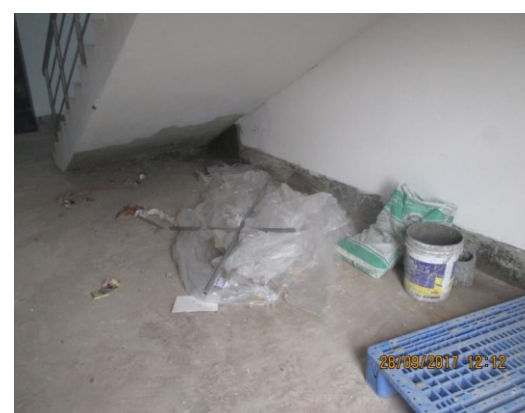
| 8 | Egress | Storage was located in several exit stairs. | Remove storage from the exit stairs and egress path | Immediate |

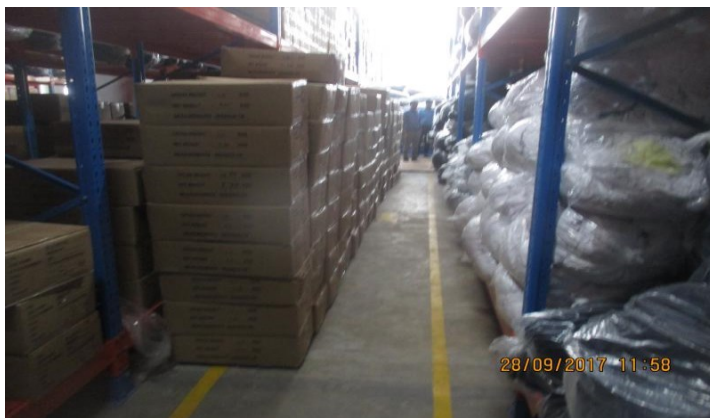
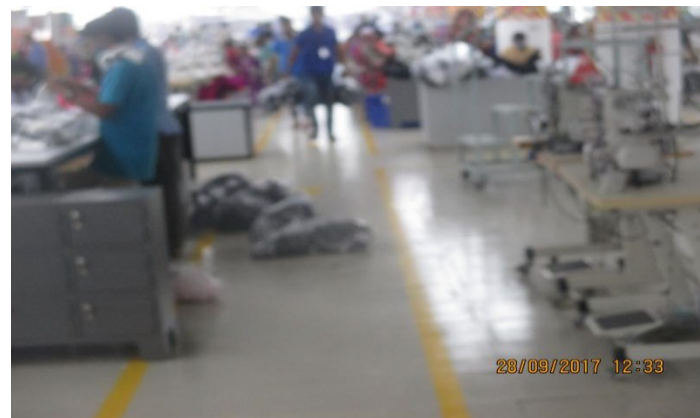
| 9 | Egress | Storage were located in several egress paths. | Keep egress path and stair clear of storage | Immediate |

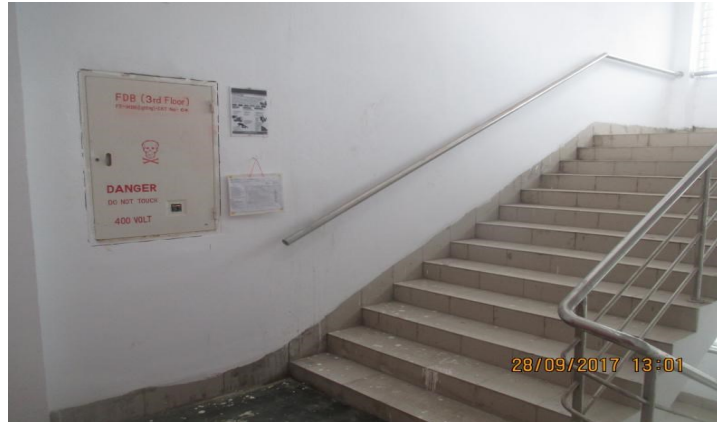
| 10 | Egress | Electrical DB were located in exit stairs. | Remove storage from the exit stairs and egress path | Immediate |

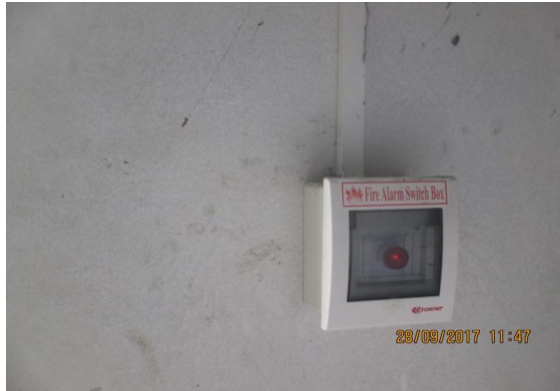
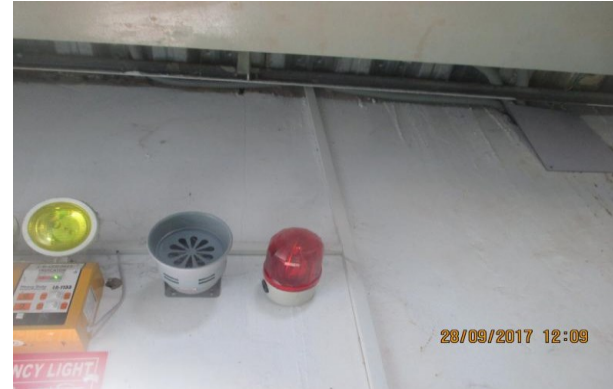
| 12 | Fire Detection and Alarm System | The fire detection and alarm system is antiquated, not a listed system and does not provide alarm and notification features consistent with acceptable standards. | Replace the fire detection system with a new, listed addressable fire detection system in accordance with NFPA 72. | Design within 4 months, Install within 9 months |

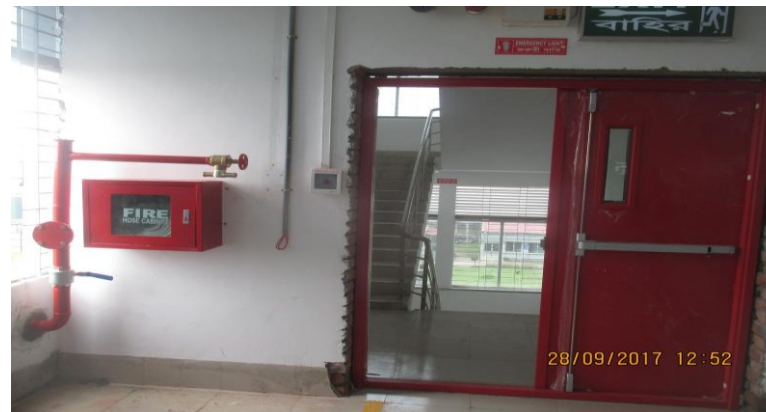
| 13 | Fire Protection System | The existing building has an occupied floor greater than 10 meter (33 feet) and is not provided with proper standpipe protection. | Install a new standpipe system, fire pump & fire department connection in accordance with NFPA 14,20,22 & 24. A class I system shall be permitted in buildings protected throughout by an automatic sprinkler system. | Design within 4 months, Install within 9 months |
