Mayc's Garments Ltd.

House No. 18/19, Road no. 1, Block –KHA, Section-6, Mirpur, Dhaka.
(23.805996 N, 90.367568 E)

2nd April 2018

Observations

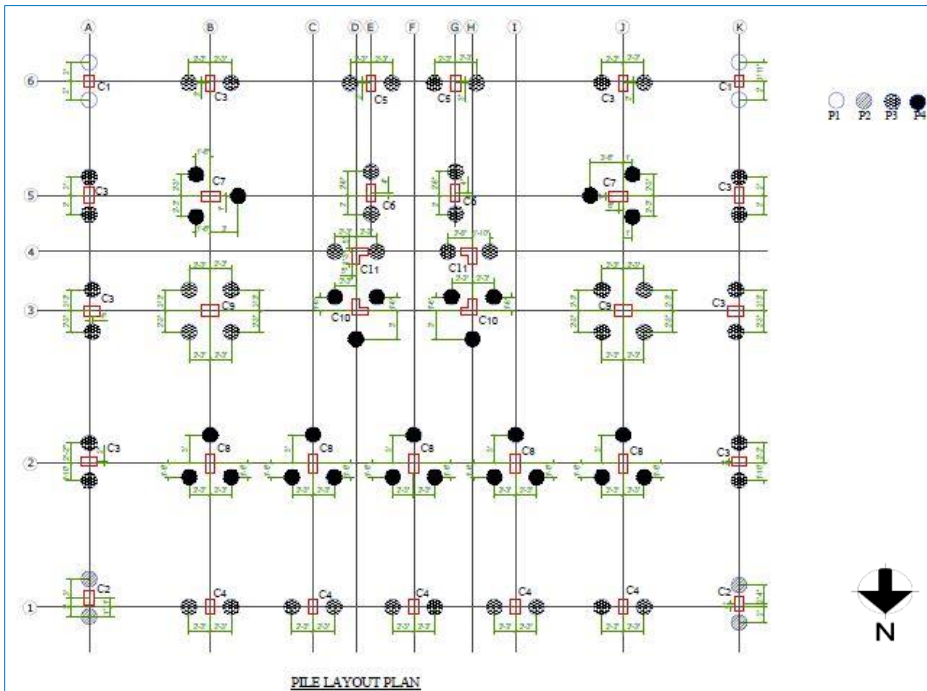
Foundation layout plan

As per soil test report, R.C.C. strip footing or individual column footing was recommended. But during inspection, pile foundation was observed on structural drawing of the building. No recommendation was found on soil test report regarding pile bearing capacity.

Cursory calculation indicates that pile appears to be stressed above normal design limits. Factor of safety (FoS) is less than the minimum requirement of BNBC. Factory engineer is required to review the adequacy of pile considering actual bearing capacity of soil and comply with BNBC.

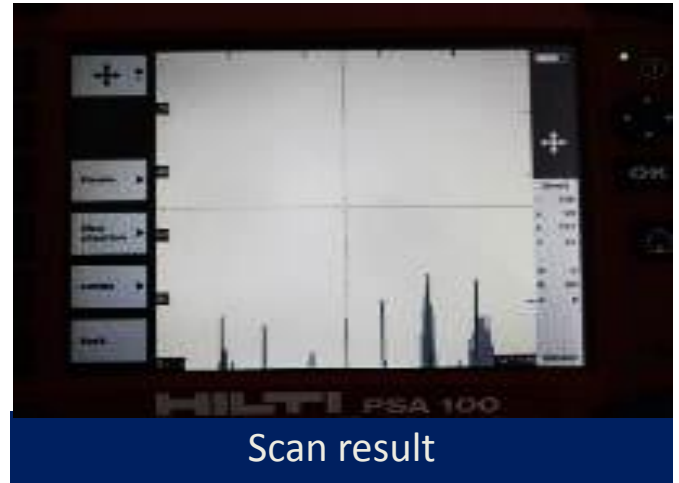
Scan result

Nos. of rebar in all C-8 type column at basement level does not match with provided column schedule. 16 nos. of rebars were found by ferro scan where as 22 nos. rebars were shown in column schedule.

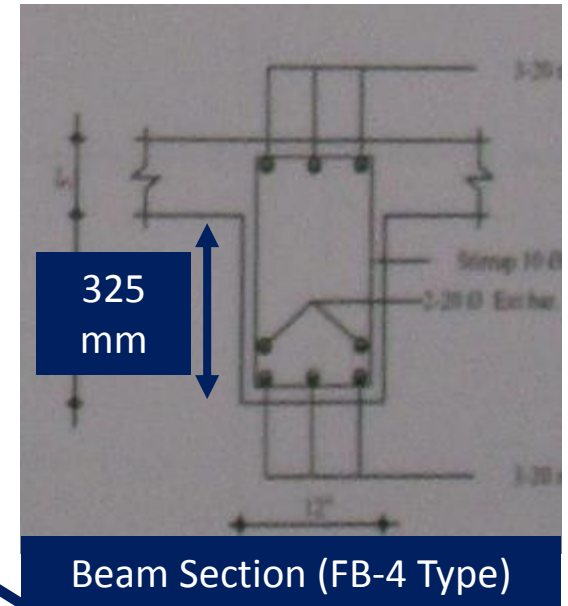
Beam Section (FB-4 Type)

The width of marked FB-4 type was found less than the provided drawing section in every floor. Factory is required to revise As Built drawing as per actual condition.

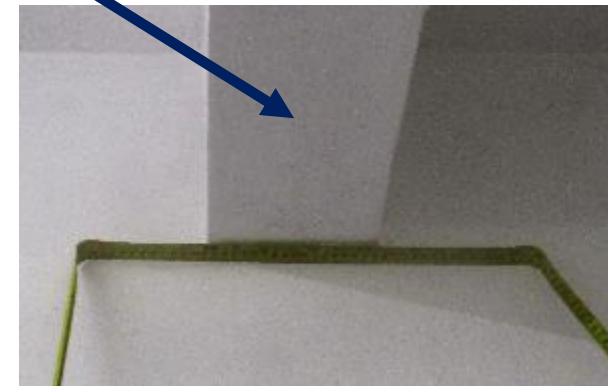
The width of the marked FB-4 type beam was observed 150 mm instead of 325 mm.

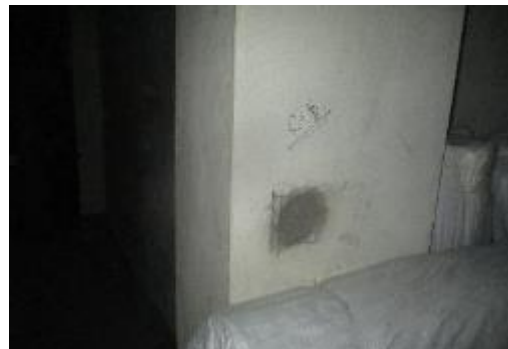
Core cutting location

An Engineering Assessment (EA) has been prepared following BNBC for the eight (B+G+6) storied factory building. Core has been taken from columns for the evaluation of concrete strength. The concrete strength was used for all reinforced concrete members (Columns, beams, slab). However, core cutting location has been verified in the time of inspection. Factory is required to submit the revised EA to Accord for further review.

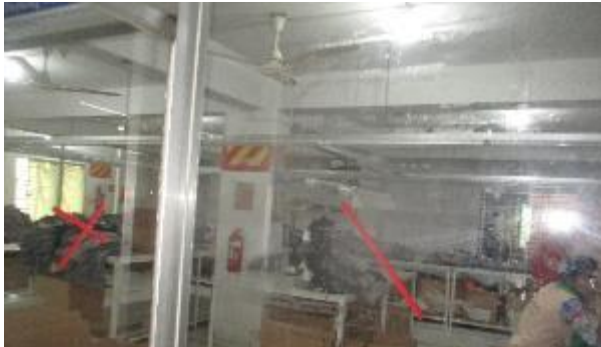
Loading on 3rd floor packing section

Factory designated consulting firm has prepared a load plan considering 5kpa maximum allowable floor loading for 2nd & 3rd floor storage areas.

During inspection, no over loading was observed and FoS calculation for internal column was found satisfactory considering 3 kpa allowable floor live loading for existing structure.

Factory is required to maintain the floor live load 3 kpa until prepared load plan reviewed by Accord.

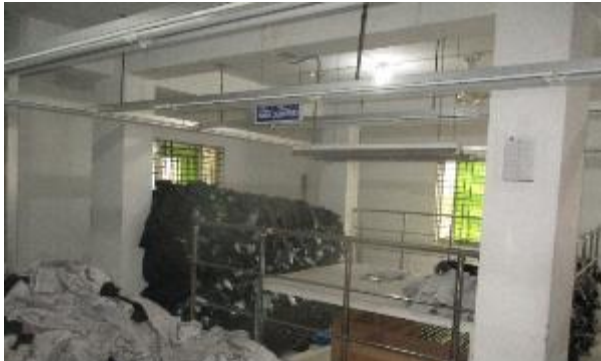
Loading on 2nd floor cutting section

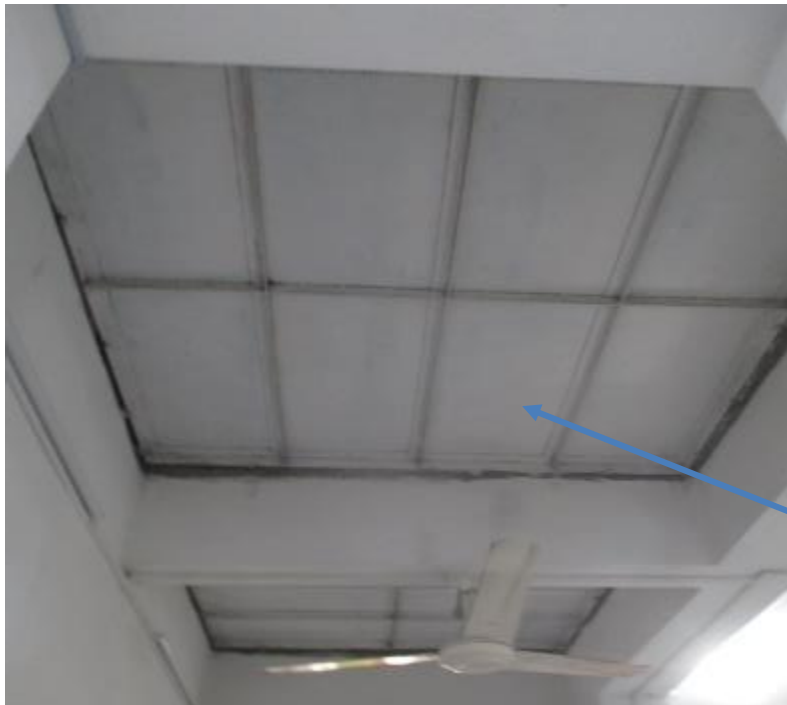
Slab opening covered by steel sheet

Slab opening was found on GF to 3rd floor slab which was covered by steel sheet supported by angle. Factory is required to replace the steel sheet as per engineer's recommendation.

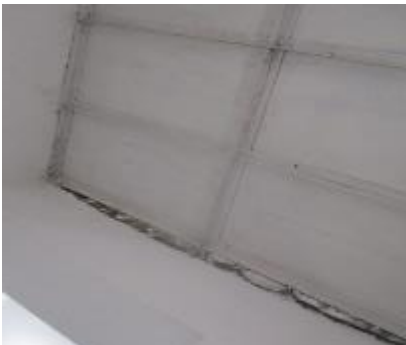
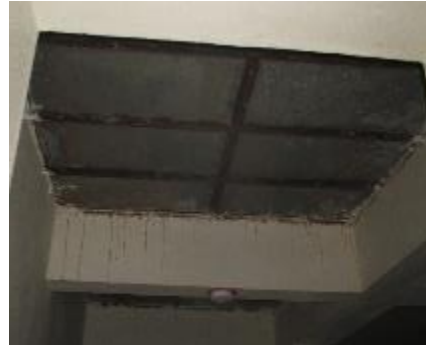
Steel sheet poorly connected with RC slab by welding

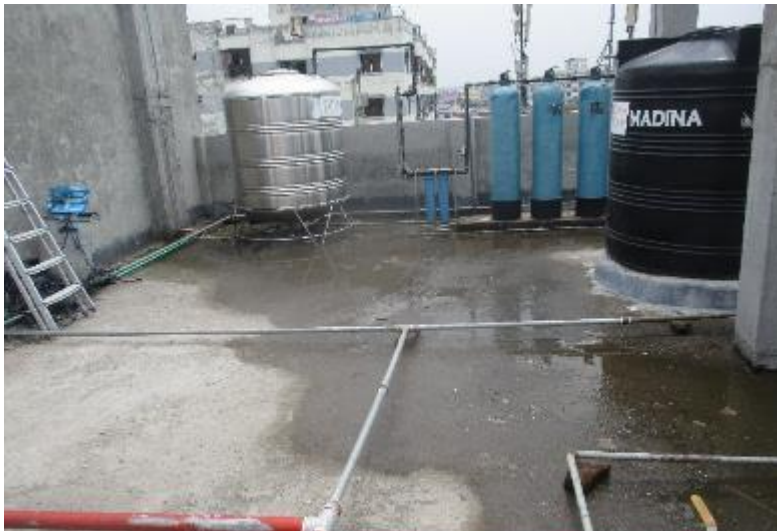
Standing water on roof

Water ponding was found at roof of the factory building. Also stacking of construction materials found on roof. Factory is required to remove the construction materials from roof and improve water drainage system to avoid water clogging.

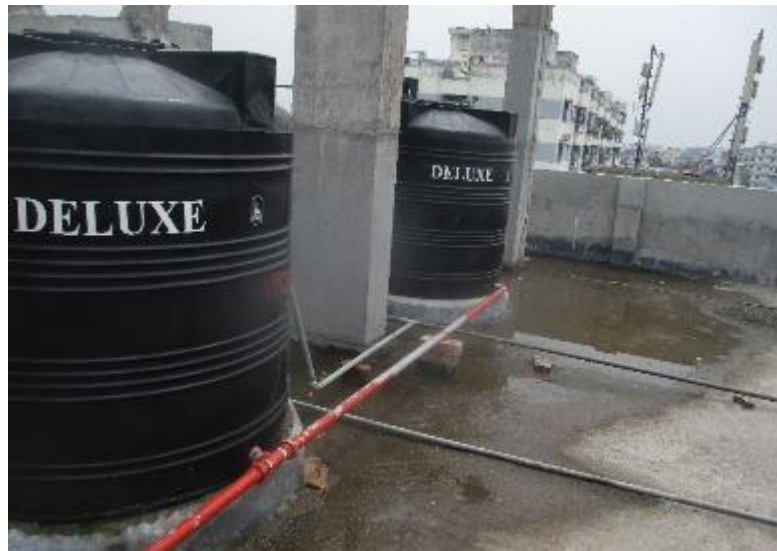
Standing water on roof

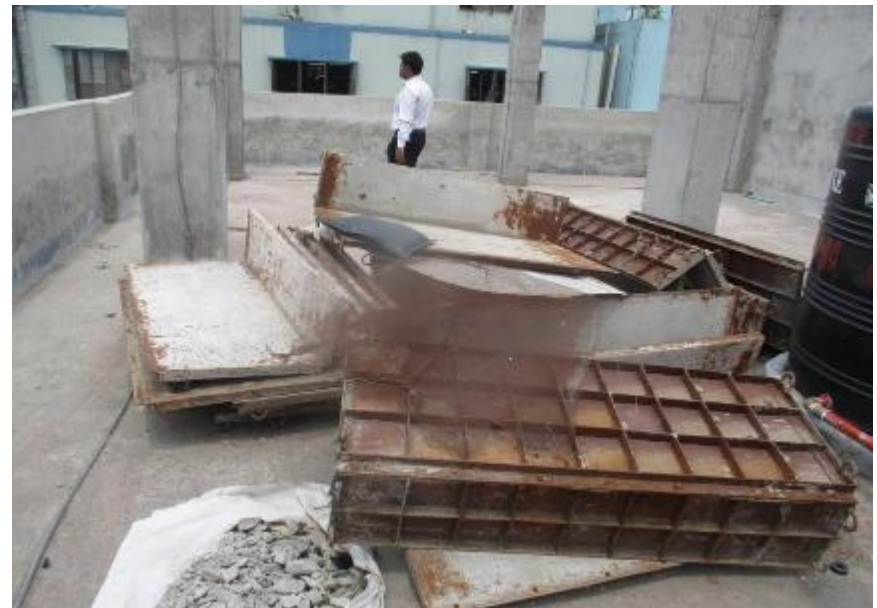
Stacking of construction materials
