# Green Smart Shirts Ltd.

Tapirbari, Sreepur Gazipur- 1740 |  
(24.237098N, 90.433191E)  
30<sup>th</sup> April 2018

# Observation

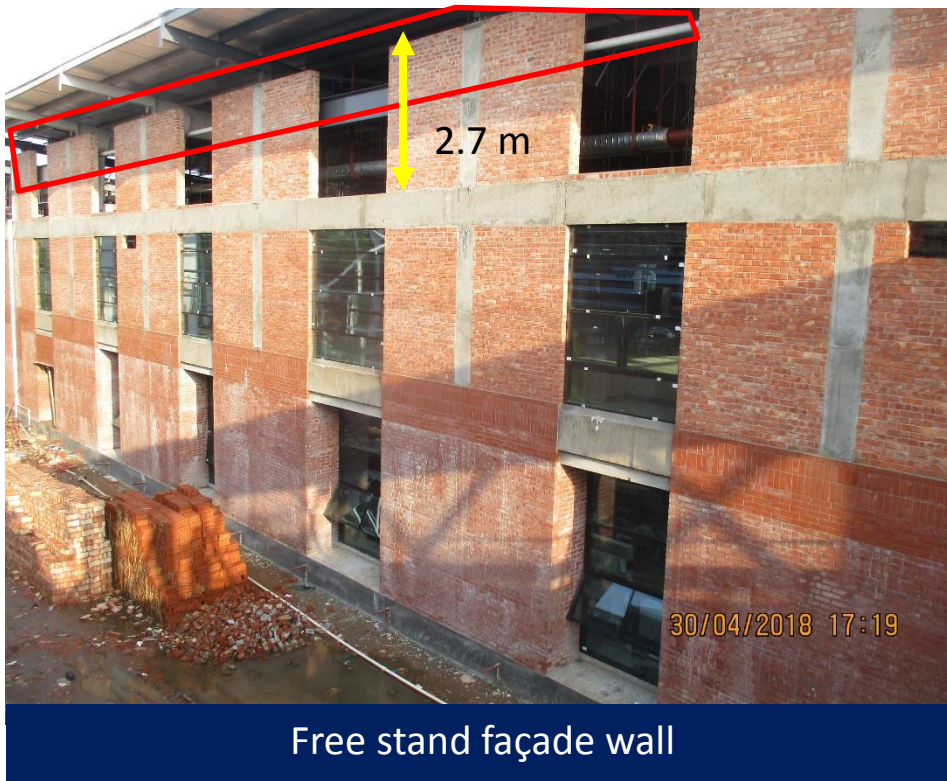
Free stand façade wall

Free standing masonry façade wall observed. Lateral stability of façade wall is required to be checked against lateral loads.

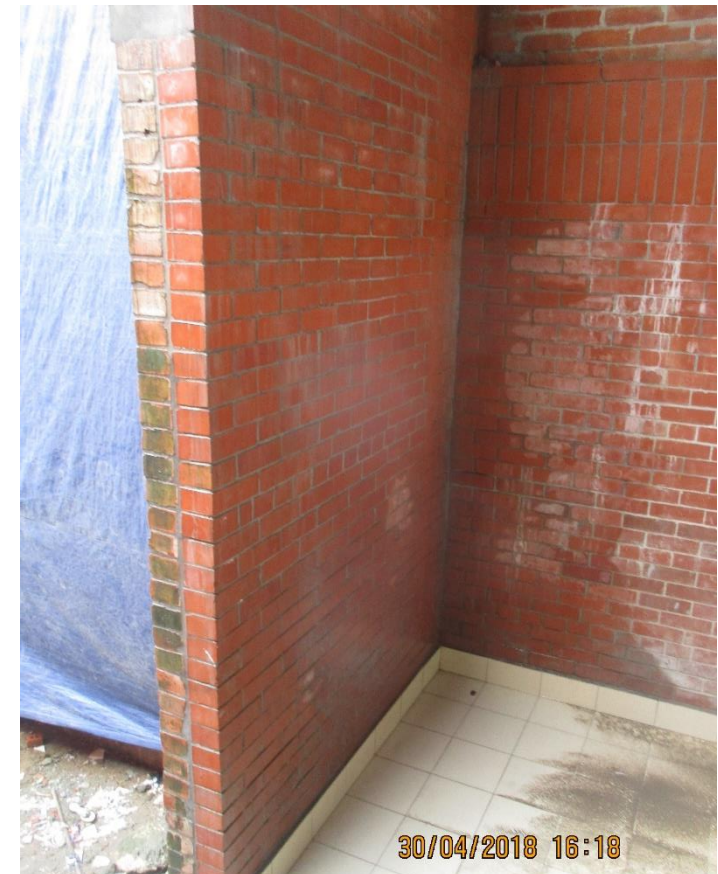
Section of façade wall, two 125 mm connected to each other.

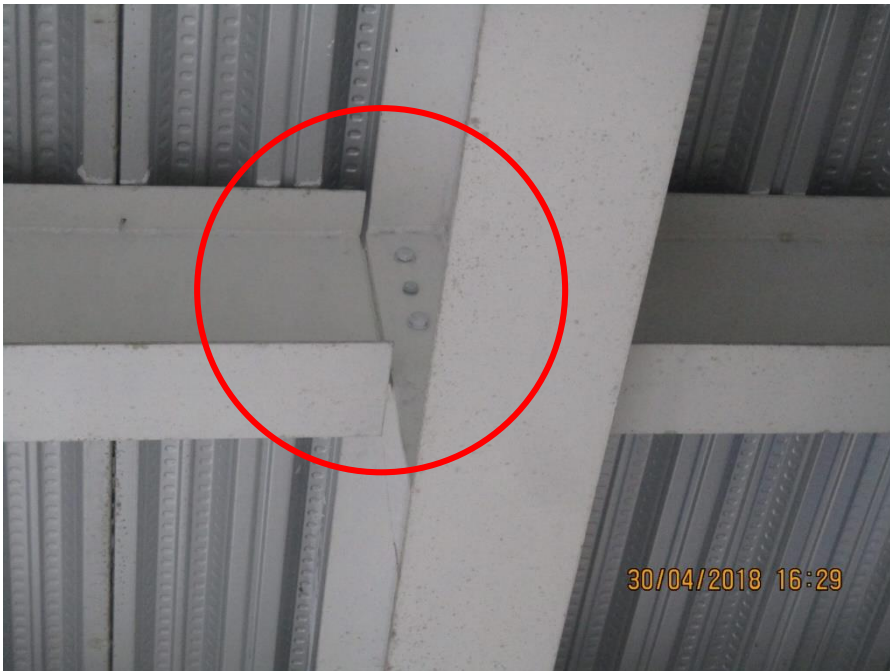
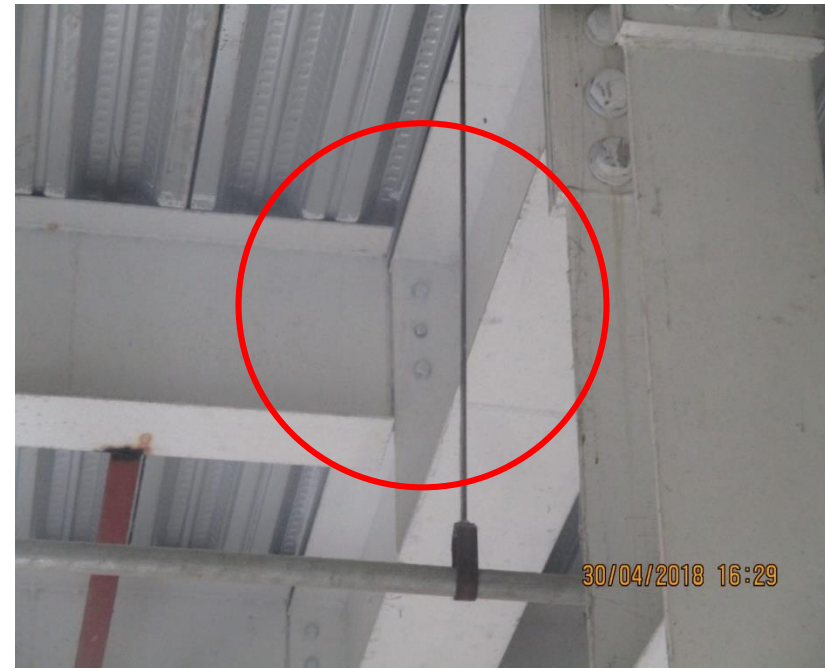
# Undersize bolt in sub-beam and main beam joint

Under sized bolts were observed on several location at sub-beam to main beam connection at ground floor. Factory is required to replace the under sized bolt with bolt which was considered in connection design.

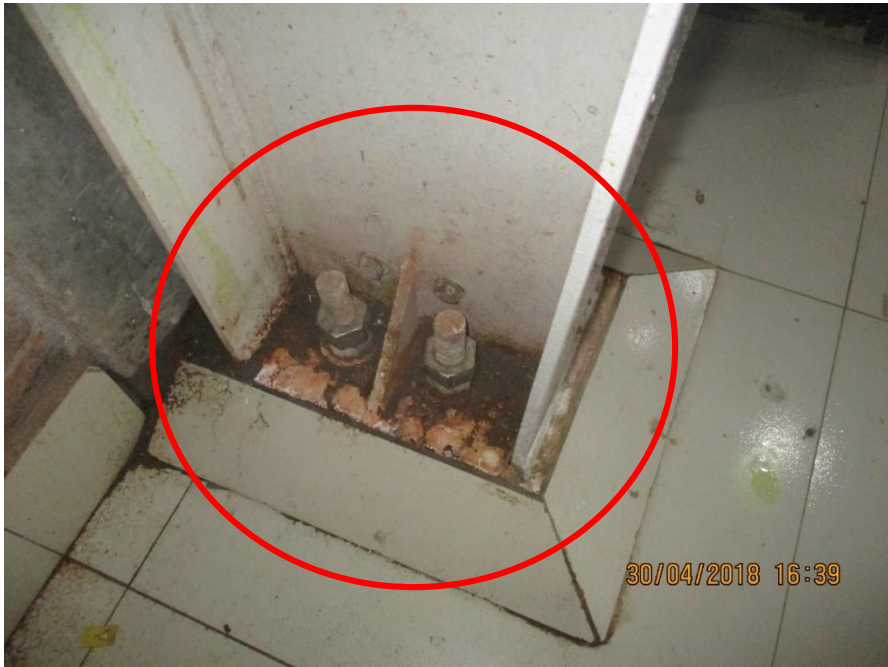
Corrosion observed at Steel column at ground floor

Corrosion was observed on steel columns on different locations of 1st and ground floor areas. Factory is required to identify the corroded locations and take proper remedial measures.

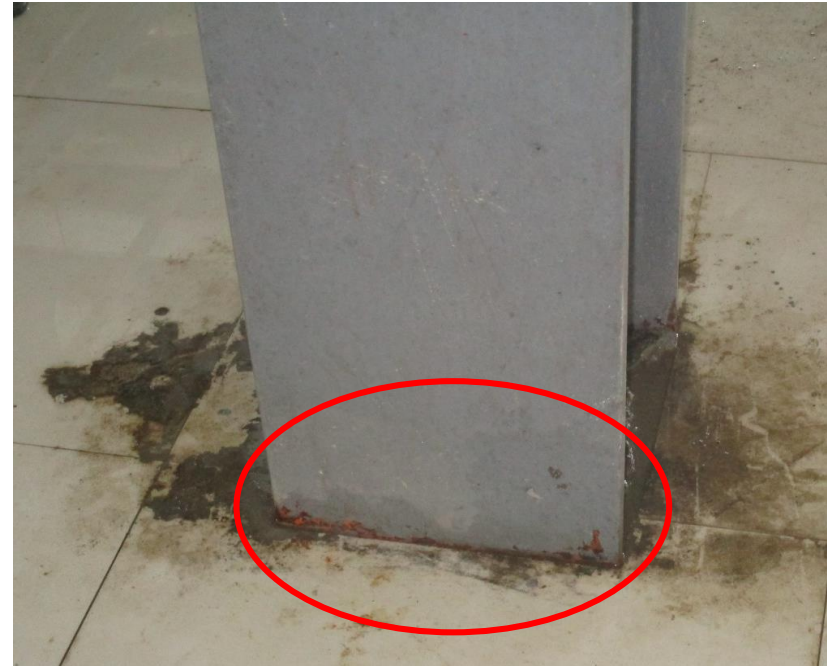
Corrosion was observed at joint of deck slab and steel column in 1<sup>st</sup> floor

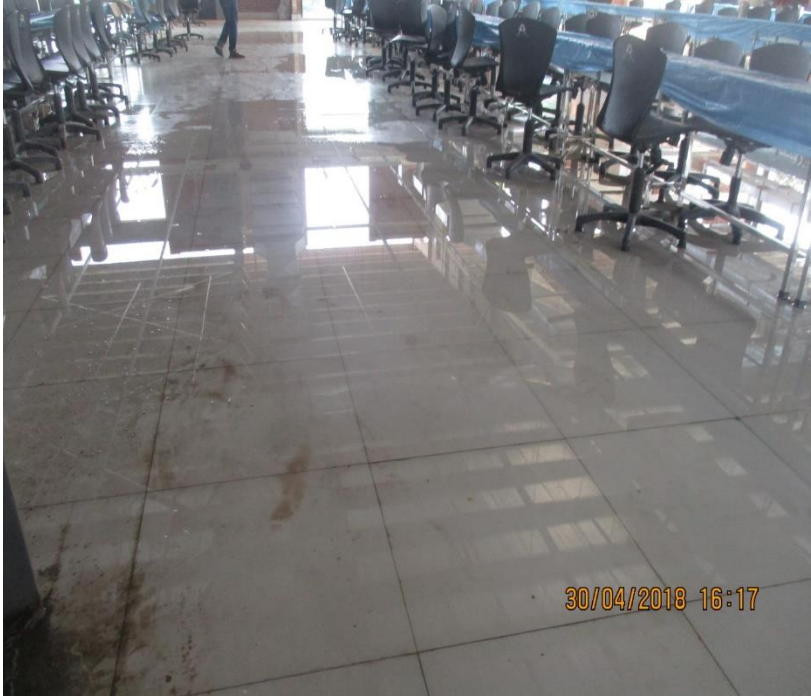
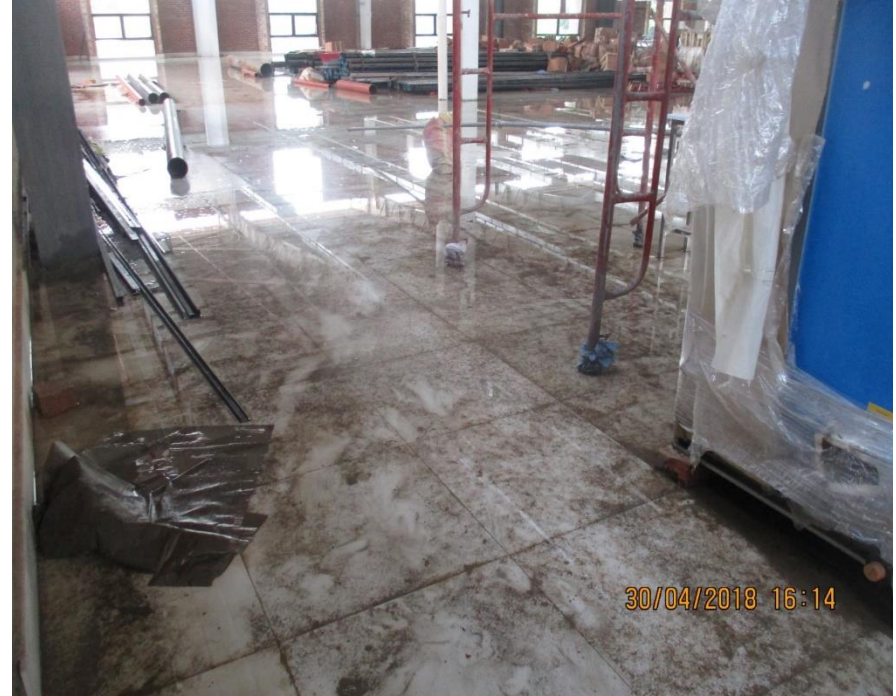
## Water clogging on 1st floor

During inspection, water clogging was observed on 1<sup>st</sup> floor in several area. Factory is required to take measure to prevent water ingress.

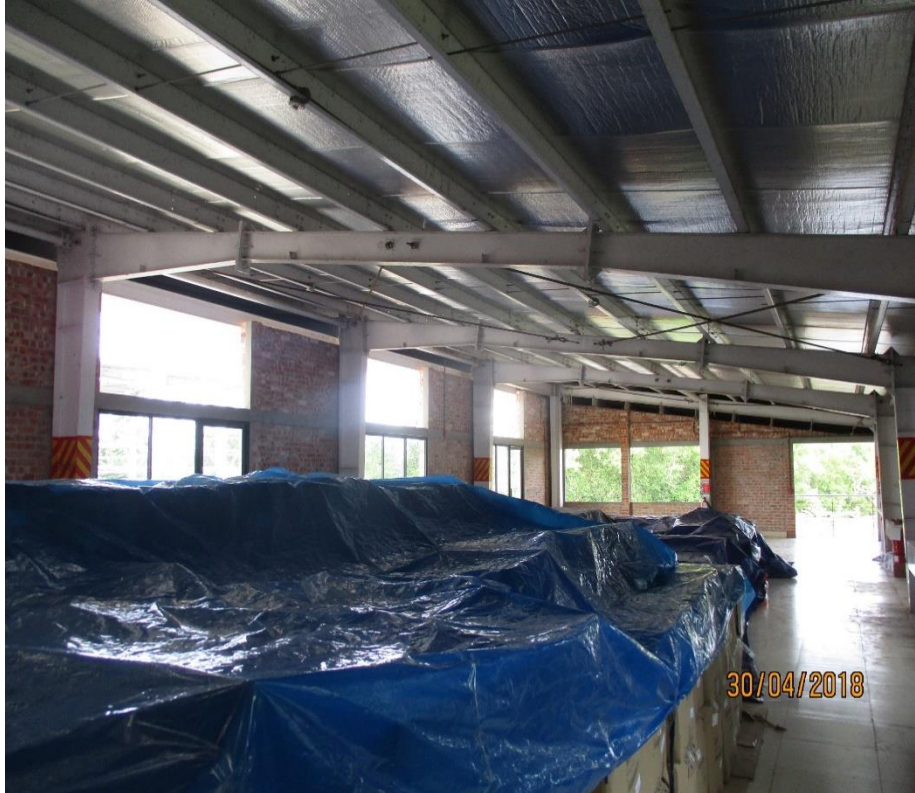
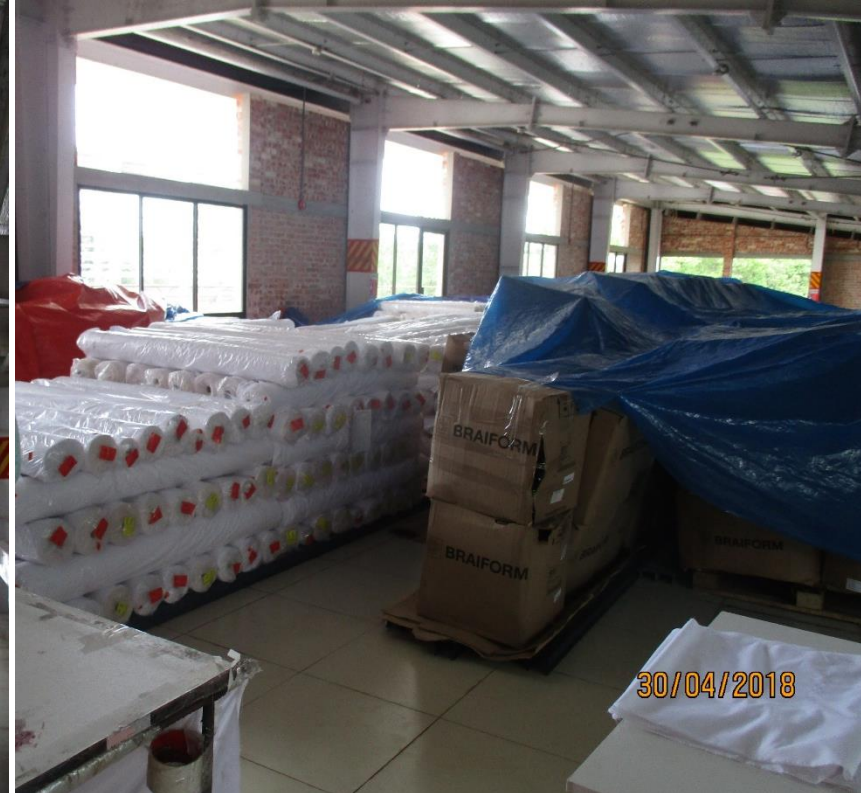
# Implement floor load management program

No load management program was being implemented. Factory is required to implement load management program as per its floor loading capacity and follow the load plans for all floors of the buildings and ensure that the workers understand the loading requirements.

7	(Facility building) Implement floor load management program	Factory engineer is required to implement load management program as per its floor loading capacity.	6-weeks

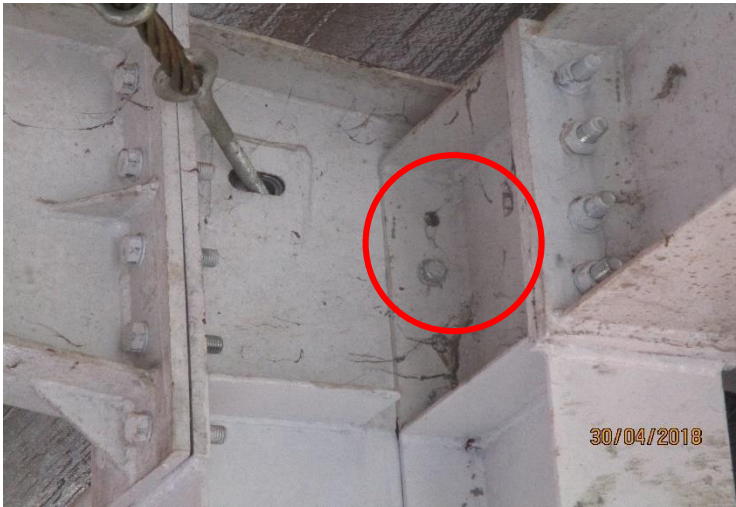
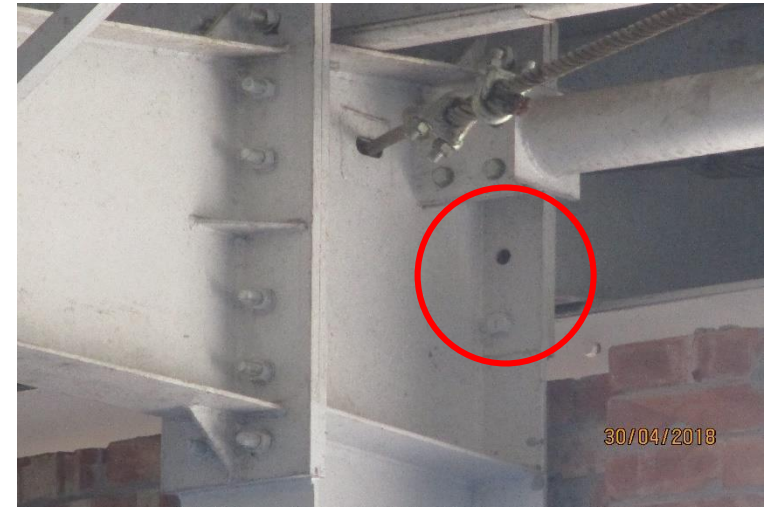
Missing Bolt at several locations

Item No.	Observation	Recommended Action Plan	Recommended Timeline
8	(Facility building) Bolt missing and corrosion on steel member	Building engineer is required to identify the point where bolts are missing and installed missing bolts as per steel fabrications drawings.	6-weeks
9	(Facility building) Bolt missing and corrosion on steel member	Factory Engineer to suggest and implement proper remedial measures to protect steel sections from corrosion.	6-weeks
10	(Utility building) Implement floor load management program	Follow the load plan (5kPa) and implement load management program as per its floor loading capacity.	6-weeks
11	(Utility building) Water ponding on lobby	Factory is required to improve the drainage system for prevention of water ponding.	6-weeks
12	(Connecting Bridge) Review the placement of bracing system	Factory engineer is required to review design and replace bracing system.	6-weeks

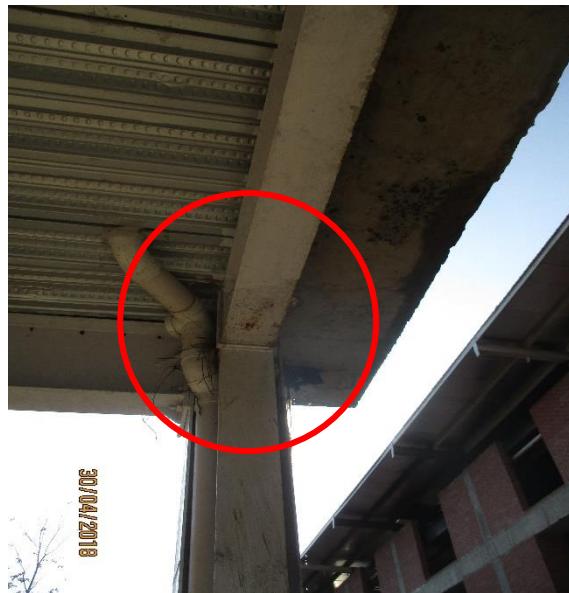
Corrosion was observed on steel columns. Factory is required to identify the locations and take proper remedial measures.

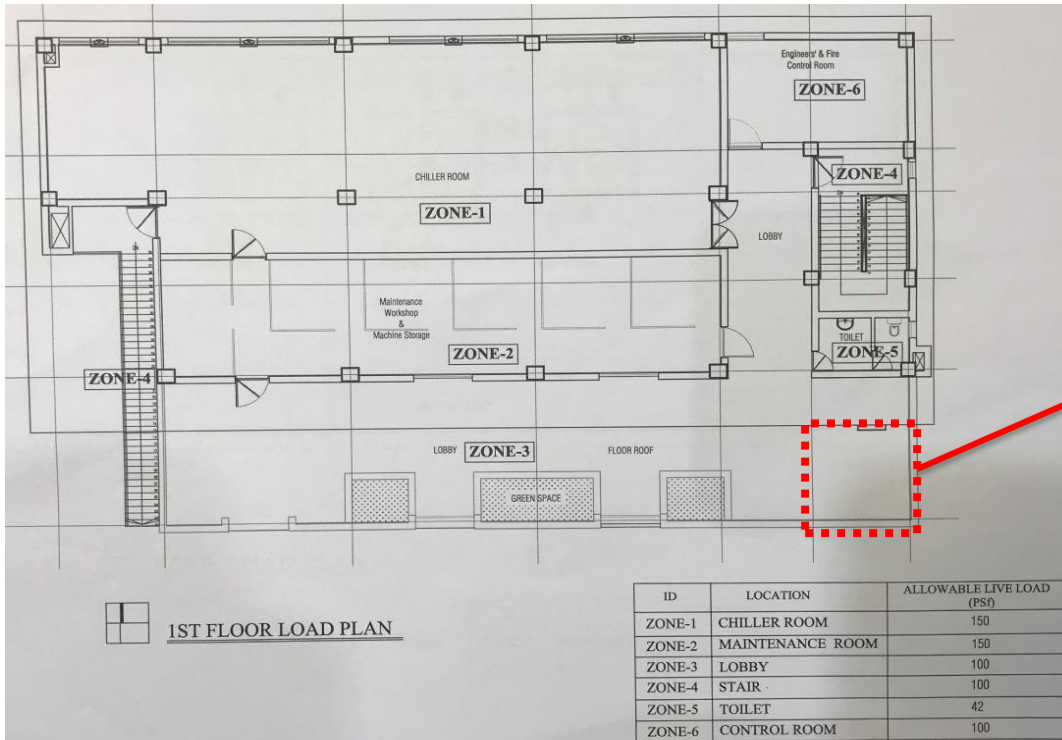
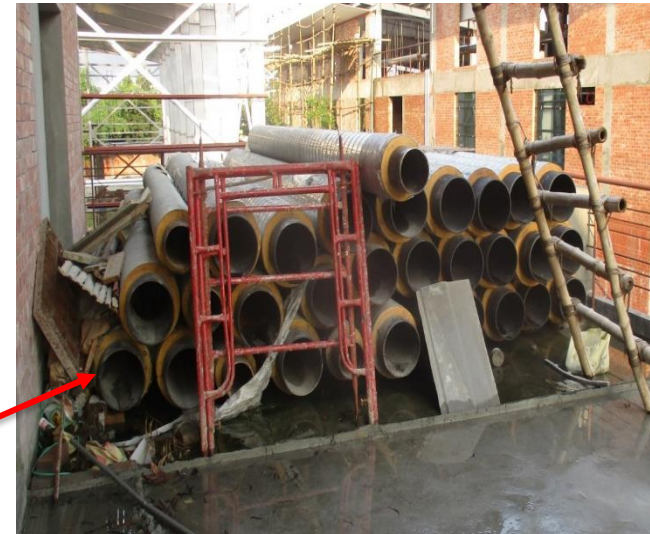
Overloading was observed above 5 kPa on lobby.

Measured was found below 3Kpa on every floor except at lobby area. FoS calculation for internal column showed the capacity to be adequate considering 5kPa floor loading. Limit the loading below 5 kPa.

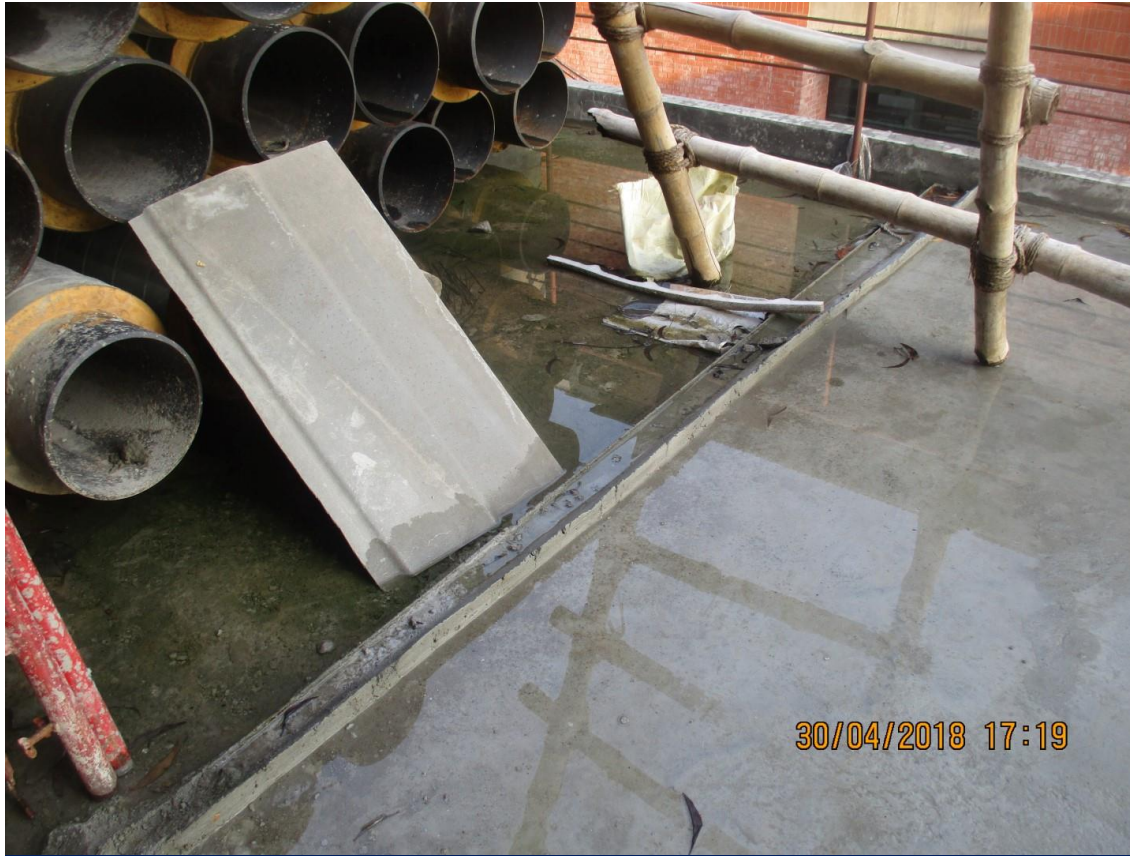
# Water ponding on lobby

During inspection, water ponding was observed on lobby area. Factory is required to improve the drainage system for prevention of water ponding.

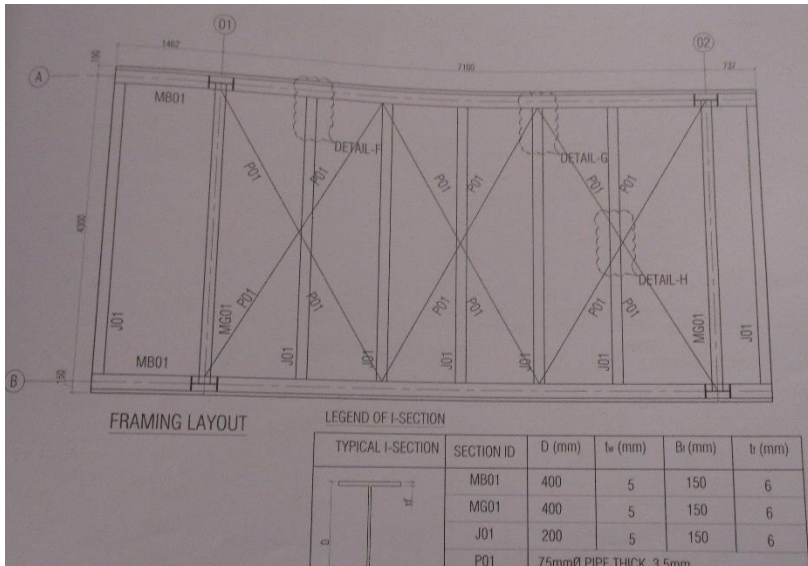
Frame bracing layout of connecting bridge

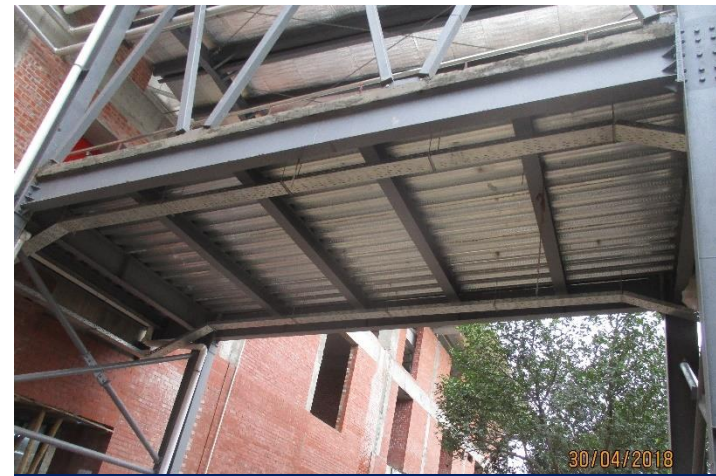
Frame not installed as per drawing

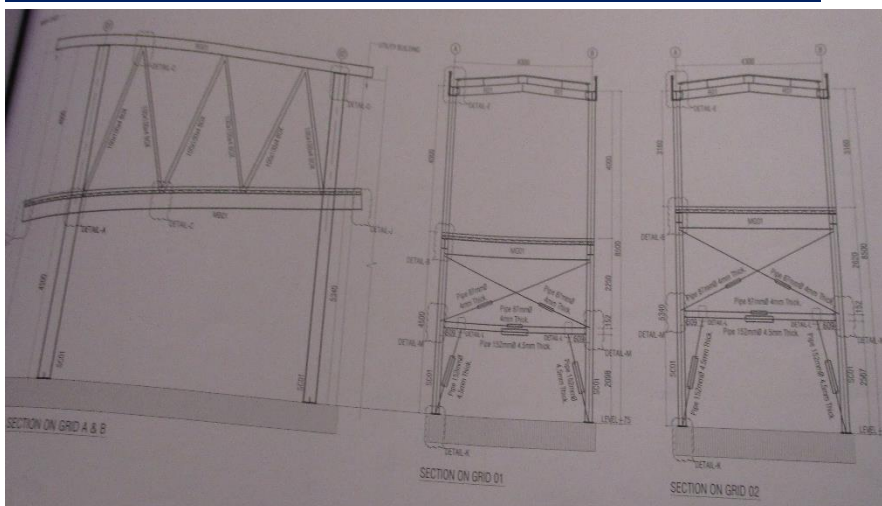
Proposed vertical bracing layout

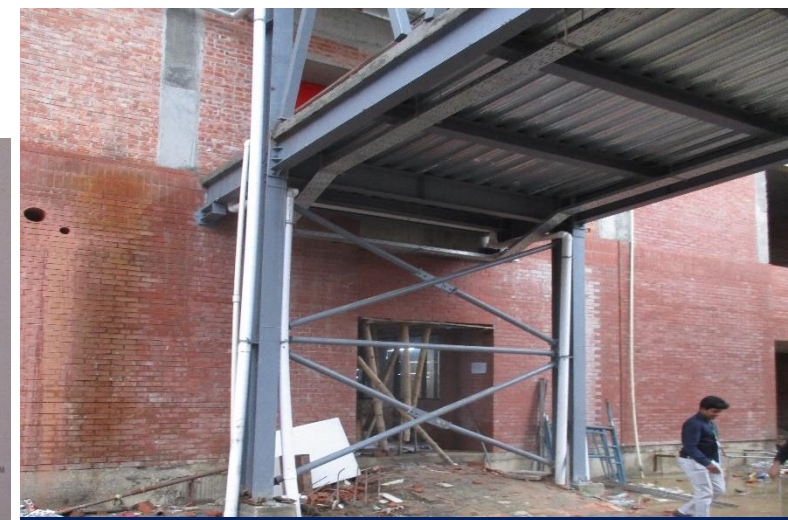
Provided bracing is blocking exit point. Building engineer is required to review design and replace bracing system.
