# IFL FACTORY LIMITED

140 Dhour Uttara Turag, Uttara, Dhaka

6<sup>th</sup> May 2018

# Observations

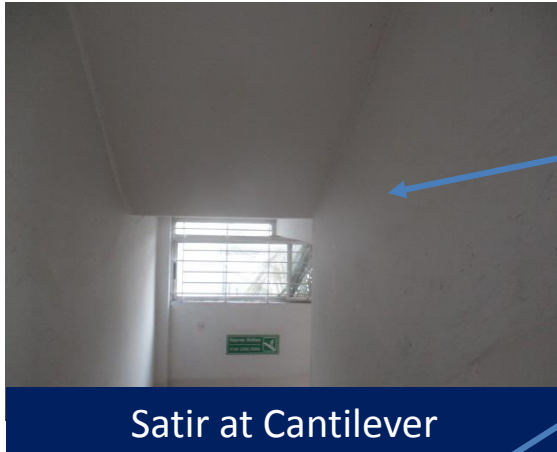
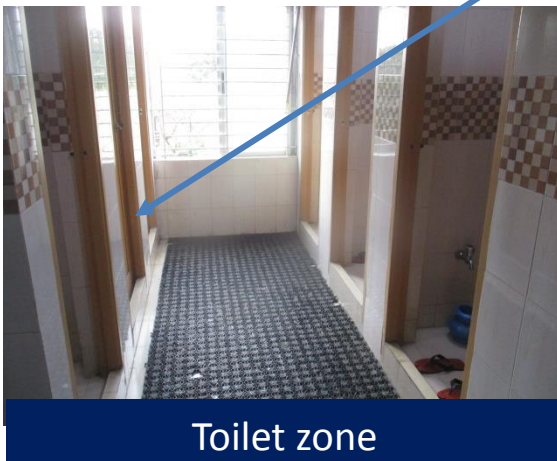
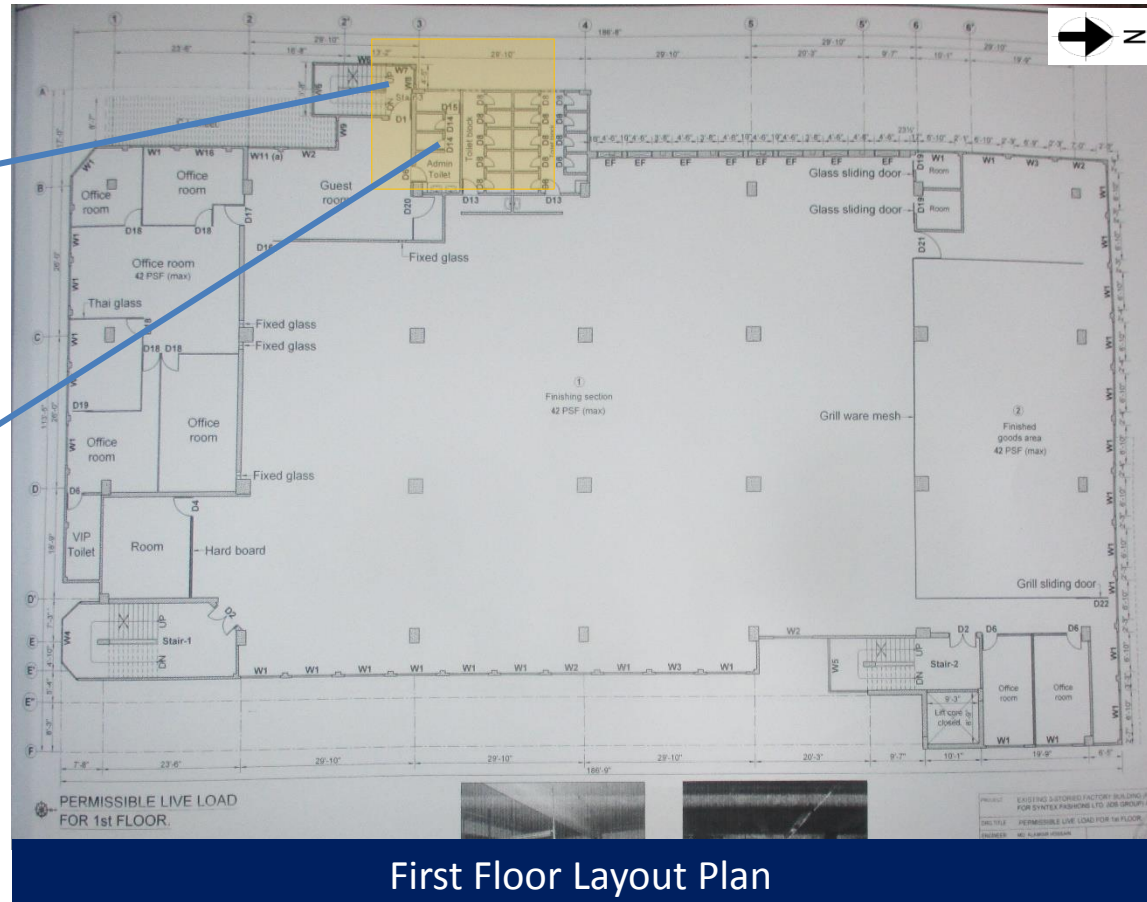
**Column stress exceeds the normal design limits**

Cursory calculations indicate that the working stress of ground floor column & foundation under toilet area exceeds the normal design limits, assuming minimum concrete strength. Building engineer to verify in-situ concrete strength and confirm grade of steel reinforcement used.

Satir at Cantilever

Toilet zone

| Item No. | Observation | Recommended Action Plan | Recommended Timeline |
|---|---|---|---|
| 1 | (Factory building)<br>Column stress exceeds the normal design limits | Factory Engineer to review design, loads and columns & foundation stresses in area identified above. | 6-weeks |
| 2 | (Factory building)<br>Column stress exceeds the normal design limits | Verify in-situ concrete stresses by 100mm dia. cores from min. 4 no. column from ground floor level. | 6-weeks |
| 3 | (Factory building)<br>Column stress exceeds the normal design limits | Produce and actively manage a loading plan for all floor plates within the factory giving consideration to floor capacity and column capacity. | 6-weeks |
| 4 | (Factory building)<br>Column stress exceeds the normal design limits | Continue to implement load plan | 6-months |
| 5 | (Factory building)<br>Column stress exceeds the normal design limits | Remedial works to be carried out if required. | 6-months |

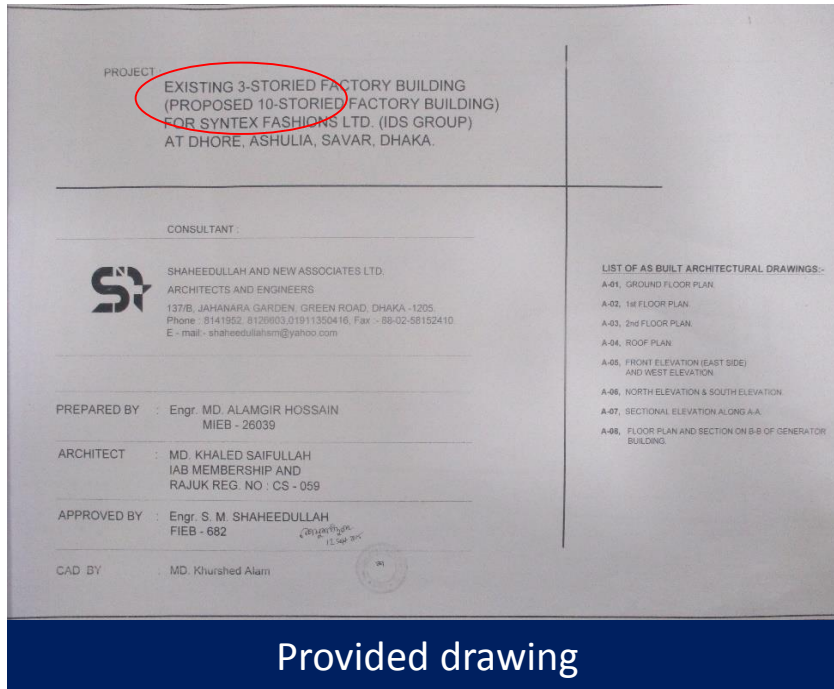
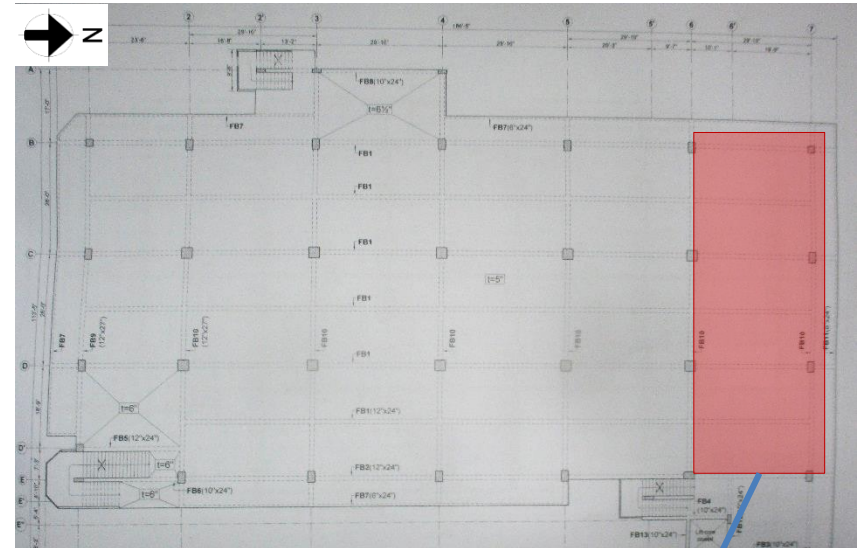
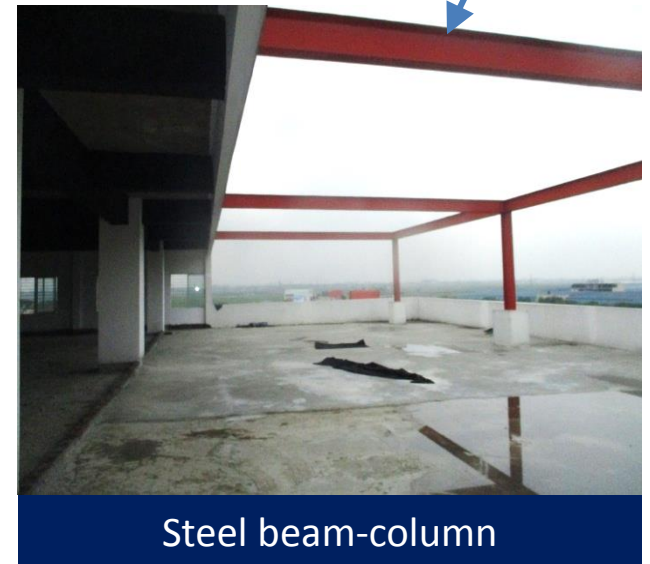
# **Insufficient as-built drawings of factory building & utility buildings.**

During inspection the building was 6 storied. A set of as-built drawing has been provided for 3 storied factory building which was prepared in 2015. However, factory is required to prepare full set of as-built drawing.

At 5<sup>th</sup> floor steel column & beams are found at North side of the building. No details were found for steel part.

| Item No. | Observation | Recommended Action Plan | Recommended Timeline |
|---|---|---|---|
| 6 | (Factory Building & Utility Buildings)<br>Insufficient as-built drawings of factory building & utility buildings | Building Engineer to survey as-built structure and prepare an “as constructed” drawings which reflect the actual site dimensions with complete structural information. | 6-weeks |

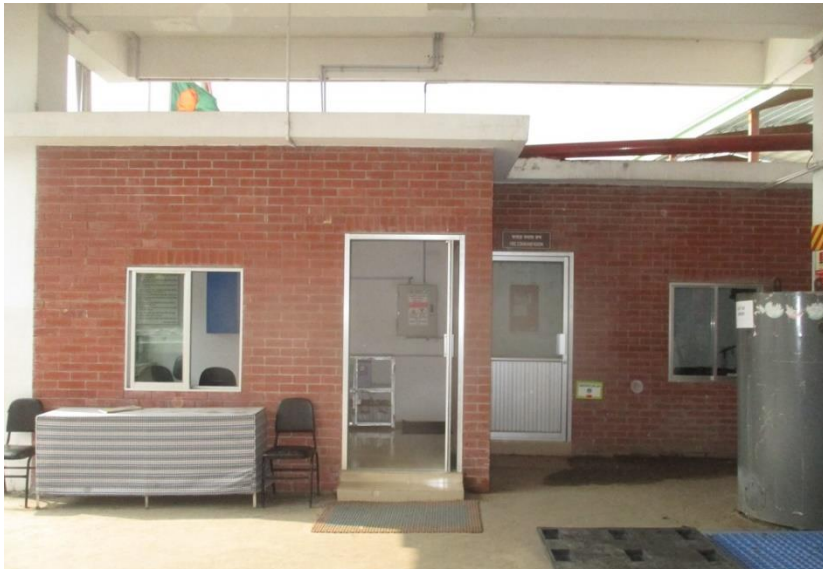
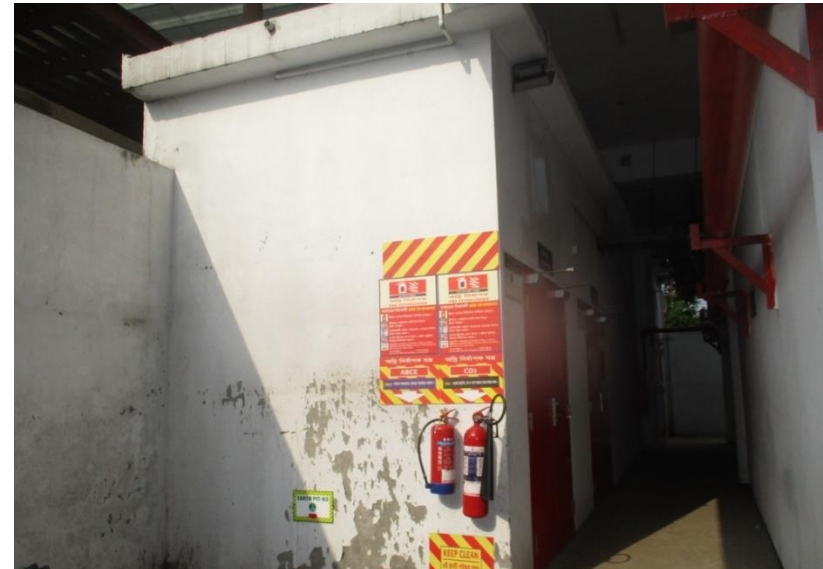
Utility Building - 1

Utility Building - 2

Structural drawings are not prepared for utility building. Only layout has been prepared for utility building 1 & 2. Factory engineer is required to Prepare “as constructed” drawings which reflect the actual site dimensions with complete structural information.

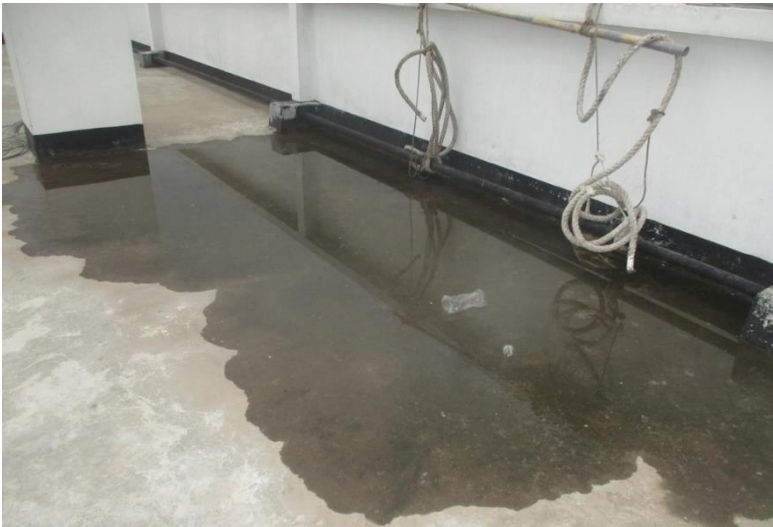
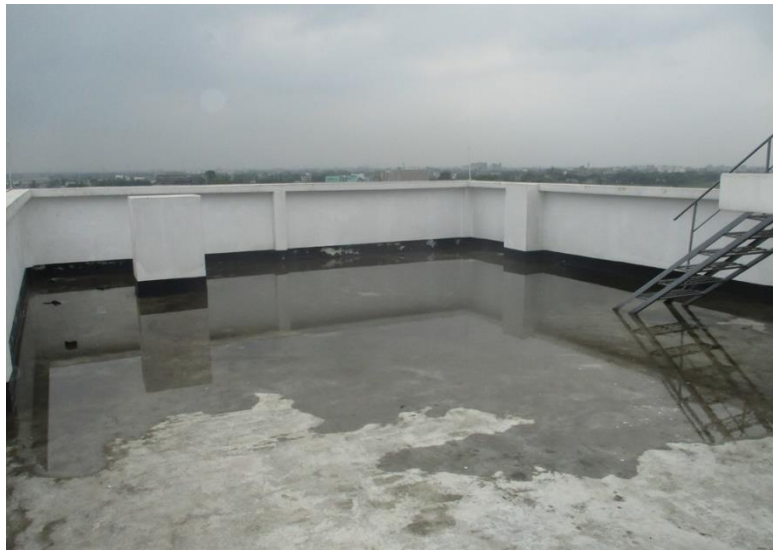
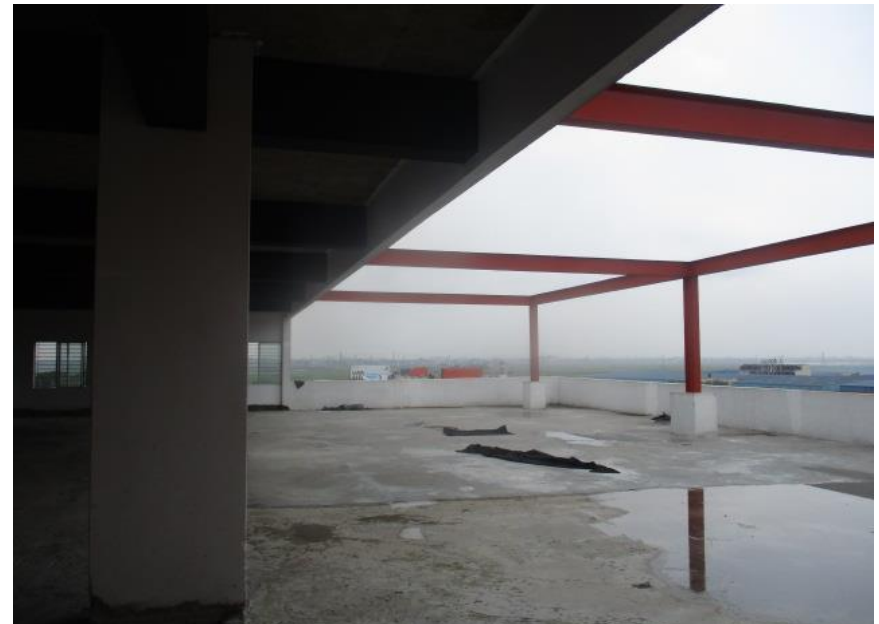
# Water ponding on roof

Stagnant water on roof

Water ponding was found at 5<sup>th</sup> floor and roof of the factory building. Factory is required to improve water drainage system to avoid water clogging.

Stagnant water on 5<sup>th</sup> floor

| Item No. | Observation | Recommended Action Plan | Recommended Timeline |
|---|---|---|---|
| 7 | (Factory Building)<br>Water ponding on roof | Factory is required to provide water proofing layer and improve water drainage system to avoid water clogging. | 6-weeks |

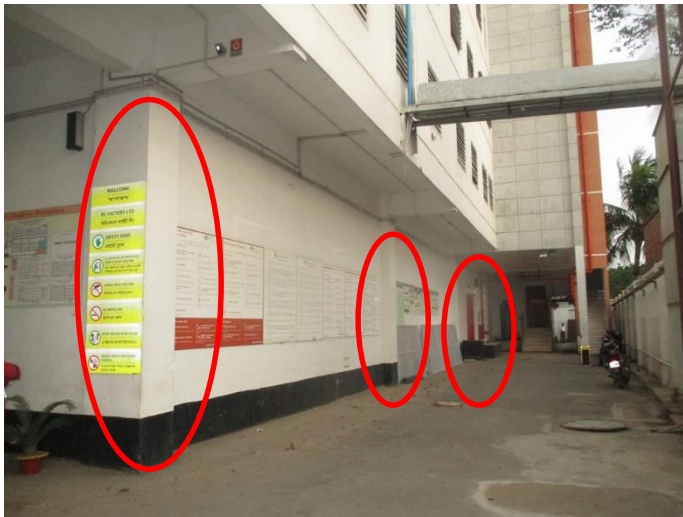
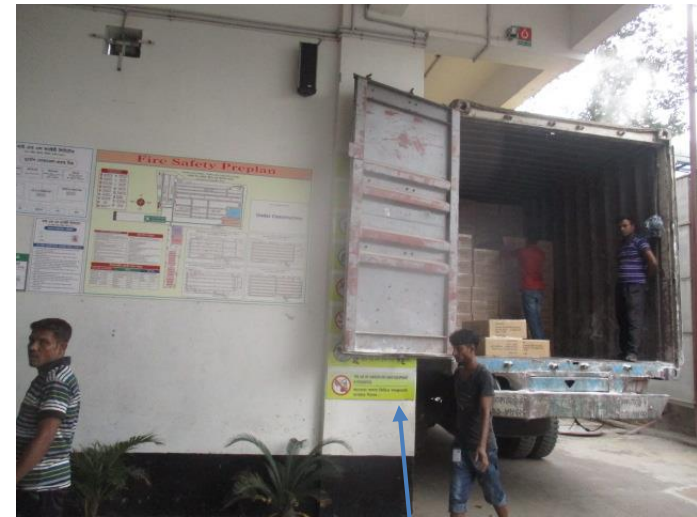
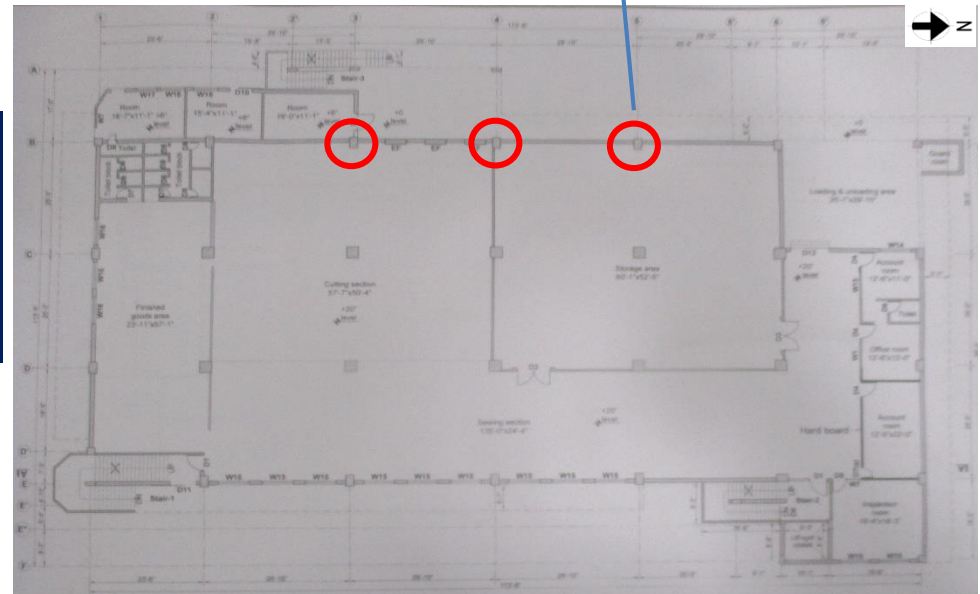
# Columns susceptible to vehicle impact

Impact protection not provided to columns at loading –unloading area. Columns are susceptible to impact loading from vehicles.

| Item No. | Observation | Recommended Action Plan | Recommended Timeline |
|---|---|---|---|
| 8 | (Factory Building)<br>Columns susceptible to vehicle impact | Install a barrier to prevent vehicle impact in columns. | 6-weeks |

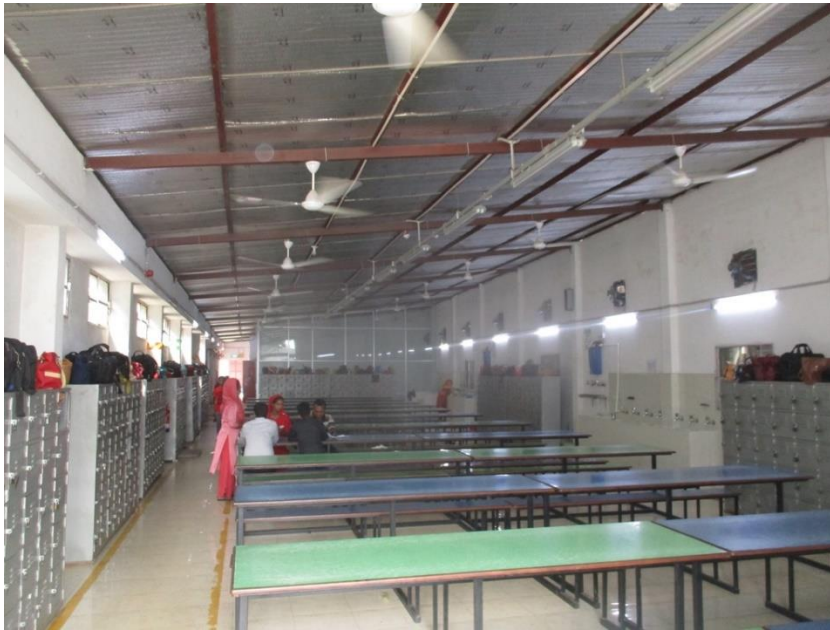
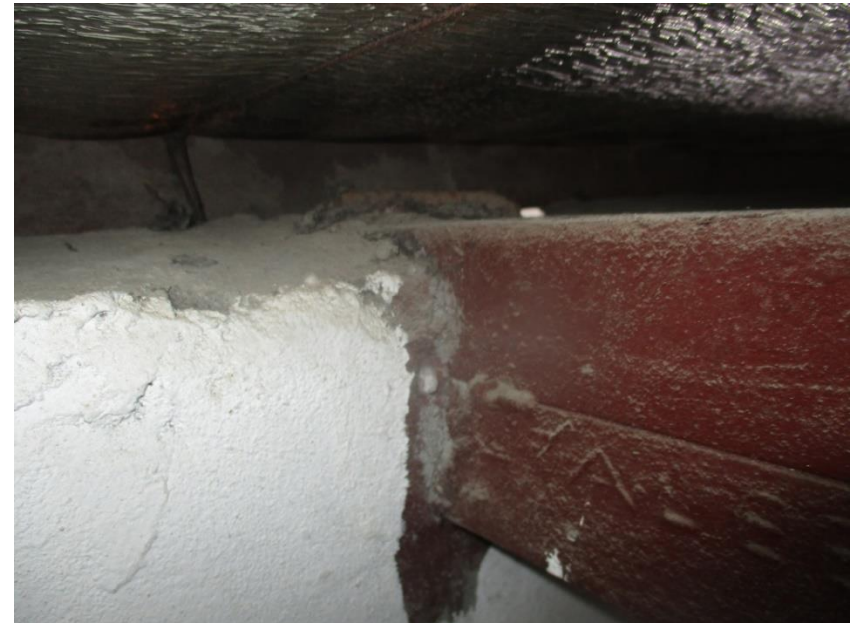
# Apparently non-engineered single storied steel shed

As-built drawings were not available for single storied steel shed. Lateral load transferring media was not available in this structure. Also there are no proper connection. Building engineer to prepare as-built drawings and check the stability of the structure under lateral and vertical loading.

Rafter and purlin layout

Rafter connection with brick wall

| Item No. | Observation | Recommended Action Plan | Recommended Timeline |
|---|---|---|---|
| 9 | (Single Storied Steel Shed)<br>Apparently non-engineered single storied steel shed | Prepare update as-built documentation for single storied steel shed. | 6-weeks |
| 10 | (Single Storied Steel Shed)<br>Apparently non-engineered single storied steel shed | Building engineer to check the capacity of the structure under lateral and vertical loading. | 6-weeks |
| 11 | (Single Storied Steel Shed)<br>Apparently non-engineered single storied steel shed | Carry out remedial works resulting from engineering assessment of building. | 6-months |
