Islam Garments

Islam Knit Design

Zarun, Konabari, Gazipur, Dhaka
(+23.9955N, 90.3263E)

16 September 2013

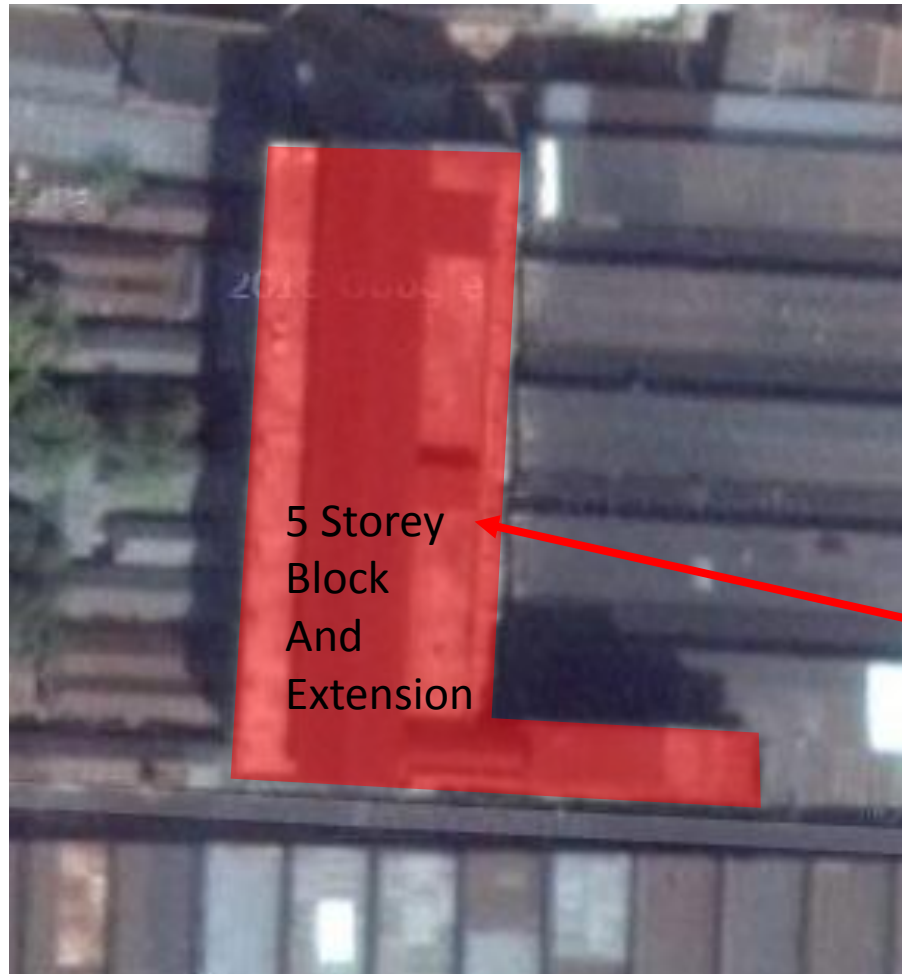
5 Storey
Block
And
Extension

Item 1 High Stress to Building internal columns

ITEM 1: High Stresses on Internal Columns Observed to 5 Storey Block , We require removal of personnel now, with column strength checks and the production of a Detailed Engineering Assessment before this building is used again

Verify concrete strengths in internal columns and reduce loads

**Remove all personnel
from this building
until results of
columns strengths
and Building
Engineering
assessment is
complete**

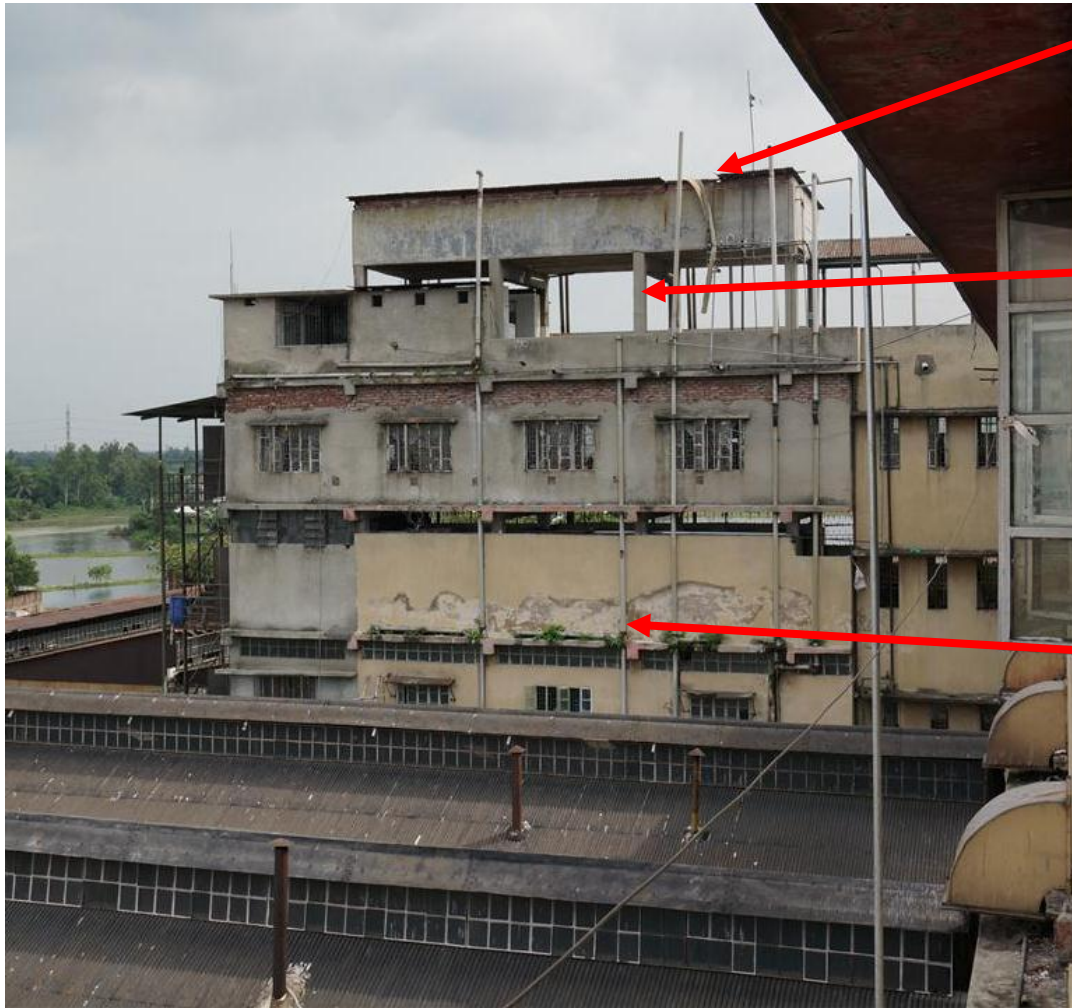
Heavy water tank, not on design drawing.

Limited North-South stability, only pairs of columns, no in-fill walls

Water ingress causing corrosion to structure and facade

ITEM 2:(5 storey building) South extension building has low lateral strength, large loads at roof and is corroded.

Check Of South Extension required

Item No.	Observation	Recommended Action Plan	Recommended Timeline
7	(5 storey building) South extension building has low lateral strength, large loads at roof and is corroded	Engineer to prove existing lateral stability works to code, or propose a retrofit.	6-weeks
8	(5 storey building) South extension building has low lateral strength, large loads at roof and is corroded	Sources of water corrosion to be removed.	6-weeks
9	(5 storey building) South extension building has low lateral strength, large loads at roof and is corroded	Complete structural retrofit and repair corrosion to facades and structure, or demolish.	6-months

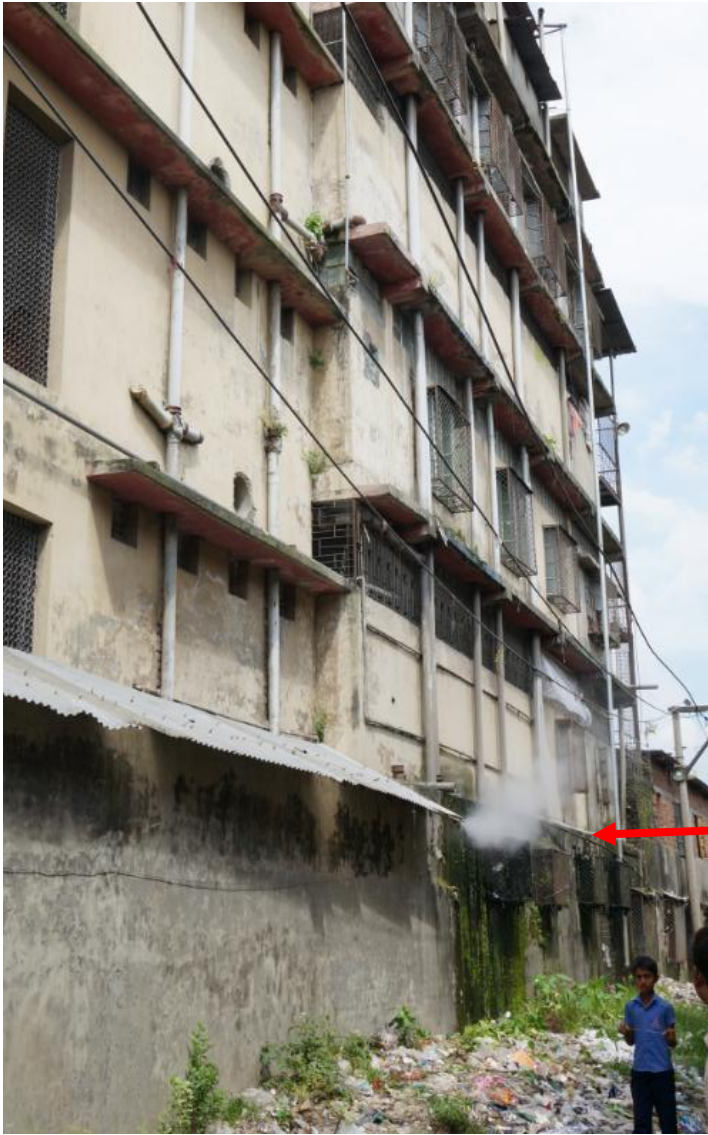
Steam rejection causing constant wetting and corrosion

Check Of South Extension required

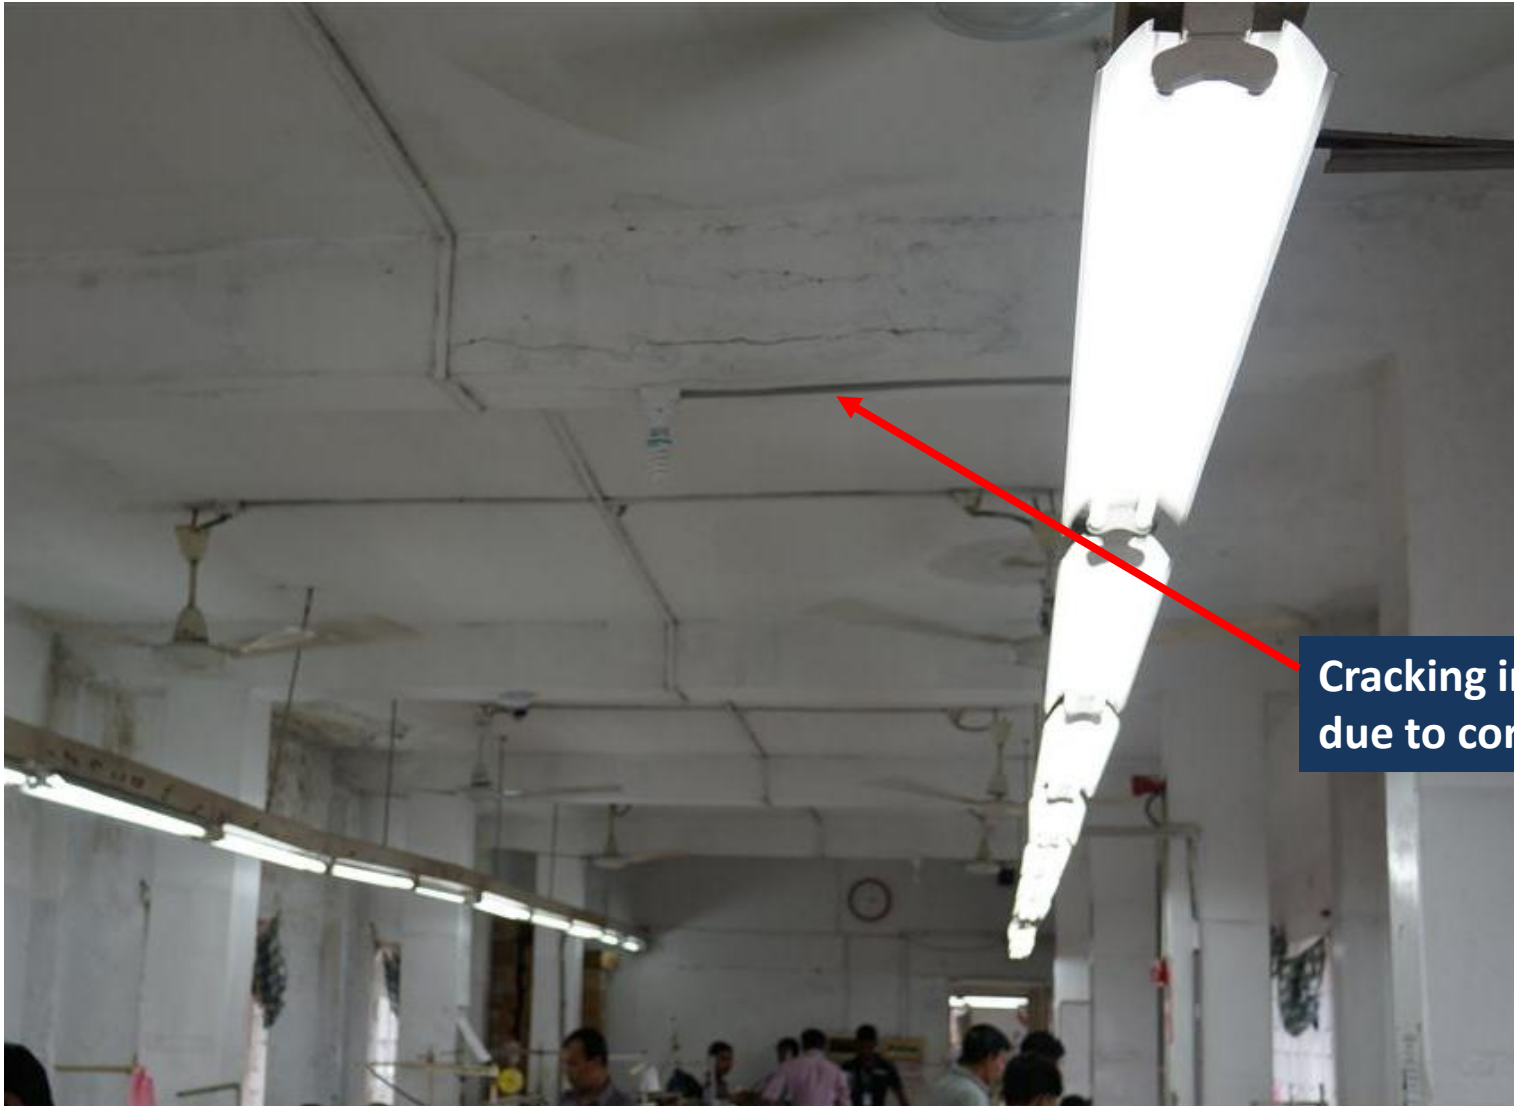
Cracking in beam likely due to corrosion of rebar

Check Of South Extension required

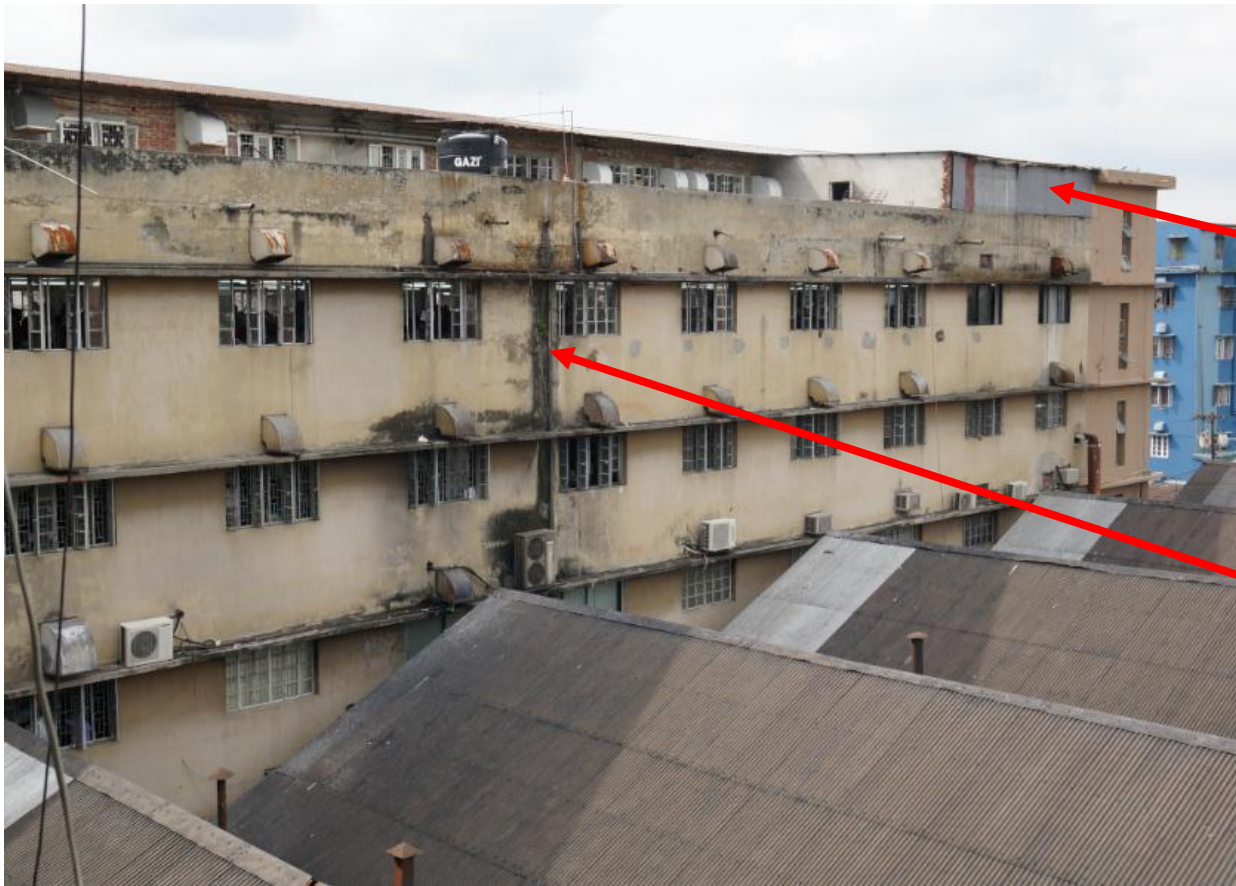
Lightweight steel structure, not on permit plans

Roof drainage causing corrosion to structural masonry wall

ITEM 4: (5 storey building) Roof drainage is not managed as is causing damage to structural load bearing masonry walls.

Check on roof additions required

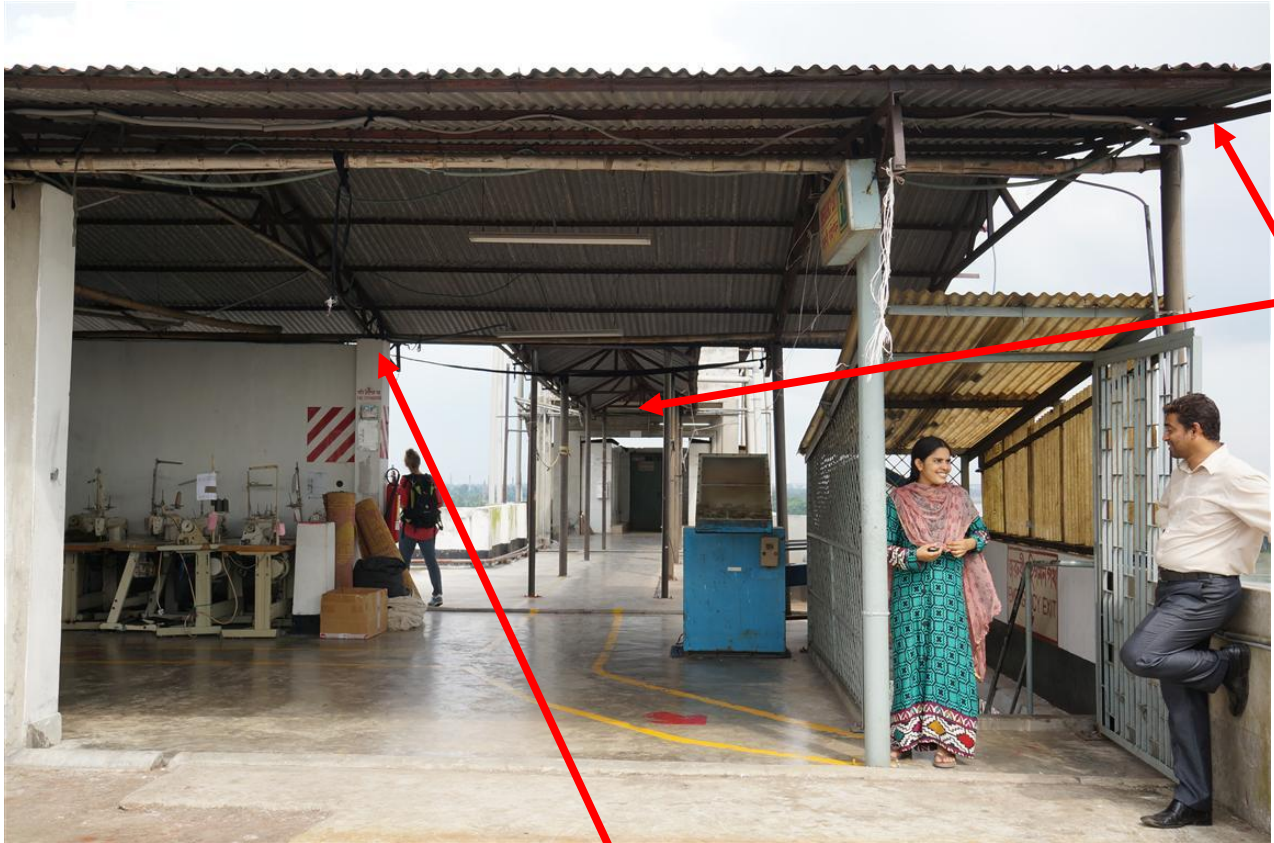
Lightweight steel structures, not on permit plans, open to wind uplift

Inadequate tie-down details

ITEM 3: (5 storey building) Lightweight steel roof additions do not appear to be strong enough for severe wind events or access loading

Check on roof additions required

Item No.	Observation	Recommended Action Plan	Recommended Timeline
10	(5 storey building) Lightweight steel roof additions do not appear to be strong enough for severe wind events or access loading	Addition structures should be Designed and upgraded to support code vertical and wind loads by the building Engineer, or they should be vacated and removed.	6-months
11	(5 storey building) Roof drainage is not managed as is causing damage to structural load bearing masonry walls	Engineer to inspect load bearing masonry walls including the exterior and propose a suitable repair. Roof drainage system to be installed	6-months
12	(10 storey building) Adjacent large steel factory roof is imposing lateral loads on concrete columns between floors	The building Engineer should verify the column strength in bending, or design an alternate load path for the loads from the large steel roof	6-months

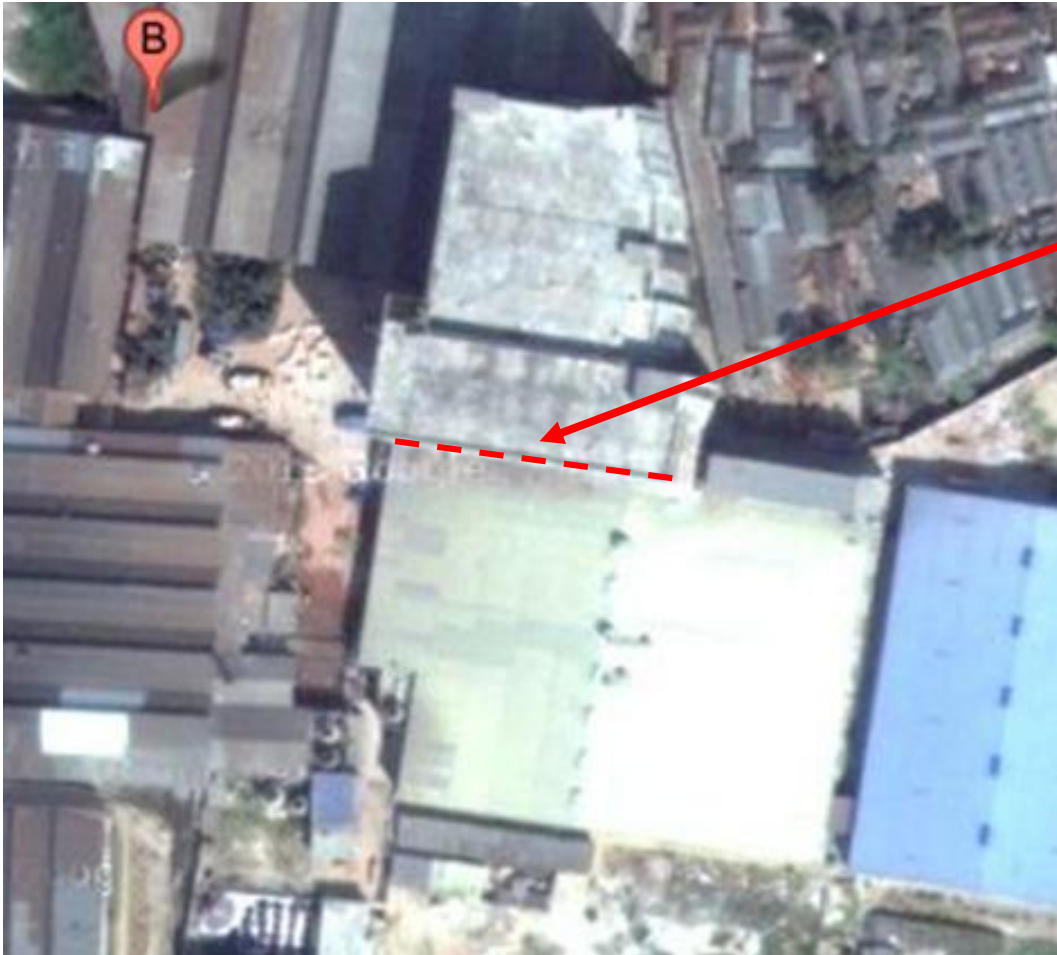
**Interface large steel shed roof
and 10-storey building**

**Check on building interface
required**

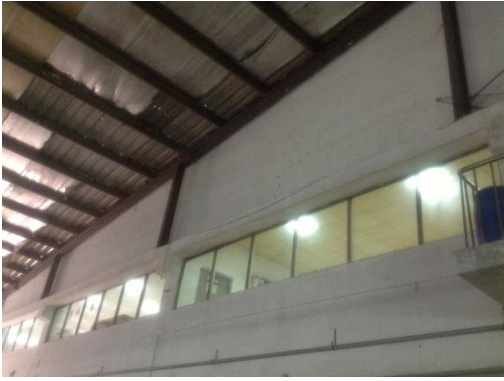
Lateral load from large steel shed roof is imposed on building columns between floor levels

ITEM 5: (10 storey building) Adjacent large steel factory roof is imposing lateral loads on concrete columns between floors

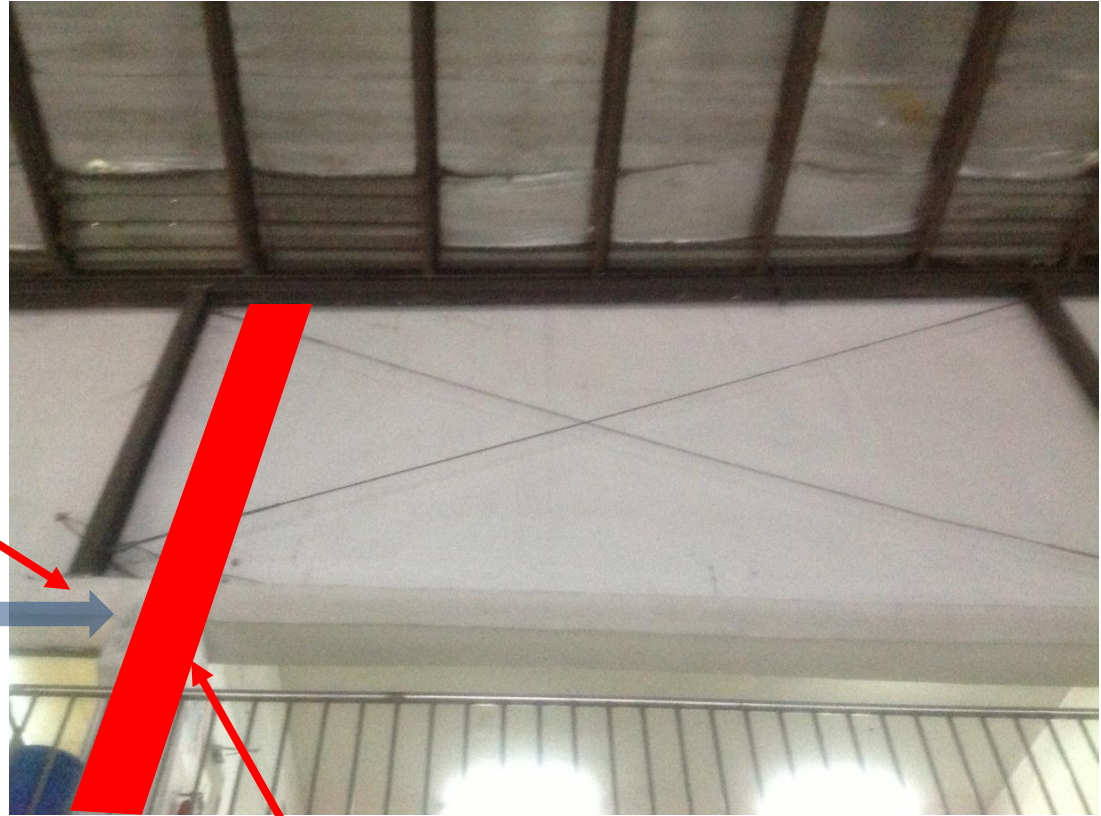
Reinforced concrete column of 10-storey building

Check on building interface required

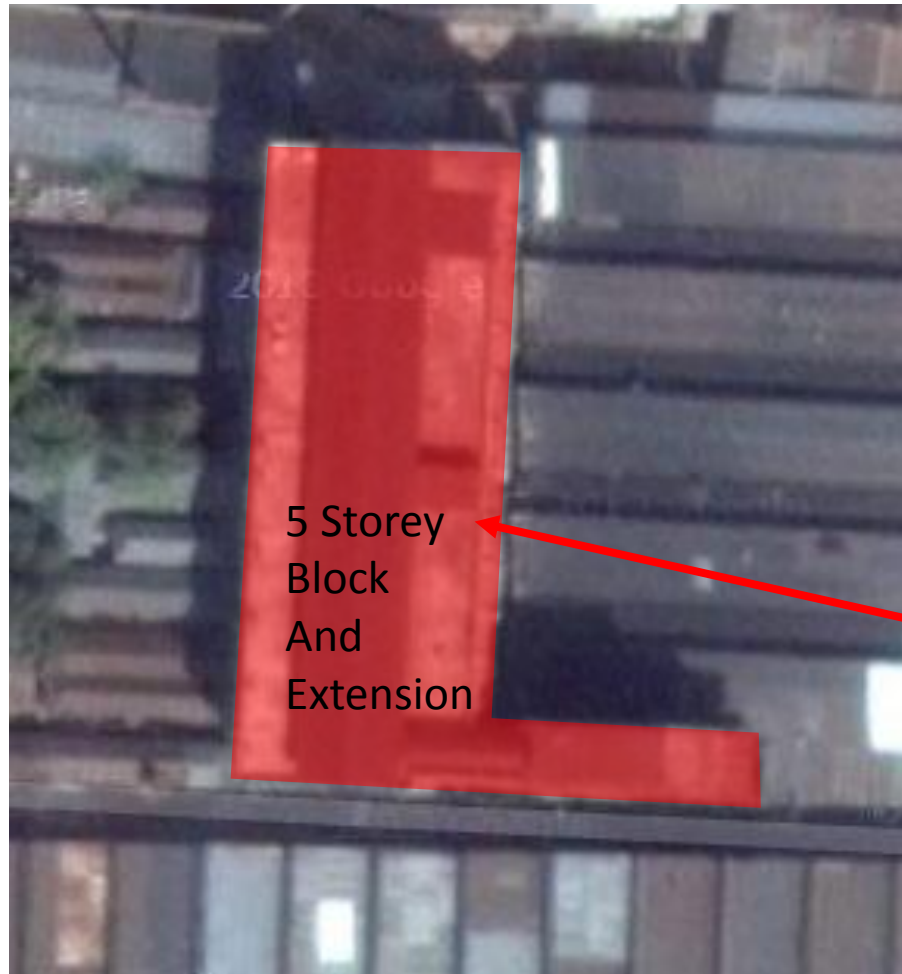
Item 1 High Stress to Building internal columns

Verify concrete strengths in internal columns and reduce loads

Remove all personnel from this building until results of columns strengths and Building Engineering assessment is complete
