FIRE SAFETY INSPECTION REPORT

Factory Name: Mayc's Garments Ltd.

ACCORD ID: 23128

Date: 2nd April, 2018

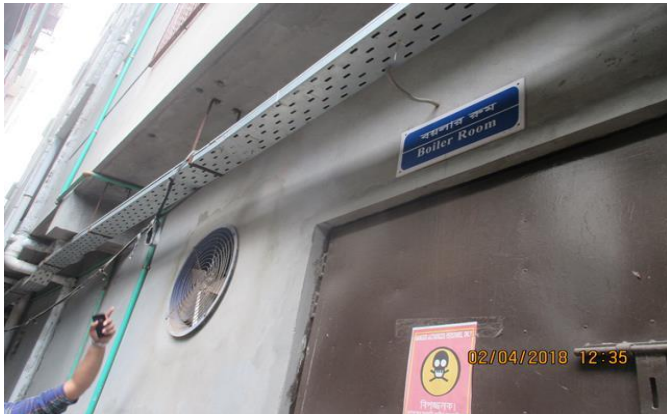
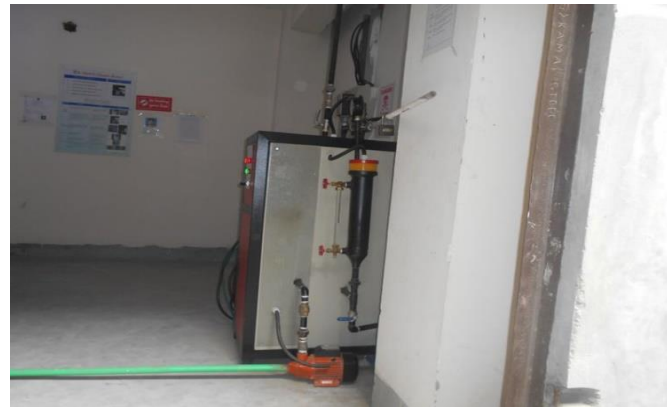
The boiler room is not separated from egress court by fire rated construction.

Boilers or other heat producing equipment shall be separated from other occupancies by a minimum 1-hr (2-hr for high-rise building) fire rated construction (wall, floor, slab etc.). Seal all penetrations and openings (door, window etc.) should be protected by 0.75-hr (45 min) fire rated materials to maintain the fire separation if required. All exhaust systems shall discharge to the exterior of the building in a safe location.
Or
Relocate it to exterior of the building and maintain a minimum 3m (10 ft.) spatial separation distance from the building.

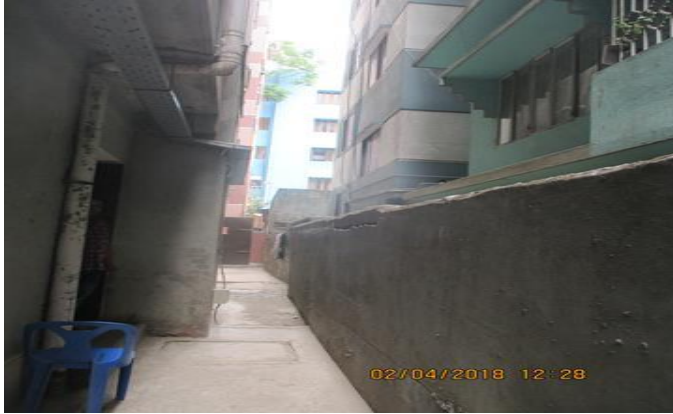
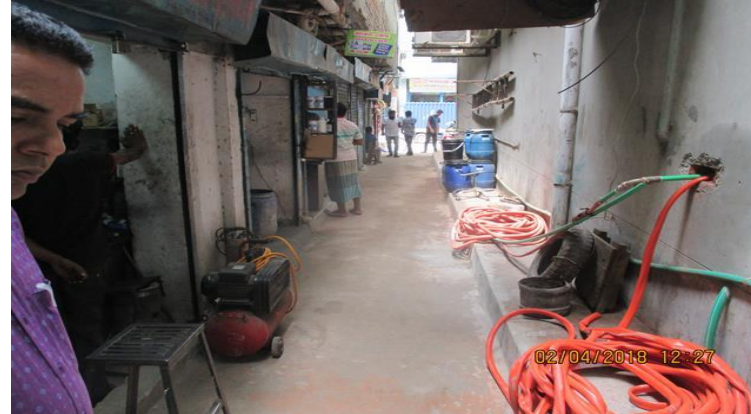
The exit discharge path is less than 10 ft. wide and is not separated from the building interior.
Location: West side of factory building.

Seal all penetrations and openings to the interior of the building along the discharge path, up to a height of 10 ft. to provide a minimum 1-hr fire separation.

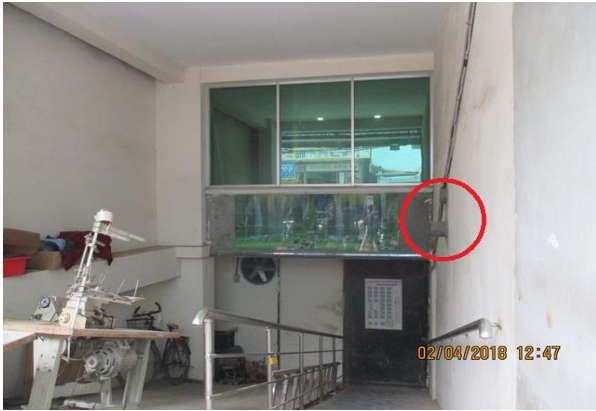
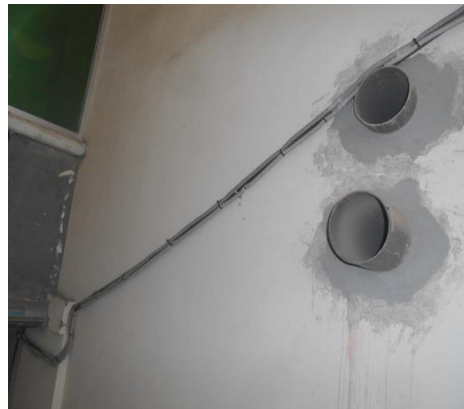
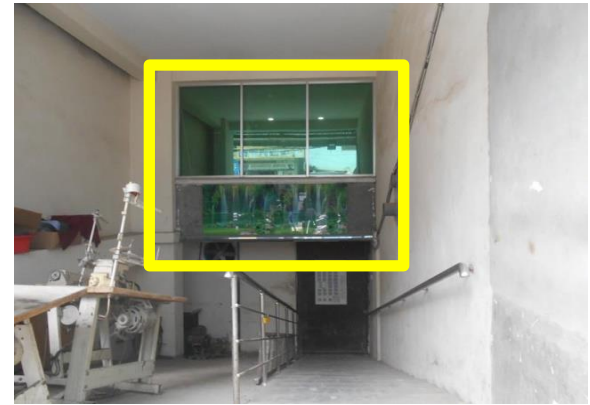
Unsealed penetrations and openings are located in exit discharge from basement.

Seal all penetrations and openings in the wall of exit enclosure walls (full thickness of the wall) by fire rated materials to maintain the fire resistance rating.

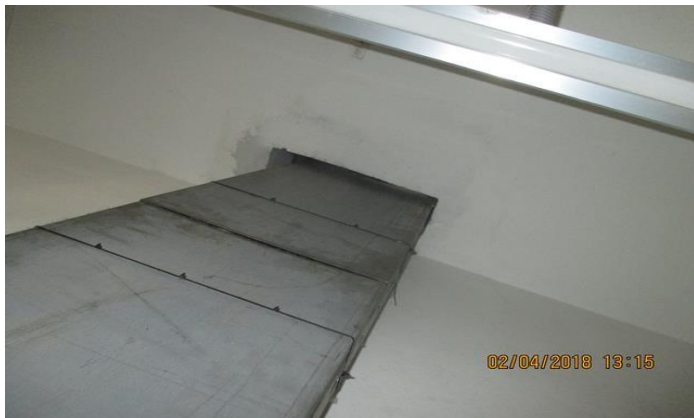
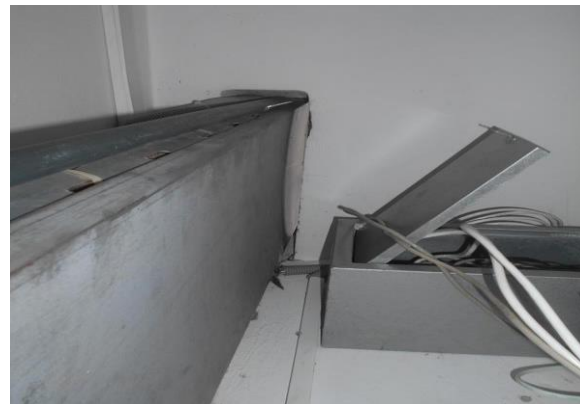
Penetrations through floor/ceiling assemblies are found unsealed for cable shaft.

Seal all penetrations and openings in floor/ceiling (full thickness of the floor/ceiling) assemblies by fire rated materials to maintain the fire resistance rating. Provide a minimum 2-hr fire rated shaft to separate the utility risers from each floor if required.

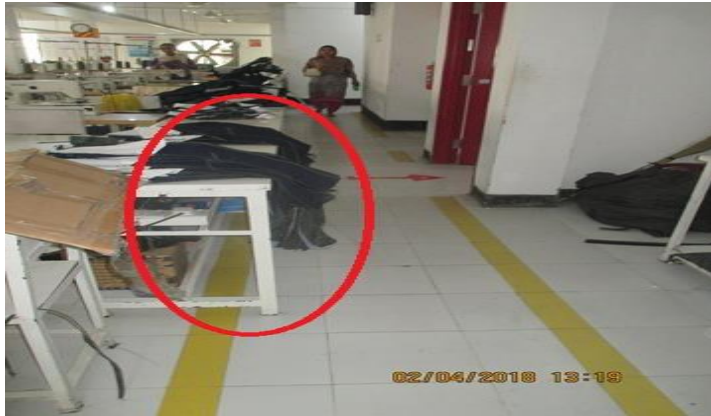
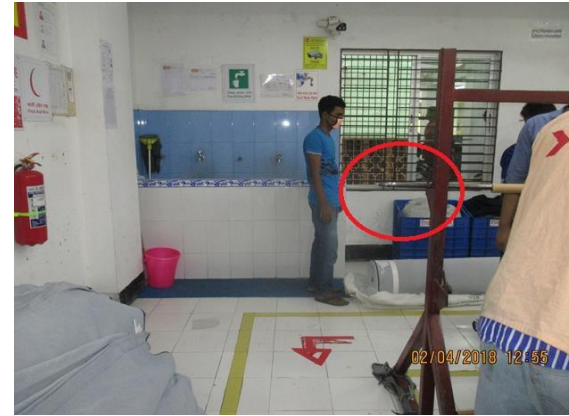
| 5 | Egress | During the inspection egress aisles were obstructed by machine and available clear width were found less than 36 inch. | Provide aisles free from obstructions and with minimum clear widths of 36-inch. | Immediate |

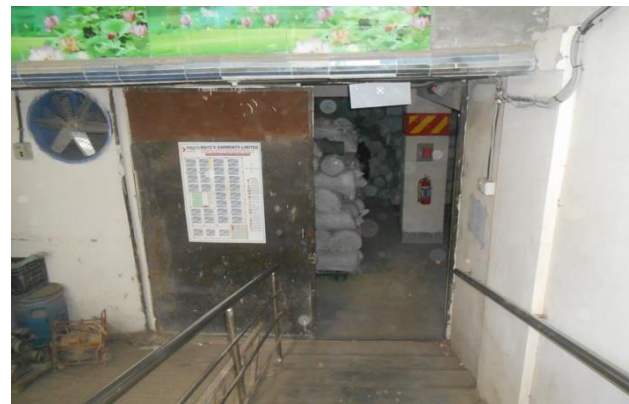
| 6 | Egress | Sliding type doors have provided along means of egress from basement. | Replace all collapsible/sliding/shutter type doors & gates by the side-hinged swinging type doors. If locks are required for security reasons, utilize special door locking features complying with NFPA 101. | Within 1 months |

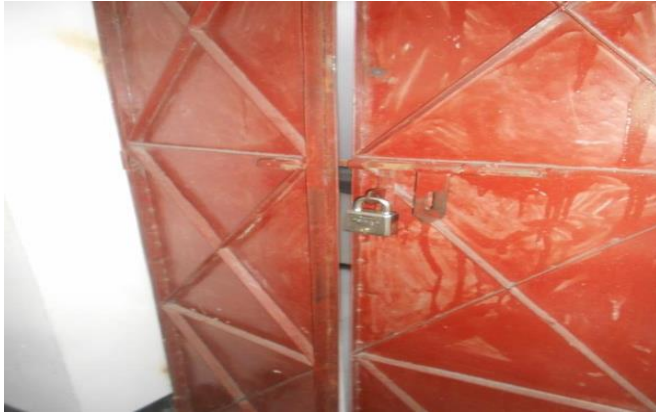
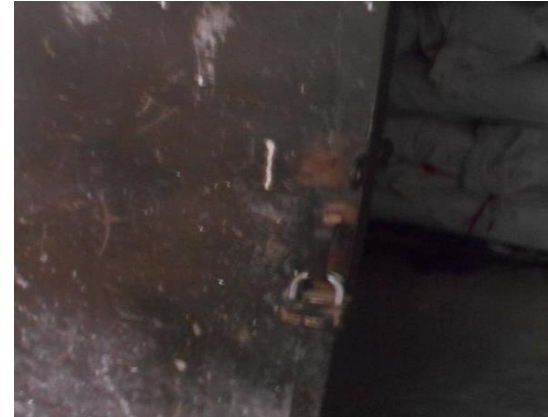
Doors along means of egress are provided with non compliant locking system.

1. Remove all non compliant locking features from egress doors.
2. If locks are required for security reasons, utilize special door locking features complying with NFPA 101.
3. Doors may be locked where the latch and lock are disengaged with one motion where the occupant load does not exceed 49 persons.
4. Doors may be provided with locking hardware from the ingress side provided that a panic bar is installed on any door with an occupant load exceeding 49 persons.

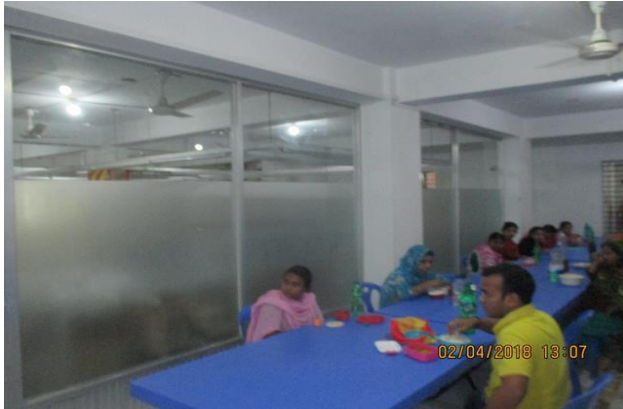
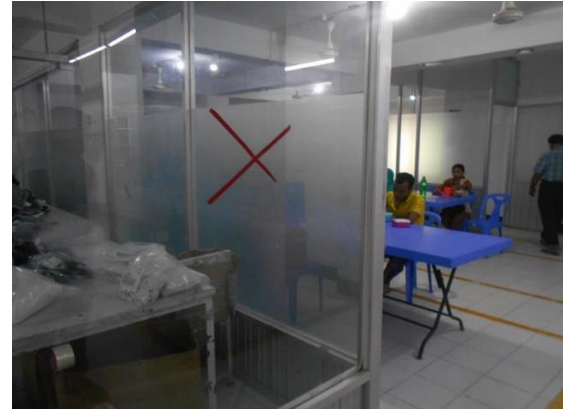
Dinning space is not separated from production area by Fire rated construction.

Remove dinning space from this location or, alternatively, provide minimum 3-hour fire rated separation.

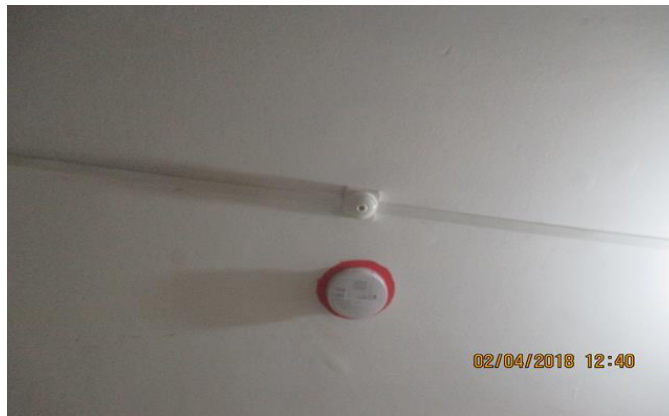
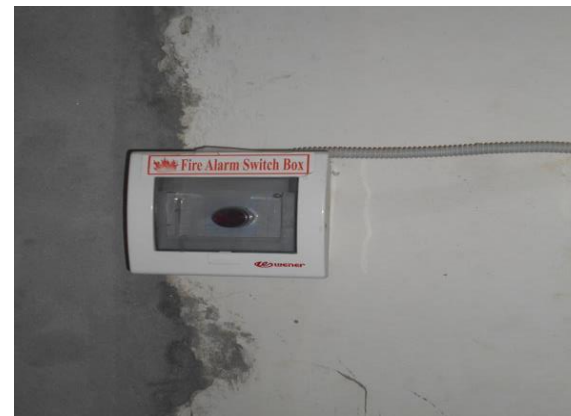
The existing fire alarm system is not a listed system and does not provide automatic alarm and notification features consistent with acceptable standards.

Replace the fire alarm system with a new, listed addressable fire alarm system in accordance with NFPA 72.

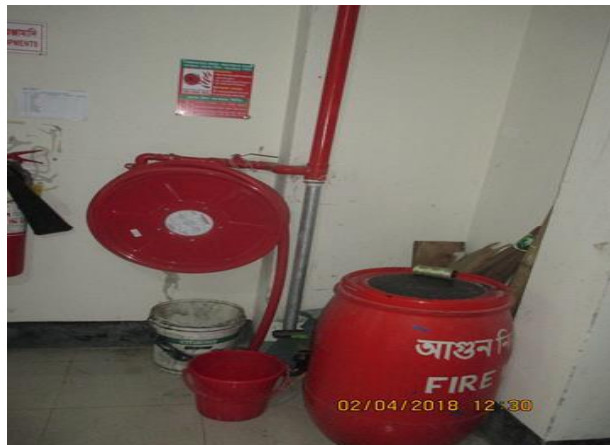
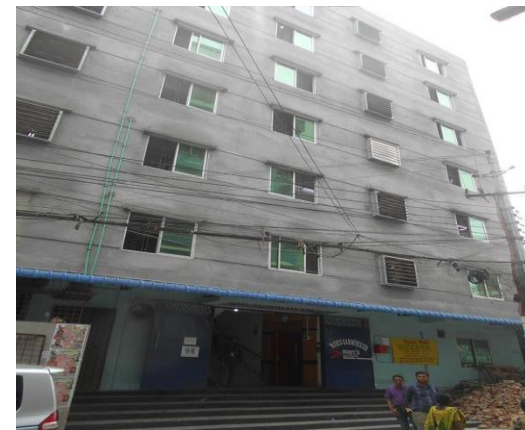
| 12 | Standpipe System | The existing building has an occupied floor greater than 10 m (33 feet) and is not provided with standpipe system as per NFPA 14. | Install a new class III standpipe system & fire department connection in accordance with NFPA 14. | Design with in 4 months, install within 9 months. |

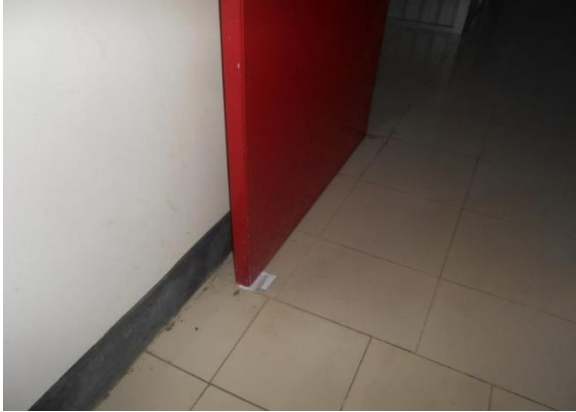
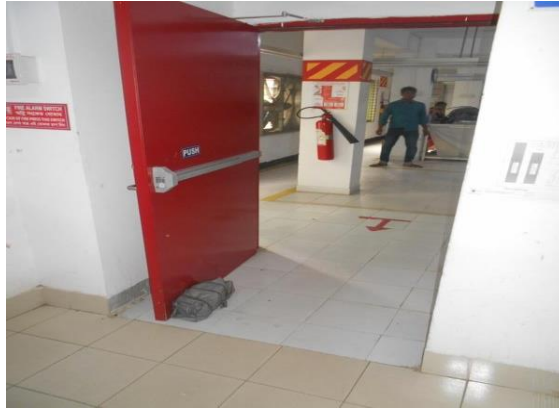
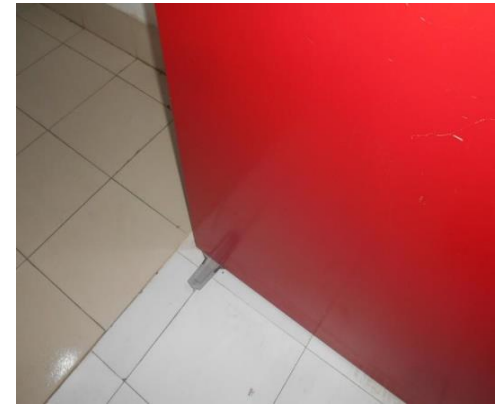
| 16 | Others | Exit stairs are being separated from other occupancy by fire rated assemblies. Fire door has been installed. However door-coordinates were found at fault. As the doors were open by non-mechanical means, Factory should interfaced fire door with FACP. | Inspect, test and maintain the fire door's functionality and Provide interfacing with FACP | Within 3 months |

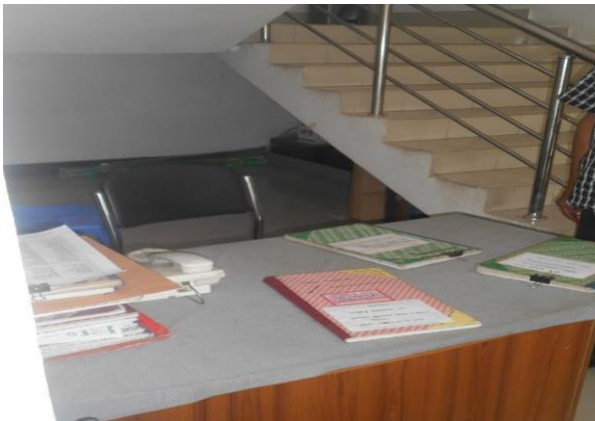
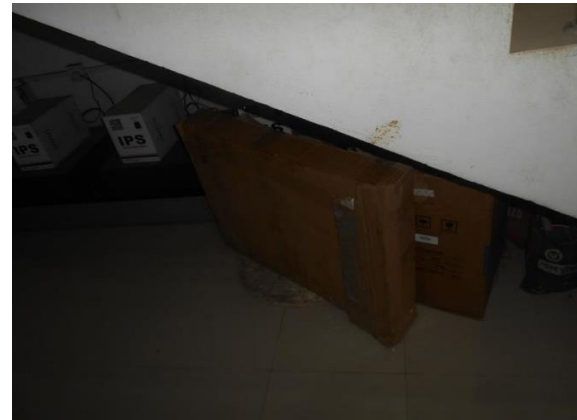
Storage was located in the exit stair.

Remove all storage from exit stairs.

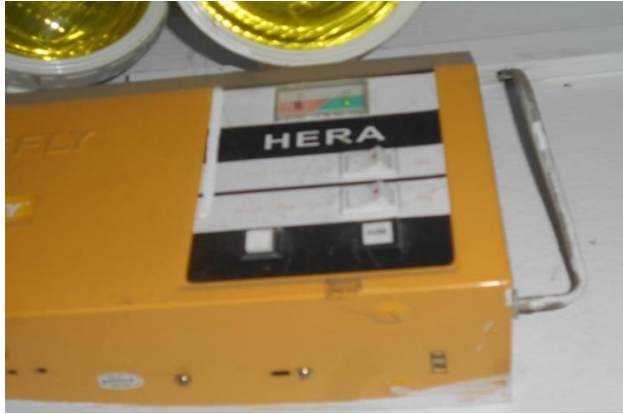
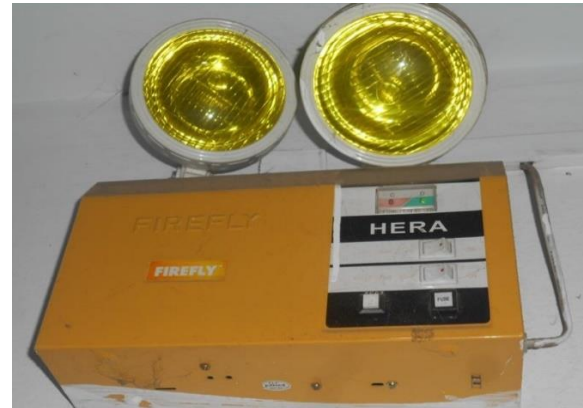
| 18 | Egress Lighting | Manual on-off switch is provided for [emergency lighting / exit signage] units. | Remove manual on/off switches from emergency lighting / exit signage units to prevent them from being switched off. | Within 3 months |
