FIRE SAFETY INSPECTION REPORT

Green Smart Shirts Ltd

ACCORD ID: 23220

Date: 30, April 2018

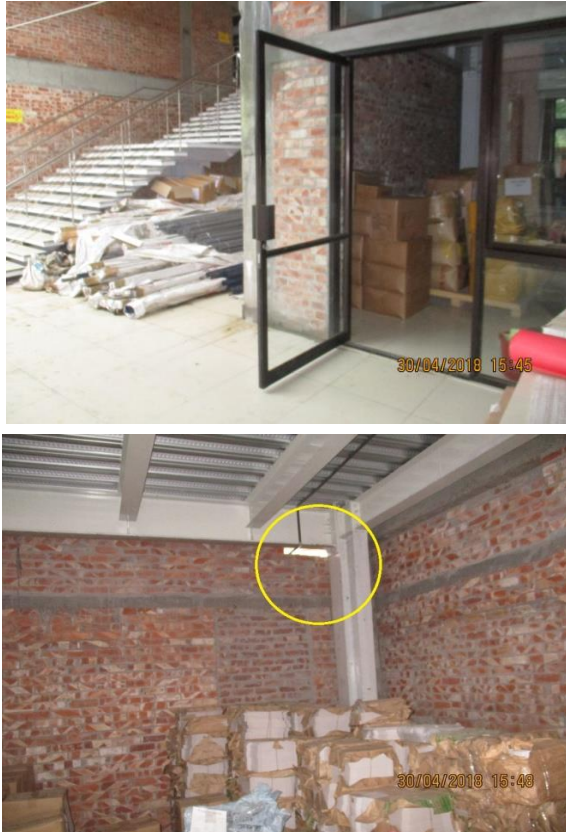
Sl No.	Category	Findings	Required Action	Remediation Time Frame	Pictorial Evidence
1	Fire Rated Construction	Rooms used for storage of combustible materials are not separated from the surrounding occupancy. Location: Ground floor, Facility Building	Rooms used for storage of combustible materials shall be separated from the surrounding occupancy with a minimum 1 hour construction.	Within 03 Months

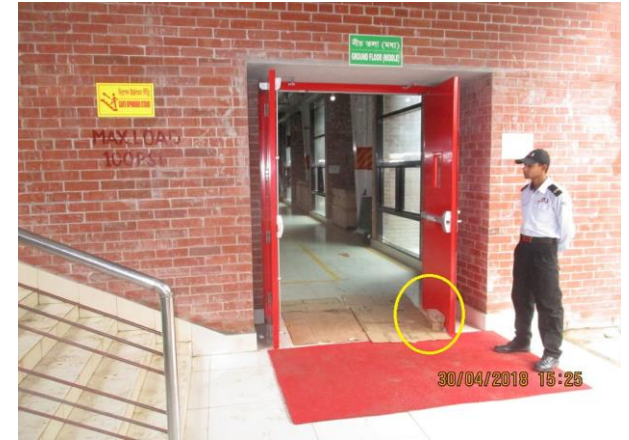
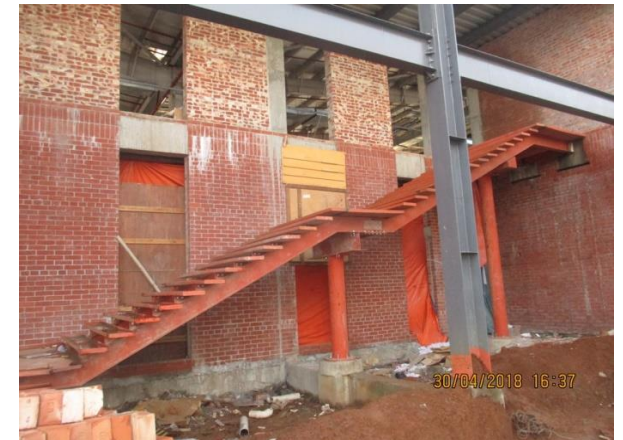
2

The both exit stairs are not separated by fire-rated construction due to installed fire doors are not properly interfaced with fire alarm system

Separate the exit stairs from work areas and other building spaces on all floor levels by minimum 1- hr. fire-rated construction. Provide minimum 1- hr. fire rated doors as well as listing documents and seal all unprotected openings and penetrations to maintain the fire separation. Ensure that all fire doors are self-closing and positive latching, and are provided with fire exit (panic) hardware where serving production floors or assembly occupancies. If fire doors are required to be held open for functional reasons, provide automatic-closing devices tied to the fire alarm system. Once fire doors are installed, every door in a stair enclosure serving more than 5 stories shall be provided with re-entry unless it meets ACCORD standard 6.8.3.1.

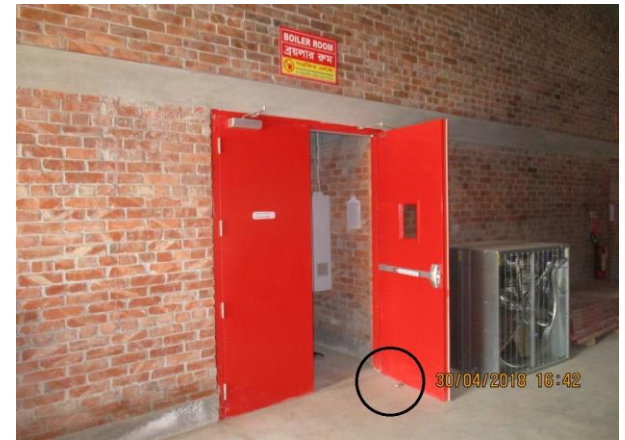
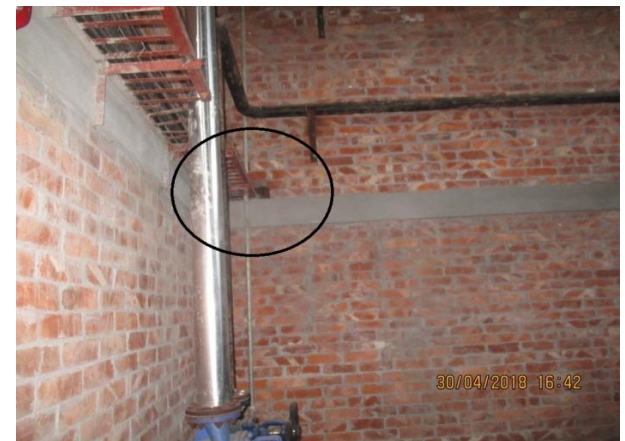
3

Generator/boiler/compressor/switchgear rooms are not properly separated by fire rated construction with other occupancy. Unsealed penetrations have observed on the rated wall. Even fire doors have found open by external objects.

Location: Ground floor, Utility Building

Generator/boiler/compressor/switchgear rooms shall be separated from other occupancies by a minimum 2-hr fire rated construction (wall, floor, slab etc.). Seal all penetrations and openings (door, window etc.) should be protected by 1.5-hr fire rated materials to maintain the fire separation if required. All exhaust systems shall discharge to the exterior of the building in a safe location.

If fire doors are required to be held open for functional reasons, provide automatic-closing devices tied to the fire alarm system.

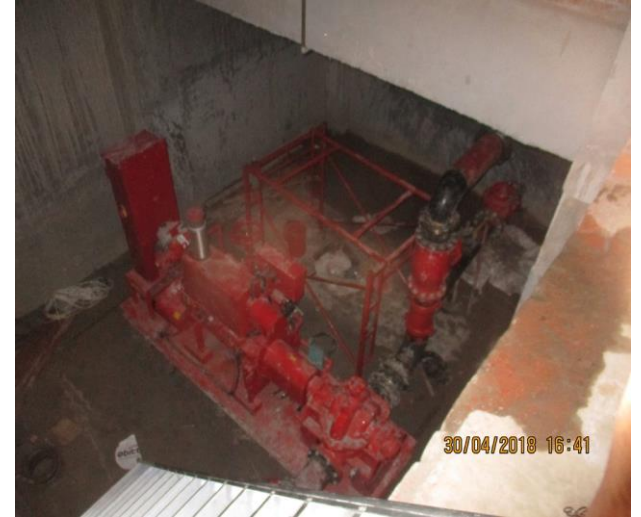
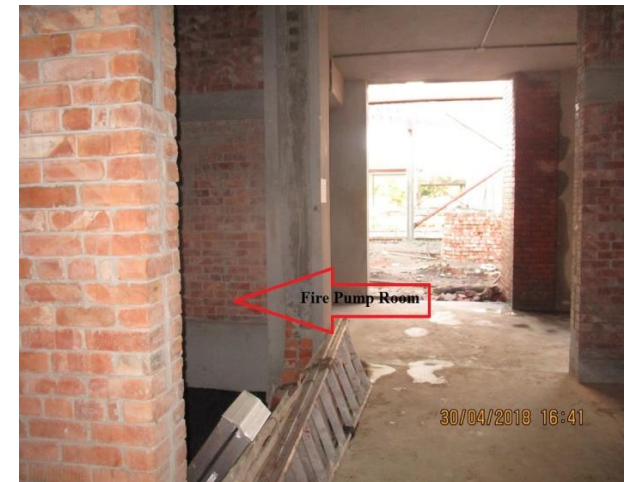
4

Fire pump room is not properly separated by fire rated construction with other Occupancies/Areas

Location: Ground floor, Utility Building

Fire pump room shall be separated from other occupancies by a minimum 2-hr fire rated construction (wall, floor, slab etc.). Seal all penetrations and openings (door, window etc.) should be protected by 1.5-hr fire rated materials to maintain the fire separation if required. All exhaust systems shall discharge to the exterior of the building in a safe location.

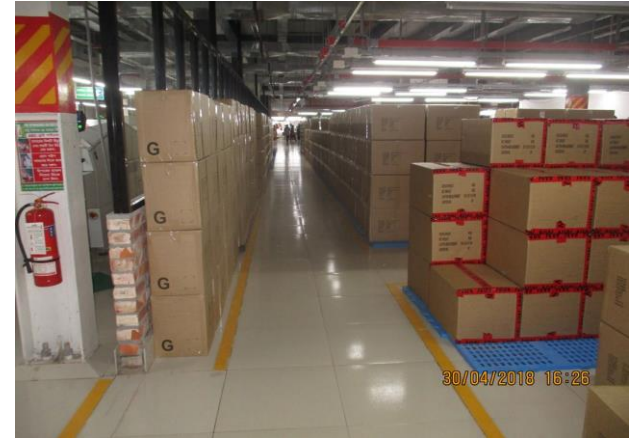
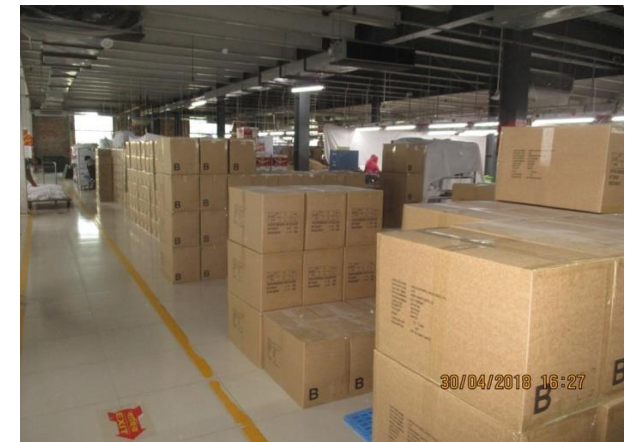
5

Areas used for in-process storage of combustible materials are open to the surrounding occupancy

Location: Ground floor, Main production building

Provide defined storage areas and limit the storage arrangement as follows:-

1. **General Condition:** Maximum height of 2.4m and maximum area of 23m². Separate areas of unenclosed combustible storage by a minimum clear distance of 3m.

2. **If sprinkler protected:** maximum height of 3.66m and maximum area of 93m². Separate areas of unenclosed combustible storage by a minimum clear distance of 3m.

3. Enclose the storage area from the surrounding occupancy with a minimum 1 hour construction.

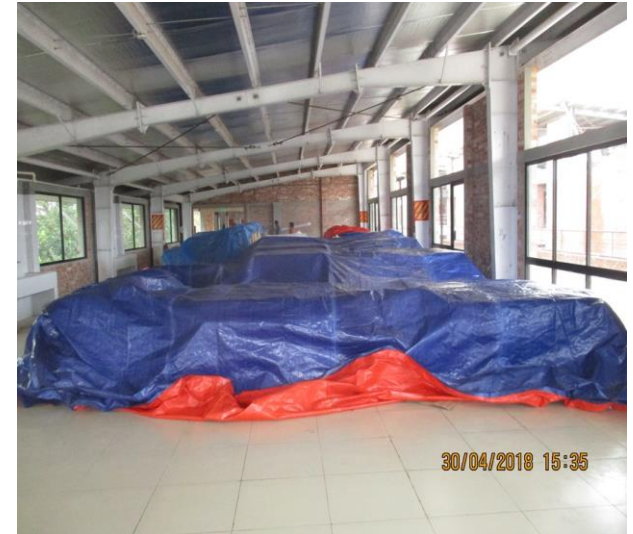
6 Fire Rated Construction
 It has observed that dining area has been occupied with combustible materials without separations.
 Location: 1st floor, facility building

Remove the stored materials from dining areas

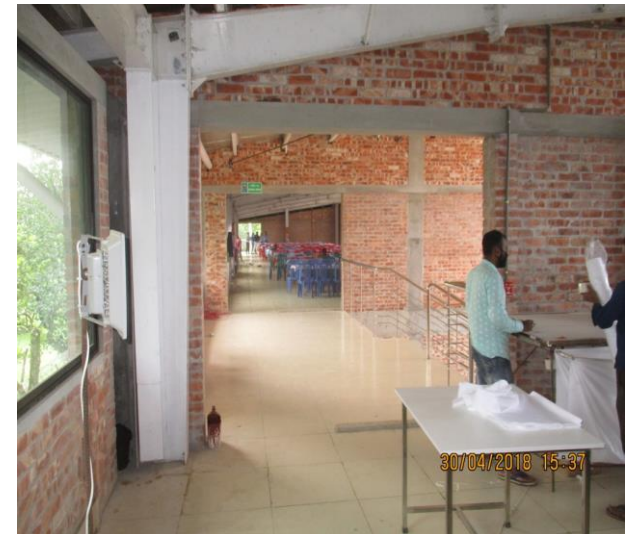
7 Egress Lighting
 Exit sign not provided at exit.
 Location: Main production building, Facility building and utility building

Lighted exit signs shall be placed at entrance to an exit. Additional exit signs shall be placed throughout the facility anywhere the continuation of the egress is not obvious.
 Lighted exit signs shall be provided with either battery backup or uninterruptable power supply systems and shall be continuously illuminated.

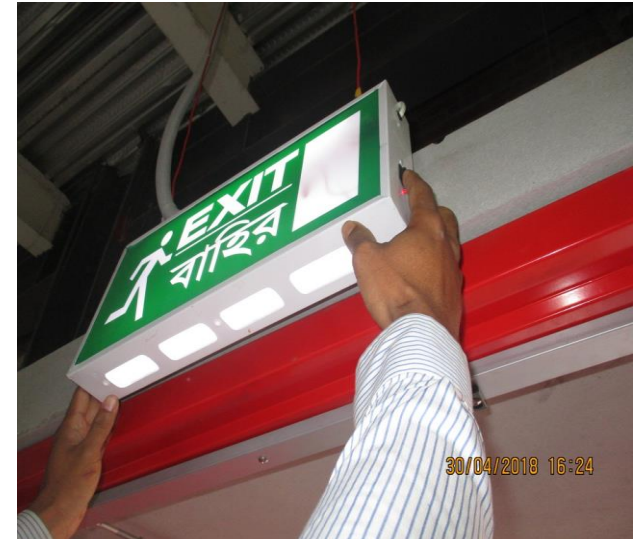
8 Egress Lighting Manual on-off switch is provided for [emergency lighting / exit signage] units.

Remove manual on/off switches from emergency lighting / exit signage units to prevent them from being switched off.

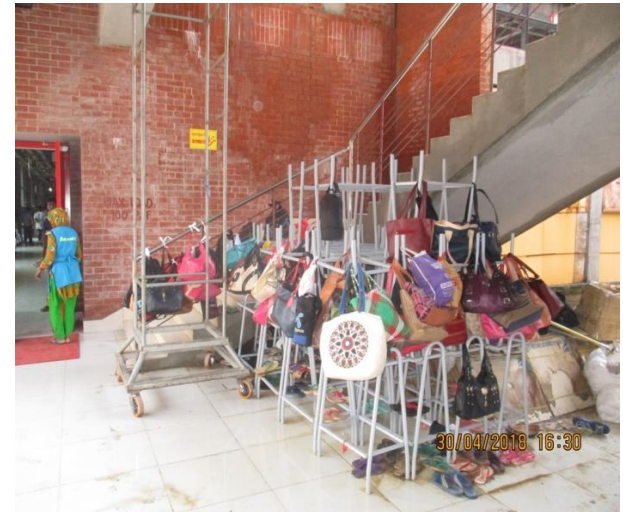
10 Egress
 Storage was located underneath of exit stair
 Location: Main production and facility building

Remove all storage from exit stairs. Immediately

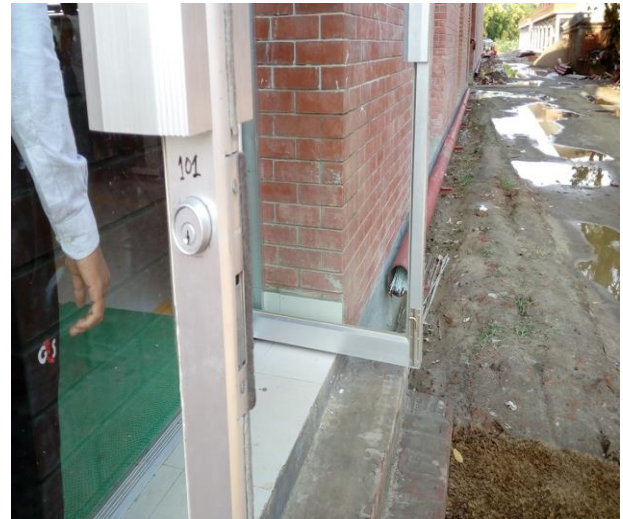
11 Egress
 Doors along means of egress are provided with non compliant locking system.
 Location: S-W corner door, ground floor

1. Remove all non compliant locking features from egress doors.
 2. If locks are required for security reasons, utilize special door locking features complying with NFPA 101. Immediately

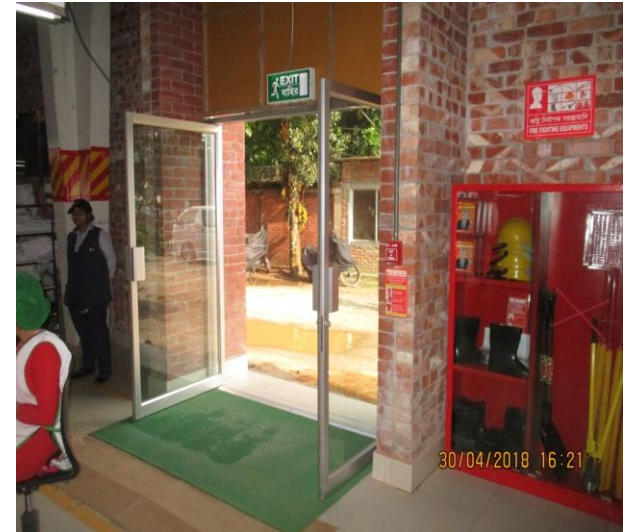
12 Egress

Egress door serving 50 or more occupants but does not swing in the direction of egress travel.

Location: S-W corner door, ground floor

Modify swing direction of egress doors to the direction of egress travel.

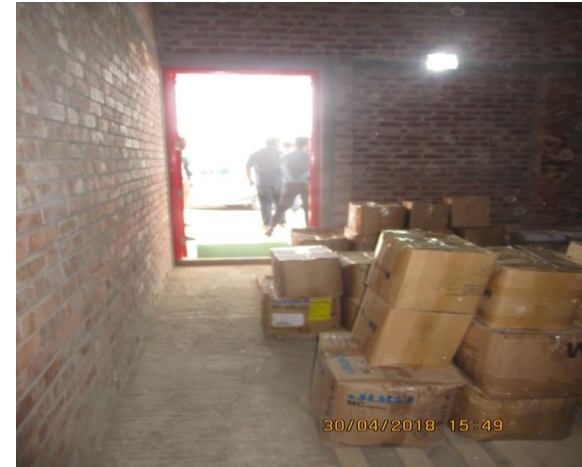
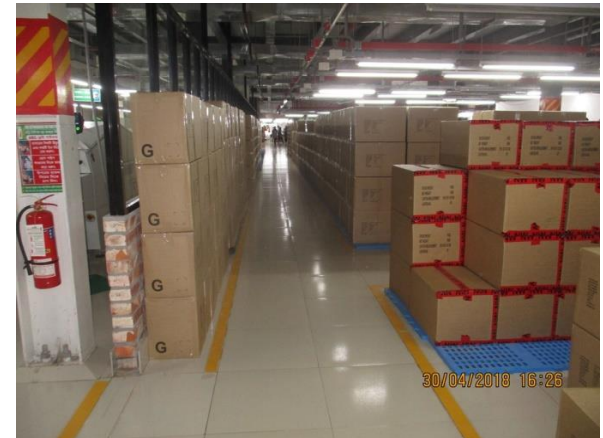
13

The egress path along means of egress has interrupted by obstruction/storage.

Means of egress shall be maintained continuously free and clear of all obstructions/storage.
Or
Keep egress paths and stairs clear of storage.

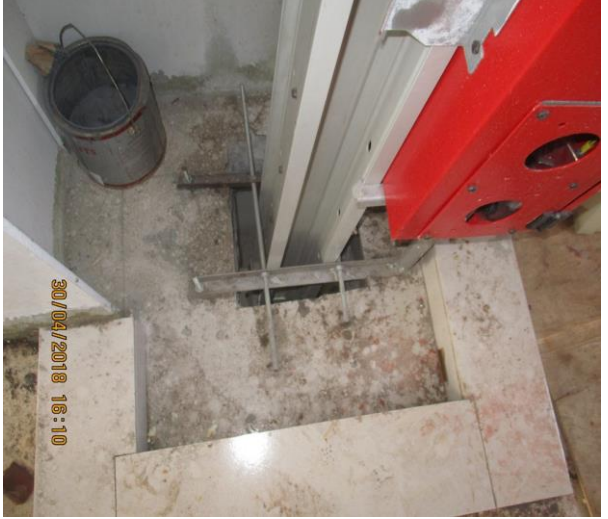
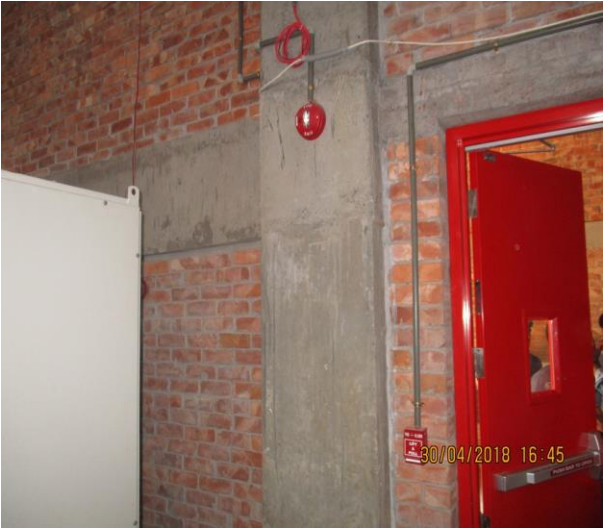
14	Fire Rated Construction	Penetrations through floor/ceiling assemblies are found unsealed.	Seal all penetrations and openings in floor/ceiling (full thickness of the floor/ceiling) assemblies by fire rated materials to maintain the fire resistance rating. or Provide a minimum 2-hr fire rated shaft to separate the utility risers from each floor if required.	Within 03 Months

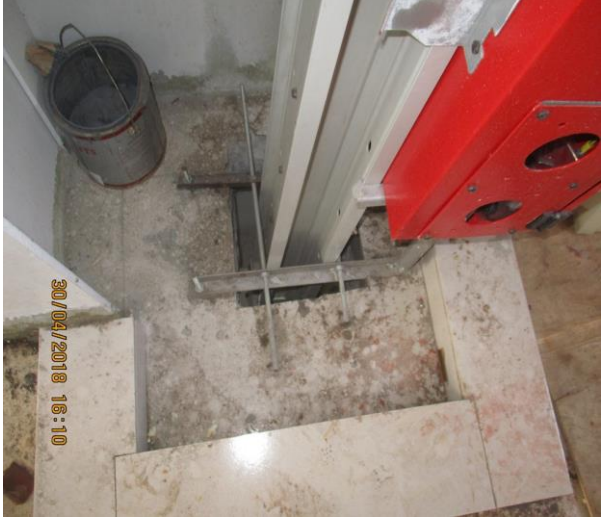
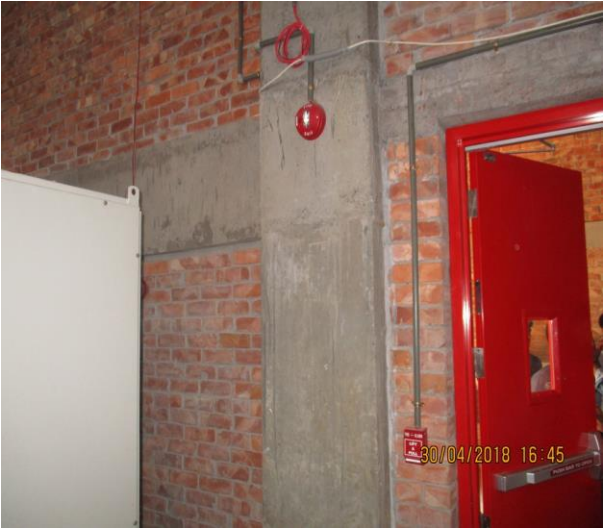
15	Fire Alarm & Detection System	The factory has been designed & started install the addressable fire alarm system without having approval from AHJ (Authorities Having Jurisdiction). Note: They have submitted the as-built design/drawing of fire alarm system to Accord.	Existing addressable fire alarm & detection system shall be designed & installed as per NFPA 72. Materials shall be listed and 3rd party certified. Modify the system (if required) after getting approval from AHJ.	Design within 04 Months & Installation Within 06 Months

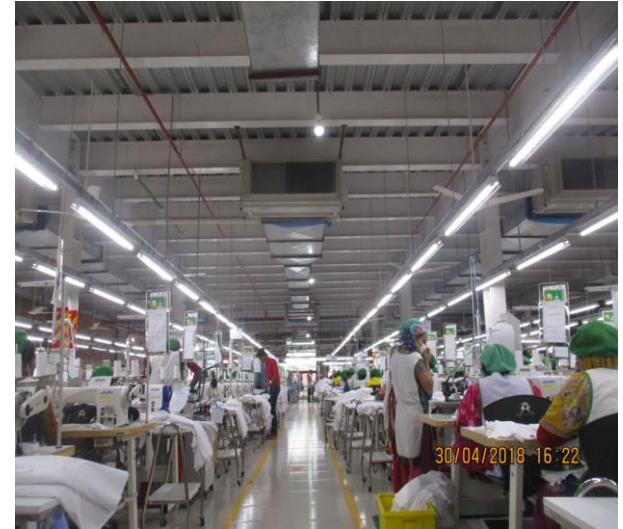
18

Since the 02 storey production building is steel-composite type and all structural members are resting on steel column and girder which are not fire resistive type.

Construction of new non-high-rise factories containing G and/or H2 occupancies (factories) shall be Type 1 or Type 2 construction as required in BNBC Part 2 Table 3.2.4.
