# Redpoint Jackets Ltd

Dhaka Export Processing Zone, Ganakbari, Savar, Dhaka  
(+23.7514N, 90.3917E)

8 December 2013

# Survey Observations

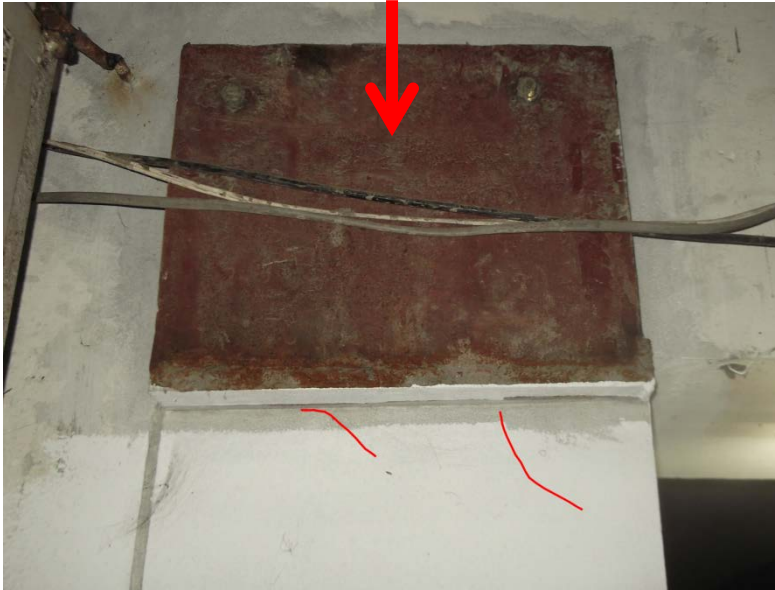
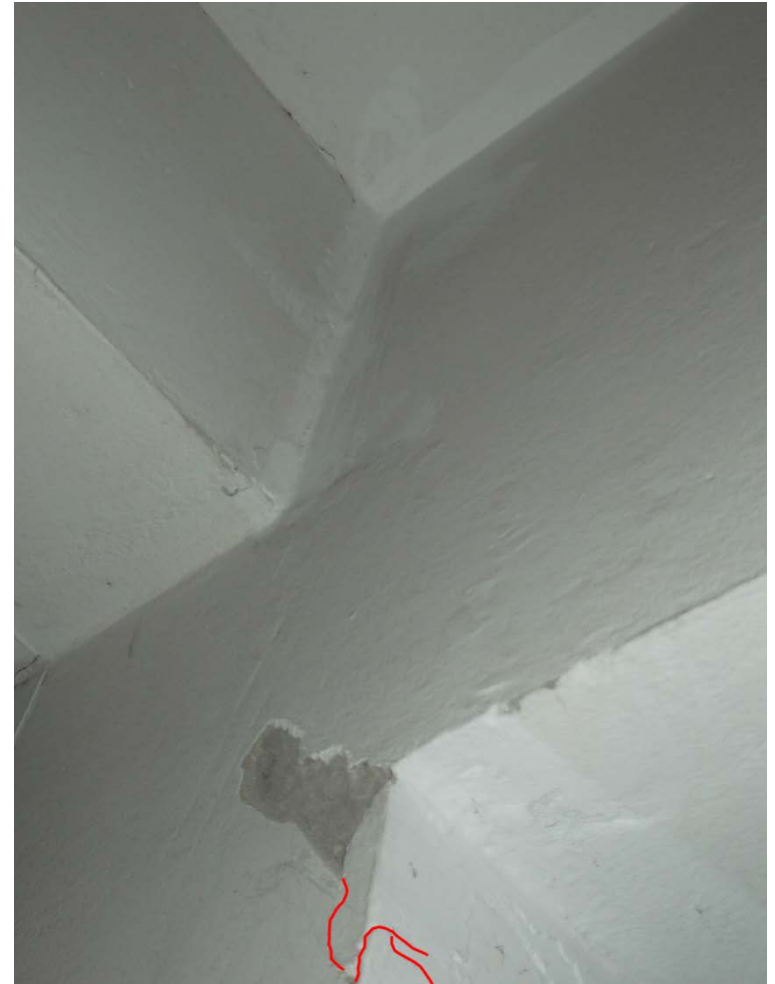
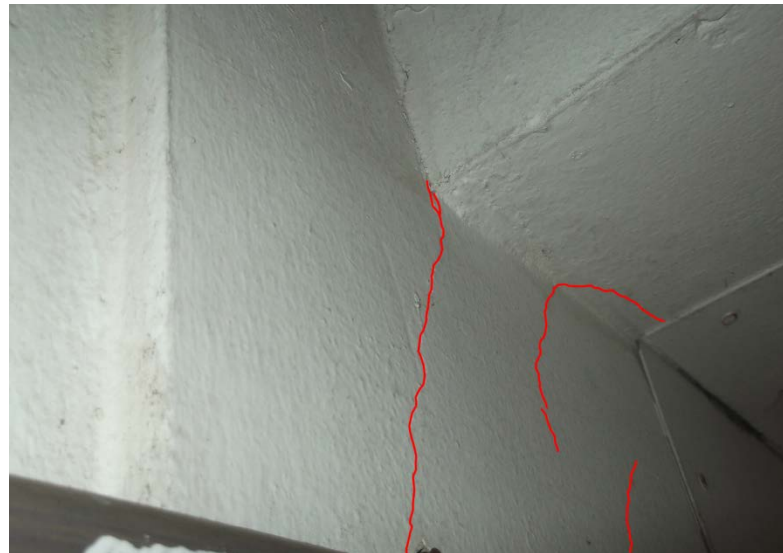
**Cracks on the underside of 1<sup>st</sup> and 2<sup>nd</sup>  
floors at the junction of the  
beam/column on gridlines E/6, F/6 and  
G/6**

## Evidence of remedial works

Cracks at the junction of the beam / column

Cracks in beams / columns

Cracks on the underside of 1st and 2nd floors at the junction of the beam/column on gridlines E/6, F/6 and G/6

- Sections of plaster finish to beams/columns to be removed to investigate if cracks penetrate the building structure.

- Building Engineer to carry out design check on beams to confirm that these cracks are non-structural.
- Building Engineer to monitor location of cracks and ensure that further remedial works are carried out where required

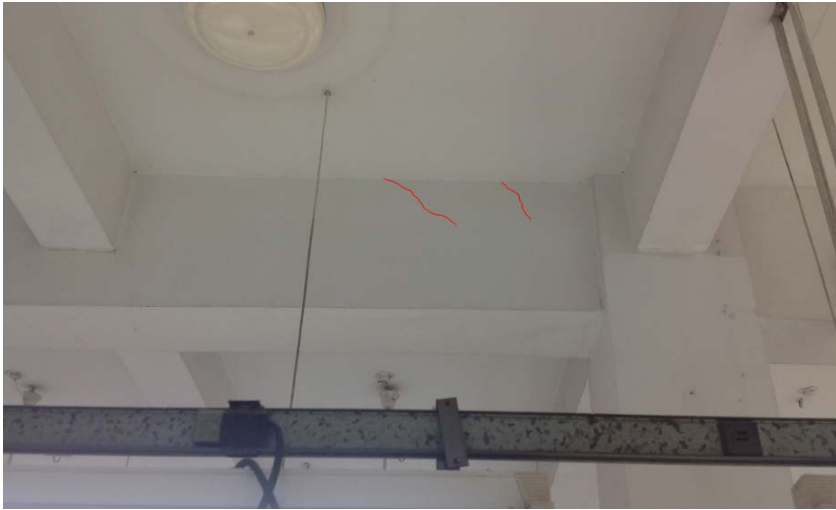
**Cracking to beams/slab/brickwork on the  
underside of 2<sup>nd</sup> floor**

**Crack in beam – u/side 2<sup>nd</sup> floor**

- Sections of plaster finish to beams/slab to be removed to investigate if cracks penetrate the building structure.

- Building Engineer to carry out design check on beams/slab to confirm that these cracks are non-structural.
- Building Engineer to issue details of repair works to be completed

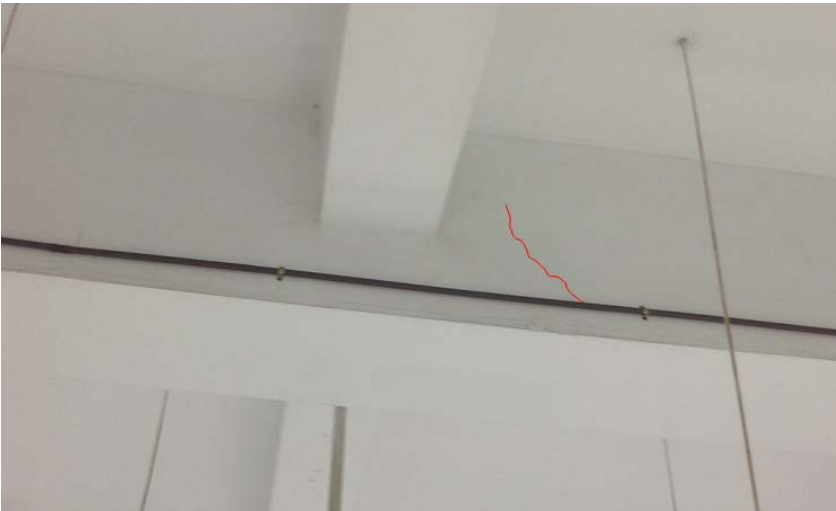
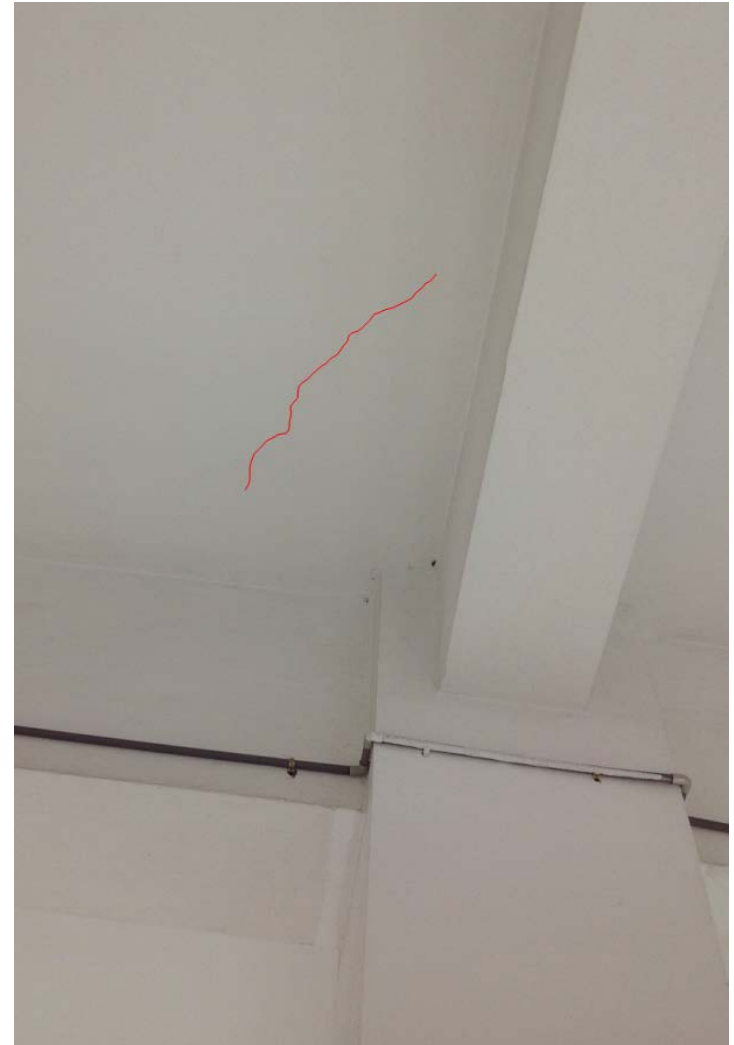
**Crack in slab u/side 2<sup>nd</sup> floor**

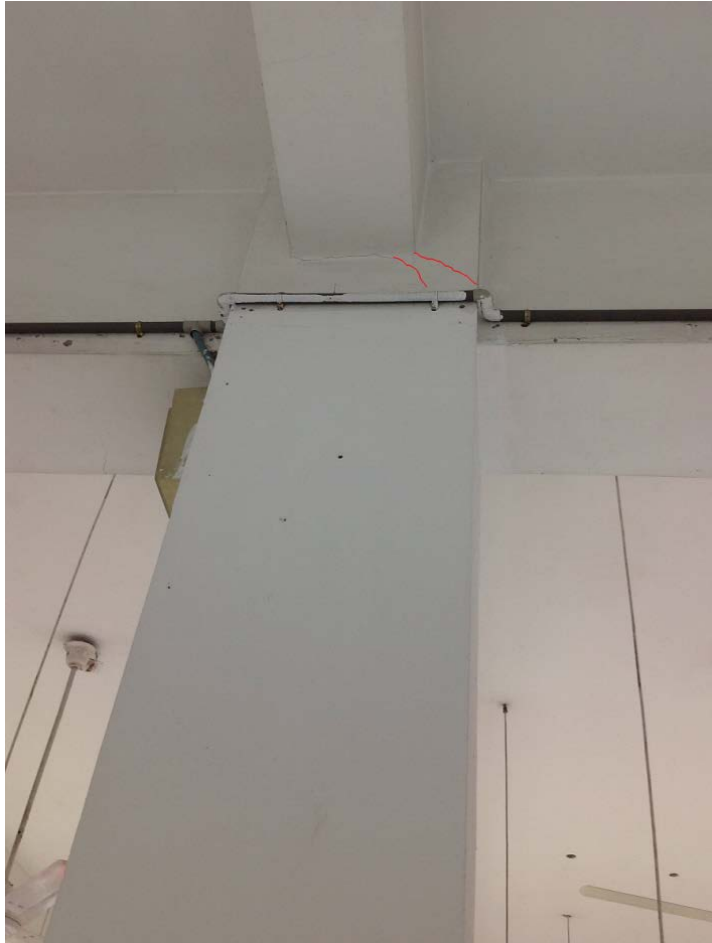
**Crack in column 1<sup>st</sup> floor**

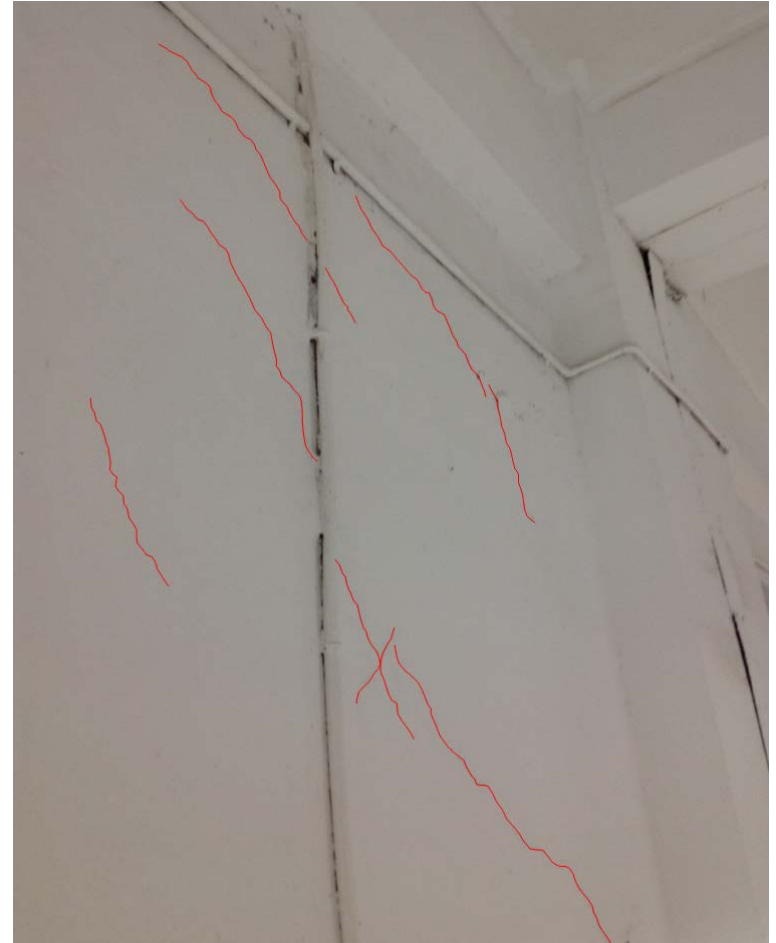
**Crack in partitions 1<sup>st</sup> floor**

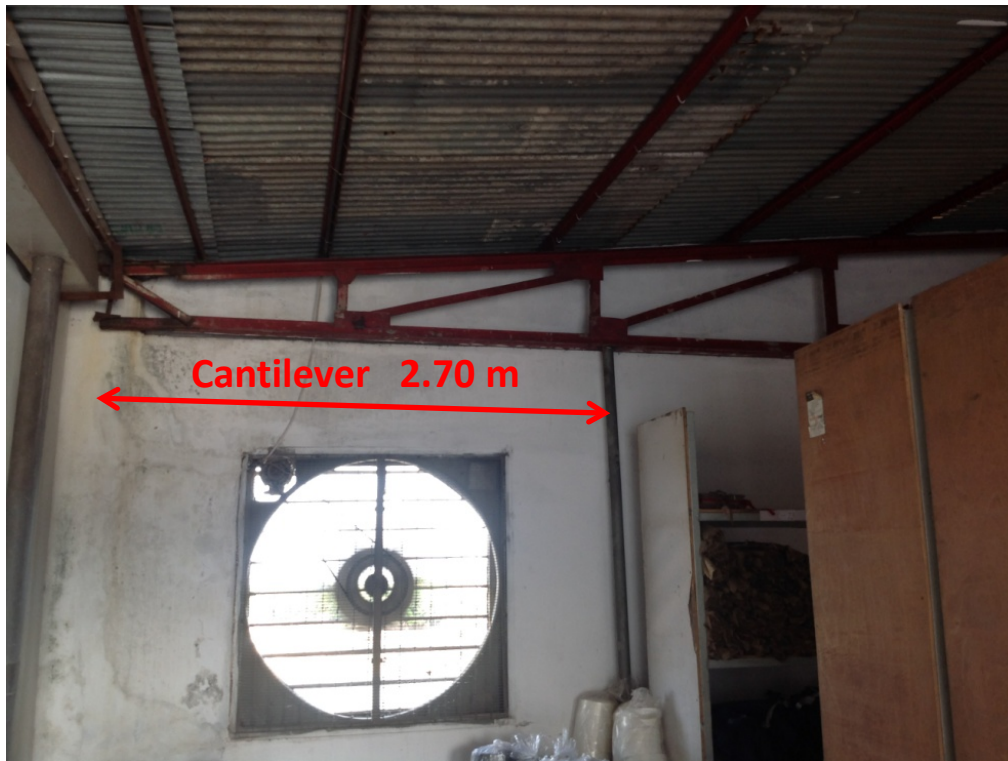
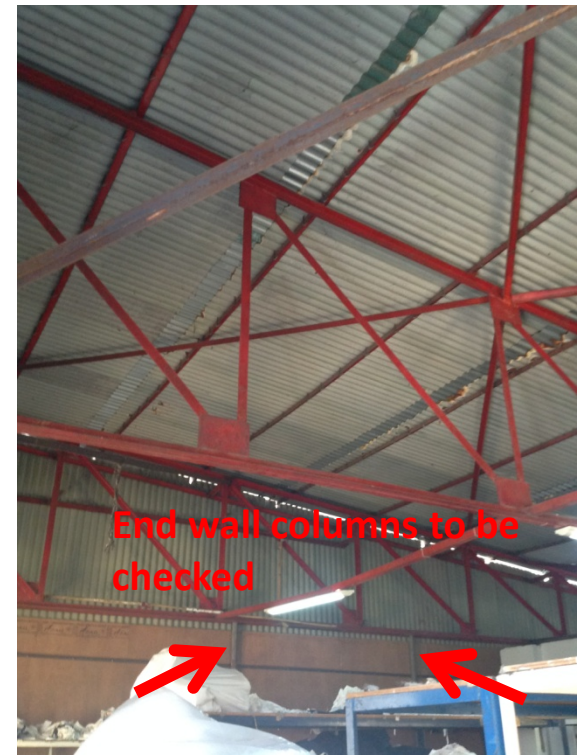
**Steel roof to 2<sup>nd</sup> floor store**

**Steel roofs to dining and store area on 2<sup>nd</sup> floor do not appear to be strong enough to resist high wind loading**

**Secondary roof structures, comprising metal deck/purlins and columns, not shown on the structural design drawings, may be susceptible to wind uplift.  
No obvious stability system is evident.**

**Lightweight roof steel structure not shown on the structural design drawings**

**Cantilever section of truss to be reviewed by Building Engineer**

- Steel roofs to dining and store area should be designed by the Building Engineer and, if required, upgraded to support code vertical and wind loads or they should be vacated and removed

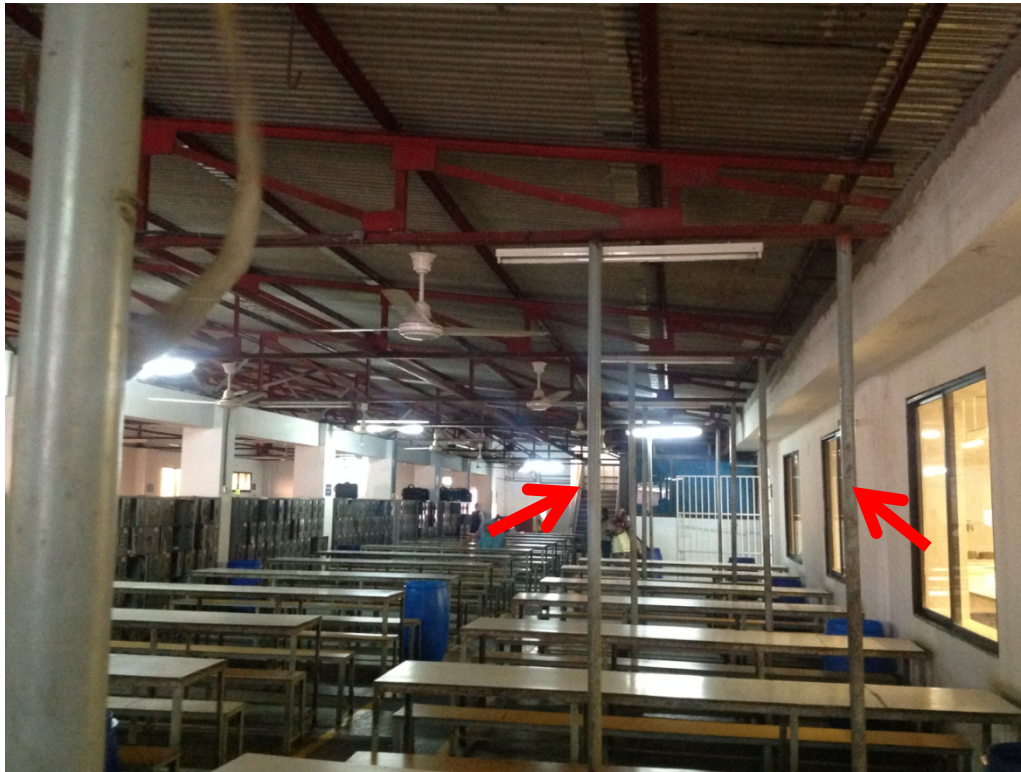
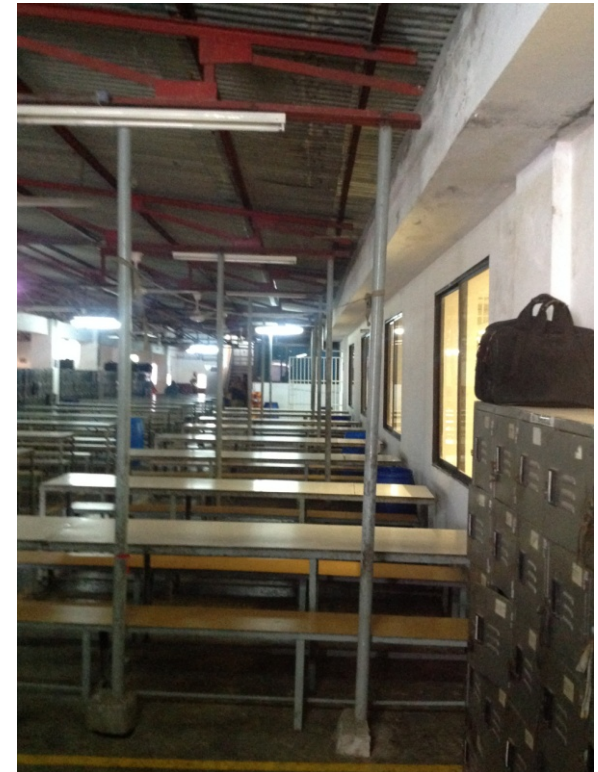
**Steel roof to Dining Area**

**Secondary roof structures, comprising metal deck/purlins and columns, not shown on the structural design drawings, may be susceptible to wind uplift.  
No obvious stability system is evident.**

**Lightweight roof steel structure not shown on the structural design drawings**

**Retrofit support columns to truss to be reviewed by Building Engineer**

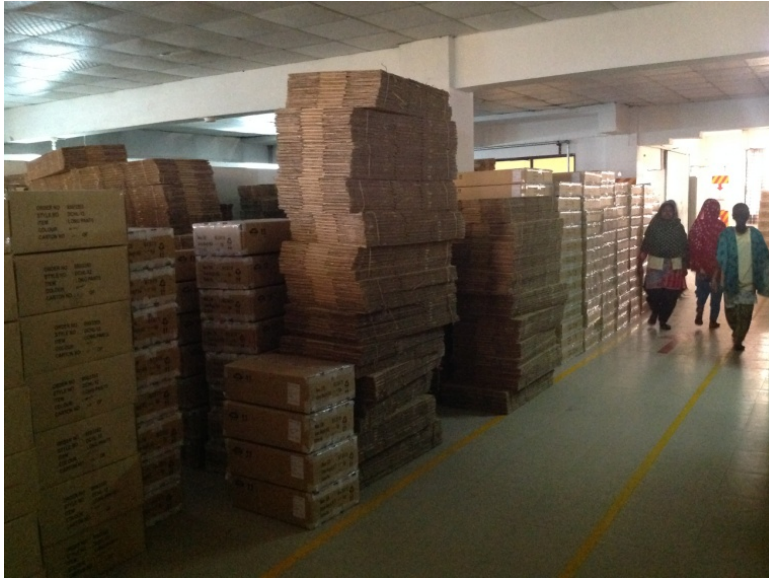
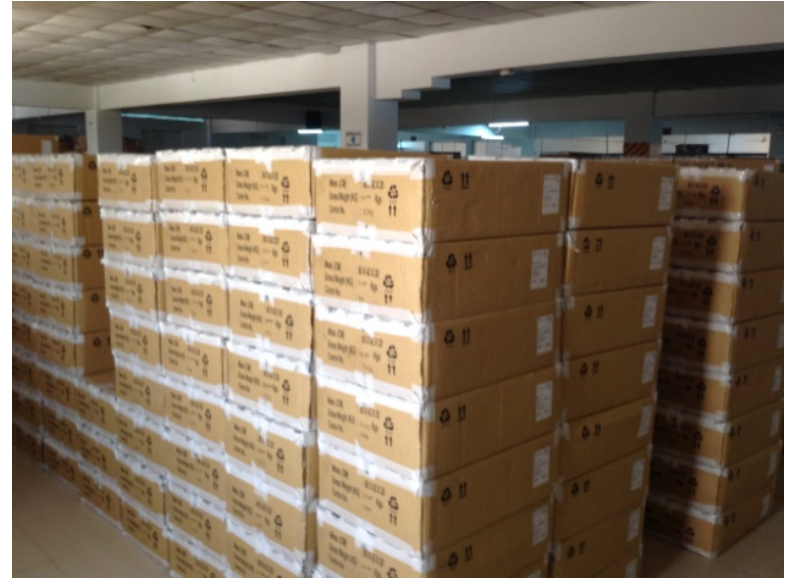
# **Load management of storage loads in Finished Goods area on 3<sup>rd</sup> Floor**

**Storage loads in Finished Goods area**

- Produce and actively manage a loading plan for all floor plates within the factory giving consideration to floor capacity and column capacity.

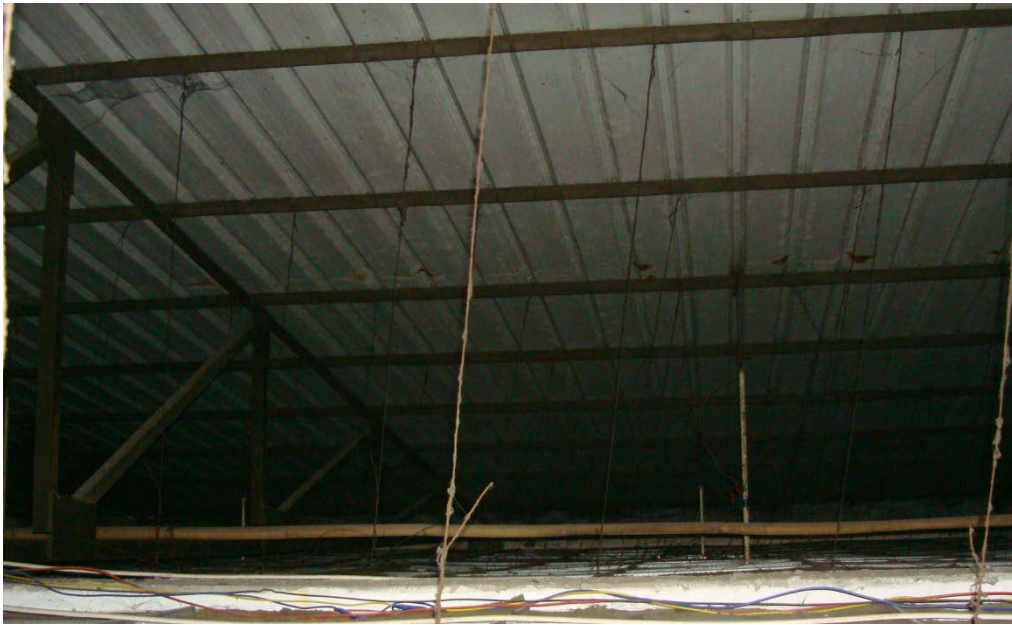
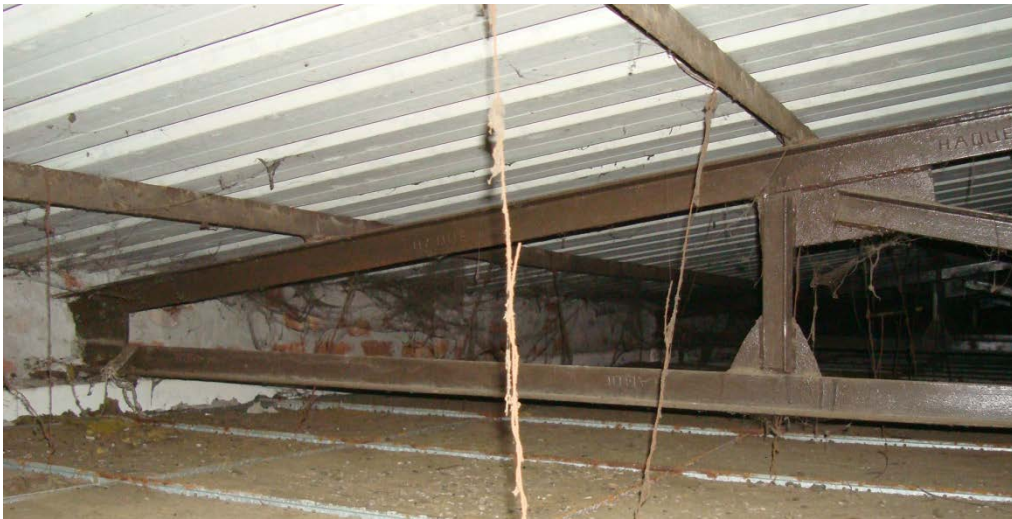
### **3<sup>rd</sup> Floor - Lightweight steel roof**

**Check required to confirm that steel roof  
over 3<sup>rd</sup> floor factory area is designed to  
resist high wind loading**

**Lightweight roof steel structure to the 3<sup>rd</sup> floor factory area is not shown on the structural design drawings.**

**Limited access was available for inspection by removing ceiling tiles locally.**

**Building Engineer to confirm that steel roof has been designed for code specified wind and live loads and that a stability bracing system has been provided.**

- The steel roof over the 3<sup>rd</sup> floor factory area should be designed by the Building Engineer and, if required, upgraded to support code vertical and wind loads or they should be vacated and removed.

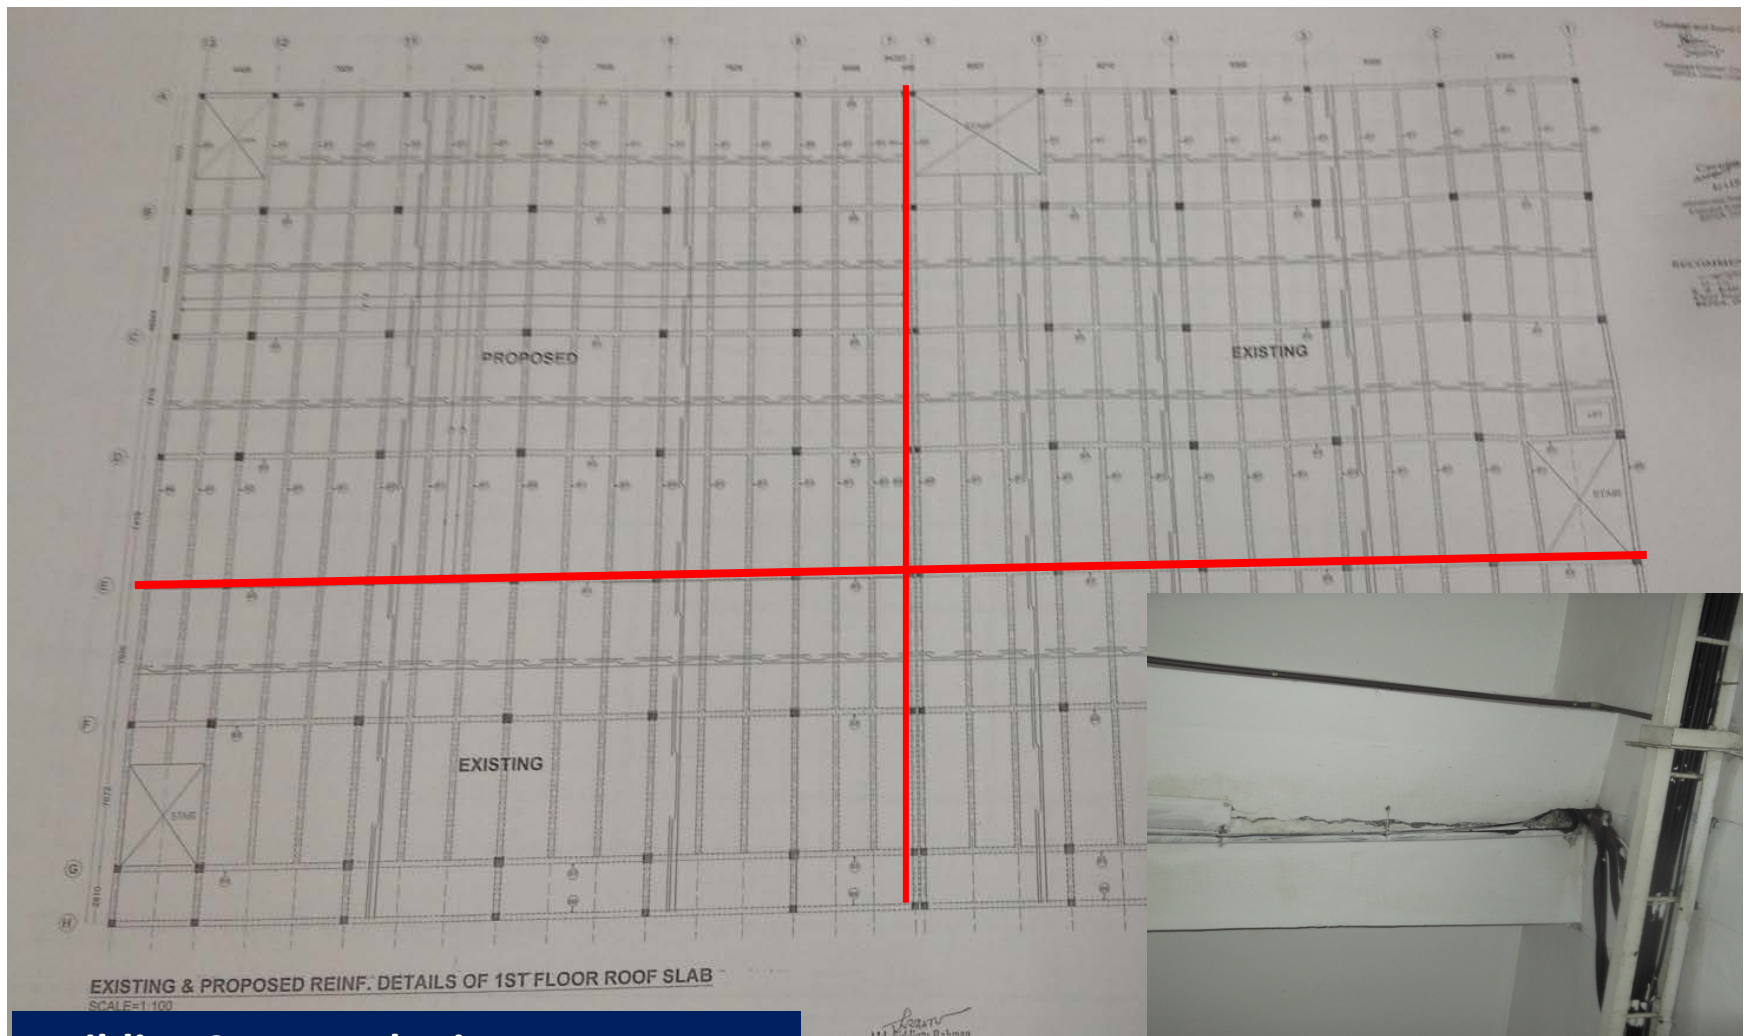
# **Level difference between floor slabs constructed during the different phases of construction**

**Building Structural Joints –  
Between different phases of  
construction**

- Building Engineer to carry out on-going monitoring of floor slab levels along the line of the two construction joints at each floor level to confirm that no relative movement is now taking place and that the current level difference is associated with an error in the alignment of the floor slabs at construction.

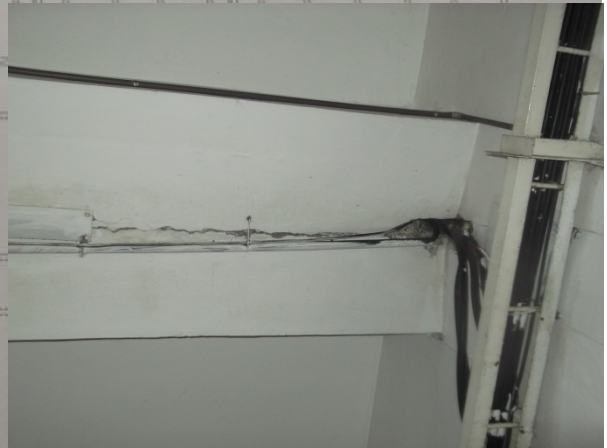
**Evidence of movement on  
underside of structural joint**

**Building constructed in different  
phases**

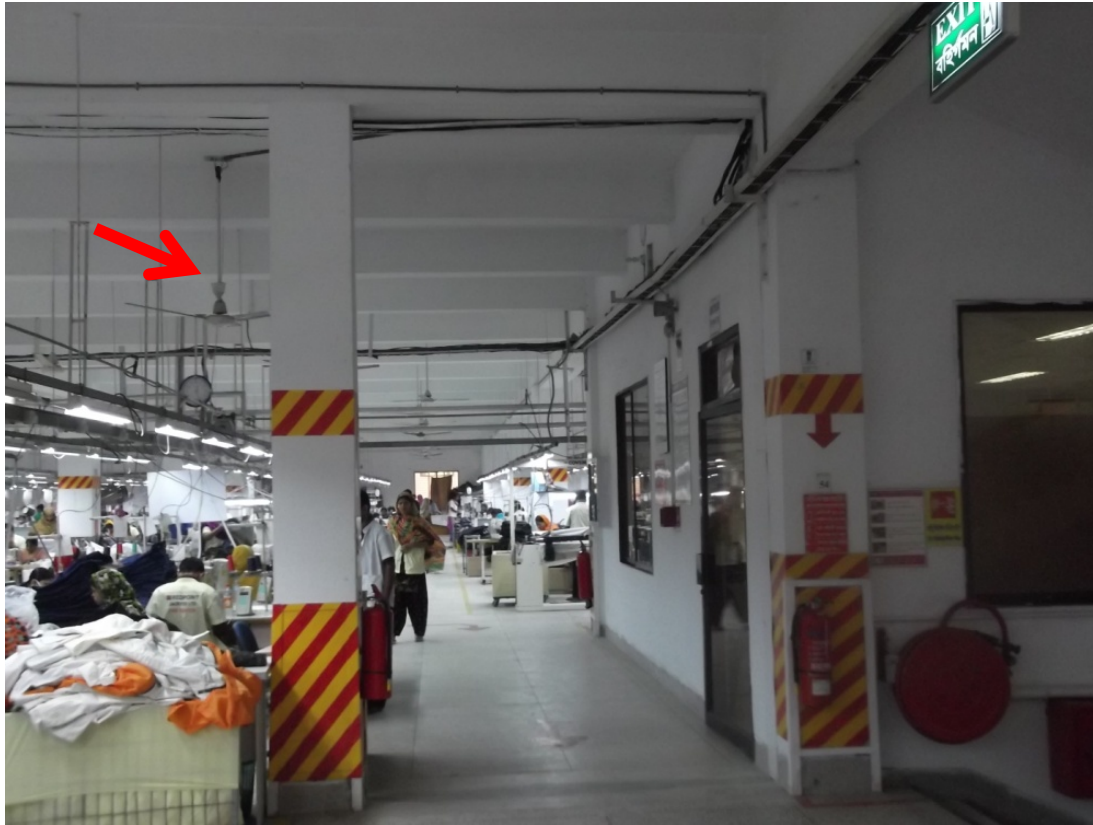
**Redundant brick columns on gridline 6/B-C  
at ground and 1<sup>st</sup> floors to be removed**

Redundant plastered 2  
No brick columns on  
ground and 1<sup>st</sup> floors to  
be removed to ensure  
that structural beam  
above acts as designed

- Two plastered brick columns to be removed, as they are now redundant, and may provide support to the beam above in the event of an increase in floor load. This additional support would result in a beam support point which it is understood would not have been included in the original design.

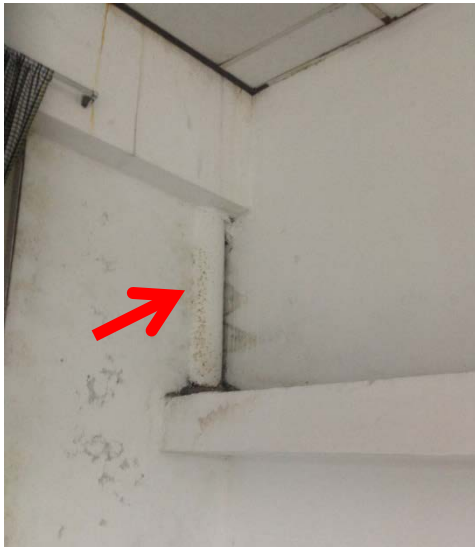
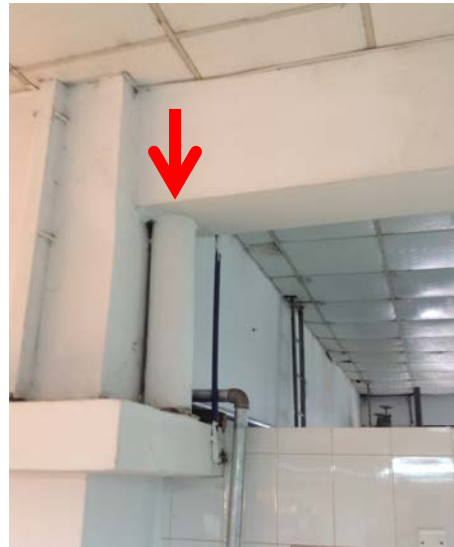
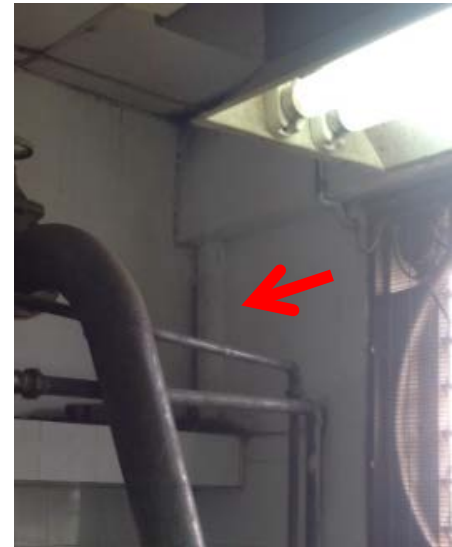
**Support arrangement for water tank at the south – west corner of factory is unclear**

**Water tank on the 3<sup>rd</sup> floor with four circular steel stub columns not shown on the structural design drawings – support arrangement unclear. Tank being decommissioned.**

Support arrangement for water tank at the south – west corner of factory is unclear. (Note – this issue was highlighted in the previous inspection by Ludwig Meyer and we understand that it is currently being actioned by decommissioning the water tank.)

- Tank to be drained/emptied  
Soonest

- Water tank to be decommissioned and a replacement tank provided in a location to be agreed with the Building Engineer
