# Parkscene Bangladesh Ltd Parkstar (Parkzone)

Mouza Kunia . JL No,. 406, Gazipur Sadar. Gazipur

(23.934767N, 90.387349E)  
20th April 2014

# Observations

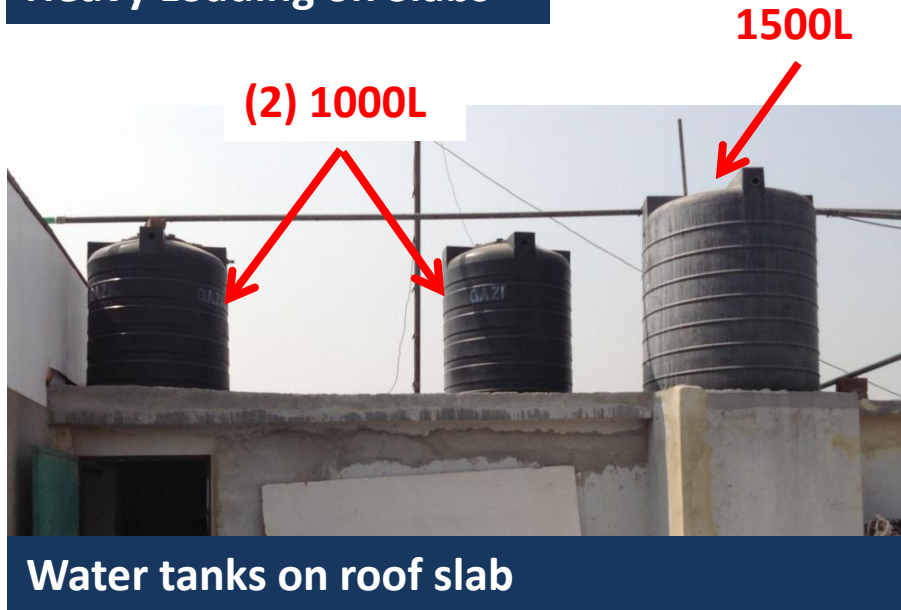
Heavy loading was observed in several locations on floor and roof slabs:

- Water tanks on the roof slabs above stairs
- Toilet areas
- Storage areas
- Masonry partition walls at 2<sup>nd</sup> Floor

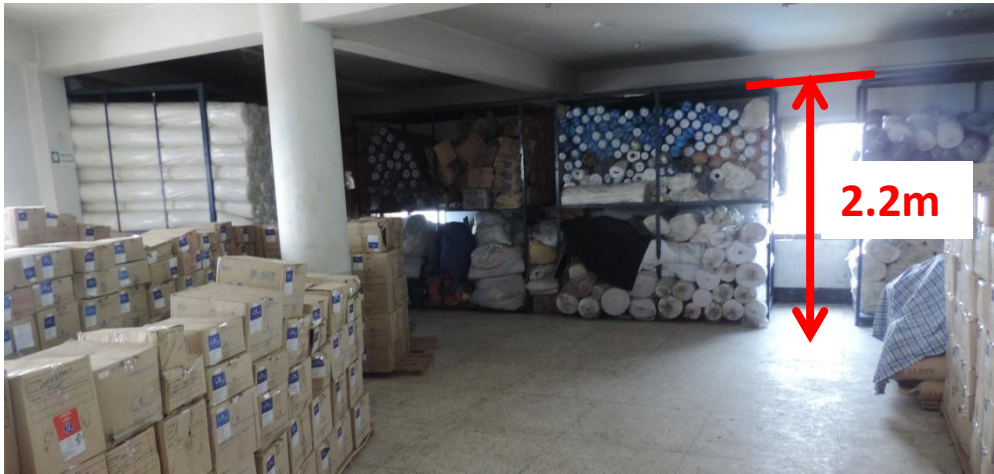
2.2m

$5 \text{ kN/m}^2$   
estimated live load

| Item No. | Observation | Recommended Action Plan | Recommended Timeline |
|---|---|---|---|
| 8 | Heavy loading noted in isolated areas of some floor plates | Building engineer to produce loading plans to be displayed at each floor level. | 6-weeks |
| 9 | Heavy loading noted in isolated areas of some floor plates | Factory manager to actively manage floor usage in accordance with the loading plan. | 6-months |

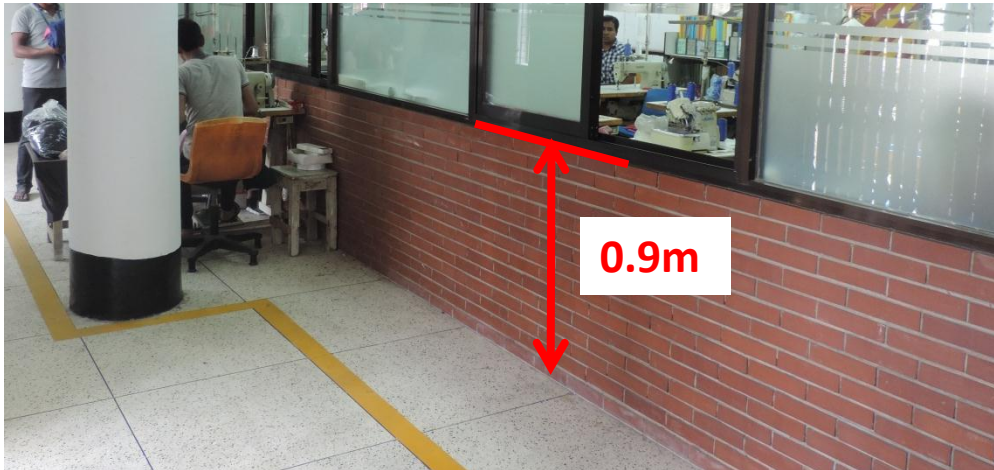
## Storage areas

0.9m

$2 \text{ kN/m}$  estimated  
superimposed dead load

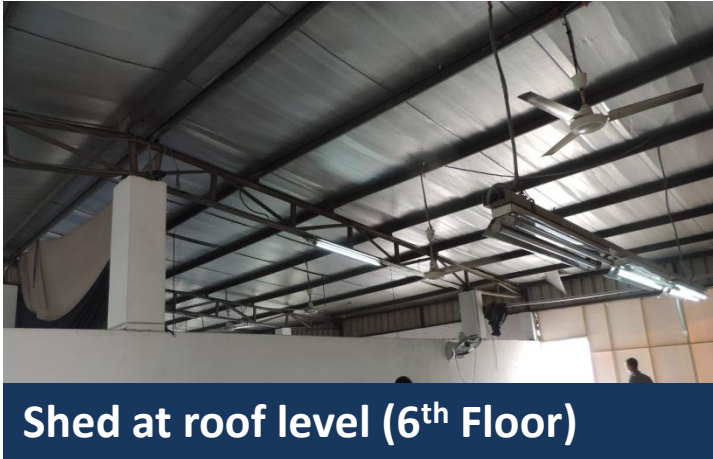
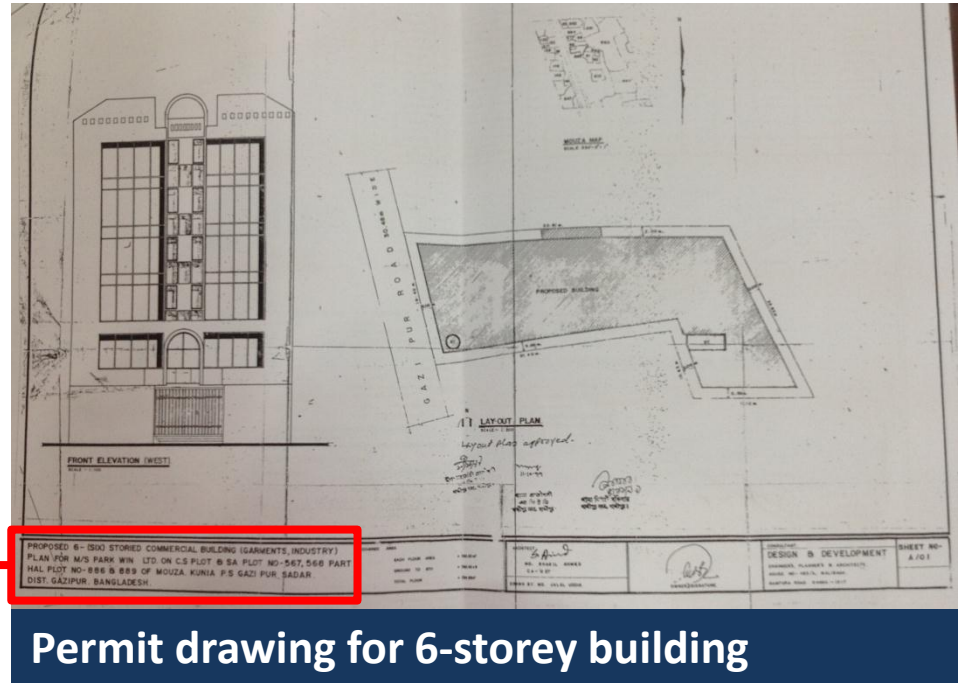
A shed roof has been erected over the former R.C. roof to create a usable floor space at the roof level (6<sup>th</sup> Floor), so the building now has seven (7) occupied storeys. The Building Permit is for a 6-storey building. The 6<sup>th</sup> Floor is currently being used for sewing and prayer, and it has also been used for dining.

| Item No. | Observation | Recommended Action Plan | Recommended Timeline |
|---|---|---|---|
| 13 | Non – permitted additional storey and associated non engineered structure | As-built documents to be completed as part of DEA | 6-weeks |
| 14 | Non – permitted additional storey and associated non engineered structure | Engineer inspect and design and detail remedial works | 6-weeks |
| 15 | Non – permitted additional storey and associated non engineered structure | Carry out remedial works as required | 6-months |

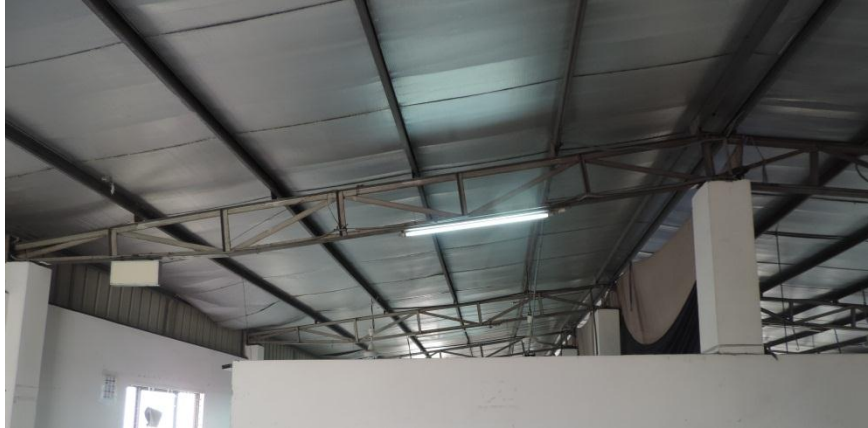
**Lack of horizontal bracing in roof**

**Two observations of the roof shed require engineering verification:**

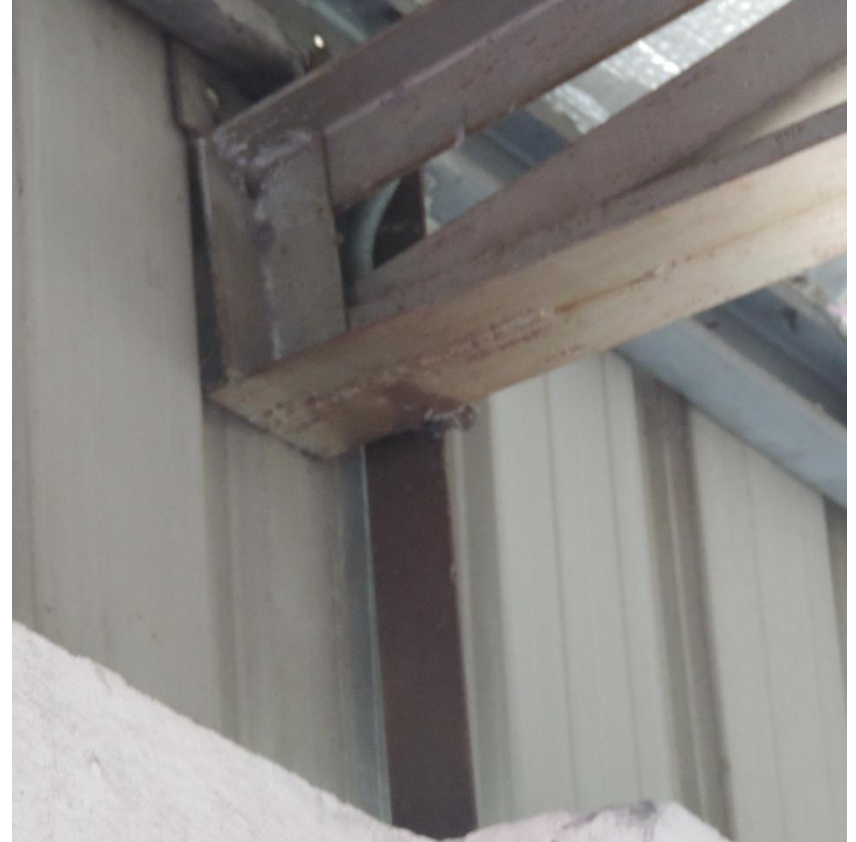
**Non-engineered connection to column**

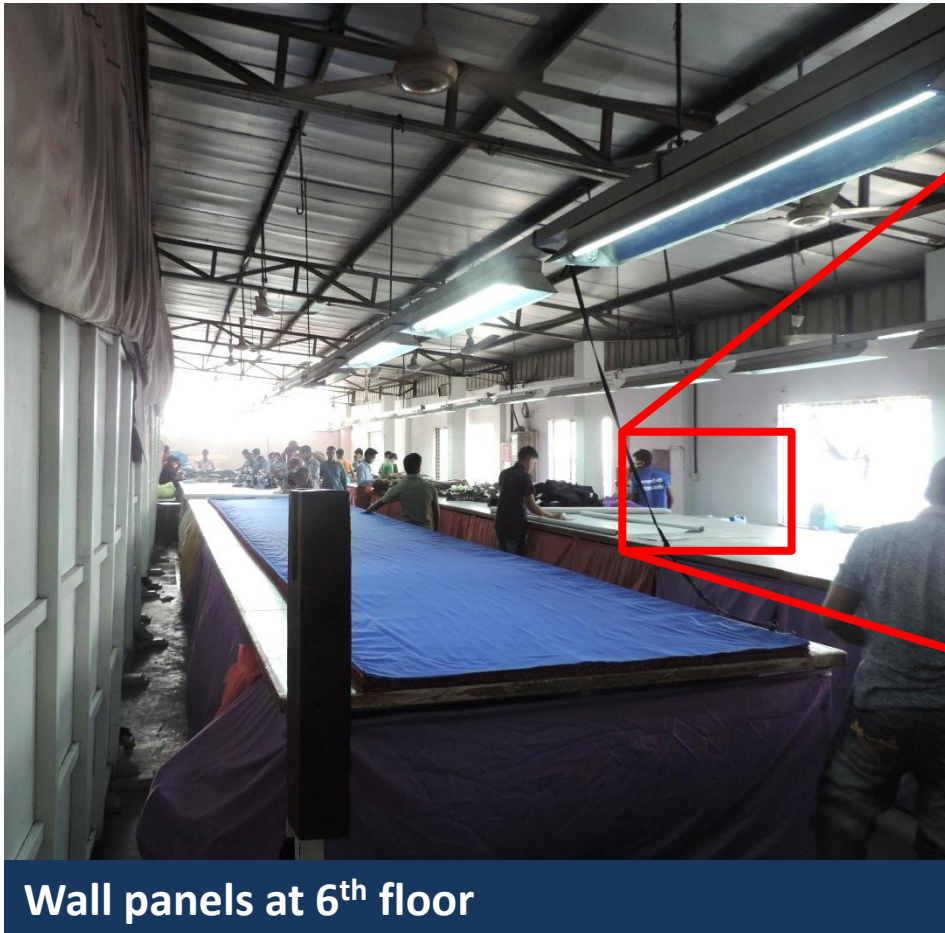
A crack was observed in the masonry wall panel below a window between the roof trusses at the 6<sup>th</sup> floor.  
This was an isolated area

Crack in wall panel

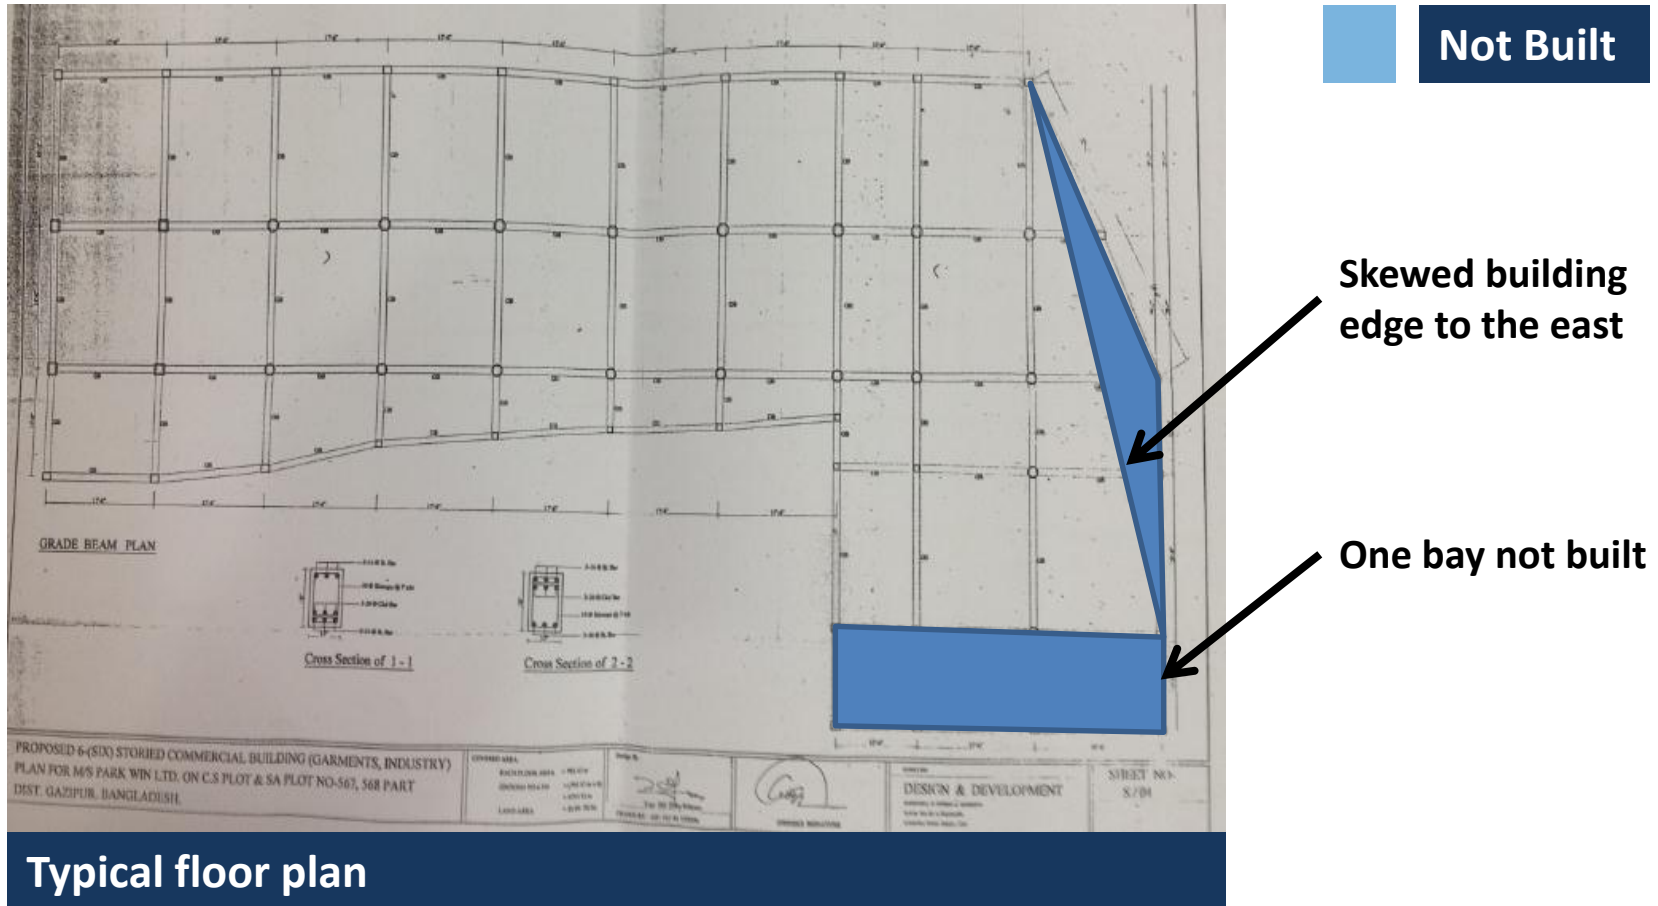
The typical floor plan which was built differs from the Permit Drawings. One bay at the south end of the building was not built, and the profile of the building edge to the east is skewed.

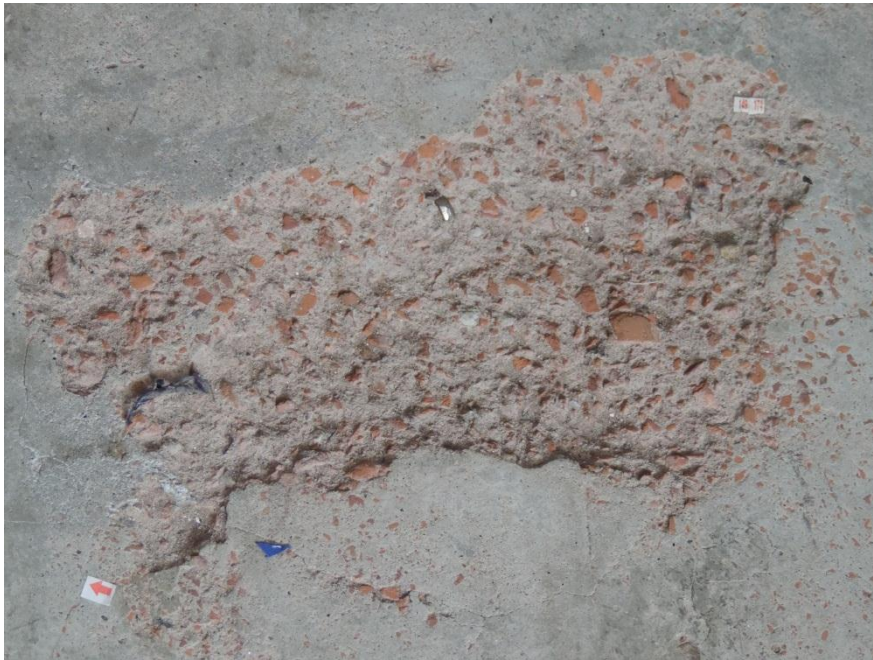
**Brick aggregate was observed in the 6<sup>th</sup> Floor slab and in columns at the Ground Floor.**

**Brick aggregate in slab**

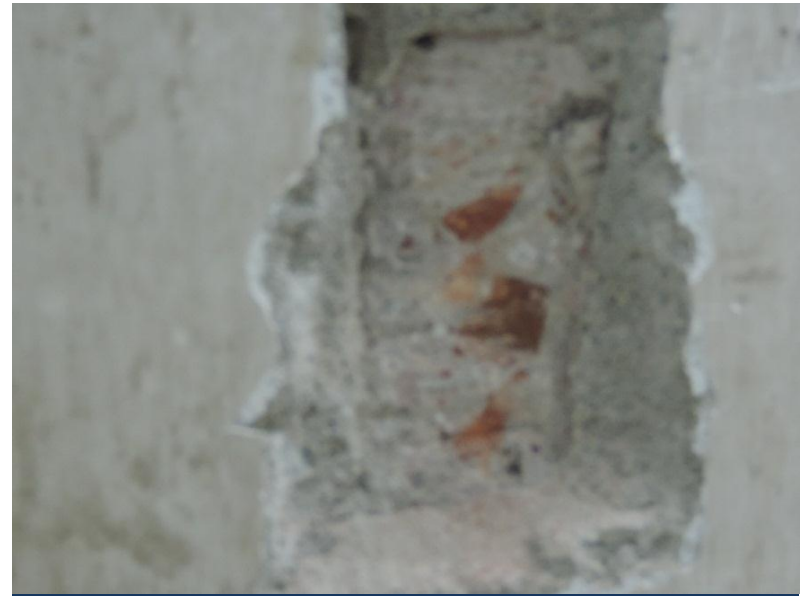
**Brick aggregate in column**

| Item No. | Observation | Recommended Action Plan | Recommended Timeline |
|---|---|---|---|
| 3 | Heavily loaded columns in toilet areas | Verify insitu concrete strengths (using min. 4 no. 100mm dia. Cores and/or assessment of available concrete strength data) and existing reinforcement for all columns | Immediate - Now |

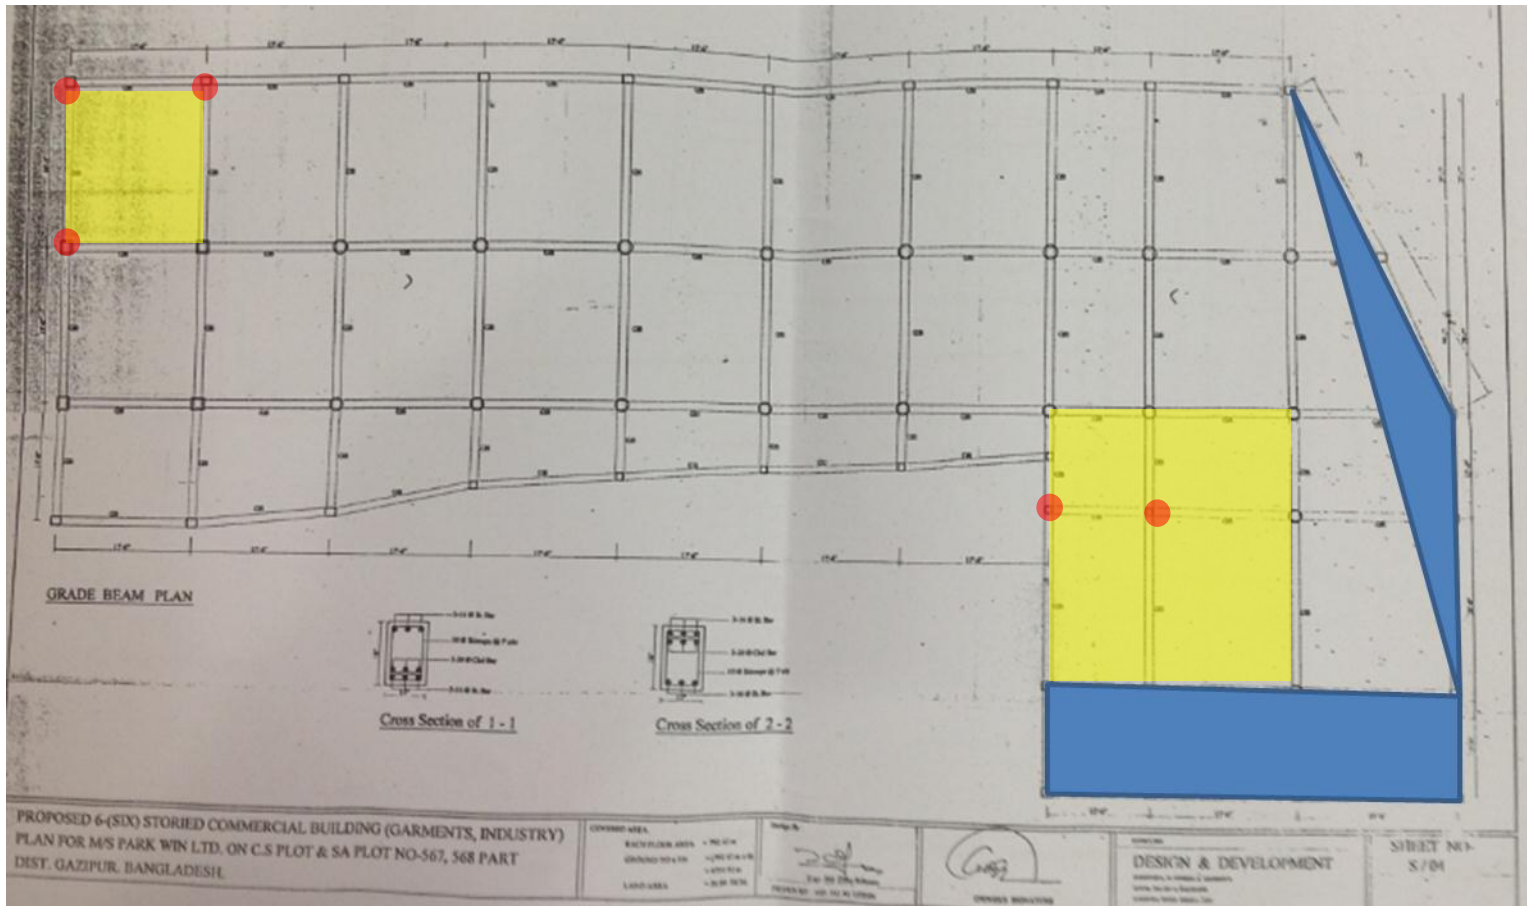
## Heavy loaded columns

- Heavy Loaded columns
- Area where loading is not to exceed  $1.0\text{kN/m}^2$  prior to completion of DEA

| Item No. | Observation | Recommended Action Plan | Recommended Timeline |
|---|---|---|---|
| 1 | Heavily loaded columns in toilet areas | Live load to be controlled as per limits on following page | Immediate - Now |
| 2 | Heavily loaded columns in toilet areas | Detail Engineering Assessment of as-built structure to be commenced as per attached scope. | Immediate - Now |
| 4 | Heavily loaded columns in toilet areas | Detail Engineering Assessment to be completed | 6-weeks |
| 5 | Heavily loaded columns in toilet areas | Produce and actively manage a loading plan for all floor plates within the factory giving consideration to floor capacity and column capacity. | 6-weeks |
| 6 | Heavily loaded columns in toilet areas | Make alterations to the toilets as required. | 6-weeks |
| 7 | Heavily loaded columns in toilet areas | Continue to implement load plan for all floor plates within the factory. | 6-months |
