# Divine Design Ltd. Alamode Apparels

Chittagong, Bangladesh  
(22°22'55.5"N 91°51'53.5"E)

20 APRIL 2014

# Observations

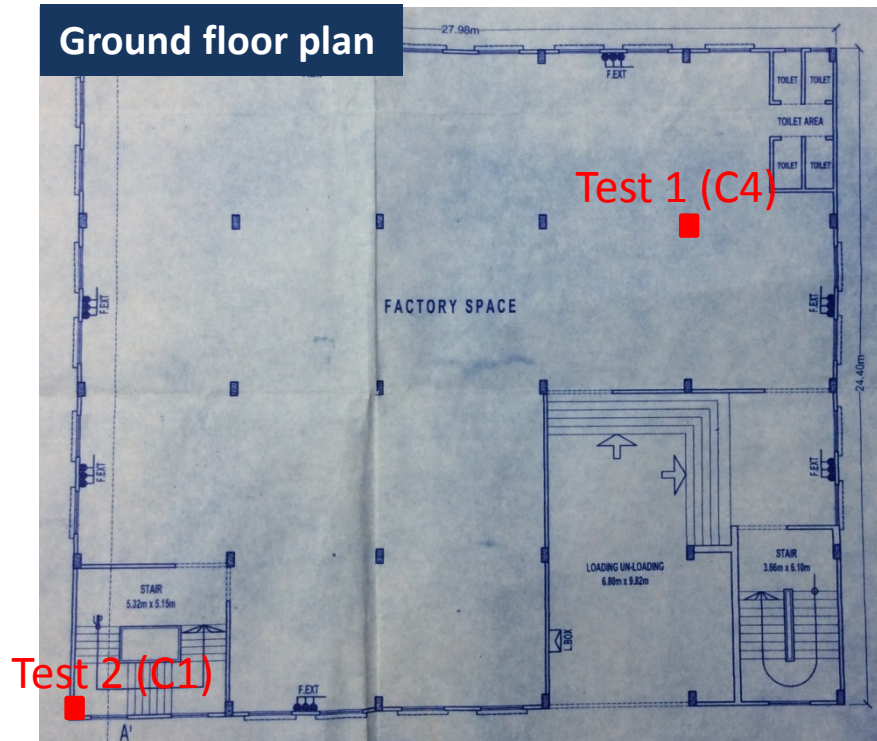
## Ground floor plan

## Highly-stressed columns at Ground Floor

Cursory calculations indicate that columns are stressed in excess of normal design limits. Reasons for this may stem from the following:

- Cantilever increases load on the first column particularly when loaded with storage.
- Internal partition walls in brickwork adding to the general live load.
- 8 floors in parts of the building. Whilst the building appears to have a permission for 8 floors this may not have been taken account of in the original design.
- Storage load in excess of usual 3kPa, the design load for slabs according to code.
- Brick aggregate found in the columns instead of stone aggregate as suggested on structural drawings.

- Only lightweight operations (max. 100kg/m<sup>2</sup> - 1kPa) or access ways / escape routes are permitted in shaded zones at all levels. No storage allowed.
- Verify insitu concrete stresses by cores (100mm diameter) at min. 4 no. non-critical columns on ground floor.
- **Detail Engineering Assessment to be commenced immediately, see attached scope.**

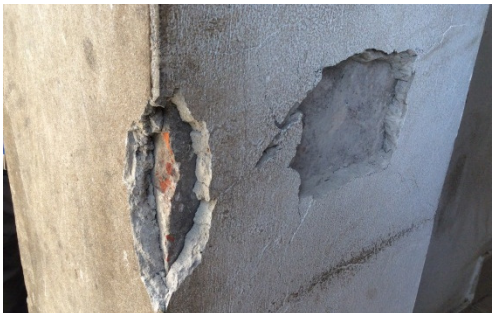
Tested Ground Floor Column – Brick Chips

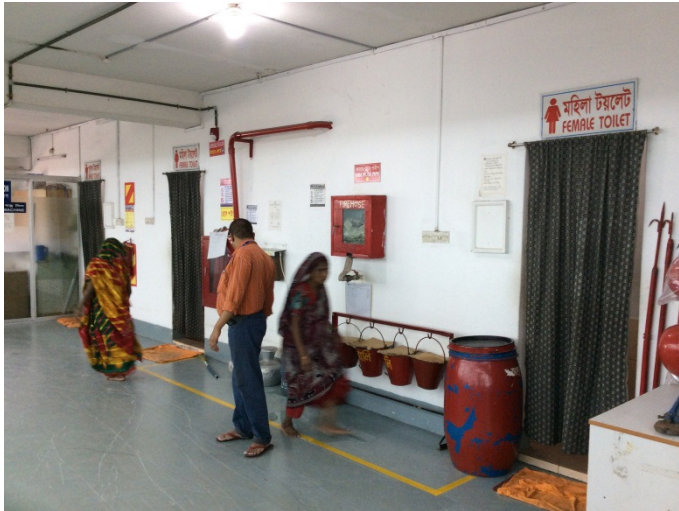
**High loadings on slab  
(storage, toilet areas with brick partitions)**

Toilet Build-up + partition walls

**Building Engineer to prepare controlled loading plans, based on floor slab and column capacity, for all floors which will designate maximum permitted storage density and where storage may be placed.**

- Extent of floor build-up and partition walls and their respective loads onto the slab to be surveyed / identified and compared against the capacity of floor slab which will be assessed as part of Detail Engineering Assessment (Refer to Item 1)

- Reduce dead load / live load or carry out strengthening of floor slab as required.

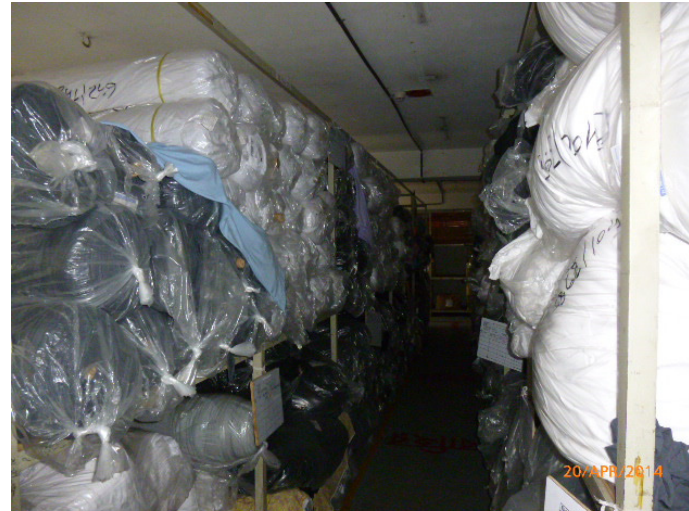
Storage 6<sup>th</sup> floor

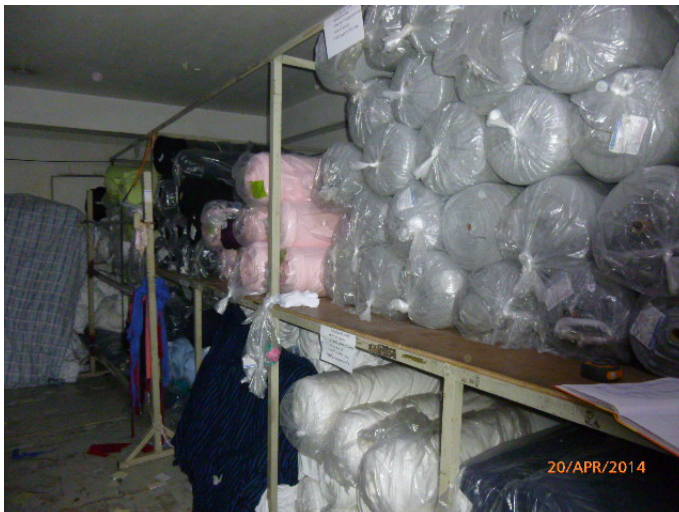
Storage 2<sup>nd</sup> floor

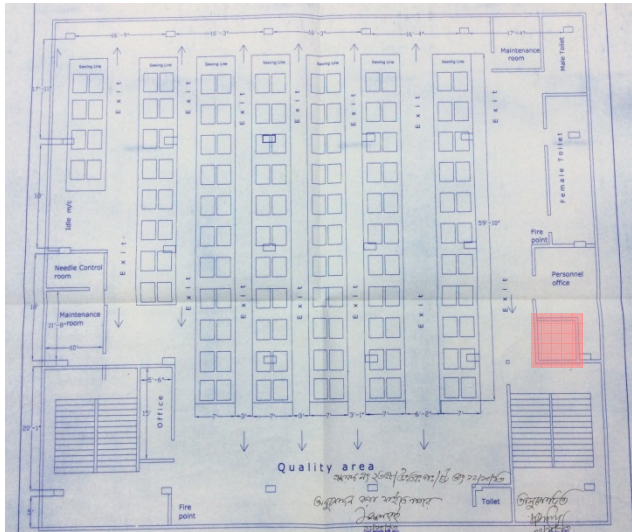
Lift shaft on architectural drawing

No information about lift shaft on structural drawings:

- No foundation shown,
- Not clear if brick or concrete,
- Not clear if borne by each slab on each level or actually load-bearing

- Should be kept unused.

- As part of Detail Engineering Assessment (refer to Item 1), Building Engineer to commence re-survey of as-built structure and check foundation for the unused lift shaft.

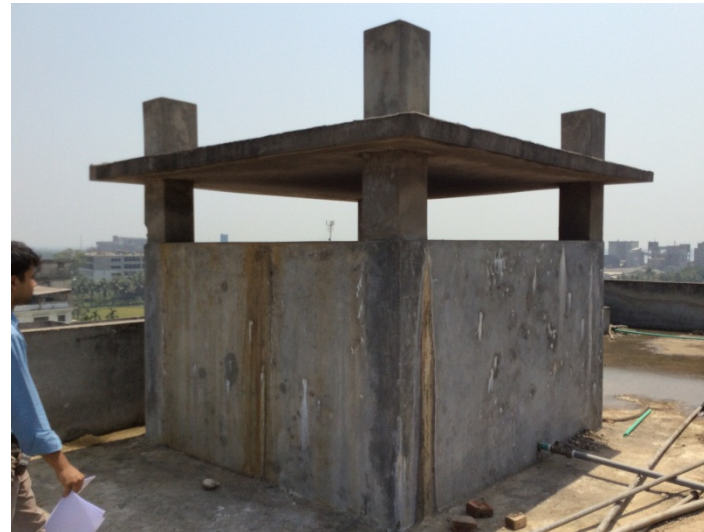
Water tank on top of lift shaft

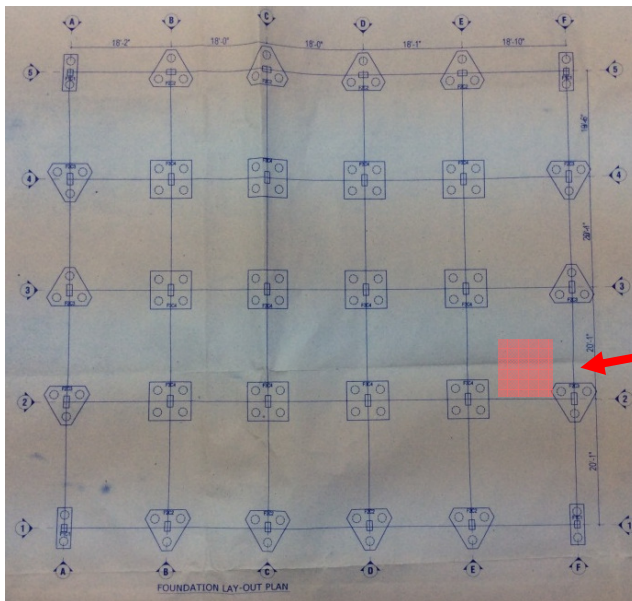
Unused lift shaft

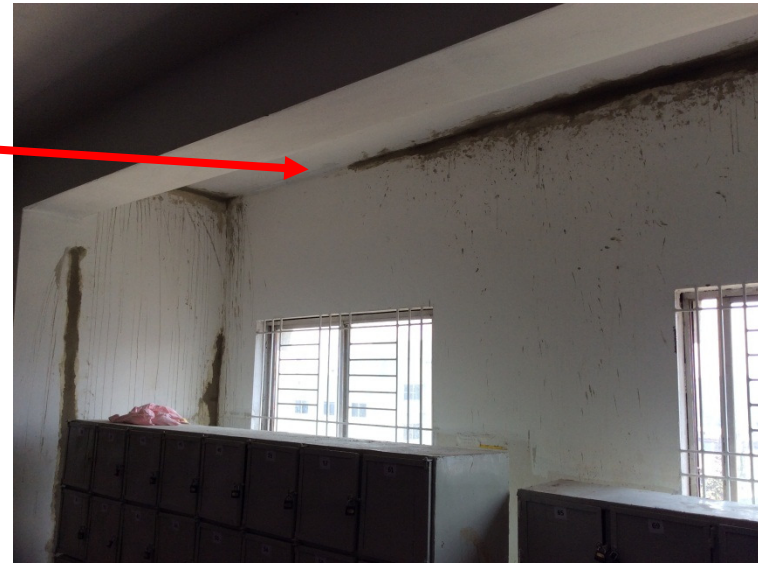
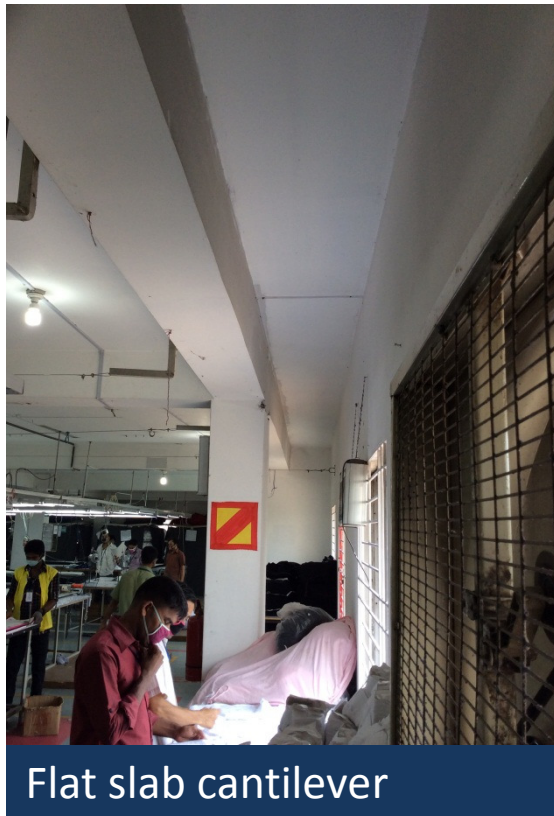
(Repaired) cracks: indication of high deflection of cantilever

Flat slab cantilever

- Remove storage from cantilever slabs.

- Create controlled loading plans for all floors designating where storage can / cannot be placed along cantilevering edges.
- Provide calculations showing the structural adequacy of the cantilever slab, taking into account the loading plans, facade and all built structure, including additions beyond the original design, as part of Detail Engineering Assessment (refer to Item 1).

- Reduce live load or carry out strengthening as required.

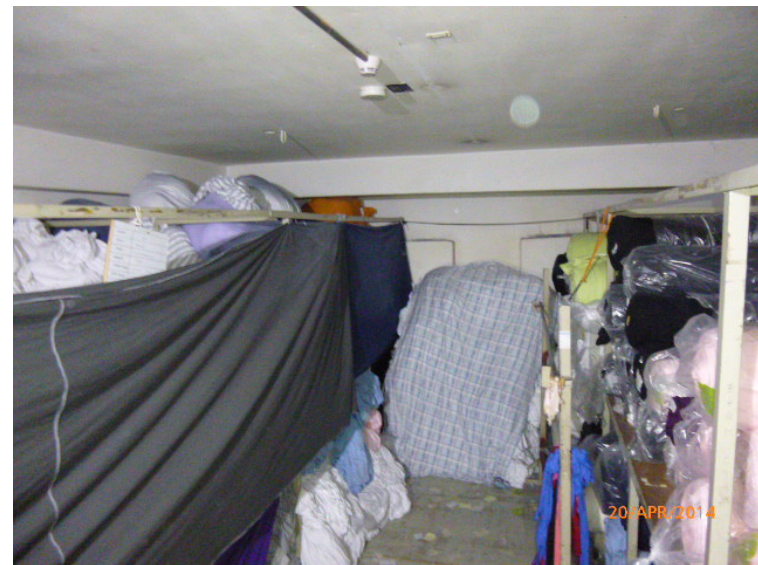
High load on cantilever

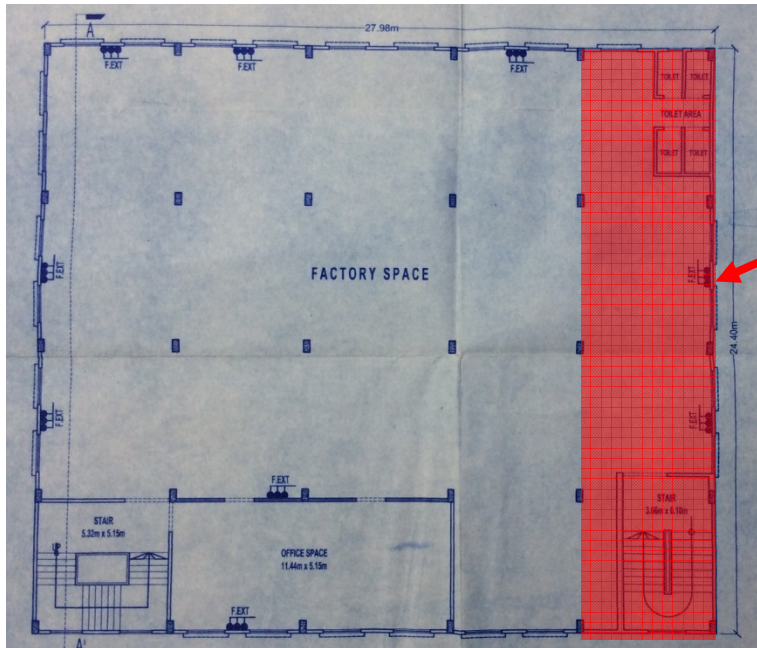
Additional structure of one bay on roof  
(not shown on drawings)

- Provide calculations showing the structural adequacy of the roof, columns underneath to carry the extra loading as part of the Detail Engineering Assessment (refer to Item 1).

- Remove additional RC structure if required.

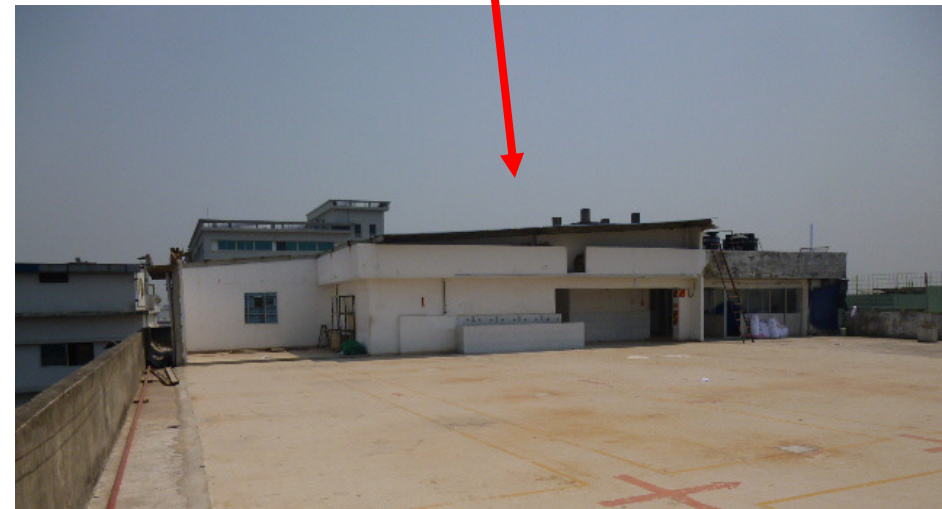
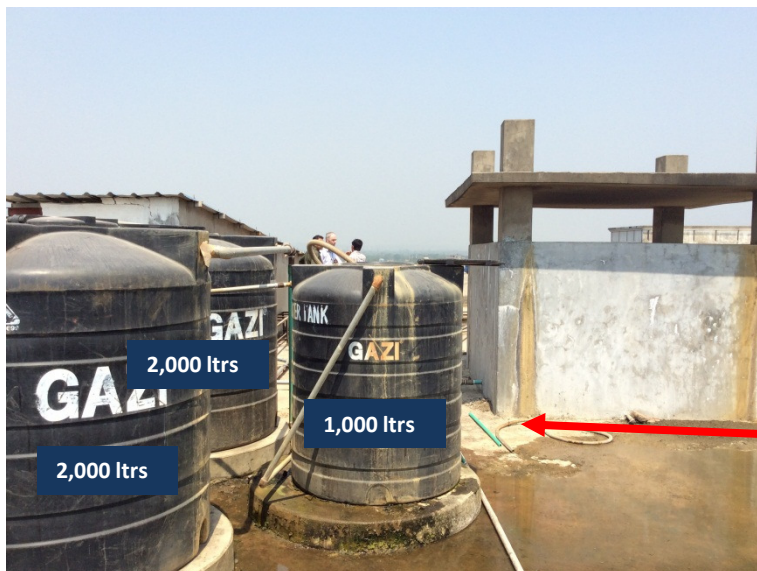
High loads on additional structure: 3 plastic  
water tanks and one concrete water tank

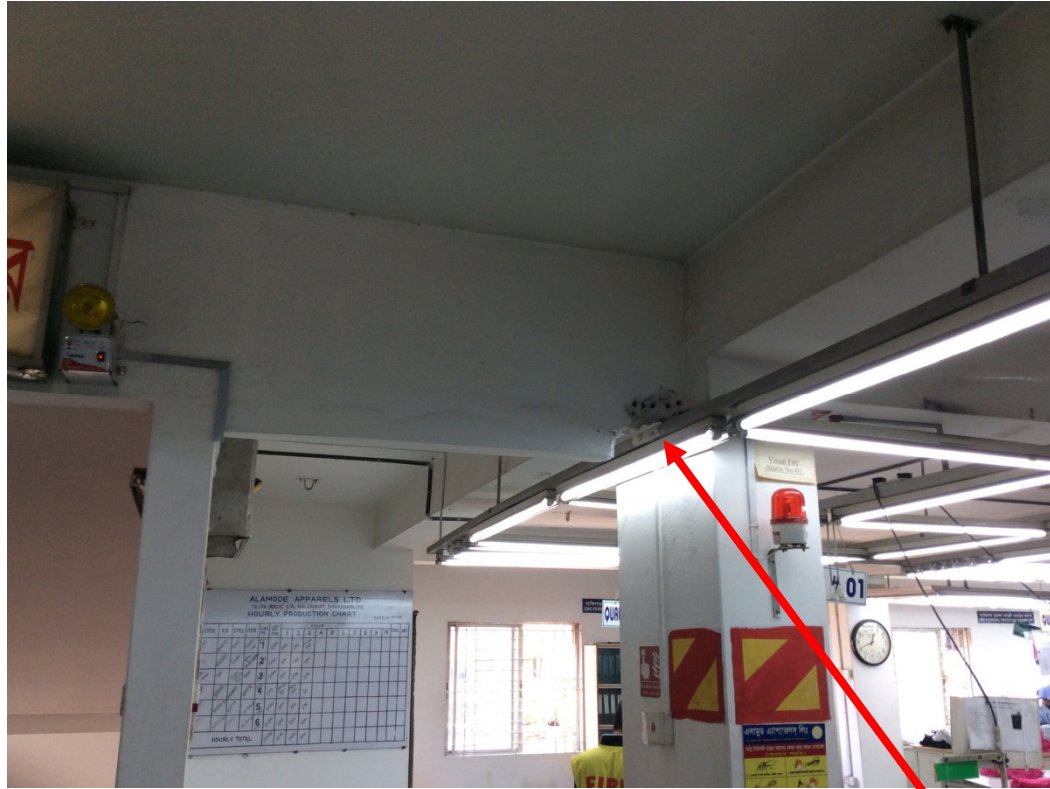
Partly removed lintel beam  
resulting in unsafe brickwork

- Provide temporary propping to lintel.

- Restore lintel beam.

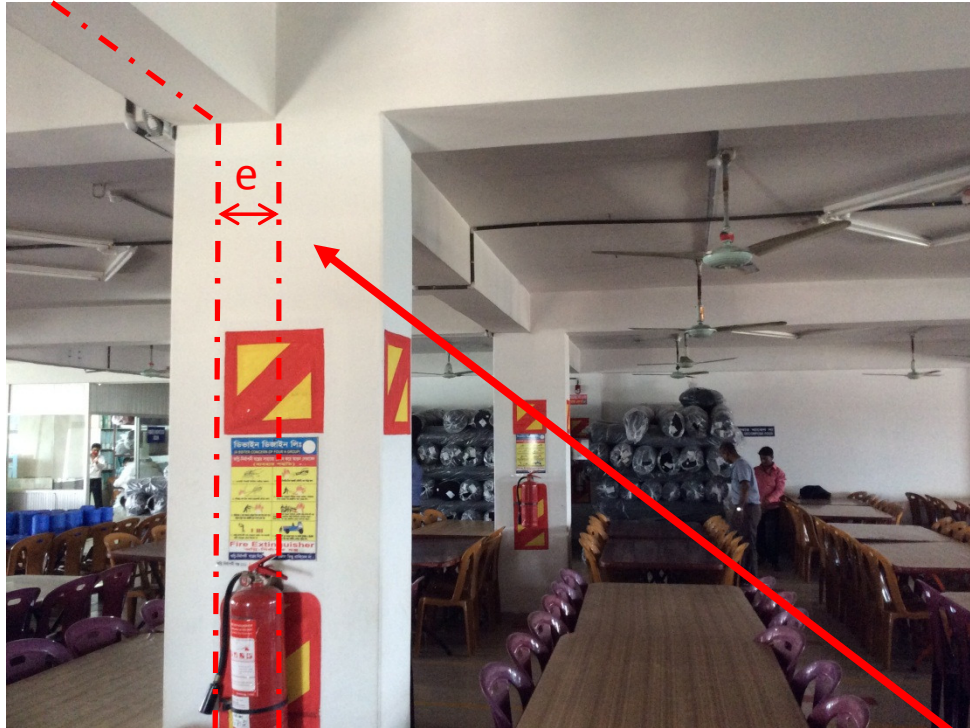
Eccentric beam-column connection  
on every floor  
(not shown on structural drawings)

- Provide calculations showing the structural adequacy of the building taking into account the eccentricity of the beam-column connection as part of the Detail Engineering Assessment (refer to Item 1).

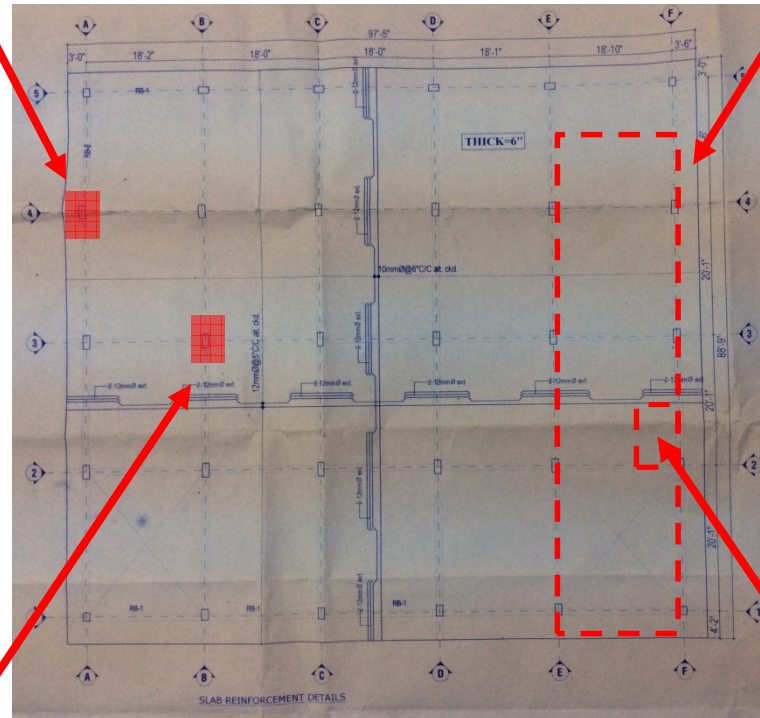
Different column size for columns C3

Additional structure of one bay on roof not shown on drawings

Eccentric beam-column connection not shown on drawings

Lift shaft not shown on drawings

- As part of Detail Engineering Assessment (refer to Item 1), Building Engineer to commence re-survey of as-built structure and update drawings including a verification of the column sizes, lift shaft, beam-column connection etc.

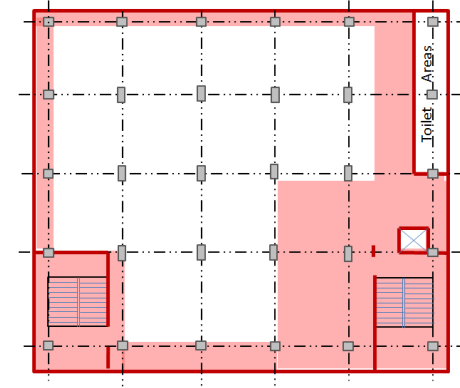
Check column stresses and verify concrete strengths in columns surrounding stair core
