FIRE SAFETY INSPECTION REPORT

Factory Name: Wucho Fashion Ltd.

ACCORD ID: 23189

Date: 3rd May, 2018

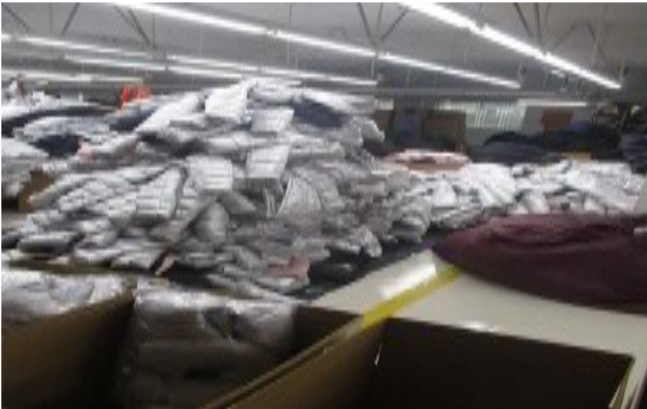
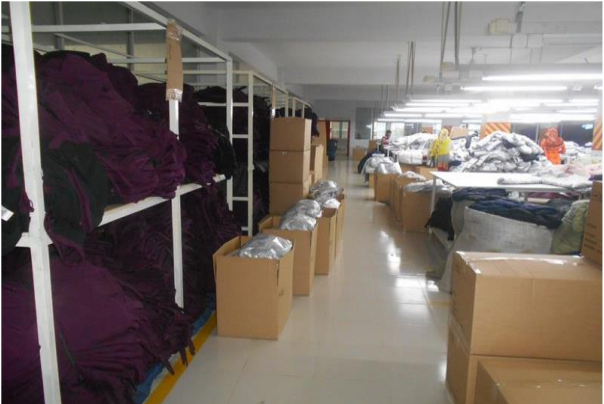
2	Fire Rated Construction	<p>Rooms used for storage of combustible materials are not separated from the surrounding occupancy/areas</p> <p>Location: Basement Floor- besides dining area, Ground Floor- finished good store in east portion of cutting table</p>	<p>Rooms used for storage of combustible materials shall be separated from the surrounding occupancy with a minimum 1 hour construction.</p>	<p>Within 3 months</p>

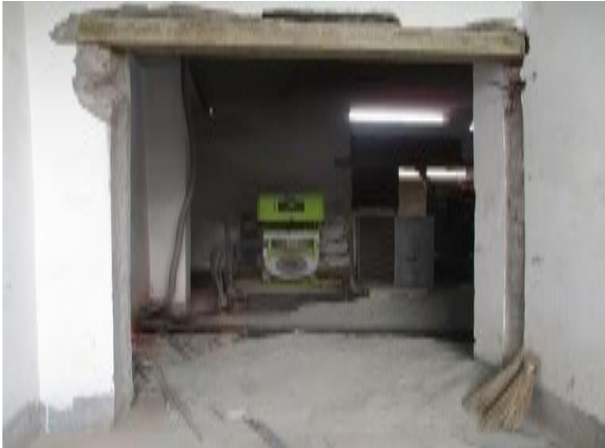
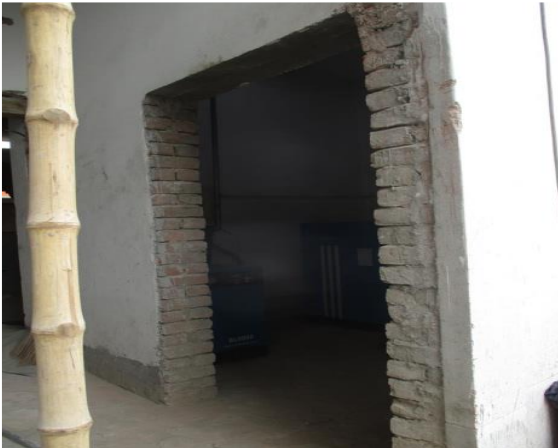
4	Fire Rated Construction	<p>The exit stairs are not separated from production floors on each floor by fire-rated construction. Fire doors are installation works are in progress.</p>	<p>Stair shall be enclosed with a minimum 2-hr fire-rated construction. Seal all unprotected openings and provide minimum 1.5-hr fire rated doors to separate the exit stairs from work areas and other building spaces on all floor levels. Ensure that the fire doors are self-closing, positive latching and that they are provided with fire exit (panic) hardware where serving production floors.</p> <p>If fire doors are required to be held open for functional reasons, provide automatic-closing devices tied to the fire alarm system.</p>	Within 3 months

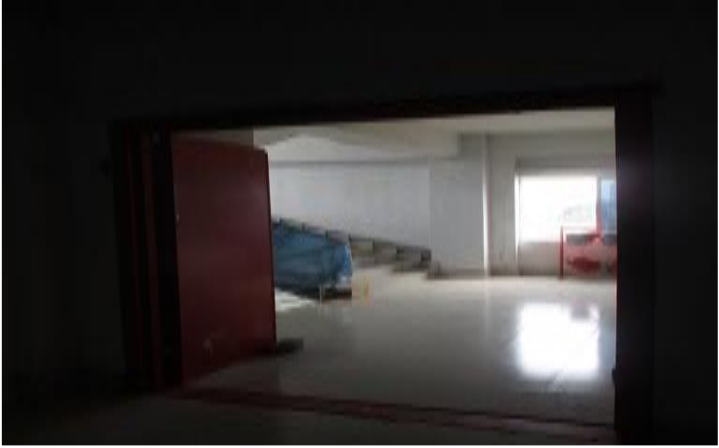
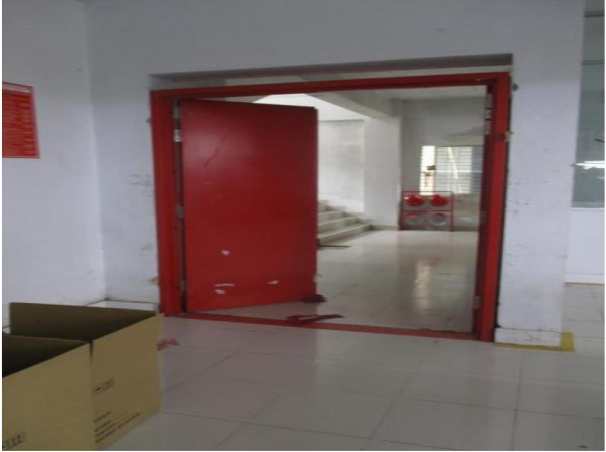
5	Fire Rated Construction	South east exit stair is discharge the occupants inside the building at basement floor .	<ol style="list-style-type: none"> 1. Modify stair to discharge directly outside. <li style="text-align: center;">Or 2. Provide 2-hr fire-rated exit passageway leading directly outside (vestibules to separate any storage areas). <li style="text-align: center;">Or 3. Provide sprinkler protection for discharge floor in accordance with NFPA 13. 	Within 3 months

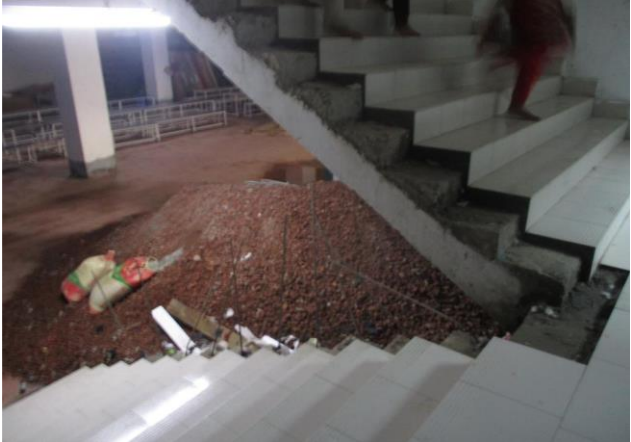
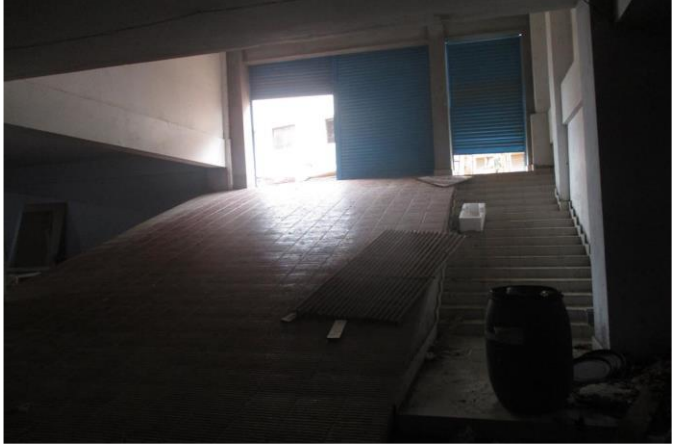
6	Fire Rated Construction	Exit enclosure is not separated from building interior's unsealed penetrations.	Seal all penetrations and openings in exit stair enclosure walls to maintain the fire separation.	Within 3 months

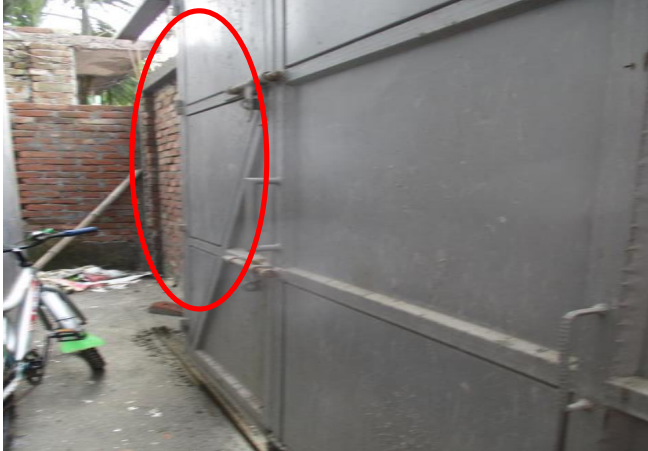
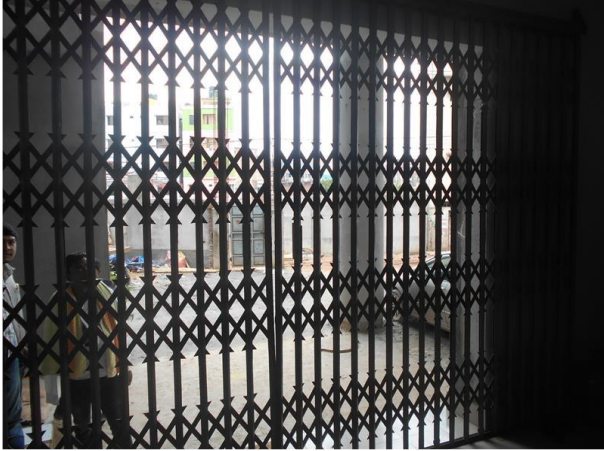
11	Egress	<p>Collapsible and Sliding type doors have provided along means of egress.</p> <p>Location: Collapsible gates were found in Exit doors at north west portion and at north east portion besides the stairs at ground floor. Sliding doors were found in exit doors at north west portion besides the stair with the wrong swinging direction and finished good store at ground floor and staff office at 2nd floor)</p>	<p>Replace all collapsible/sliding/shutter type doors & gates by the side-hinged swinging type doors.</p>	<p>Within 3 months</p>

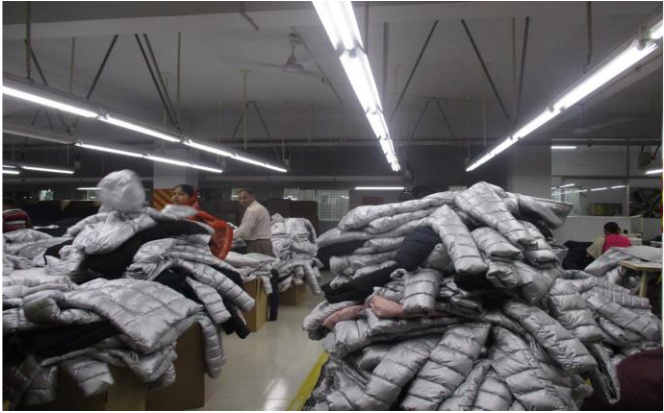
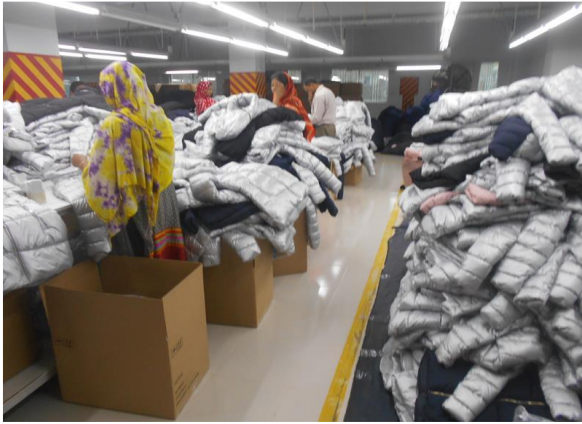
13	Egress	<p>During the inspection egress aisles were obstructed by combustible storages and available clear width were found less than 36 inch.</p>	<p>Provide aisles free from obstructions and with minimum clear widths of 36-inch.</p>	<p>Immediate</p>

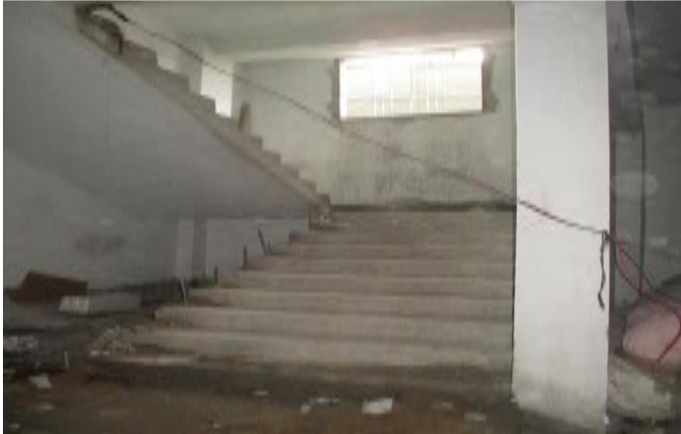
15	Egress	Intermediate handrail has not been provided in south stair.	Provide intermediate handrail having a minimum height of 34 in.	Within 3 months

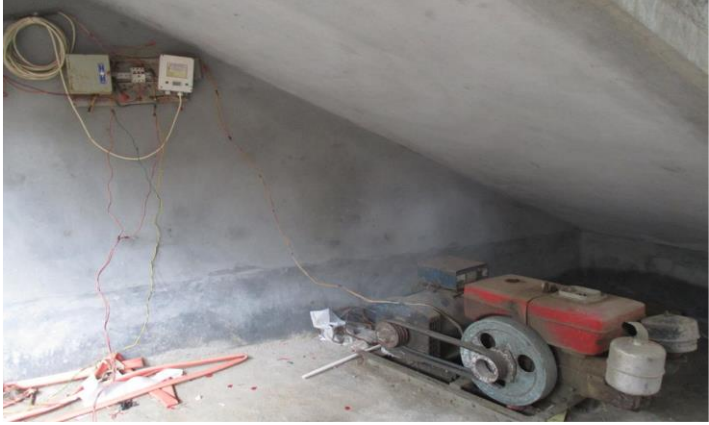
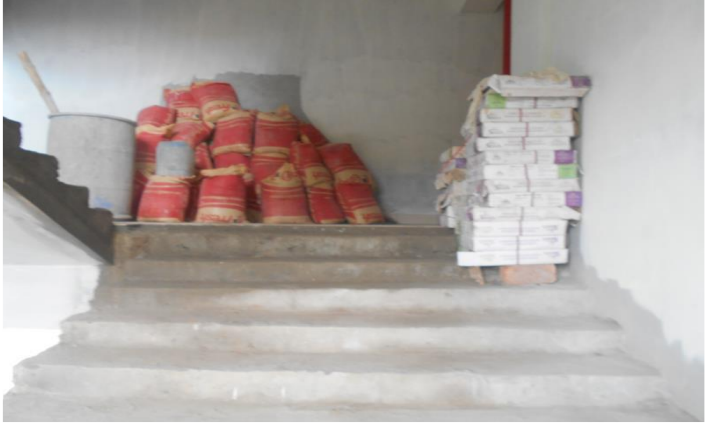
SI No.	Category	Findings	Required Action	Remediation Time Frame
18	Egress	Storage was located in the exit stairs. Location: diesel machine underneath north stair at ground floor and other types of storages were found in all stairs throughout all floors.	Remove all storage from exit stairs.
