# Amex Knitting & Dyeing Industries Ltd. (Unit 2)

Sufia Plaza, 327/3/B-C, South Jattrabari, Dhaka-1204, Bangladesh  
(23.708897, 90.437078)  
12<sup>th</sup> June, 2014

# Observations

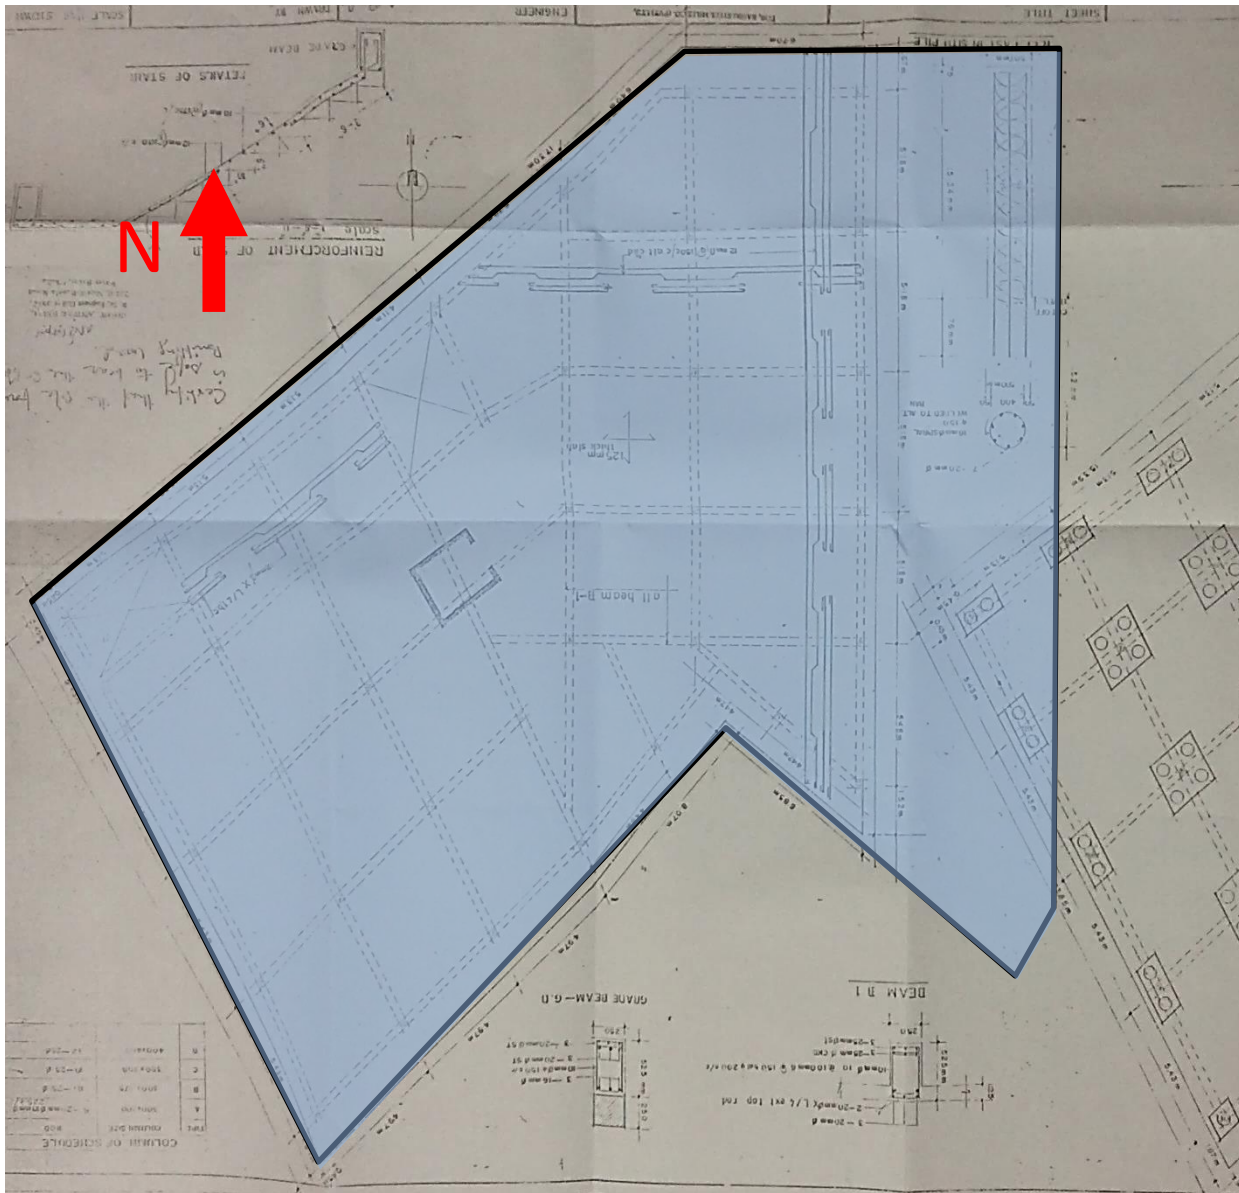
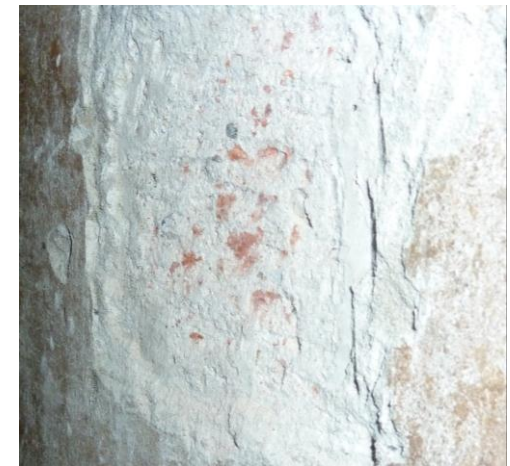
Brick aggregate noted in columns.

Cursory calculations indicate that for all columns, the actual size appears to be smaller than required by code for the applied dead and live load, assuming typical concrete strength

| Item No. | Observation | Recommended Action Plan | Recommended Timeline |
|---|---|---|---|
| 1 | High stresses in columns | Reduce floor load to a maximum of 1.5 kPa throughout the main factory building. | Immediate - Now |
| 2 | High stresses in columns | Factory Engineer to review design, loads and column stresses in all columns in the building | Immediate - Now |
| 3 | High stresses in columns | Verify insitu concrete strength either by taking 100mm diameter cores from 4 columns or by using existing cylinder strength data if available. Cores MUST NOT be from very highly stressed locations. Verify reinforcement and grade of steel reinforcement used. | Immediate - Now |
| 4 | High stresses in columns | A Detail Engineering Assessment of the entire building to be commenced, see attached Scope. | Immediate - Now |
| 5 | High stresses in columns | Detail Engineering Assessment for the entire building to be completed. | 6-weeks |
| 6 | High stresses in columns | Produce and actively manage a loading plan for all floor plates within the factory giving consideration to floor capacity and column capacity. | 6-weeks |
| 7 | High stresses in columns | Continue to implement load plan | 6-months |

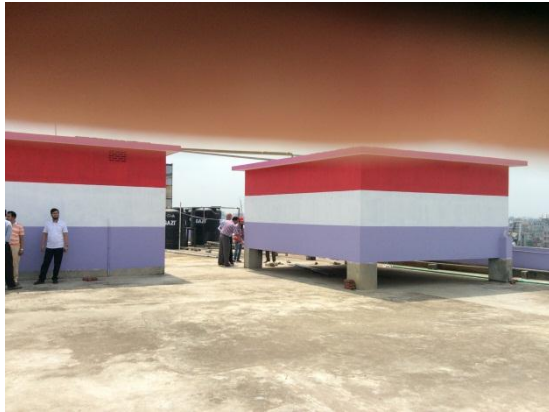
**RC Tank over South side of Roof**

Cursory calculations indicate that weight of roof-top concrete tank and its contents contribute significantly to the potential overloading of supporting columns, assuming typical concrete strength

| Item No. | Observation | Recommended Action Plan | Recommended Timeline |
|---|---|---|---|
| 8 | Additional Roof structures observed | As part of the Detail Engineering Assessment (DEA) check columns, slabs and beams supporting the Water Tank and other roof structures. | 6-weeks |
| 9 | Additional Roof structures observed | Building Engineer to review as-built structure and if required, prescribe relevant structural improvements to ensure these meets BNBC requirements as part of the DEA (refer to Item 1 above). | 6-weeks |
| 10 | Additional Roof structures observed | Carry out any structural alterations directed by the engineer. | 6-months |

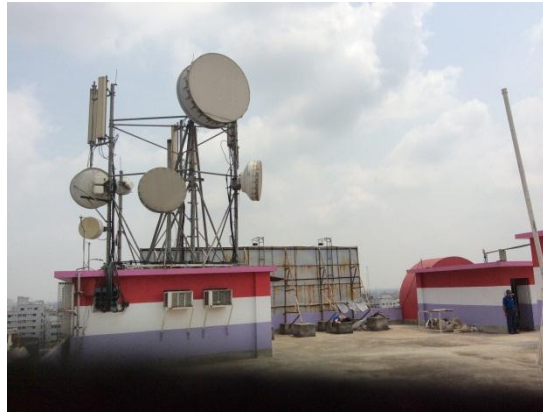
**Communication Tower over South side of Roof**

Additional weight and wind loads from roof-top communication tower are supported by roof structure

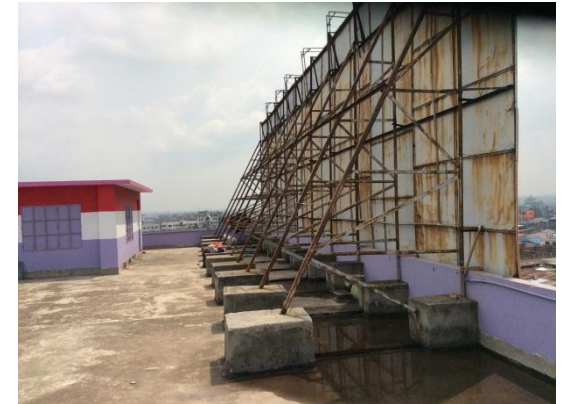
**Billboards on N East and N West sides of Roof**

Additional weight and wind loads from Billboards are supported by roof structure

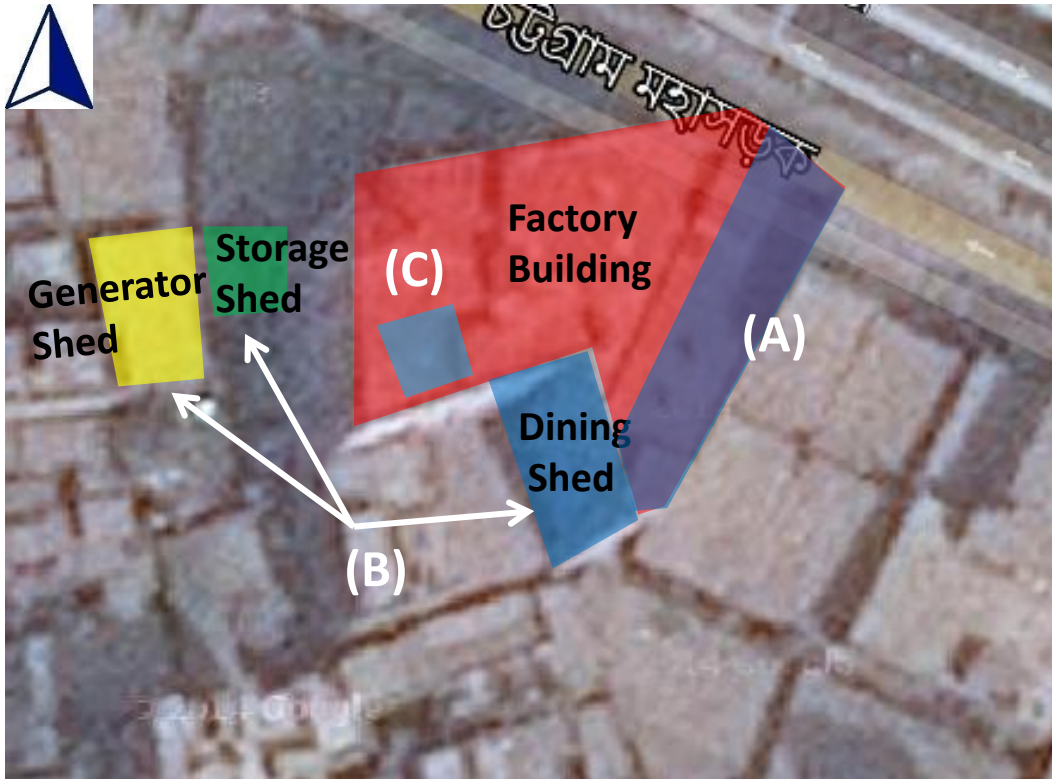
**Building drawings do not match  
as-built building details.**

## Drawings do not show:

- (A): Information on the East side of building. (Permit application submitted June 2014).
- (B): Dining, Storage and Generator Sheds
- (C): Reinforced concrete Roof Water Tank and other roof structures.

| Item No. | Observation | Recommended Action Plan | Recommended Timeline |
|---|---|---|---|
| 11 | Building permit drawings do not match as-built building details, missing structural information | Building Engineer to develop accurate and complete as-built structural drawings as part of the Detail Engineering Assessment (refer to Item 1 above). | 6-weeks |

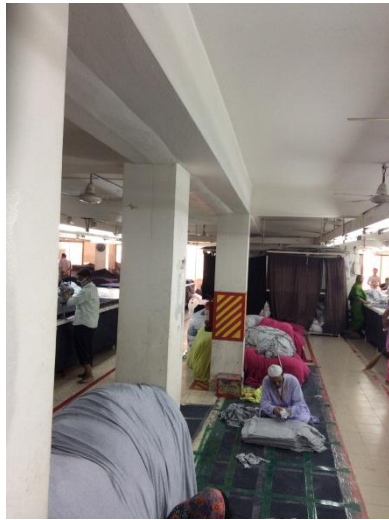
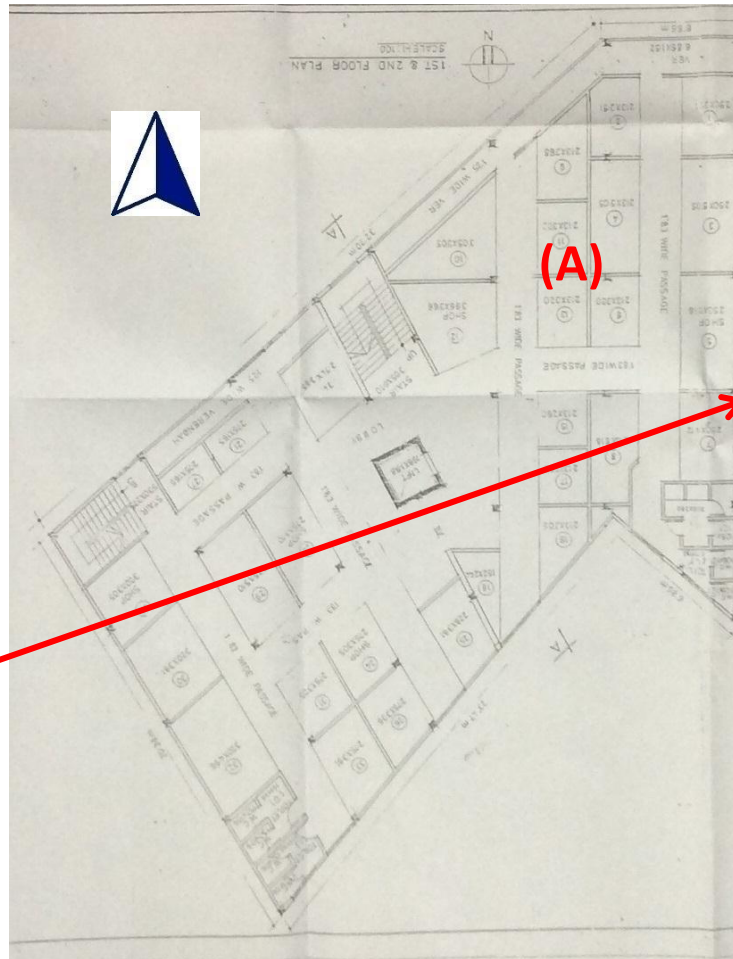
**Indicative Building Plan**

East part (A) of building and West part (B) appear to be separate structural systems but appear to be connected along the interface line.

Two sets of offset columns observed along the interface.

East part of building appears to have internal columns made from two halves, with a gap in between.

Cracking was observed in beams and columns along the interface line.

| Item No. | Observation | Recommended Action Plan | Recommended Timeline |
|---|---|---|---|
| 12 | Building appears to be made from separate structures | Building Engineer to investigate the connection between the building parts and develop accurate and complete as-built structural drawings clarifying the structural system along the interface line between the parts as part of the Detail Engineering Assessment (refer to Item 1 above). | 6-weeks |

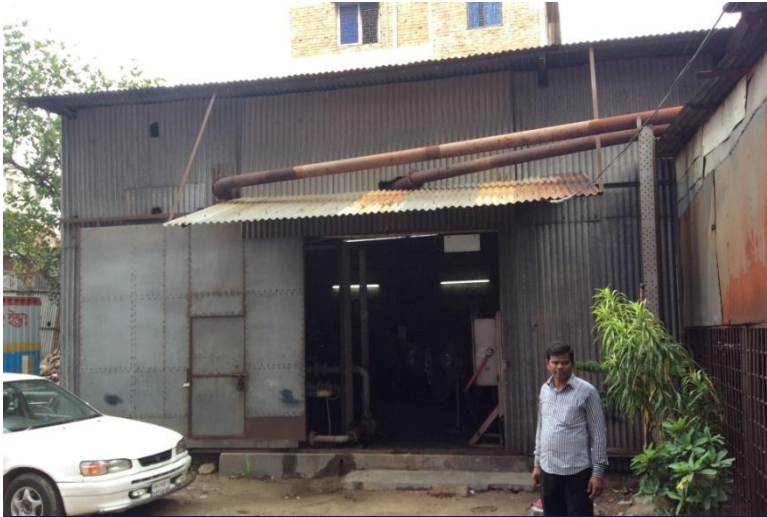
Generator Shed

Steel structures to the shed buildings contain small steel sections and lateral stability structural systems are unclear.

| Item No. | Observation | Recommended Action Plan | Recommended Timeline |
|---|---|---|---|
| 13 | Apparently non-engineered light steel structures | Building engineer to review the structures, their connections and lateral stability systems and if required, prescribe relevant structural improvements to ensure these meets BNBC requirements. | 6-months |
