# FIRE SAFETY INSPECTION REPORT

**Factory Name: Saadatia Sweaters Ltd(New)**

**ACCORD ID: 23191**

# Fire Safety Inspection Report

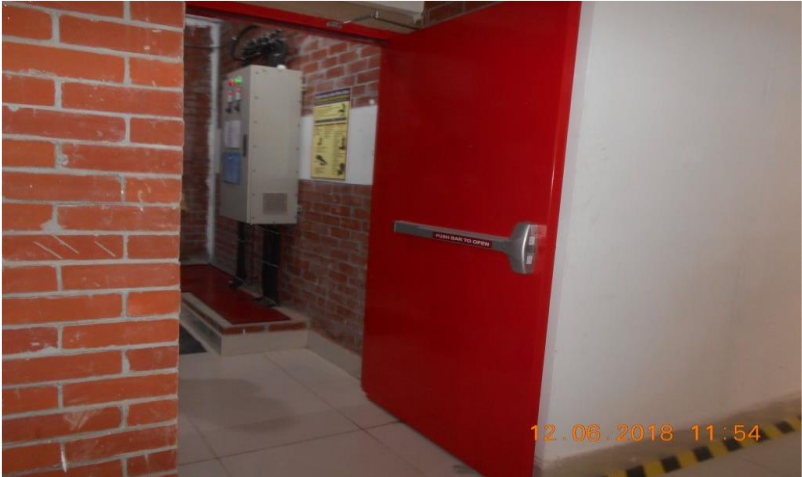
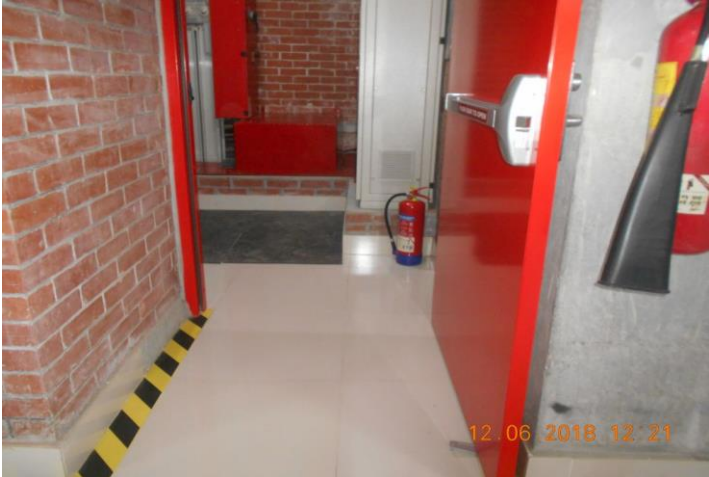
SI No.	Category	Findings	Required Action	Remediation Time Frame
2	<b>Fire Rated Construction</b>	Penetrations through floor/ceiling assemblies are found unsealed. Fire door has been installed for BBT riser room. Fire doors were open by non-mechanical means (without automatic-closing devices tied to the fire alarm system)	<p>Seal all penetrations and openings in the wall of exit enclosure walls (full thickness of the wall) by fire rated materials to maintain the fire resistance rating. Provide a minimum 2-hr fire rated shaft to separate the utility risers from each floor if required.</p> <p>Ensure that all fire doors are self-closing and positive latching, and are provided with fire exit (panic) hardware where serving production floors or assembly occupancies. If fire doors are required to be held open for functional reasons, provide automatic-closing devices tied to the fire alarm system.</p>	<b>Within 3 months</b>

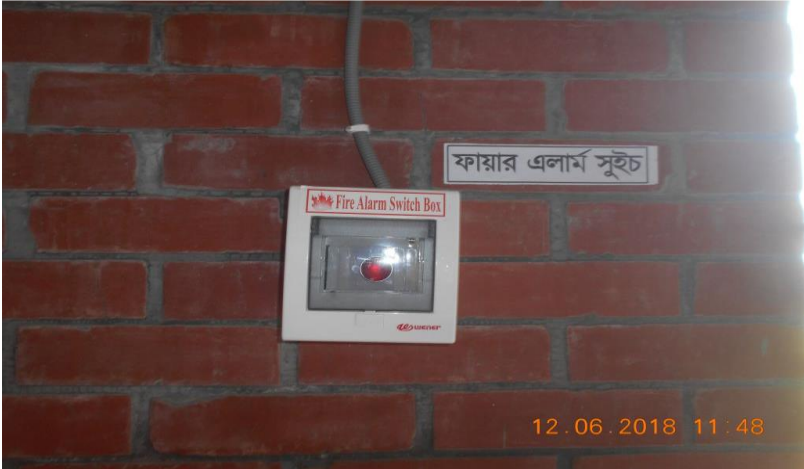
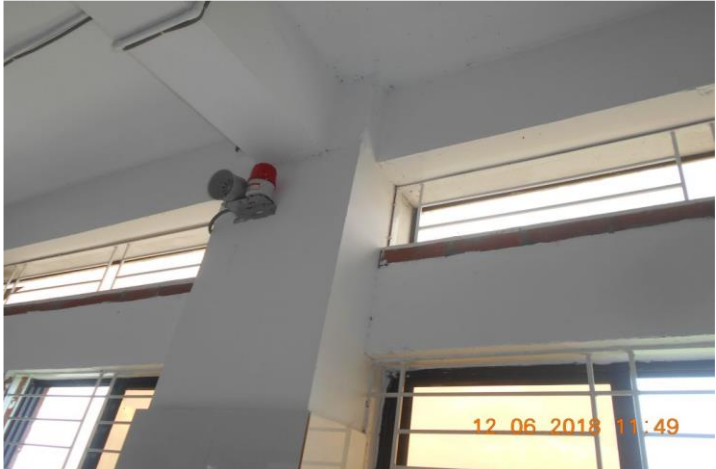
11	<b>Fire Detection &amp; Alarm System (ITM)</b>	Inspection, testing, and maintenance for the fire alarm system is not in accordance with NFPA 72 or as per Accord standard.	Inspect, test and maintain the fire alarm system, and keep written records on-site, in accordance with NFPA 72 or as per Accord standard.	<b>Within 3 months</b>

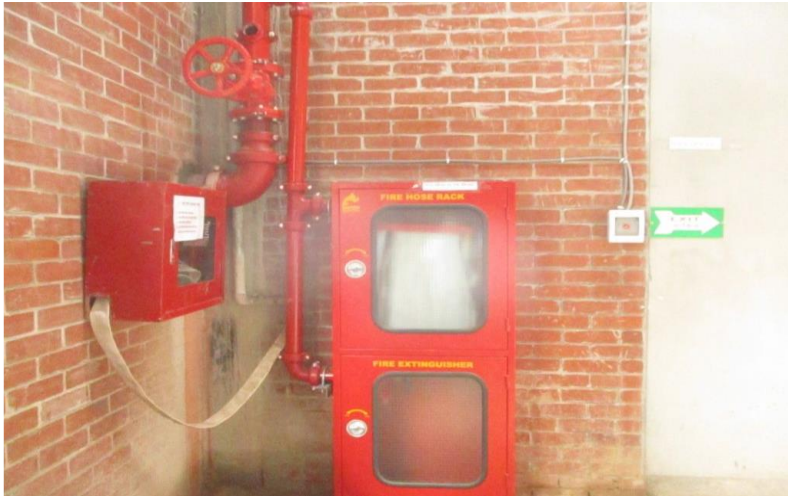
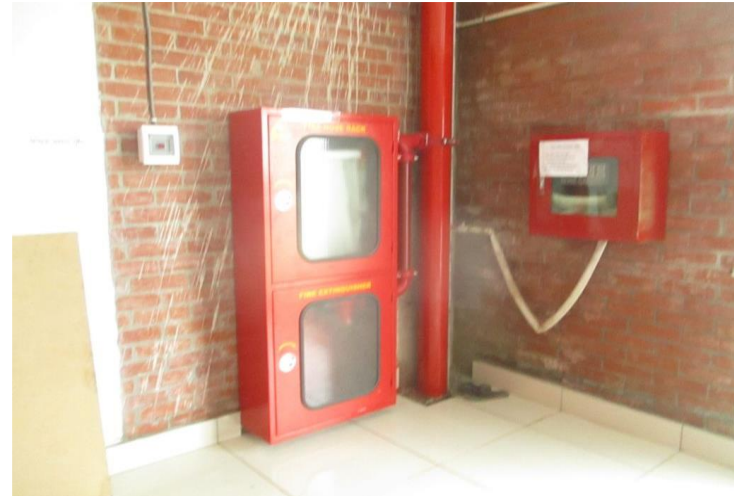
Sl No.	Category	Findings	Required Action	Remediation Time Frame
12	<b>Fire Protection</b>	Fire pump, water supply & standpipe system installation requires detailed review to confirm compliance with NFPA 14, 20, 22, 25 and ACCORD standards.	Submit as built drawings, testing records, listing information and other relevant documentation to the ACCORD for review and approval, modification shall have to done as per the reviewed design (if required).	<b>Design within 2 months, Install/Modify within 6 months</b>

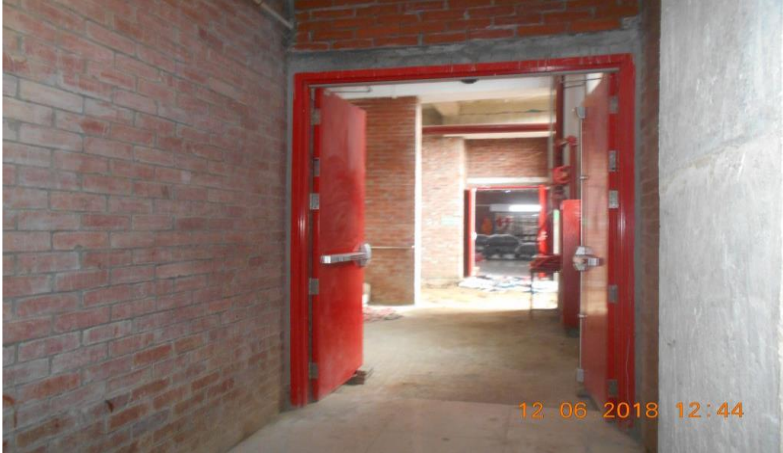
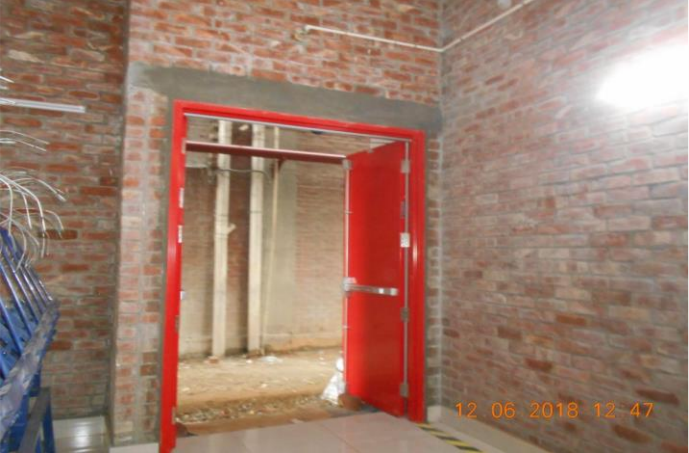
16	<b>Egress Lighting</b>	Directional signs are not provided where direction of the path of travel to an exit has changed.	Illuminated directional signs shall be provided where there is a change in the direction for the path of travel and the direction to an exit is not obvious.	<b>Within 3 months</b>

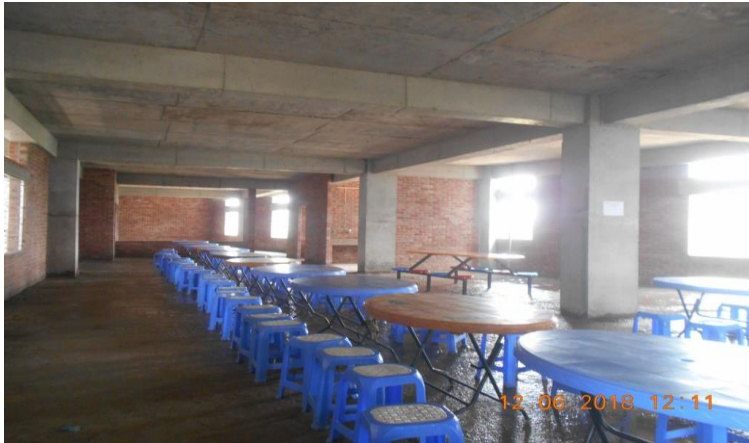
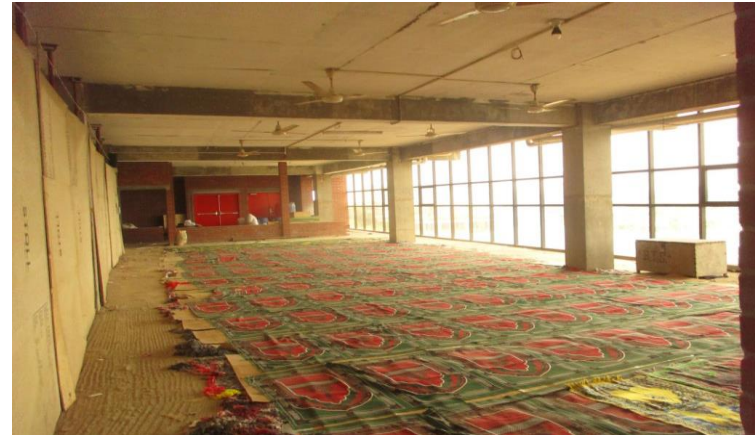
SI No.	Category	Findings	Required Action	Remediation Time Frame
17	<b>Egress Lighting</b>	Based on the number and location of emergency lights observed, adequate illumination levels are not anticipated along egress routes.	Test the emergency lighting system on each floor and provide additional emergency fixtures to provide adequate illumination along the means of egress. Provide a minimum illumination of 10 lux at the floor level within exit stairs and exit discharge paths and minimum 2.5 lux along exit access aisles.	<b>Within 3 months</b>
