# AR Jeans Producer Ltd.

Pukurpar, Kathgora, Zirabo, Ashulia

20<sup>th</sup> March 2018

# Observations

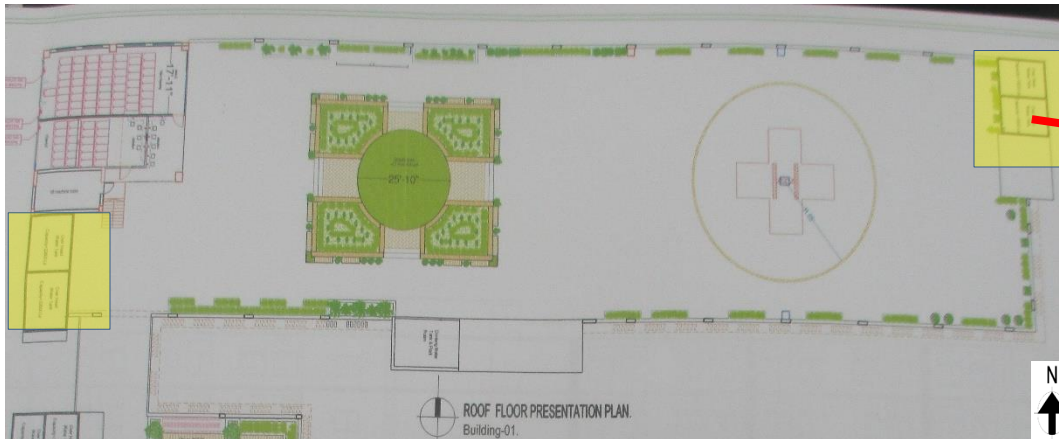
Roof layout plan

Cursory calculations indicate that few Columns under toilet area & water tank would appear to be stressed in excess of normal design limits, assuming minimum concrete strength. Building Engineer to review design, loads and columns stresses. Also, prepared load plan need to be revised based on floor, column and foundation capacity.

| Item No. | Observation | Recommended Action Plan | Recommended Timeline |
|---|---|---|---|
| 1 | (Building-1)<br>Column and Footing to be stressed above normal design limits | Factory Engineer to review design, loads, columns and footings stresses. | 6-weeks |
| 4 | (Building-1)<br>Column and Footing to be stressed above normal design limits | Produce and actively manage a loading plan for all floor plates within the factory, giving consideration to floor, column and foundation capacity. | 6-weeks |

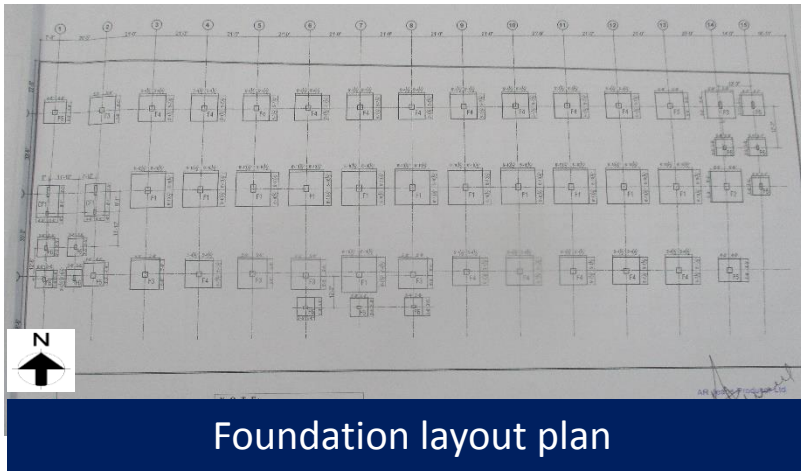
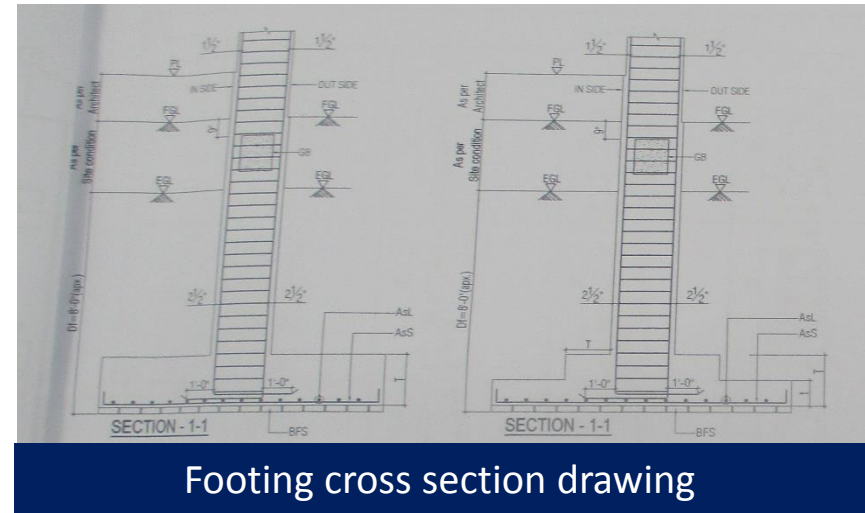
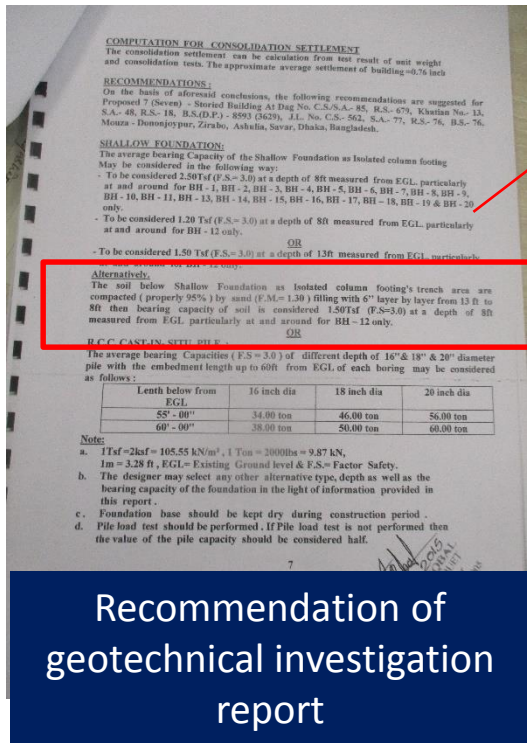
**Alternatively.**  
The soil below Shallow Foundation as Isolated column footing's trench area are compacted ( properly 95% ) by sand (F.M.= 1.30 ) filling with 6" layer by layer from 13 ft to 8ft then bearing capacity of soil is considered 1.50Tsf (F.S=3.0) at a depth of 8ft measured from E.G.L particularly at and around for BH - 12 only.

Recommended soil bearing capacity 1.5 Tsf for 8 ft. (2.44 m) depth, Considering FoS = 3 around borehole-12.

Cursory calculation indicates that footing appears to be stressed above normal design limits. Factor of safety (FoS) is less than the minimum requirement BNBC. Factory engineer is required to review the adequacy of footings considering actual depth and bearing capacity of footing and comply with BNBC.

| Item No. | Observation | Recommended Action Plan | Recommended Timeline |
|---|---|---|---|
| 2 | (Building-1)<br>Column and Footing to be stressed above normal design limits | Verify in-situ concrete strength and aggregate type by taken min. 4 nos. 100mm dia. core samples from ground floor columns. | 6-weeks |

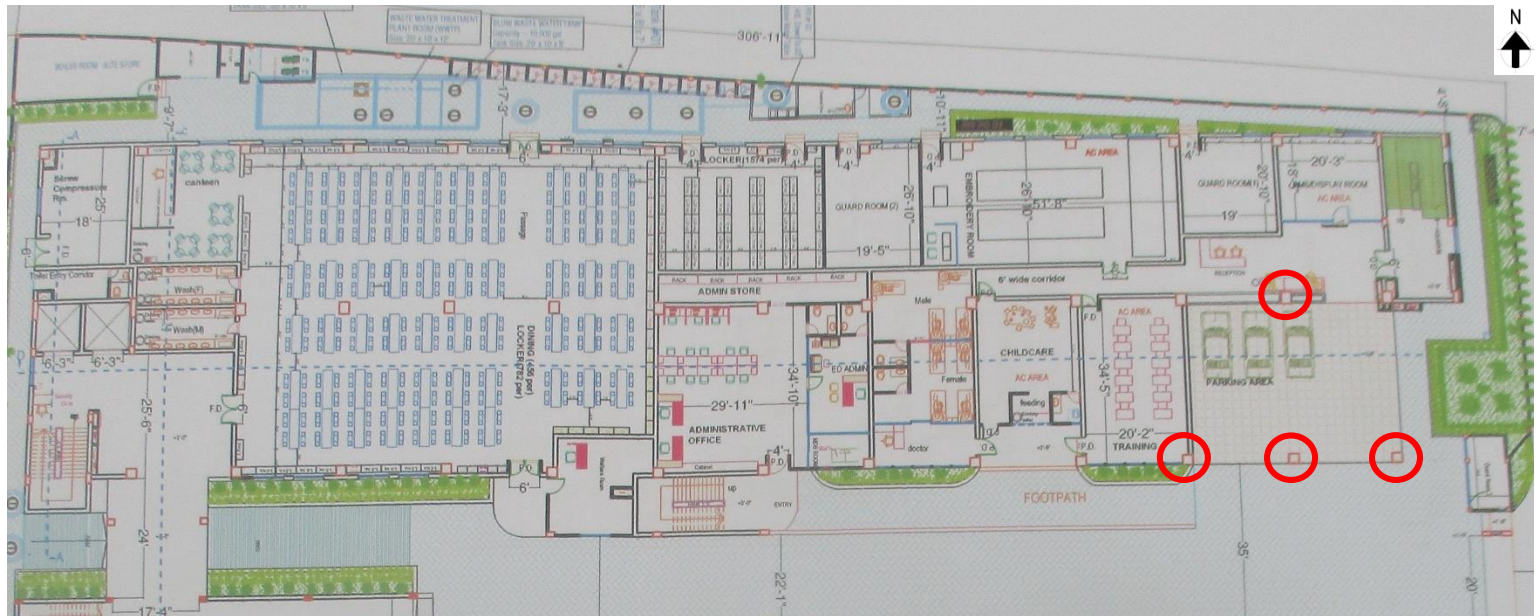
Ground floor layout plan

Impact protection not provided to columns at loading –unloading area. Columns are susceptible to impact loading from vehicles.

| Item No. | Observation | Recommended Action Plan | Recommended Timeline |
|---|---|---|---|
| 7 | (Building-1)<br>Columns susceptible to vehicle impact | Install a barrier to prevent vehicle impact in columns. | 6-weeks |

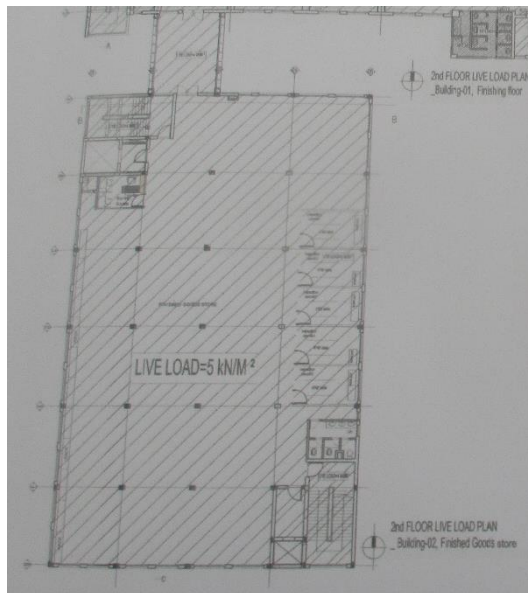
Load Plan of 2<sup>nd</sup> floor

Factory engineer has prepared a floor load plan considering 5kpa live load. Cursory calculations indicates that columns appears to be stressed above normal design limit based on 3 kpa live load. So, prepared load plan need to be revised based on floor, column and foundation capacity.

| Item No. | Observation | Recommended Action Plan | Recommended Timeline |
|---|---|---|---|
| 11 | (Building-2)<br>Column and Footing to be stressed above normal design limits | Produce and actively manage a loading plan for all floor plates within the factory, giving consideration to floor, column and foundation capacity. | 6-weeks |

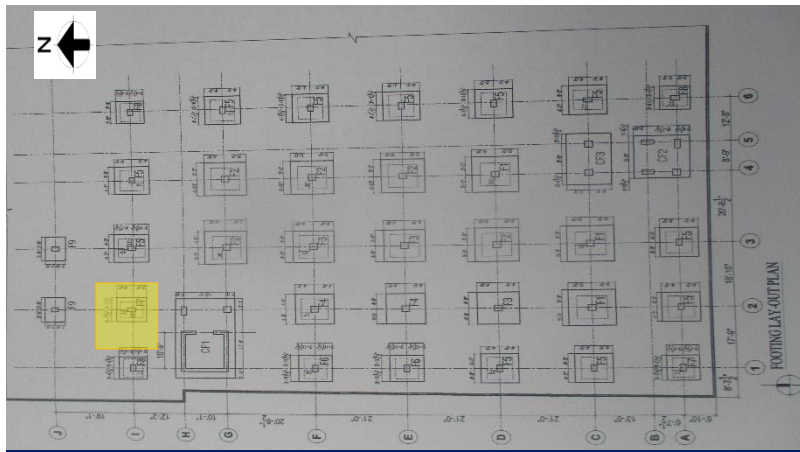
Foundation layout plan

Cursory calculation indicates that footing appears to be stressed above normal design limits. Factor of safety (FoS) is less than the minimum requirement BNBC. Factory engineer is required to review the adequacy of footings considering actual depth and bearing capacity of footing and comply with BNBC.

| Item No. | Observation | Recommended Action Plan | Recommended Timeline |
|---|---|---|---|
| 8 | (Building-2)<br>Column and Footing to be stressed above normal design limits | Factory Engineer to review design, loads, columns and footings stresses. | 6-weeks |

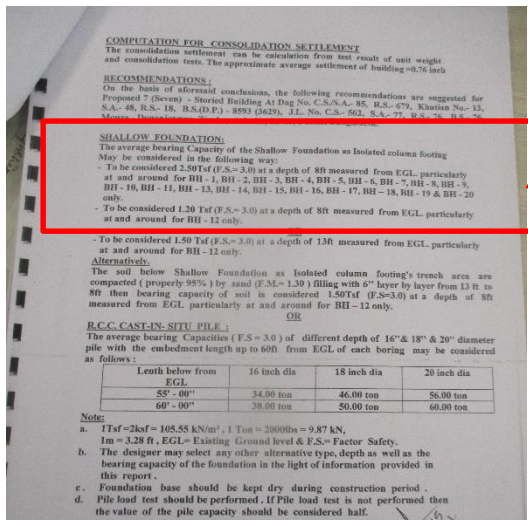
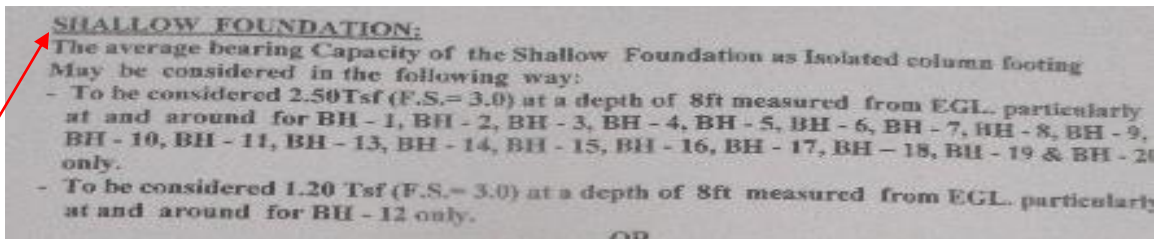
Recommendation of geotechnical investigation report

Recommended soil bearing capacity 2.5 Tsf for 8 ft. (2.44 m) depth, Considering FoS = 3 around BH-3, 4, 5 & 6.

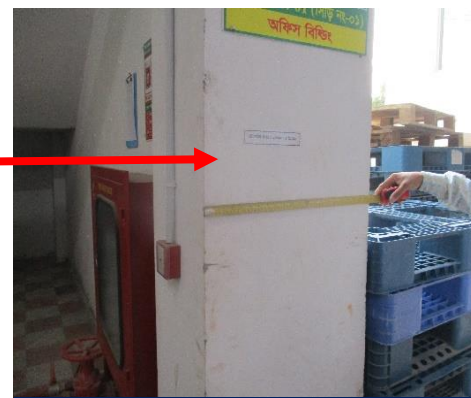
C-1 type column

Number of rebar for C-5 column does not match with column schedule. 16 nos. of rebar are found by ferro scan whereas 20 nos. of rebars are shown in column schedule. On grid I-2, C-3 type column is shown in layout but that column size is similar to C-1 type column.

| Item No. | Observation | Recommended Action Plan | Recommended Timeline |
|---|---|---|---|
| 14 | (Building-2)<br>Discrepancies between provided drawings and on site condition | Building Engineer to survey as-built structure and prepare accurate as-built survey information for the building. | 6-weeks |

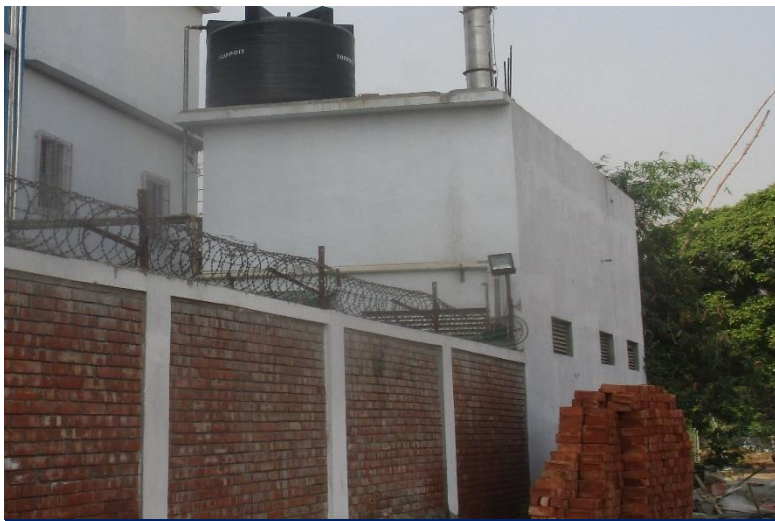
Boiler Building

Architectural drawings are not prepared for all utility structures. Also mismatch found in provided structural drawings for generator, sub-station and boiler buildings. Number of rebar in column for generator & sub-station building do not match with column schedule. And grid dimensions are not matched for boiler building.

| Item No. | Observation | Recommended Action Plan | Recommended Timeline |
|---|---|---|---|
| 15 | (Building: 3, 4, & 5)<br>Lack of architectural drawings and mismatch in structural drawings | Prepare an “as constructed” drawings which reflect the actual site dimensions with complete structural information. | 6-weeks |

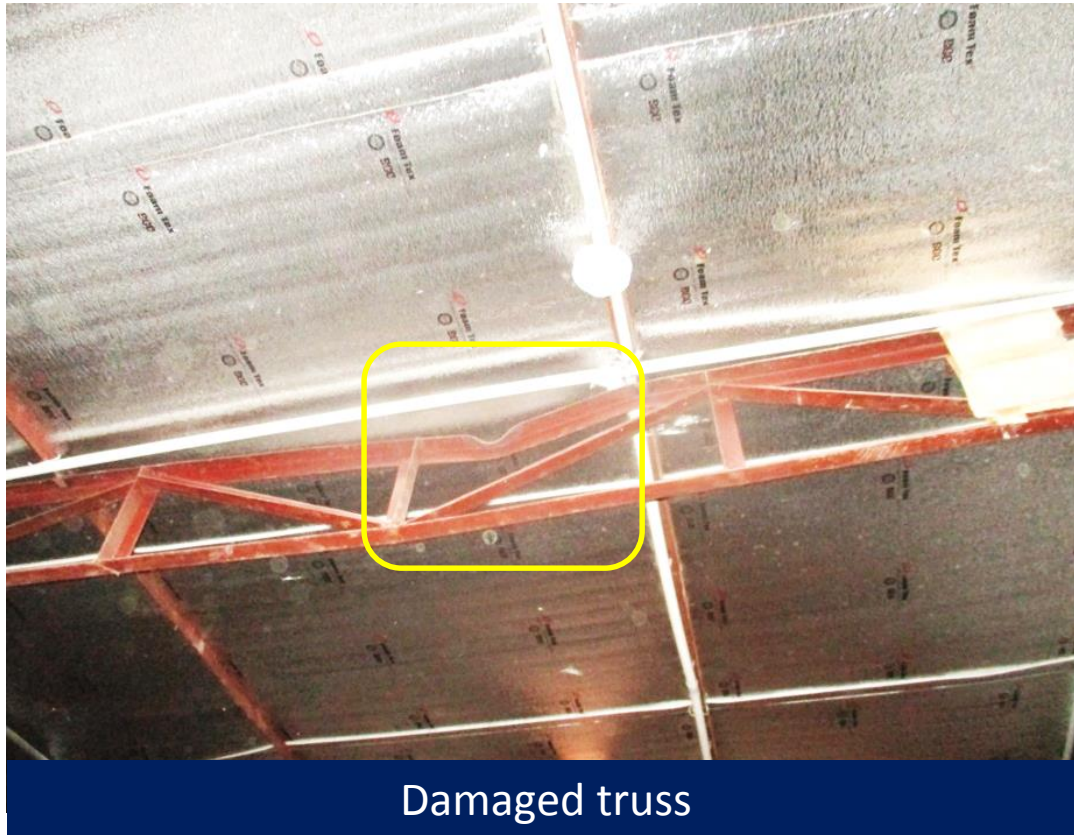
Damaged truss

A damaged truss was found at wastage go-down above pump room. Factory engineer is required to repair the damaged member and check the adequacy of the roof truss.

| Item No. | Observation | Recommended Action Plan | Recommended Timeline |
|---|---|---|---|
| 16 | (Building: 5)<br>Damaged truss on wastage go-down | Factory engineer is required to repair the damaged member and check the adequacy of the roof truss. | 6-weeks |

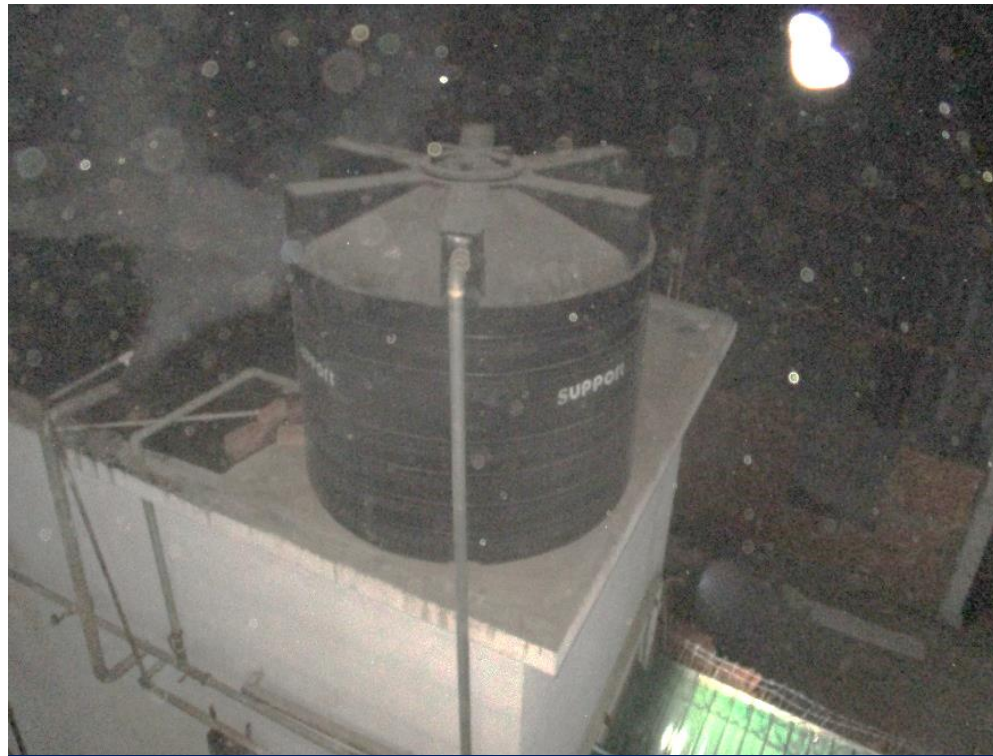
5000 ltr. water tank above boiler building

A 5000 ltr. Water tank was found above boiler building. Factory engineer is required to check the slab and column capacity for applied water tank's load.

| Item No. | Observation | Recommended Action Plan | Recommended Timeline |
|---|---|---|---|
| 17 | (Building: 3)<br>Heavy water tank above boiler room | Factory engineer is required to check the slab and column capacity for applied water tank’s load. | 6-weeks |
